To: Michael J. Hager

Date: August 25, 2021

From: Shanta B. Keller, PE
Katie Kinsella, PWS

Re: Sudbury to Hudson Transmission Reliability and Mass Central
Rail Trail Project
MassDEP File # 301-1287
Inspection of Culverts and Drainage Structures– Town of
Sudbury, Massachusetts

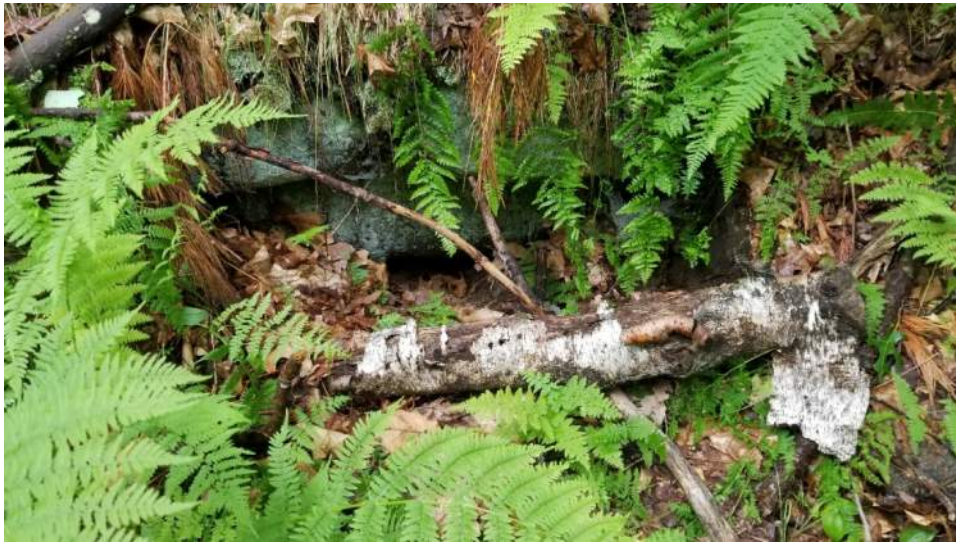
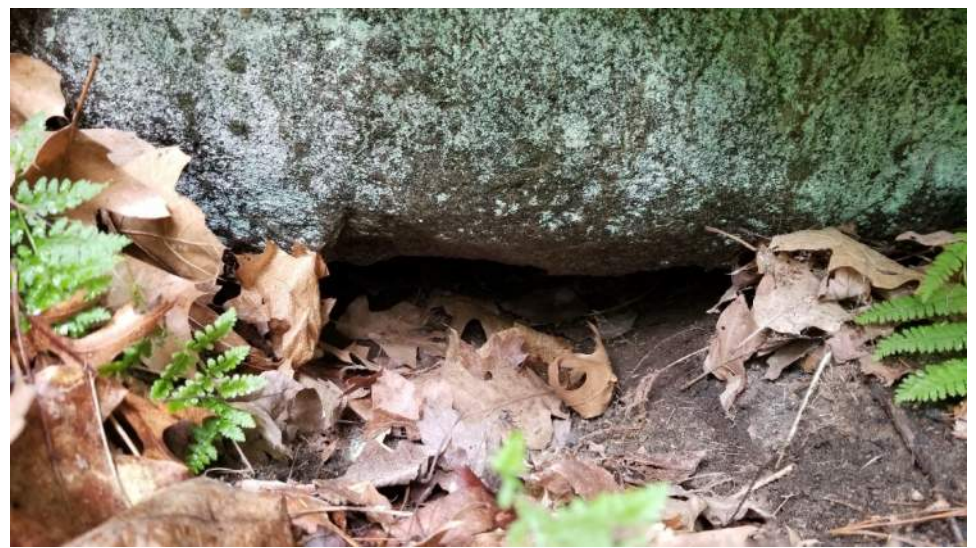
Structure ID	129A
Station	368+84
Plan Sheet	44
Type	Drainage Structure
Size/Material	2'x2.5' Stone Box, Metal Pipe at North End
Existing Ground Cover	8.2 feet
2017 Inspection Results	South end partially collapsed; north end not found. Appears clear inside 10 ft. in from south end.
2021 Inspection Results	Structural: North end found; both structure ends partially collapsed. No evidence of instability in interior or slopes. The proposed work is not anticipated to have an adverse impact on the existing structure.
	Wildlife Passage: Existing potential passage for amphibians and small mammals. The existing potential passage capabilities for amphibians and small mammals will be retained post-construction.
Work Proposed	No work is proposed to the existing drainage structure.

View of southern end of Structure 129A

View of southern end of Structure 129A with limited wildlife passage

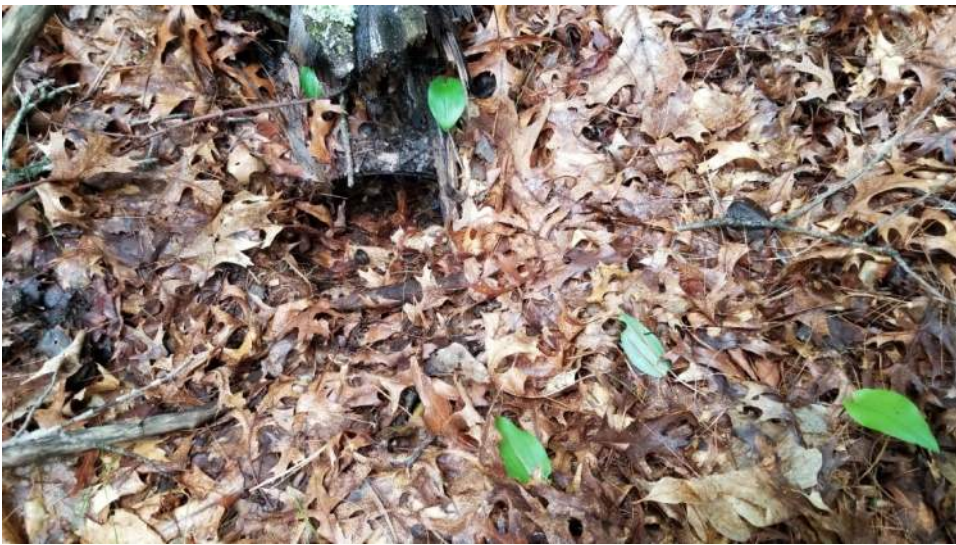
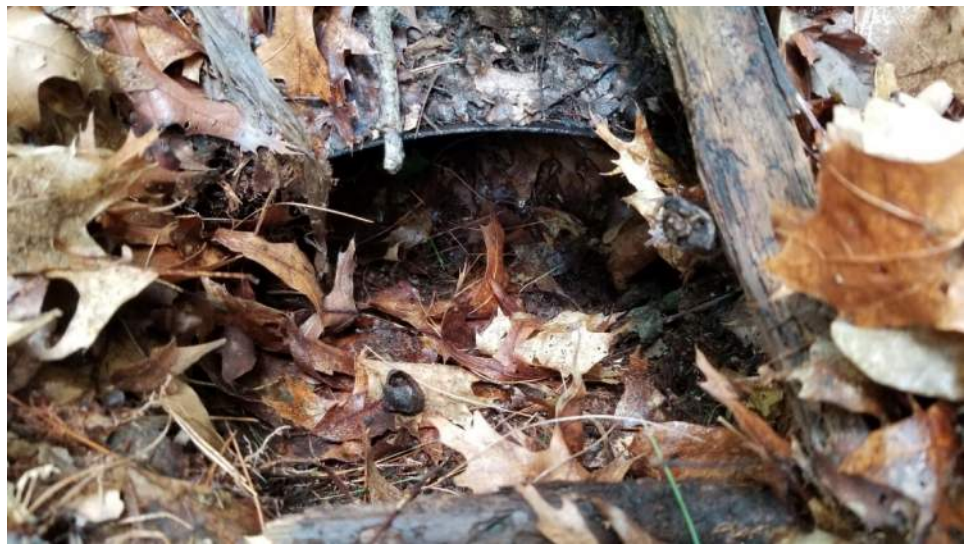
View of northern end of Structure 129A

View of northern end of Structure 129A with limited wildlife passage

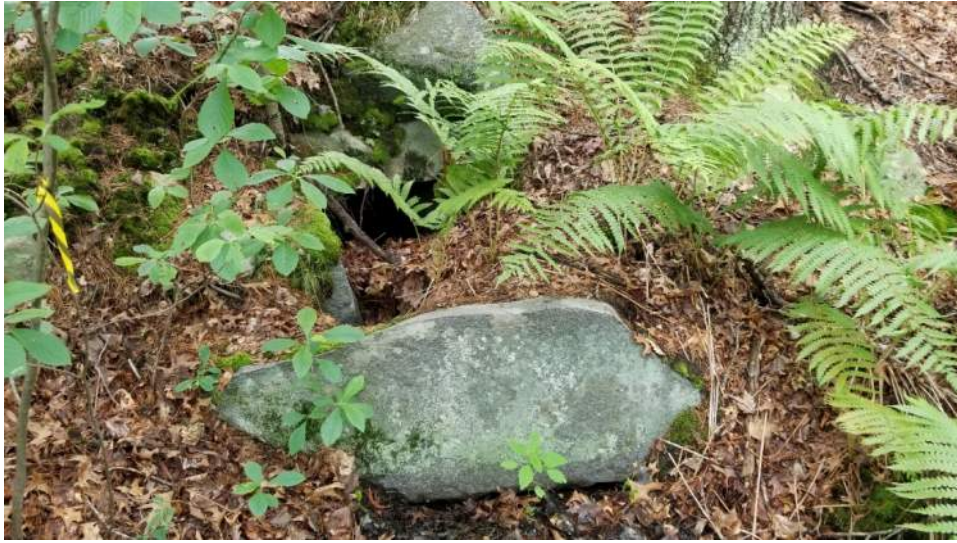
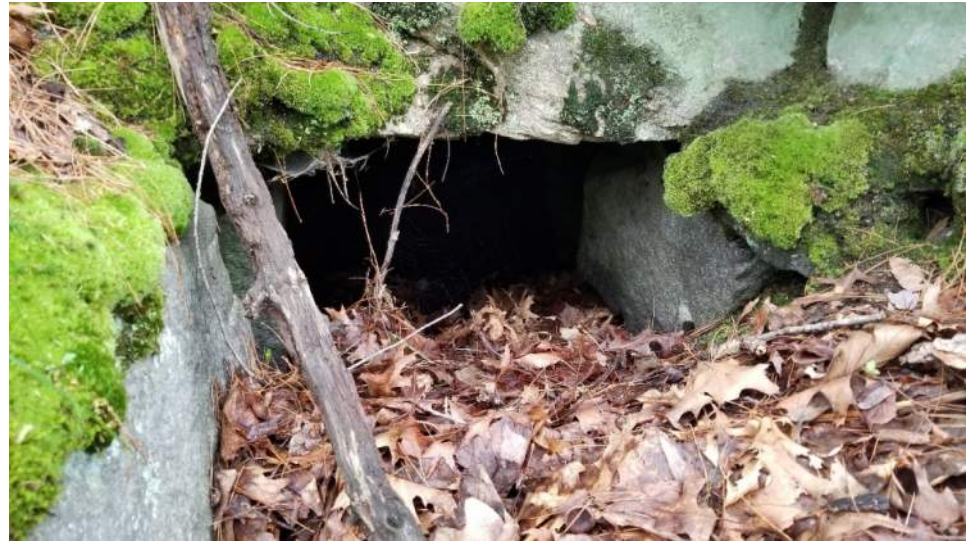
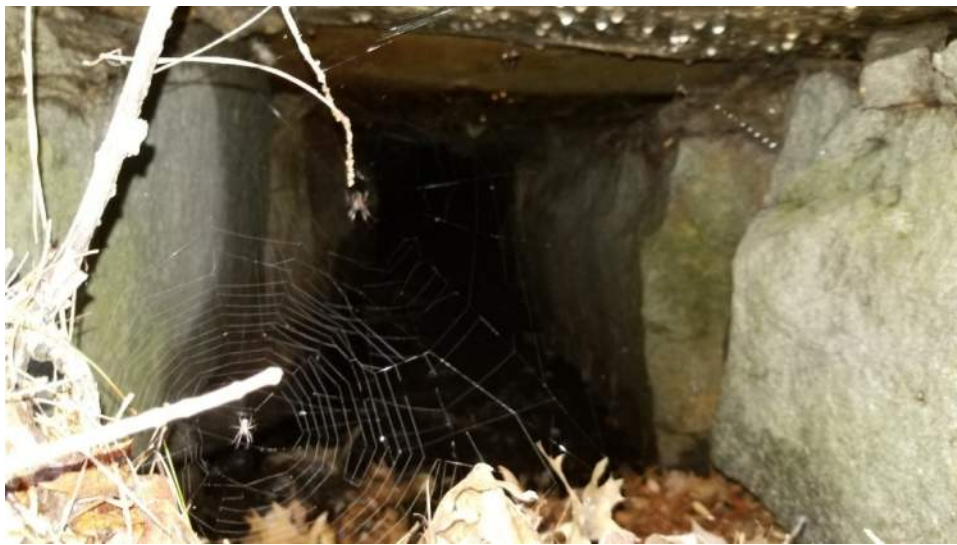
Structure ID	127J
Station	410+25
Plan Sheet	48
Type	Drainage Structure
Size/Material	2'x2' Stone Box
Existing Ground Cover	8.1 feet
2017 Inspection Results	South headwall and wingwall partial collapse; north end total collapse. Running water audible.
2021 Inspection Results	<p>Structural: South headwall and wingwall partial collapse; north end total collapse. No imminent failure mechanisms or changed structural conditions since 2017 were observed. The proposed work is not anticipated to have an adverse impact on the existing structure.</p> <p>Wildlife Passage: No existing wildlife passage capabilities because the north side is buried.</p>
Work Proposed	No work is proposed to the existing drainage structure.

View of southern end of Structure 127J

View through Structure 127J from southern end

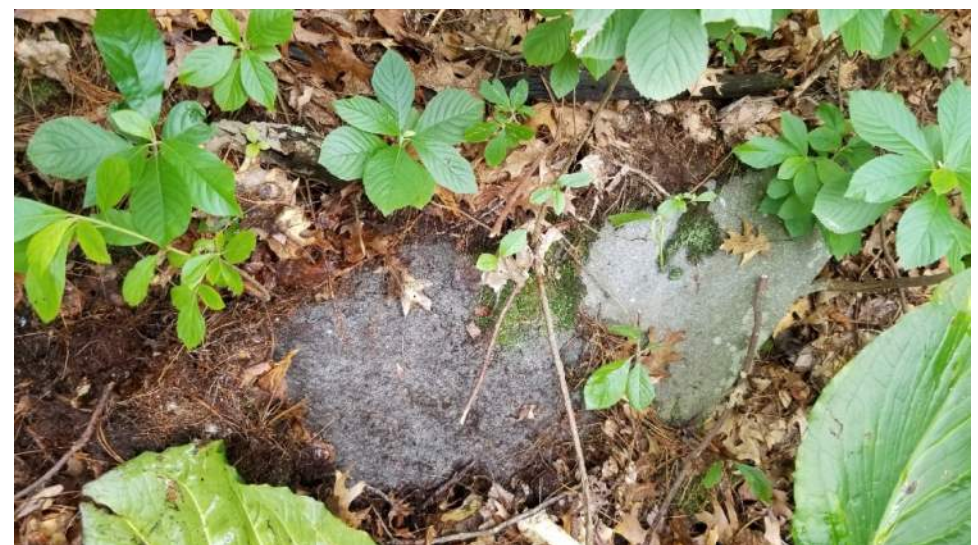
Possible portion of buried pipe and headwall of northern end of Structure 127J

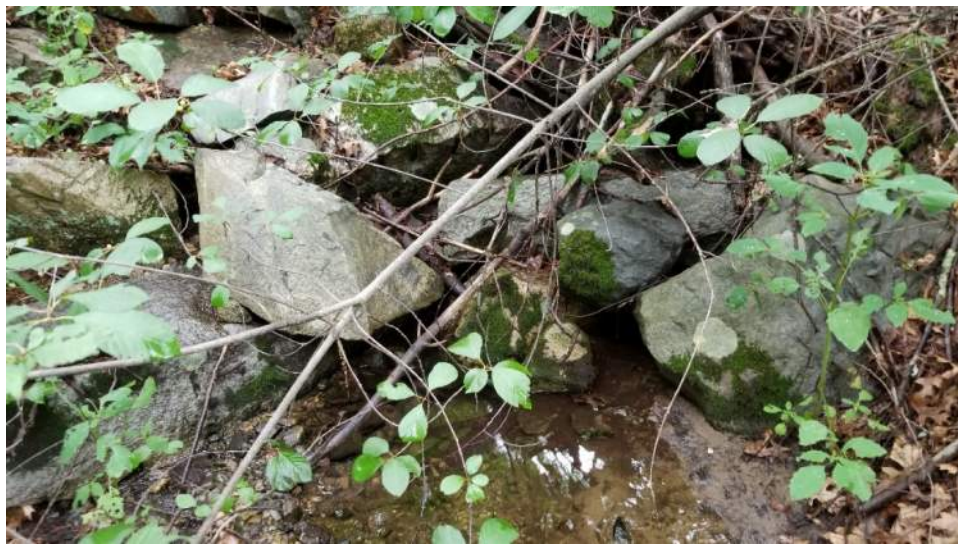
Structure ID	127I
Station	517+96
Plan Sheet	51
Type	Culvert
Size/Material	1'x2' Stone Box
Existing Ground Cover	8.1 feet
2017 Inspection Results	South headwall collapsed; north end partially filled with debris. Water visibly flowing.
2021 Inspection Results	Structural: South headwall collapsed; north end partially filled with debris. Water was observed flowing through both ends of the culvert. No imminent failure mechanisms or changed structural conditions since 2017 were observed. The proposed work is not anticipated to have an adverse impact on the existing structure.
	Wildlife Passage: Existing condition allows potential passage for amphibians and small mammals. Clearing out the debris will improve potential passage capabilities for amphibians and small mammals.
Work Proposed	The Contractor shall clear out debris in the north end by hand. The existing structure will remain.

View of southern end of Structure 1271

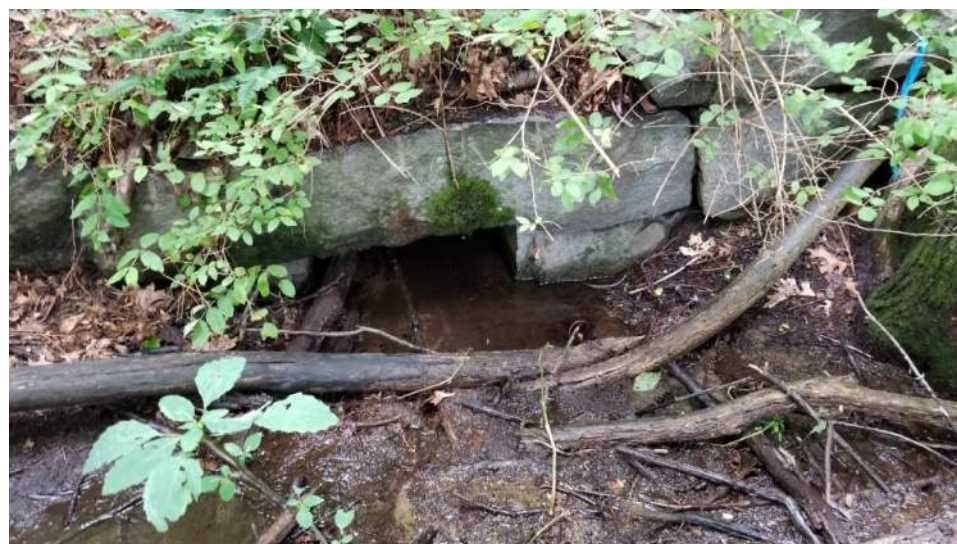
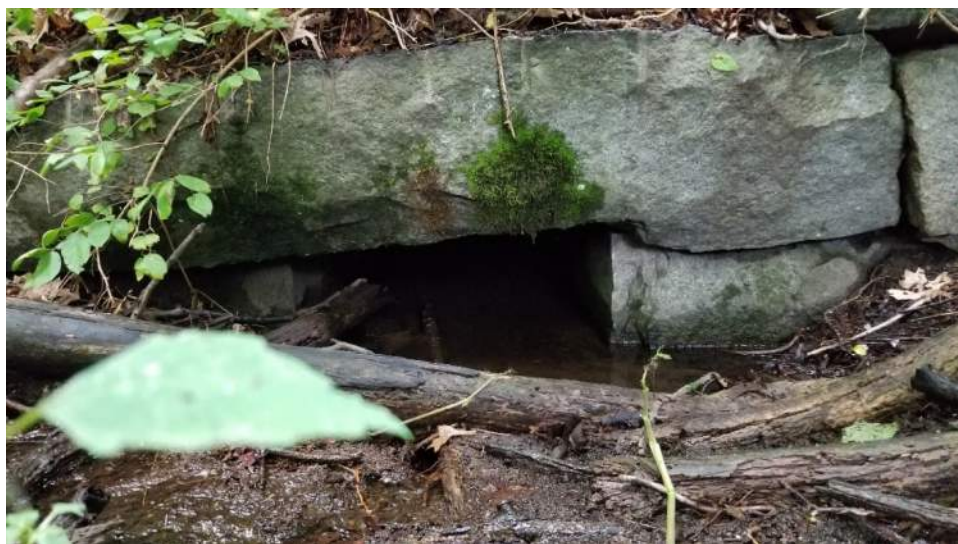
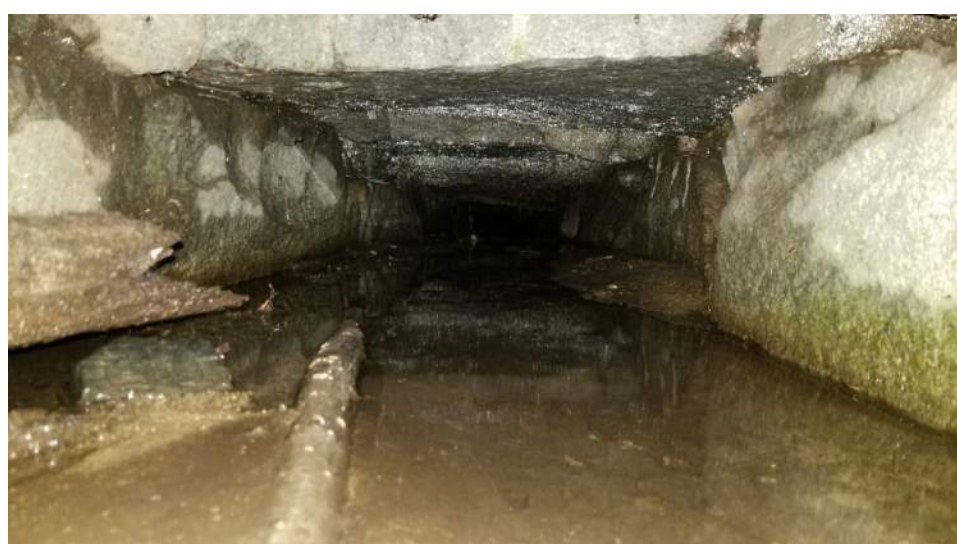
View of northern end of Structure 1271

Alternate view of northern end of Structure 1271

View through Structure 1271 from the northern end

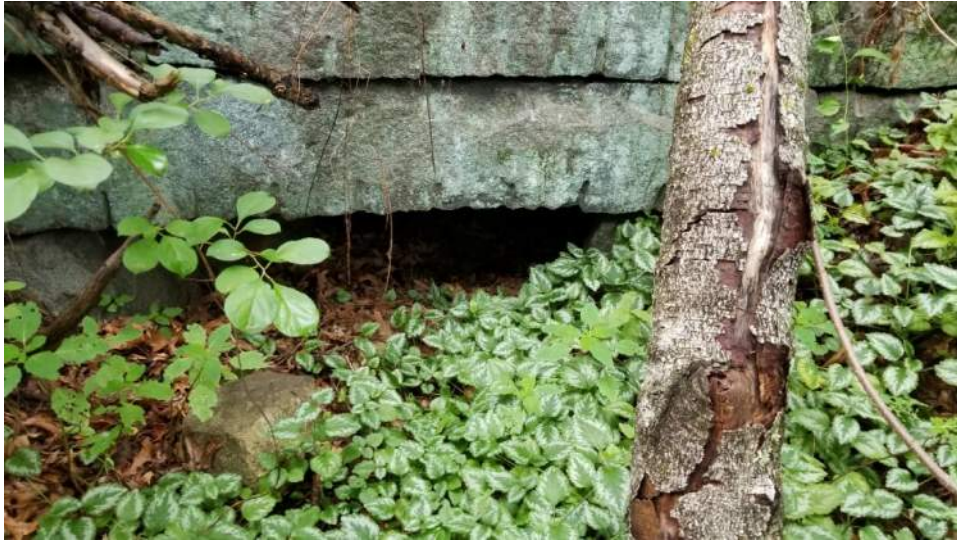
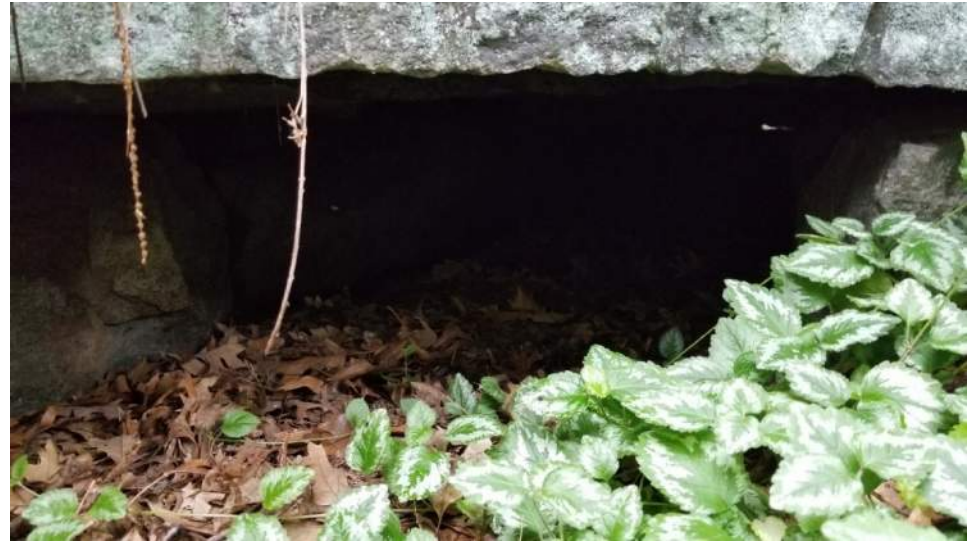
Structure ID	127H
Station	521+64
Plan Sheet	51
Type	Drainage Structure
Size/Material	1.5'x3' Stone Box
Existing Ground Cover	10.6 feet
2017 Inspection Results	South end in fair condition but trees located on headwall; north headwall partially collapsed. Clear all the way through.
2021 Inspection Results	Structural: South end in fair condition but trees located on headwall; north headwall partially collapsed. No imminent failure mechanisms or changed structural conditions since 2017 were observed. The proposed work is not anticipated to have an adverse impact on the existing structure.
	Wildlife Passage: Existing condition allows potential passage for amphibians and small mammals. The existing wildlife passage capabilities for amphibians and small mammals will be retained.
Work Proposed	Two approximately 12"-diameter trees will be cut and removed because they are causing wingwall damage; no grubbing will occur. The existing structure will be retained.

View of southern end of Structure 127H

View through southern end of Structure 127H; light through the northern end is visible

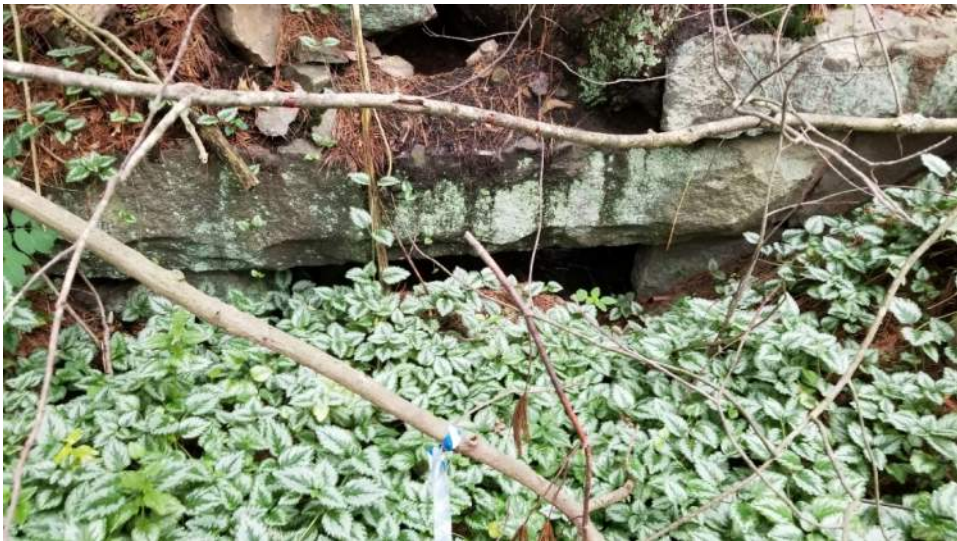
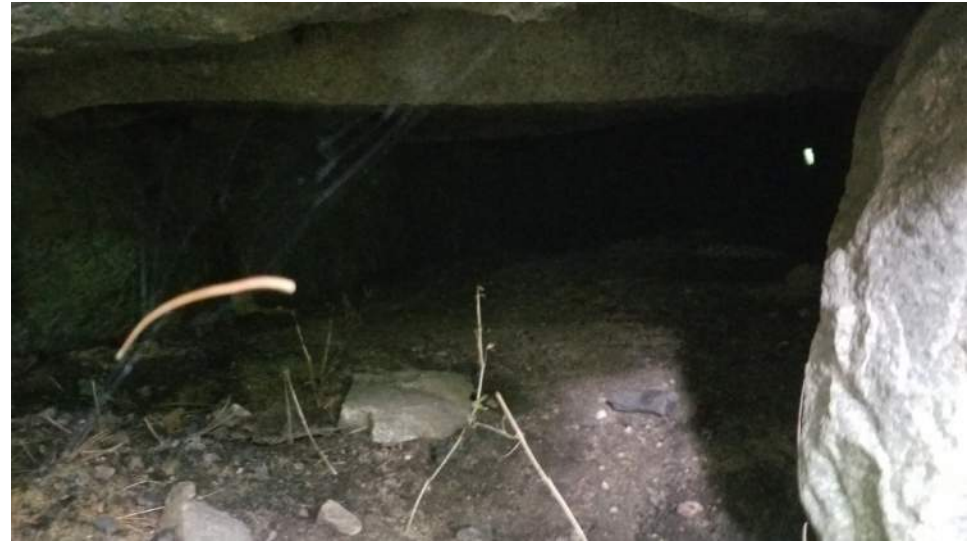
View of northern end of Structure 127H

View through northern end of Structure 127H; light through the southern end is visible

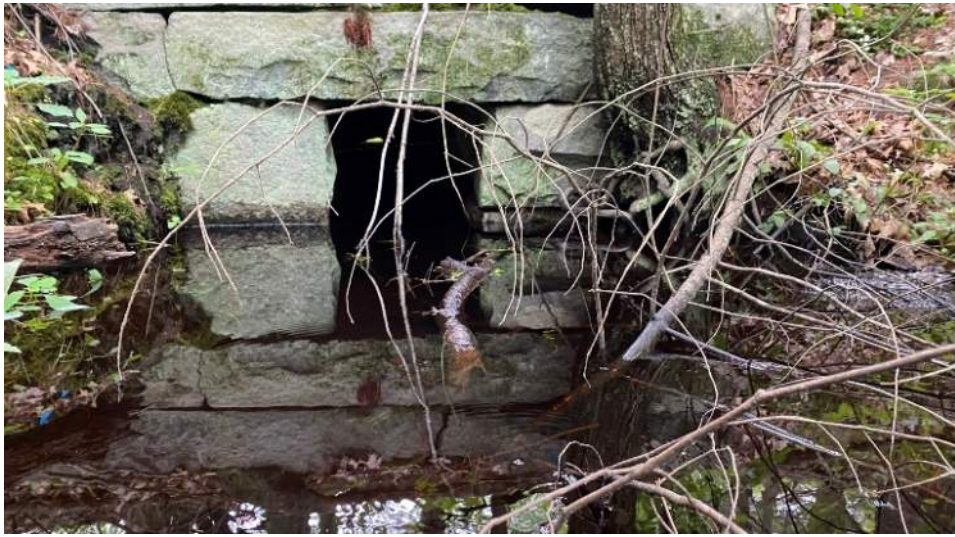
Structure ID	127G
Station	527+30
Plan Sheet	52
Type	Culvert
Size/Material	2'x2' Stone Box
Existing Ground Cover	13.4 feet
2017 Inspection Results	South end in fair condition; north bulged from trees. Clear all the way through.
2021 Inspection Results	Structural: South end in fair condition; north bulged from trees. Clear all the way through. No imminent failure mechanisms or changed structural conditions since 2017 were observed. The proposed work is not anticipated to have an adverse impact on the existing structure.
	Wildlife Passage: Existing condition allows the for potential passage for amphibians and small mammals. The potential passage capabilities for amphibians and small mammals will be retained.
Work Proposed	The culvert will be retained. No work is proposed to existing structure.

View of southern end of Structure 127G. Small window of daylight visible at northern end.

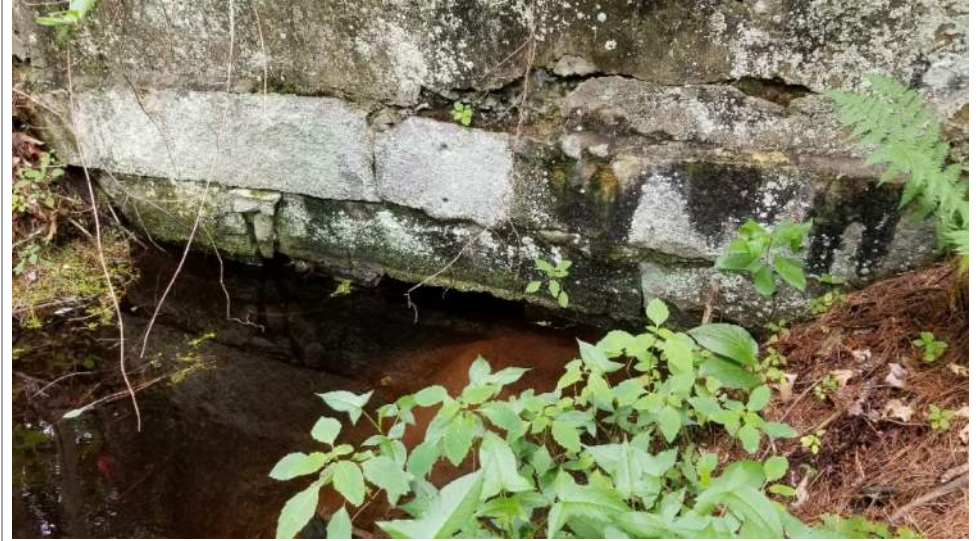
View of northern end of Structure 127G; most of culvert was submerged at time of the inspection

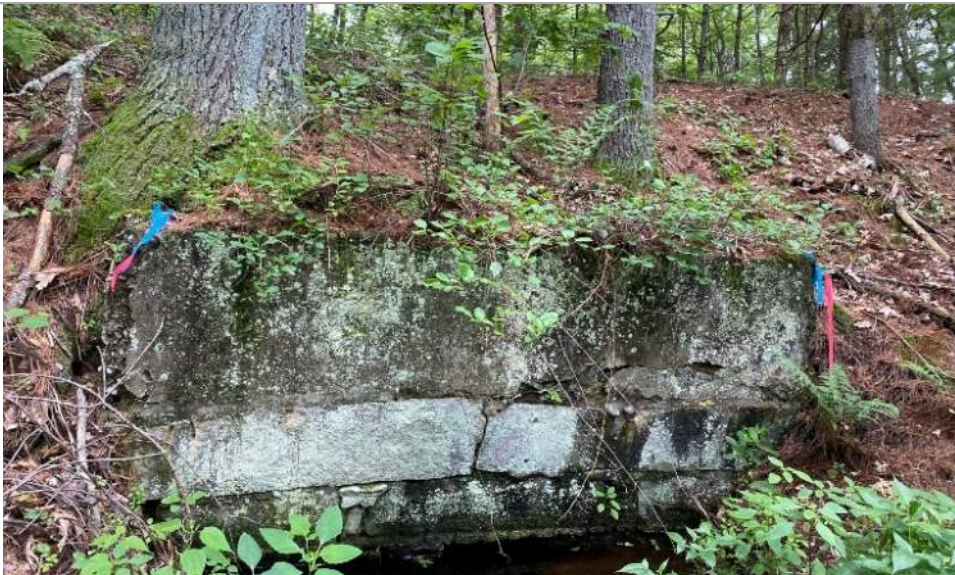
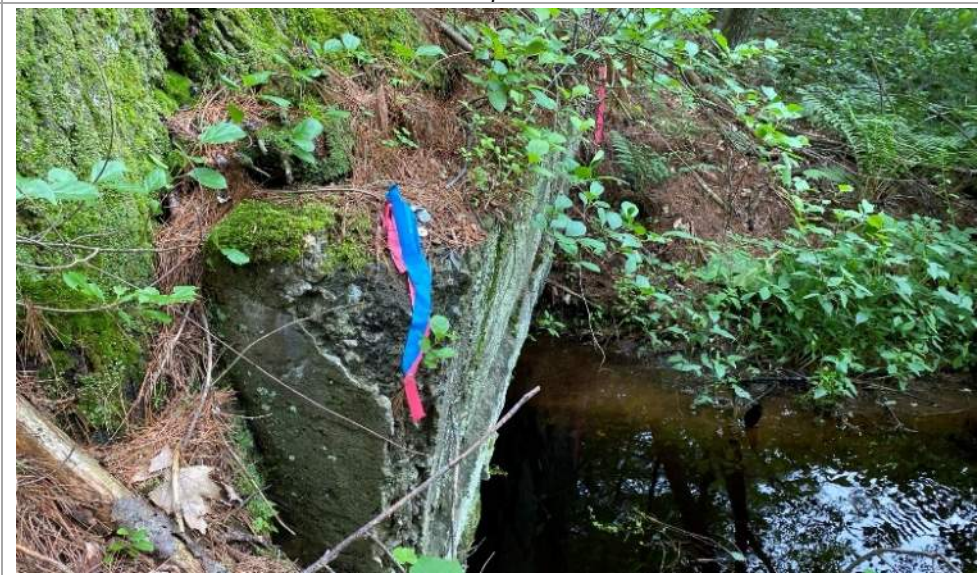
View of headwall at northern end and embankment.

Headwall at northern end has shifted outward.

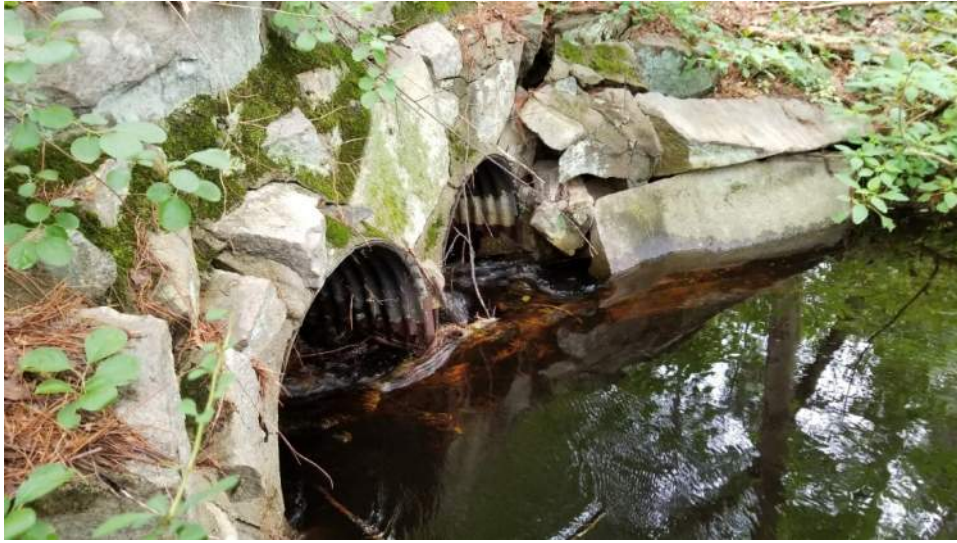
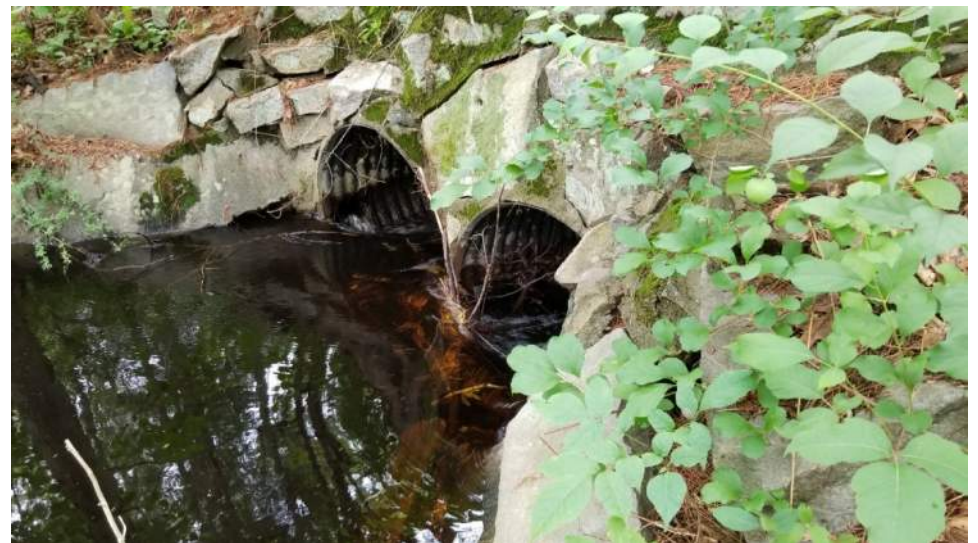
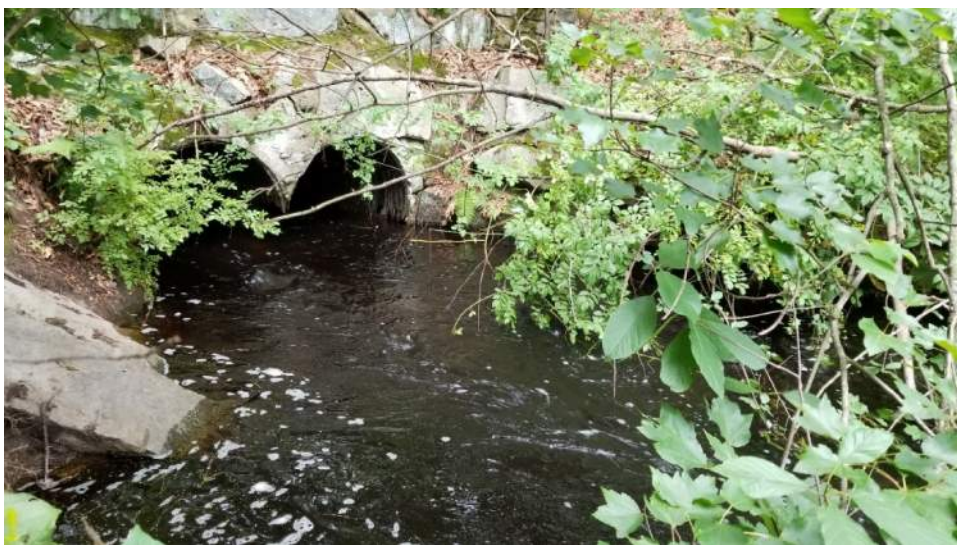
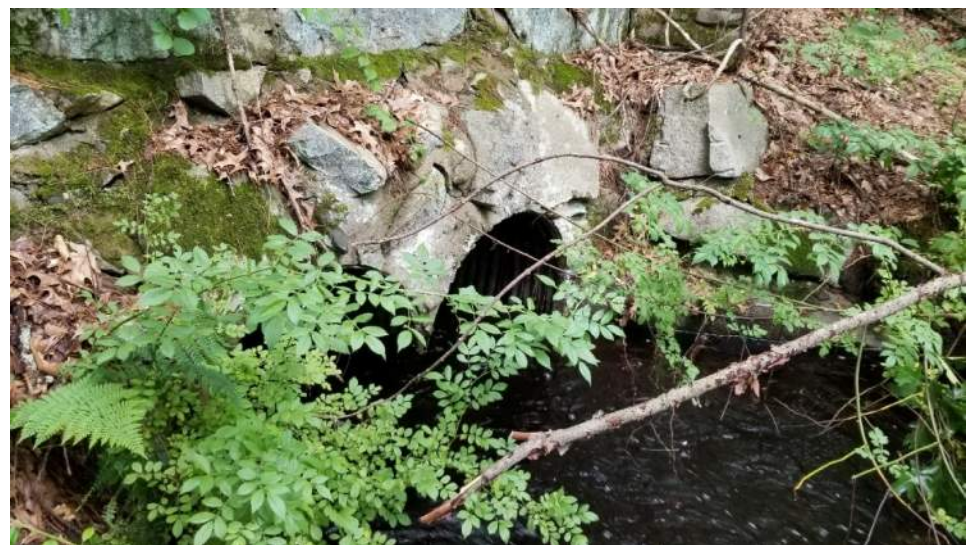
Structure ID	127F (Dudley Brook)
Station	539+40
Plan Sheet	54
Type	Culvert
Size/Material	Two 36" Corrugated Metal Pipes, presumably lining original stone boxes
Existing Ground Cover	8.9 feet
2017 Inspection Results	South wingwalls partially collapsed; north wingwalls and headwalls in fair condition. Both ends of pipes heavily corroded. Clear all the way through; interior in fair condition.
2021 Inspection Results	<p>Structural: South wingwalls partially collapsed; north wingwalls and headwalls in fair condition. Both ends of pipes heavily corroded. Clear all the way through; interior in fair condition. No imminent failure mechanisms or changed structural conditions since 2017 were observed. The proposed work is not anticipated to have an adverse impact on the existing structure.</p> <p>Wildlife Passage: The existing two 36-inch pipes allows potential passage for amphibians and small and medium mammals. The potential passage capabilities for amphibians and small and medium mammals will be retained.</p>

View of southern end of Structure 127F from western bank

View of southern end of Structure 127F from eastern bank

View of northern end of Structure 127F from western bank

View of northern end of Structure 127F from eastern bank

Work Proposed	The existing structures will be retained. No work is proposed to the existing structures.

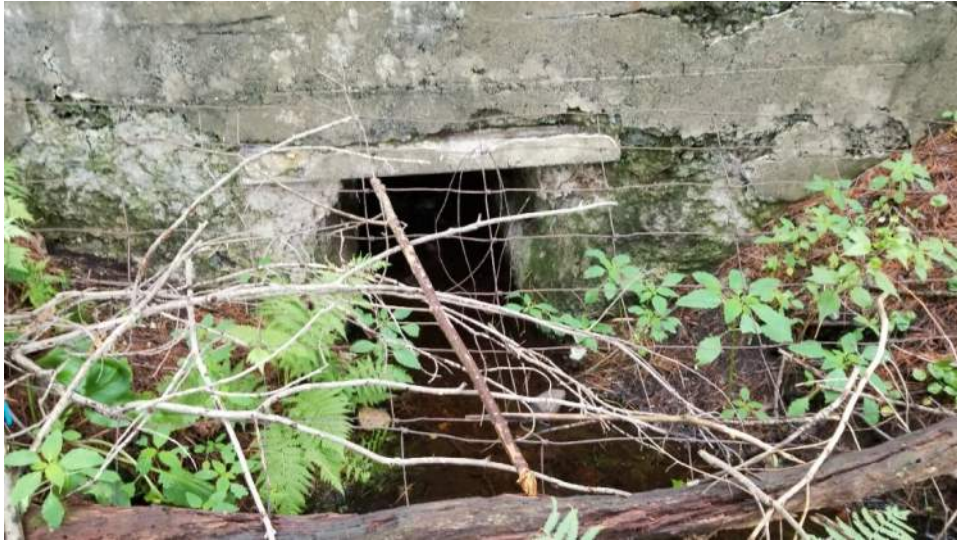
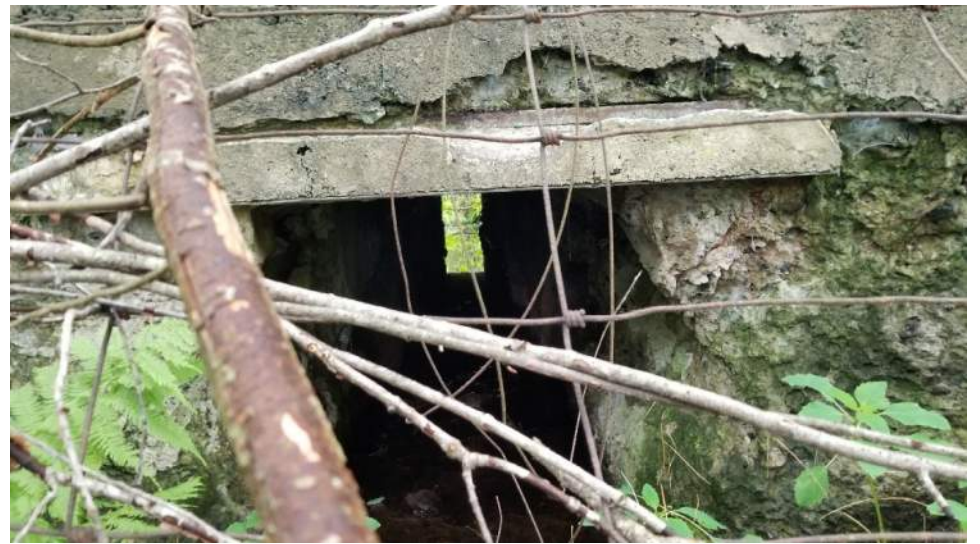
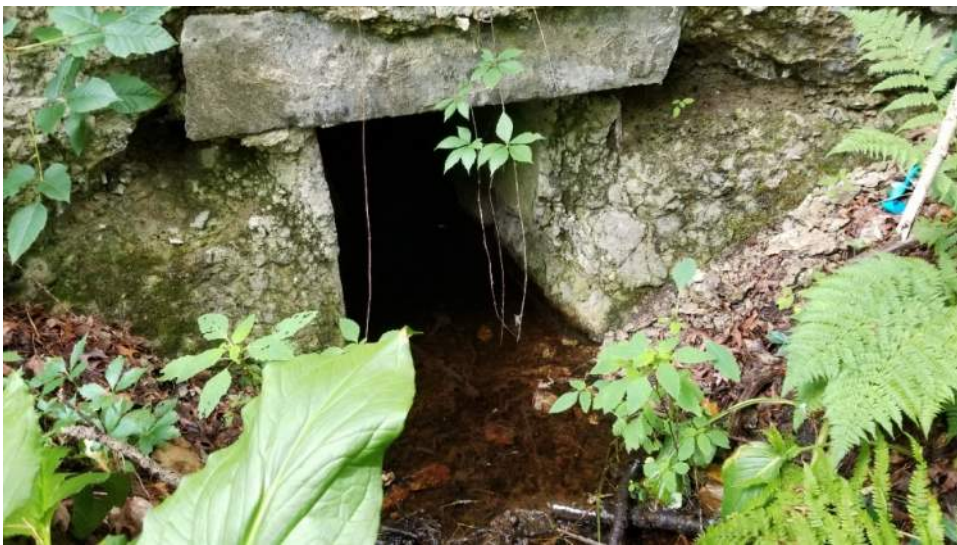
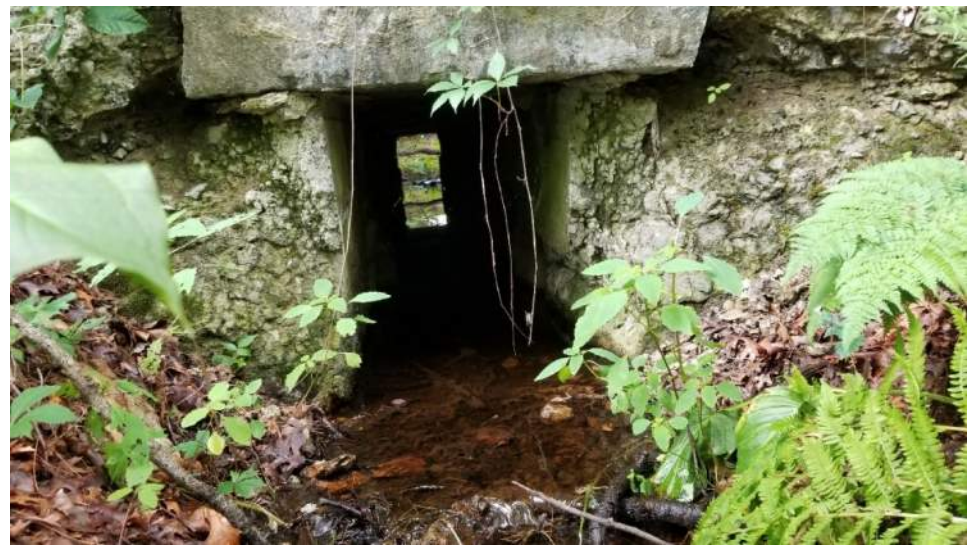
Structure ID	127E
Station	560+82
Plan Sheet	57
Type	Culvert
Size/Material	3'x2' Concrete Box
Existing Ground Cover	7.5 feet
2017 Inspection Results	Both concrete ends and headwalls have concrete spalling. Clear all the way through. Interior appears to be stone.
2021 Inspection Results	Structural: Both ends and headwalls have concrete spalling. Clear all the way through. No imminent failure mechanisms or changed structural conditions since 2017 were observed. The proposed work is not anticipated to have an adverse impact on the existing structure.
	Wildlife Passage: Both sides are completely open, allowing for potential passage for amphibians and small and medium mammals. The potential passage capabilities for amphibians and small mammals will be retained.
Work Proposed	The culvert will be retained. No work is proposed to the existing structure.

View of southern end of Structure 127E

View through southern end of Structure 127E; visible straight through culvert

View of northern end of Structure 127E

View through northern end of Structure 127E; visible straight through culvert

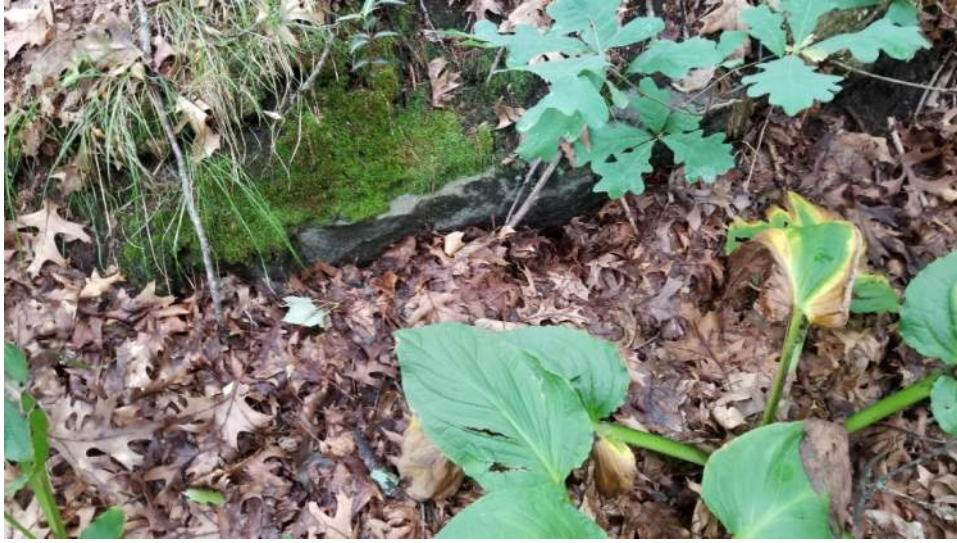
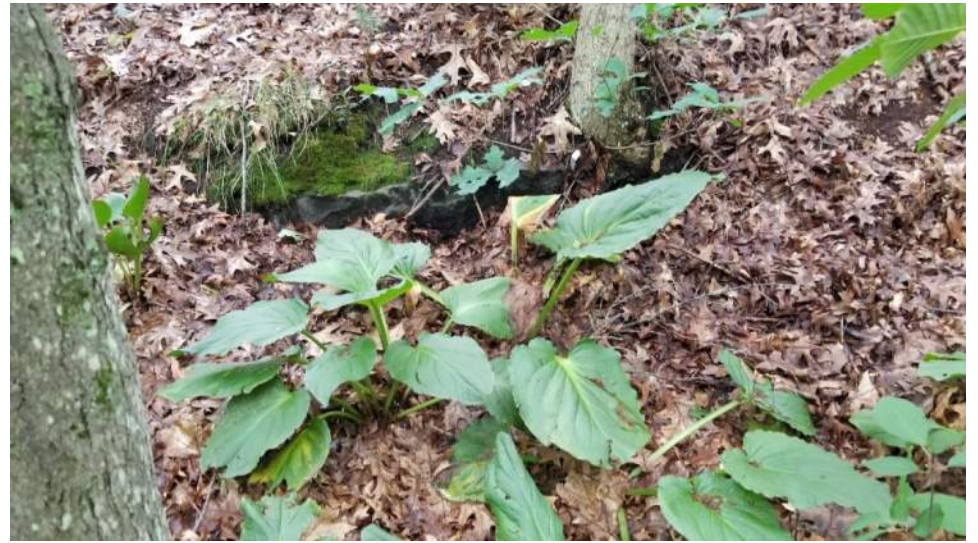
Structure ID	127D
Station	577+31
Plan Sheet	58
Type	Drainage Structure
Size/Material	1'x2' Stone Box
Existing Ground Cover	6.7 feet
2017 Inspection Results	South end not found; north headwall mostly buried.
2021 Inspection Results	Structural: Both ends mostly buried. No changed structural conditions since 2017 were observed. The proposed work is not anticipated to have an adverse impact on the existing structure.
	Wildlife Passage: No existing wildlife passage potential because the north and south headwalls are buried.
Work Proposed	The drainage structure will be retained. No work is proposed to the existing structure.

View of north end of Structure 127D

Alternate view of northern end of Structure 127D

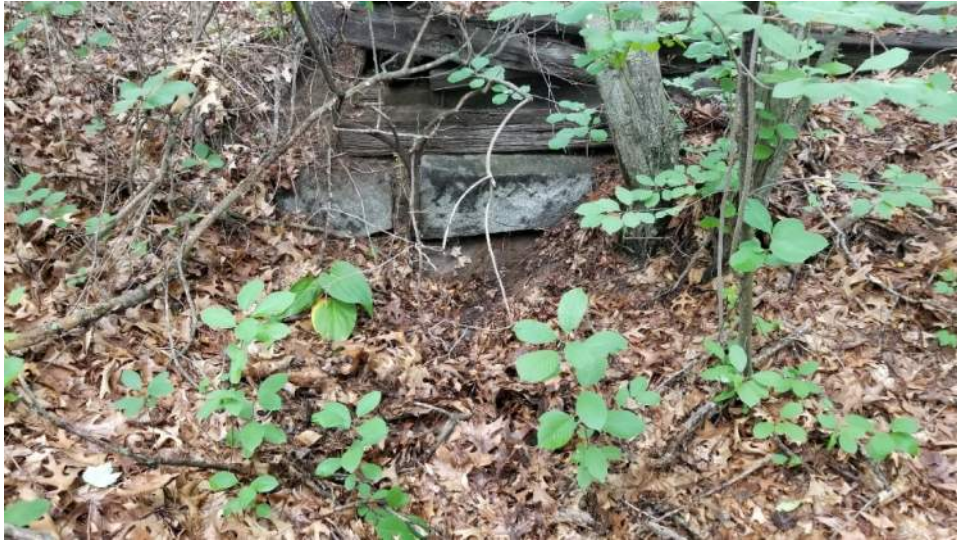
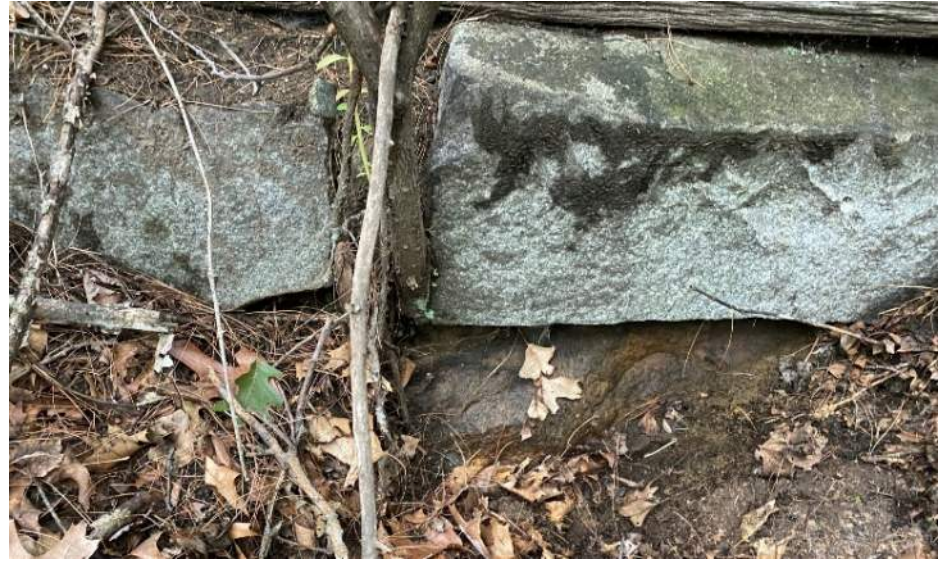
Structure ID	127C
Station	593+18
Plan Sheet	59
Type	Culvert
Size/Material	2'x2' Stone Box
Existing Ground Cover	3.9 feet
2017 Inspection Results	South end filled with dirt; north end not found. Interior in fair condition.
2021 Inspection Results	<p>Structural: No imminent failure mechanisms or changed structural conditions since 2017 were observed. The north end was found, partially buried. South end filled with dirt. Interior in fair condition. The proposed work is not anticipated to have an adverse impact on the existing structure.</p> <p>Wildlife Passage: Both ends allow for potential passage for small amphibians only. The buried condition of both ends of the pipe restricts potential passage for mammals. The potential passage capabilities for small amphibians will be retained.</p>
Work Proposed	The culvert structure will be retained. No work is proposed to the existing structure.

View of south end of Structure 127C

Debris at buried south opening

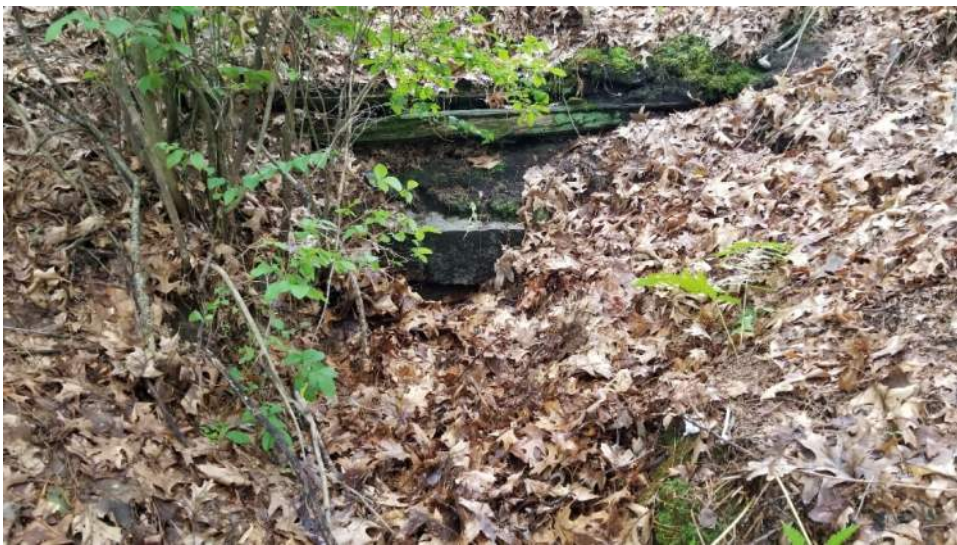
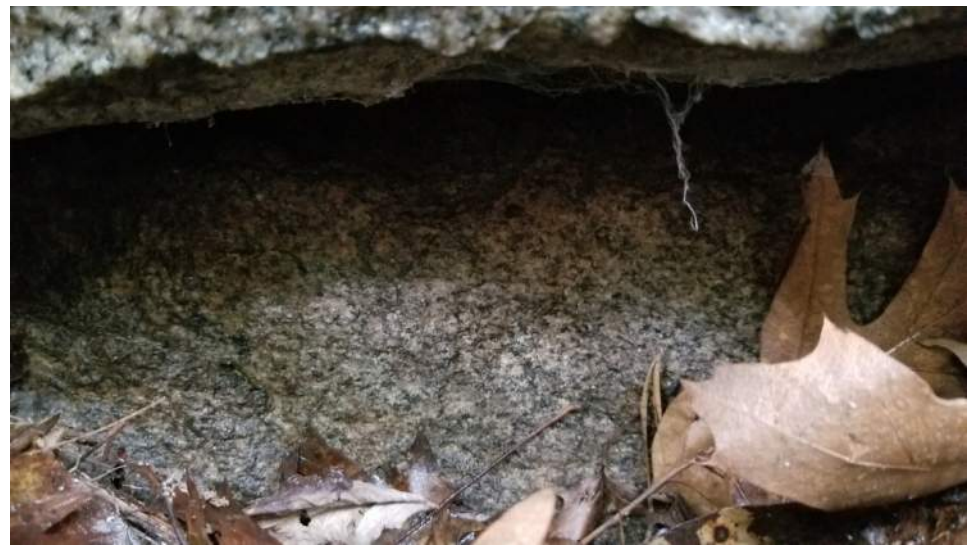
View of north end of Structure 127C

View inside north end of pipe

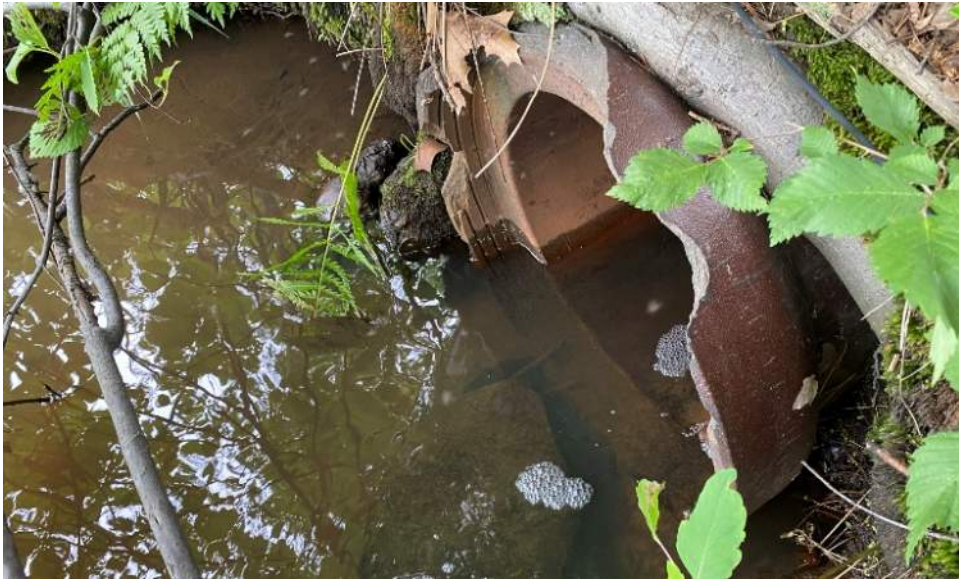
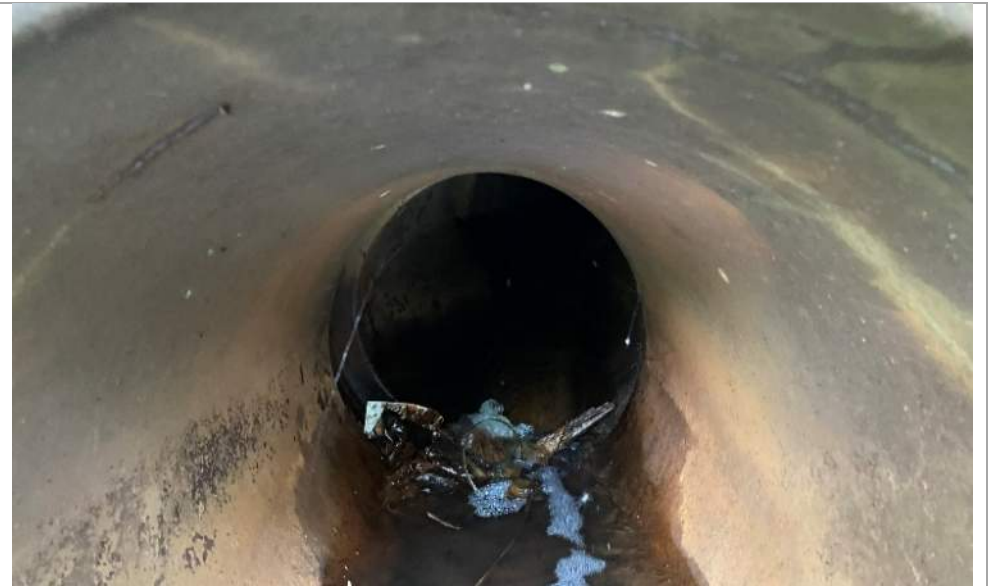
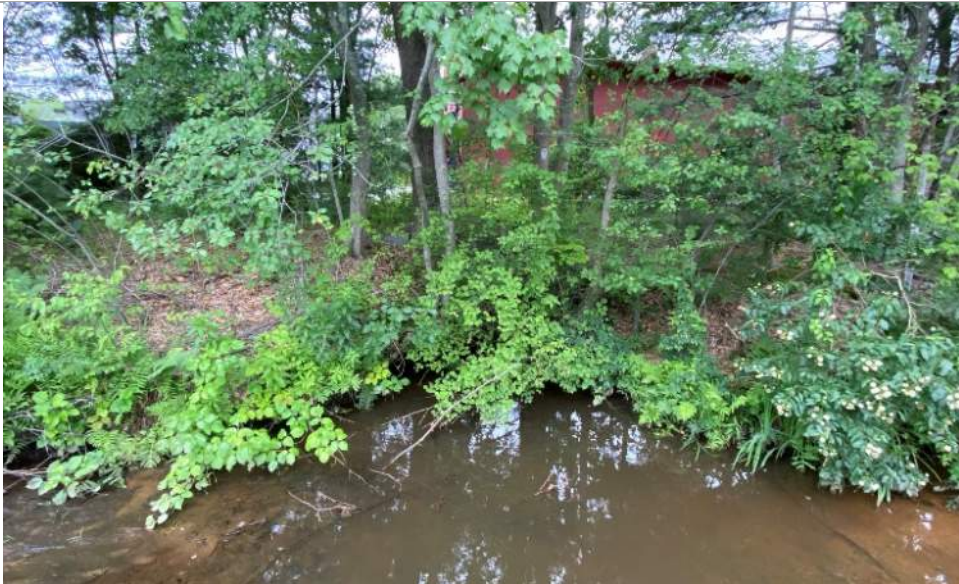
Structure ID	127B
Station	704+56
Plan Sheet	62
Type	Drainage Structure
Size/Material	24" Cast Iron Pipe
Existing Ground Cover	3.0 feet
2017 Inspection Results	South end appears to be catch basin in lumber yard; north end bell end chipped.
2021 Inspection Results	<p>Structural: South end inlet within lumber yard; north end bell end chipped. No imminent failure mechanisms or changed structural conditions since 2017 were observed. The proposed work is not anticipated to have an adverse impact on the existing structure.</p> <p>Wildlife Passage: The southern end of the drainage structure is an inlet within a fenced lumber yard parking lot and, given its location within a developed area, the structure not likely to serve as a wildlife corridor and provides limited to no wildlife passage. Existing wildlife passage, if any, will remain.</p>
Work Proposed	Transmission line will be installed beneath drainage structure. No work is proposed to the existing structure.

North end (outlet) of Structure 127B

Looking through the pipe from the north side to the south side

North end and embankment
