To: Michael J. Hager

Date: August 25, 2021

From: Shanta B. Keller, PE
Katie Kinsella, PWS

Re: Sudbury to Hudson Transmission Reliability and Mass Central
Rail Trail Project
MassDEP File # 301-1287
Inspection of Culverts and Drainage Structures– Town of
Sudbury, Massachusetts

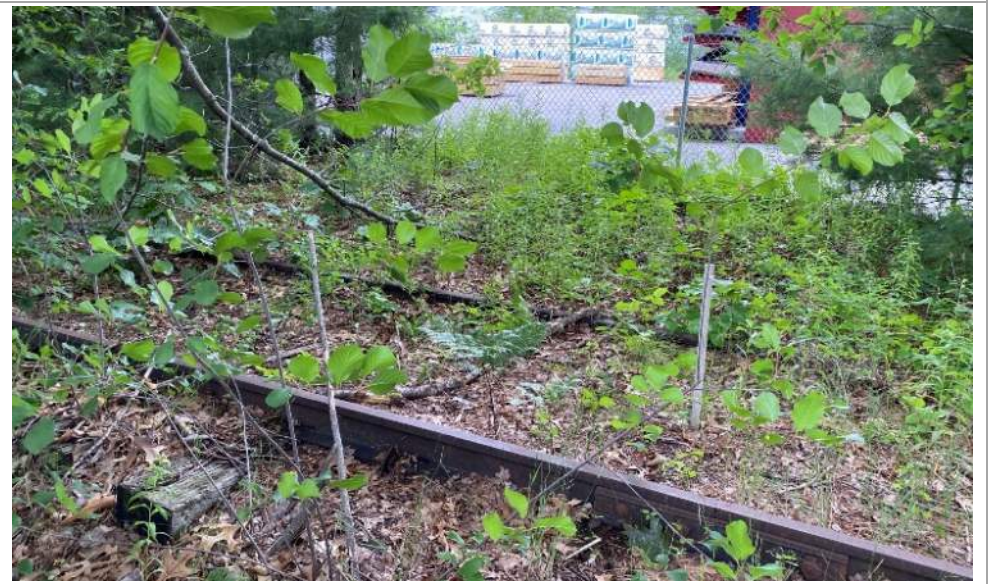
Unable to locate south end (inlet) at lumber yard parking lot.

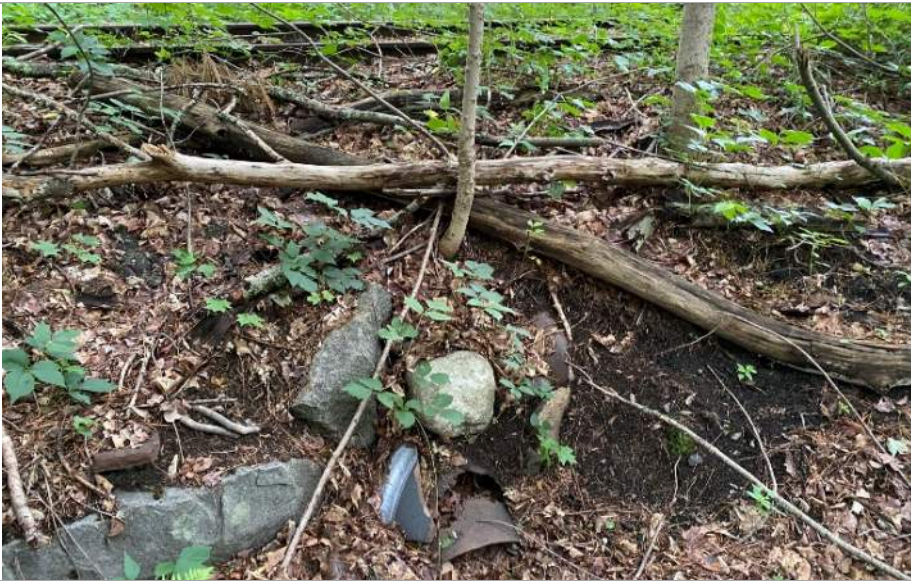
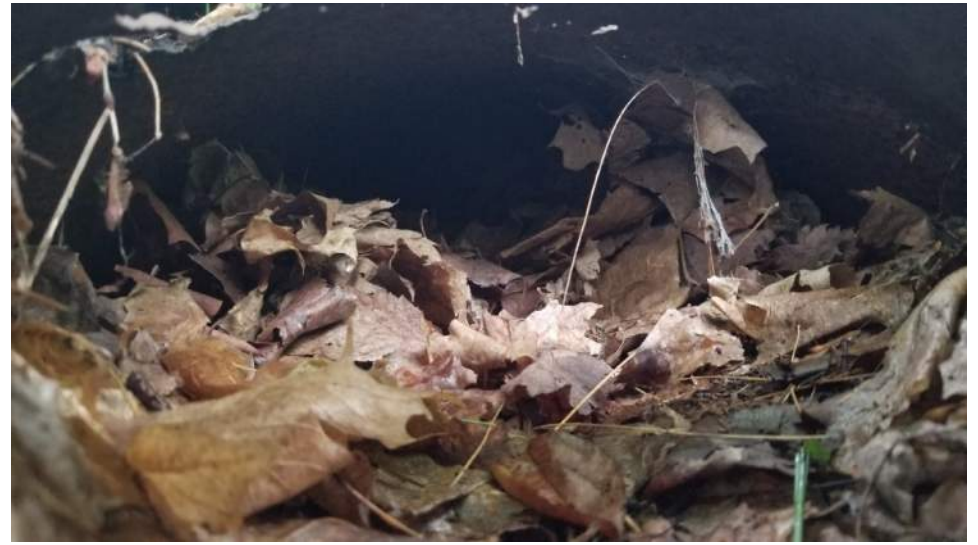
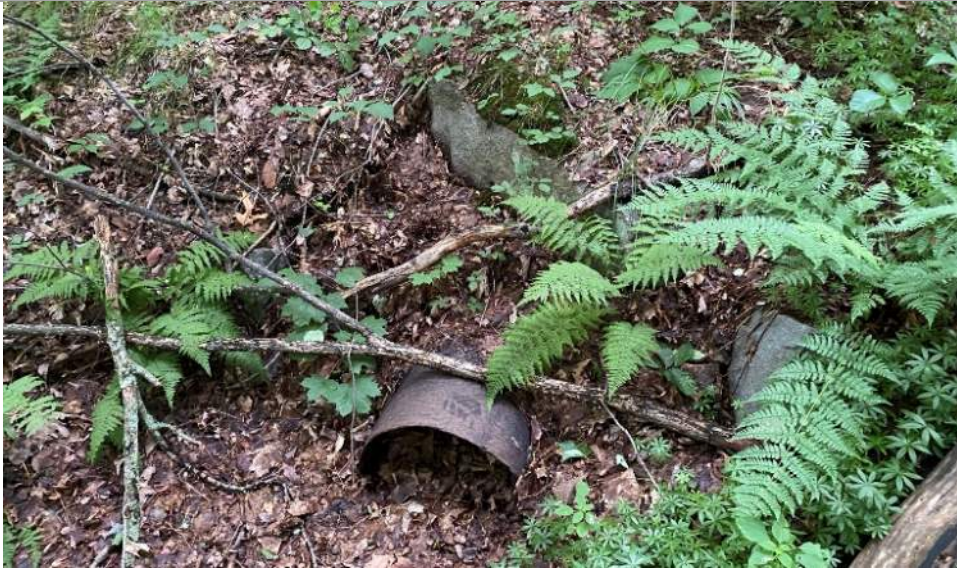
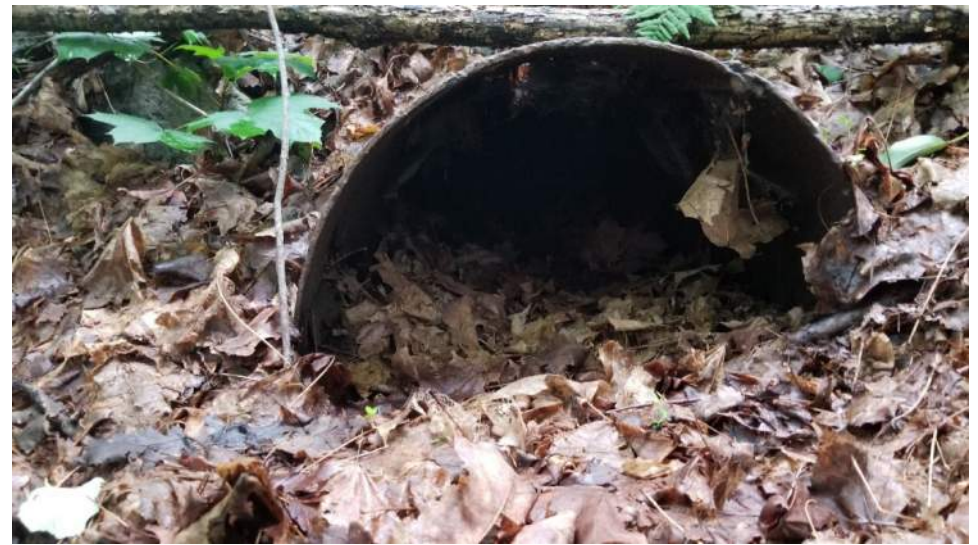
Structure ID	127A
Station	713+63
Plan Sheet	64
Type	Drainage Structure
Size/Material	24" Cast Iron to be replaced with 24" Ductile Iron Pipe
Existing Ground Cover	1.9 feet
2017 Inspection Results	Lined with metal pipe, resulting in 19-in. pipe opening. Mostly filled with dirt. At south end original pipe broken and liner pipe heavily corroded; minor corrosion of liner pipe at north end.
2021 Inspection Results	<p>Structural: No changed structural conditions since 2017. Mostly filled with dirt; south end original pipe broken; liner pipe heavily corroded. Minor corrosion of liner pipe at north end. Structure will be removed and replaced.</p> <p>Wildlife Passage: Existing pipe provides potential for passage for amphibians and small mammals. Replacing the pipe will improve potential passage capabilities for amphibians and small mammals.</p>
Work Proposed	The drainage structure will be replaced with a 24" ductile iron pipe with concrete headwall.

South End and embankment

Looking through southern end of the pipe

North end and embankment

Looking through the northern end of the pipe

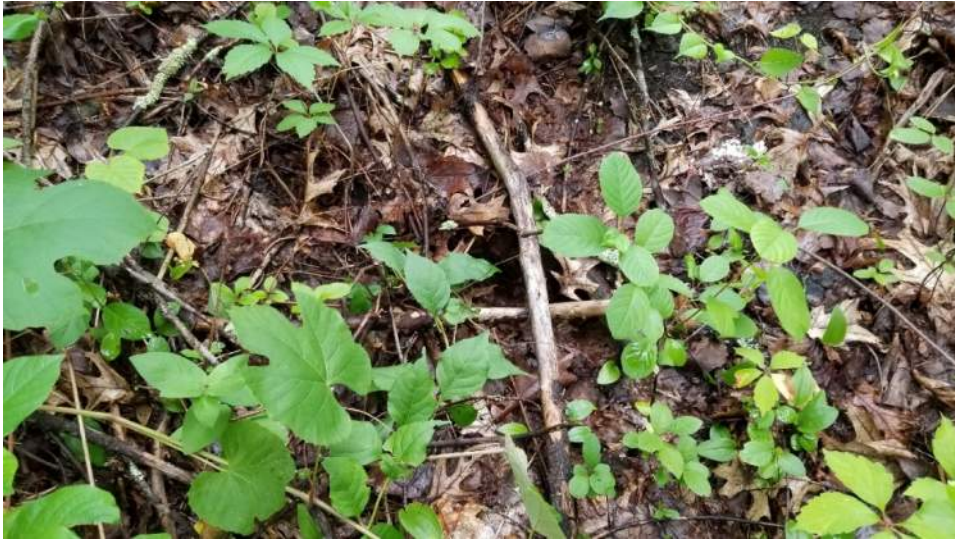
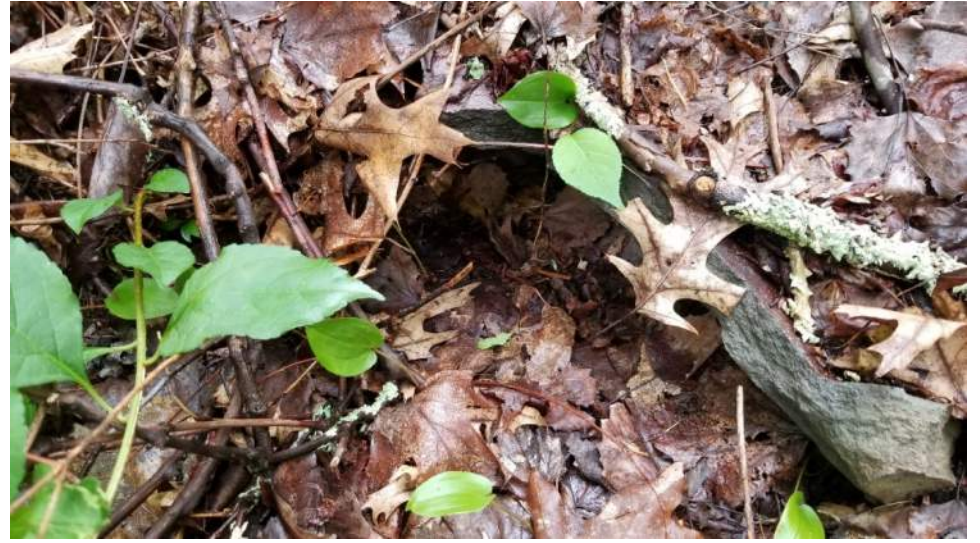
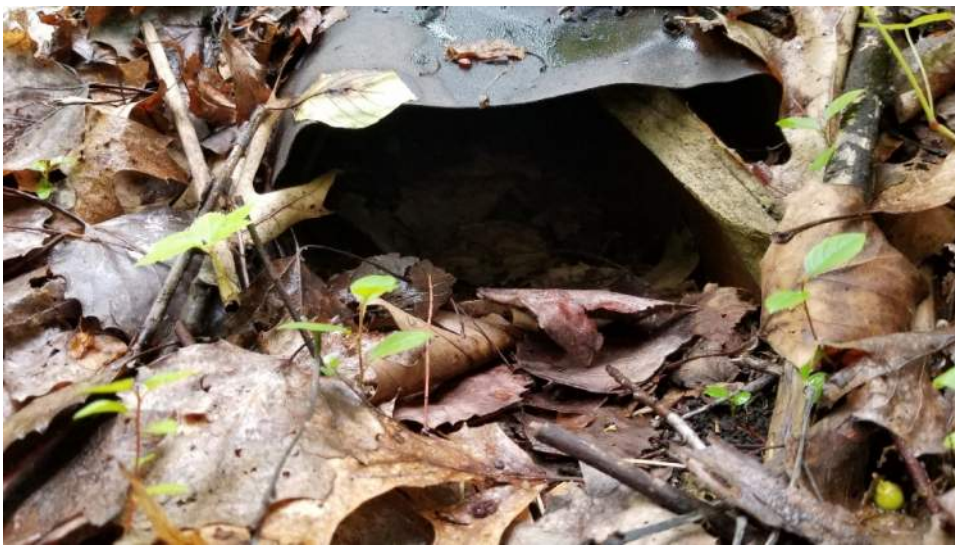
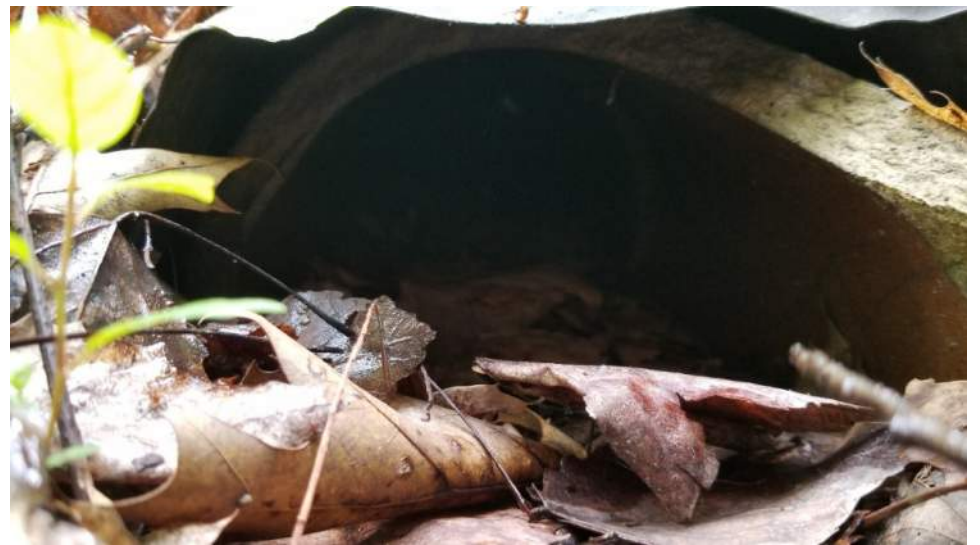
Structure ID	126D
Station	738+77
Plan Sheet	66
Type	Drainage Structure
Size/Material	18" Cast Iron will be replaced with 18" Ductile Iron Pipe
Existing Ground Cover	2.8 feet
2017 Inspection Results	South end broken and half filled with dirt; north end broken and buried.
2021 Inspection Results	Structural: No changed structural condition since 2017. South end broken and filled with dirt; north end broken and partially buried. Structure will be removed and replaced.
	Wildlife Passage: Existing pipe provides potential passage for amphibians and small mammals. Replacing the structure will improve potential passage capabilities for amphibians and small mammals.
Work Proposed	The drainage structure will be replaced with an 18" ductile iron pipe with concrete headwall.

Looking down at southern end of pipe

Close up view of southern end of pipe

Northern end of pipe

View through northern end of pipe

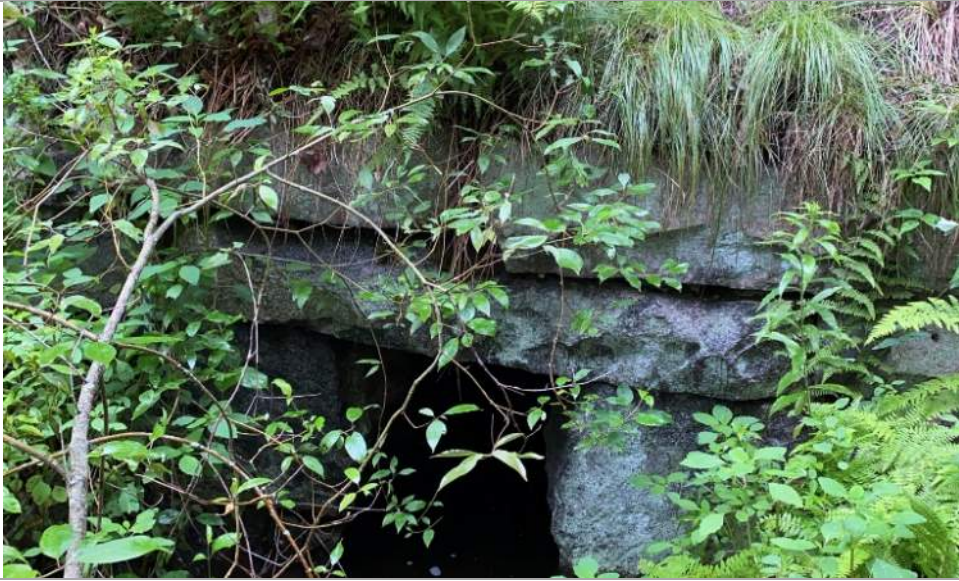
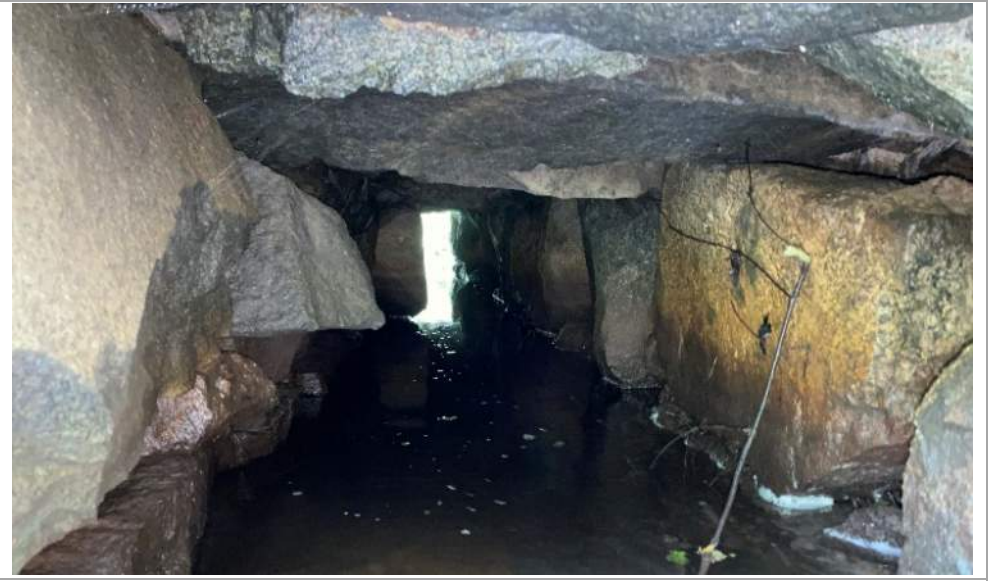
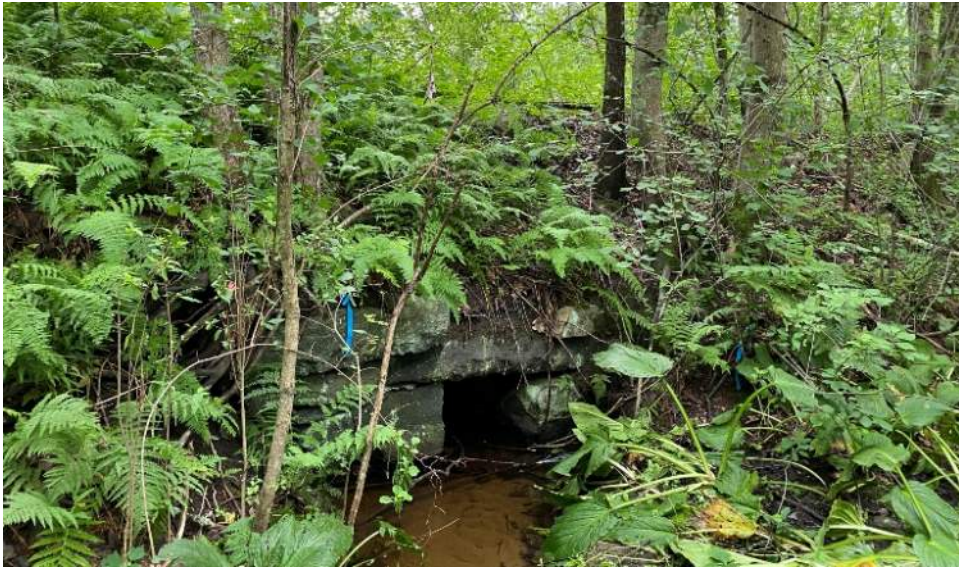
South (outlet) end

Looking through stone culvert from the north side to the south side

North (inlet) end and embankment

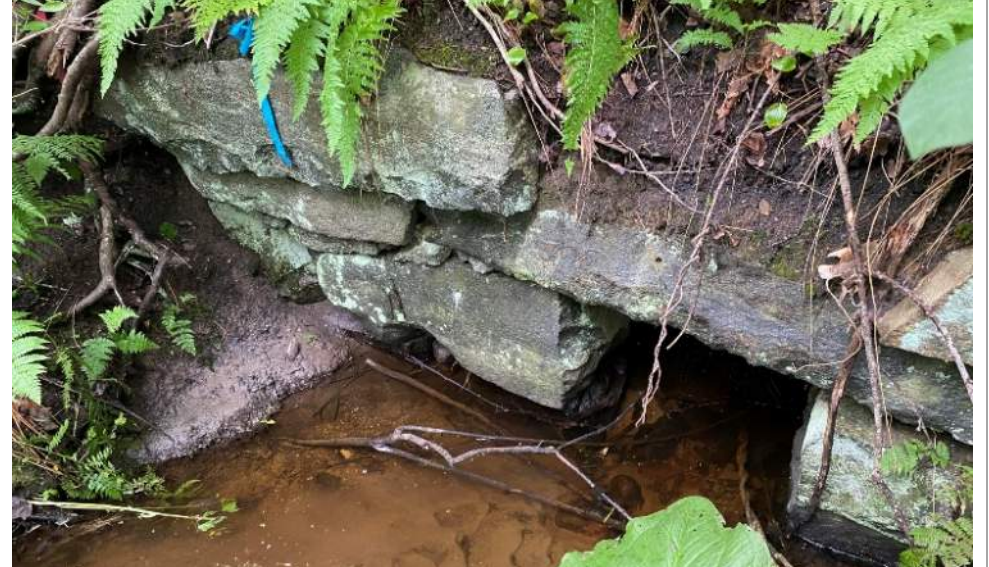
Structure ID	126B
Station	747+39
Plan Sheet	67
Type	Culvert
Size/Material	18" Cast Iron
Existing Ground Cover	5.9 feet
2017 Inspection Results	North headwall bulged due to vegetation. Clear all the way through.
2021 Inspection Results	<p>Structural: No imminent failure mechanisms or changed structural conditions since 2017 were observed. North headwall bulged due to vegetation. Clear all the way through. The proposed work is not anticipated to have an adverse impact on the existing structure.</p> <p>Wildlife Passage: Existing culvert provides potential passage for amphibians and small and medium mammals. The existing potential passage capabilities for amphibians and small and medium mammals will be retained.</p>
Work Proposed	Vegetation on the northeast wingwall will be cut and removed; no grubbing will occur. The culvert will be retained. No work is proposed to the existing structure.

Bulging and missing stones at north headwall due to vegetation growth

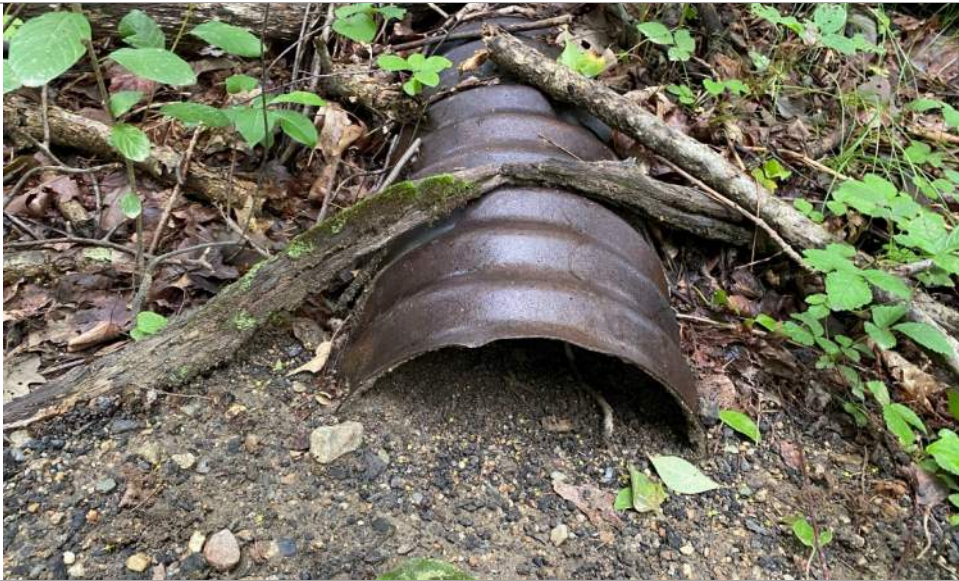
Structure ID	126A
Station	752+17
Plan Sheet	67
Type	Drainage Pipe
Size/Material	12" Corrugated Metal
Existing Ground Cover	4.9 feet
2017 Inspection Results	Half full of sediment. Both ends in fair condition.
2021 Inspection Results	<p>Structural: Half full of sediment; both ends in fair condition. No imminent failure mechanisms or changed structural conditions since 2017 were observed. The proposed work is not anticipated to have an adverse impact on the existing structure.</p> <p>Wildlife Passage: Existing pipe provides potential passage for amphibians and small mammals. The sediment will be cleared out of the drainage pipe by hand, improving potential passage capabilities for amphibians and small mammals.</p>
Work Proposed	The drainage structure will be retained, and no work is proposed to the existing structure.

South end of culvert, partially filled with sediment. Sediment will be removed.

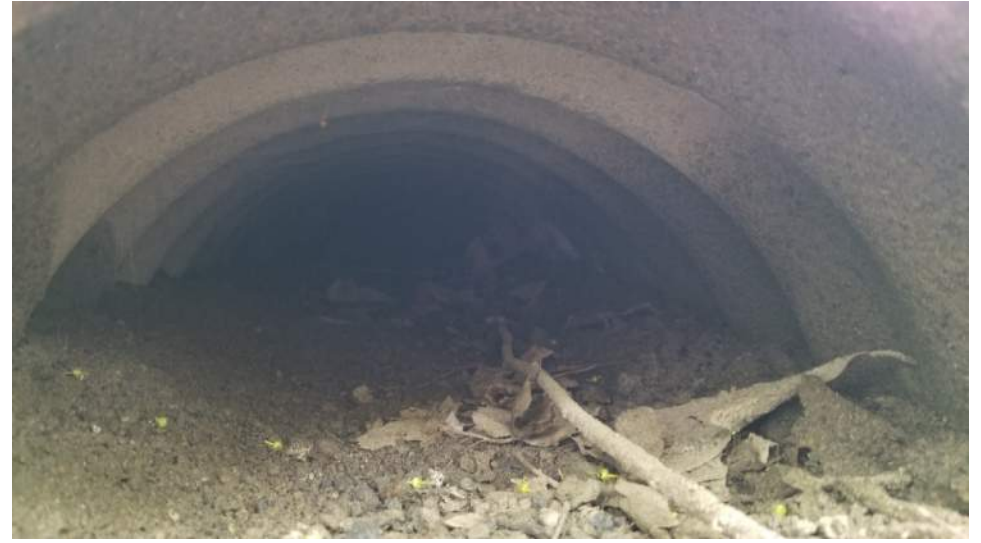
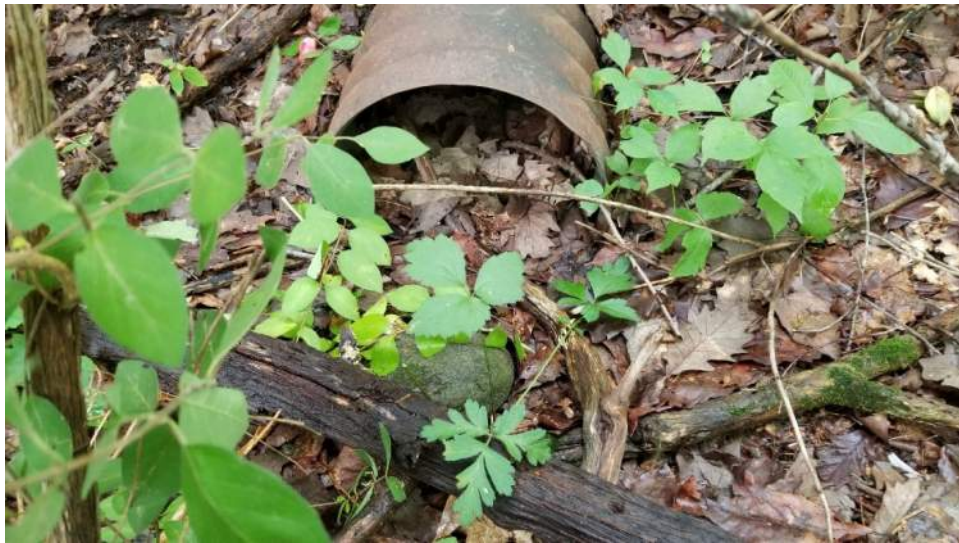
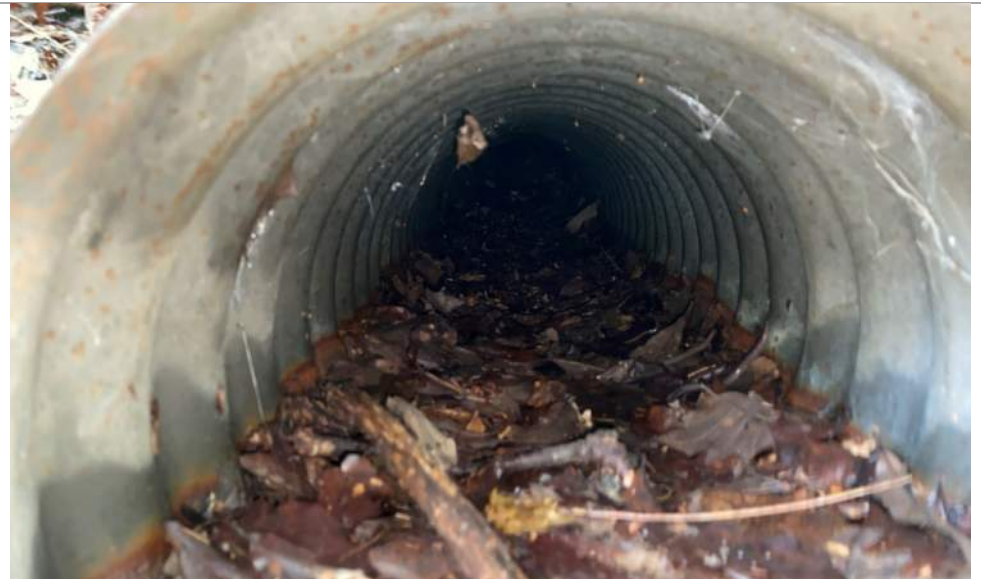
View through culvert from south end

North end of culvert and embankment

View of the inside of culvert from the north end.

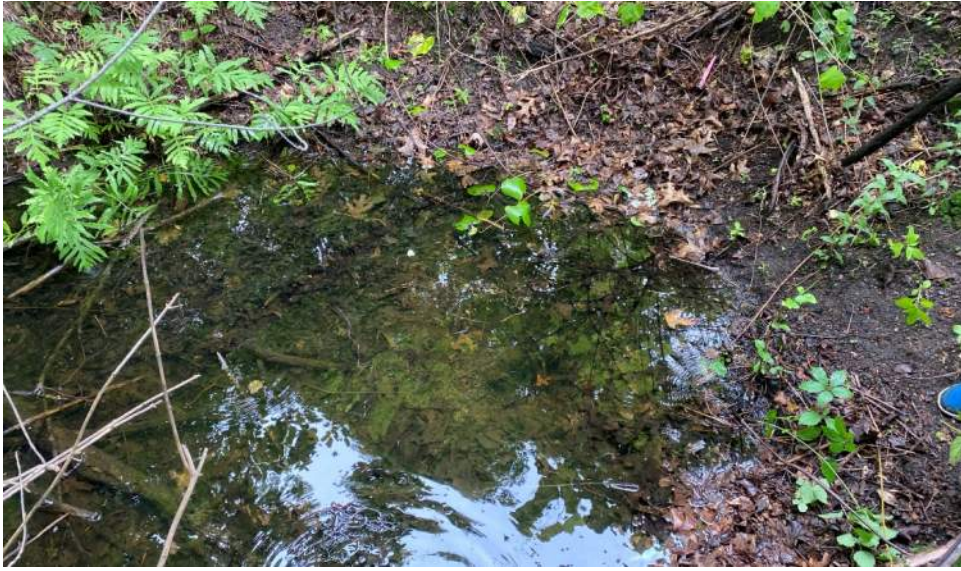
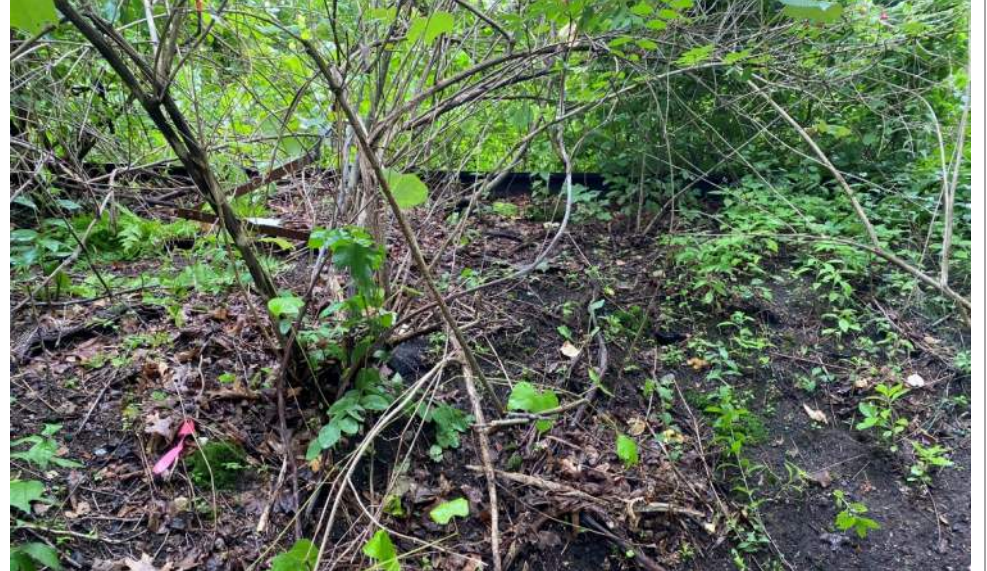
Structure ID	125B
Station	764+60
Plan Sheet	69
Type	Drainage Pipe
Size/Material	12" Reinforced Concrete Pipe
Existing Ground Cover	2.8 feet
2017 Inspection Results	Completely buried; north end under vernal pool.
2021 Inspection Results	<p>Structural: The existing structure could not be observed, but there is no evidence of recent or imminent structural failures or settlement. The proposed work is not anticipated to have an adverse impact on the existing buried structure.</p> <p>Wildlife Passage: Existing pipe is buried and does not provide any potential passage.</p>
Work Proposed	The existing pipe will be extended to the south to maintain vernal pool hydrology.

View near south end of culvert. Unable to locate inlet or outlet.

View of south embankment.
