Weekly Environmental Compliance Summary

Sudbury to Hudson Transmission Reliability Project (USEPA Tracking # MAR1003UW)

Week of: February 6 to February 10, 2023

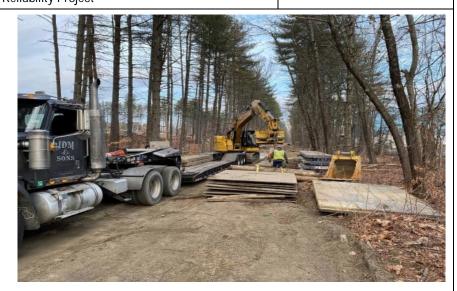
Photo No.: 2 Date: 2-6-23

Bond conducting site work at MH#10 within Segment 4 at approximate Sta#196+00, looking westward.

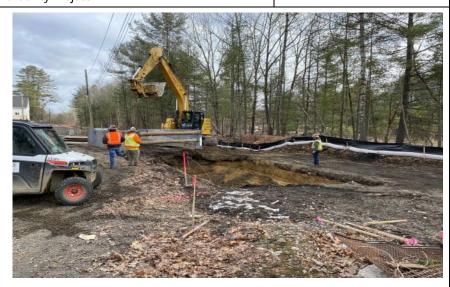
Photo No.: 4 Date: 2-6-23

Bond conducting site work at MH#8 within Segment 3 at approximate Sta#157+50, looking eastward.

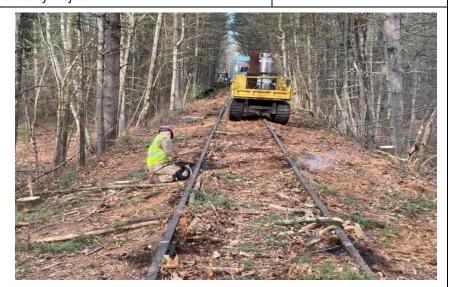
Moosehead cutting rail Segment 9 at approximate Sta# 527+00, looking westward.

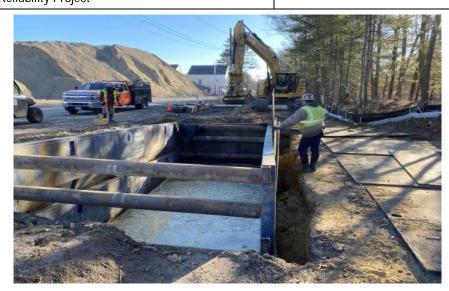
Bond conducting site work at MH#8 within Segment 3 at approximate Sta#157+50, looking eastward.

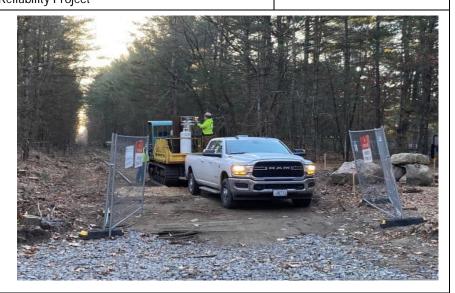
Moosehead preparing to cut rail Segment 9 at Dutton Road, looking eastward.

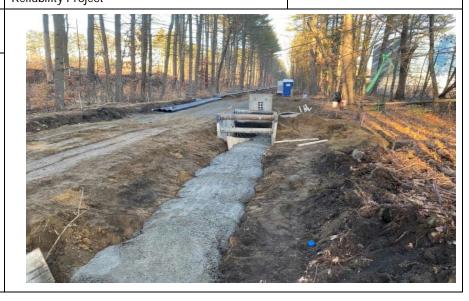
Backfilling of ROW from MH#10 (following conduit installation) within Segment 4 at approximate Sta#196+00, looking westward.

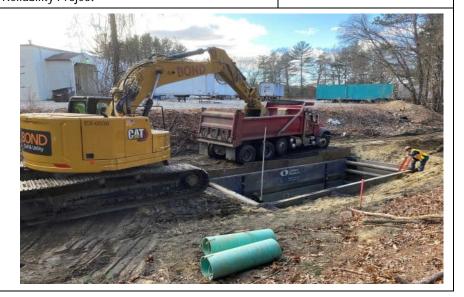
Bond conducting site work at MH#9 within Segment 3 at approximate Sta#177+00, looking westward.

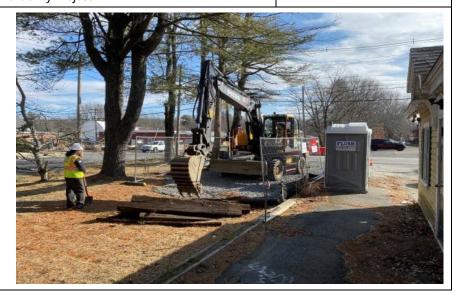
ET&L removing historic features (concrete blocks to be preserved) off Union Avenue, looking eastward.

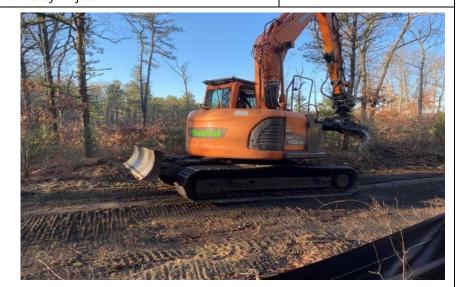
Moosehead removing rails/ties & stumps within Segment 7 at approximate Sta# 365+50, looking northward.

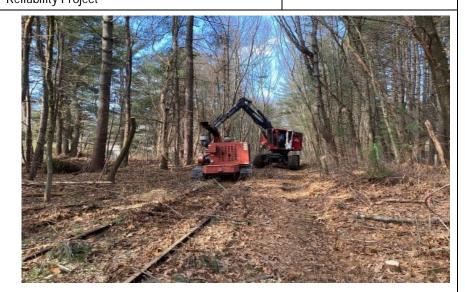
Moosehead chipping within Segment 10 at approximate Sta#545+00, looking westward.

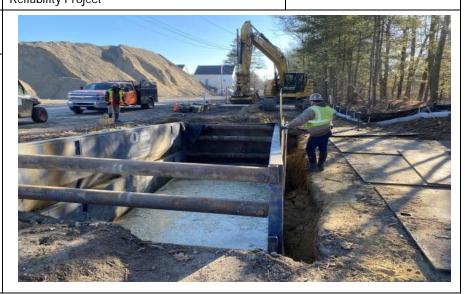
View of area being pumped at work operation at MH#8, at approximate Sta.# 157+50 in Segment 3, looking eastward.

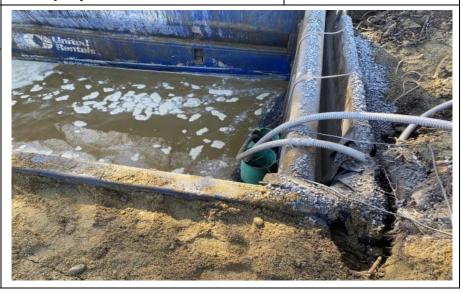
View of pumping operation at MH#8. This is the location of dewatering water prior to treatment. Water appeared to be cloudy.

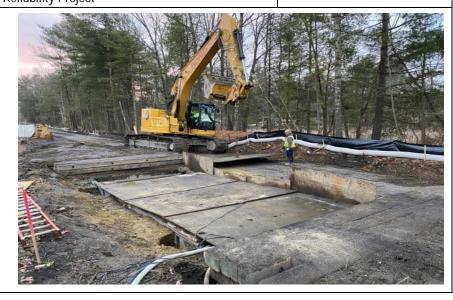
Bond working at MH#8 within Segment 3 at approximate Sta.# 157+50, looking eastward.

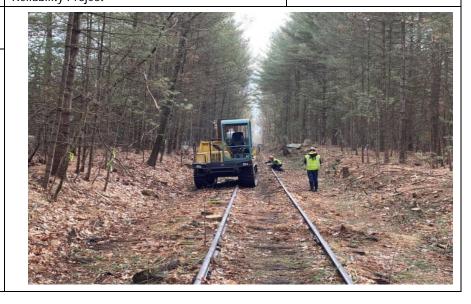
Moosehead cutting rail within Segment 9 at approximate Sta.# 503+00, looking eastward.

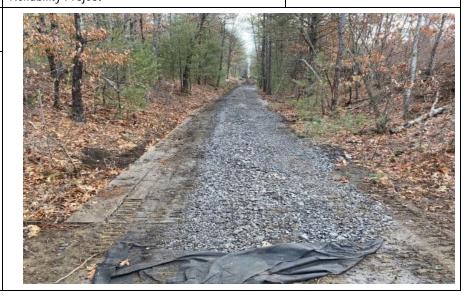
Current state of 200' Black Racer time of year restrictive area with new stone access, looking eastward.

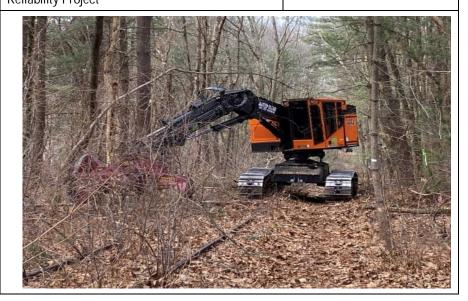
Clearing operation by Moosehead within Segment 10 at approximately 550+00, looking westward.

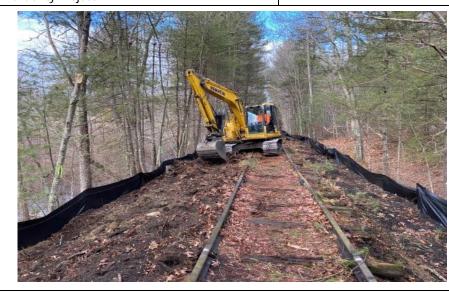
Rail/Tie removal by Moosehead within Segment 10 at approximate Sta.#410+00, looking westward.

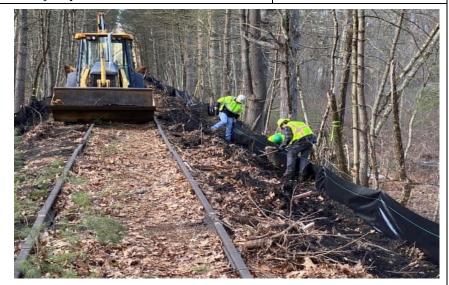
Silt fencing placement by MON within Segment 9 at approximate Sta# 528+00, looking westward.

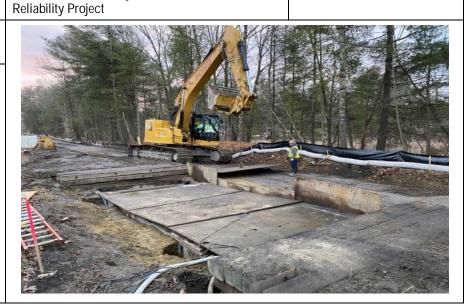
View of area being pumped at work operation at MH#8, at approximate Sta.# 157+50 in Segment 3, looking eastward.

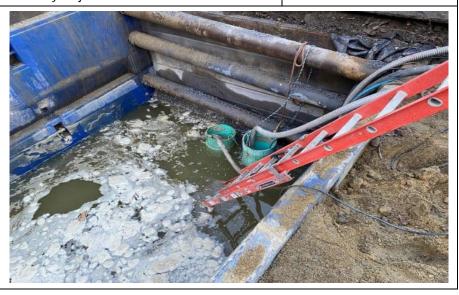
View of pumping operation at MH#8. This is the location of dewatering water prior to treatment. Water appeared to be cloudy.

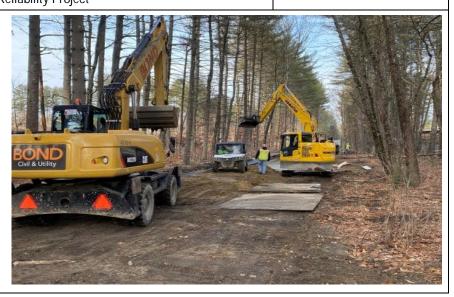
Bond working at conduit installation within Segment 4 at approximate Sta.# 196+00, looking westward.

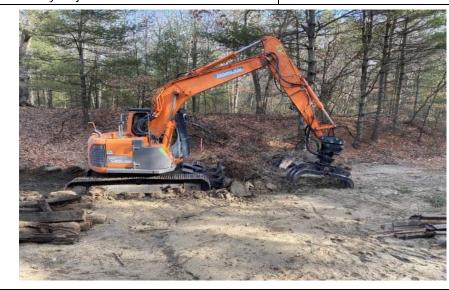
Moosehead removing rail/ties within Segment 7 at approximate Sta.# 391+50, looking northward.

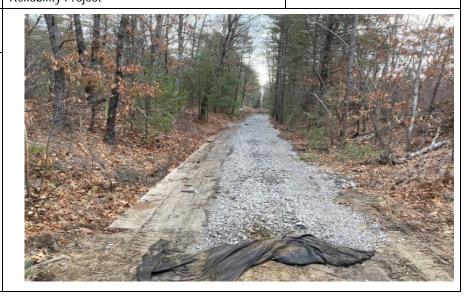
Current state of 200' Black Racer time of year restrictive area with new stone access, looking eastward.

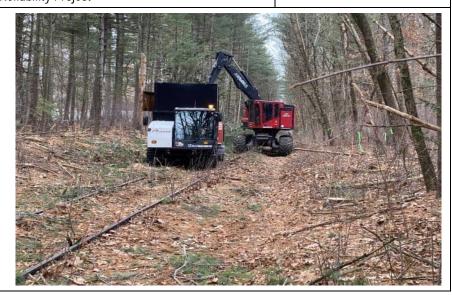
Chipping operation by Moosehead within Segment 10 at approximately 550+00, looking westward.

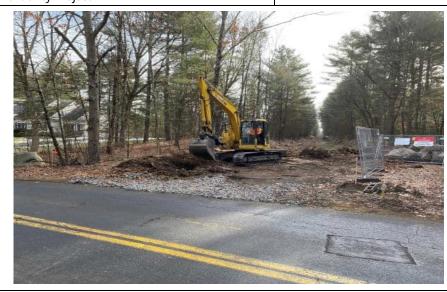
Stump removal by Moosehead within Segment 9 at Dutton Road, looking eastward.

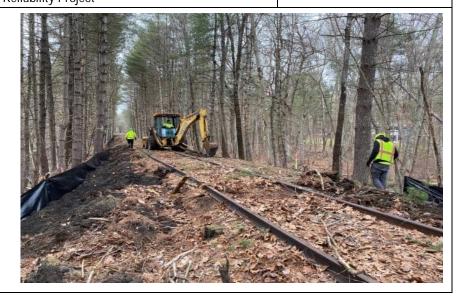
Silt fencing placement by MON within Segment 10 at approximate Sta# 539+00, looking westward.
