**Weekly Environmental Compliance Summary**

**Sudbury to Hudson Transmission Reliability Project (USEPA Tracking # MAR1003UW)**

Sudbury, Hudson, and Stow, MA

Week of: February 27 to March 3, 2023

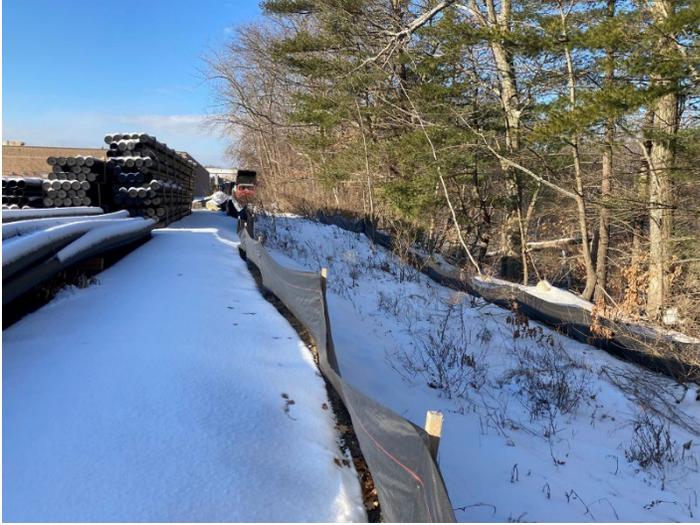
<p><b>Description:</b> View of silt fence installed at laydown yard on Robert Bonazzoli Ave. Facing southwest.</p>

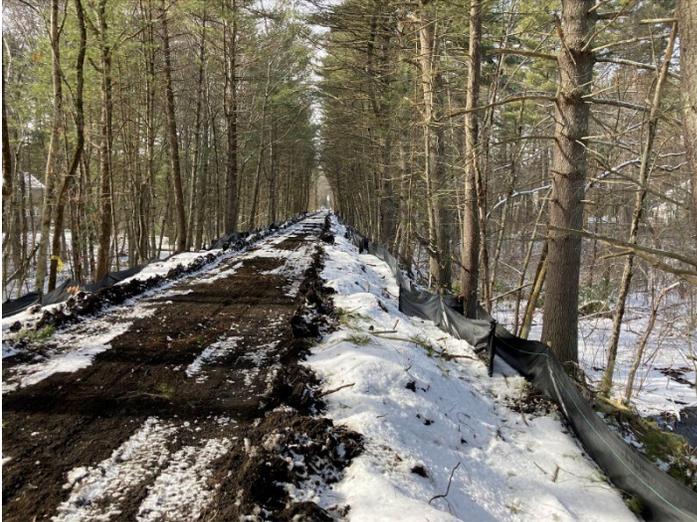
<b>Description:</b> View of silt fence where previously damaged in segment 9. Silt fence has been repaired (routine maintenance has been addressed). Facing west.

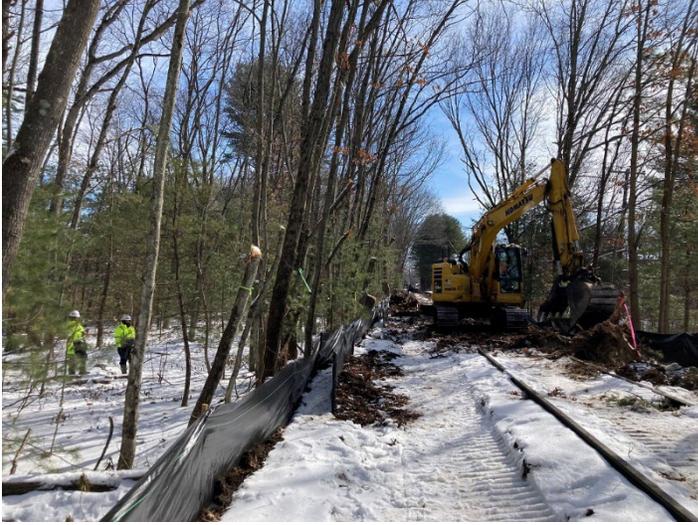
<p><b>Description:</b>                  Rail and tie removal work was conducted over culvert #127C at Sta. #398+50 in segment 11 off Union Ave. Rick Alexander (Sudbury DPW) and Polina Safran (SWCA) were onsite to oversee the work in this area. Facing east.</p>

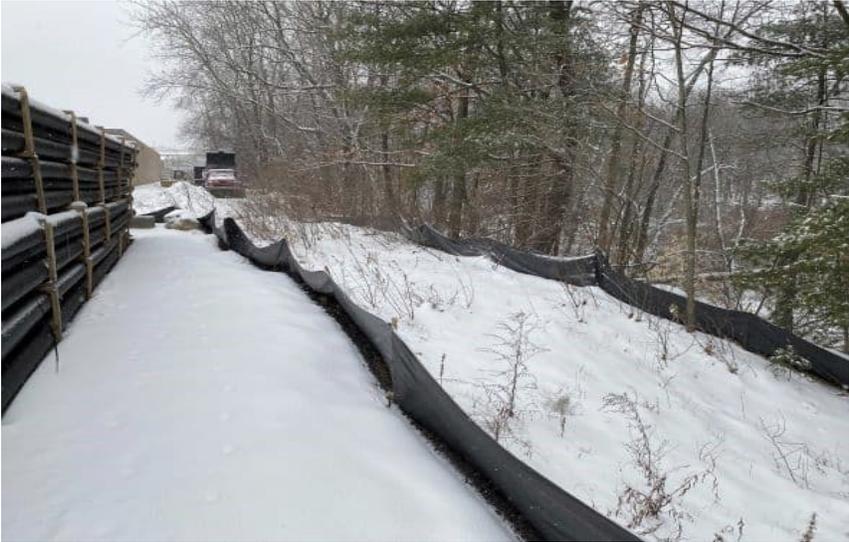
<p>Description:</p> <p>New silt fencing north side of Bonazzoli laydown yard, looking westward.</p>

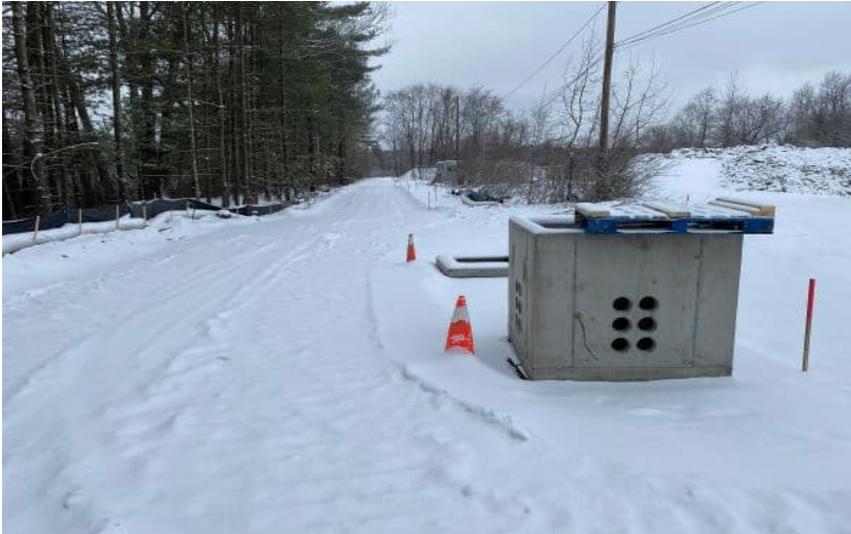
<p>Description:                  Manhole#8 in Segment 3 at approximate Sta#157+00, looking westward.</p>

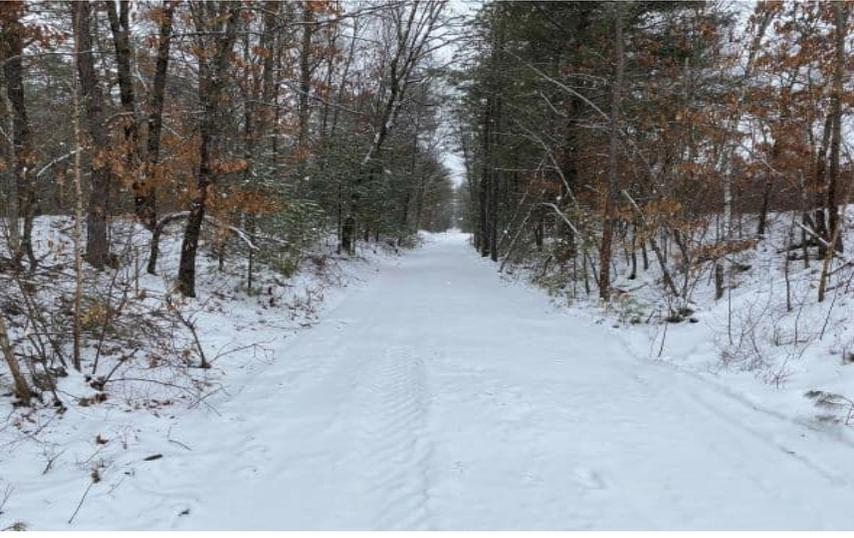
<p>Description:</p> <p>Black Racer restrictive area (current condition), looking eastward.</p>

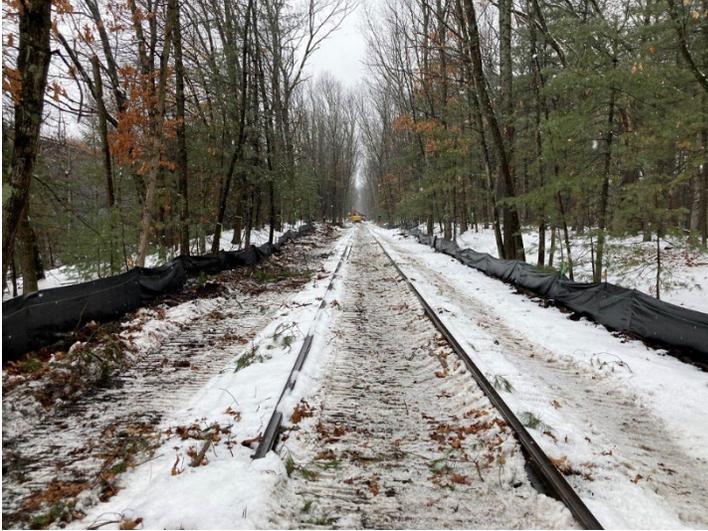
<p><b>Description:</b> View of silt fence installed by ET&amp;L in segment 11. Facing west.</p>

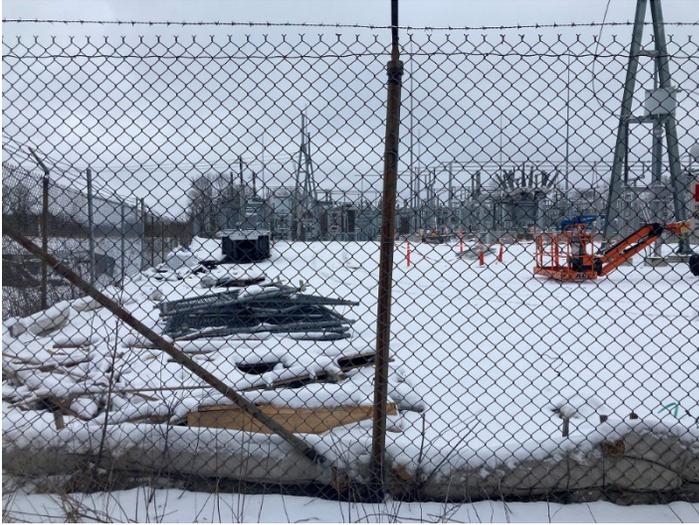
<b>Description:</b> View of Sudbury Substation. No active construction at time of inspection. Facing west.

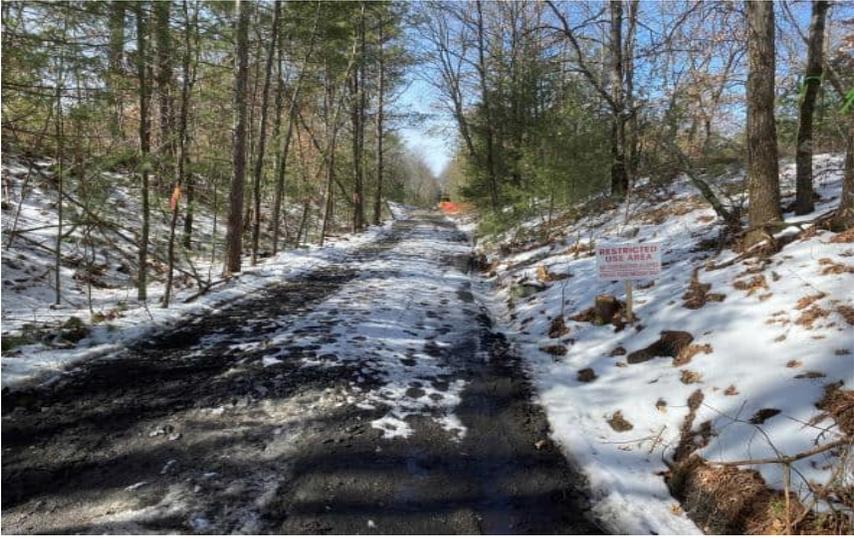
<p>Description:</p> <p>Black Racer restrictive area (current condition), looking westward.</p>

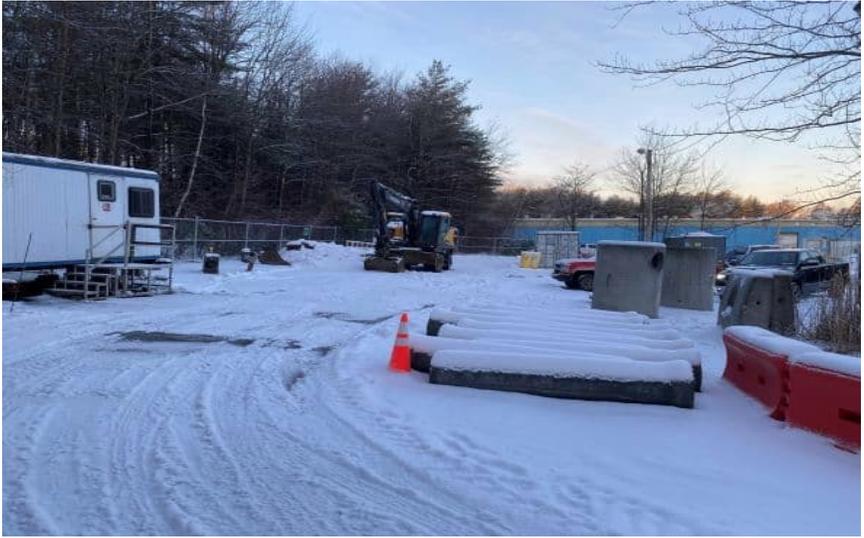
Description:  Main Street Laydown yard, looking westward.

4. Straw Wattles Main St. laydown yard	<input type="checkbox"/> Yes <input checked="" type="checkbox"/> No	N/A	<input type="checkbox"/> Yes <input checked="" type="checkbox"/> No	N/A	Straw wattles are operating properly. It is recommended that straw wattles with plastic netting be replaced with biodegradable compost filter tubes (per Eversource Requirement).

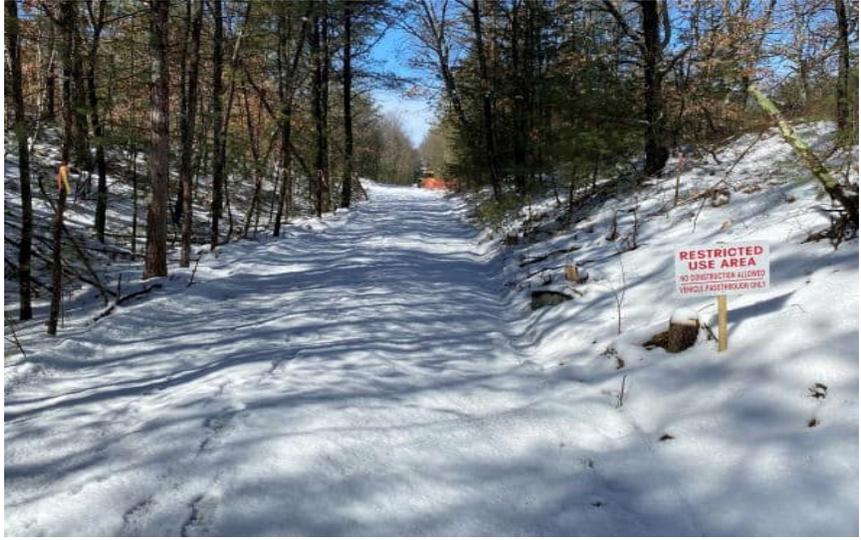
Description:  Current state of 200' Black Racer time of year restrictive area with new stone access, looking westward.

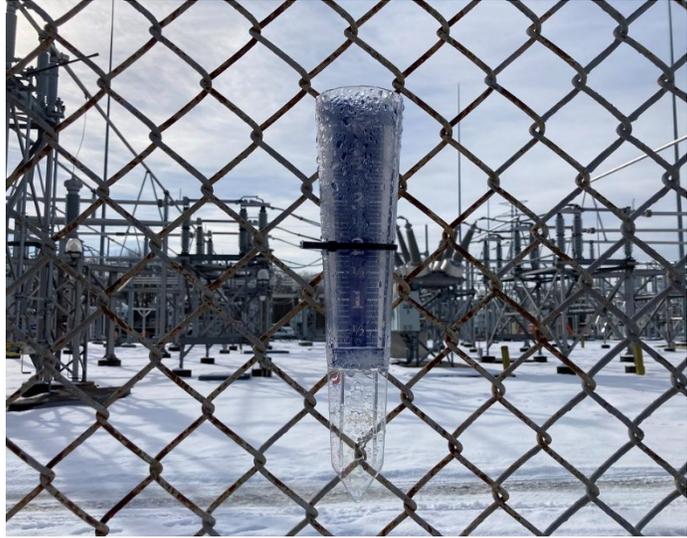
<b>Description:</b> View of rain gauge at Sudbury Substation. 0.25" observed in gauge at 9:00am. Facing south.

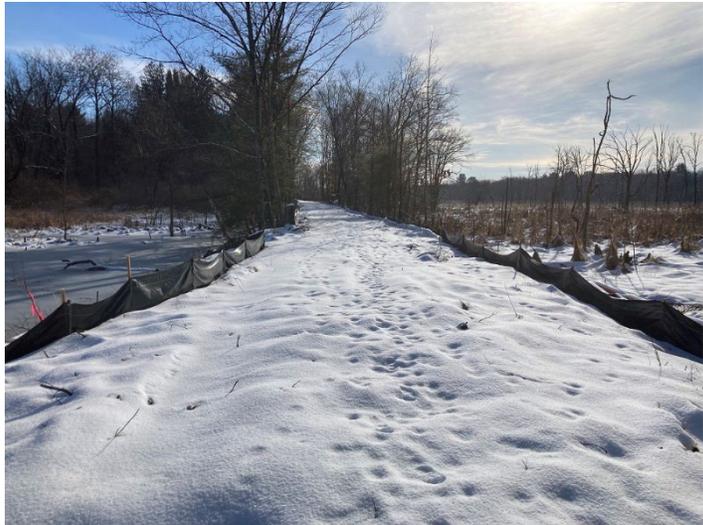
<b>Description:</b> View of E&S controls in segment 14 near bridge 127. Controls are in good condition and operating properly. Facing east.

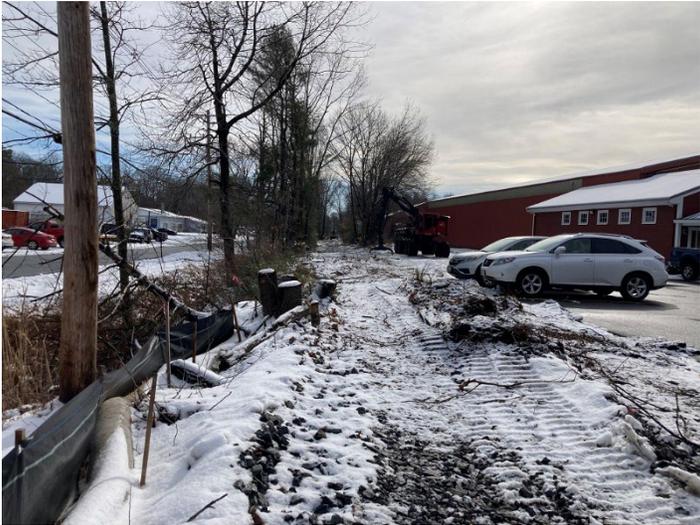
<b>Description:</b> View of construction entrance to segment 12 off Union Ave. E&S controls in this area are in good condition and operating properly. Facing east.

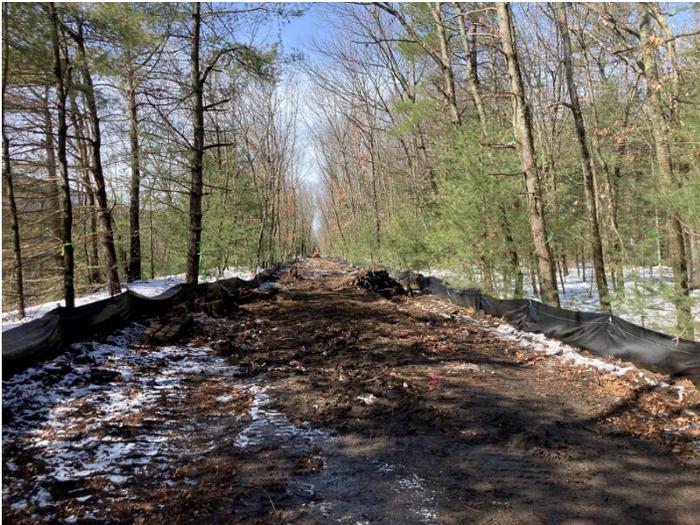
Due to miscommunication, rail and tie removal work was conducted in this area prior to inspection of silt fence. Rails were removed throughout entire section with minimal ground disturbance. Tie removal with ground disturbance occurred from approximately Sta. #589+50 to Sta. #591+25. Upon discovery, work ceased and Lori Capone (Sudbury CC) was informed immediately. Lori observed this area during the silt fence inspection.

<b>Description:</b> Section of silt fence in segment 11 (approximately Sta. #585+25-591+25) was inspected by Lori Capone (Sudbury CC). Due to miscommunication, rail and tie removal work was conducted in this area prior to inspection of silt fence. See comments section on cover page for more information. Facing west.

-Section of silt fence in segment 11 (approximately Sta. #585+25-591+25) was inspected by Lori Capone (Sudbury CC). One repair was requested, which was completed immediately. Silt fence was then approved.

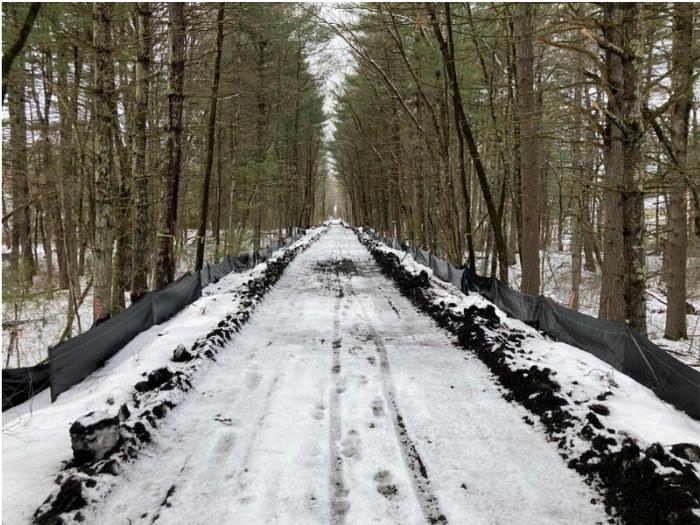
<b>Description:</b> View of syncopated silt fence in segment 9 off of Peakham Rd. Facing west.

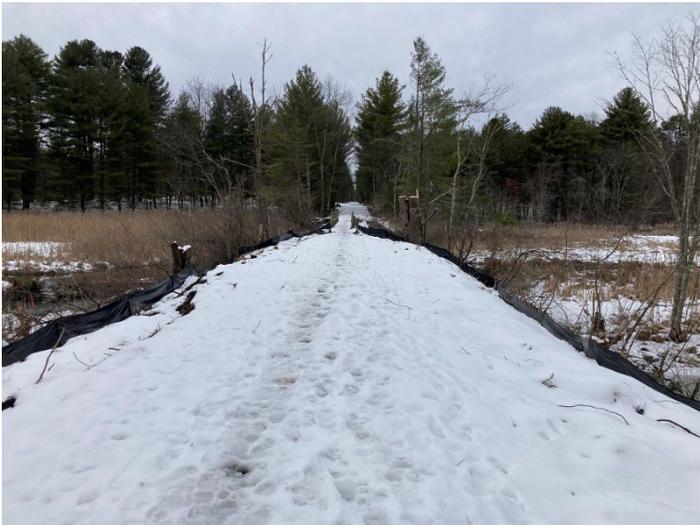
<b>Description:</b> View of E&S controls in segment 8 near bridge 128. Controls are in good condition and operating properly. Facing west.

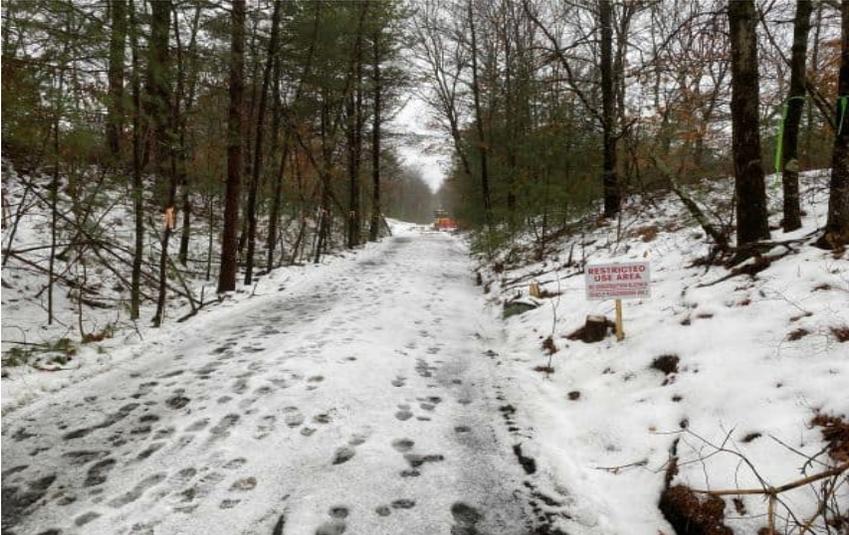
Description:  Current state of 200' Black Racer time of year restrictive area with new stone access, looking westward.

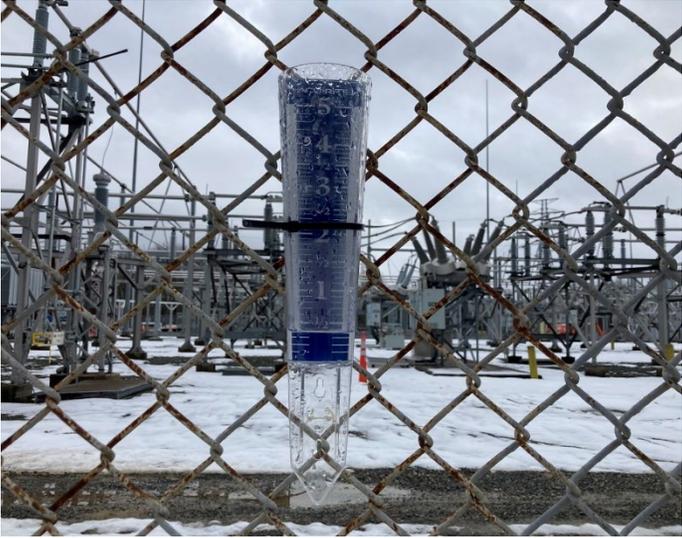
<b>Description:</b> View of rain gauge at Sudbury Substation. 0.45" observed in guage at 3:00pm. Facing south.

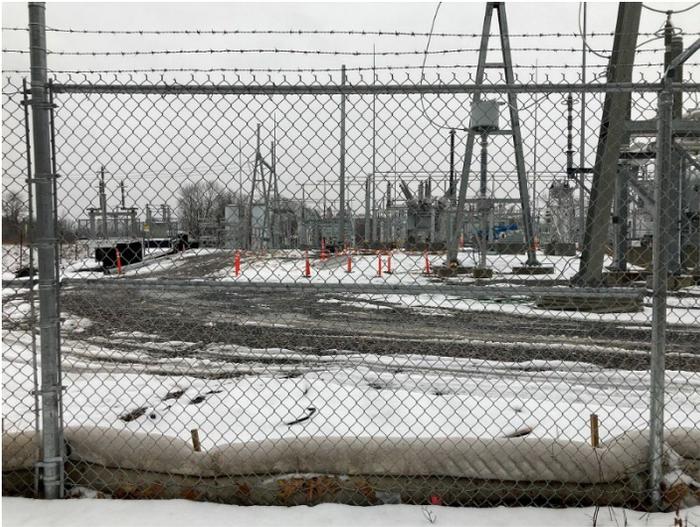
<b>Description:</b> View of construction area at Sudbury Substation. Area was inactive at time of inspection. Filter tubes are operating properly. Facing west.

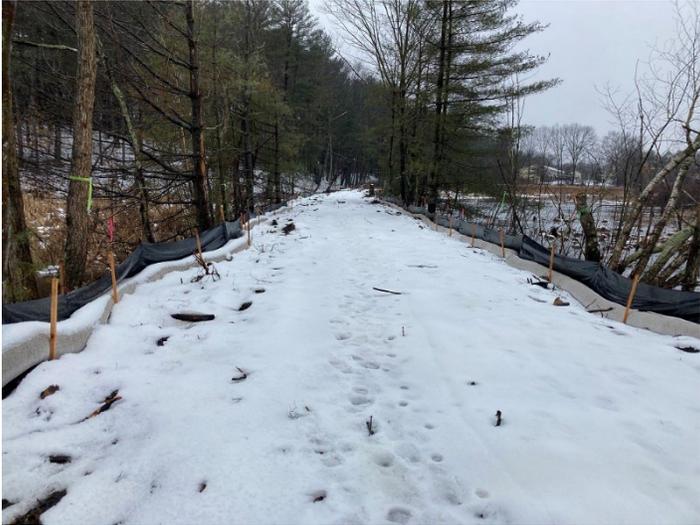
<b>Description:</b> View of E&S controls in segment 14 near bridge 127. Controls are in good condition and operating properly. Facing west.

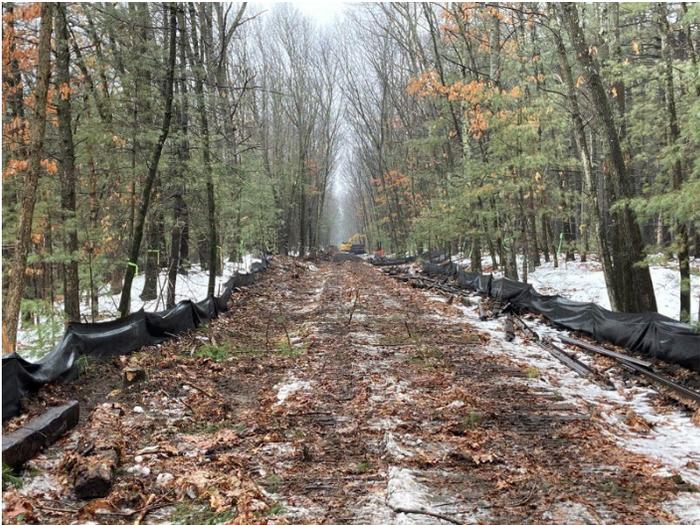
<b>Description:</b> Section of segment 11 off Union Ave. Moosehead is performing rail and tie removal in this area. Silt fence is in good condition and operating properly. Facing west.

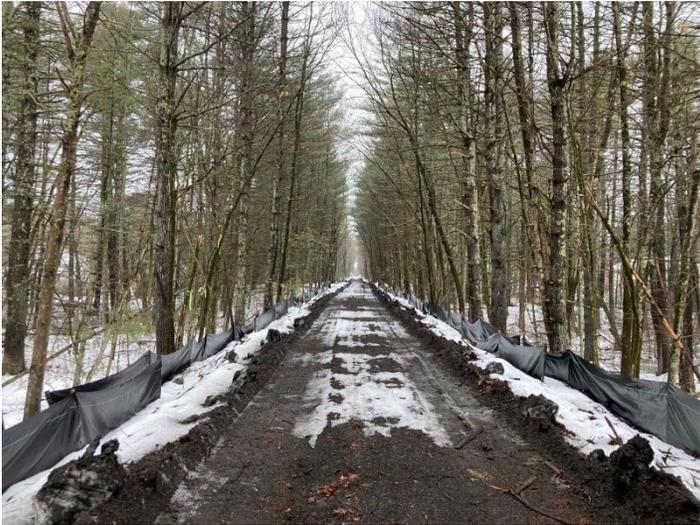
<b>Description:</b> View of syncopated silt fence in segment 9 off of Peakham Rd. Facing west.

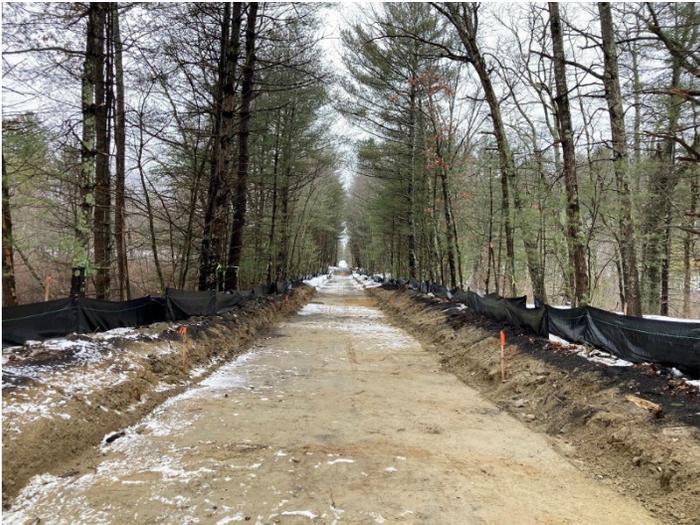
<b>Description:</b> View of syncopated silt fence in segment 8 off of Dutton Rd. Facing west.

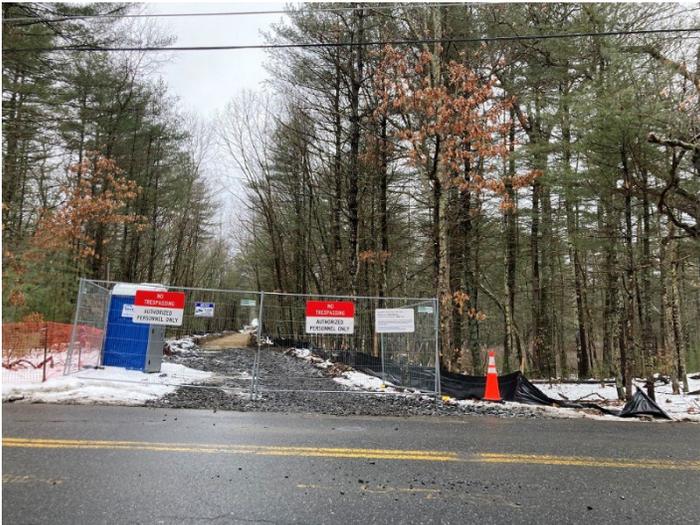
<b>Description:</b> View of construction entrance to segment 8 at Dutton Rd. Repair silt fence at entrance (routine maintenance). Facing west.
