**Weekly Environmental Compliance Summary**

**Sudbury to Hudson Transmission Reliability Project (USEPA Tracking # MAR1003UW)**

Week of: March 6 to March 10, 2023

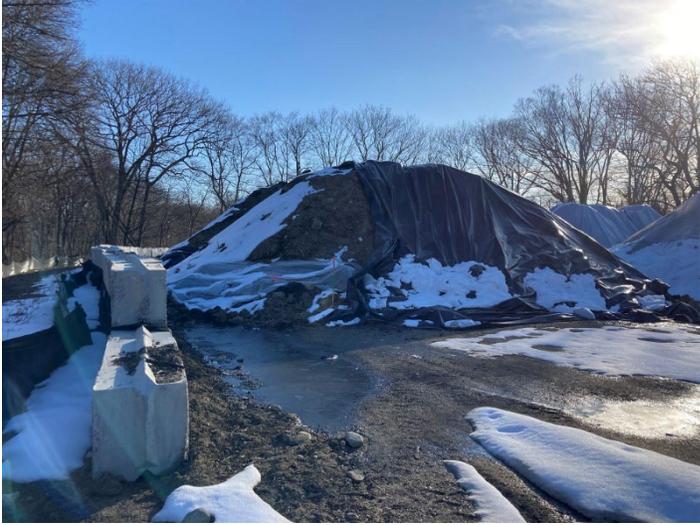
<p align="right"><b>PHOTOGRAPHIC LOG</b></p>	
<p><b>Client Name:</b> Eversource</p>		<p><b>Site Location:</b> Sudbury to Hudson Transmission Reliability Project</p>	<p><b>Town:</b> Hudson</p>
<p><b>Photo No.:</b> 1</p>	<p><b>Date:</b> 3/07/2023</p>

<p><b>Description:</b> View of laydown yard at Stowe Ct. Ensure stockpiles are being covered at the end of each workday. Facing northeast.</p>

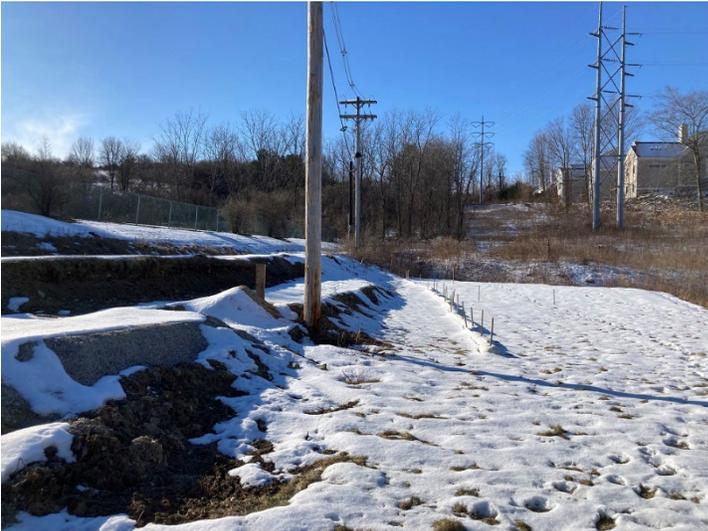
<p align="right"><b>PHOTOGRAPHIC LOG</b></p>	
<p><b>Client Name:</b> Eversource</p>		<p><b>Site Location:</b> Sudbury to Hudson Transmission Reliability Project</p>	<p><b>Town:</b> Hudson</p>
<p><b>Photo No.:</b> 2</p>	<p><b>Date:</b> 3/07/2023</p>

<p><b>Description:</b> View of filter tubes at MH #1 area. Tubes are operating properly. Facing south.</p>

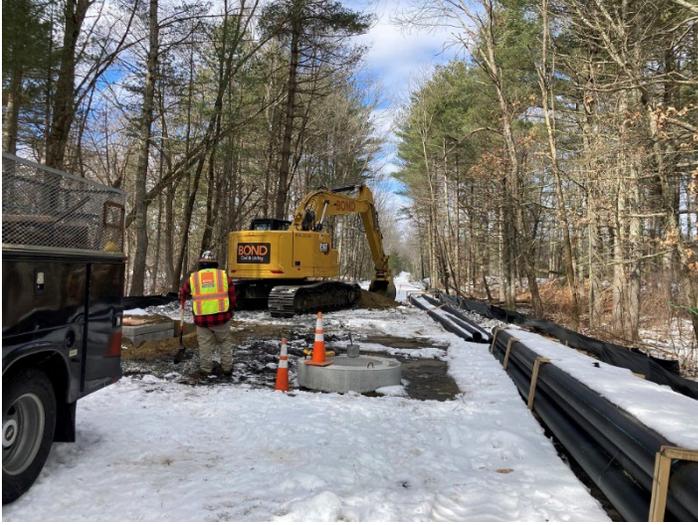
<p align="right"><b>PHOTOGRAPHIC LOG</b></p>	
<p><b>Client Name:</b> Eversource</p>		<p><b>Site Location:</b> Sudbury to Hudson Transmission Reliability Project</p>	<p><b>Town:</b> Hudson</p>
<p><b>Photo No.:</b> 5</p>	<p><b>Date:</b> 3/07/2023</p>

<p><b>Description:</b> Hand hole installation occurred at MH #13 at Sta. #333 – Sta. #336 in segment 5. This section of the project is within the time of year restricted area for vernal pools. Work ceased upon discovery and equipment was escorted out of the area by Ariel Leclerc. No activity noted in nearby vernal pools. Facing west.</p>

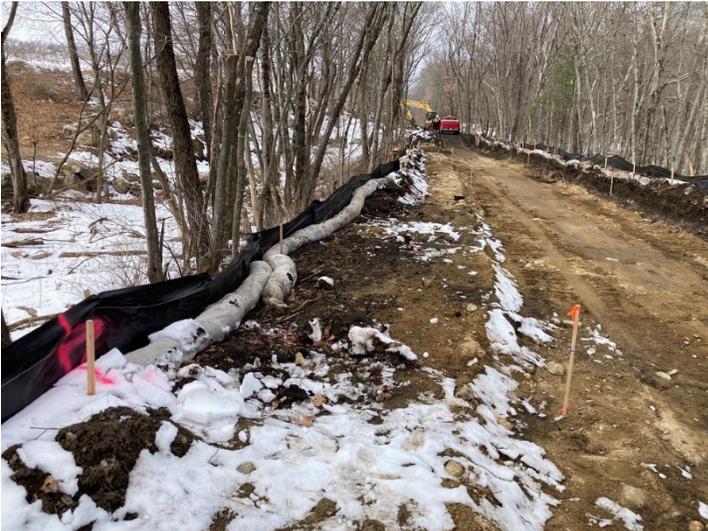
<b>PHOTOGRAPHIC LOG</b>	
<b>Client Name:</b> Eversource		<b>Site Location:</b> Sudbury to Hudson Transmission Reliability Project	<b>Town:</b> Hudson
<b>Photo No.:</b> 2	<b>Date:</b> 3/08/2023

<b>Description:</b> View of segment 1 at approximately sta. #131. ET&L completed E&S repairs throughout segment 1 on 3/08/2023. Facing west.

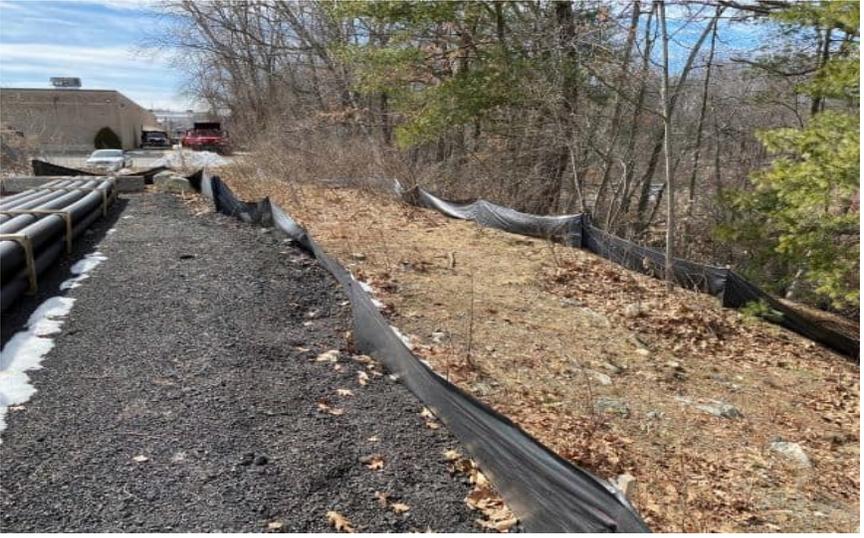
<p>Description:</p> <p>New silt fencing north side of Bonazzoli laydown yard, looking westward.</p>

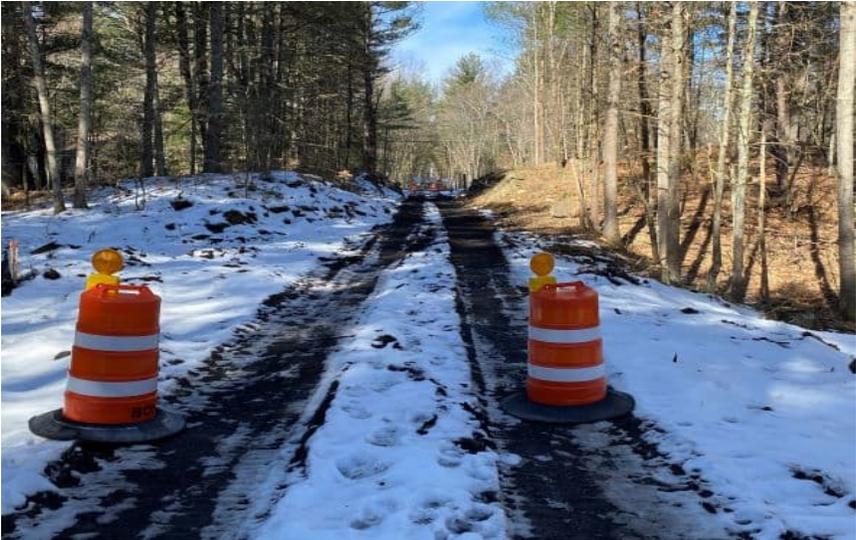
<p>Description:</p> <p>Newly placed barrels, marking extent of vernal pool restriction areas, within Segment 10 at approximate Sta# 534+00, second set at Peakham Road, looking westward.</p>

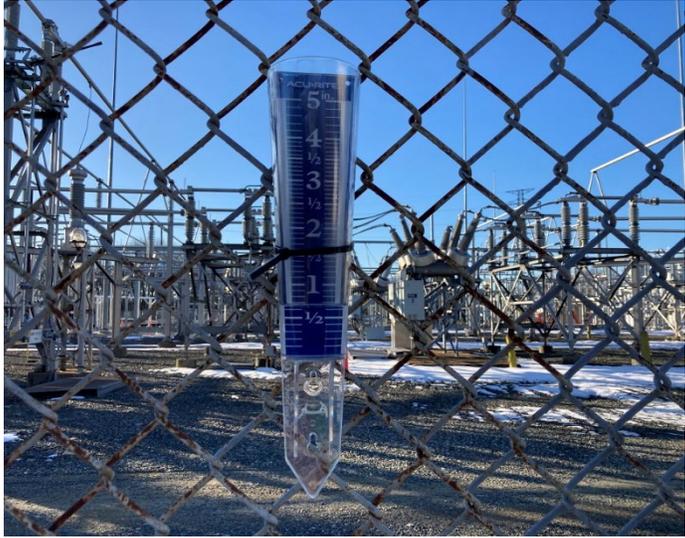
<b>Description:</b> View of rain gauge at Sudbury Substation. 0.65" observed in gauge at 7:30am. Facing south.

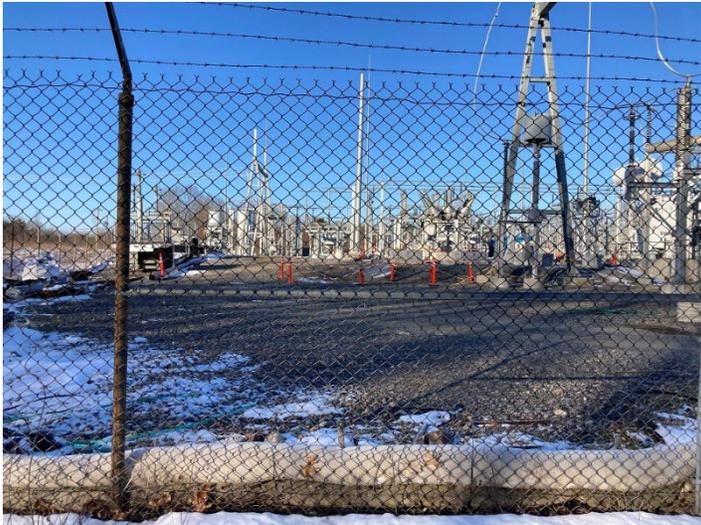
<b>Description:</b> View of construction area at Sudbury Substation. Area was inactive at time of inspection. Filter tubes are operating properly. Facing west.

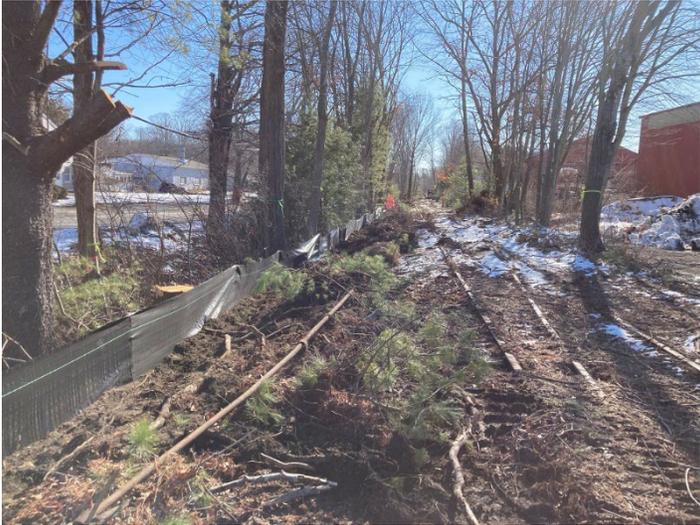
<b>Description:</b> Silt fence installation in progress in segment 12. Facing west.

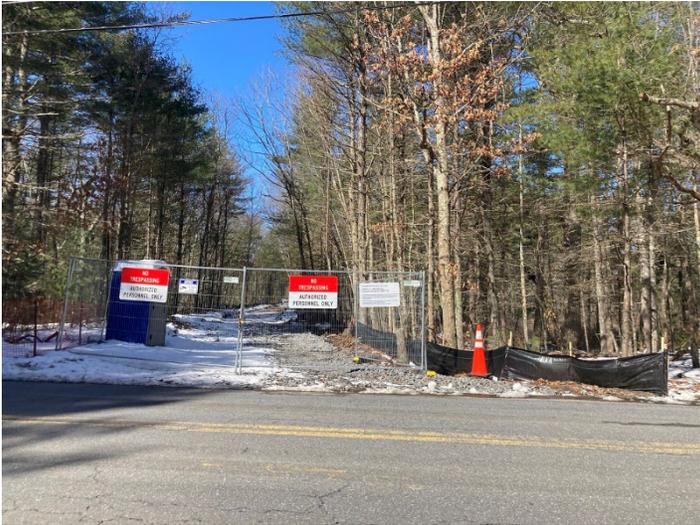
<b>Description:</b> View of construction entrance to segment 8 at Dutton Rd. Silt fence in this area has been repaired. Facing west.

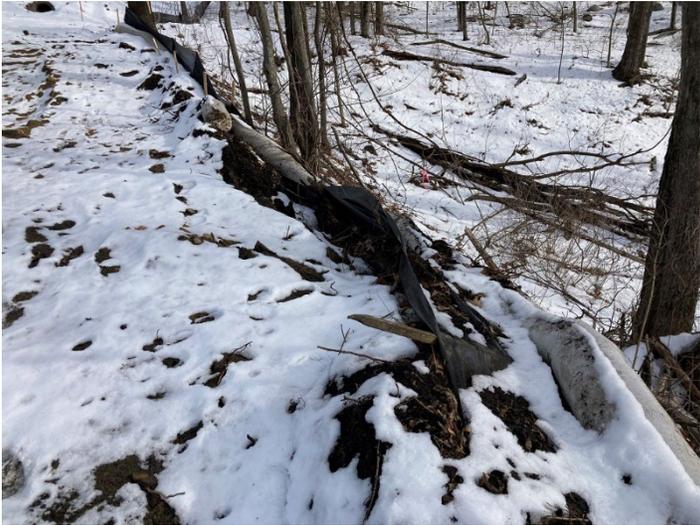
<b>11. Silt Fencing &amp; Filter Tubes in Stow (segment 1 Off Chestnut St)</b>	<input checked="" type="checkbox"/> Yes <input type="checkbox"/> No	1	<input type="checkbox"/> Yes <input checked="" type="checkbox"/> No	3/06/2023	-Repair silt fence and filter tubes where damaged in multiple places in segment 1 (routine maintenance).

<b>Description:</b> View of E&S controls at approximately sta. #131 in segment 1. Repair silt fence and filter tubes where needed in multiple locations in segment 1 (routine maintenance). Facing east.

**-Repair silt fence and filter tubes where damaged in multiple places in segment 1.**

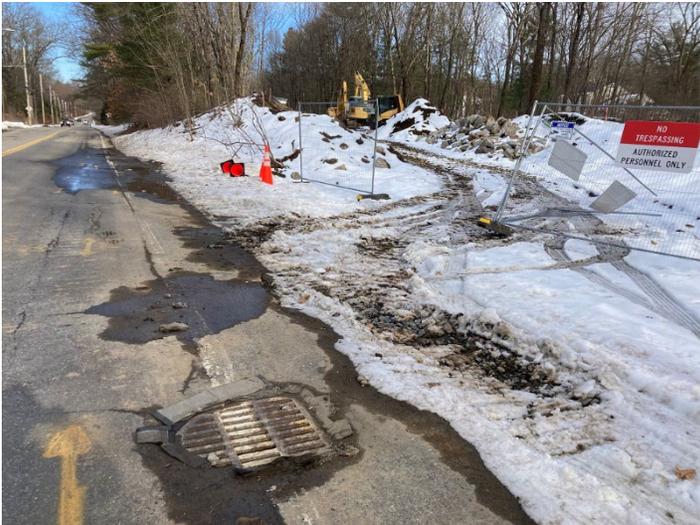
<b>Description:</b> View of construction entrance to segment 1 at Wilkins St. Silt sack inlet protection is operating properly. Facing northeast.

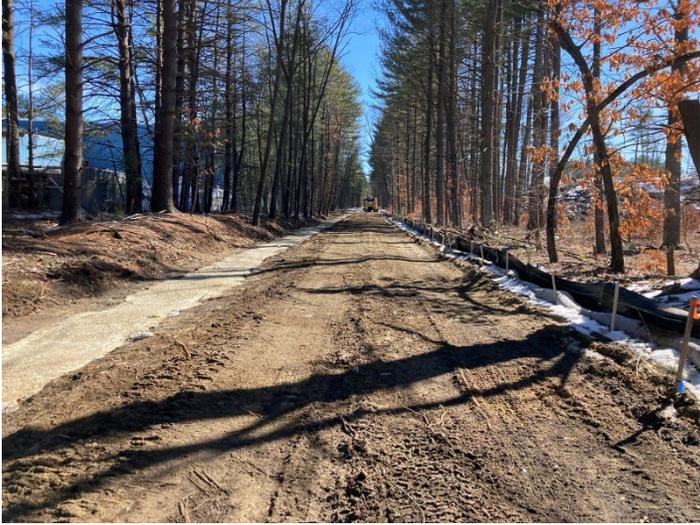
<b>Description:</b> View of segment 4. E&S controls are operating properly. Facing east.
