Client: Town of Sudbury
 Project Name: Sudbury-Hudson Transmission Reliability
 Inspector: Jeffrey Polidor
 Project No: 22012F
 Inspection Date: 5/05/23 Arrival Time: 7:00 AM
 Weather: Light rain, 50°F Departure Time: 10:00 AM

Sudbury to Hudson
 115kV Underground Transmission Line
 Sudbury - Hudson, MA
 Date: November 16, 2018

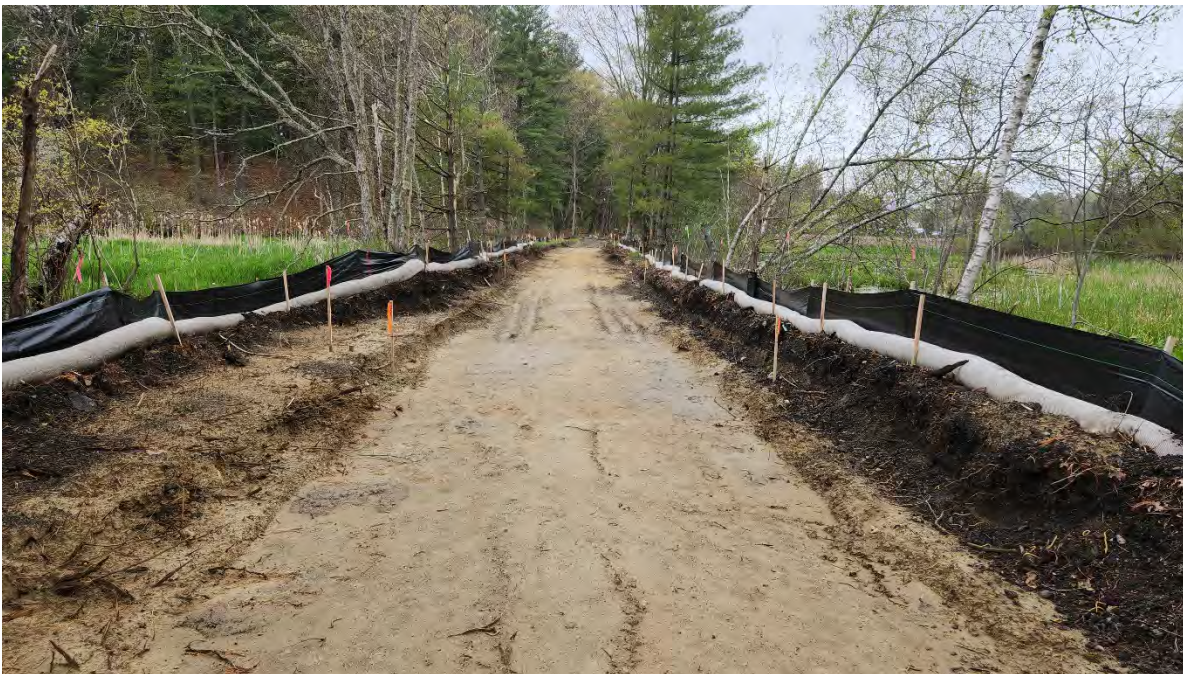
- Silt fence and filter tube are functioning properly along segments 14 and 11 (Photos 1 and 4).
- Silt fence is sagging and filter tube is broken along segment 13 (Photo 2).
- Silt fence along segment 12 is sagging along Hop Brook behind tree stump (Photo 3).
- Construction entrance STA407+50 has visible sediment tracking into the road (Photo 5).
- Silt fence along segment 10 has two broken stakes and is starting to rip. (Photos 6 and 7).
- Silt fence has a broken stake along segment 9 (Photo 8).
- Silt fence along segment 8 has a broken stake and noticeable sagging near Hop Brook Bridge (Photo 9).
- Silt fence along segment has noticeable sagging near Hop Brook Bridge (Photo 10).

**Photo 1:** Silt fence and filter tube functioning properly along segment 14.

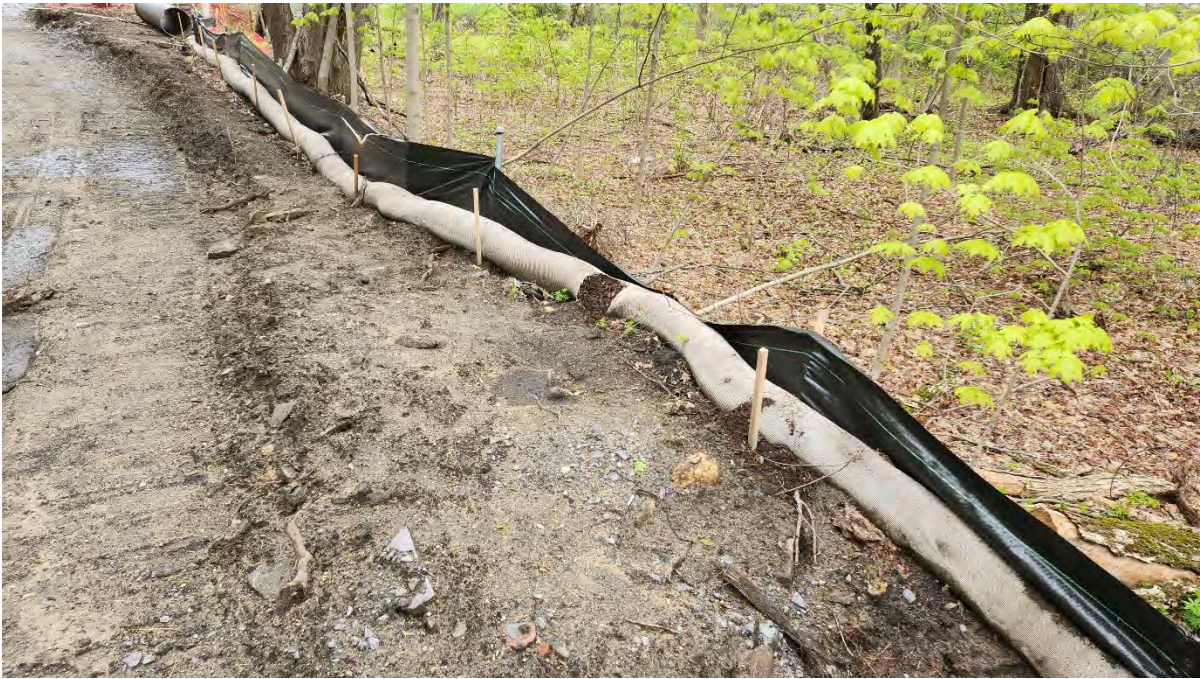
Photo 2: Broken filter tube and notable sagging in the silt fence along segment 13.
Photo taken on 5/05/23

1. Repair silt fence and filter tube as noted above.
2. Add stones to construction entrance STA407+50.

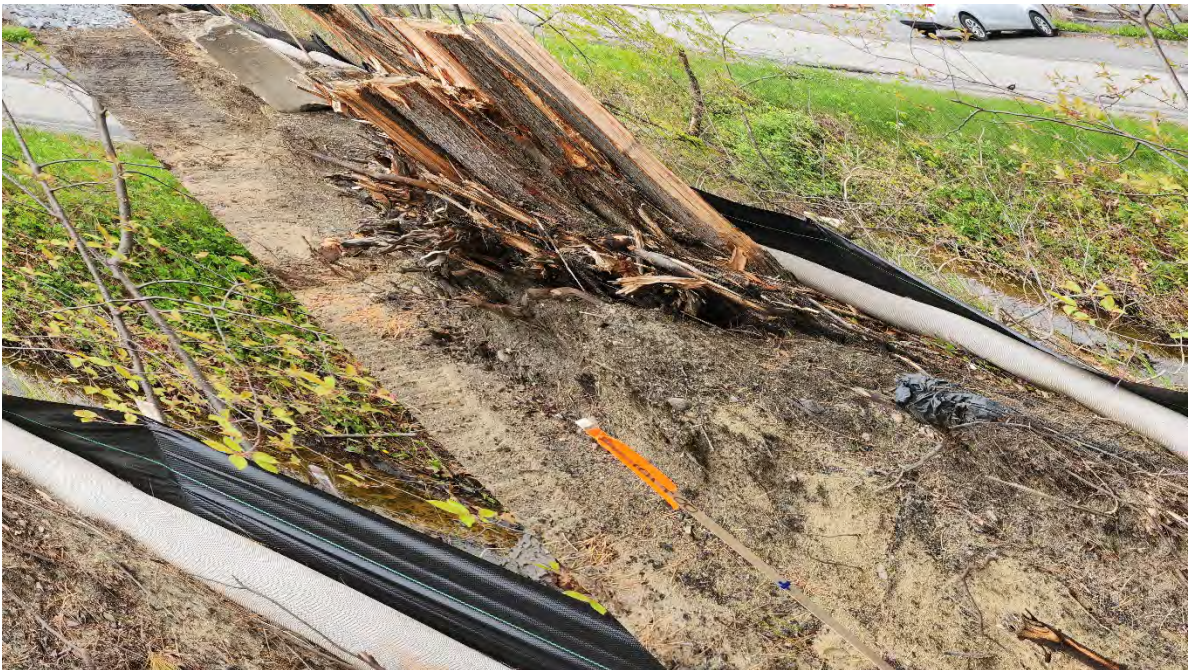
Photo 3: Notable sagging in the silt fence along segment 12.
Photo taken on 5/05/23

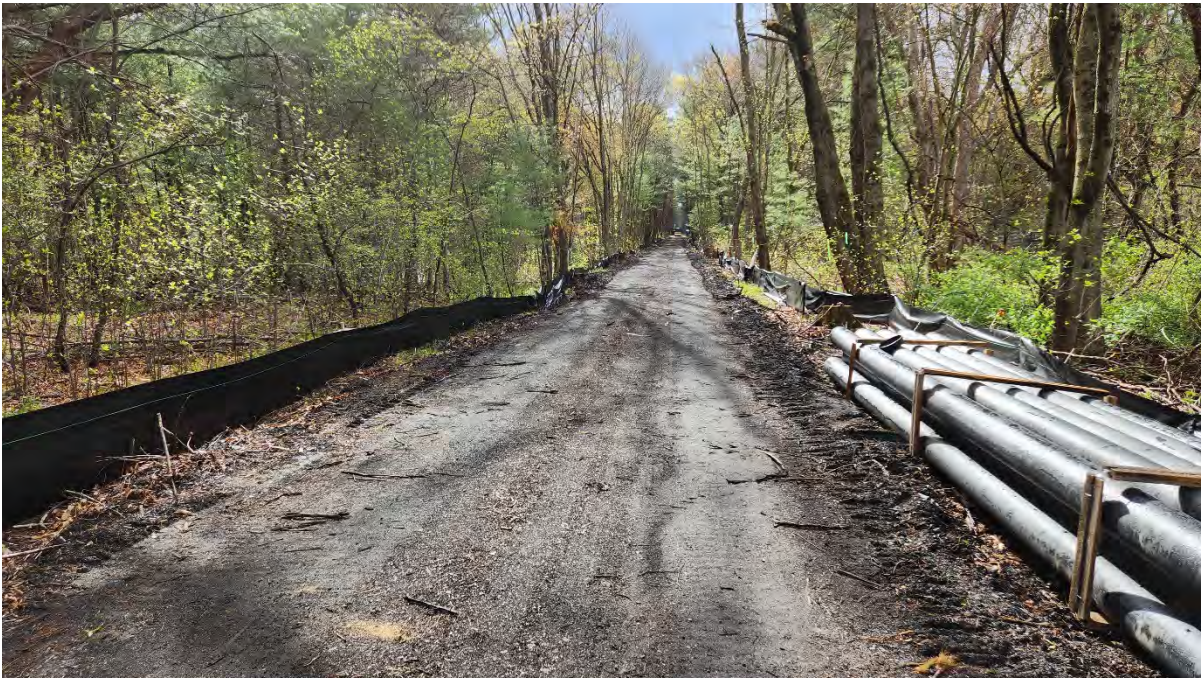
Photo 4: Silt fence functioning properly along segment 11.
Photo taken on 5/05/23

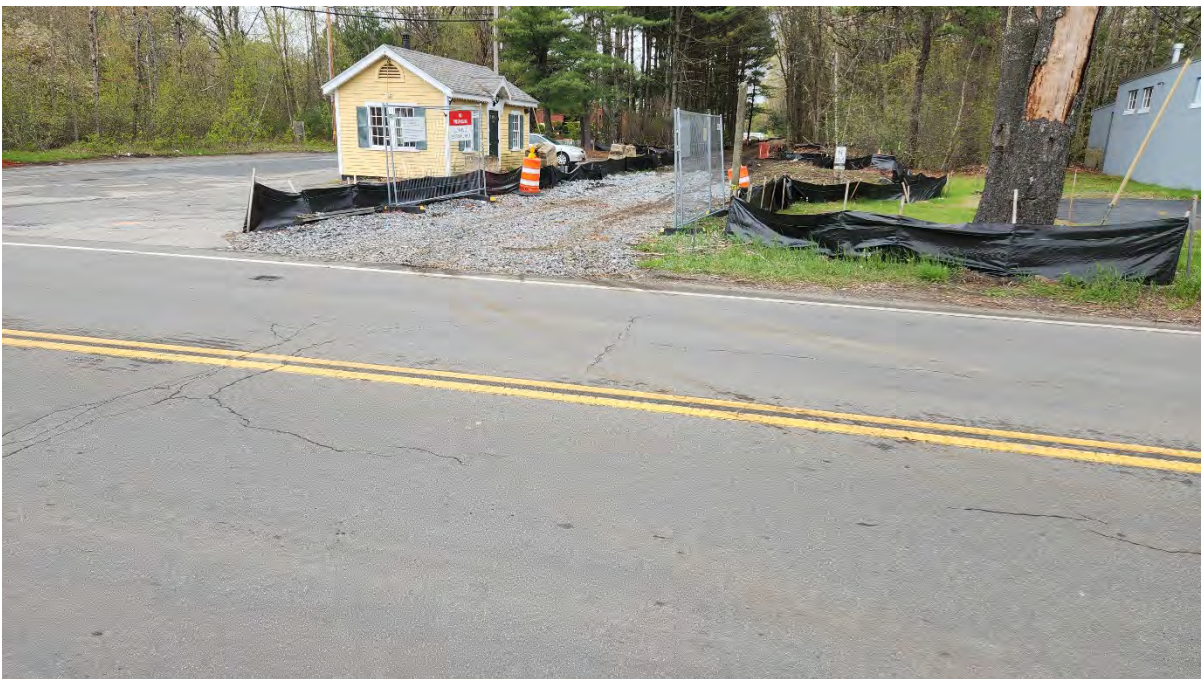
Photo 5: Construction entrance STA407+50 has visible sediment tracking into road.
Photo taken on 5/05/23

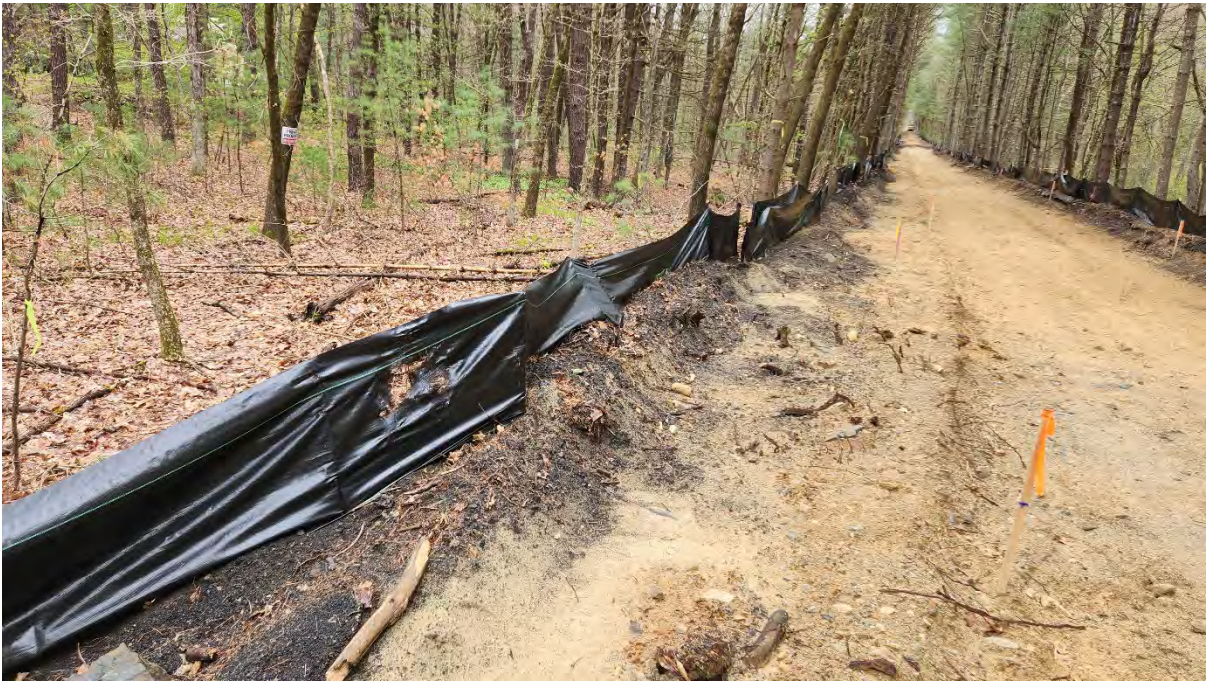
Photo 6: Silt fence ripping and a broken stake in the fence along segment 10.
Photo taken on 5/05/23

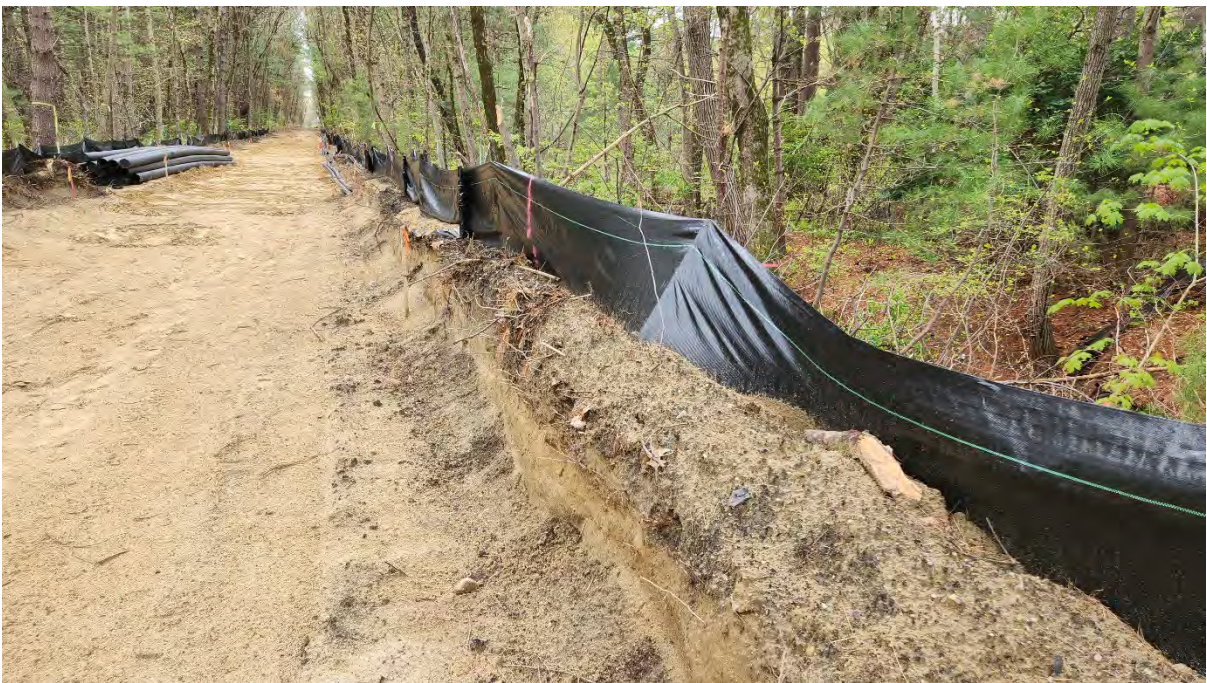
Photo 7: Broken stake in the silt fence along segment 10.
Photo taken on 5/05/23

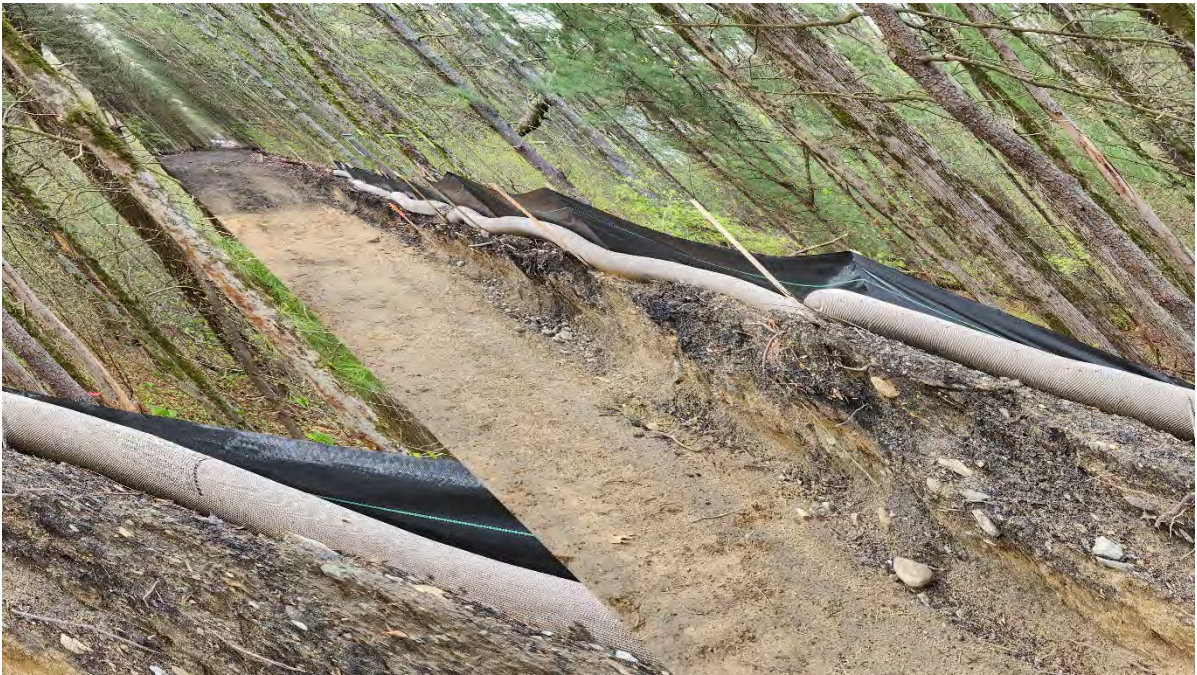
Photo 8: Broken stake in the silt fence along segment 9.
Photo taken on 5/05/23

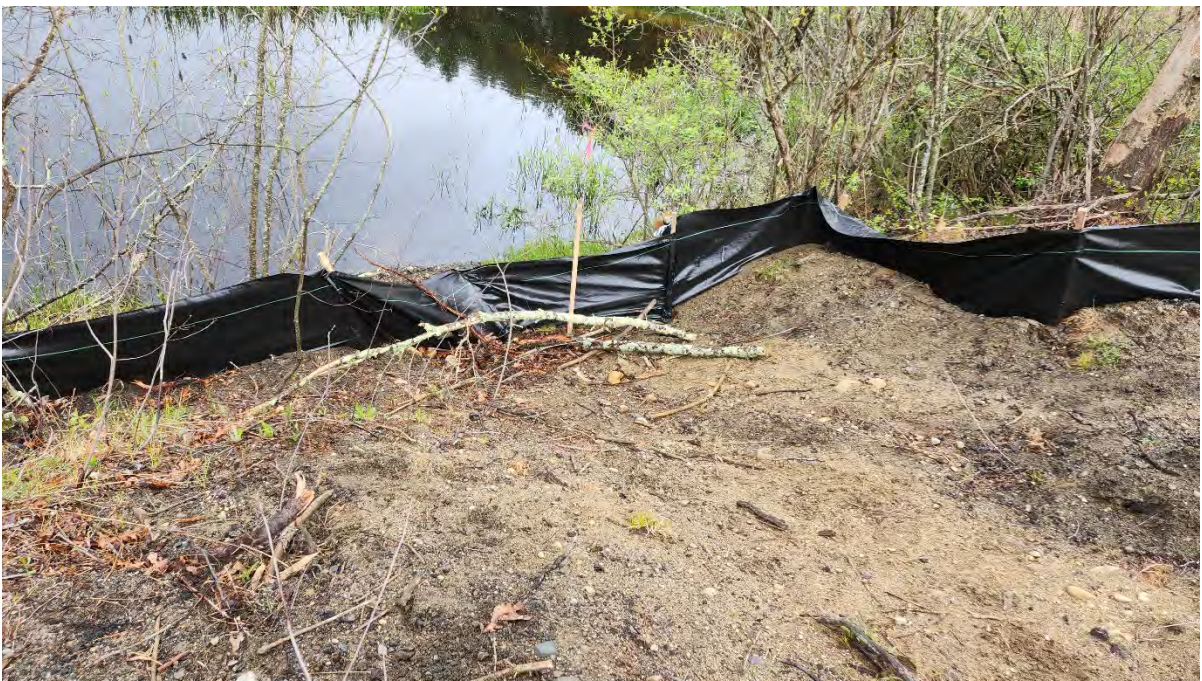
Photo 9: Silt fence sagging and broken stake in the fence at Hop Brook Bridge along segment 8.
Photo taken on 5/05/23

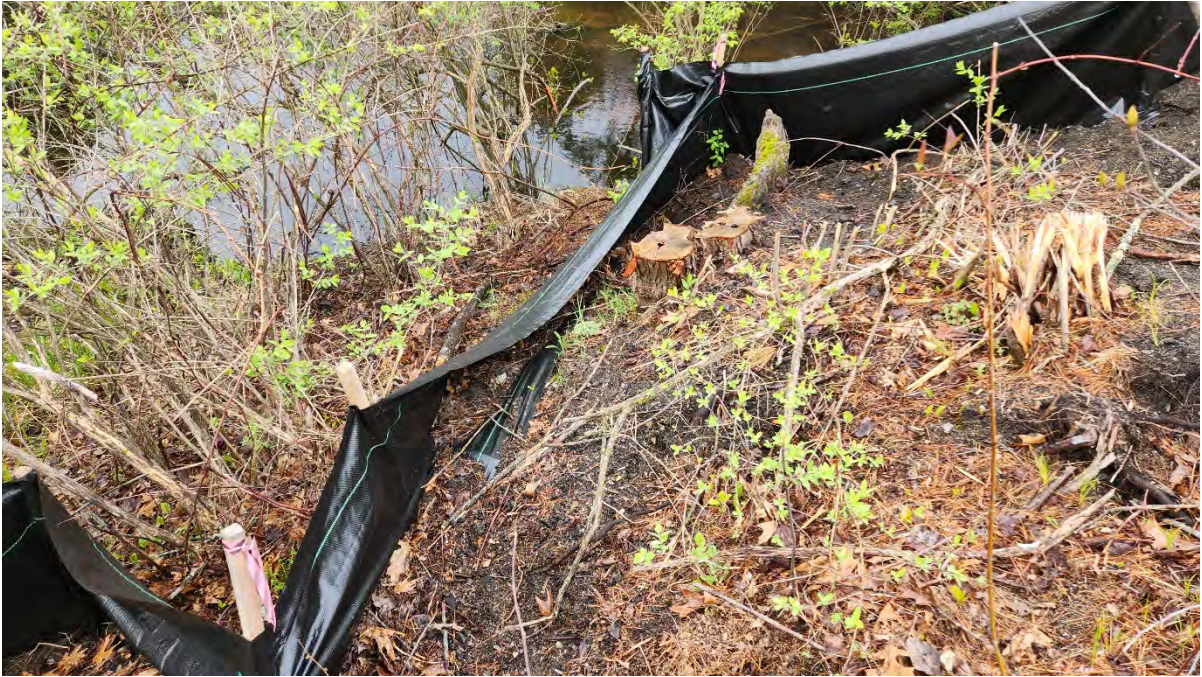
Photo 10: Silt fence sagging at Hop Brook Bridge along segment 7.
Photo taken on 5/05/23
