Field Report No. 10	page
---------------------	------

Client:			Town of Sudbury
	Project Name:		Sudbury-Hudso	n Transmission Reliability
	Inspector:			Jeffrey Polidor
	Project No:			22012F
Lardov Witton	Inspection Date:	5/24/23	Arrival Time:	12:00 PM
Horsley Witten Group, Inc.	Weather:	Sunny, 75°F	<b>Departure Time:</b>	3:00 PM

Sudbury to Hudson

115kV Underground Transmission Line

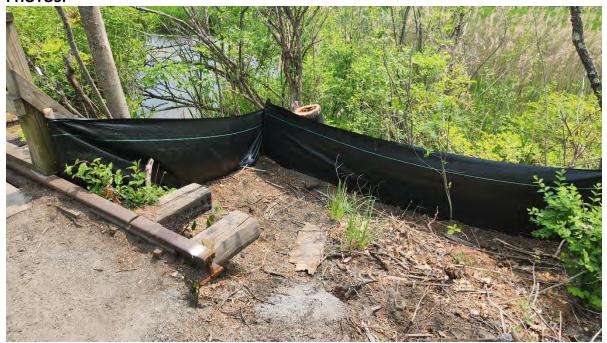
**Photo 1:** Silt fence and filter tube functioning properly along segment 14. Photo taken on 5/24/23

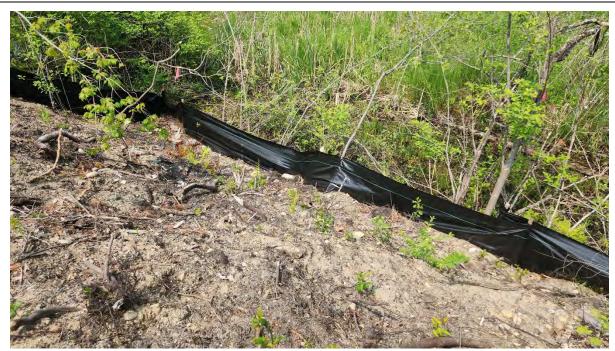
- Silt fence and filter tube are functioning properly along segments 14, 12, 11, 10, 8, and 7 (Photos 1, 4, 5, 6, 9, and 10).
- Silt fence is sagging in one location and lifted above the ground in a second location along segment 13 near Hop Brook Bridge (Photos 2-3).
- Construction entrance at STA 407+50 has visible sediment tracking into the road (Photo 7).
- Silt fence has a broken stake along segment 9 (Photo 8).

**Photo 2:** Broken stake in the silt fence along segment 13 near Hop Brook Bridge. Photo taken on 5/24/23

1. Repair silt fence and filter tube as noted above.

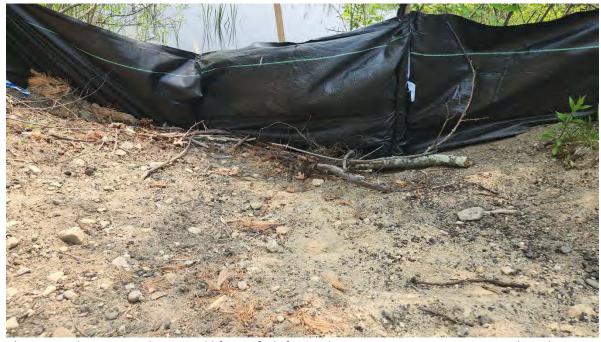
**Photo 3:** Debris accumulating and lifting of silt fence along segment 13 near Hop Brook Bridge. Photo taken on 5/24/23

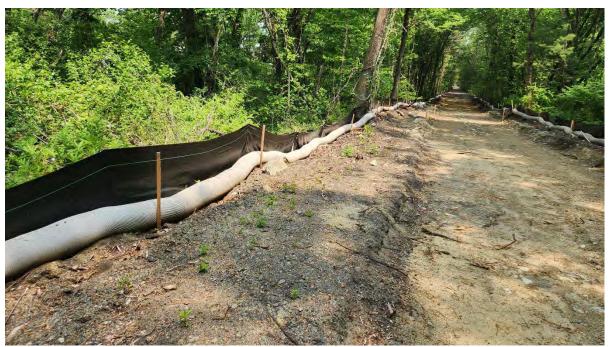
**Photo 4:** Silt fence functioning properly along segment 12. Photo taken on 5/24/23

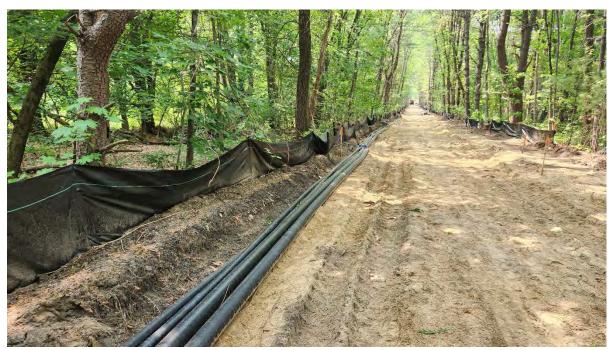
**Photo 5:** Silt fence functioning properly along segment 11. Photo taken on 5/24/23

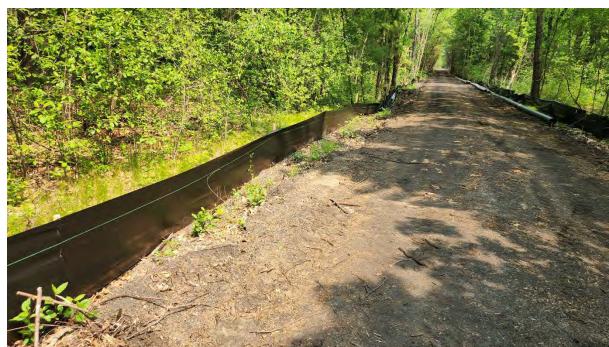
**Photo 6:** Silt fence functioning properly along segment 10. Photo taken on 5/24/23

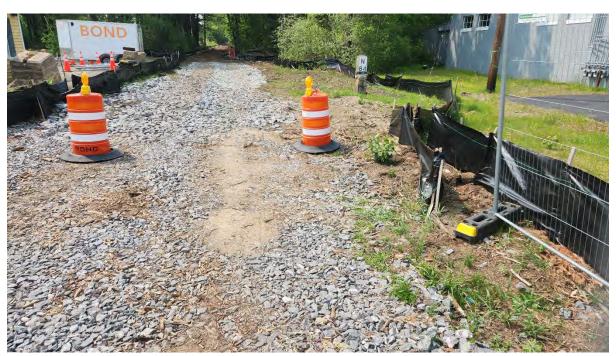
**Photo 7:** Construction entrance at STA 407+50 has visible sediment tracking onto the road. Photo taken on 5/24/23

2. Add stones to the construction entrance at STA 407+50.

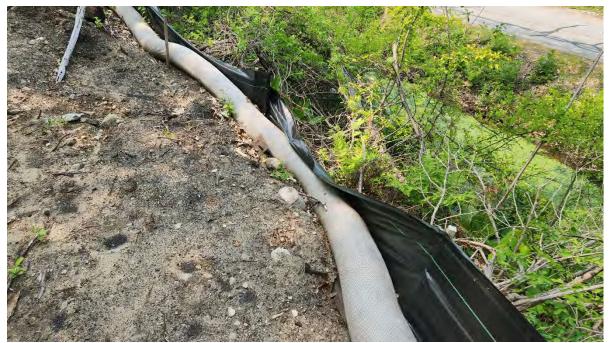
**Photo 8:** Broken stake in the silt fence along segment 9. Photo taken on 5/24/23

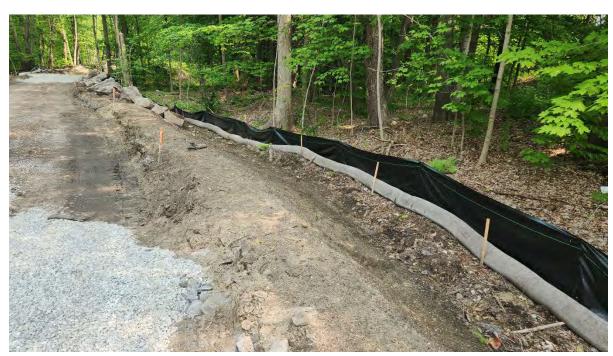
**Photo 9:** Silt fence functioning properly along segment 8. Photo taken on 5/24/23

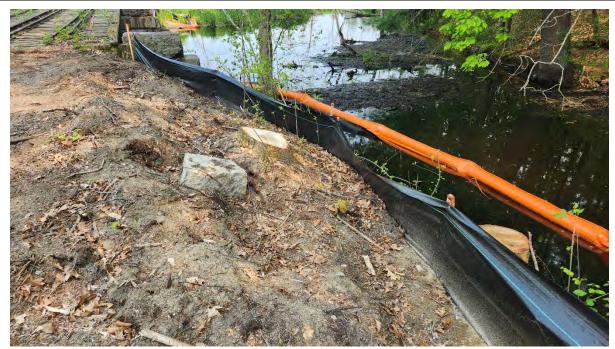
**Photo 10:** Silt fence functioning properly along segment 7. Photo taken on 5/24/23
