## Weekly Environmental Compliance Summary

**Sudbury to Hudson Transmission Reliability Project (USEPA Tracking # MAR1003UW)**

Week of: May 8 to May 12, 2023

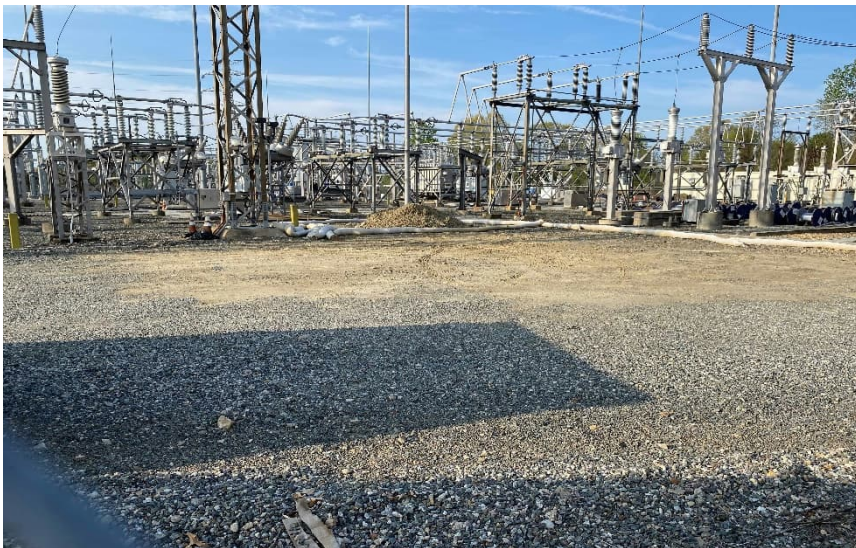
<b>PHOTOGRAPHIC LOG</b>	
Client Name: Eversource		Site Location: Sudbury to Hudson Transmission Reliability Project	
Photo No.: 1      Date: 5-9-23		Town: Sudbury	
Description:  Sudbury Substation, new spoil pile, looking southward.

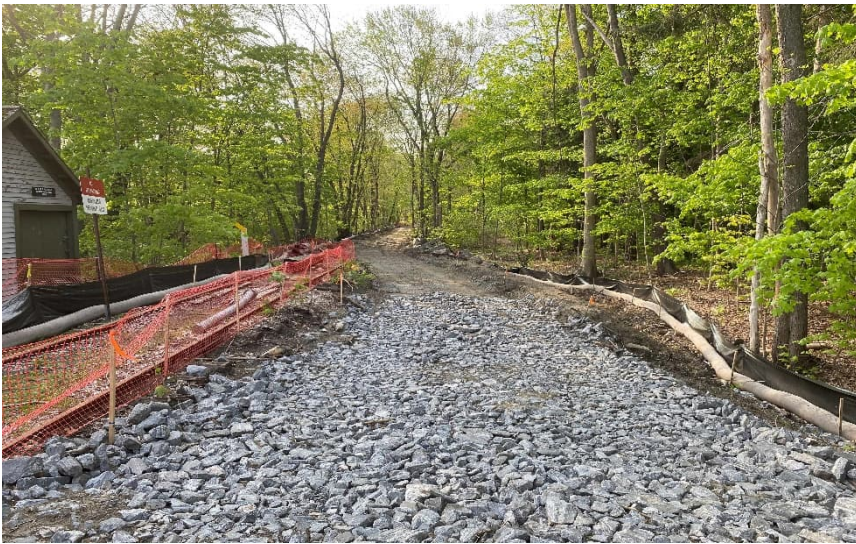
<b>PHOTOGRAPHIC LOG</b>	
Client Name: Eversource		Site Location: Sudbury to Hudson Transmission Reliability Project	
Photo No.: 2      Date: 5-9-23		Town: Sudbury	
Description:  Right-of-way within segment 13, existing erosion control, looking eastward.

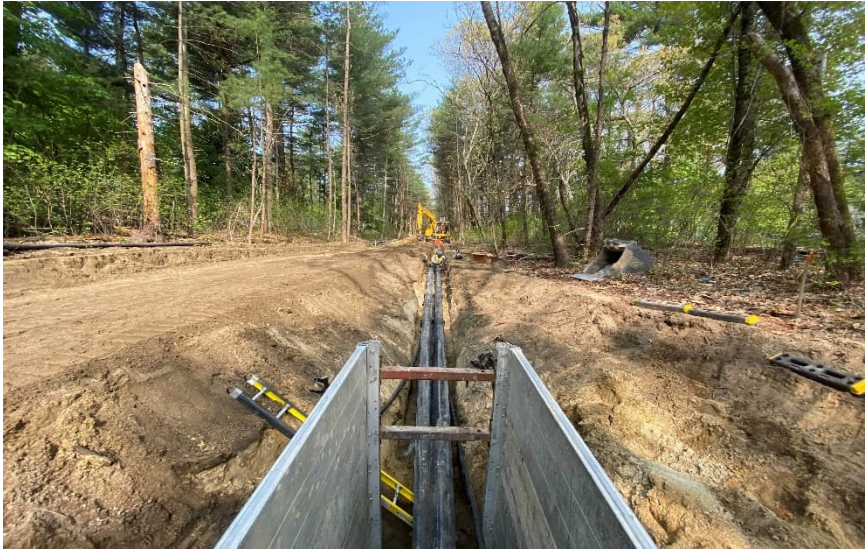
<b>PHOTOGRAPHIC LOG</b>	
Client Name: Eversource		Site Location: Sudbury to Hudson Transmission Reliability Project	
Photo No.: 3      Date: 5-9-23		Town: Sudbury	
Description:  Conduit work within segment 10 from manhole #21, looking westward.

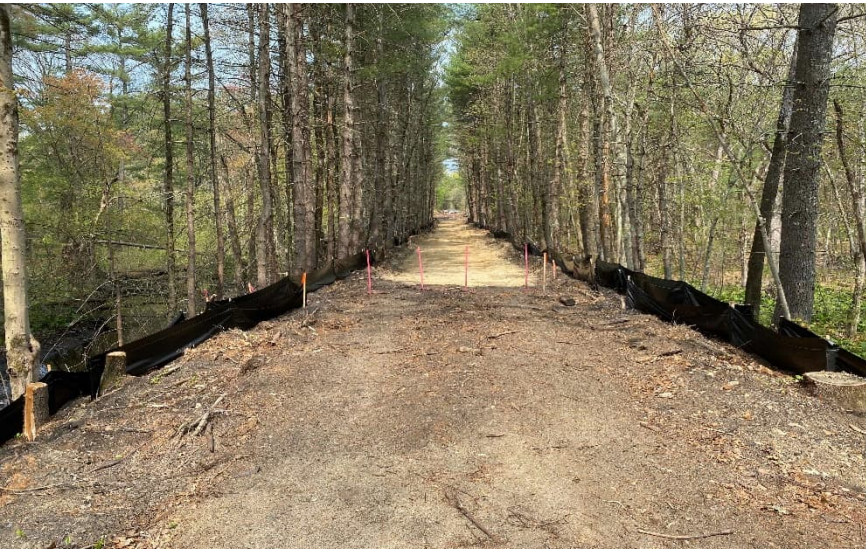
<b>PHOTOGRAPHIC LOG</b>	
Client Name: Eversource		Site Location: Sudbury to Hudson Transmission Reliability Project	
Photo No.: 4      Date: 5-9-23		Town: Sudbury	
Description:  Right-of-way within Segment 10 at approximate Sta# 539+10, existing erosion control, looking eastward.

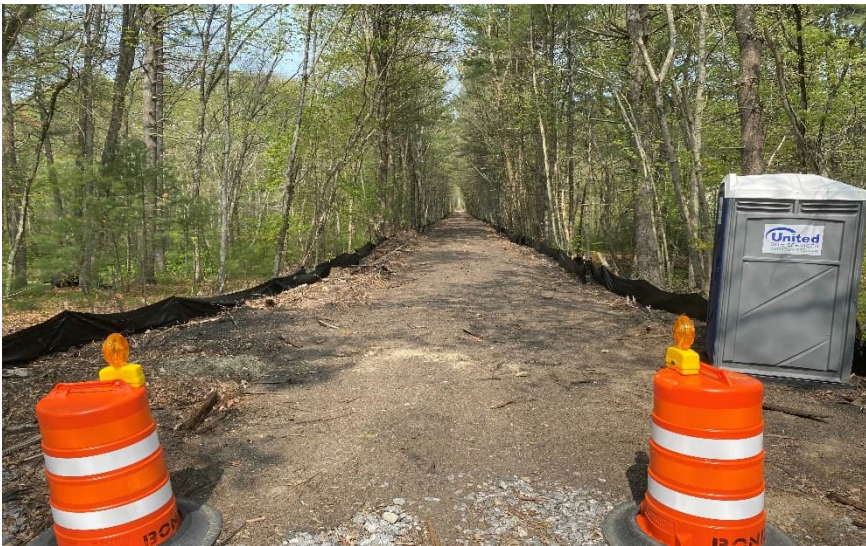
<b>PHOTOGRAPHIC LOG</b>	
Client Name: Eversource		Site Location: Sudbury to Hudson Transmission Reliability Project	
Photo No.: 5      Date: 5-9-23		Town: Sudbury	
Description:  Right-of-way within Segment 9 at Peakham Road, existing erosion control, looking westward

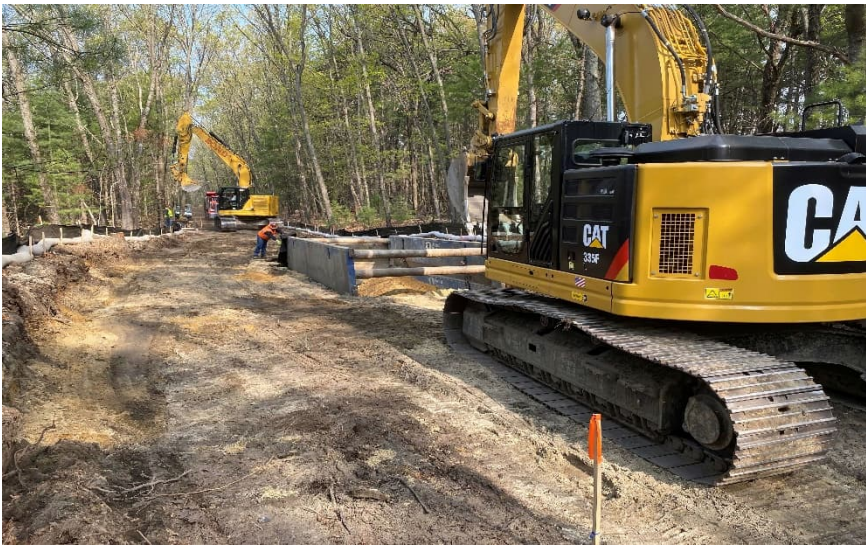
<b>PHOTOGRAPHIC LOG</b>	
Client Name: Eversource		Site Location: Sudbury to Hudson Transmission Reliability Project	
Photo No.: 6      Date: 5-9-23		Town: Sudbury	
Description:  Right-of-way at manhole 23 within segment 11, looking westward.

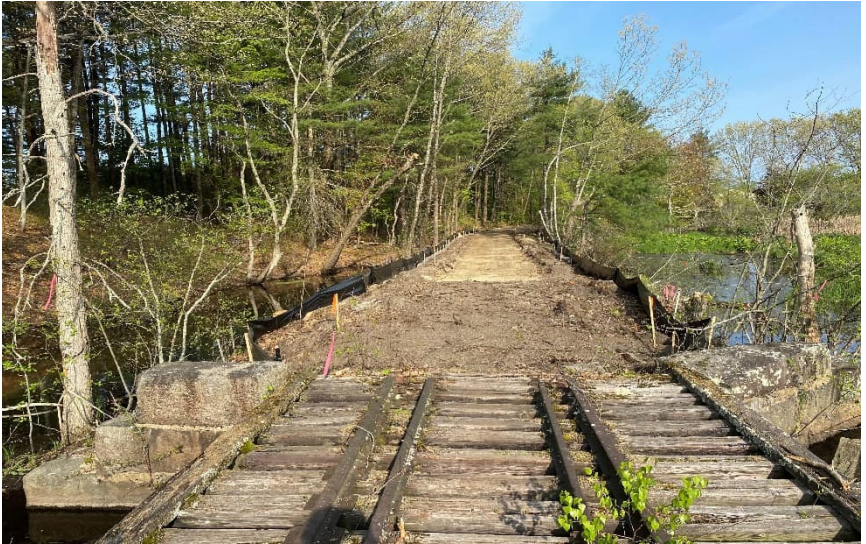
<h2 style="text-align: center;">PHOTOGRAPHIC LOG</h2>	
Client Name: Eversource		Site Location: Sudbury to Hudson Transmission Reliability Project	
Town: Sudbury			
Photo No.: 7	Date: 5-9-23

Description:  Right-of-way at Bridge 127 looking into Segment 13, existing erosion control, looking westward.

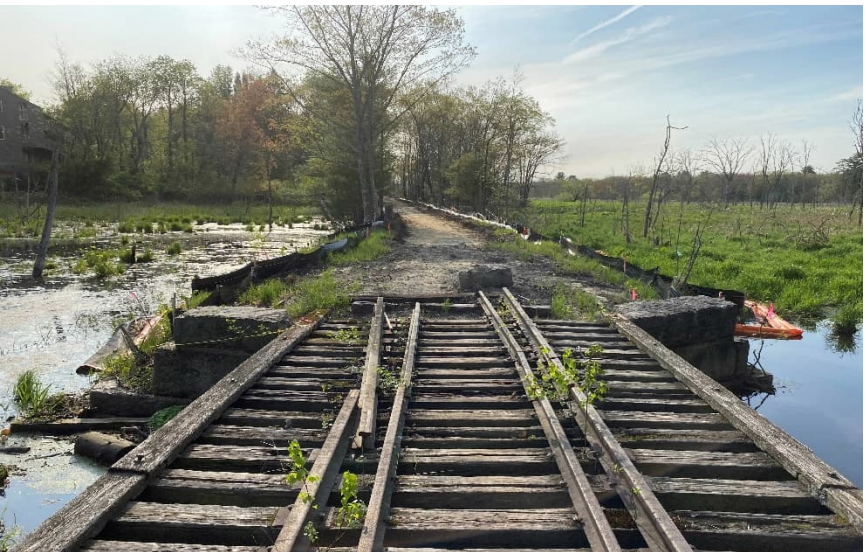
<h2 style="text-align: center;">PHOTOGRAPHIC LOG</h2>	
Client Name: Eversource		Site Location: Sudbury to Hudson Transmission Reliability Project	
Town: Sudbury			
Photo No.: 8	Date: 5-9-23

Description:  Right-of-way at Bridge 127 looking into Segment 14, existing erosion control, looking eastward.

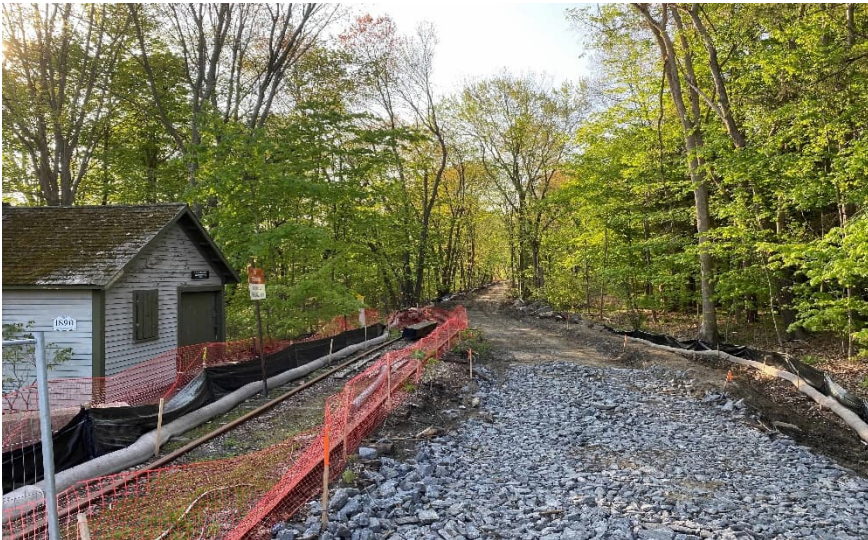
<b>PHOTOGRAPHIC LOG</b>	
Client Name: Eversource		Site Location: Sudbury to Hudson Transmission Reliability Project	
Photo No.: 1      Date: 5-10-23		Town: Sudbury	
Description:  Right-of-way within segment 13, existing erosion control, looking eastward.

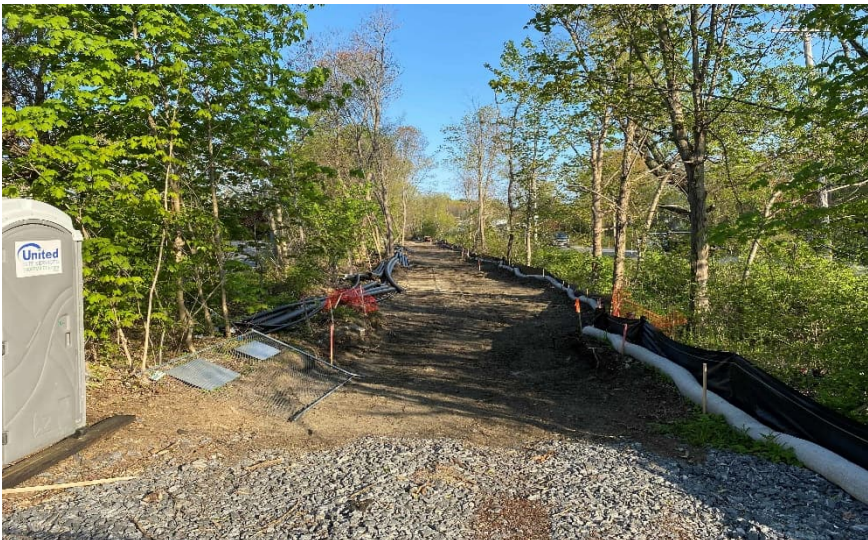
<b>PHOTOGRAPHIC LOG</b>	
Client Name: Eversource		Site Location: Sudbury to Hudson Transmission Reliability Project	
Photo No.: 2      Date: 5-10-23		Town: Sudbury	
Description:  Right-of-way within segment 12, existing erosion control, looking westward.

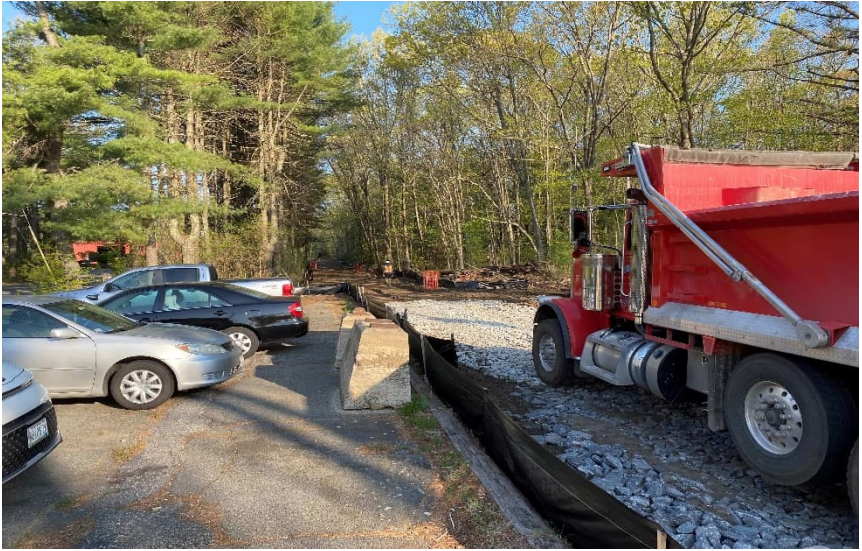
<b>PHOTOGRAPHIC LOG</b>	
Client Name: Eversource		Site Location: Sudbury to Hudson Transmission Reliability Project	
Town: Sudbury			
Photo No.: 3	Date: 5-10-23

Description:  Access to segment 11 with vernal pool monitor leading equipment to manhole #23, looking westward.

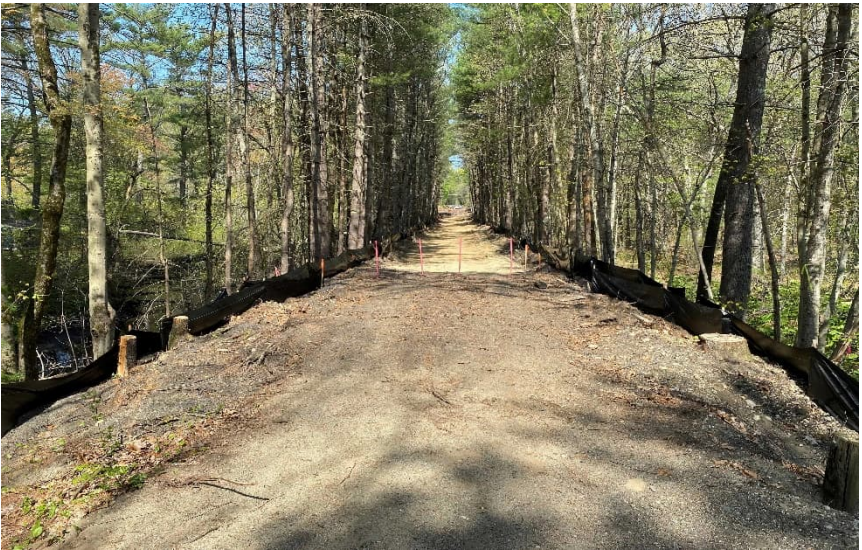
<b>PHOTOGRAPHIC LOG</b>	
Client Name: Eversource		Site Location: Sudbury to Hudson Transmission Reliability Project	
Town: Sudbury			
Photo No.: 4	Date: 5-10-23

Description:  Right-of-way within Segment 10 at approximate Sta# 539+10, existing erosion control, looking westward.

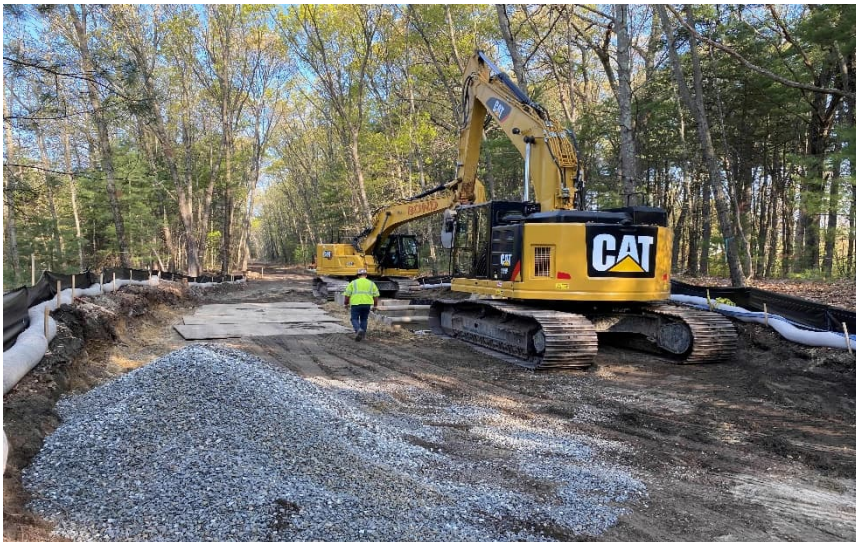
<b>PHOTOGRAPHIC LOG</b>	
Client Name: Eversource		Site Location: Sudbury to Hudson Transmission Reliability Project	
Photo No.: 5      Date: 5-10-23		Town: Sudbury	
Description:  Right-of-way within Segment 11 at manhole #23, existing erosion control, looking westward

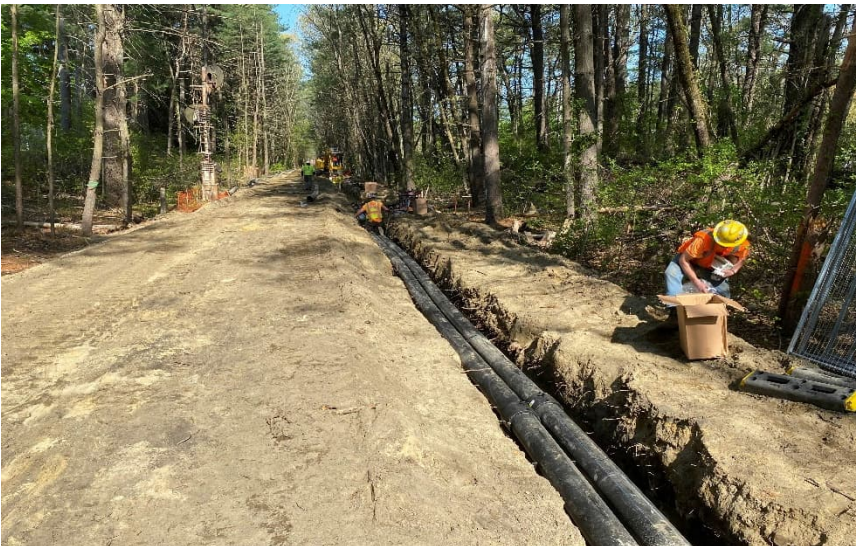
<b>PHOTOGRAPHIC LOG</b>	
Client Name: Eversource		Site Location: Sudbury to Hudson Transmission Reliability Project	
Photo No.: 6      Date: 5-10-23		Town: Sudbury	
Description:  Conduit work within segment 10, looking westward.

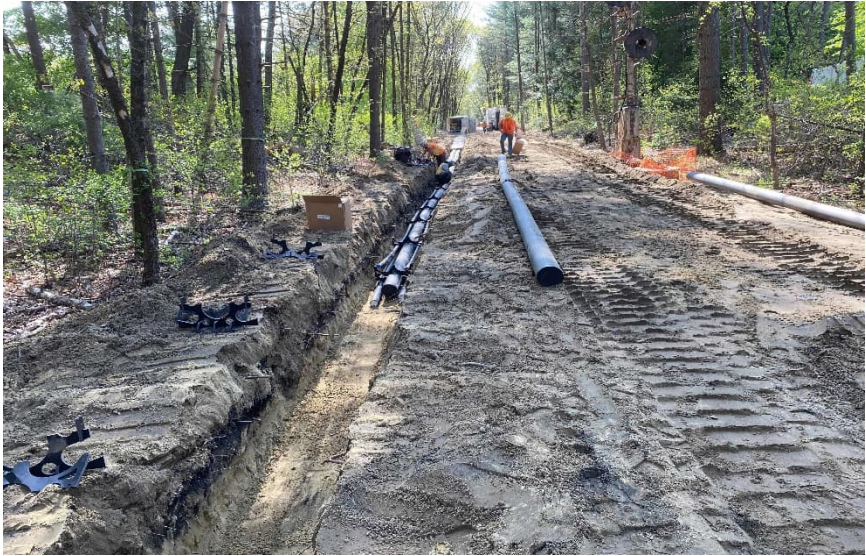
<b>PHOTOGRAPHIC LOG</b>	
Client Name: Eversource		Site Location: Sudbury to Hudson Transmission Reliability Project	
Town: Sudbury			
Photo No.: 7	Date: 5-10-23

Description:  Conduit work within segment 10, looking eastward.

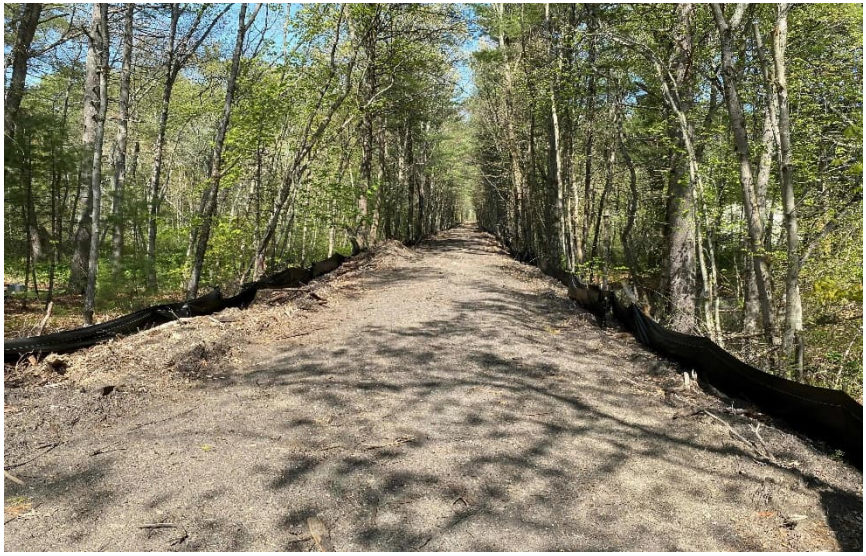
<b>PHOTOGRAPHIC LOG</b>	
Client Name: Eversource		Site Location: Sudbury to Hudson Transmission Reliability Project	
Town: Sudbury			
Photo No.: 8	Date: 5-10-23

Description:  Right-of-way at Segment 9, off Peakham Road, existing erosion control, looking westward.

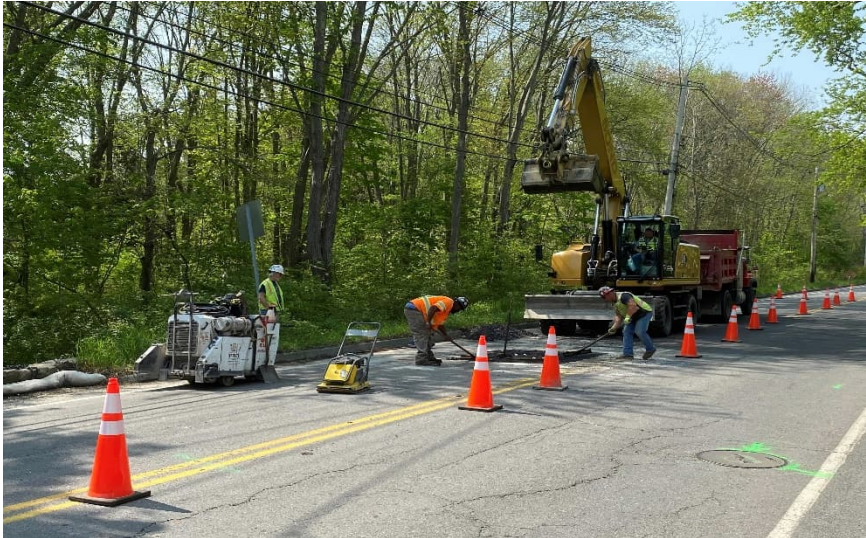
<b>PHOTOGRAPHIC LOG</b>	
Client Name: Eversource		Site Location: Sudbury to Hudson Transmission Reliability Project	
Town: Hudson			
Photo No.: 1	Date: 5-11-23

Description:  Bond working within Forest Avenue, near manhole #4, looking eastward.

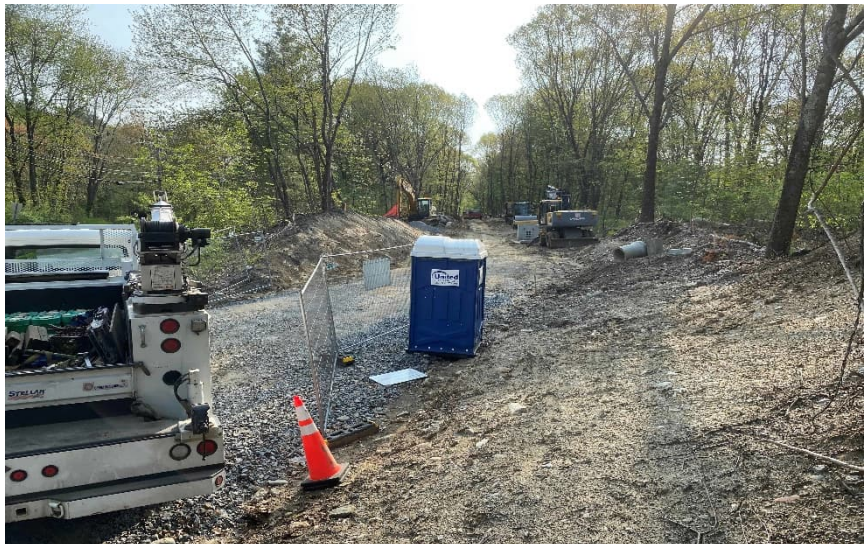
<b>PHOTOGRAPHIC LOG</b>	
Client Name: Eversource		Site Location: Sudbury to Hudson Transmission Reliability Project	
Town: Hudson			
Photo No.: 2	Date: 5-11-23

Description:  ET&L busting rock within segment 1, looking eastward.

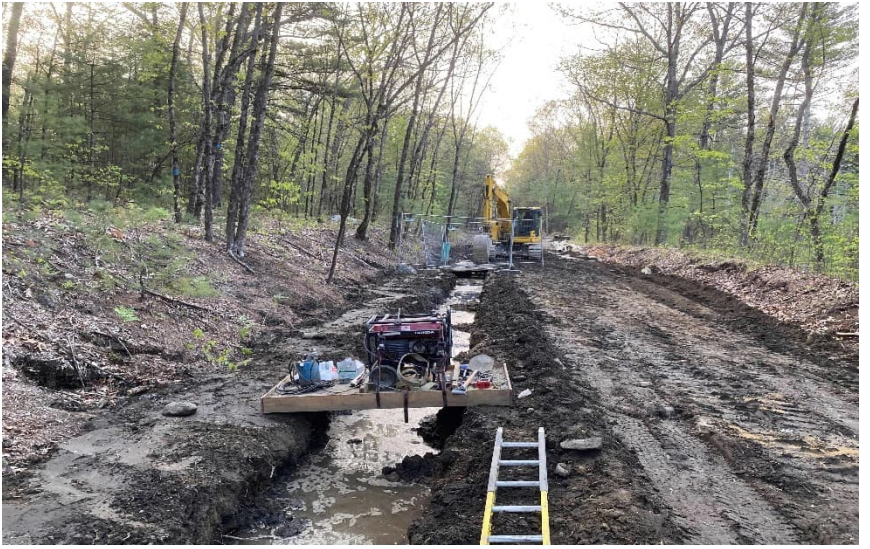
<b>PHOTOGRAPHIC LOG</b>	
Client Name: Eversource		Site Location: Sudbury to Hudson Transmission Reliability Project	
Town: Hudson			
Photo No.: 3	Date: 5-11-23

Description:  Conduit work within segment 5, looking eastward.

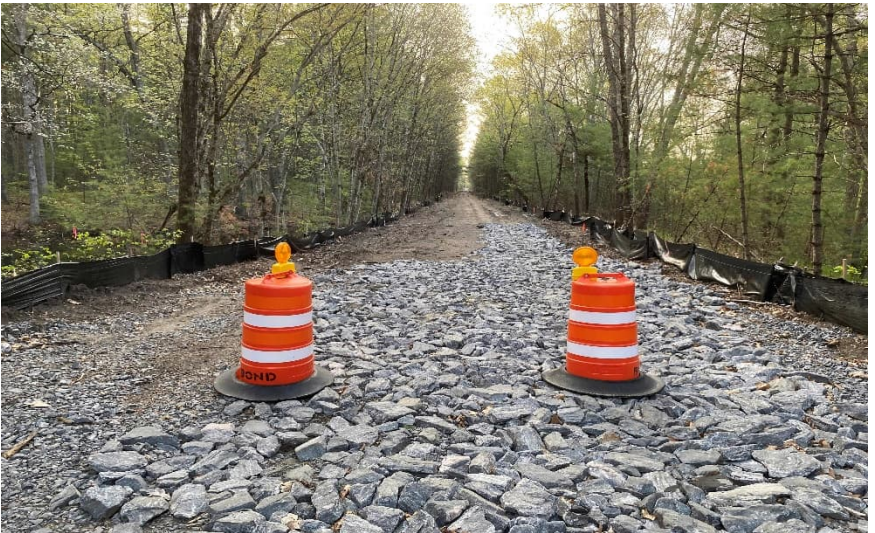
<b>PHOTOGRAPHIC LOG</b>	
Client Name: Eversource		Site Location: Sudbury to Hudson Transmission Reliability Project	
Town: Hudson			
Photo No.: 4	Date: 5-11-23

Description:  Right-of-way within Segment 6, existing erosion control, looking eastward.

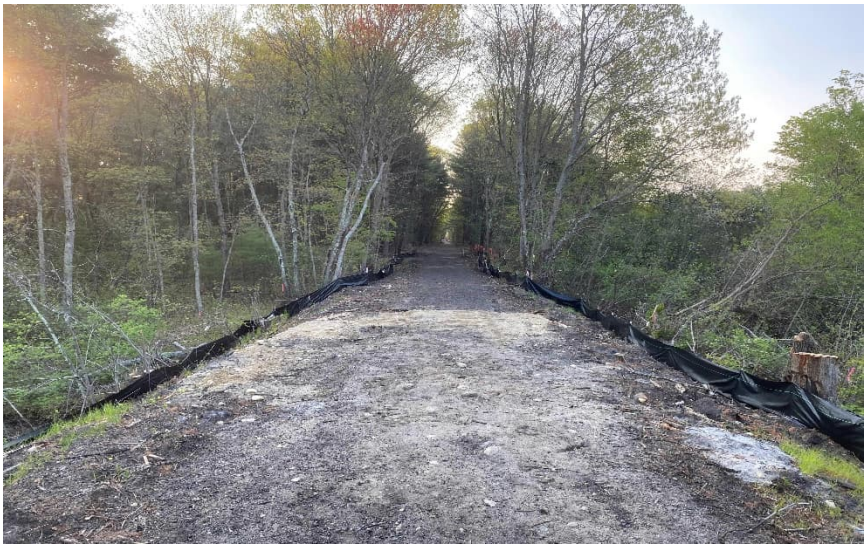
<b>PHOTOGRAPHIC LOG</b>	
Client Name: Eversource		Site Location: Sudbury to Hudson Transmission Reliability Project	
Photo No.: 5      Date: 5-11-23		Town: Sudbury	
Description:  Right-of-way within Segment 8, existing erosion control, looking eastward

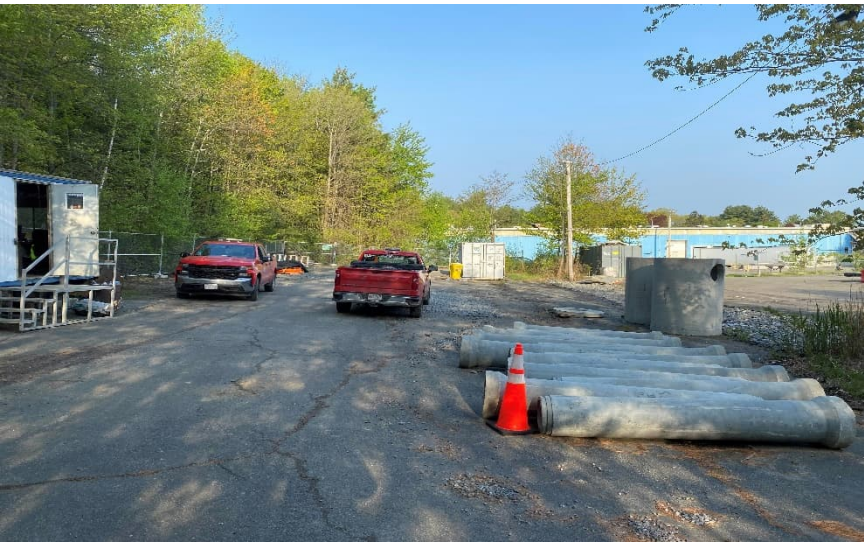
<b>PHOTOGRAPHIC LOG</b>	
Client Name: Eversource		Site Location: Sudbury to Hudson Transmission Reliability Project	
Photo No.: 6      Date: 5-11-23		Town: Hudson	
Description:  Laydown yard at 555 Main Street, looking westward.

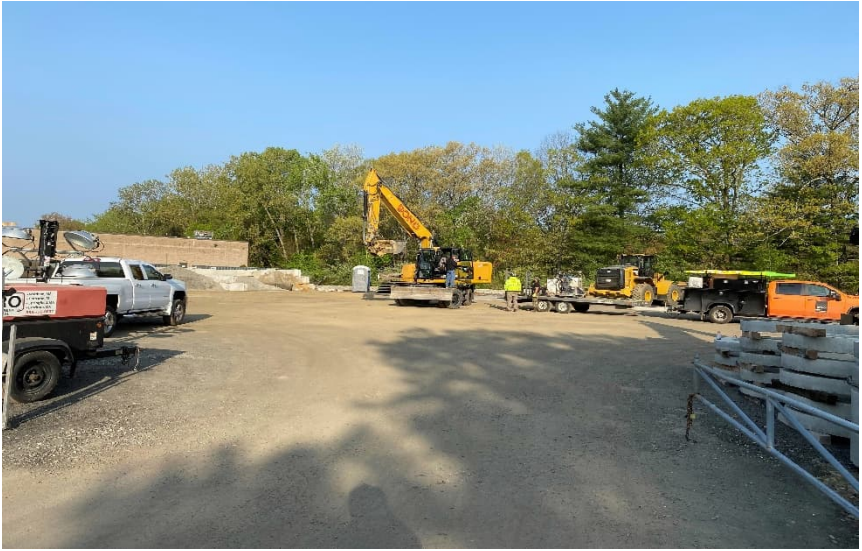
<b>PHOTOGRAPHIC LOG</b>	
Client Name: Eversource		Site Location: Sudbury to Hudson Transmission Reliability Project	
Town: Hudson			
Photo No.: 7	Date: 5-11-23

Description:  Laydown yard at Bonazzoli Avenue, looking westward.

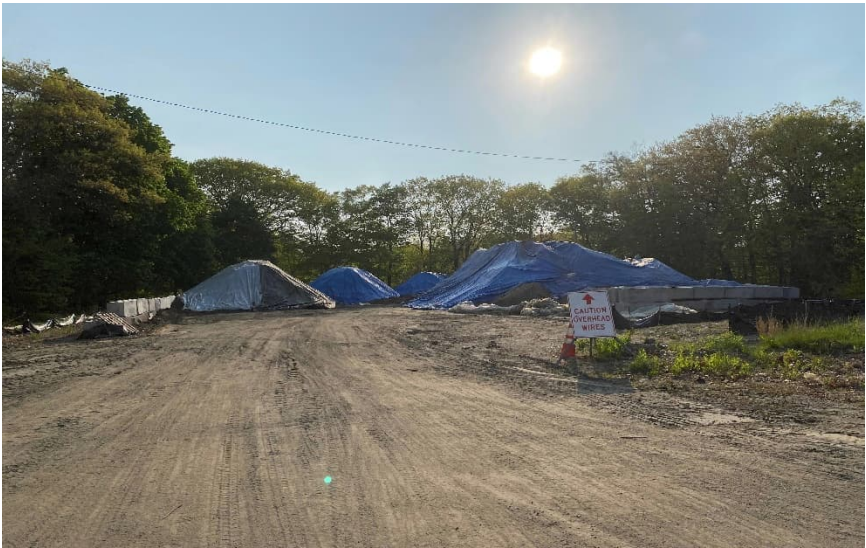
<b>PHOTOGRAPHIC LOG</b>	
Client Name: Eversource		Site Location: Sudbury to Hudson Transmission Reliability Project	
Town: Hudson			
Photo No.: 8	Date: 5-11-23

Description:  Laydown yard at Stowe Court, looking westward.

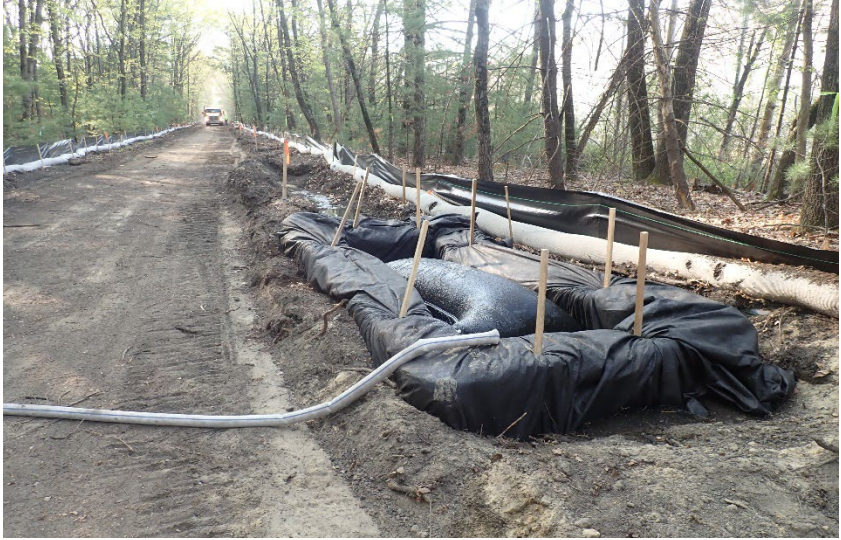
<b>PHOTOGRAPHIC LOG</b>	
<b>Client Name:</b> Eversource		<b>Site Location:</b> Sudbury to Hudson Transmission Reliability Project	
<b>Town:</b> Sudbury			
<b>Photo No.:</b> 1	<b>Date:</b> 5-11-23

<b>Description:</b>  View of dewatering setup associated with manhole #23 and view of erosion controls within right-of-way within segment 11. Looking eastward.

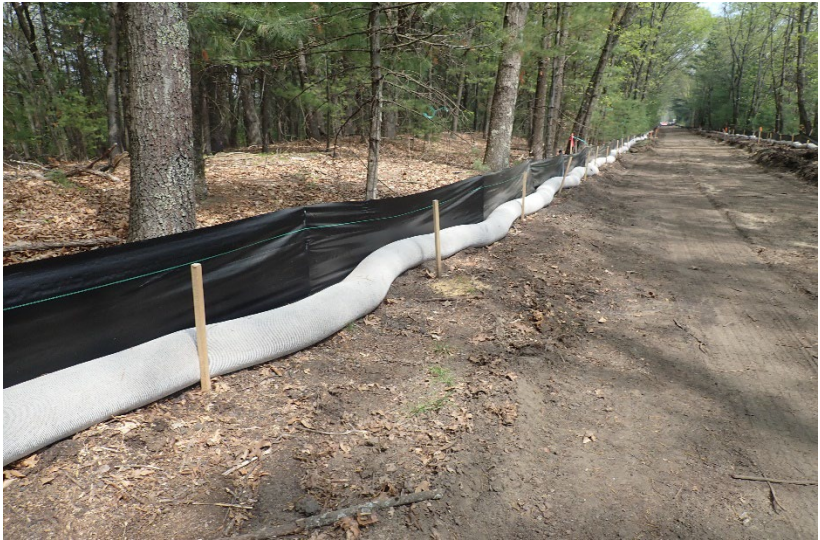
<b>PHOTOGRAPHIC LOG</b>	
<b>Client Name:</b> Eversource		<b>Site Location:</b> Sudbury to Hudson Transmission Reliability Project	
<b>Town:</b> Sudbury			
<b>Photo No.:</b> 2	<b>Date:</b> 5-11-23

<b>Description:</b>  View of existing erosion controls within segment 11, looking eastward.

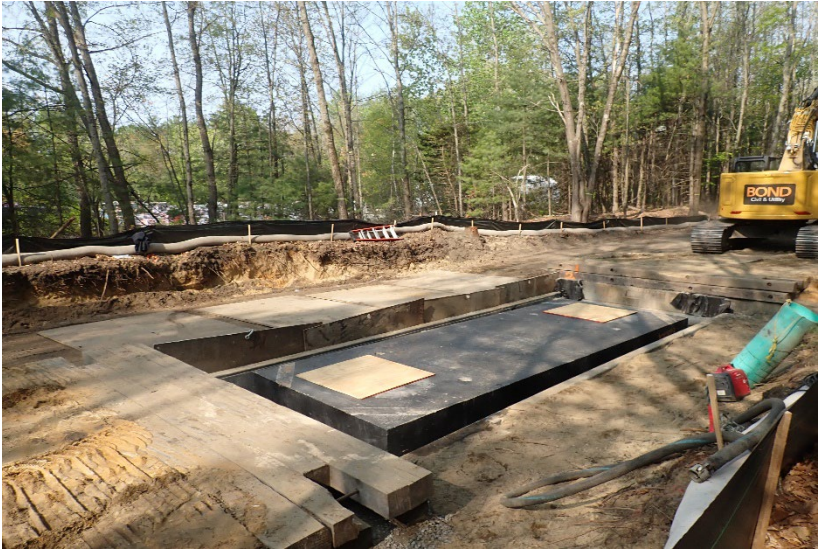
<b>PHOTOGRAPHIC LOG</b>	
<b>Client Name:</b> Eversource		<b>Site Location:</b> Sudbury to Hudson Transmission Reliability Project	
<b>Town:</b> Sudbury			
<b>Photo No.:</b> 3	<b>Date:</b> 5-11-23

<b>Description:</b>  View of manhole #23 installation within segment 11, looking northwest.

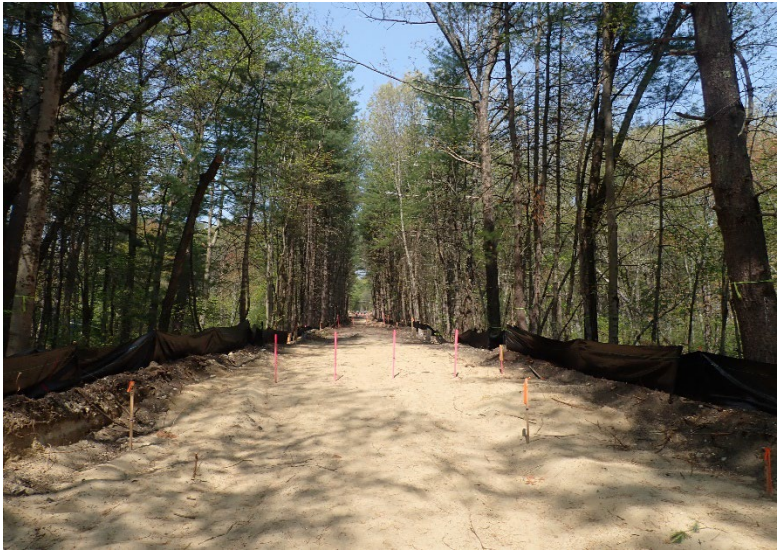
<b>PHOTOGRAPHIC LOG</b>	
<b>Client Name:</b> Eversource		<b>Site Location:</b> Sudbury to Hudson Transmission Reliability Project	
<b>Town:</b> Sudbury			
<b>Photo No.:</b> 4	<b>Date:</b> 5-11-23

<b>Description:</b>  View of existing erosion controls near culvert crossing within Segment 10, looking westward.

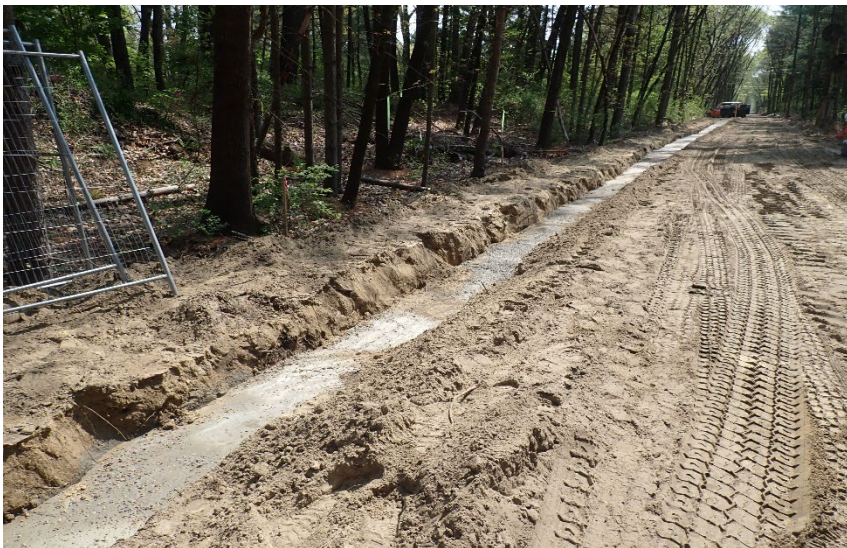
<b>PHOTOGRAPHIC LOG</b>	
<b>Client Name:</b> Eversource		<b>Site Location:</b> Sudbury to Hudson Transmission Reliability Project	
<b>Town:</b> Sudbury			
<b>Photo No.:</b> 6	<b>Date:</b> 5-11-23

<b>Description:</b>  View of conduit work within segment 10, looking eastward.

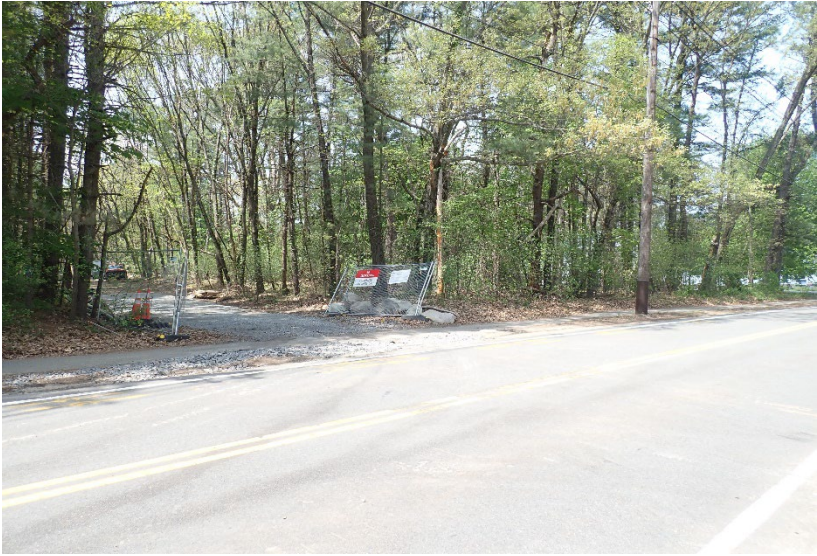
<b>Description:</b>  View of construction entrance to segment 10, where active work is occurring. Looking southwest.

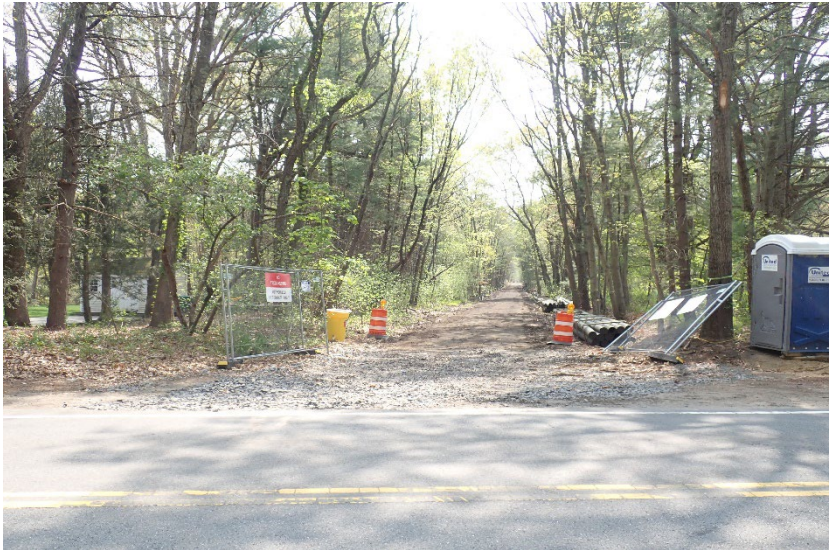
<b>Description:</b>  View of construction entrance to segment 11 where active work is occurring. Looking eastward.

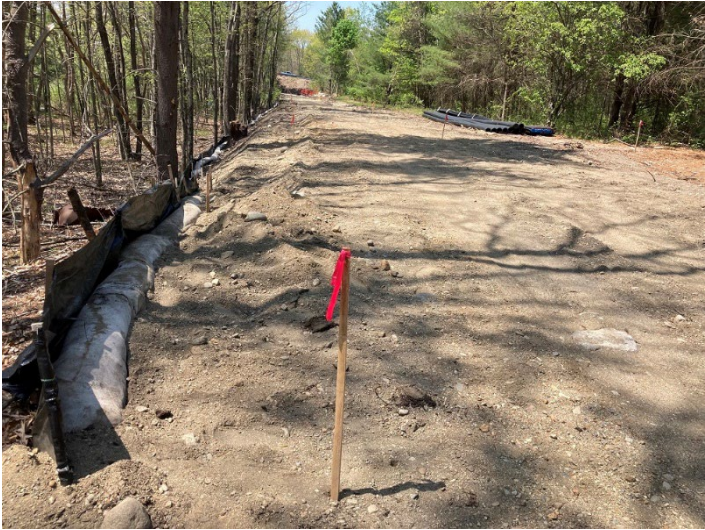
<b>Description:</b> View of repaired E&S controls in segment 2. Facing west.

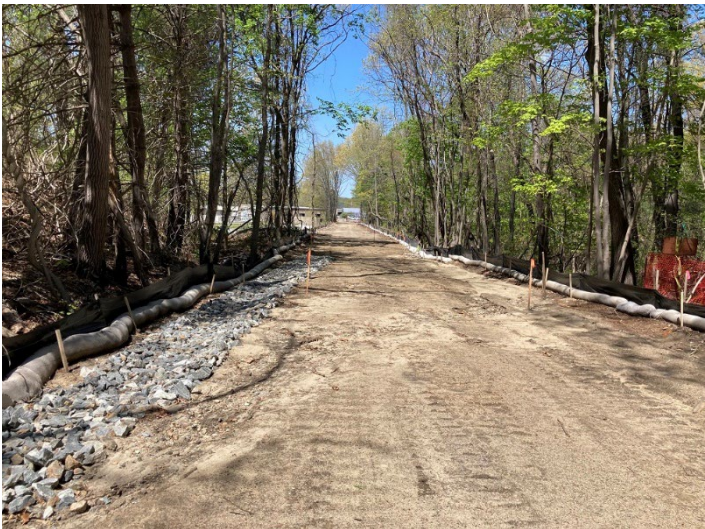
**-Segment 3- E&S controls are in good condition, but sediment is present just beyond controls at approximately Sta. #174. Sediment did not reach any jurisdictional areas.**

<b>Description:</b> View of segment 3. E&S controls are in good condition, but sediment is present just beyond controls at approximately Sta. #174. Sediment did not reach any jurisdictional areas. Facing west.

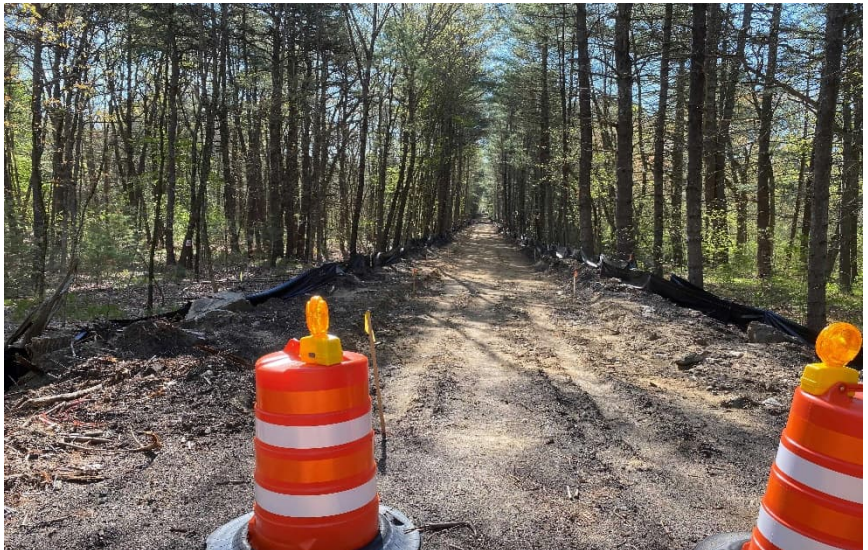
Description:  Right-of-way within Segment 10 off Parmenter Road, existing erosion control, looking eastward.

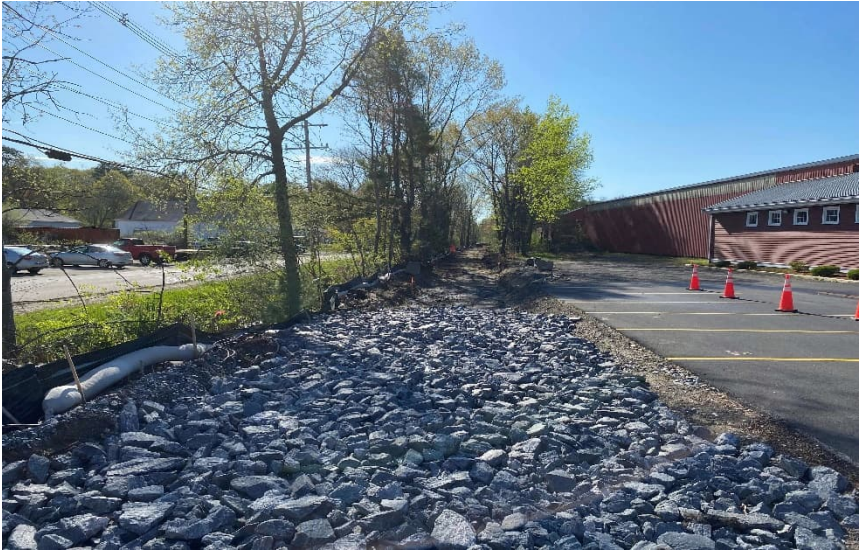
Description:  Right-of-way within Segment 12 off Union Avenue, existing erosion control, looking eastward.

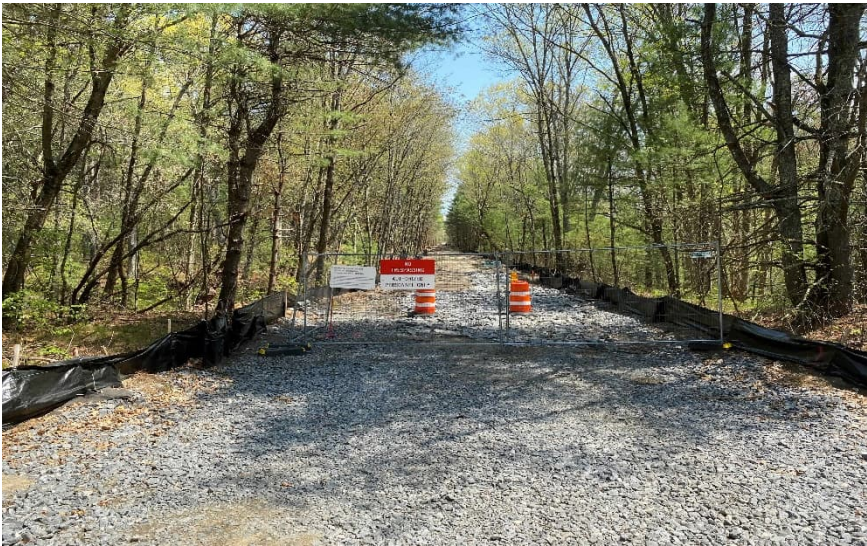
Description:  Right-of-way within Segment 6 off White Pond Road, existing erosion control, looking eastward.

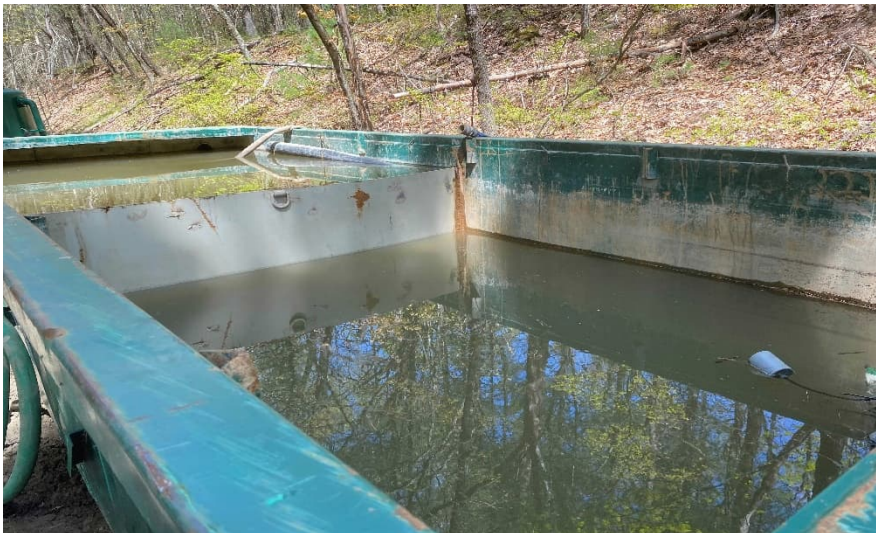
<b>PHOTOGRAPHIC LOG</b>	
Client Name: Eversource		Site Location: Sudbury to Hudson Transmission Reliability Project	
Photo No.: 2		Date: 5/7/2023	
Description: View of pumping operation at Segment 5 at approximate Sta# 307+00 (frac tank to filtration system to dewatering bag within bale corral), looking westward.

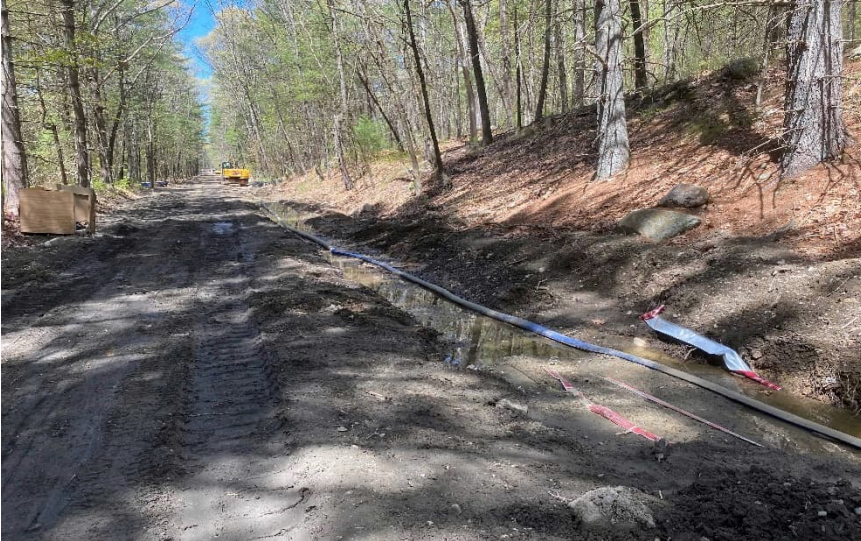
<b>PHOTOGRAPHIC LOG</b>	
Client Name: Eversource		Site Location: Sudbury to Hudson Transmission Reliability Project	
Photo No.: 4		Date: 5/7/2023	
Description: Segment 5 at approximate Sta# 307+00. View of discharge bag/bales, looking westward. Water appeared to be clear.

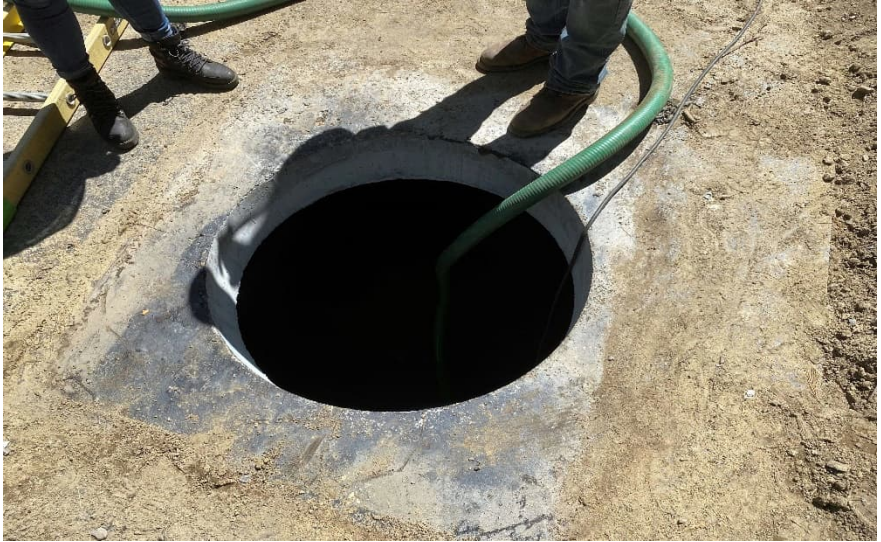
Description: View of area being pumped at work operation within Segment 10 at MH#21, off Horse Pond Road. Water appeared clear.

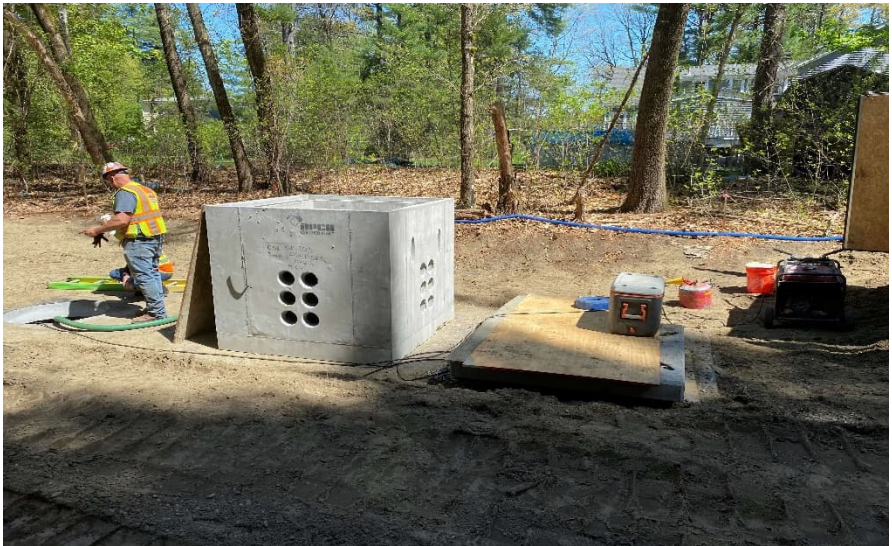
Description: View of pumping operation within Segment 10 at MH#21, looking eastward.

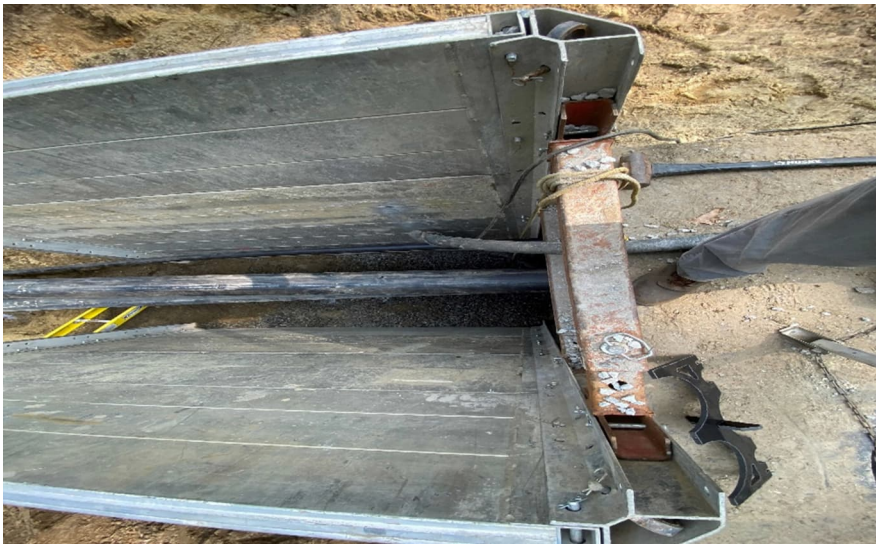
Description: View of area being pumped at work operation within Segment 10 next to MH#21, off Horse Pond Road. Water appeared clear.

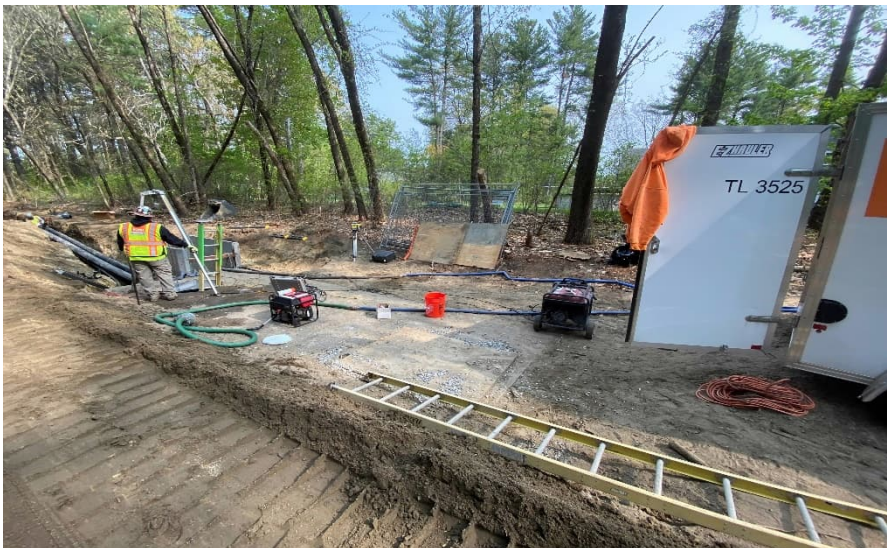
Description: View of pumping operation within Segment 10 at MH#21, looking eastward.

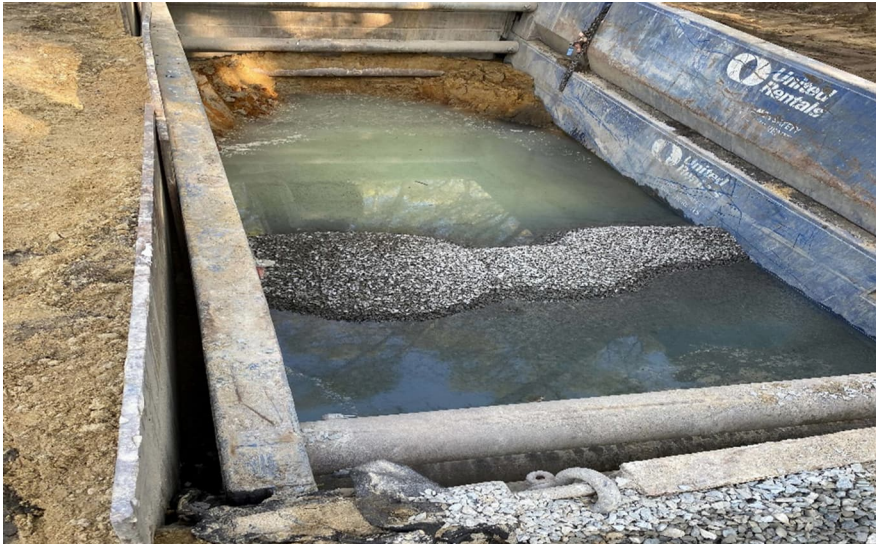
Description: View of area being pumped at work operation within Segment 11 next to MH#23, off Union Avenue. Water appeared clear.
