## Weekly Environmental Compliance Summary

**Sudbury to Hudson Transmission Reliability Project (USEPA Tracking # MAR1003UW)**

Week of: May 8 to May 12, 2023

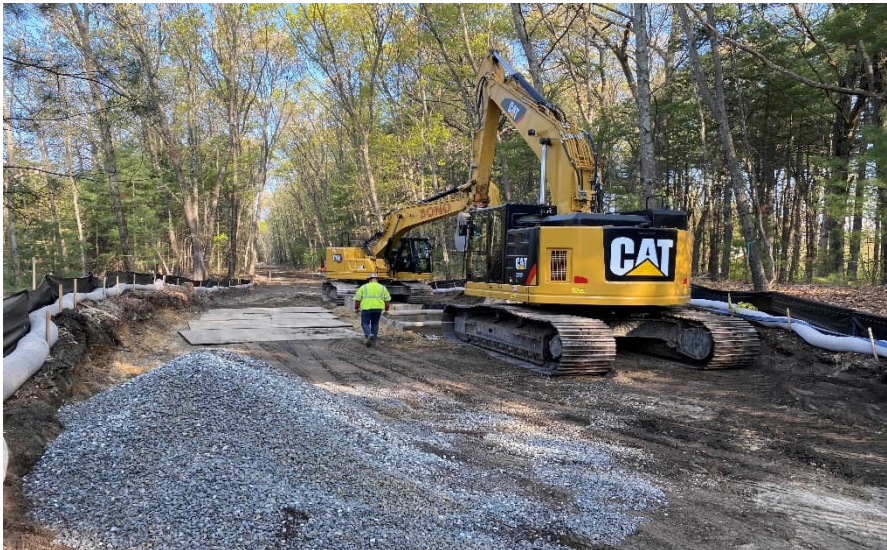
Description: View of pumping operation within Segment 11 at MH#23, looking westward.

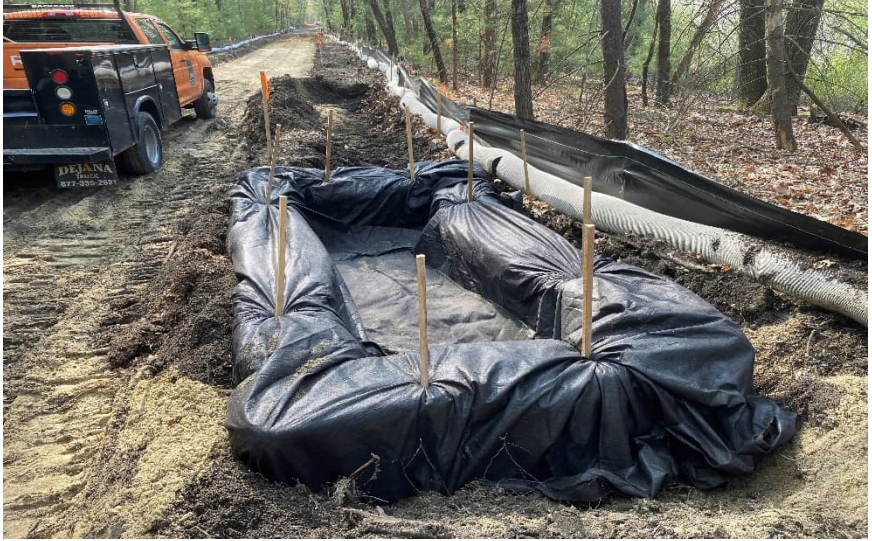
Description: Segment 11 near MH#23. View of discharge bag/bales, looking eastward. Water appeared to be clear.

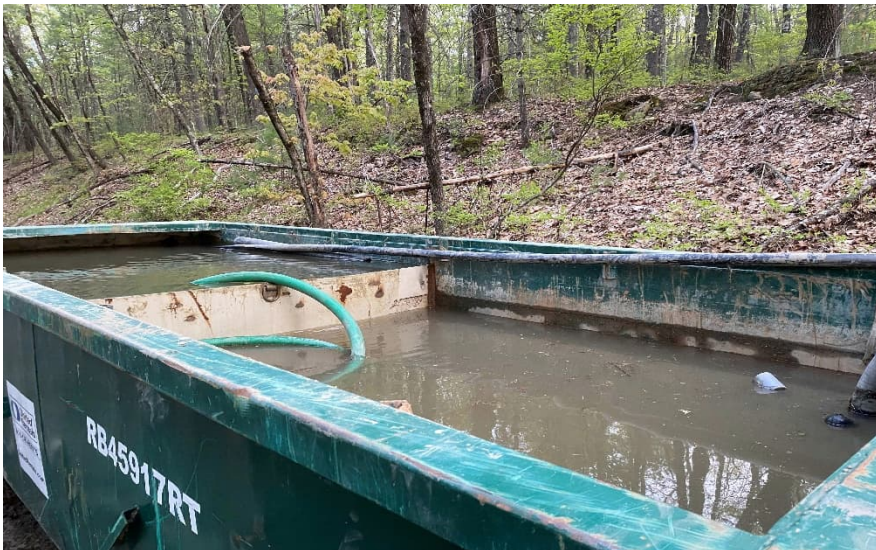
<b>PHOTOGRAPHIC LOG</b>	
Client Name: Eversource		Site Location: Sudbury to Hudson Transmission Reliability Project	
Photo No.: 2		Date: 5/11/2023	
Description: View of pumping operation at Segment 5 at approximate Sta# 307+00 (frac tank to filtration system to dewatering bag within bale corral), looking eastward.

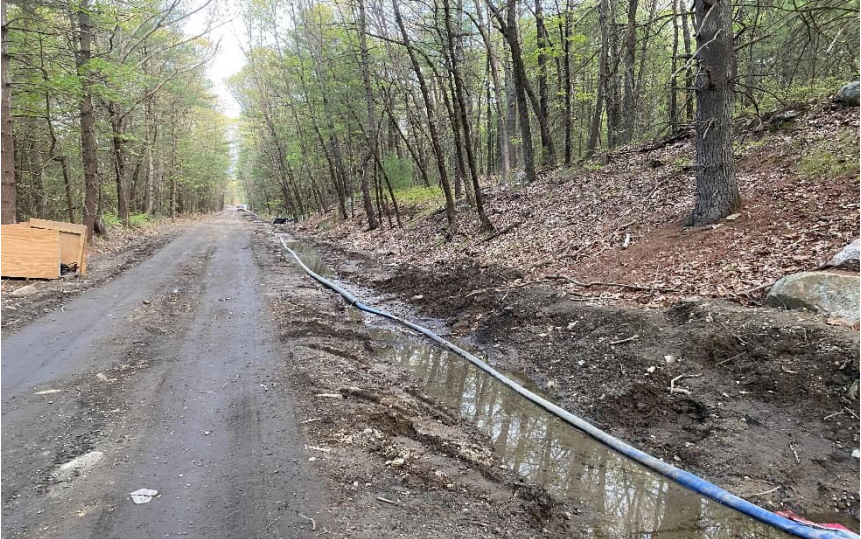
Description: Segment 5 at approximate Sta# 307+00. View of dewatering operation, looking westward.

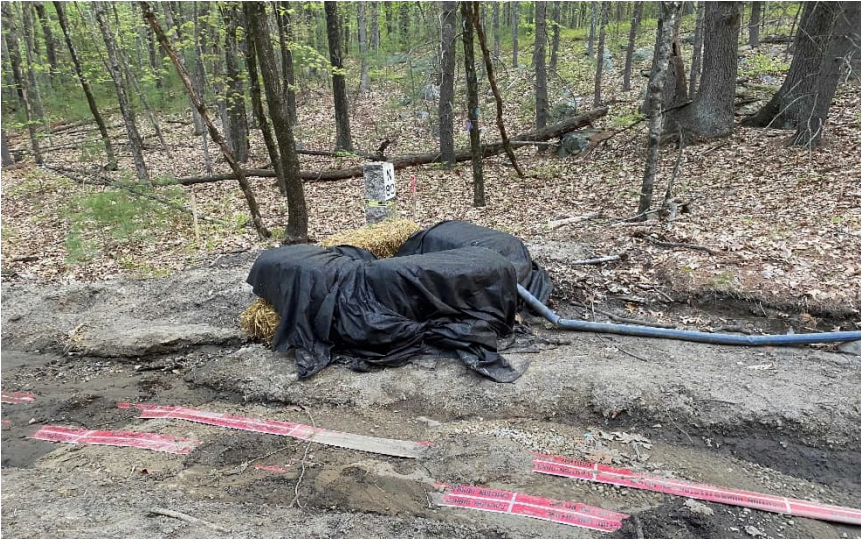
Description: Segment 5 at approximate Sta# 307+00. View of discharge bag/bales, looking eastward. Water appeared to be clear.

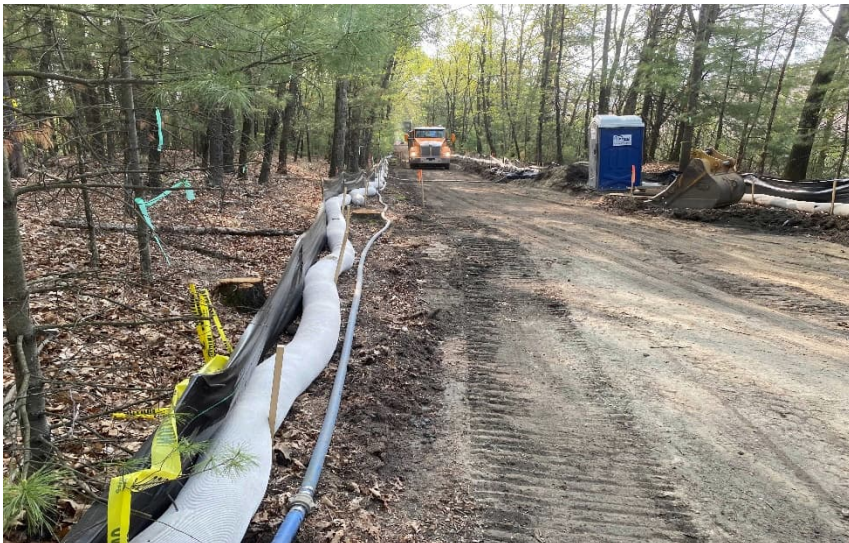
Description: Segment 11 at manhole #23. View of dewatering operation, looking eastward.

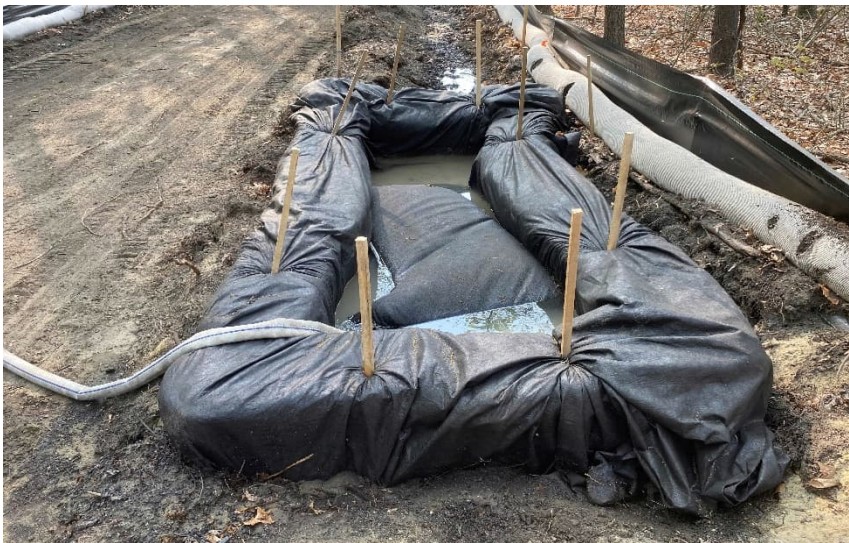
Description: Segment 11 near MH#23. View of discharge bag/bales, looking eastward. Water appeared to be clear.
