Horsley Witten Group, Inc.

Client:			Town of Sudbury
Project Name:		Sudbury-Hudso	on Transmission Reliability
Inspector:			Jeffrey Polidor
Project No:			<u>22012F</u>
Inspection Date:	6/15/23	Arrival Time:	11:00 AM
Weather:	Sunny, 70°F	Departure Time:

Sudbury to Hudson 115kV Underground Transmission Line Sudbury - Hudson, MA Date: November 16, 2018

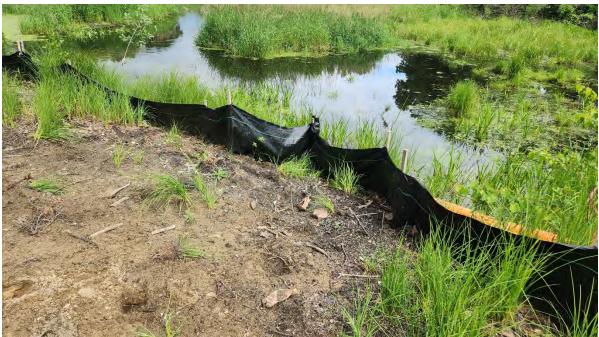
**Photo 1:** Silt fence and filter tube functioning properly along segment 14 near Hop Brook Bridge. Photo taken on 6/15/23

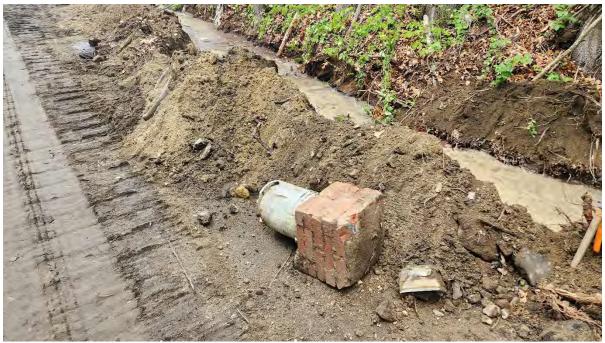
**Photo 2:** Trash next to standing water along segment 14. Photo taken on 6/15/23

- 1. Repair silt fence and filter tube as noted above.
- 2. Clean garbage along segment 14.

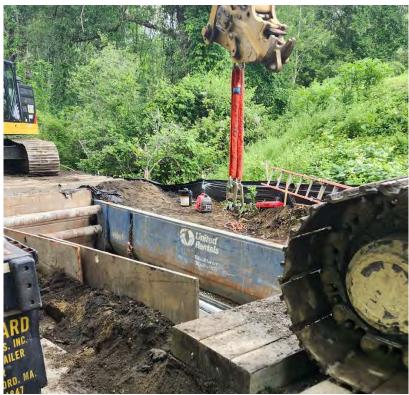
**Photo 3:** Manhole being installed along segment 14. Photo taken on 6/15/23

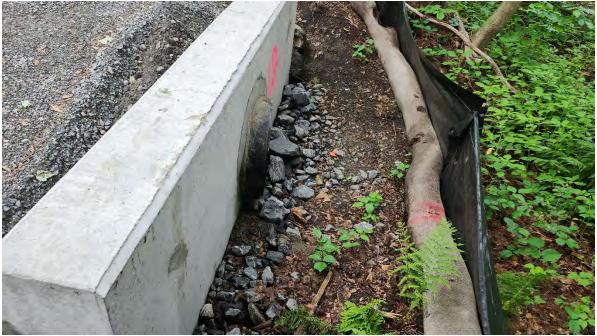
**Photo 4:** Silt fence and filter tube functioning properly next to installed culvert along segment 13. Photo taken on 6/15/23

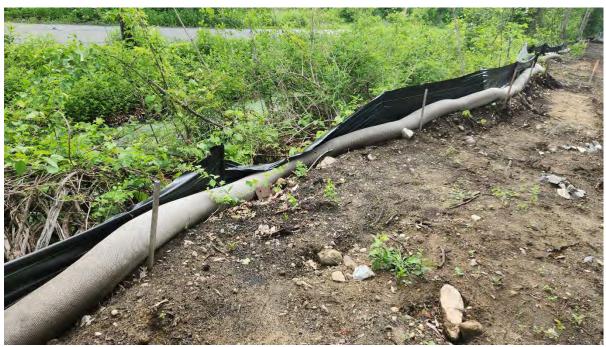
**Photo 5:** Silt fence and filter tube sagging along segment 12. Photo taken on 6/15/23

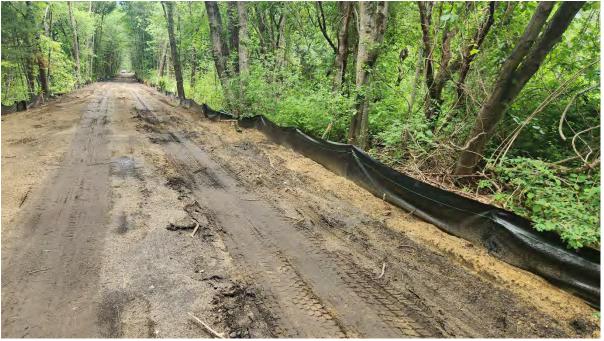
**Photo 6:** Silt fence functioning properly along segment 11. Photo taken on 6/15/23

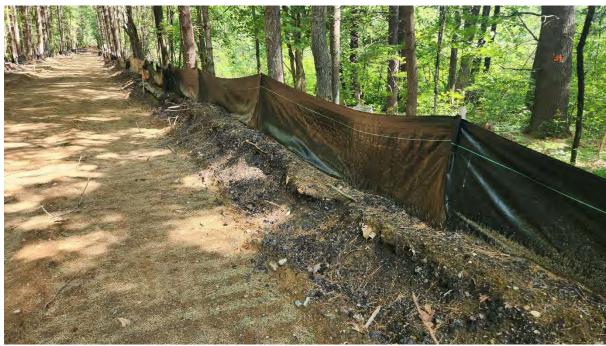
**Photo 7:** Silt fence functioning properly along segment 10. Photo taken on 6/15/23

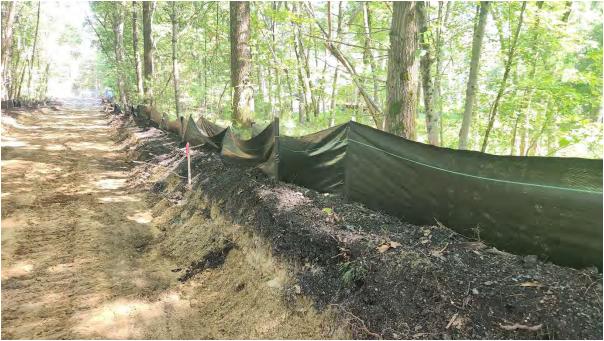
**Photo 8:** Silt fence functioning properly along segment 9. Photo taken on 6/15/23

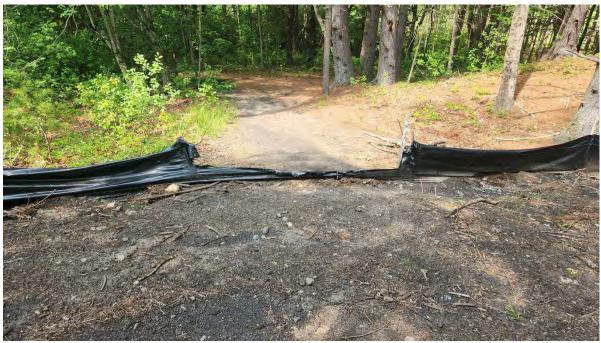
**Photo 9:** Rip in the silt fence along segment 8. Photo taken on 6/15/23

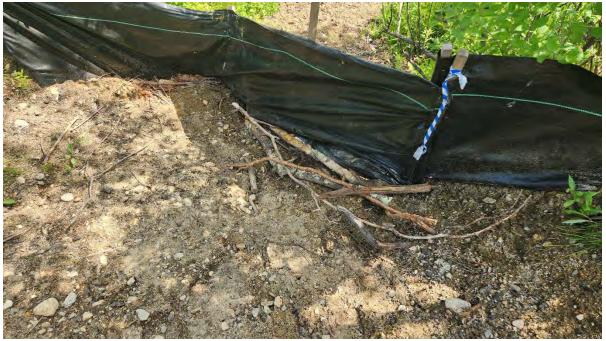
**Photo 10:** Debris pile up in the silt fence along segment 8 near Hop Brook Bridge. Photo taken on 6/15/23

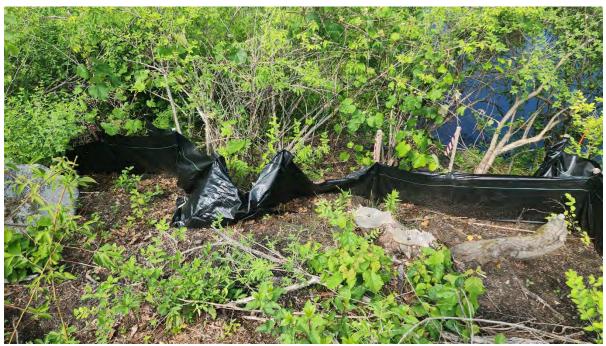
- Silt fence and filter tube are functioning properly along segments 14, 13, 11, 10, and 9 (Photos 1, 4, 6, 7, and 8).
- Trash was noted beside standing water on segment 14 (Photo 2). •
- An electrical manhole was being installed along segment 14 (Photo 3).
- Silt fence and filter tube was sagging along segment 12 (Photo 5). ٠
- Silt fence is ripped along segment 8 (Photo 9).
- Debris pile up is lifting the silt fence along segment 8 near Hop Brook Bridge (Photo 10).
- Silt fence has a broken stake along segment 7 near Hop Brook Bridge (Photo 11).

**Photo 11:** Broken stake in the silt fence along segment 7 near Hop Brook Bridge. Photo taken on 6/15/23
