Horsley Witten Group, Inc.

Client:			Town of Sudbury
Project Name:		Sudbury-Hudsor	n Transmission Reliability
Inspector:			Jeffrey Polidor
Project No:			22012F
Inspection Date:	6/26/23	Arrival Time:	11:00 AM
Weather:	<u>Cloudy, 80°</u> F	Departure Time:	2:00 PM

Contractor(s) equipment: Excavator (4) Dumpster (2) Roller (1) Reference Plan: Sudbury to Hudson 115kV Underground Transmission Line Sudbury - Hudson, MA Date: November 16, 2018

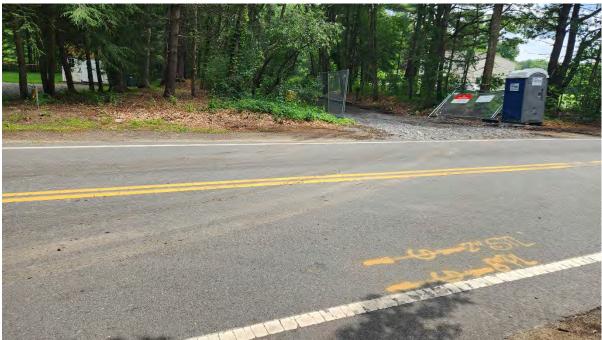
- Silt fence and filter tube are functioning properly along segments 7 and 9-14.
- Construction entrance at STA 361+00 on Horse Pond Road has visible sediment tracking into the road (Photo 1).
- Silt fence has one broken stake and is ripped in two spots along segment 8 (Photos 2-4).
- Debris pile up is lifting the silt fence along segment 8 near Hop Brook Bridge, allowing sediment to wash under the fence and into Hop Brook. (Photos 5-6).

Photo 1: Sediment in road from construction entrance STA 361+00. Photo taken on 6/26/23

- 1. Repair silt fence as noted above.
- 2. Add stones to the construction entrance at STA 361+00.
- 3. Clear debris from the silt fence along segment 8 near Hop Brook Bridge.

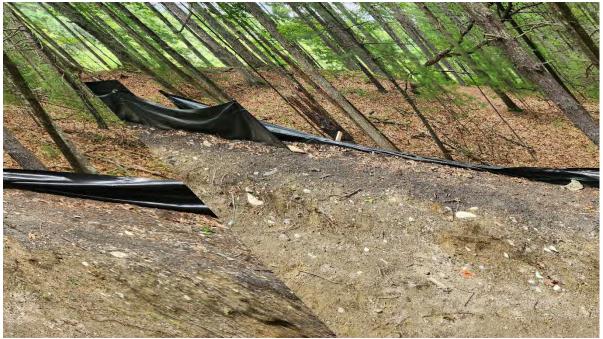
Photo 2: Broken stake in the silt fence along segment 8. Photo taken on 6/26/23

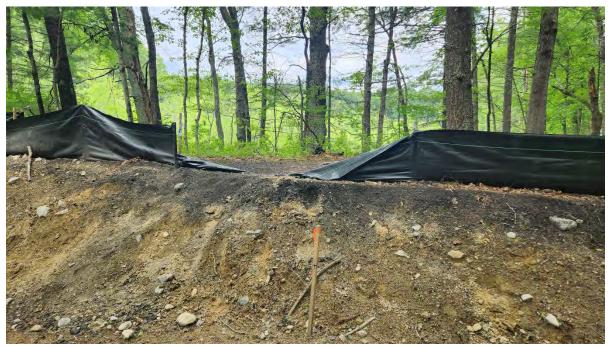
Photo 3: Rip in the silt fence along segment 8. Photo taken on 6/26/23

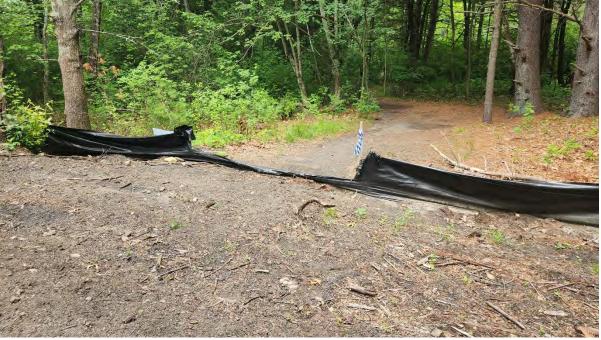
Photo 4: Rip in the silt fence along segment 8. Photo taken on 6/26/23

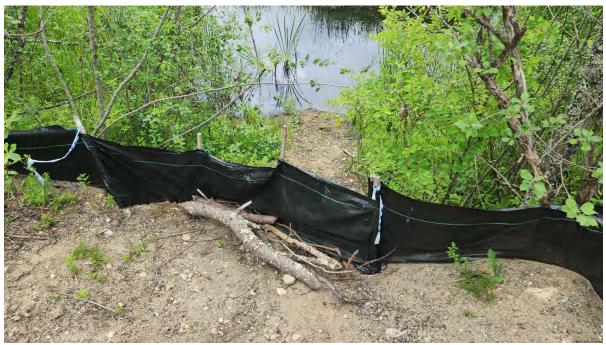
Photo 5: Debris piled up on the silt fence along segment 8 near Hop Brook Bridge. Sediment is washing under the silt fence and into Hop Brook. Photo taken on 6/26/23

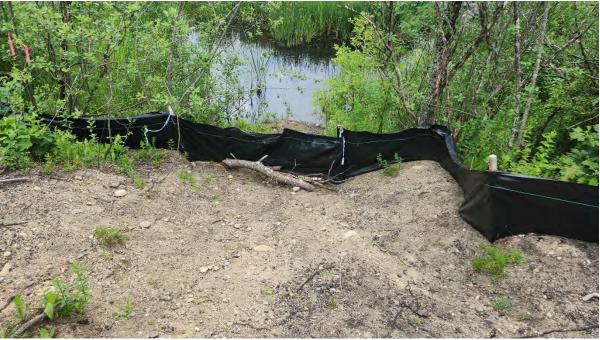
Photo 6: Debris piled up on the silt fence along segment 8 near Hop Brook Bridge. Photo taken on 6/26/23
