Horsley Witten Group, Inc.

Client:			Town of Sudbury
Project Name:		Sudbury-Hudson	n Transmission Reliability
Inspector:			Jeffrey Polidor
Project No:			22012F
Inspection Date:	7/19/23	Arrival Time:	9:00 AM
Weather:	<u>Cloudy, 80°</u> F	Departure Time:	1:00 PM

Contractor(s) equipment: Excavator (4) Dumpster (2) Roller (1) Reference Plan: Sudbury to Hudson 115kV Underground Transmission Line Sudbury - Hudson, MA Date: November 16, 2018

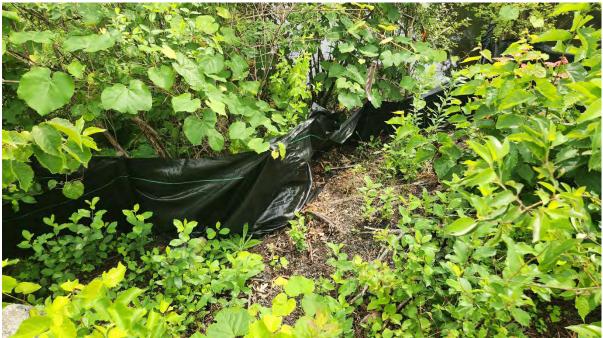
- Silt fence and filter tube are functioning properly along segments 9-14.
- Silt fence has a broken stake and is bagging along segment 7 near Hop Brook Bridge (Photo 1).
- Silt fence has one broken stake and is ripped along segment 8 (Photos 2-3).
- Debris pile up is lifting the silt fence along segment 8 near Hop Brook Bridge, allowing sediment to wash under the fence and into Hop Brook. (Photos 4-5).

Photo 1: Broken stake and bagging in the silt fence along segment 7 near Hop Brook Bridge. Photo taken on 7/19/23

- 1. Repair silt fence as noted above.
- 2. Clear debris from the silt fence along segment 8 near Hop Brook Bridge.

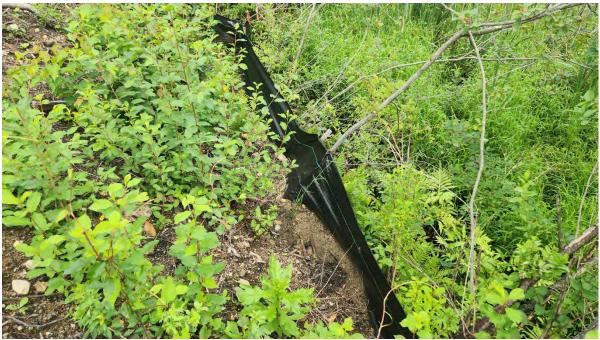
Photo 2: Broken stake in the silt fence along segment 8 near Hop Brook Bridge. Photo taken on 7/19/23

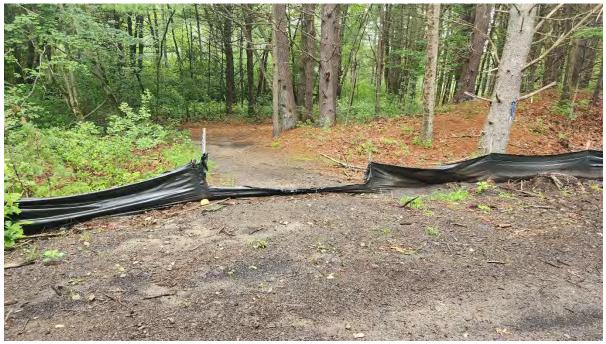
Photo 3: Rip in the silt fence along segment 8. Photo taken on 7/19/23

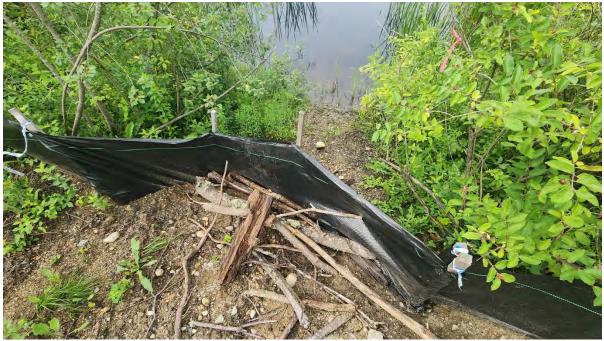
Photo 4: Debris piled up on the silt fence along segment 8 near Hop Brook Bridge. Sediment is washing under the silt fence and into Hop Brook. Photo taken on 7/19/23

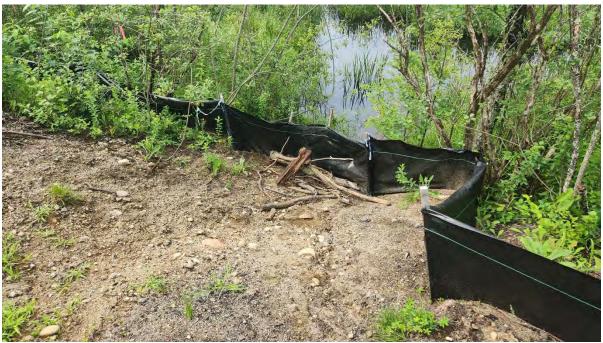
Photo 5: Debris piled up on the silt fence along segment 8 near Hop Brook Bridge. Sediment is washing under the silt fence and into Hop Brook. Photo taken on 7/19/23
