**Weekly Environmental Compliance Summary**

**Sudbury to Hudson Transmission Reliability Project (USEPA Tracking # MAR1003UW)**

Sudbury, Hudson, and Stow, MA

Week of: July 10 to July 14, 2023

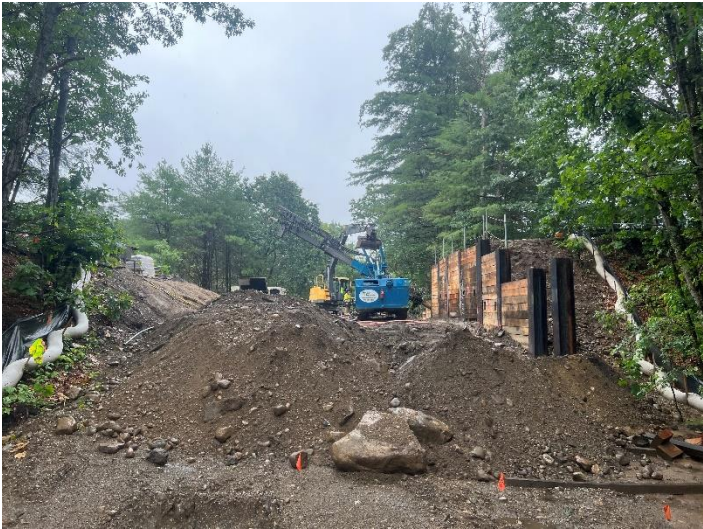
<b>PHOTOGRAPHIC LOG</b>	
<b>Client Name:</b> Eversource		<b>Site Location:</b> Sudbury to Hudson Transmission Reliability Project	
<b>Town:</b> Hudson			
<b>Photo No.:</b> 4	<b>Date:</b> 7/10/2023

<b>Description:</b> View of drilling tie-backs at Chestnut St. Water being used for drilling is contained within infiltration basin and not observed to be discharging off-site. Facing east.

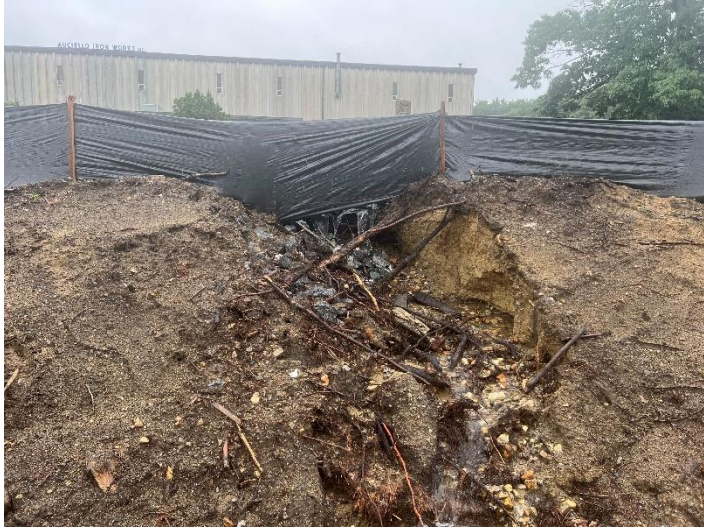
<b>PHOTOGRAPHIC LOG</b>	
<b>Client Name:</b> Eversource		<b>Site Location:</b> Sudbury to Hudson Transmission Reliability Project	
<b>Town:</b> Hudson			
<b>Photo No.:</b> 5	<b>Date:</b> 7/10/2023

<b>Description:</b> View of one of the stormwater washouts in segment 3. Two stormwater washouts are in need of repair in this segment. Facing north.

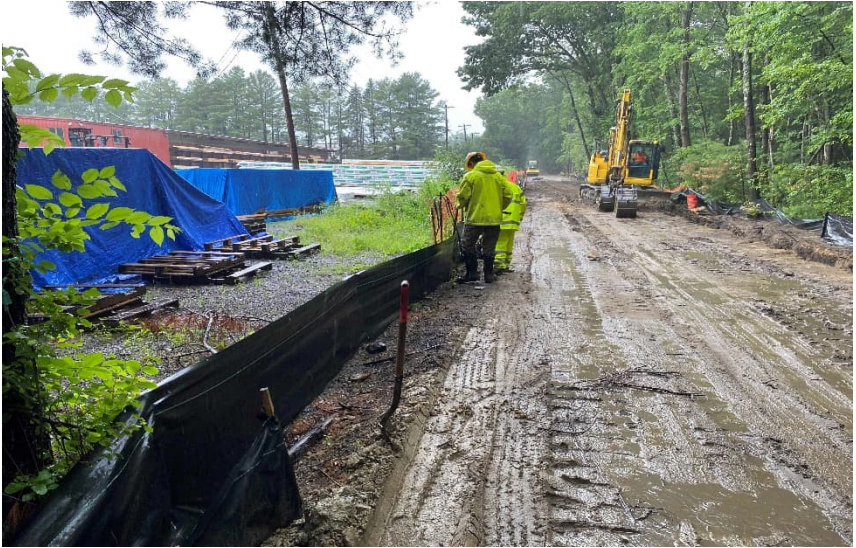
<b>PHOTOGRAPHIC LOG</b>	
Client Name: Eversource		Site Location: Sudbury to Hudson Transmission Reliability Project	
Town: Sudbury			
Photo No.: 8	Date: 7-10-23

Description:  Erosion control repairs within segment 11, looking westward.

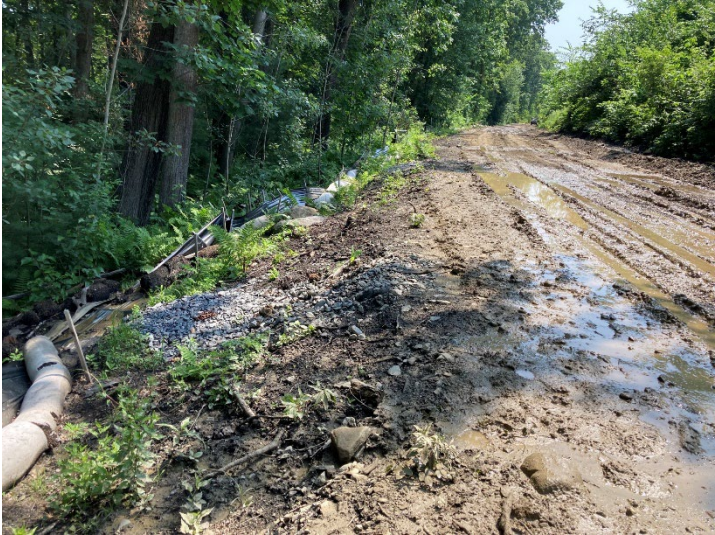
<b>PHOTOGRAPHIC LOG</b>	
<b>Client Name:</b> Eversource		<b>Site Location:</b> Sudbury to Hudson Transmission Reliability Project	
<b>Town:</b> Hudson			
<b>Photo No.:</b> 3	<b>Date:</b> 7/12/2023

<b>Description:</b> View of damaged E&S controls at Sta. #116 left in segment 1 where stormwater discharge is occurring. Recommend reinstalling swale in this area when feasible. Repairs to E&S controls are needed throughout this segment (routine maintenance). Facing northeast.

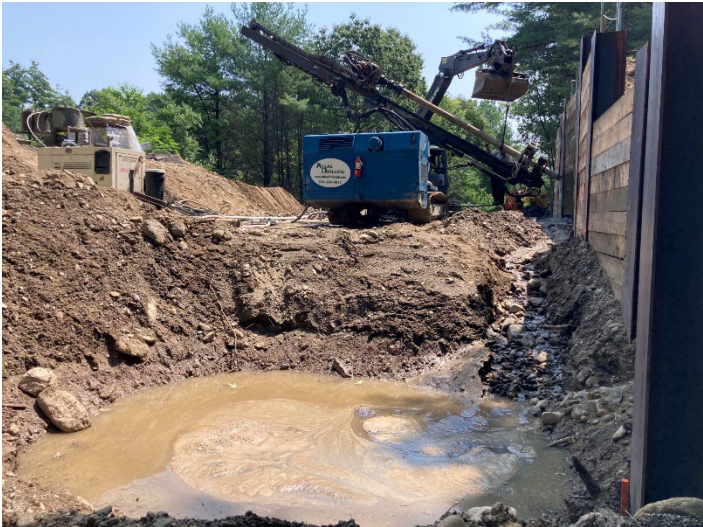
<b>PHOTOGRAPHIC LOG</b>	
<b>Client Name:</b> Eversource		<b>Site Location:</b> Sudbury to Hudson Transmission Reliability Project	
<b>Town:</b> Hudson			
<b>Photo No.:</b> 4	<b>Date:</b> 7/12/2023

<b>Description:</b> View of drilling tie-backs at Chestnut St. Water being used for drilling is contained within infiltration basins and not observed to be discharging off-site. Facing east.

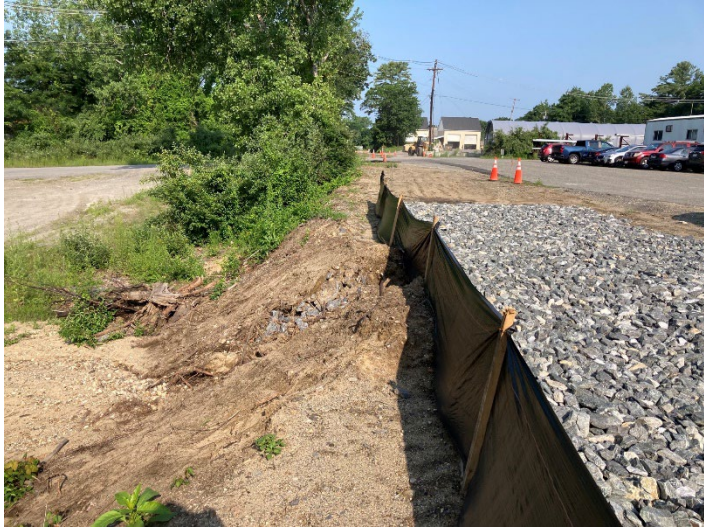
<b>PHOTOGRAPHIC LOG</b>	
<b>Client Name:</b> Eversource		<b>Site Location:</b> Sudbury to Hudson Transmission Reliability Project	
<b>Town:</b> Hudson			
<b>Photo No.:</b> 5	<b>Date:</b> 7/12/2023

<b>Description:</b> View of erosion and washout noted at approximately Sta. #166 rt in segment 3. Recommend repairing erosion and removing deposited sediment. Repair silt fence where undermined (routine maintenance). Facing west.

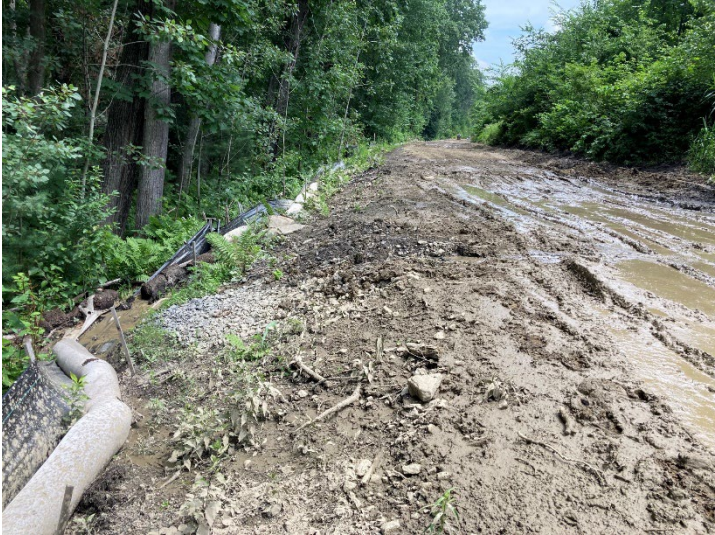
<b>PHOTOGRAPHIC LOG</b>	
<b>Client Name:</b> Eversource		<b>Site Location:</b> Sudbury to Hudson Transmission Reliability Project	
<b>Town:</b> Hudson			
<b>Photo No.:</b> 3	<b>Date:</b> 7/13/2023

<b>Description:</b> View of damaged E&S controls at Sta. #116 left in segment 1 where stormwater discharge is occurring. Recommend reinstalling swale in this area when feasible. Repairs to E&S controls are needed throughout this segment (routine maintenance). Facing east.

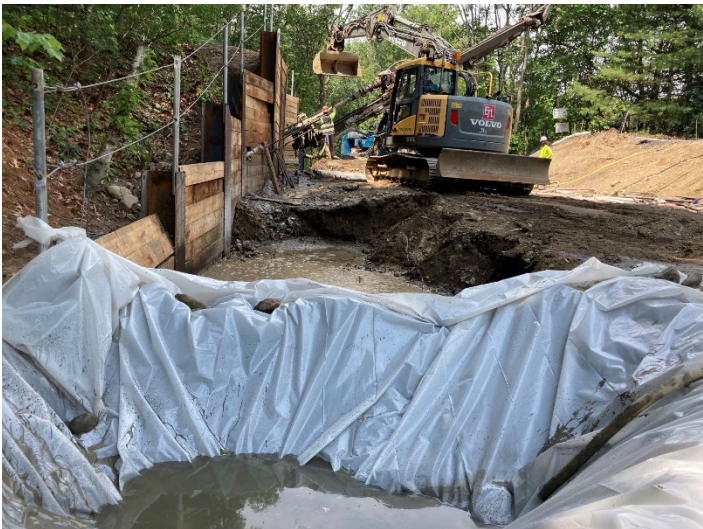
<b>PHOTOGRAPHIC LOG</b>	
<b>Client Name:</b> Eversource		<b>Site Location:</b> Sudbury to Hudson Transmission Reliability Project	
<b>Town:</b> Hudson			
<b>Photo No.:</b> 4	<b>Date:</b> 7/13/2023

<b>Description:</b> View of drilling tie-backs at Chestnut St. Water being used for drilling is contained within infiltration basins and not observed to be discharging off-site. Lined pit has been installed for grout washout. Facing west.

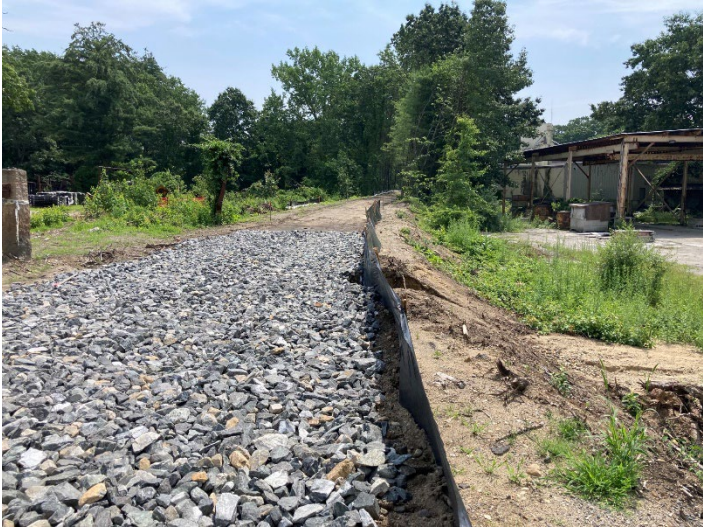
<b>PHOTOGRAPHIC LOG</b>	
<b>Client Name:</b> Eversource		<b>Site Location:</b> Sudbury to Hudson Transmission Reliability Project	
<b>Town:</b> Hudson			
<b>Photo No.:</b> 5	<b>Date:</b> 7/13/2023

<b>Description:</b> View of erosion and washout noted at approximately Sta. #166 rt in segment 3. Recommend repairing erosion and removing deposited sediment. Repair silt fence where undermined (routine maintenance). Facing east.

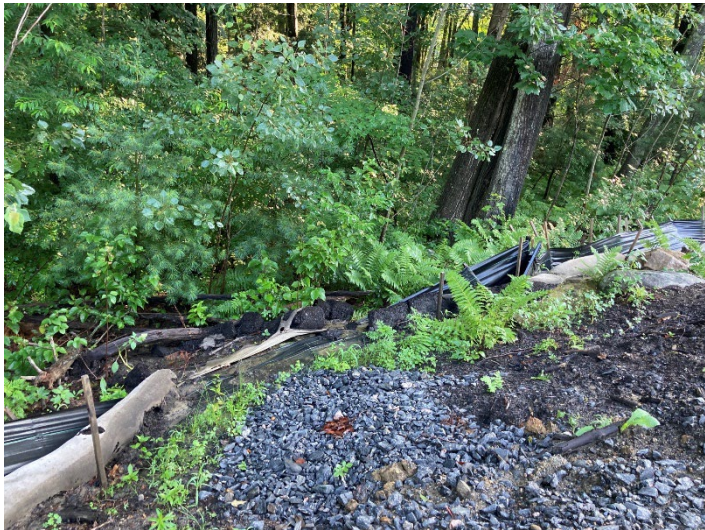
PHOTOGRAPHIC LOG	
Client Name: Eversource		Site Location: Sudbury to Hudson Transmission Reliability Project	Town: Hudson
Photo No.: 3	Date: 7-11-2023

Description: View of damaged E&S controls at Sta. #116 left in segment 1 where stormwater discharge is occurring. Repairs to E&S controls are needed throughout this segment (routine maintenance). Facing northeast.

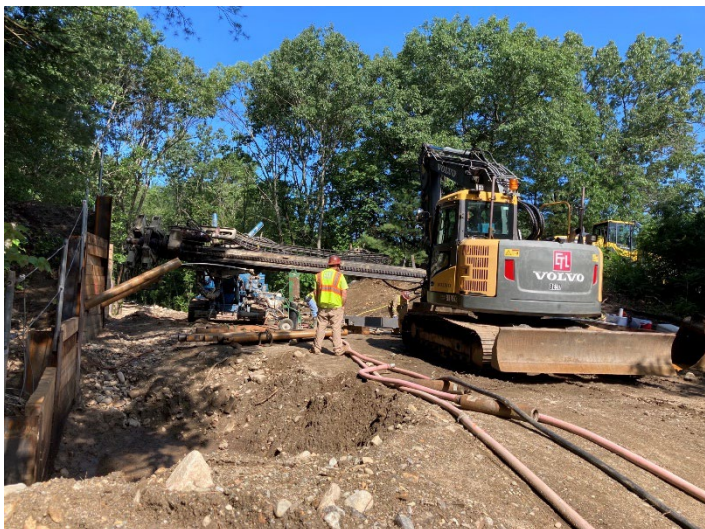
Description: View of drilling tie-backs at Chestnut St. Water is being used for drilling process and is being discharged into an infiltration basin onsite away from jurisdictional areas. Facing west.

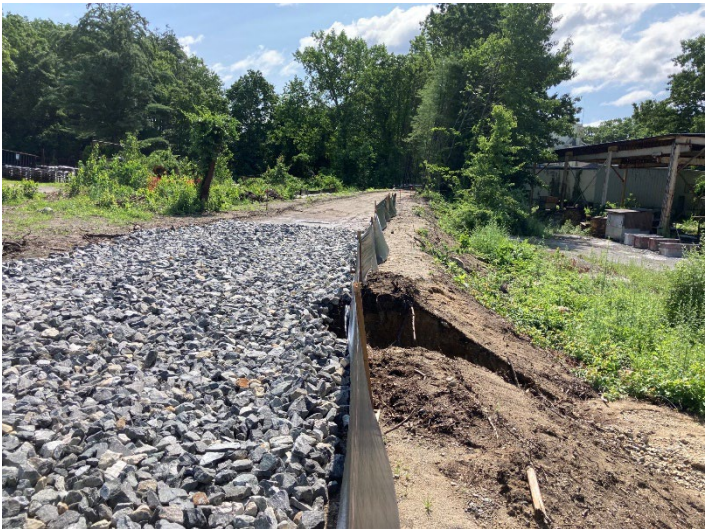
<b>Description:</b> View of erosion and washout noted at approximately Sta. #166 rt in segment 3. Recommend repairing erosion and removing deposited sediment. Repair silt fence where undermined (routine maintenance). Facing east.

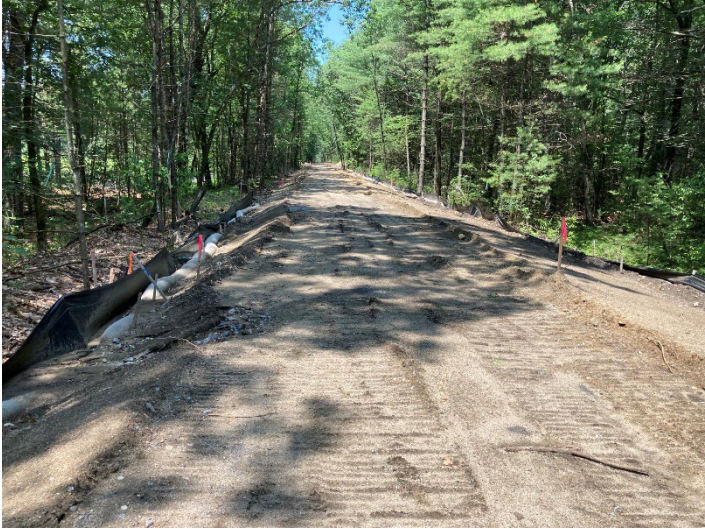
<b>Description:</b> View of Type A E&S controls in segment 5. Repairs to E&S controls are needed in this segment (routine maintenance). Facing west.

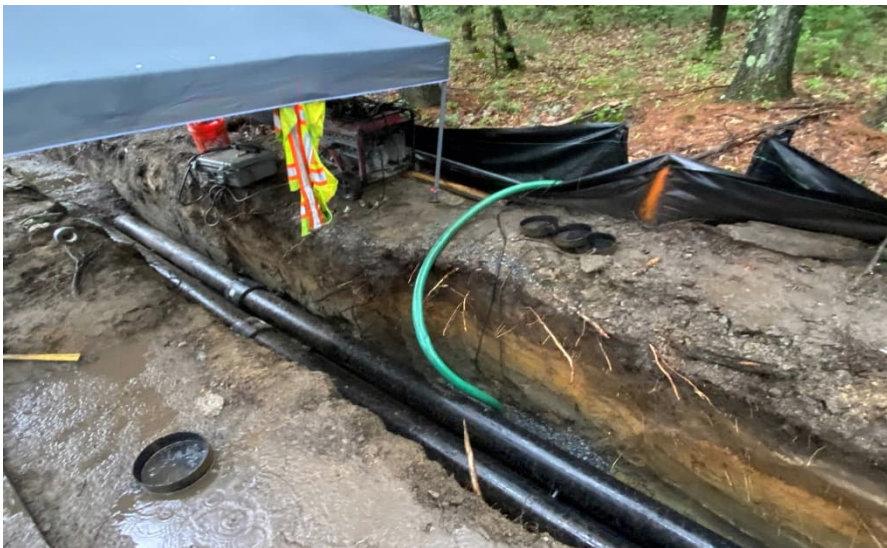
Description: View of pumping operation at Segment 11. This is the location of dewatering water prior to treatment. Water appeared to be slightly turbid.

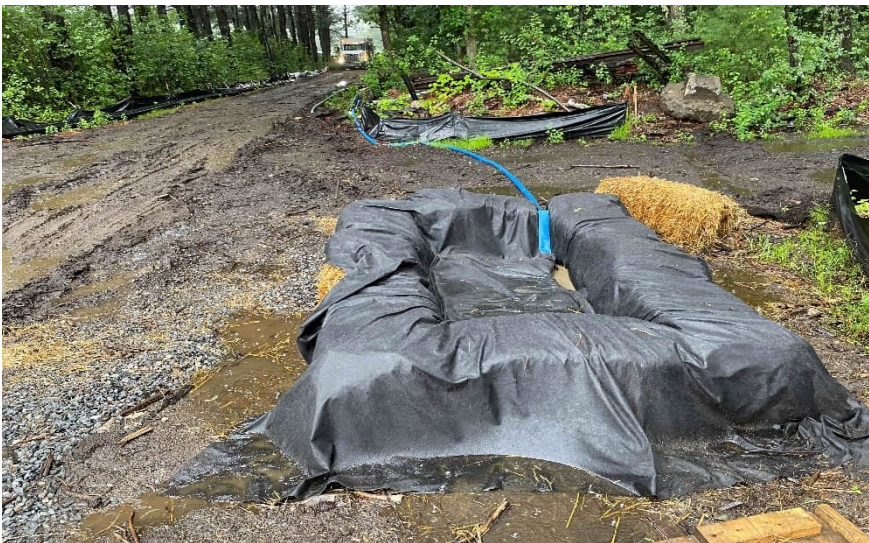
Description: Segment 11. View of discharge bag/bales, looking westward. Water discharge to bag intermittent and appeared to be slightly turbid.

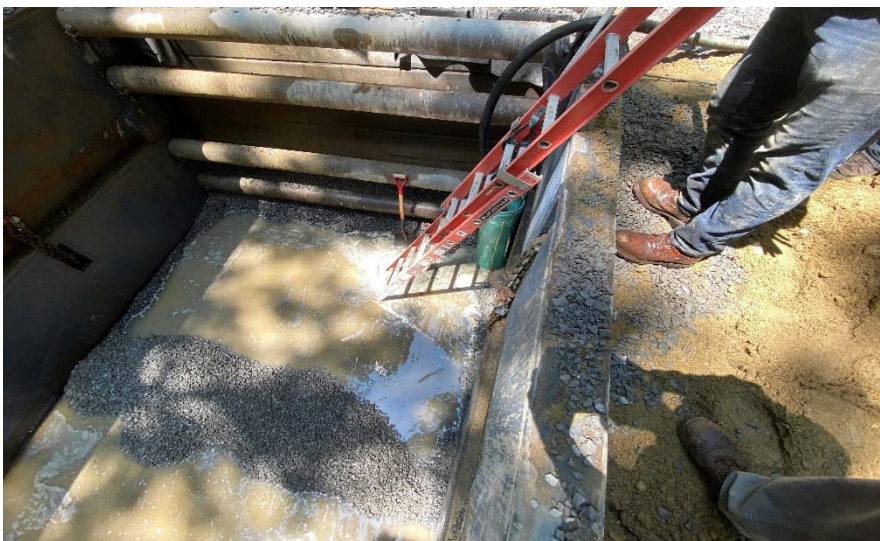
Description: View of pumping operation at Segment 8. This is the location of dewatering water prior to treatment. Water appeared to be slightly turbid.

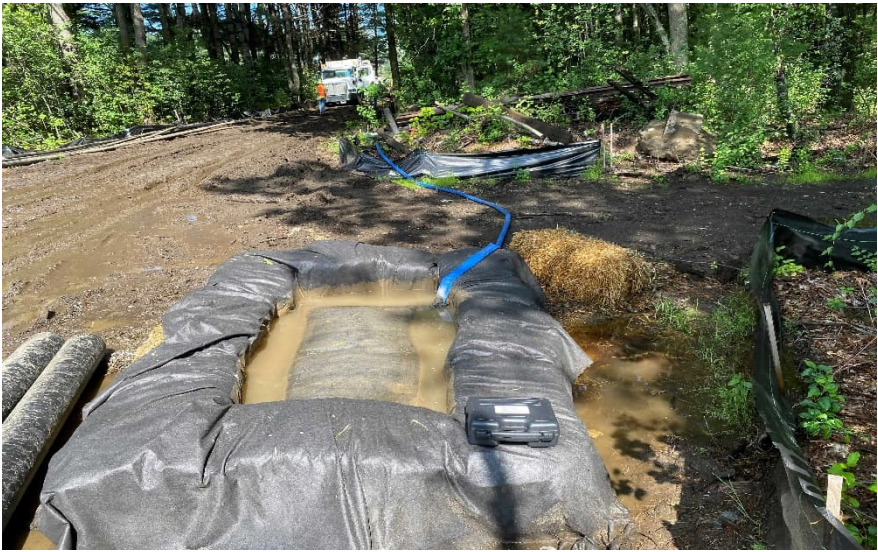
Description: Segment 11. View of discharge bag/bales, looking westward. Water discharge to bag intermittent and appeared to be slightly turbid.

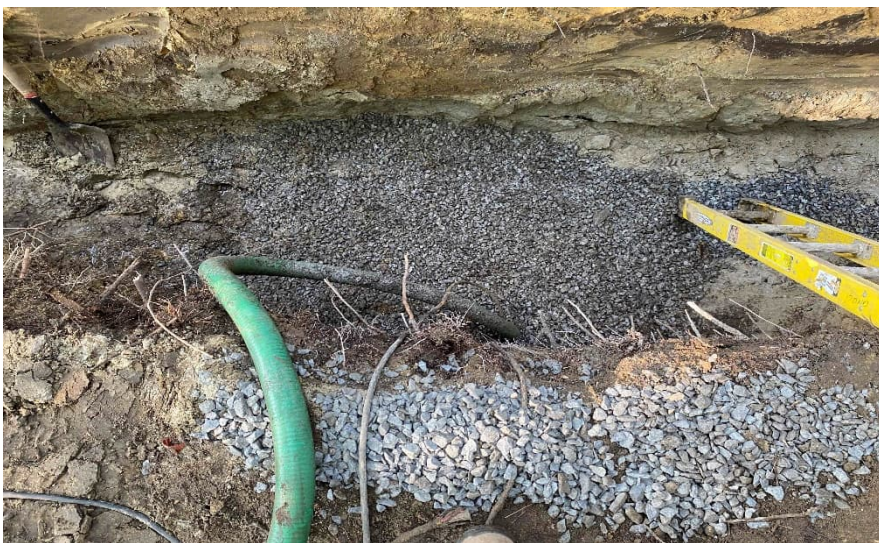
Description: View of pumping operation at Segment 11. This is the location of dewatering water prior to treatment. Water appeared to be slightly turbid.
