Field	l Report	No. 14
-------	----------	--------

Client:			Town of Sudbury
	Project Name:		Sudbury-Hudson	n Transmission Reliability
	Inspector:			Jeffrey Polidor
	Project No:			22012F
Horsley Witten	Inspection Date:	8/21/23	Arrival Time:	8:00 AM
Group, Inc.	Weather:	Cloudy, 80°F	Departure Time:	11:00 AM

Sudbury to Hudson

115kV Underground Transmission Line

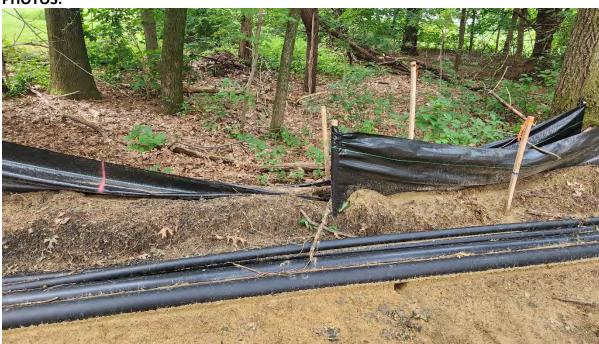
- Silt fence and filter tube are functioning properly along segments 7-9 and 14.
- Debris netting installed along segment 7 and 8 near Bridge 128. Sheeting being installed.
- Silt fence has a broken stake along segment 10 in two places (Photos 1-2).
- Silt fence has a broken stake along segment 11 in two places (Photo 3).
- Silt fence has a broken stake and filter tube is ripped along segment 12 adjacent to Hop Brook (Photo 4).
- Silt fence has a broken stake and rip along segment 13 (Photo 5).
- Bridge 127 at segment 13/14 has been removed and walers have been installed (Photo 6).

**Photo 1:** Broken stake in the silt fence along segment 10. Photo taken on 8/21/23

**1.** Repair silt fence and filter tube as noted above.

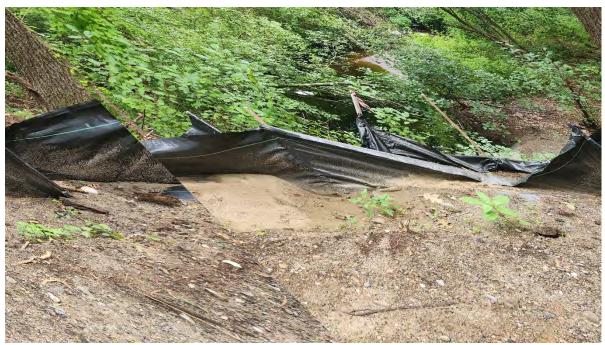
**Photo 2:** Broken stake in the silt fence along segment 10. Photo taken on 8/21/23

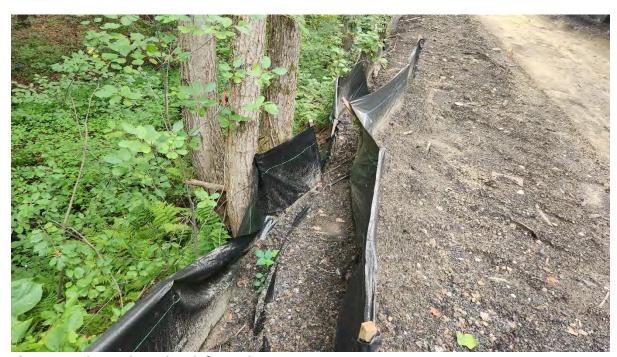
**Photo 3:** Broken stake in the silt fence along segment 11. Photo taken on 8/21/23

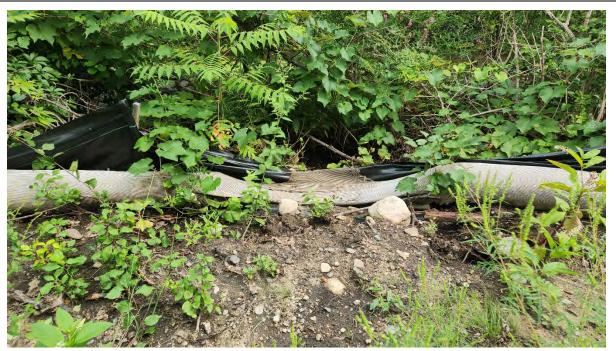
**Photo 4:** Broken stake in the silt fence and rip in the filter tube along segment 12 adjacent to Hop Brook.

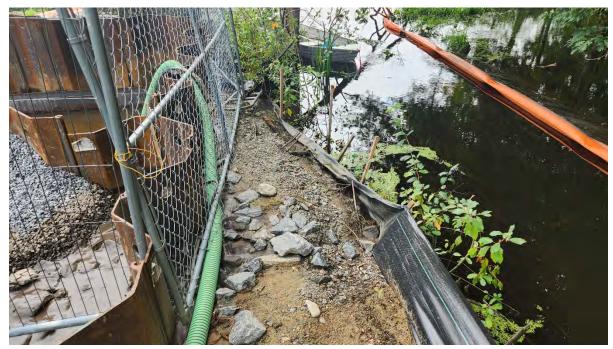
**Photo 5:** Silt fence has a broken stake and rip along segment 13 near Hop Brook. Photo taken on 8/21/23

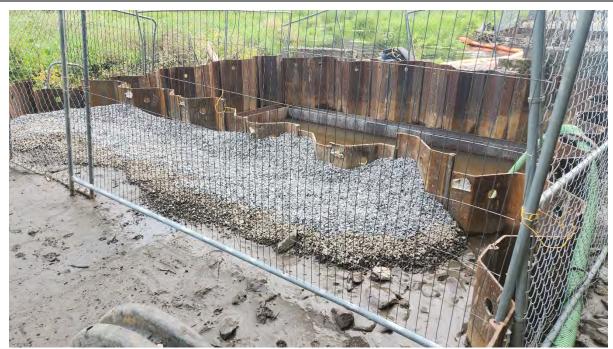
**Photo 6:** Bridge 127 removed and walers installed at segment 13/14. Photo taken on 8/21/23
