Field	Report	No.	14
-------	--------	-----	----

•				
	Client:			Town of Sudbury
	Project Name:	Sudbury-Hudson Transmission Reliability		
	Inspector:			Jeffrey Polidor
	Project No:			22012F
Horsley Witten	Inspection Date:	9/06/23	Arrival Time:	8:00 AM
Group, Inc.	Weather:	Sunny, 85°F	Departure Time:	11:30 AM

Sudbury to Hudson

115kV Underground Transmission Line

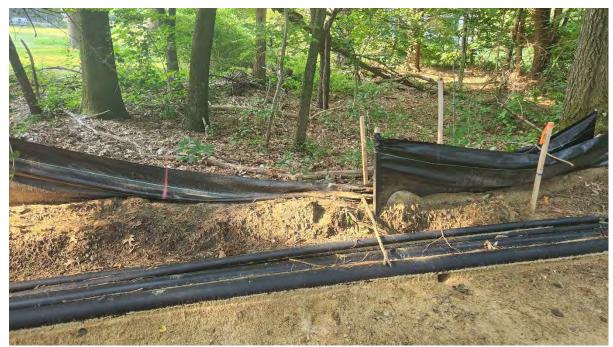
- Silt fence and filter tube are functioning properly along segments 7-9, 12, and 14.
- A manhole was being installed in between segment 8 and segment 9 (Photo 1)
- Silt fence has a broken stake along segment 10 (Photo 2).
- Sediment has tracked into the road from gravel construction entrance STA 361+00 (Photo 3).
- Silt fence has a broken stake along segment 11 in two places (Photo 3).
- Silt fence is under a boulder at a point along segment 13 (Photo 4).
- Silt fence has a broken stake at Bridge 127 along segment 13 (Photo 5)
- Form, rebar, and pour abutment wall was being installed at Bridge 127 (Photo 6).

**Photo 2:** Broken stake in the silt fence along segment 10. Photo taken on 9/06/23

**1.** Repair silt fence and filter tube as noted above.

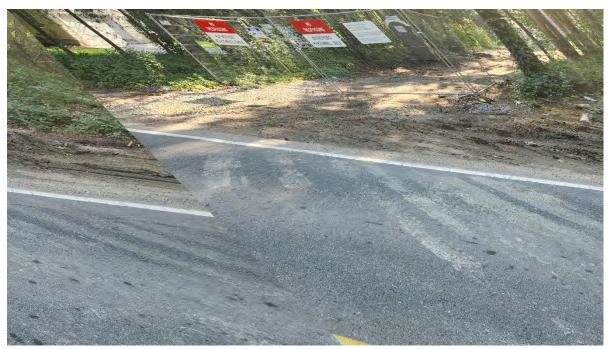
**Photo 3:** Sediment in the road from gravel construction entrance STA 361+00. Photo taken on 9/06/23
