Weekly Environmental Compliance Summary

Sudbury to Hudson Transmission Reliability Project (USEPA Tracking # MAR1003UW)

Week of: August 28 to September 1, 2023

CONSTRUCTION MONITORING REPORT

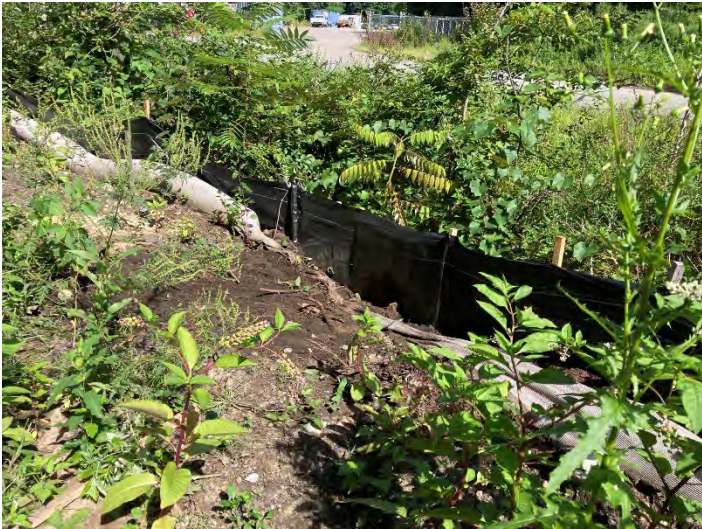
PHOTOGRAPHIC LOG	
Client Name: Eversource		Site Location: Sudbury to Hudson Transmission Reliability Project	
Town: Sudbury			
Photo No.: 4	Date: 8/29/2023

Description: Silt fence has been repaired at Sta. #707 in segment 12. New compost filter tube should be installed. Facing northwest.

-Needed E&S repairs noted yesterday (8/28/2023) were completed today.

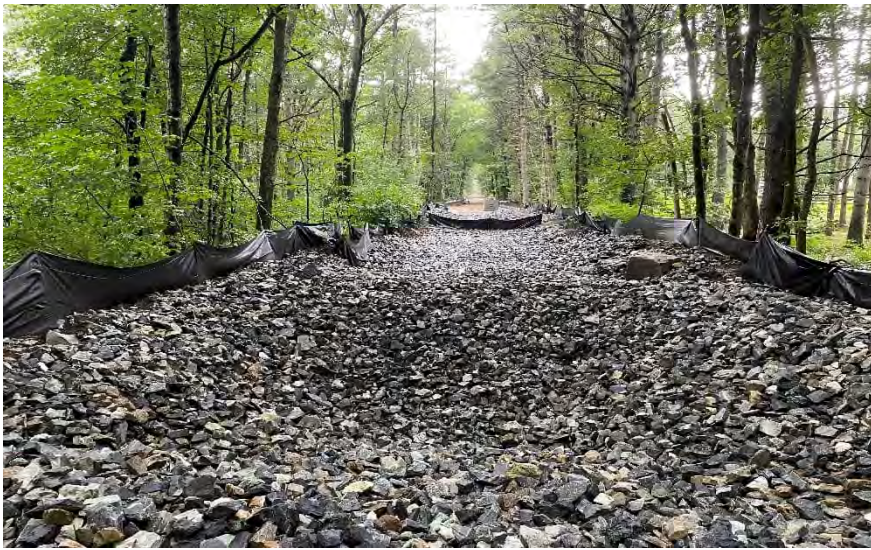
PHOTOGRAPHIC LOG	
Client Name: Eversource		Site Location: Sudbury to Hudson Transmission Reliability Project	
Town: Sudbury			
Photo No.: 2	Date: 8-30-23

Description: Work area within segment 9, recent culvert issue area, looking westward.

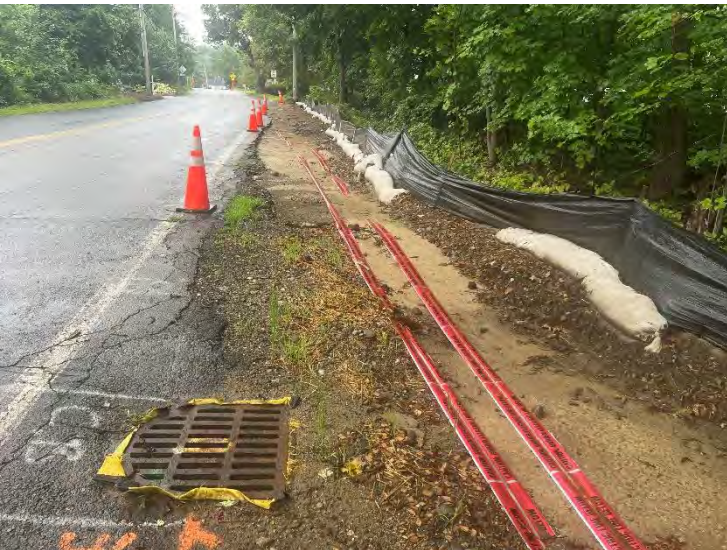
PHOTOGRAPHIC LOG	
Client Name: Eversource		Site Location: Sudbury to Hudson Transmission Reliability Project	
Town: Hudson			
Photo No.: 4	Date: 8-30-23

Description: View of installed conduit along the shoulder of Wilkins Street. Erosion controls are in good condition and working properly. Facing West

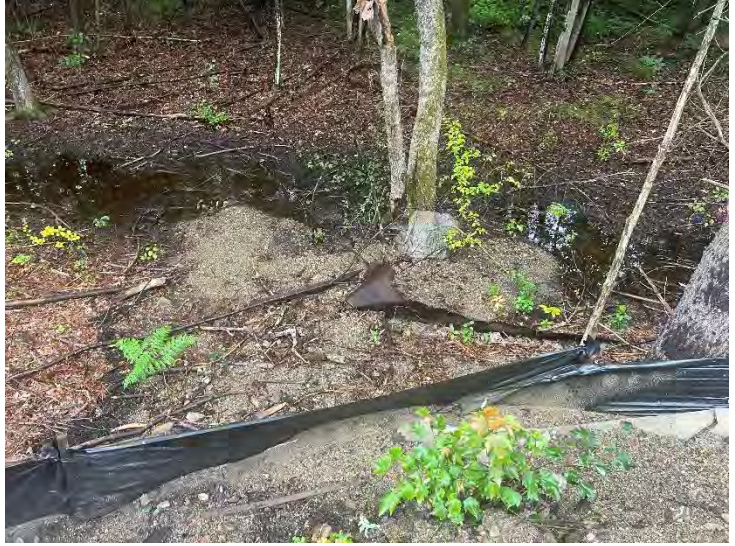
PHOTOGRAPHIC LOG	
Client Name: Eversource		Site Location: Sudbury to Hudson Transmission Reliability Project	
Town: Hudson			
Photo No.: 6	Date: 8-30-23

Description: Silt fence breach within segment 2 near station 138.00. Sediment has migrated outside of the ROW. We recommend the sediment be removed and the silt fence be repaired (Routine Maintenance). Facing South.

Sediment was removed from outside the ROW near Station 138.00, the silt fence was repaired, and the slope has been fixed.

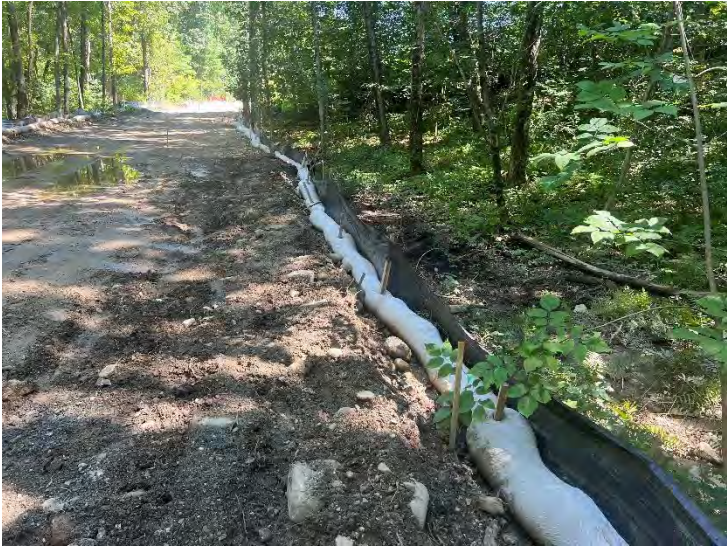
PHOTOGRAPHIC LOG	
Client Name: Eversource		Site Location: Sudbury to Hudson Transmission Reliability Project	
Town: Hudson			
Photo No.: 3	Date: 9-01-23

Description: Area where silt fence had been repaired near station 112.50 in segment 1. E&S controls in this area are in good condition and are working properly. Facing East.

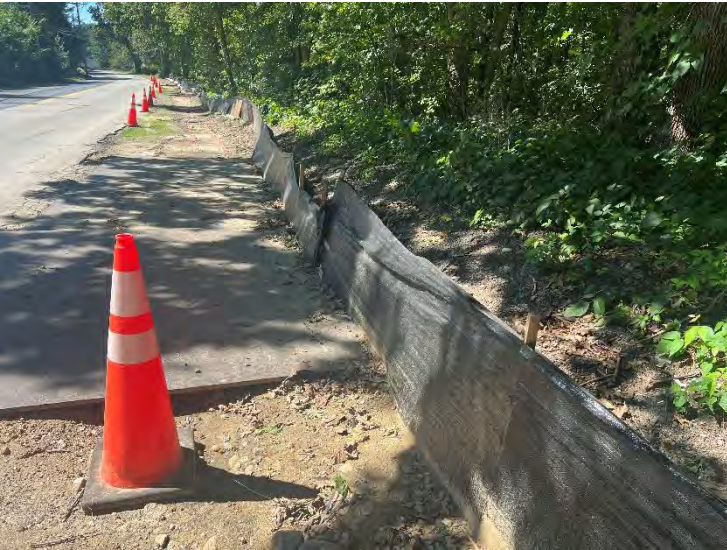
PHOTOGRAPHIC LOG	
Client Name: Eversource		Site Location: Sudbury to Hudson Transmission Reliability Project	
Town: Hudson			
Photo No.: 4	Date: 9-01-23

Description: View of installed conduit along the shoulder of Wilkins Street. Erosion controls are in good condition and working properly. Facing West

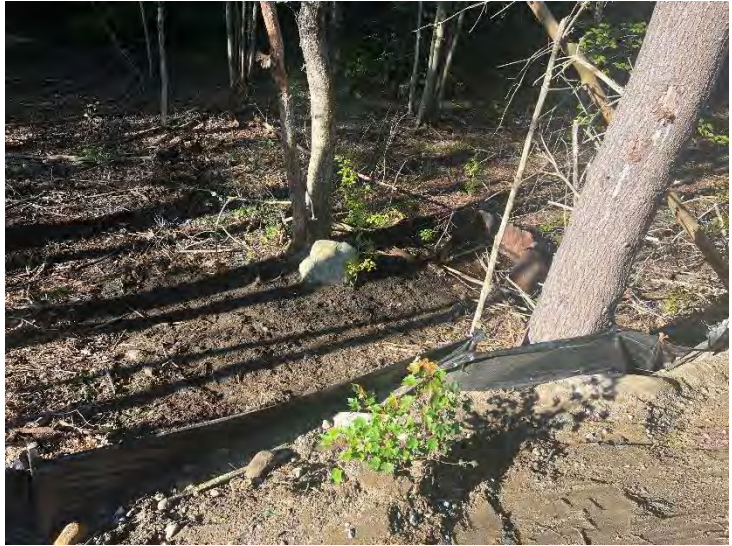
PHOTOGRAPHIC LOG	
Client Name: Eversource		Site Location: Sudbury to Hudson Transmission Reliability Project	
Town: Hudson			
Photo No.: 6	Date: 9-01-23

Description: The silt fence breach within segment 2 near station 138.00 has been repaired. Sediment has been removed, the silt fence has been repaired and the slope has been fixed. Facing South.

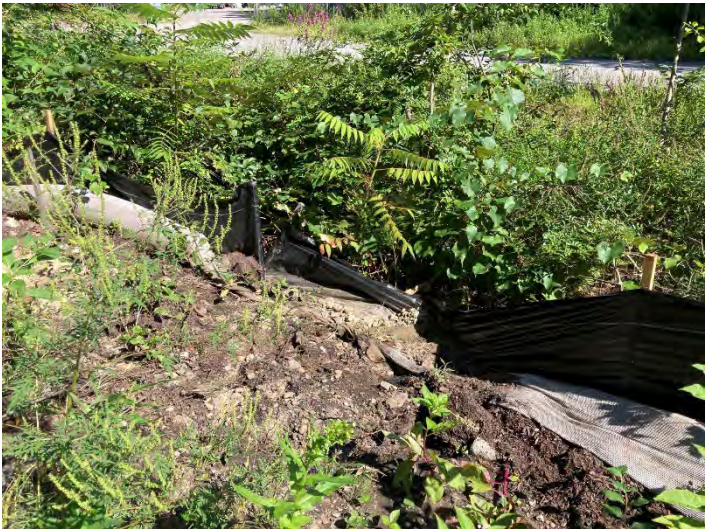
-E&S controls are in need of repair at approximately Sta. #707 in segment 12 (routine maintenance).

Description: View of damaged E&S controls at approximately Sta. #707 in segment 12. Facing northwest.

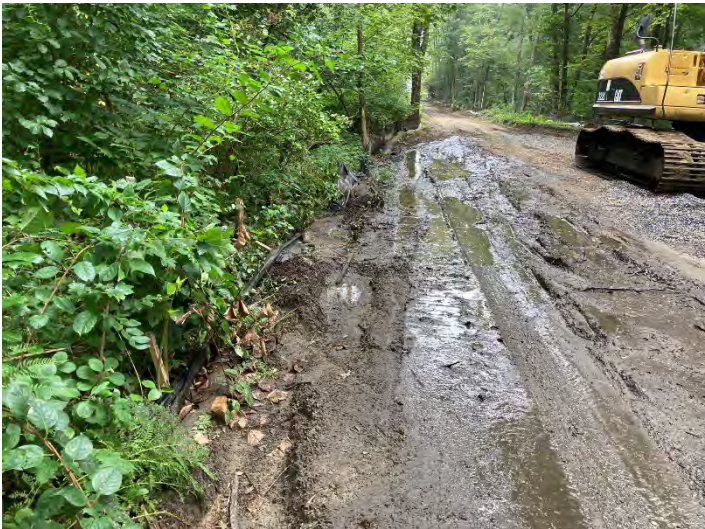
-E&S controls are in need of repair in segment 13 (routine maintenance).

Description: View of damaged silt fence in segment 13. Facing west.

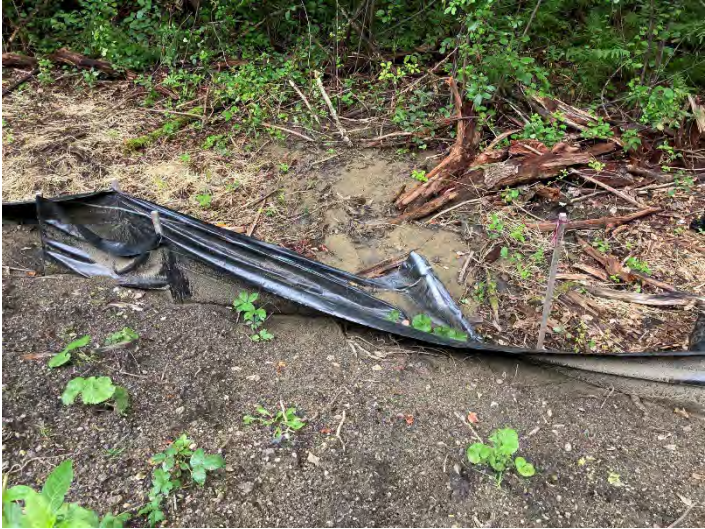
-E&S controls are in need of repairs in multiple locations in segment 14 (routine maintenance).

Description: View of Sta. #740+50 in segment 14. Silt fence is damaged and sediment has deposited beyond limit of work. Sediment did not reach wetland. E&S repairs are needed in multiple locations along segment 14. Facing south.

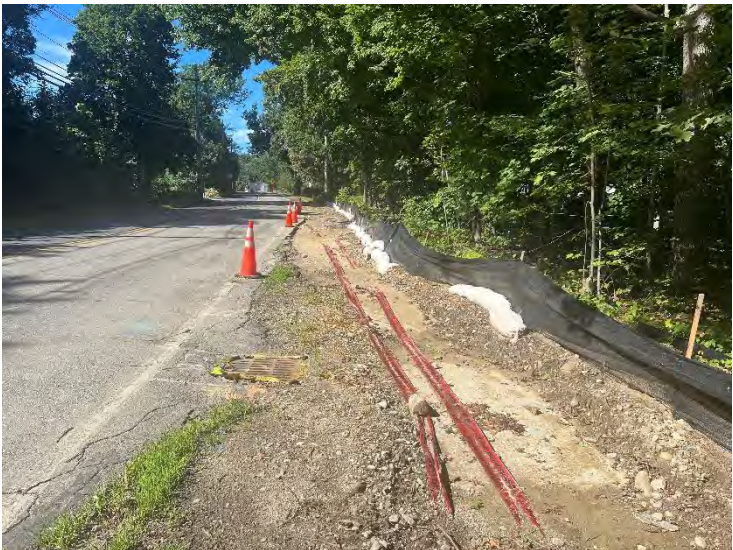
Description: View of the installed conduit along the shoulder of Wilkins Road. All E&S controls are in good condition and working properly.

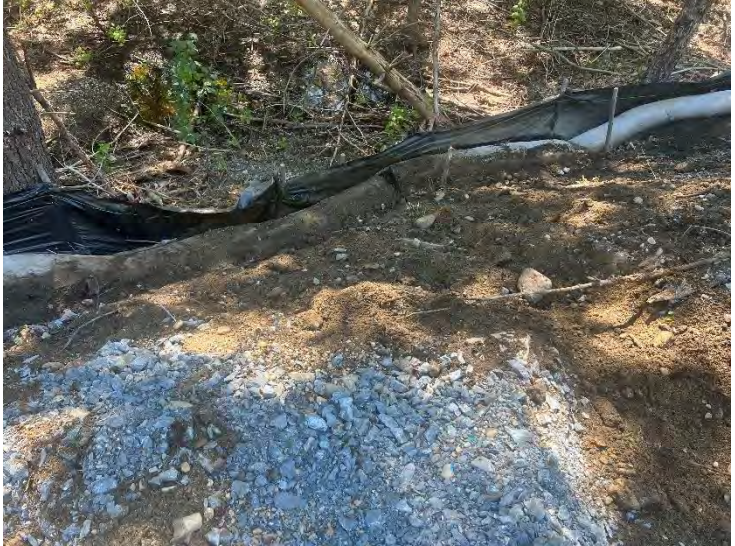
Description: View of the repaired silt fence near Station 138.00. Sediment down slope is planned to be removed 9/01/2023 (Routine Maintenance). Facing South.

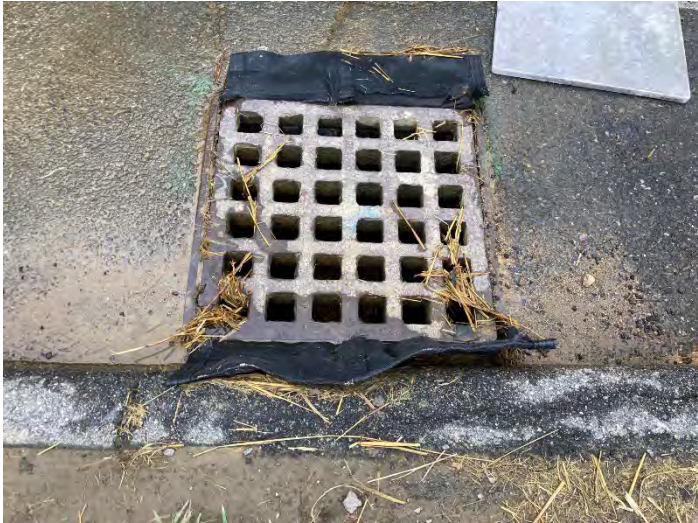
Description: View of discharge point from project (catch basin below hay bale corral on Forest Ave). Very little discharge from corral was observed at time of inspection, and therefore turbidity sample was unable to be collected.

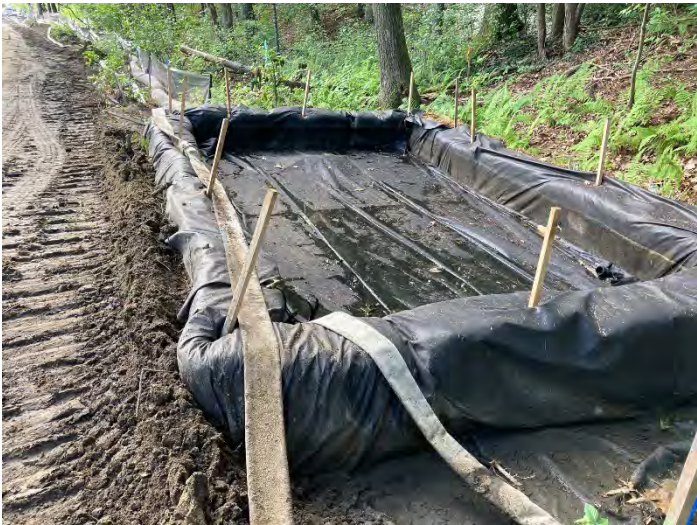
Description: Additional view of dewatering controls. No discharge from corral was observed. Facing east.

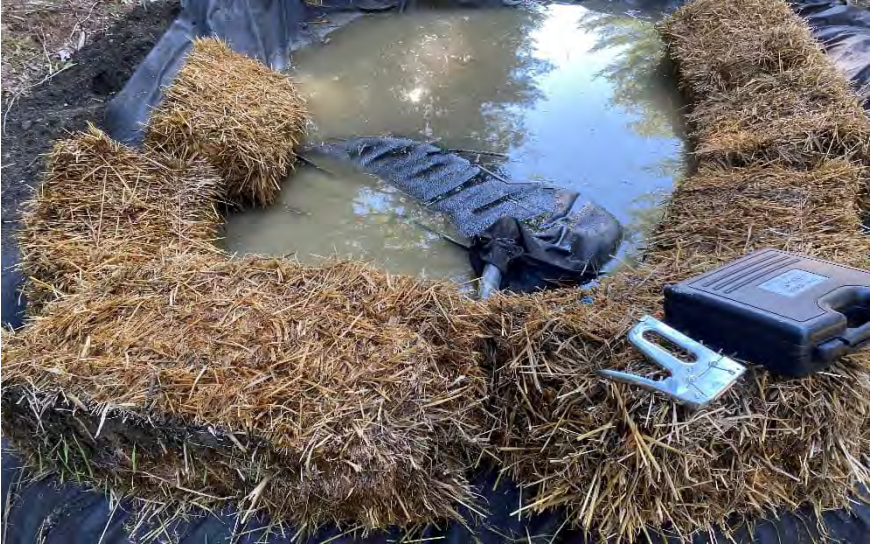
Description: Segment 7. View of discharge bag/bales, looking eastward. Water discharge to bag intermittent and appeared to be slightly turbid.
