Weekly Environmental Compliance Summary

Sudbury to Hudson Transmission Reliability Project (USEPA Tracking # MAR1003UW)

Week of: October 2, 2023 to October 6, 2023

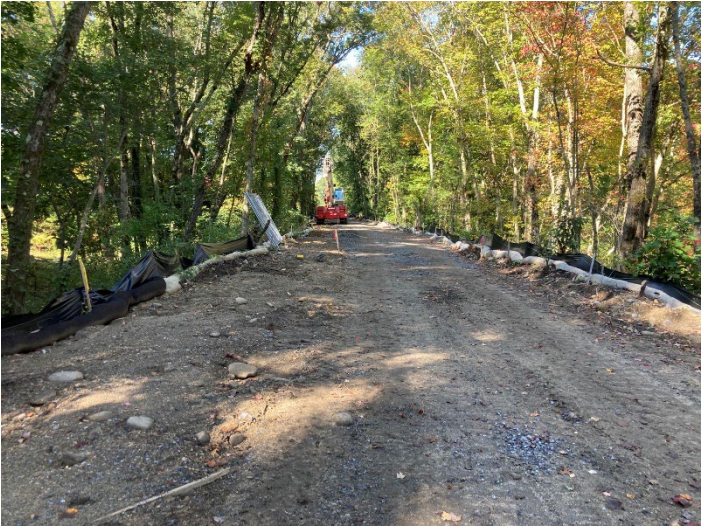
| Photo No.: 2 | Date: 10/03/2023 | | |

| Description: View of one section of segment 1 where new black compost filter tubes have been installed where tubes were previously missing. Facing west. | | | |

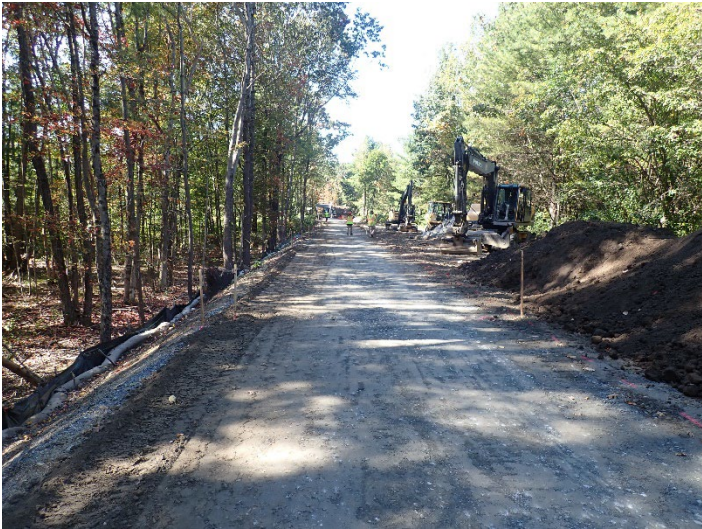
| Photo No.: 4 | Date: 10/05/2023 | | |

| Description: View of Segment 2 towards Chestnut St tunnel. Erosion controls are in good condition. Facing west. | | | |

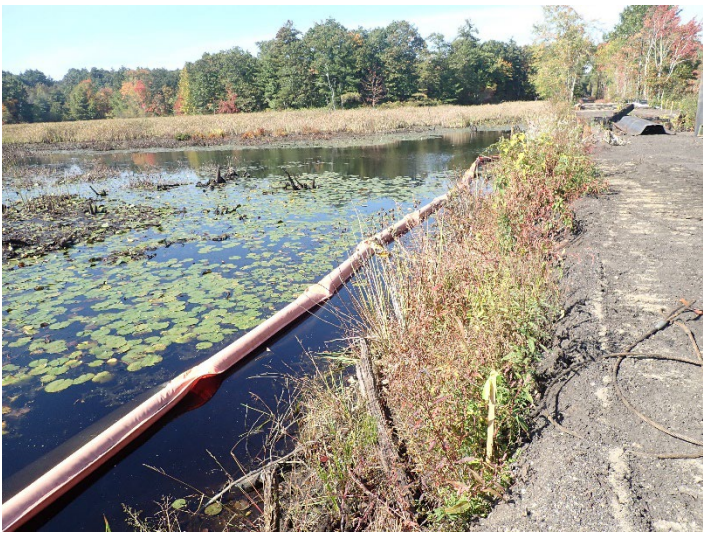
| Photo No.: 5 | Date: 10/05/2023 | | |

| Description: View of turbidity curtain at Bridge 130. Turbidity curtains at this site are in good condition. No work was conducted at the bridge today. Facing west. | | | |

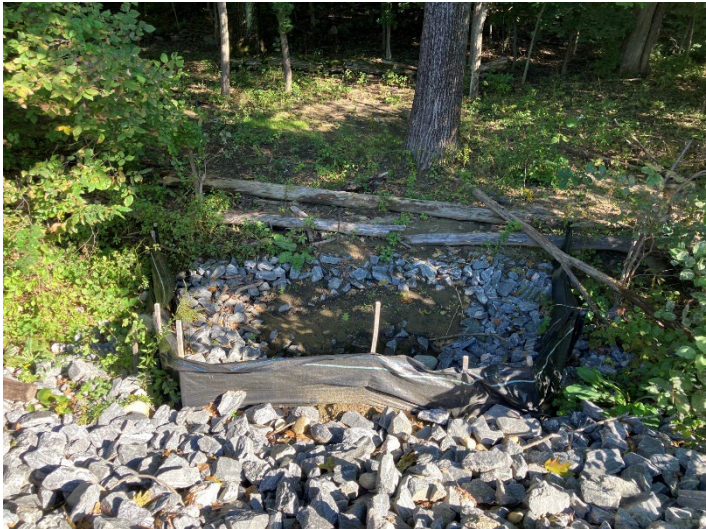
| Photo No.: 2 | Date: 10-02-2023 | | |

| Description: View of Sta. #119+25 LT (concrete headwall/drainage structure 4) in segment 1. It is recommended that sediment that has collected on rip rap be removed. Facing north. | | | |

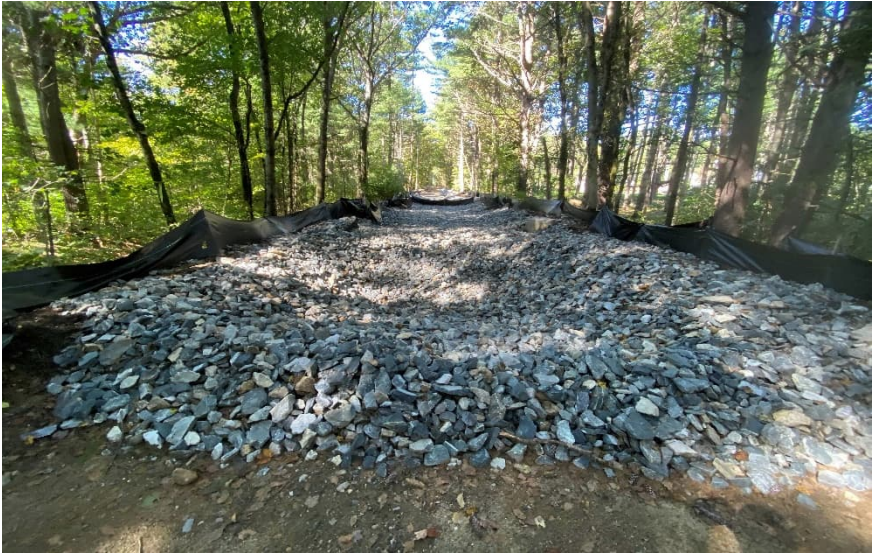
| Photo No.: 7 | Date: 10-2-23 | | |

| Description: Work area within segment 9, existing erosion control, area of previously compromised culvert, looking westward. | | | |

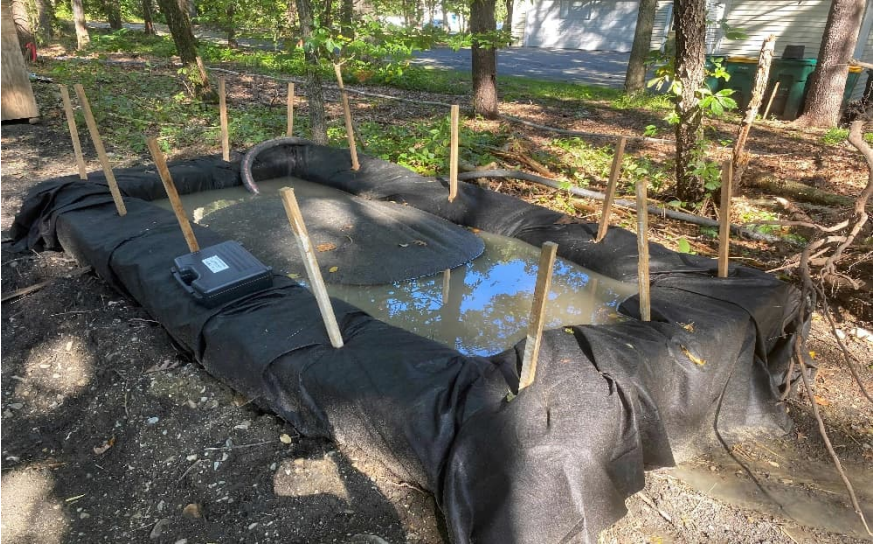
| Description: Segment 11. View of discharge bag/bales, looking westward. Water discharge to bag intermittent and appeared to be slightly turbid. | | | |

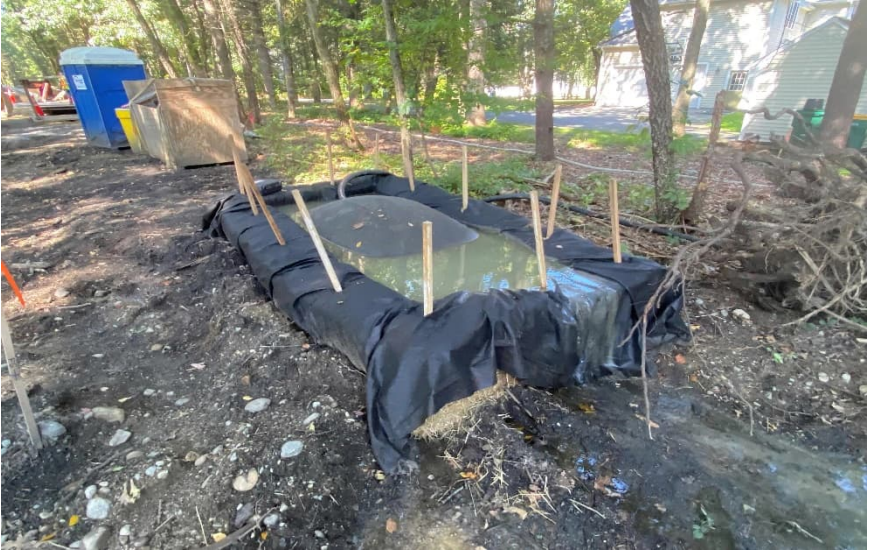
| Description: Segment 11. View of discharge bag/bales, looking westward. Water discharge to bag intermittent and appeared to be slightly turbid. | | | |

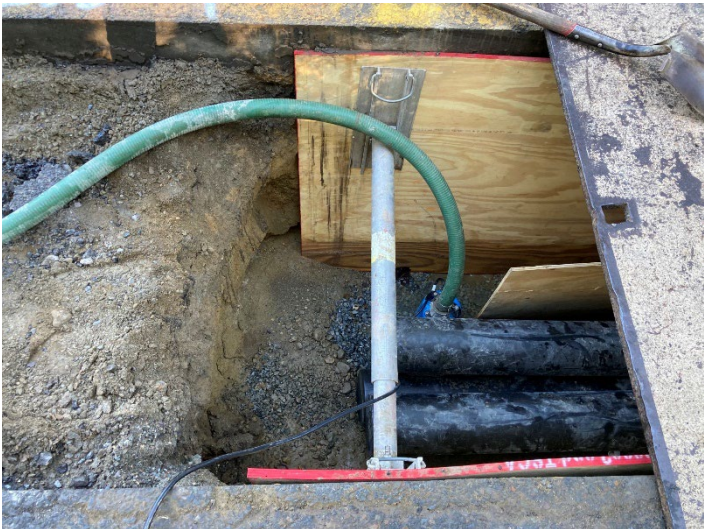
| Photo No.: 2 | Date: 10/03/2023 | | |

| Description: View of pump in trench. Unable to visualize water prior to treatment. | | | |

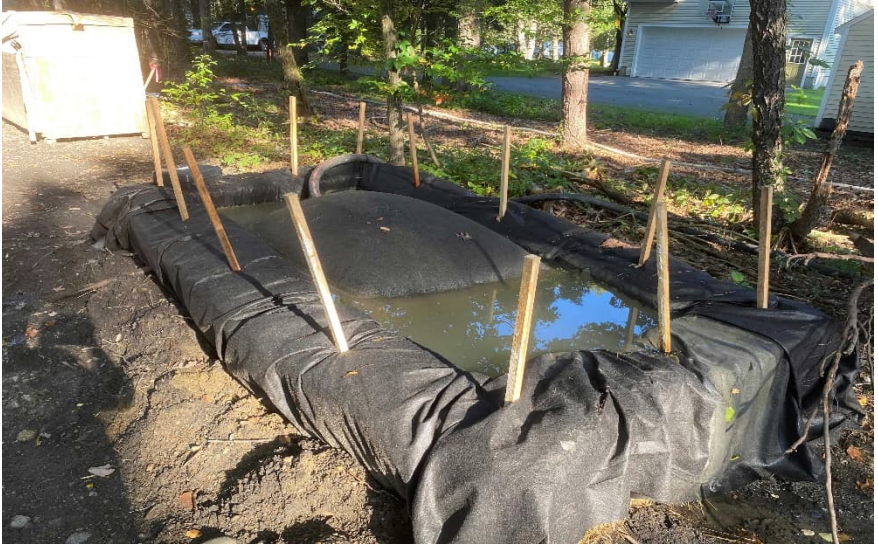
| Description: Segment 11. View of discharge bag/bales, looking westward. Water discharge to bag intermittent and appeared to be slightly turbid. | | | |

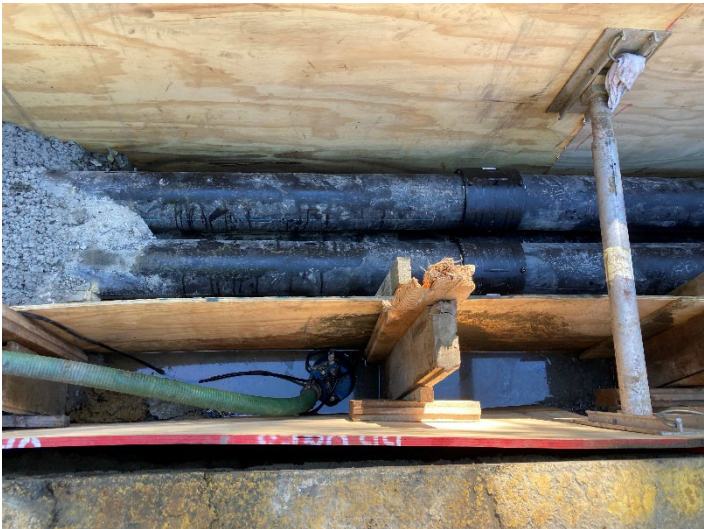
| Photo No.: 2 | Date: 10/04/2023 | | |

| Description: View of pump in trench. Water appeared to be slightly turbid prior to treatment. | | | |
