Field	l Rep	ort	No.	17
-------	-------	-----	-----	----

Client:		Town of Sudbury		
	Project Name:	Sudbury-Hudson Transmission Reliability			
	Inspector:		Jeffrey Polidor		
	Project No:		22012F		
Horsley Witten	Inspection Date:	10/23/23 Arrival Time:	8:00 AM		
Group, Inc.	Weather:	Clear, 50°F Departure Time:	11:30 AM		
Contractor(s)	equipment:	Reference Plan:

115kV Underground Transmission Line Sudbury - Hudson, MA

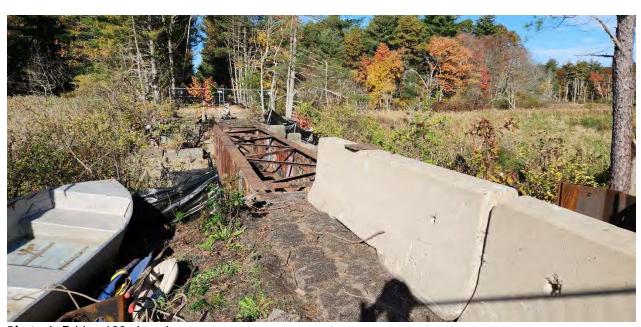
- Silt fence and filter tube are functioning properly along segments 7 and 11-14.
- Bridge 128 is closed (Photo 1).
- Silt fence is ripped in two places along segment 8 (Photo 2).
- Silt fence is ripped along segment 9.
- Drainage pipes have been delivered along segment 10 and are awaiting structure installation (Photo 3).
- Silt fence has broken stakes in two places along segment 10 (Photo 4).
- Sediment is tracked into the road at construction entrance STA 407+50 (Photo 5).
- Cut and fill was being done along segment 11 (Photo 6).

Photo 1: Bridge 128 closed. Photo taken on 10/23/23

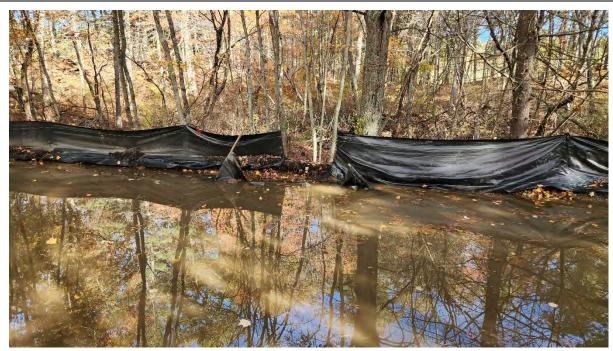
Photo 2: Rip in the silt fence in standing water along segment 8. Photo taken on 10/23/23

- 1. Repair silt fence as noted above.
- 2. Clear sediment from the street at construction entrance STA 407+50.

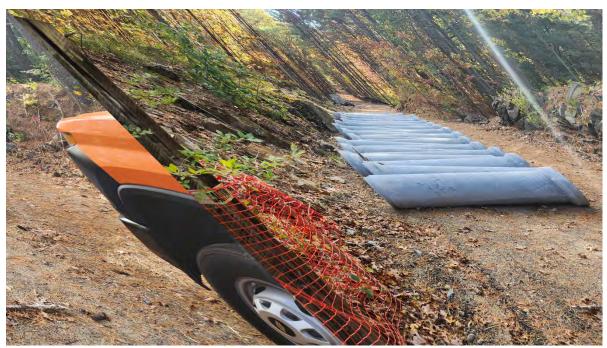
Photo 3: Drainage pipes along segment 10 waiting for structure installation. Photo taken on 10/23/23

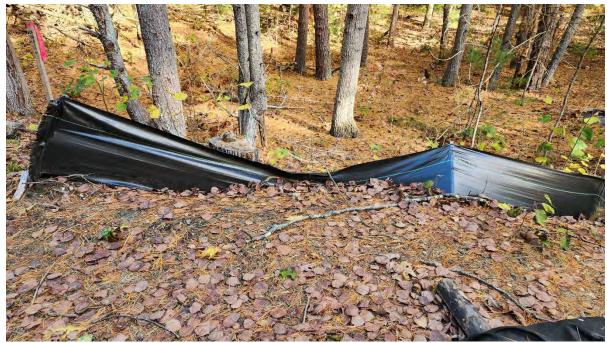
Photo 4: Broken stakes in the silt fence along segment 10. Photo taken on 10/23/23

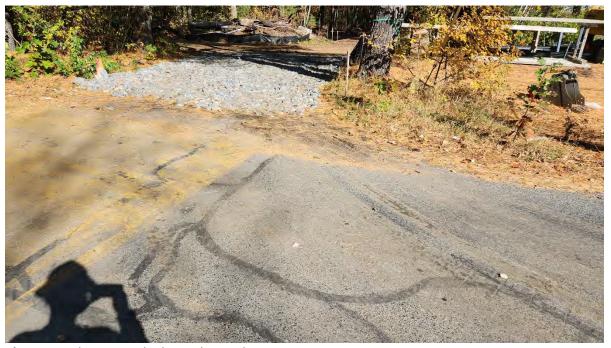
Photo 5: Sediment tracked into the road at construction entrance STA 407+50. Photo taken on 10/23/23

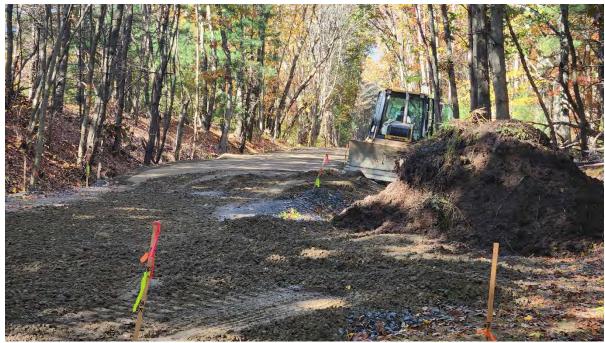
Photo 6: Earthwork activity along segment 11. Photo taken on 10/23/23
