**Weekly Environmental Compliance Summary**

**Sudbury to Hudson Transmission Reliability Project (USEPA Tracking # MAR1003UW)**

Week of: November 6, 2023 to November 10, 2023

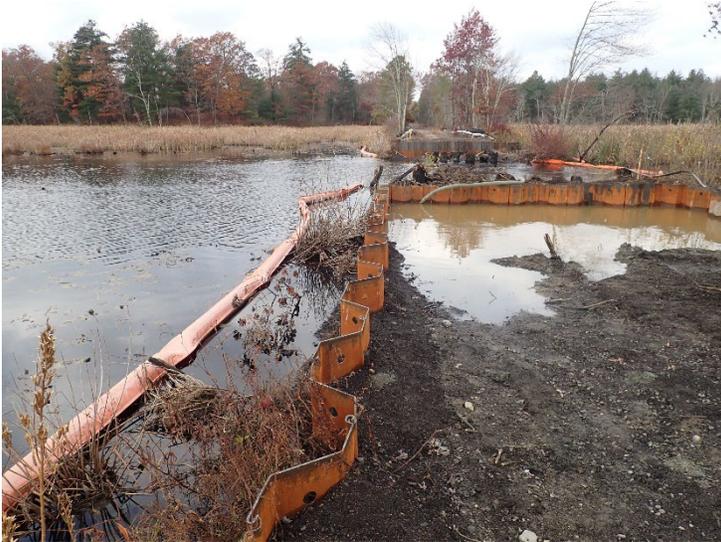
<b>Description:</b>  Work area within segment 3 looking toward segment 2, bridge 130, looking westward. Turbidity curtain in place. Crews are preparing area for future dewatering activities.

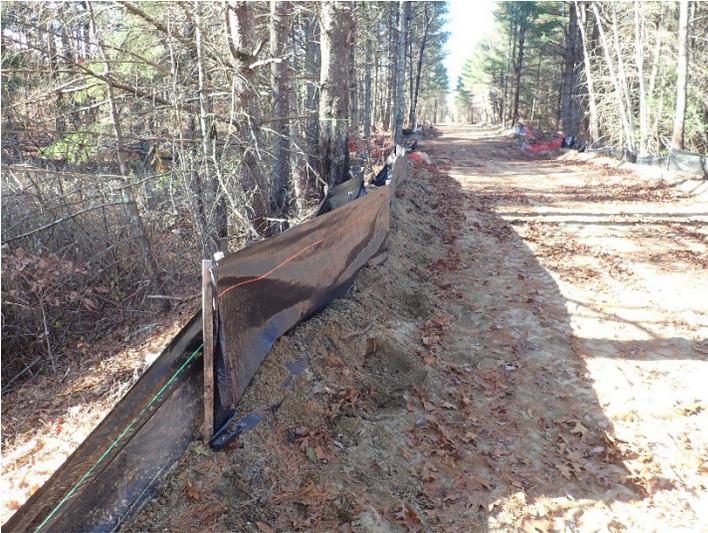
<p><b>Description:</b>                  Silt fence repaired within Segment 7, looking westward.</p>

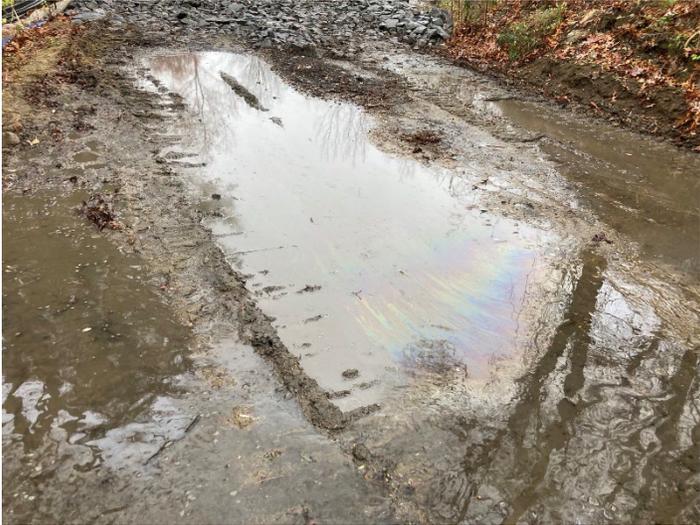
-During work at bridge 130 on 11/09/2023, a fitting cracked on ET&L's crane and a small oil leak occurred. The fitting was quickly replaced. Although oil did not appear to reach the ground at the time of the incident, residual oil created a sheen on the puddles in segment 3 when the crane traveled back to Bridge 130 after being repaired. The oil spilled was not a reportable quantity and did not appear to reach the wetlands. ET&L worked to clean up the sheen immediately.

<b>Description:</b> View of oil sheen in puddle in segment 3 following leak from crane. Facing west.

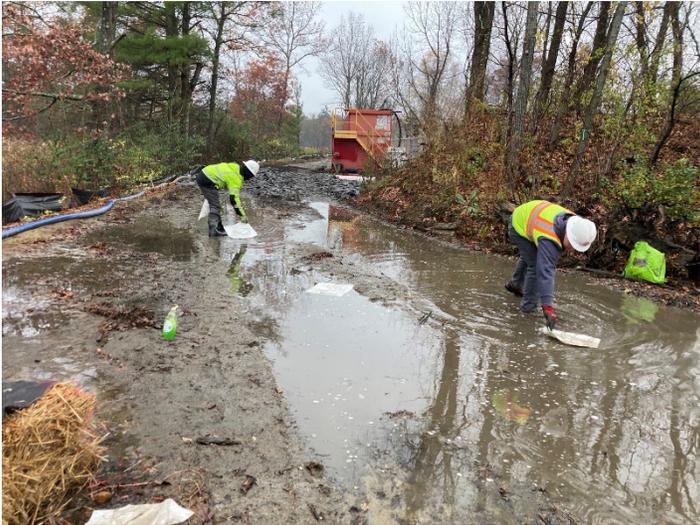
<b>Description:</b> View of ET&L conducting clean up of oil spill in segment 3. Facing west.

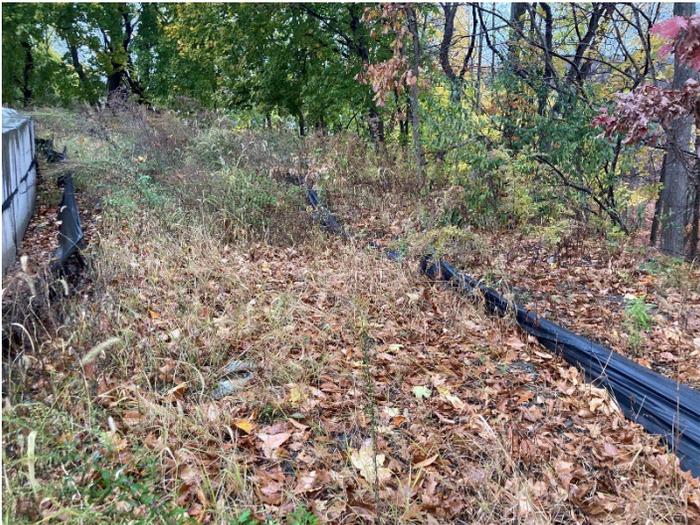
-Silt fence repair is needed where damaged at Stowe Ct laydown yard (routine maintenance).

4. Silt Fencing at laydown yards (25 Stowe Ct and 17 Bonazzoli Avenue)	<input checked="" type="checkbox"/> Yes <input type="checkbox"/> No	1	<input type="checkbox"/> Yes <input checked="" type="checkbox"/> No	11/09/2023	Silt fence repair is needed where damaged at Stowe Ct laydown yard.

<b>Description:</b> View of silt fence repair in need of repair at Stowe Ct laydown yard (routine maintenance). Facing north.

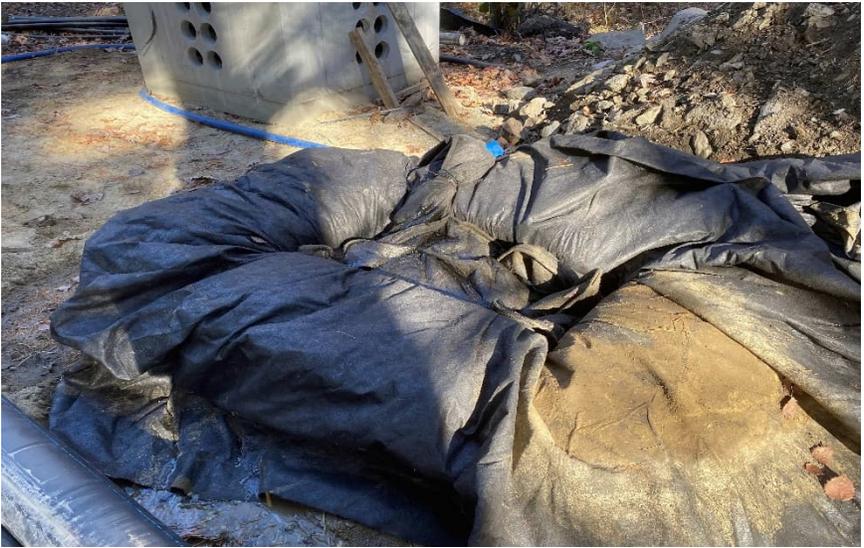
Description: Segment 10. View of discharge bag/bales, looking westward. Water discharge to bag intermittent and appeared to be slightly turbid. Discharge from corral to work area.

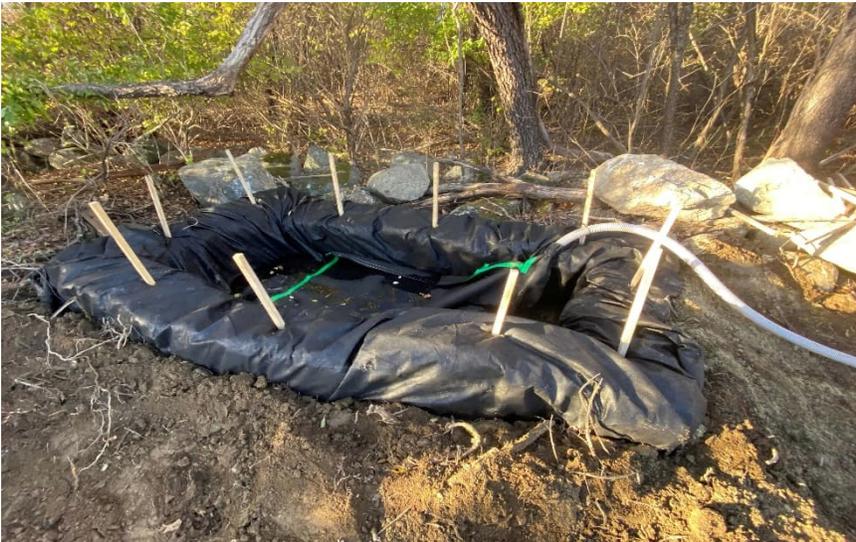
Description: Manhole #28. View of discharge bag/bales, looking westward. Water discharge to bag intermittent. Water from corral discharged to adjacent wooded area (upper middle).

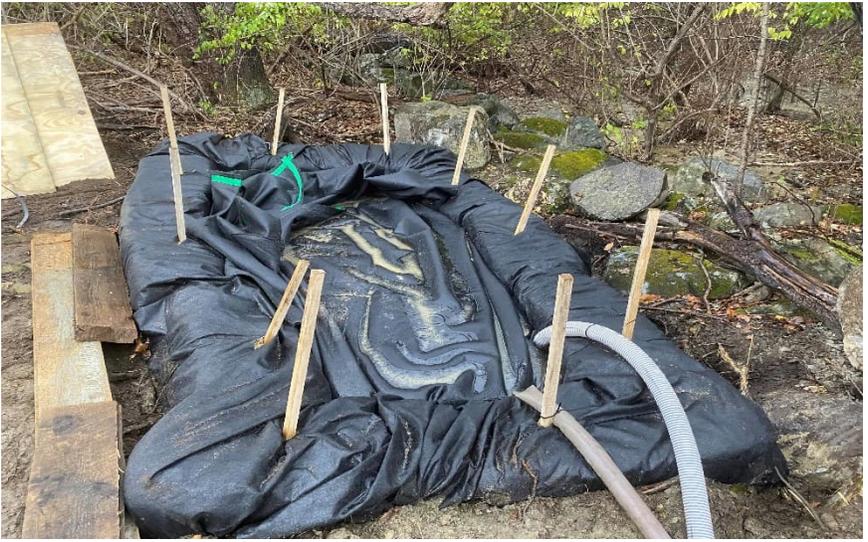
Description: Manhole #28. View of discharge bag/bales, looking southward. Water discharge to bag intermittent. Discharge from corral to adjacent wooded area (upper right).

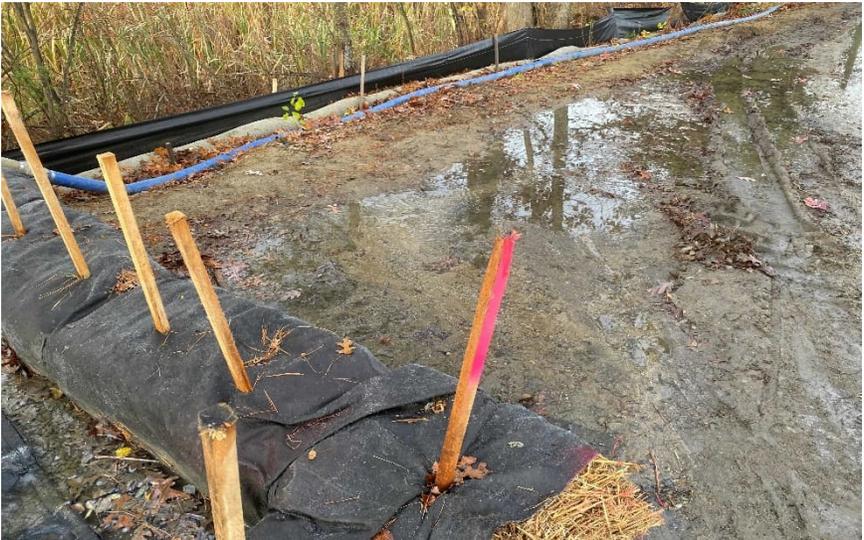
Description: Segment 3. View of discharge from bag/bales to adjacent work area, looking westward. Water discharge to bag intermittent and appeared to be slightly turbid.

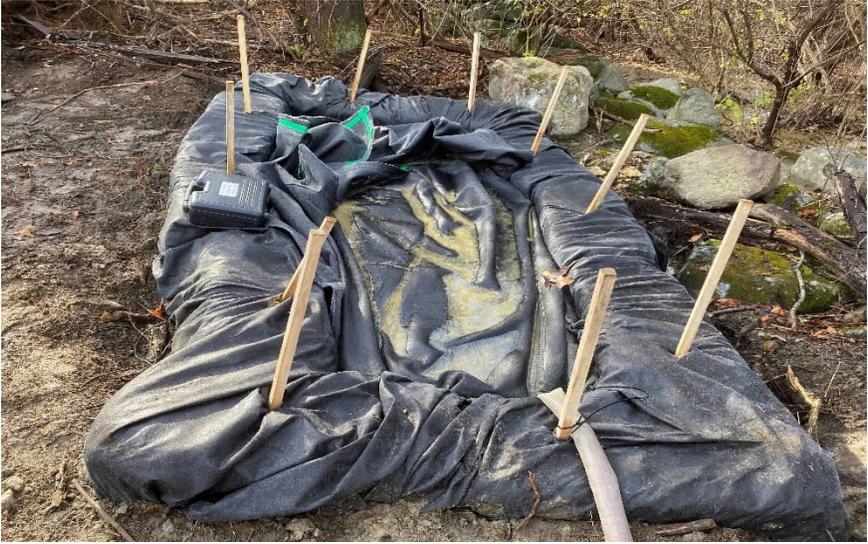
Description: Manhole #28. View of discharge bag/bales, looking southward. Water discharge to bag intermittent and flow from corral to adjacent wooded area (upper right).

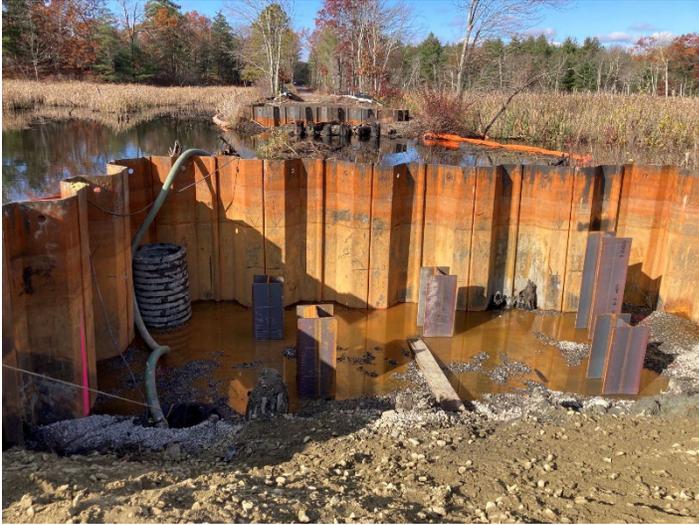
<b>Description:</b> View of work area and pumping operation at bridge 130 in segment 3. Oxidizing bacteria (natural occurring substance) observed in water. Facing west.

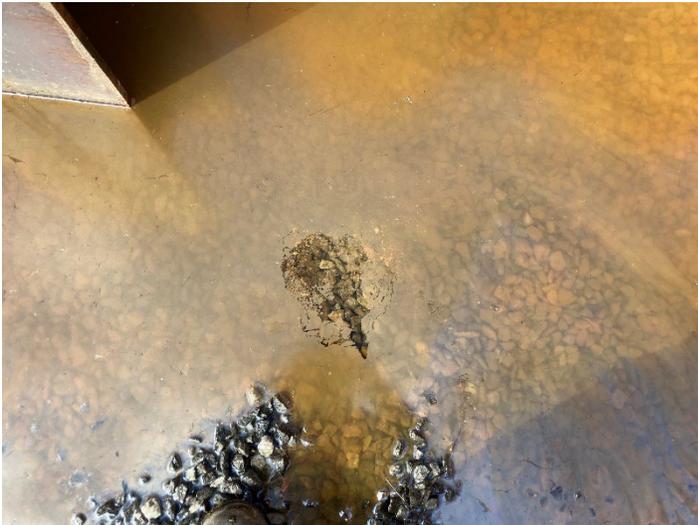
<b>Description:</b> View of water prior to treatment. Oxidizing bacteria observed in water. Water appeared mostly clear under bacteria sheen. Facing west.

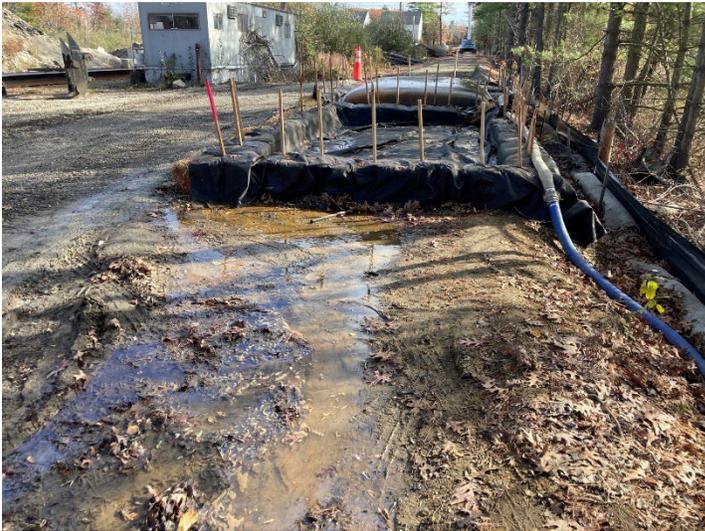
<b>Description:</b> View of discharge from controls. Discharge appeared mostly clear. Turbidity reading was below 50 NTUs. Discharge did not appear to be leaving the project at time of inspection. Oxidizing bacteria sheen noted. Facing east.
