Weekly Environmental Compliance Summary

Sudbury to Hudson Transmission Reliability Project (USEPA Tracking # MAR1003UW)

Sudbury, Hudson, and Stow, MA

Week of: November 13, 2023 to November 17, 2023

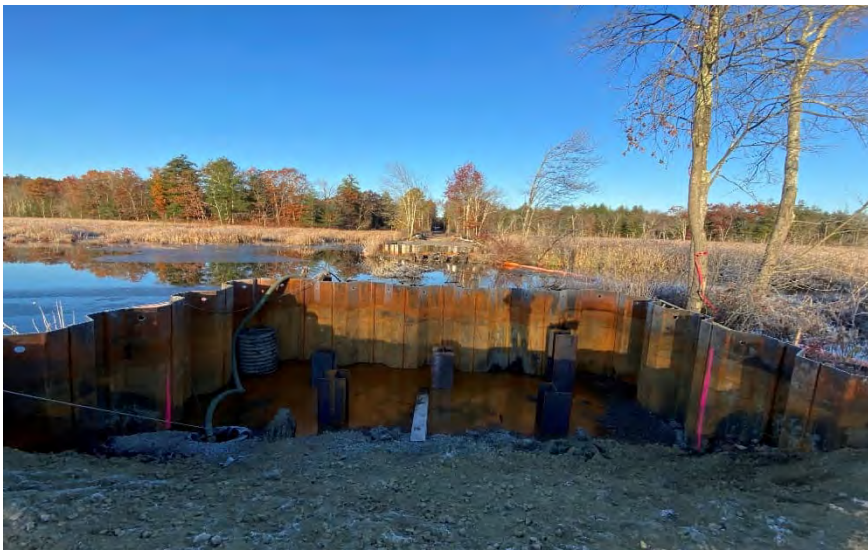
PHOTOGRAPHIC LOG	
Client Name: Eversource		Site Location: Sudbury to Hudson Transmission Reliability Project	
Photo No.: 1		Date: 11-13-23	
Description: Work area within segment 3 -> segment 2, bridge 130 work area, newly placed H-piles, looking westward.

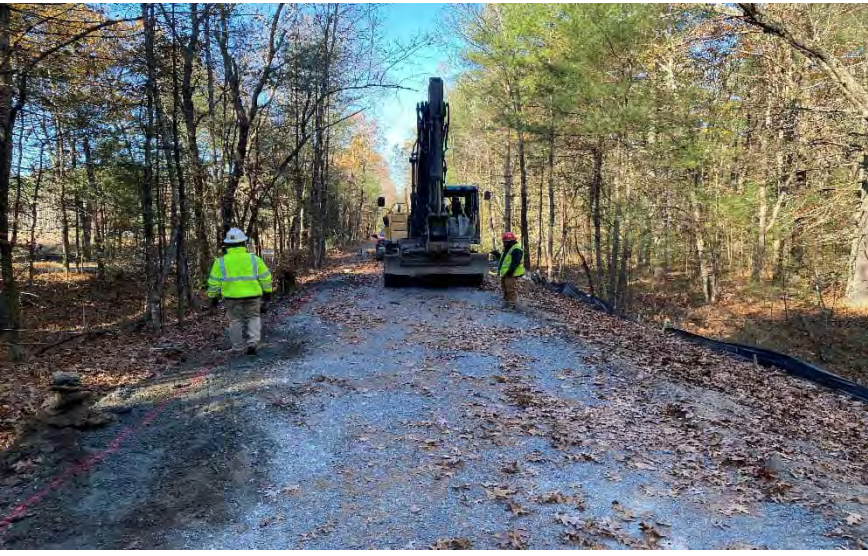
PHOTOGRAPHIC LOG	
Client Name: Eversource		Site Location: Sudbury to Hudson Transmission Reliability Project	
Town: Hudson			
Photo No.: 4	Date: 11-13-23

Description: Work area within Segment 5, grading work, existing erosion control, looking westward.

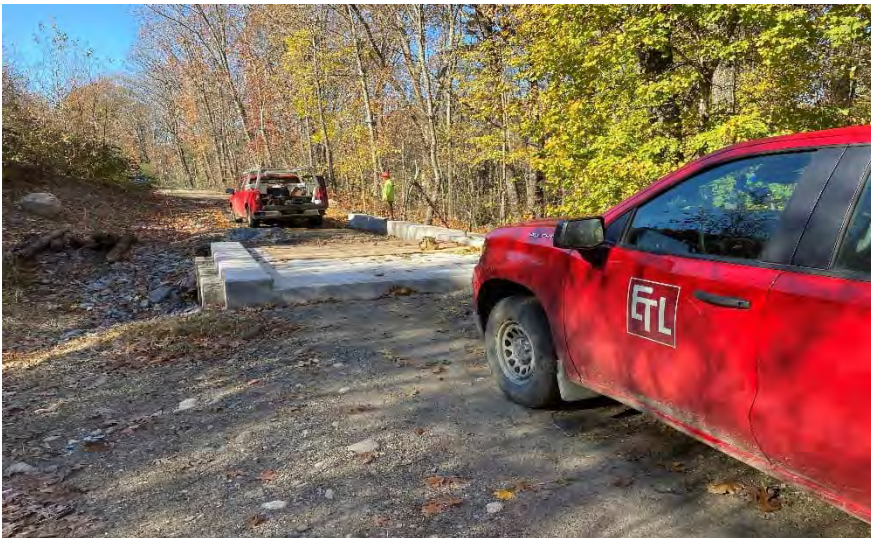
PHOTOGRAPHIC LOG	
Client Name: Eversource		Site Location: Sudbury to Hudson Transmission Reliability Project	
Photo No.: 5		Date: 11-13-23	
Description: Work area within segment 1 at cattle crossing, looking westward.

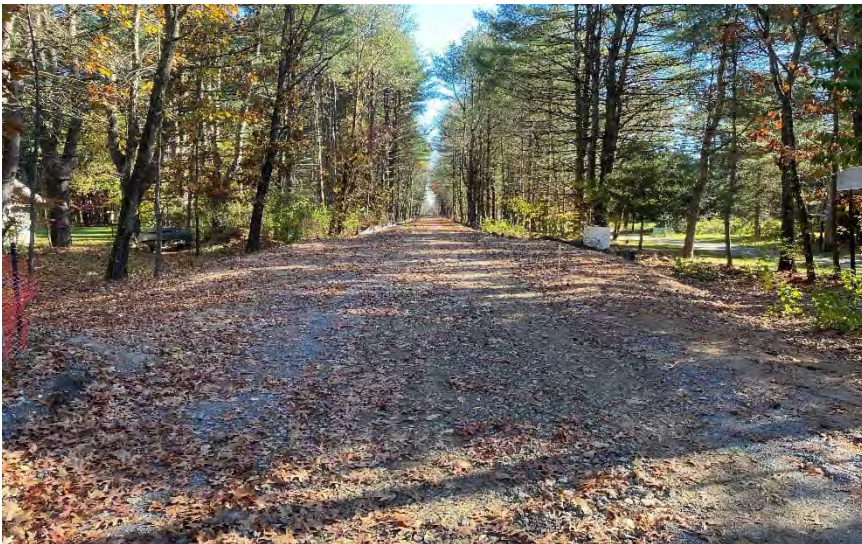
PHOTOGRAPHIC LOG	
Client Name: Eversource		Site Location: Sudbury to Hudson Transmission Reliability Project	
Photo No.: 6		Date: 11-13-23	
Description: Segment 5, Manhole #11, existing erosion control, looking eastward.

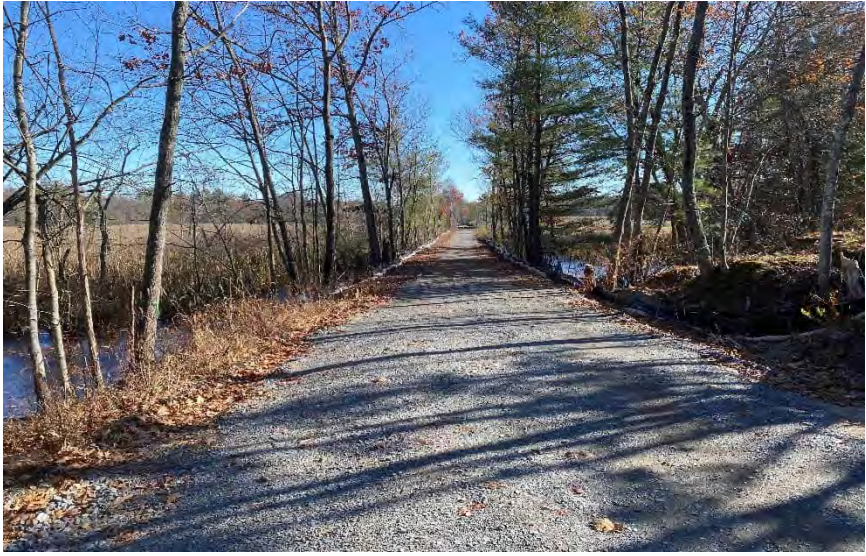
PHOTOGRAPHIC LOG	
Client Name: Eversource		Site Location: Sudbury to Hudson Transmission Reliability Project	
Town: Hudson			
Photo No.: 7	Date: 11-13-23

Description: Work area within segment 2, existing erosion control, looking eastward.

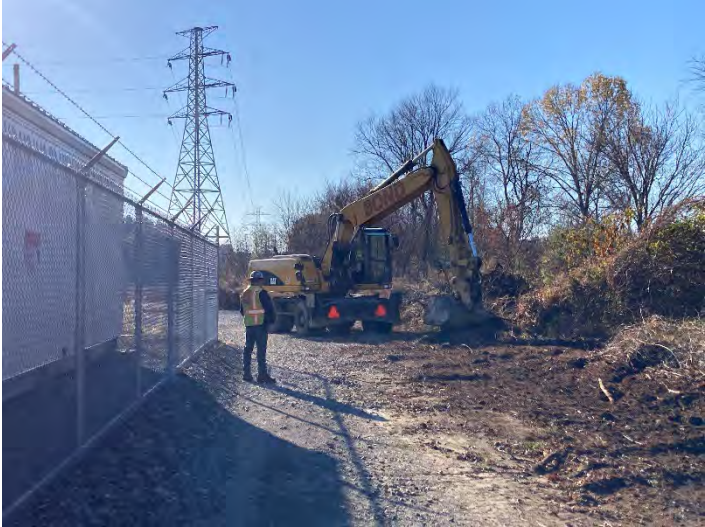
Epsilon ASSOCIATES INC.		PHOTOGRAPHIC LOG	
Client Name: Eversource		Site Location: Sudbury to Hudson Transmission Reliability Project	Town: Sudbury
Photo No.: 1	Date: 11/13/2023

Description: View of Bond working near MH #28 at Sudbury Substation. Facing south.

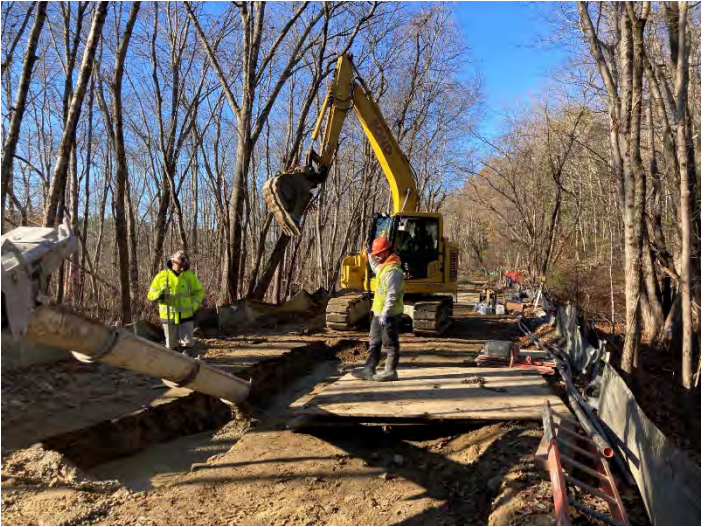
Epsilon ASSOCIATES INC.		PHOTOGRAPHIC LOG	
Client Name: Eversource		Site Location: Sudbury to Hudson Transmission Reliability Project	Town: Sudbury
Photo No.: 2	Date: 11/13/2023

Description: View of Bond conducting ductbank installation in segment 14. Facing west.

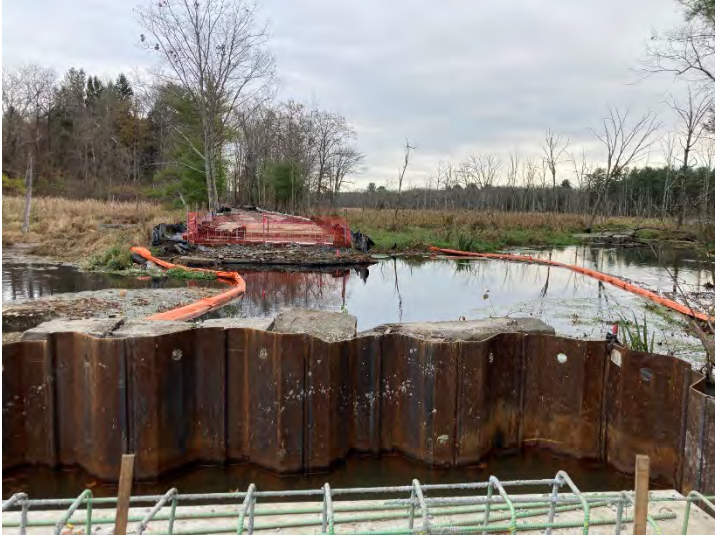
PHOTOGRAPHIC LOG	
Client Name: Eversource		Site Location: Sudbury to Hudson Transmission Reliability Project	
Town: Sudbury			
Photo No.: 3	Date: 11/13/2023

Description: View of Bridge 127 area from segment 13. Facing east.

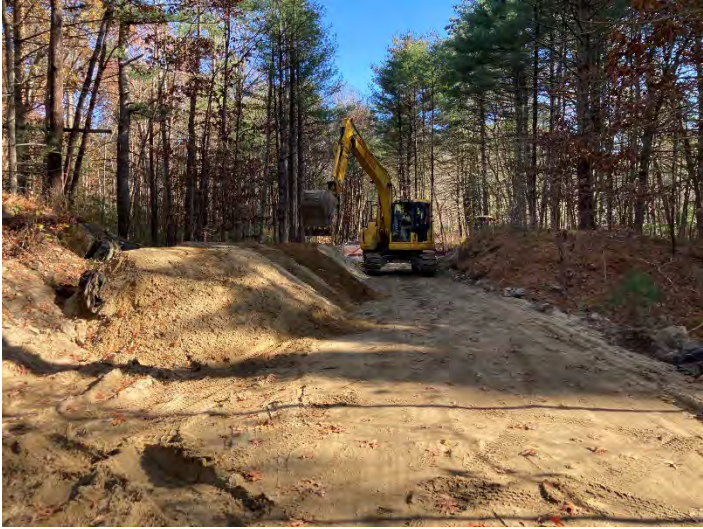
PHOTOGRAPHIC LOG	
Client Name: Eversource		Site Location: Sudbury to Hudson Transmission Reliability Project	
Town: Sudbury			
Photo No.: 5	Date: 11/13/2023

Stockpiles noted within ROW in segments 10 and 12.

Description: View of Bond working in segment 10. Stockpiles noted within ROW. Facing east.

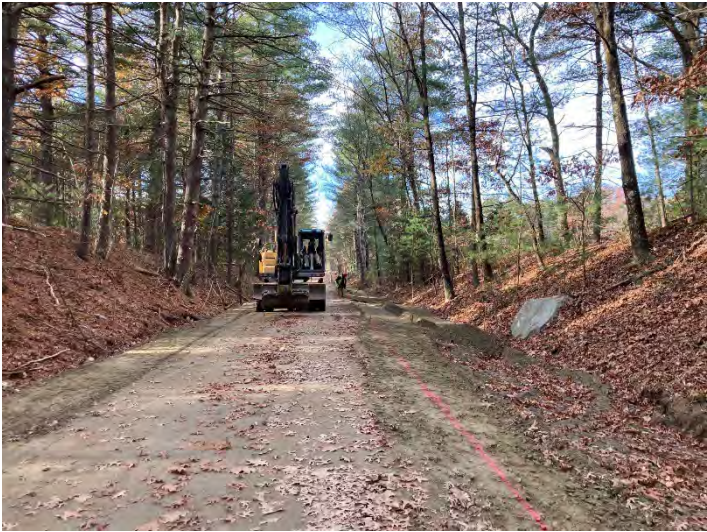
PHOTOGRAPHIC LOG	
Client Name: Eversource		Site Location: Sudbury to Hudson Transmission Reliability Project	
Town: Sudbury			
Photo No.: 6	Date: 11/13/2023

Description: View of ET&L conducting grading and gravel installation in segment 9. Facing west.

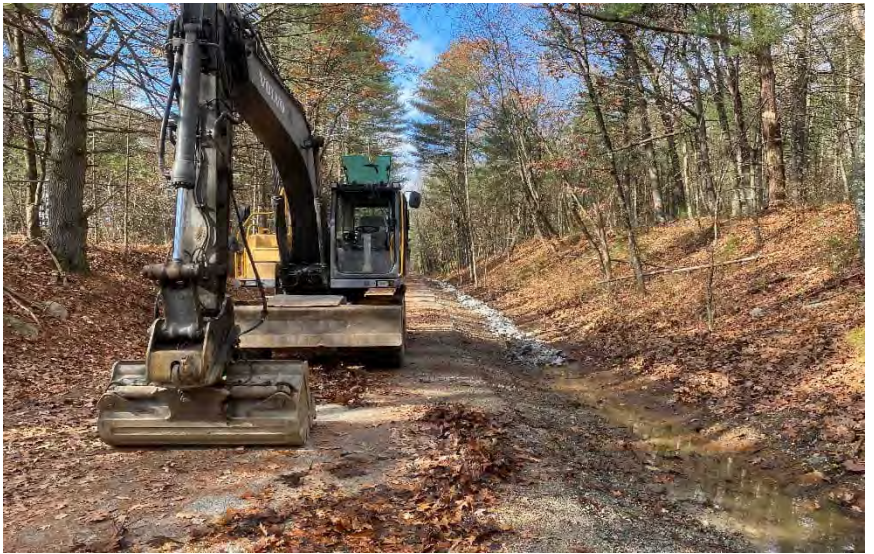
PHOTOGRAPHIC LOG	
Client Name: Eversource		Site Location: Sudbury to Hudson Transmission Reliability Project	
Town: Hudson			
Photo No.: 4	Date: 11-14-23

Description: Work area within Segment 5, grading work (lining swales with stone), looking westward.

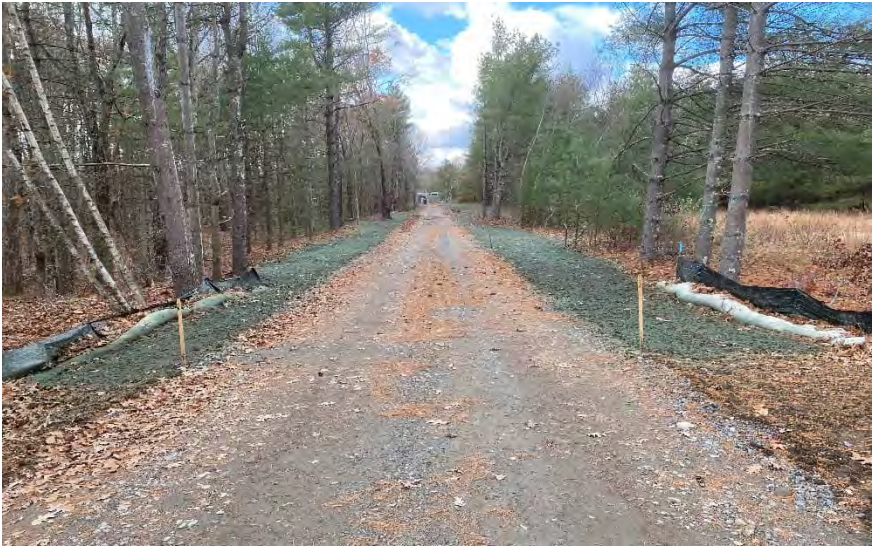
PHOTOGRAPHIC LOG	
Client Name: Eversource		Site Location: Sudbury to Hudson Transmission Reliability Project	
Town: Hudson			
Photo No.: 7	Date: 11-14-23

Description: Work area within segment 2, existing erosion control, newly placed hydroseeding, looking westward.

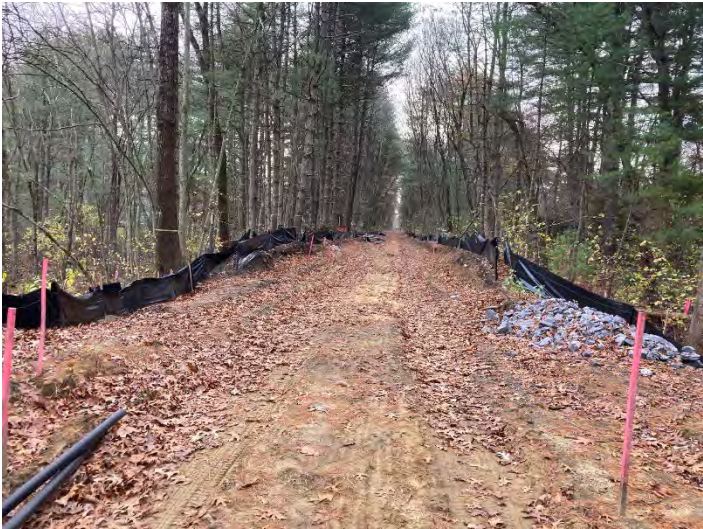
PHOTOGRAPHIC LOG	
Client Name: Eversource		Site Location: Sudbury to Hudson Transmission Reliability Project	
Town: Sudbury			
Photo No.: 4	Date: 11/14/2023

Stockpiles previously noted within ROW in segment 10 appear to have been removed.

Description: View of Dudley Brook culvert area in segment 10. Facing east.

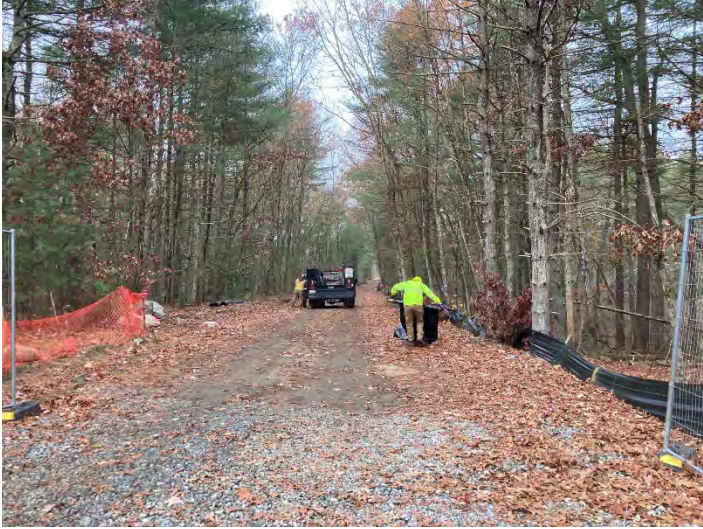
Epsilon ASSOCIATES INC.		PHOTOGRAPHIC LOG	
Client Name: Eversource		Site Location: Sudbury to Hudson Transmission Reliability Project	
Town: Sudbury			
Photo No.: 5	Date: 11/14/2023

Description: View of Bond repairing silt fence within segment 8. Facing west.

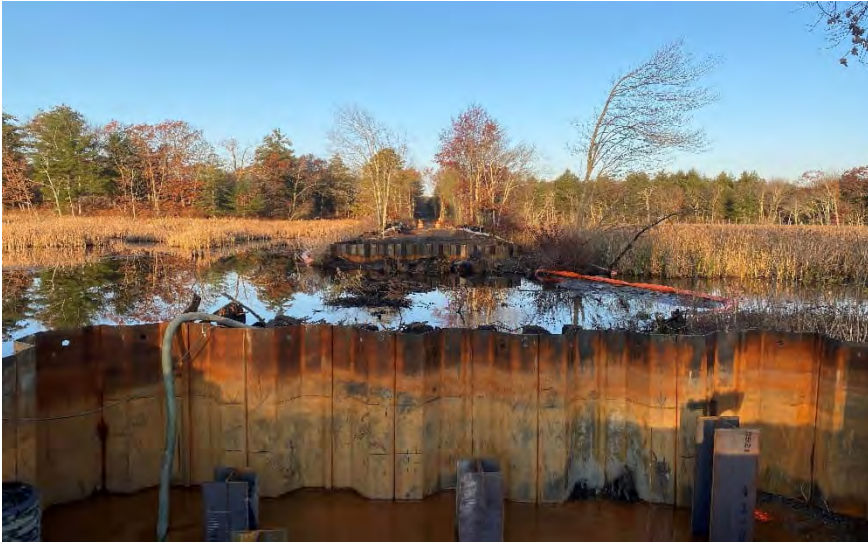
PHOTOGRAPHIC LOG	
Client Name: Eversource		Site Location: Sudbury to Hudson Transmission Reliability Project	
Town: Hudson			
Photo No.: 1	Date: 11-16-23

Description: Work area within segment 3 -> segment 2, bridge 130 work area (Fort Meadow Brook), newly placed H-piles, looking westward.

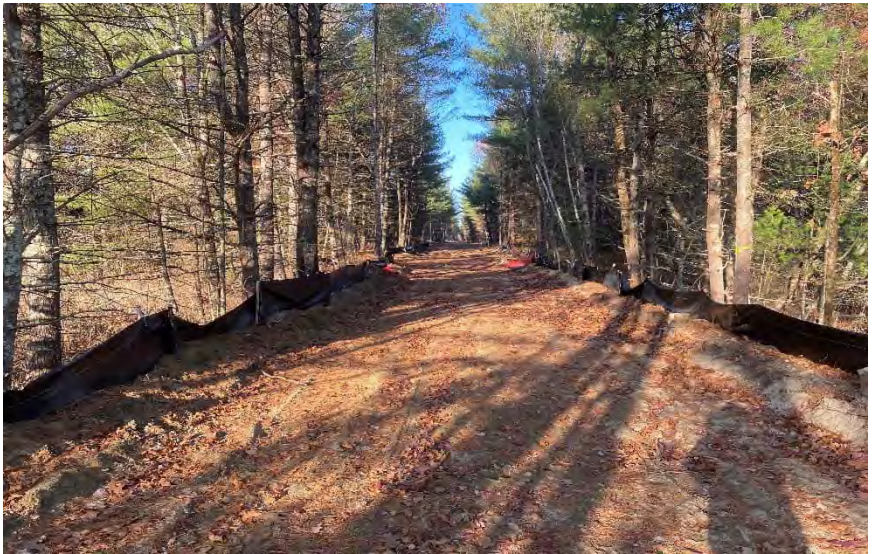
PHOTOGRAPHIC LOG	
Client Name: Eversource		Site Location: Sudbury to Hudson Transmission Reliability Project	
Town: Sudbury			
Photo No.: 4	Date: 11-16-23

Description: Work area within Segment 7, existing erosion control, looking westward.

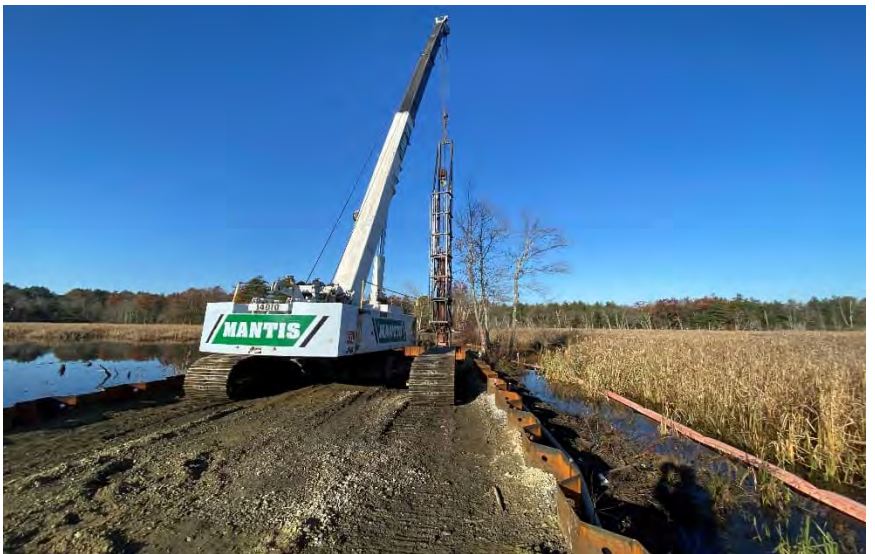
PHOTOGRAPHIC LOG	
Client Name: Eversource		Site Location: Sudbury to Hudson Transmission Reliability Project	
Town: Hudson			
Photo No.: 8	Date: 11-16-23

Description: Work area within segment 3, pile driving work, looking westward.

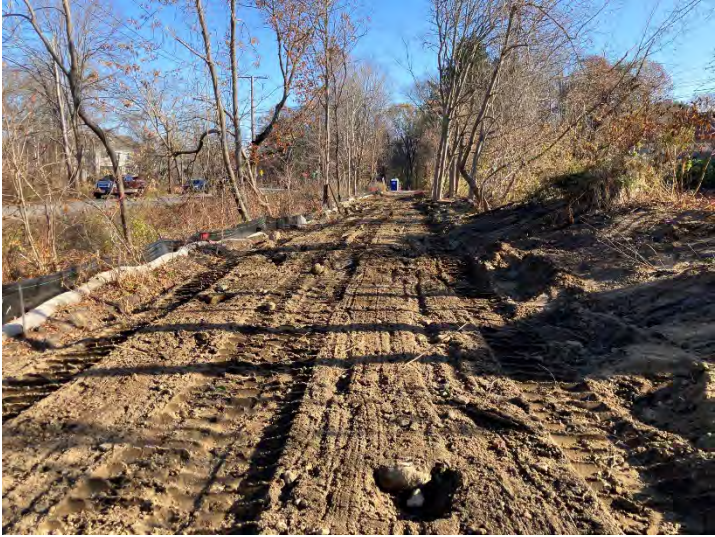
PHOTOGRAPHIC LOG	
Client Name: Eversource		Site Location: Sudbury to Hudson Transmission Reliability Project	
Photo No.: 3		Town: Sudbury	
Date: 11/16/2023

Stockpiles previously noted within ROW in segment 12 have been removed/spread.

Description: View of east end of segment 12. Stockpiles previously noted in this location have been removed/spread. Facing east.

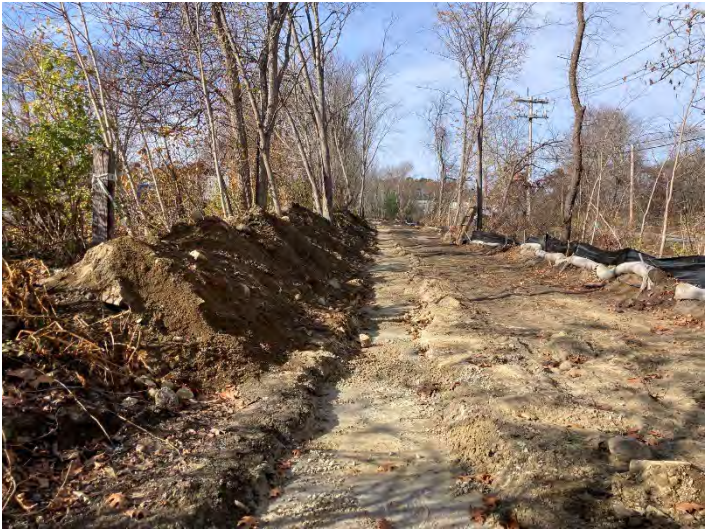
Stockpiles noted within ROW in segment 12.

Description: View of stockpiles at east end of segment 12. Facing west.

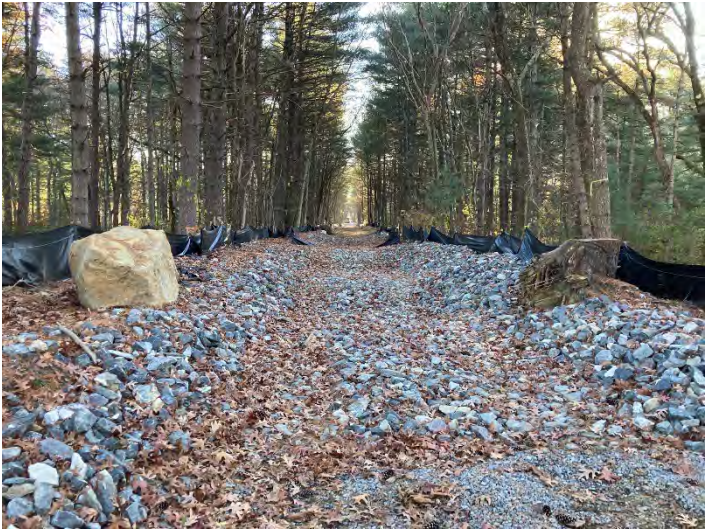
Description: View of collapsed culvert area in segment 9. Facing east.

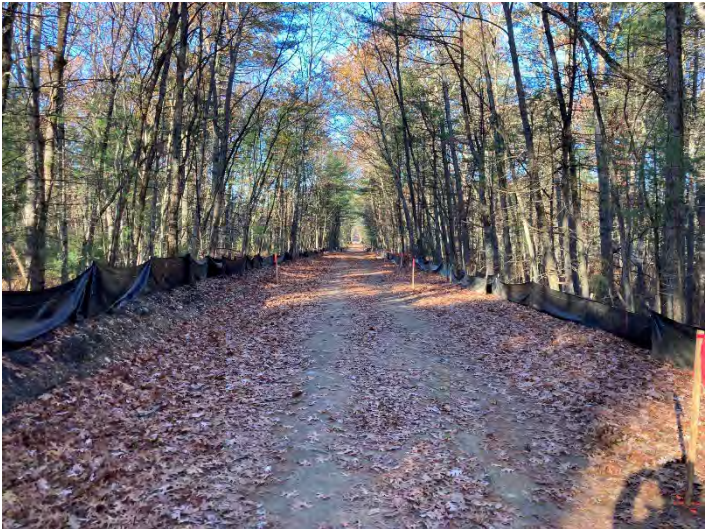
Description: View of syncopated silt fence in segment 8. Silt fence is in good condition and operating properly. Facing west.

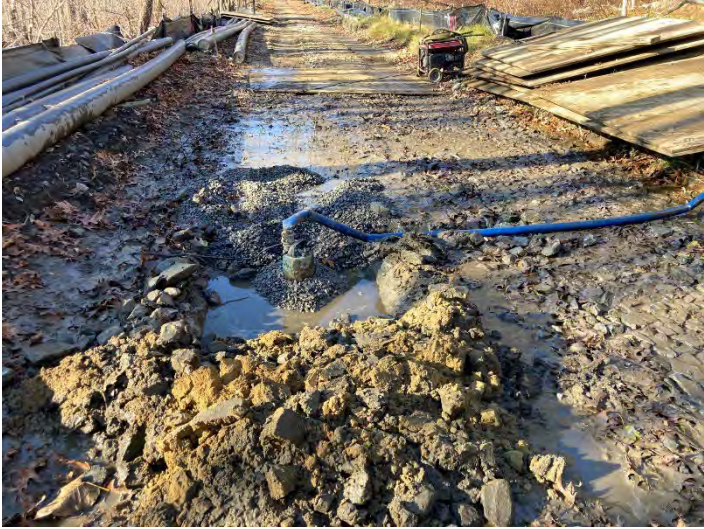
Description: View of pump in puddle in segment 14. Water appeared turbid prior to treatment. Facing west.

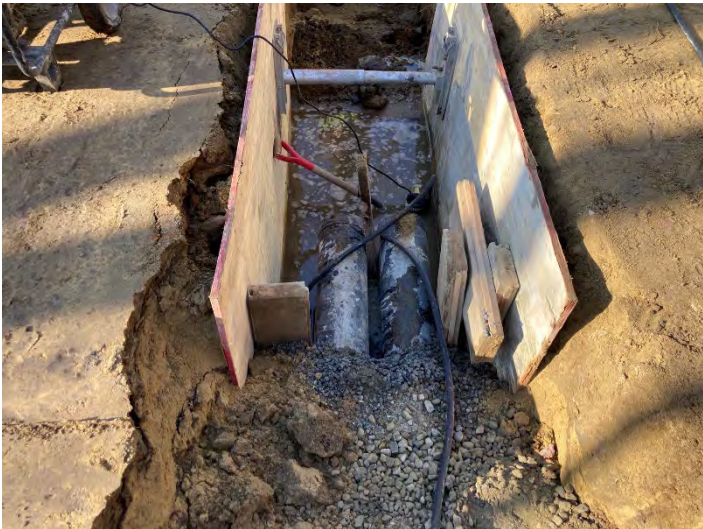
Description: View of pump in trench. Water appeared turbid prior to treatment.

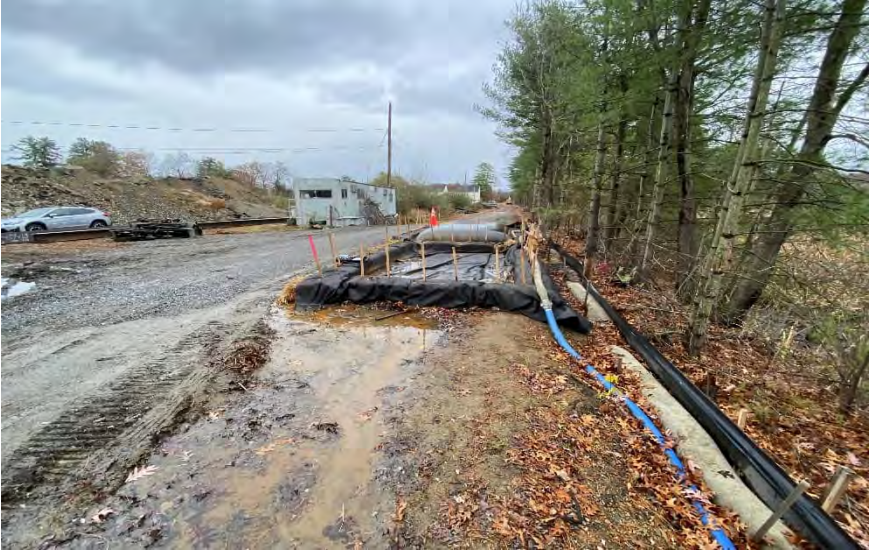
Description: Segment 3. View of discharge from bag/bales to adjacent work area, looking eastward. Water discharge to bag intermittent and appeared to be slightly turbid. Discharge from corral to work area (foreground).
