Field Report No.	18
------------------	----

Client:		Town of Sudbury
Project Name:	Sudbury-Hudson Trar	nsmission Reliability
Inspector:		Jeffrey Polidor
Project No:		22012F
Inspection Date:	11/16/23 Arrival Time:	1:00 PM
Weather:	Clear, 60°F Departure Time:	4:00 PM

Sudbury to Hudson 115kV Underground Transmission Line Sudbury - Hudson, MA Date: November 16, 2018

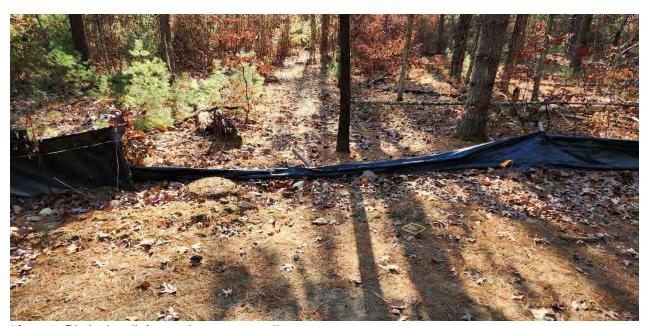
- Silt fence and filter tube are functioning properly along segments 11-14.
- Silt fence is ripped along segment 7 (Photo 1).
- Bridge 128 is being rebuilt between segment 7 and segment 8 (Photo 2).
- Sediment is tracked into the road at gravel construction entrance STA 335+50 (Photo 3).
- Concrete was being poured over installed conduit along segment 10 (Photo 4).
- Silt fence has broken stakes along segment 13 (Photo 5).
- Conduit has been installed and covered with concrete along most of segment 13 and is waiting on construction of bridge 127 (Photo 6).

Photo 1: Rip in the silt fence along segment 7. Photo taken on 11/16/23

- 1. Repair silt fence as noted above.
- 2. Clear sediment from the street at construction entrance STA 335+50.

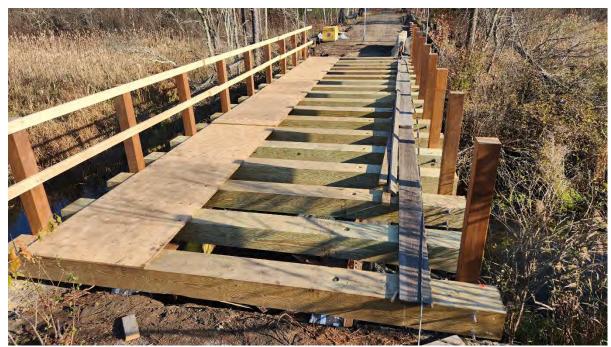
Photo 2: Bridge 128 under construction between segment 7 and segment 8. Photo taken on 11/16/23

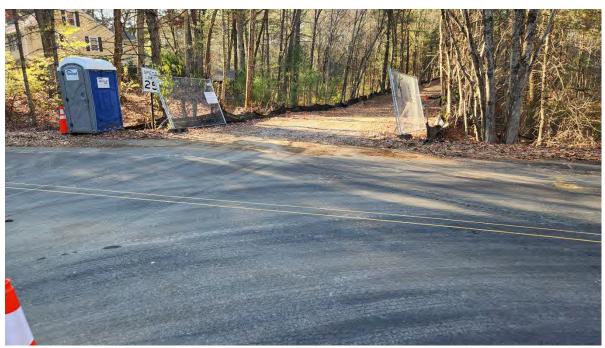
Photo 3: Sediment tracked into the road at gravel construction entrance STA 335+50. Photo taken on 11/16/23

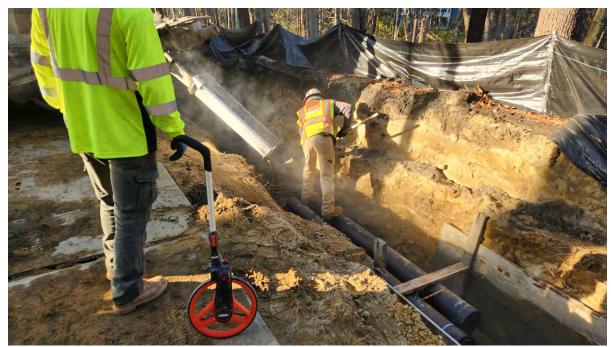
Photo 4: Concrete being poured over installed conduit along segment 10. Photo taken on 11/16/23

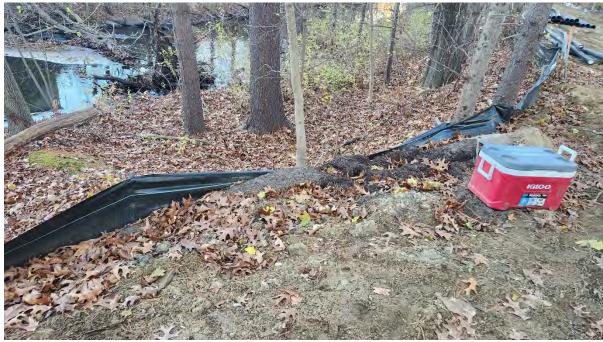
Photo 5: Broken stakes in the silt fence along segment 13. Photo taken on 11/16/23

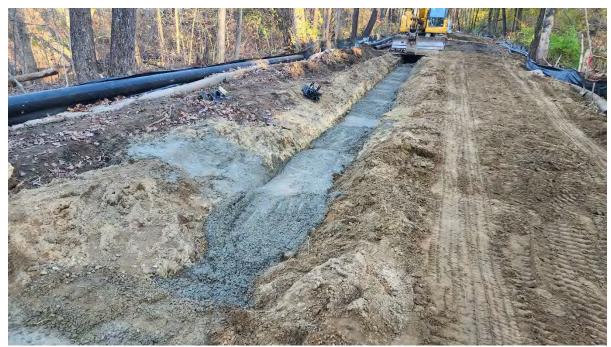
Photo 6: Installed conduit covered in concrete along segment 13. Photo taken on 11/16/23
