**Weekly Environmental Compliance Summary**

**Sudbury to Hudson Transmission Reliability Project (USEPA Tracking # MAR1003UW)**

Sudbury, Hudson, and Stow, MA

Week of: March 11, 2024 to March 15, 2024

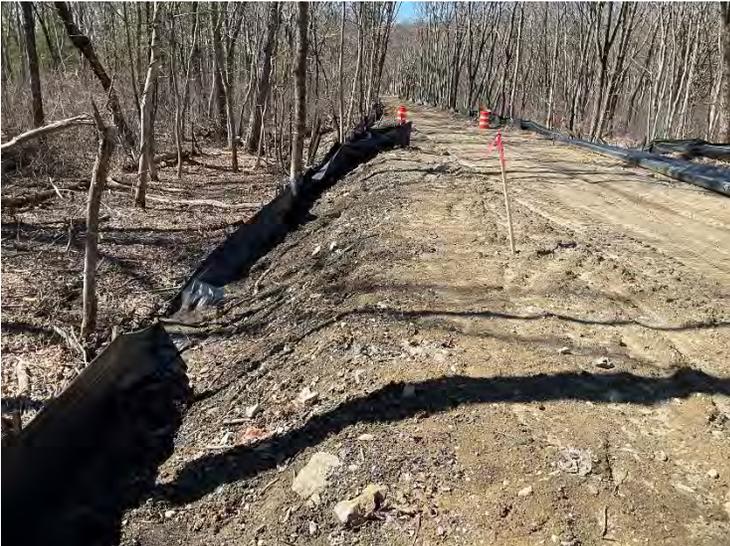
<p align="right"><b>PHOTOGRAPHIC LOG</b></p>	
<p>Client Name: Eversource</p>		<p>Site Location: Sudbury to Hudson Transmission Reliability Project</p>	<p>Town: Sudbury</p>
<p>Photo No.: 2</p>	<p>Date: 3/12/2024</p>

-Silt fence is in need of repair near MH #27 in segment 14.

<p>Description: View of damaged silt fence near MH #27 in segment 14. Facing west.</p>

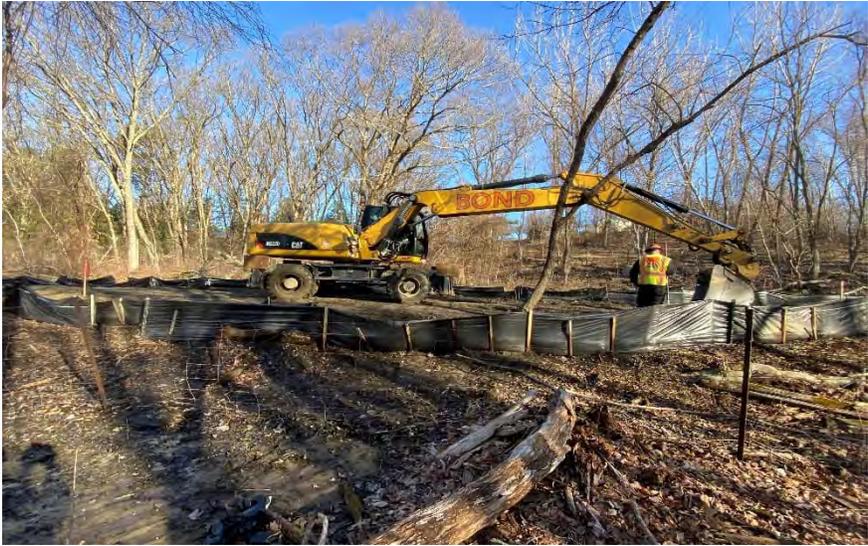
<p>Description:</p> <p>Work area within segment 14, existing erosion control, erosion control repairs at Sta # 741+25, looking westward.</p>

Accompanied Bond crew into segment 14 at Sta# 741+25, while they conducted erosion control repairs. Repairs at 741+25 included removal of a skim layer of sediment beyond the silt fencing. The material was removed by hand raking the area & an excavator removed the accumulated (hand raked) material from the area.

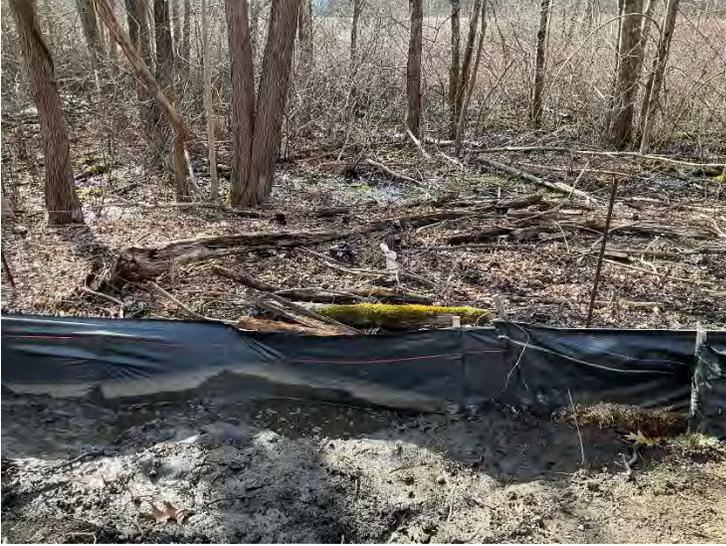
<p>Description: View of Sta. #741+25 in segment 14. Sediment has been removed from beyond silt fence. Facing south.</p>

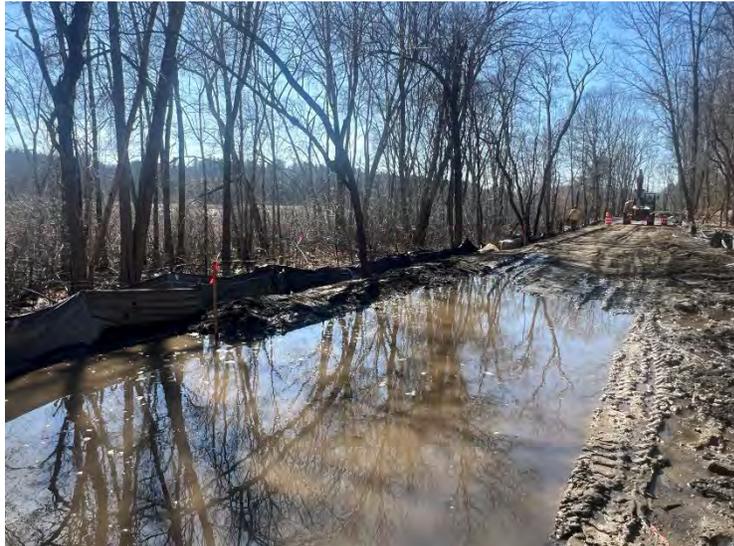
<p>Description: Additional view of Sta. #741+25. Berm was built in attempt to prevent future stormwater and sediment discharges. Soil for new berm was taken from stockpile/spoil berm at Sta. #738. Vernal pool monitor/escort was present. Facing southwest.</p>

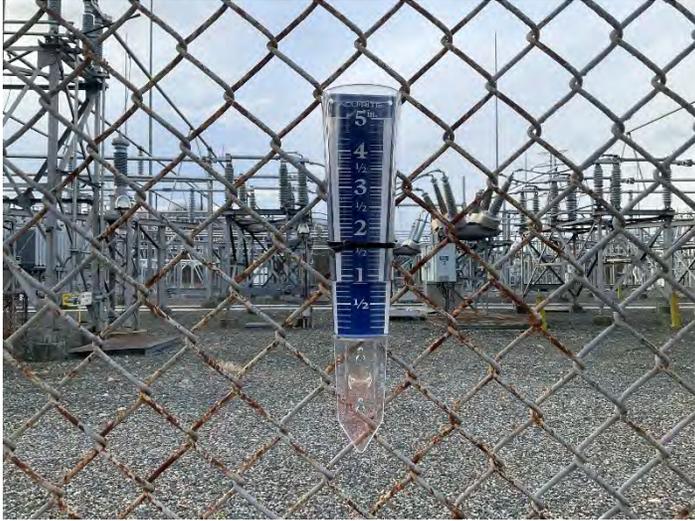
Description: View of rain gauge at Sudbury Substation. 0.90" observed in gauge. Facing south.

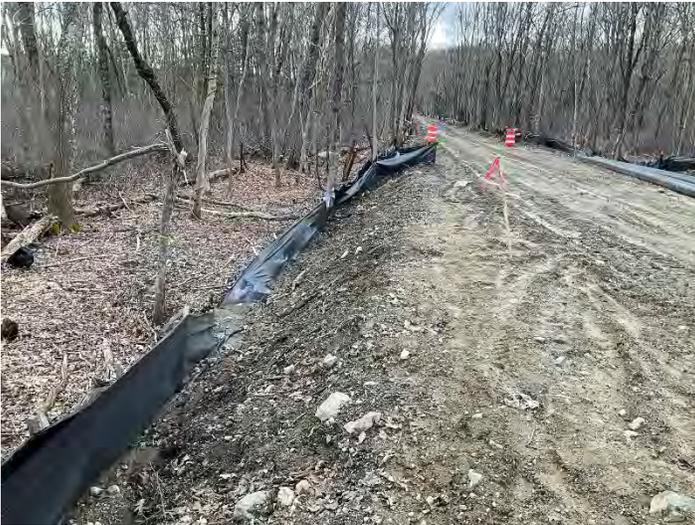
-Silt fence is in need of repair near MH #27 in segment 14.

4. Silt Fencing on ROW in Sudbury	<input checked="" type="checkbox"/> Yes <input type="checkbox"/> No	1	<input type="checkbox"/> Yes <input checked="" type="checkbox"/> No	3/11/2024	-Silt fence is installed in segments 7-14. -Silt fence repairs have been completed in segments 7, 10, and 14 since last SWPPP report. -Silt fence is in need of repair near MH #27 in segment 14 (routine maintenance).

Description: View of silt fence in need of repair near MH # 27 in segment 14. Facing west.

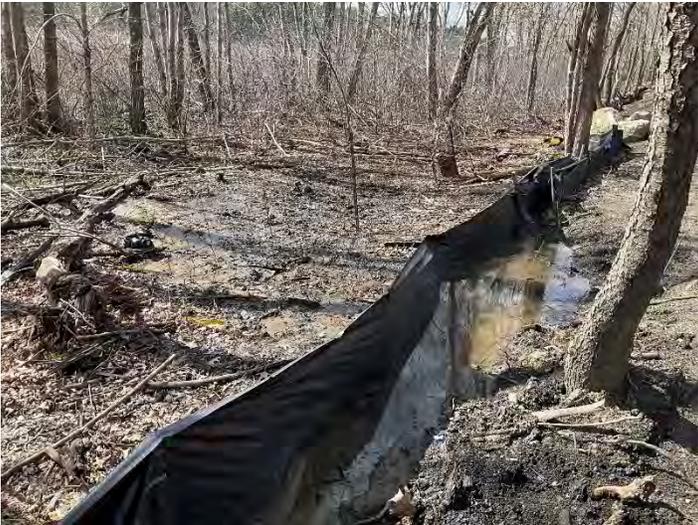
-Stormwater discharge was occurring at approximately Sta. #741+25 in segment 14 at time of inspection. Discharge appeared mostly clear. Skim layer of sediment remains from previous discharges. Some repairs took place at this location on Friday, 3/08/2024, but additional repairs and sediment removal are scheduled to be completed this week. Sediment did not appear to have reached the wetland at time of inspection. An email was sent to the project team regarding the ongoing issues at this location.

<p>Description:</p> <p>View of stormwater discharge occurring at Sta. #741+50 in segment 14. Skim layer of sediment remains from previous discharges. Some repairs took place at this location on Friday, 3/08/2024, but additional repairs and sediment removal are scheduled to be completed this week. Sediment did not appear to have reached the wetland at time of inspection. Facing southwest.</p>

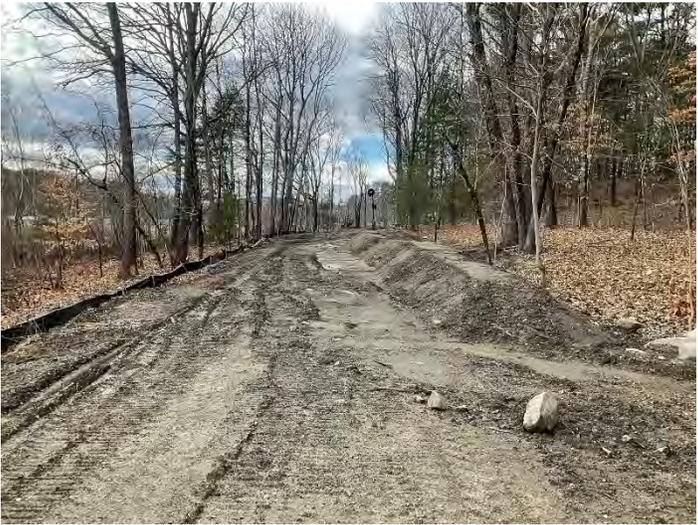
<p>Description:</p> <p>View of stockpiles noted at approximately Sta. #738 in segment 14. Stockpiles were worked upon and left as one large berm on Friday, 3/08/2024. This material should be removed on or before 3/18/2024. Facing west.</p>

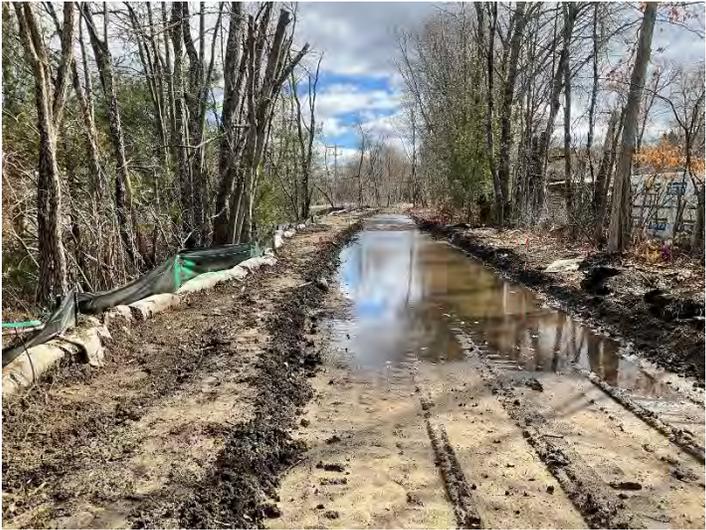
Description: View of E&S controls and ponding water in segment 12. Facing east.

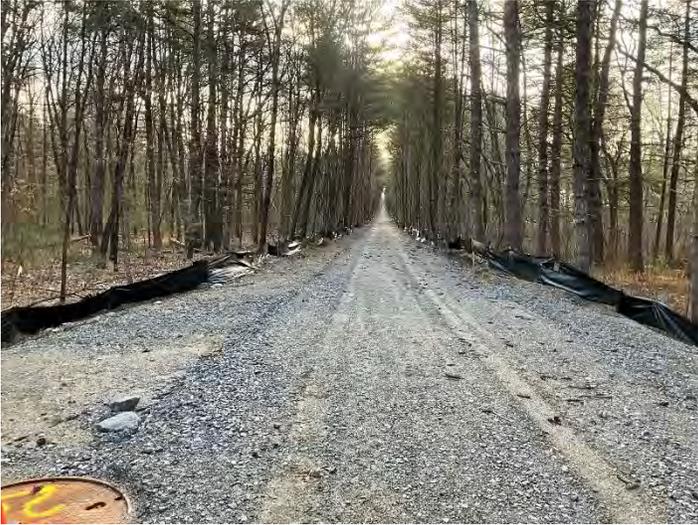
Description: View of MH #20 area in segment 10. Silt fence has been repaired at this location since last SWPPP report. Facing east.

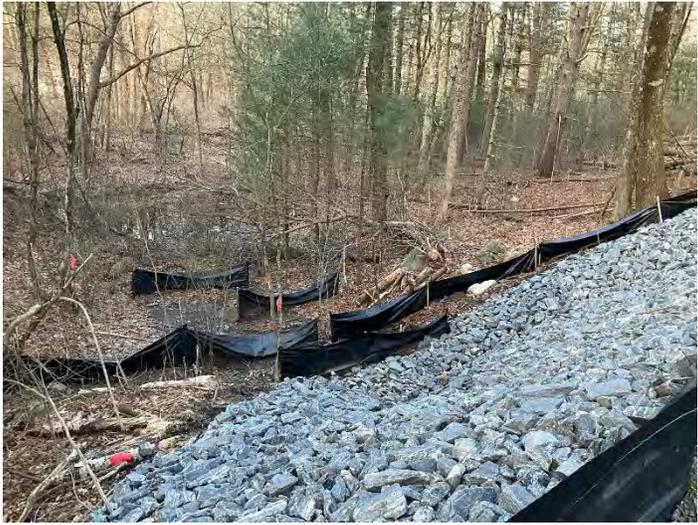
Description: View of south side/downstream side of repaired culvert in segment 9. No issues observed. Facing southwest.

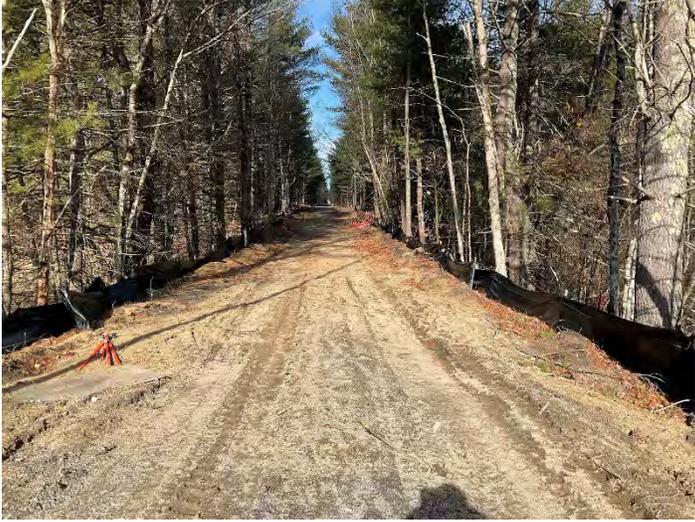
Description: View of E&S controls at east end of segment 7. Silt fence has been repaired at this location since last SWPPP report. Facing west.

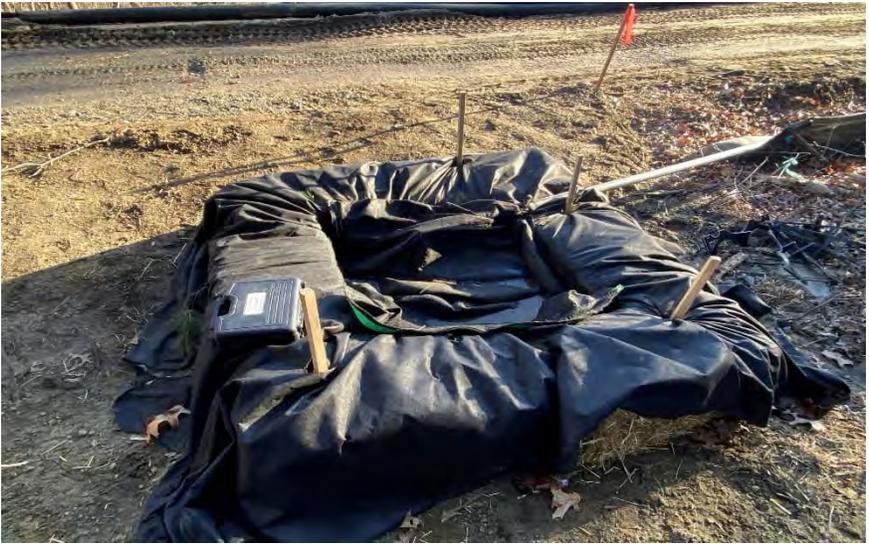
Description: Segment 13. View of discharge corral/bag, looking eastward. Water from corral/bag discharged to adjacent work area to the east. Water appeared slightly turbid, looking eastward.

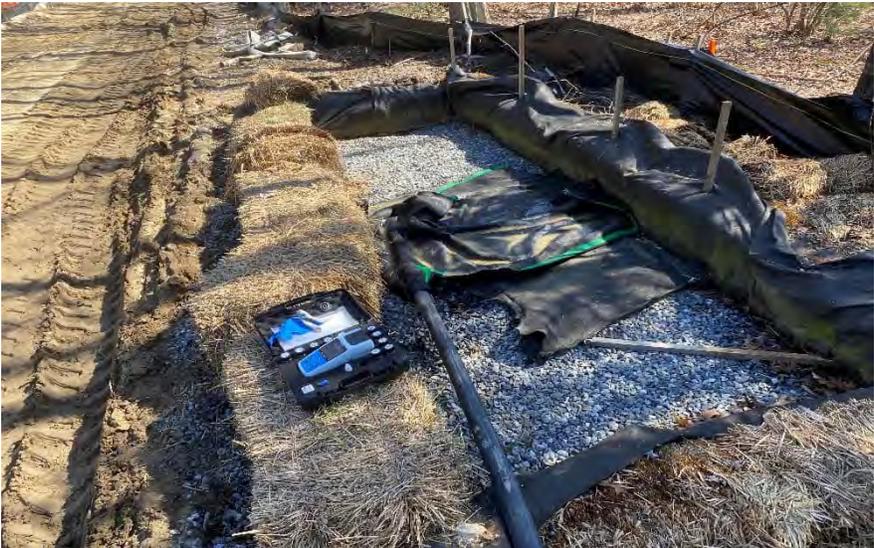
Description: Segment 14. View of discharge to bag/corral, looking eastward. Water discharged to the adjacent work area & appeared slightly turbid, looking eastward.
