**Weekly Environmental Compliance Summary**

**Sudbury to Hudson Transmission Reliability Project (USEPA Tracking # MAR1003UW)**

Sudbury, Hudson, and Stow, MA

Week of: March 18, 2024 to March 23, 2024

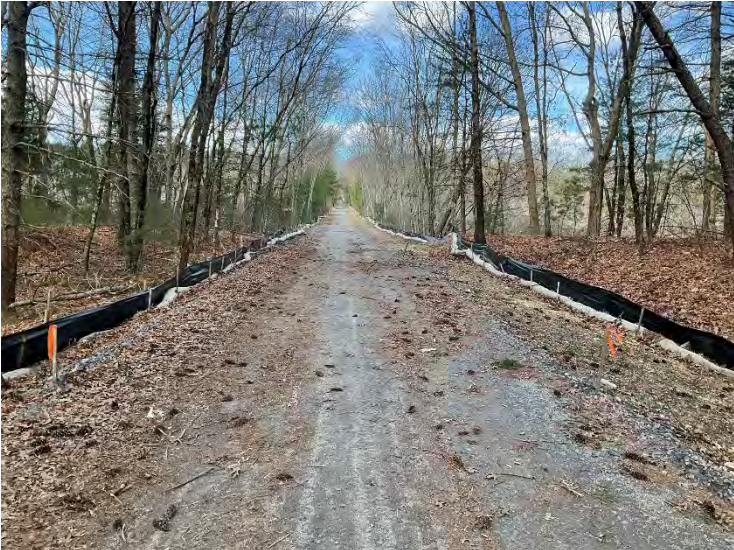
<p align="right"><b>PHOTOGRAPHIC LOG</b></p>	
<p>Client Name: Eversource</p>		<p>Site Location: Sudbury to Hudson Transmission Reliability Project</p>	<p>Town: Hudson</p>
<p>Photo No.: 2</p>	<p>Date: 3/19/2024</p>

<p>Description: View of E&amp;S controls in segment 5. Facing west.</p>

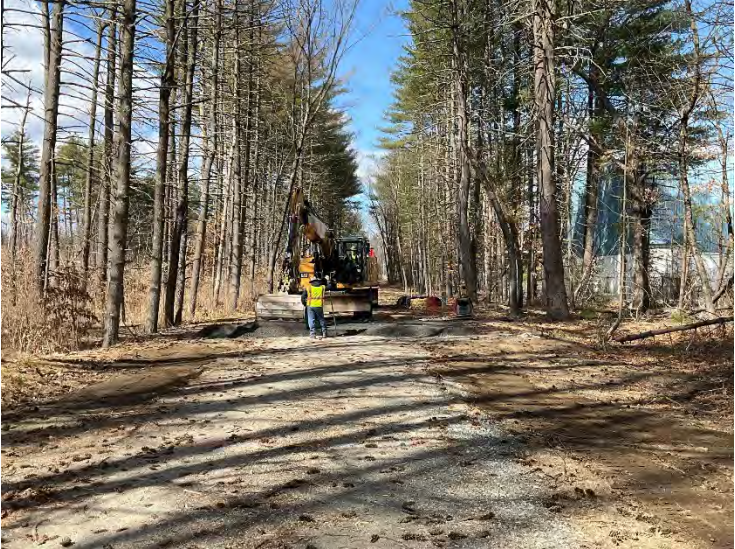
<p><b>PHOTOGRAPHIC LOG</b></p>	
<p>Client Name: Eversource</p>		<p>Site Location: Sudbury to Hudson Transmission Reliability Project</p>	<p>Town: Hudson</p>
<p>Photo No.: 3</p>	<p>Date: 3/19/2024</p>

<p>Description: View of Bond raising the grade at manholes in segment 4. Facing west.</p>

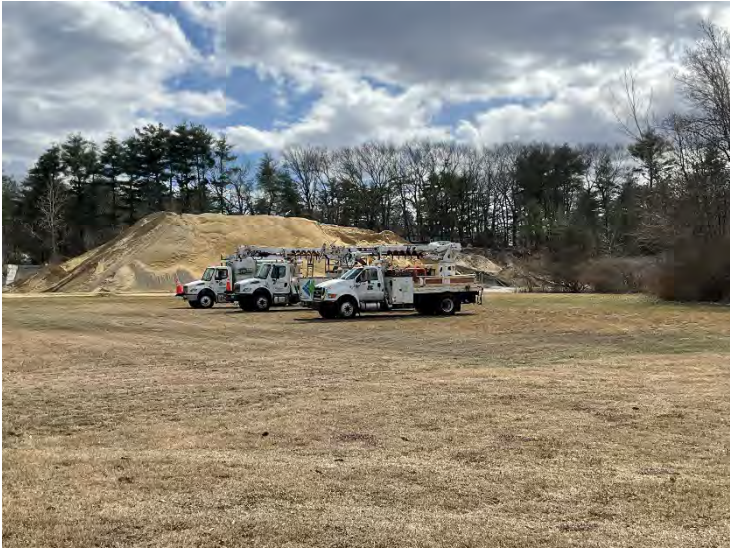
<b>PHOTOGRAPHIC LOG</b>	
Client Name: Eversource		Site Location: Sudbury to Hudson Transmission Reliability Project	Town: Hudson
Photo No.: 5	Date: 3/19/2024

<b>Description:</b> View of Haugland's laydown yard on Perkin's property near segment 3. Facing south.

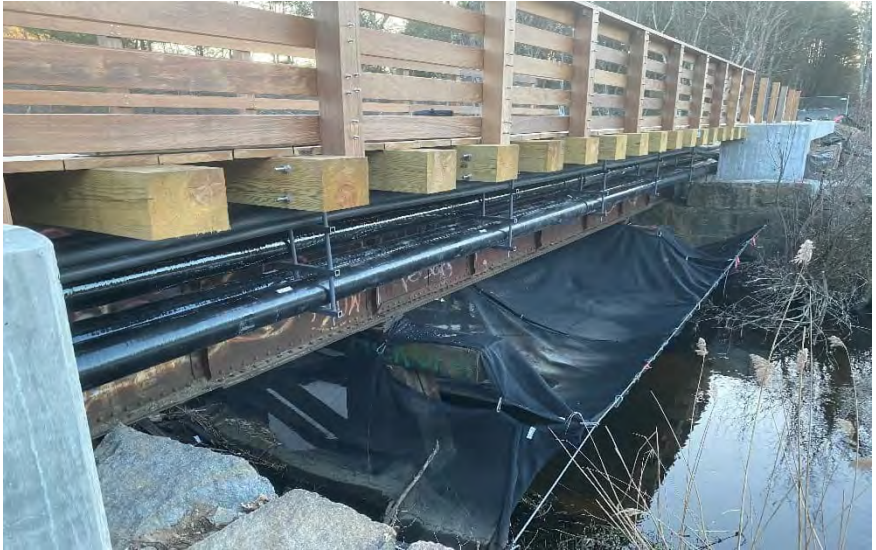
<p>PHOTOGRAPHIC LOG</p>	
<p>Client Name: Eversource</p>		<p>Site Location: Sudbury to Hudson Transmission Reliability Project</p>	<p>Town: Sudbury</p>
<p>Photo No.: 1</p>	<p>Date: 3-19-24</p>

<p>Description:                  Work area at bridge 128, conduit under the bridge, existing erosion control, looking eastward.</p>

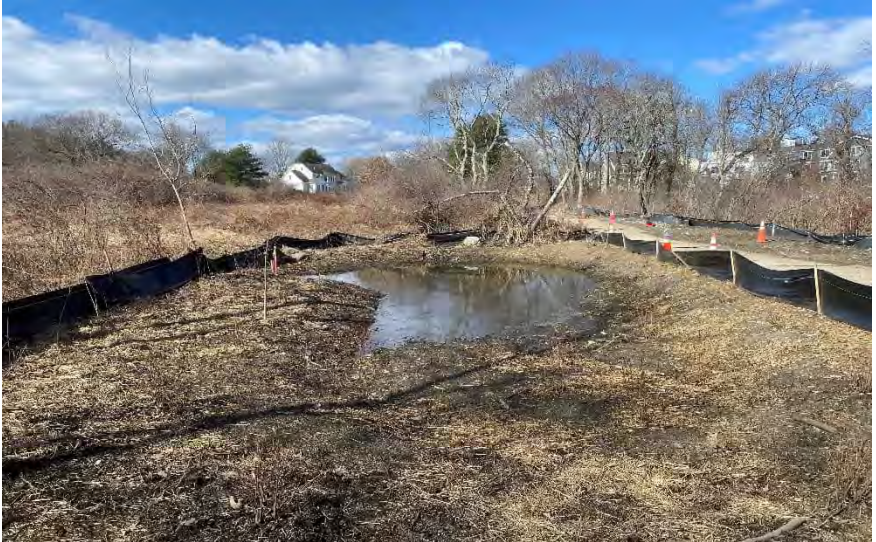
<p>PHOTOGRAPHIC LOG</p>	
<p>Client Name: Eversource</p>		<p>Site Location: Sudbury to Hudson Transmission Reliability Project</p>	<p>Town: Sudbury</p>
<p>Photo No.: 2</p>	<p>Date: 3-19-24</p>

<p>Description:                  Wetland replication area, within Segment 14, looking westward.</p>

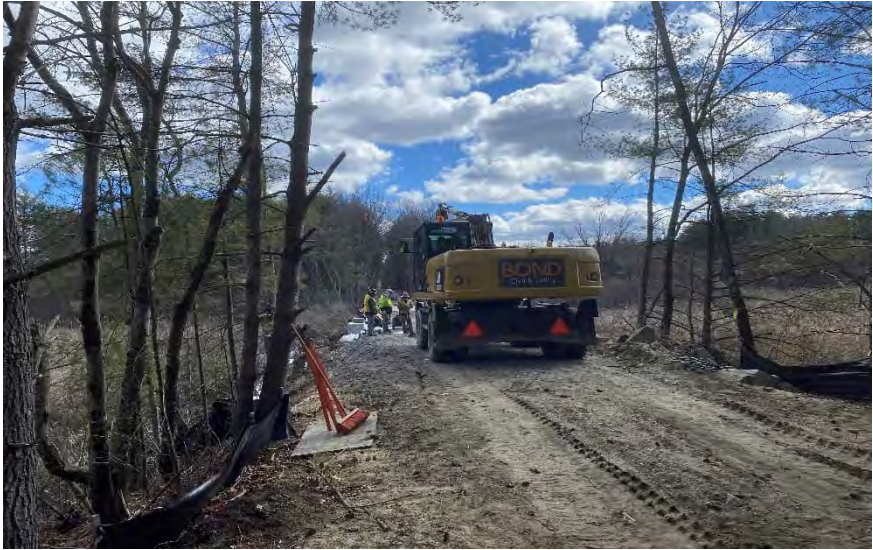
<p>PHOTOGRAPHIC LOG</p>	
<p>Client Name: Eversource</p>		<p>Site Location: Sudbury to Hudson Transmission Reliability Project</p>	<p>Town: Sudbury</p>
<p>Photo No.: 3</p>	<p>Date: 3-19-24</p>

<p>Description:</p> <p>Work area within Segment 7, conduit work off bridge 128, existing erosion control, looking eastward.</p>

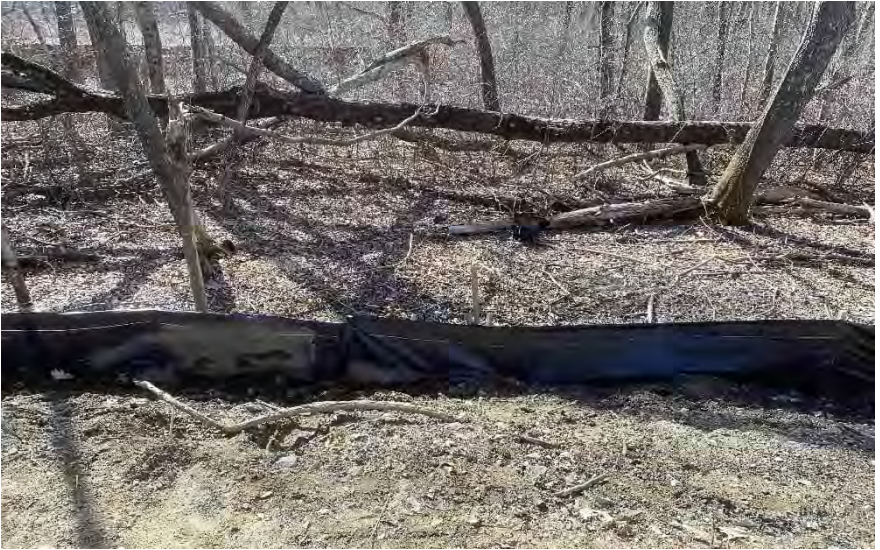
<p>PHOTOGRAPHIC LOG</p>	
<p>Client Name: Eversource</p>		<p>Site Location: Sudbury to Hudson Transmission Reliability Project</p>	<p>Town: Sudbury</p>
<p>Photo No.: 5</p>	<p>Date: 3-19-24</p>

Silt fencing repairs completed within segment 14 at Sta# 752+54, see photo 5.

<p>Description:</p> <p>Work area within Segment 14 @ STA # 752+54 repair, looking southward.</p>

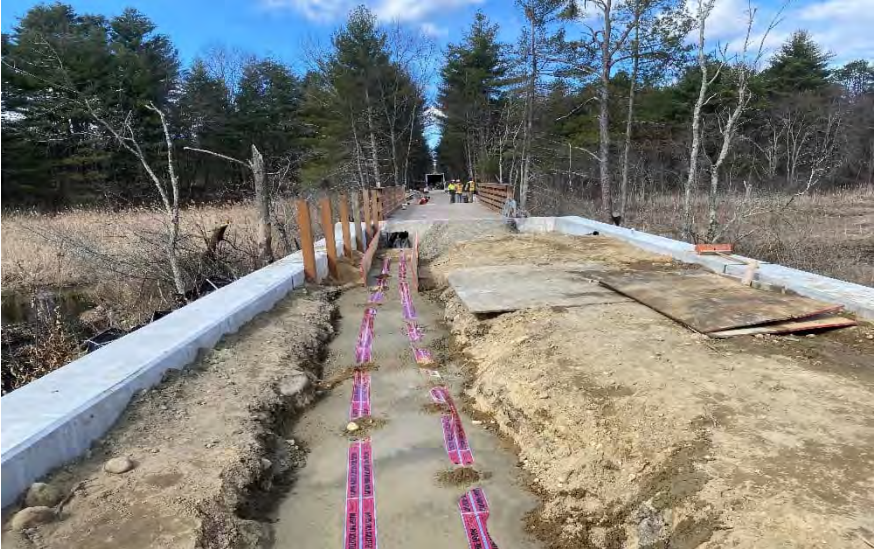
<p>PHOTOGRAPHIC LOG</p>	
<p>Client Name: Eversource</p>		<p>Site Location: Sudbury to Hudson Transmission Reliability Project</p>	<p>Town: Sudbury</p>
<p>Photo No.: 6</p>	<p>Date: 3-19-24</p>

<p>Description:</p> <p>Work area within Segment 8, conduit work, backfill with concrete, bridge 128, existing erosion control, looking westward.</p>

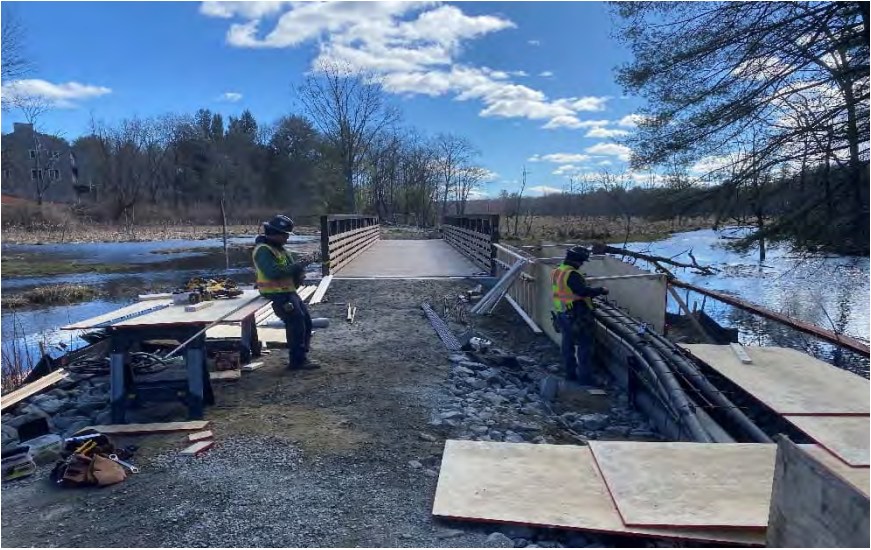
<p>PHOTOGRAPHIC LOG</p>	
<p>Client Name: Eversource</p>		<p>Site Location: Sudbury to Hudson Transmission Reliability Project</p>	<p>Town: Sudbury</p>
<p>Photo No.: 7</p>	<p>Date: 3-19-24</p>

<p>Description:</p> <p>Work area within Segment 13, conduit work at bridge 127, existing erosion control, looking eastward.</p>

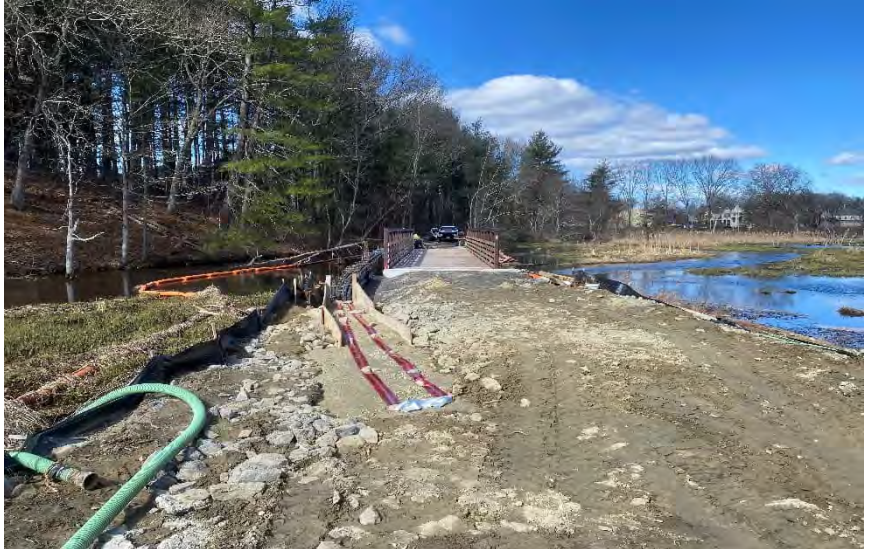
<p>PHOTOGRAPHIC LOG</p>	
<p>Client Name: Eversource</p>		<p>Site Location: Sudbury to Hudson Transmission Reliability Project</p>	<p>Town: Sudbury</p>
<p>Photo No.: 8</p>	<p>Date: 3-19-24</p>

<p>Description:</p> <p>Work area within Segment 14, conduit work at bridge 127, existing erosion control, looking westward.</p>

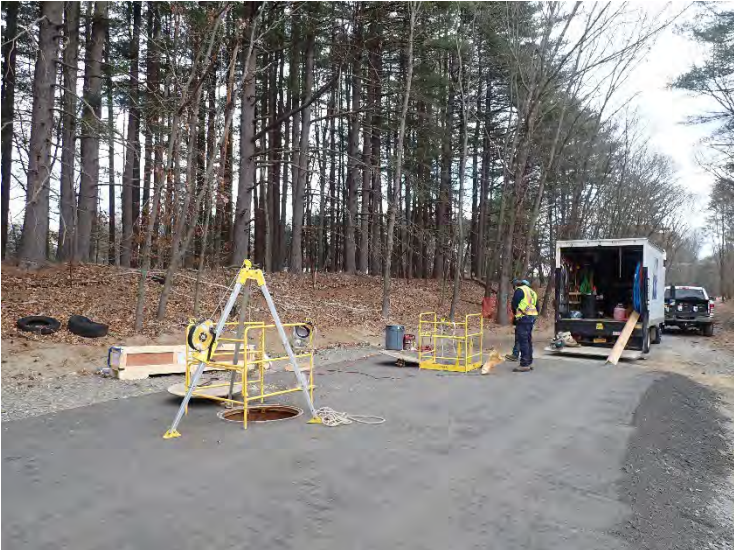
<p><b>PHOTOGRAPHIC LOG</b></p>	
<p>Client Name: Eversource</p>		<p>Site Location: Sudbury to Hudson Transmission Reliability Project</p>	<p>Town: Hudson</p>
<p>Photo No.: 2</p>	<p>Date: 3/20/2024</p>

<p>Description: View of cable pulling activities at Manhole #9 in segment 3. Facing northeast.</p>

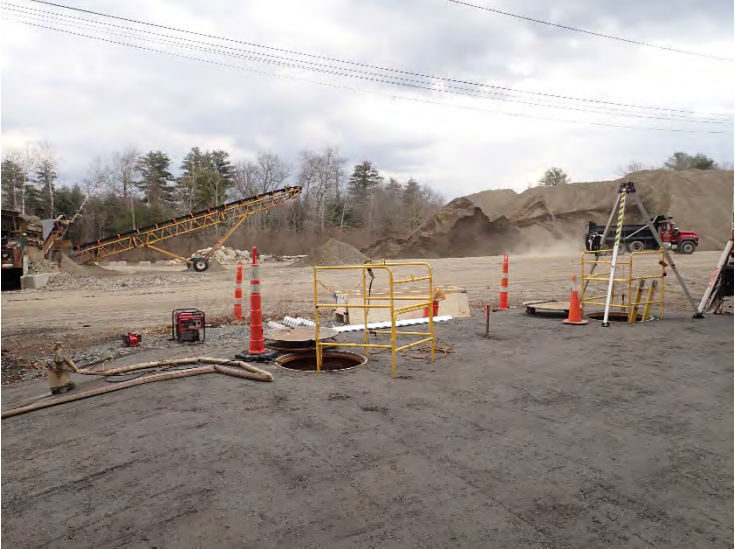
<b>PHOTOGRAPHIC LOG</b>	
Client Name: Eversource		Site Location: Sudbury to Hudson Transmission Reliability Project	Town: Hudson
Photo No.: 3	Date: 3/20/2024

<b>Description:</b> View of cable pulling activities at manhole #8 in segment 3. Facing north.

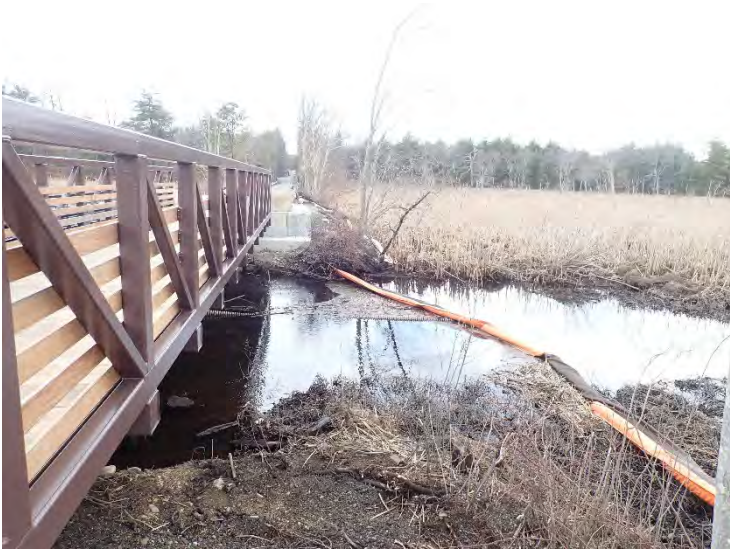
<p><b>PHOTOGRAPHIC LOG</b></p>	
<p>Client Name: Eversource</p>		<p>Site Location: Sudbury to Hudson Transmission Reliability Project</p>	<p>Town: Hudson</p>
<p>Photo No.: 7</p>	<p>Date: 3/20/2024</p>

<p>Description: View of turbidity curtain at bridge 130 in segment 2. Facing west.</p>

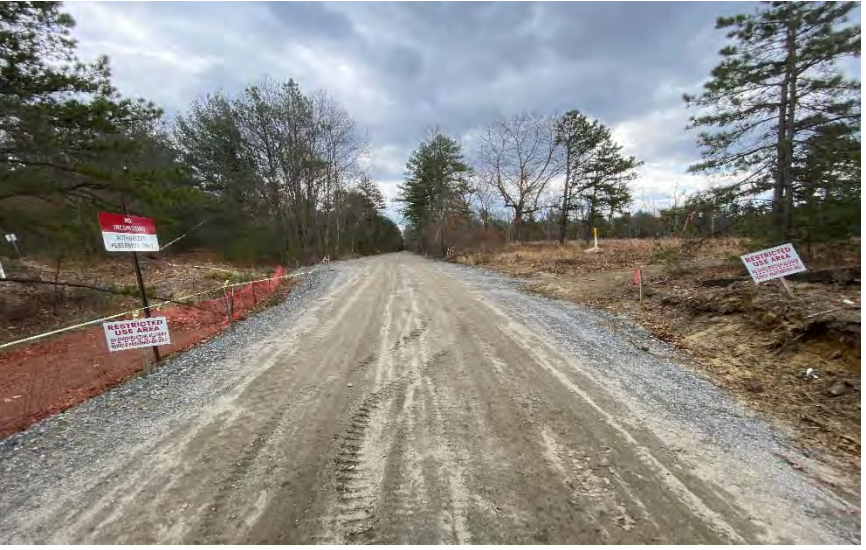
<p>PHOTOGRAPHIC LOG</p>	
<p>Client Name: Eversource</p>		<p>Site Location: Sudbury to Hudson Transmission Reliability Project</p>	<p>Town: Sudbury</p>
<p>Photo No.: 1</p>	<p>Date: 3-20-24</p>

<p>Description:</p> <p>Work area at town line, segment 7, looking eastward.</p>

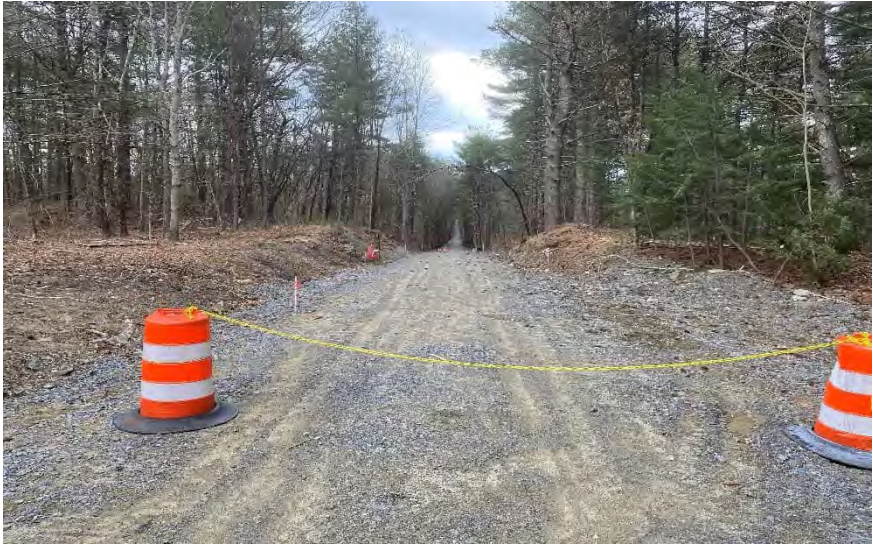
<p>PHOTOGRAPHIC LOG</p>	
<p>Client Name: Eversource</p>		<p>Site Location: Sudbury to Hudson Transmission Reliability Project</p>	<p>Town: Sudbury</p>
<p>Photo No.: 5</p>	<p>Date: 3-20-24</p>

<p>Description:</p> <p>Work area within Segment 10, looking eastward.</p>

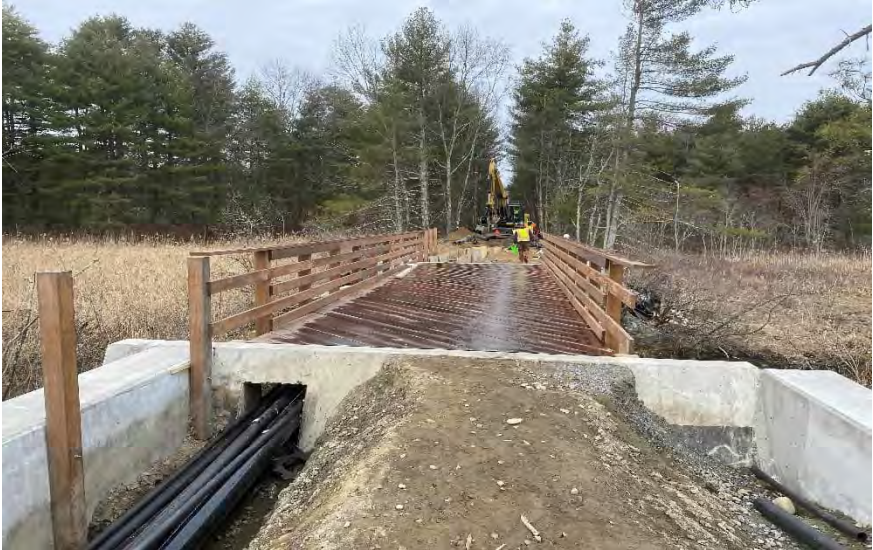
<p>PHOTOGRAPHIC LOG</p>	
<p>Client Name: Eversource</p>		<p>Site Location: Sudbury to Hudson Transmission Reliability Project</p>	<p>Town: Sudbury</p>
<p>Photo No.: 6</p>	<p>Date: 3-20-24</p>

<p>Description:</p> <p>Work area within Segment 8, conduit work, bridge 128, existing erosion control, looking westward.</p>

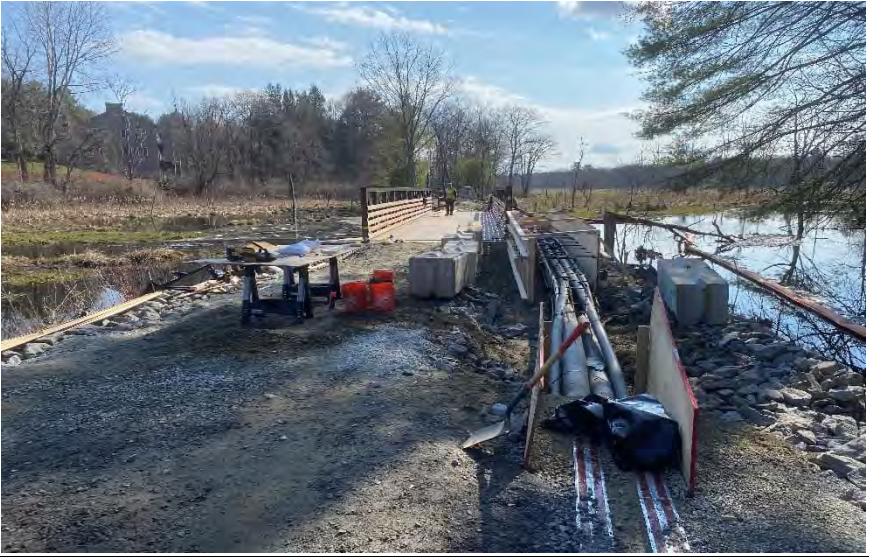
<p>PHOTOGRAPHIC LOG</p>	
<p>Client Name: Eversource</p>		<p>Site Location: Sudbury to Hudson Transmission Reliability Project</p>	<p>Town: Sudbury</p>
<p>Photo No.: 7</p>	<p>Date: 3-20-24</p>

<p>Description:</p> <p>Work area within Segment 13, conduit work at bridge 127, existing erosion control, looking eastward.</p>

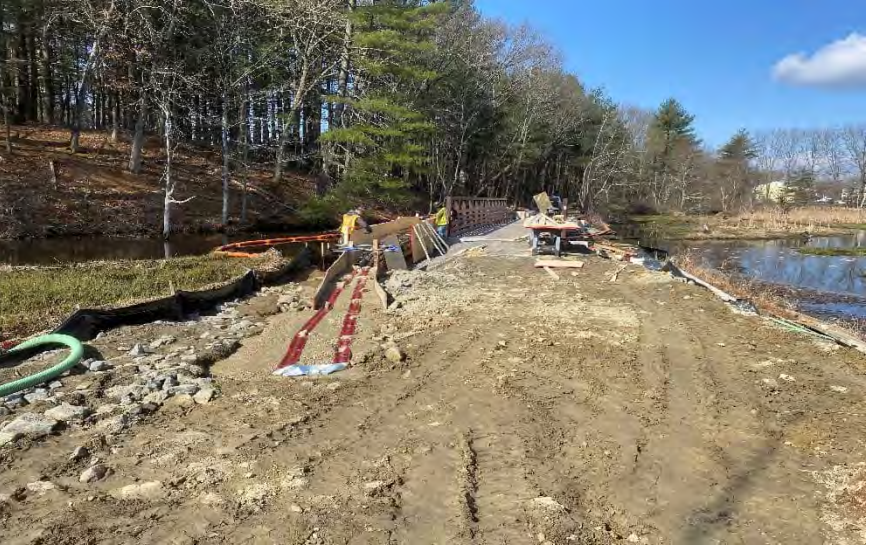
<p>PHOTOGRAPHIC LOG</p>	
<p>Client Name: Eversource</p>		<p>Site Location: Sudbury to Hudson Transmission Reliability Project</p>	<p>Town: Sudbury</p>
<p>Photo No.: 8</p>	<p>Date: 3-20-24</p>

<p>Description:</p> <p>Work area within Segment 14, conduit work at bridge 127, existing erosion control, looking westward.</p>

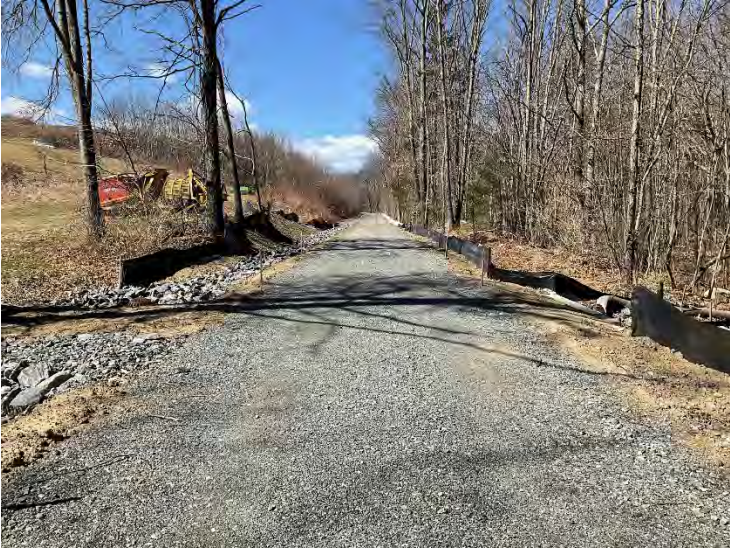
<p><b>PHOTOGRAPHIC LOG</b></p>	
<p>Client Name: Eversource</p>		<p>Site Location: Sudbury to Hudson Transmission Reliability Project</p>	<p>Town: Stow</p>
<p>Photo No.: 1</p>	<p>Date: 3/21/2024</p>

<p>Description: View of E&amp;S controls and drainage structures #5 and 6 in segment 1. Facing west.</p>

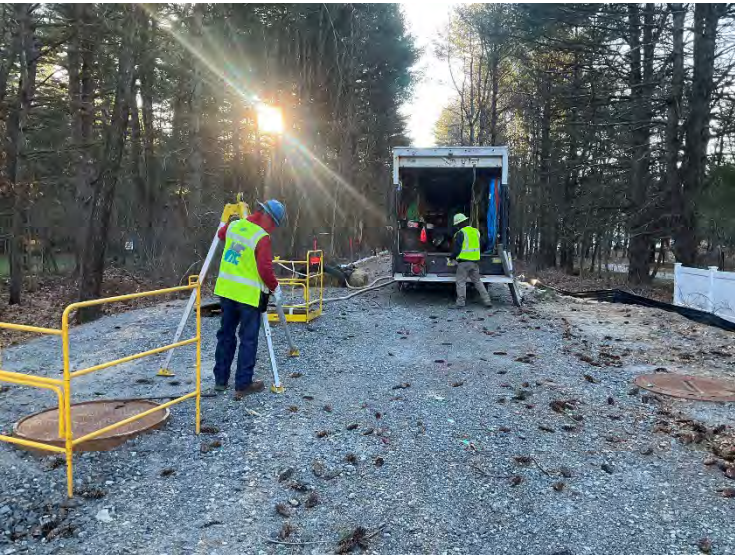
<b>PHOTOGRAPHIC LOG</b>	
Client Name: Eversource		Site Location: Sudbury to Hudson Transmission Reliability Project	Town: Hudson
Photo No.: 4	Date: 3/21/2024

Description: View of Haugland working at MH #11 in segment 5. See additional dewatering inspection report. Facing west.

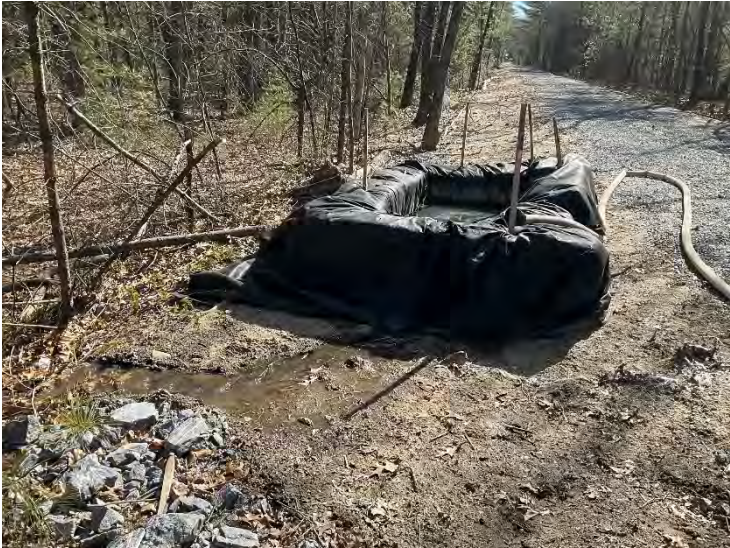
<p>Description: View of dewatering controls at MH #12 in segment 5. See additional dewatering inspection report. Facing east.</p>

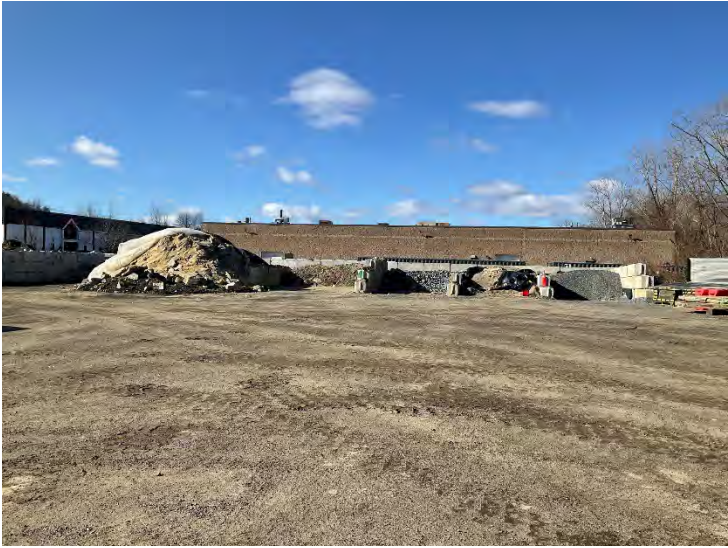
<p>Description: View of Bonazzoli laydown yard. Facing southwest.</p>

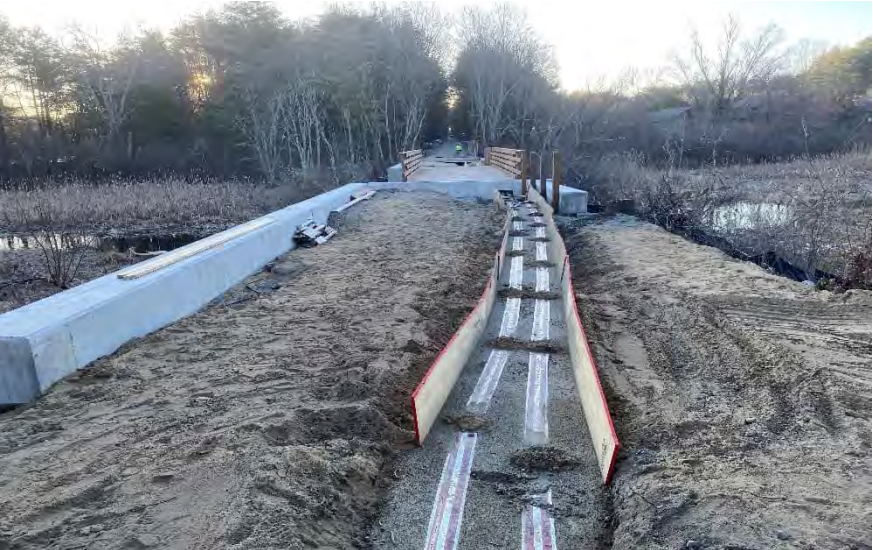
<p>Description:</p> <p>Work area within segment 7, conduit work, existing erosion control, looking eastward.</p>

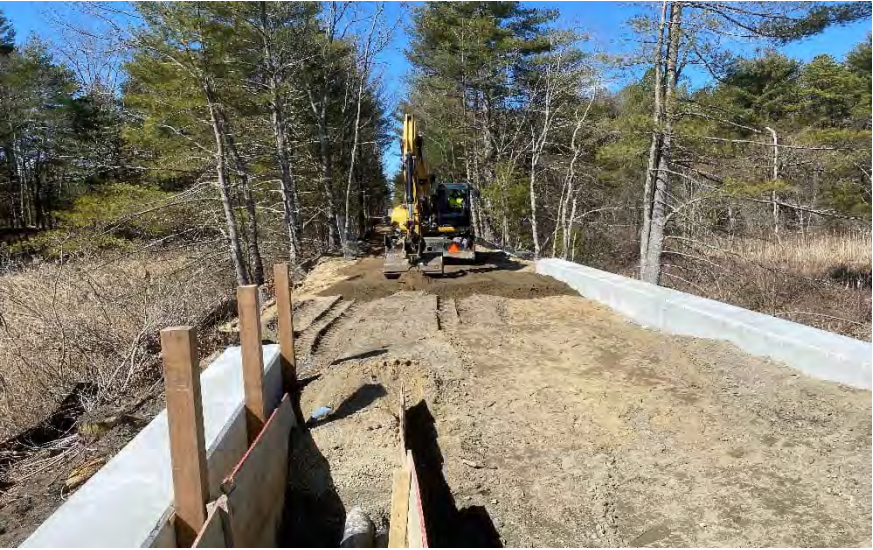
<p>Description:</p> <p>Work area within Segment 7, conduit work off bridge 128, existing erosion control, looking westward.</p>

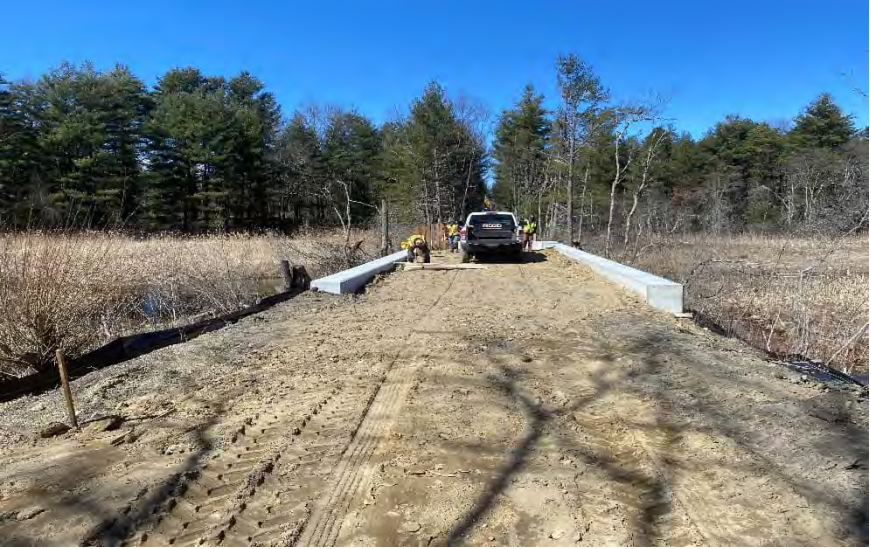
<p>Description:</p> <p>Work area within Segment 8, conduit work, bridge 128, existing erosion control, looking westward.</p>

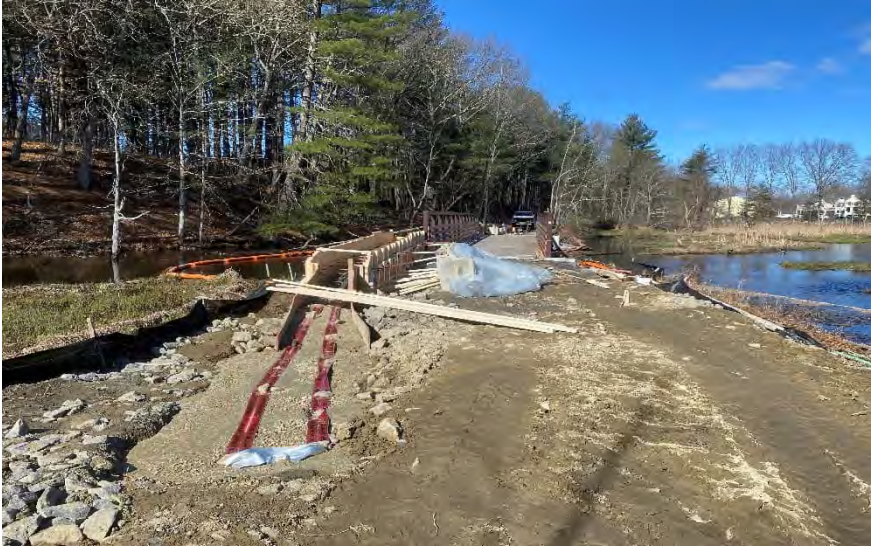
<p>Description:</p> <p>Work area within Segment 14, conduit work at bridge 127, existing erosion control, looking westward.</p>

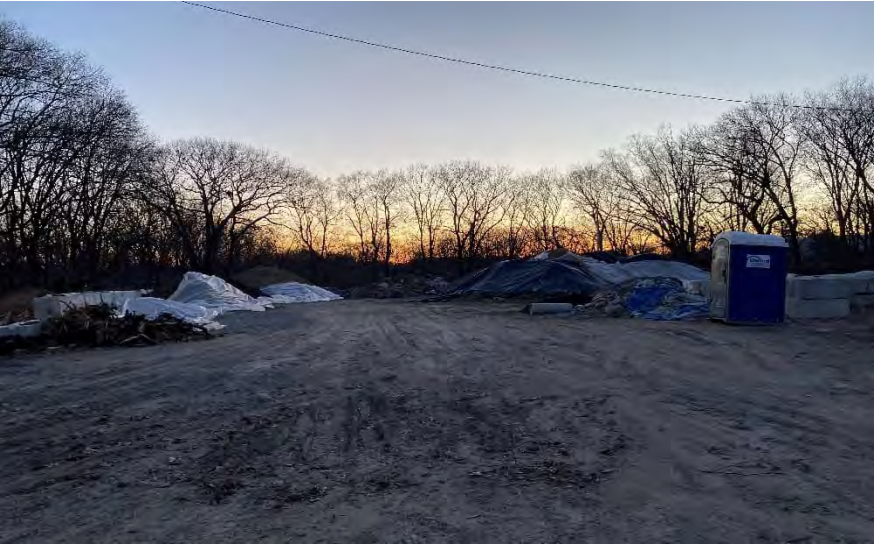
<p>Description:</p> <p>Laydown yard at Stowe Court, looking southward.</p>

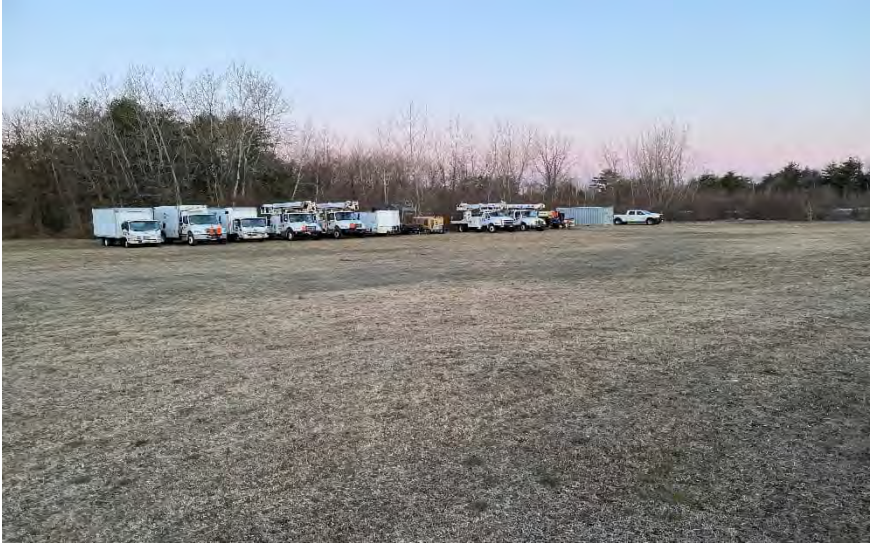
<p>Description:</p> <p>Haugland laydown yard off 260 Main Street, looking westward.</p>

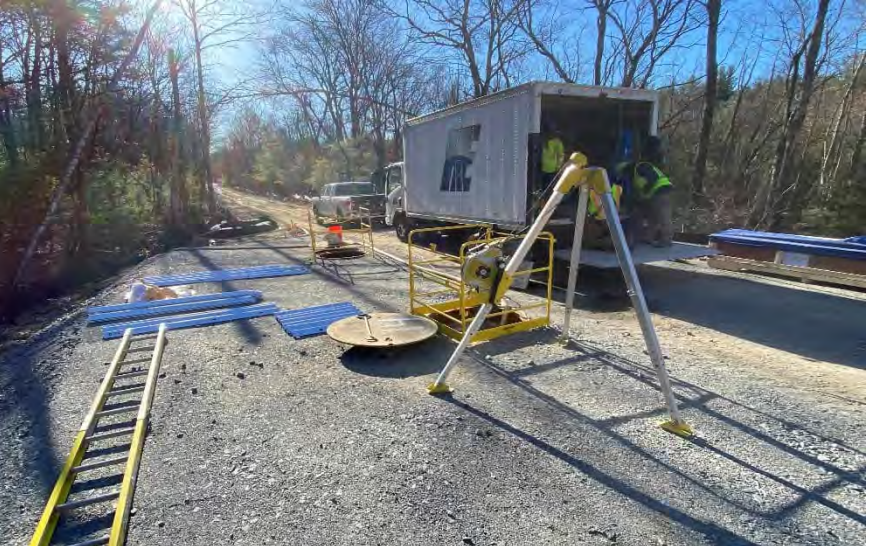
<p>Description:</p> <p>Work area at manhole #14, segment 6, racking work, existing erosion control, looking eastward.</p>

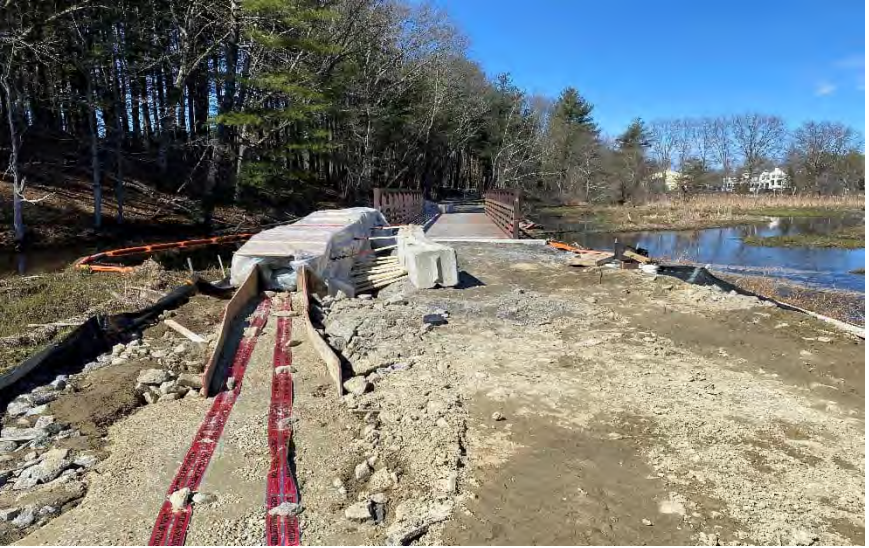
<p>Description:</p> <p>Work area within segment 14, recent conduit work near bridge 127, existing erosion control, looking westward.</p>

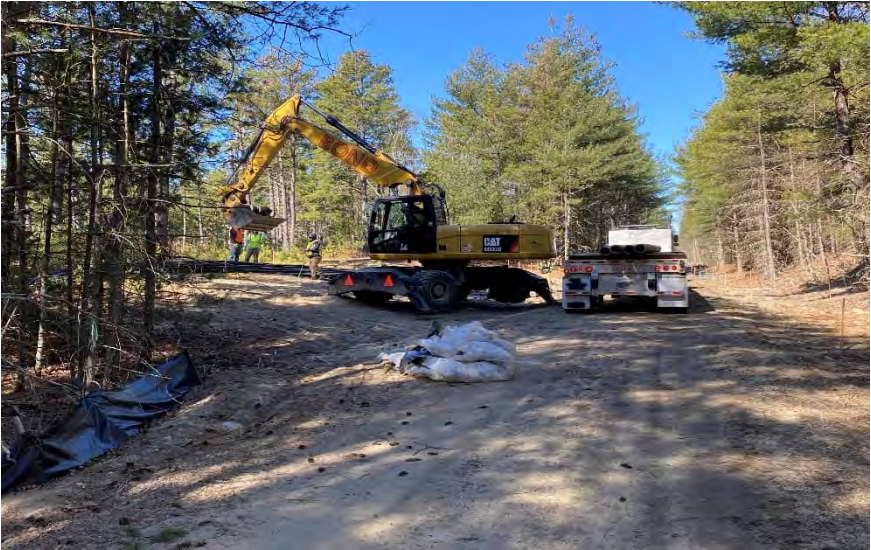
<p>Description:</p> <p>Work area within segment 7, existing erosion control, site work, looking westward.</p>

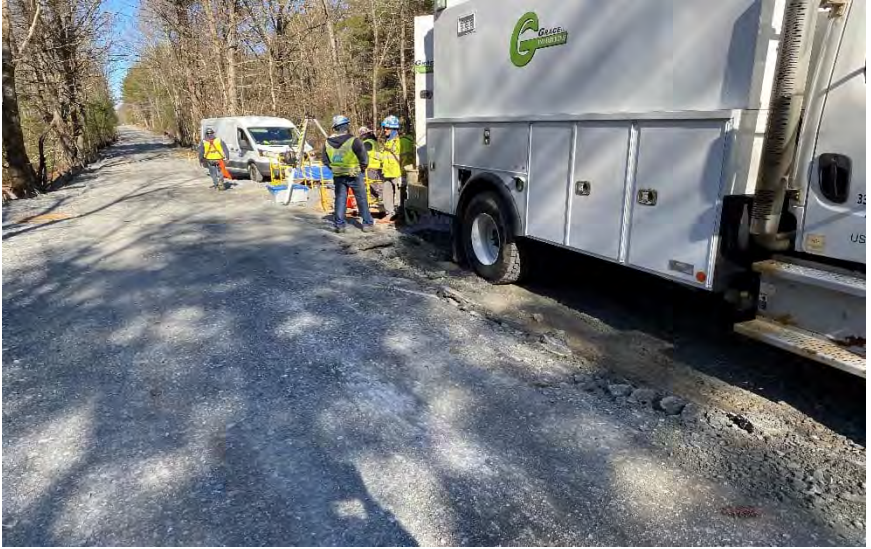
<p>Description:</p> <p>Work area at manhole #15, segment 7, racking work, existing erosion control, looking westward.</p>

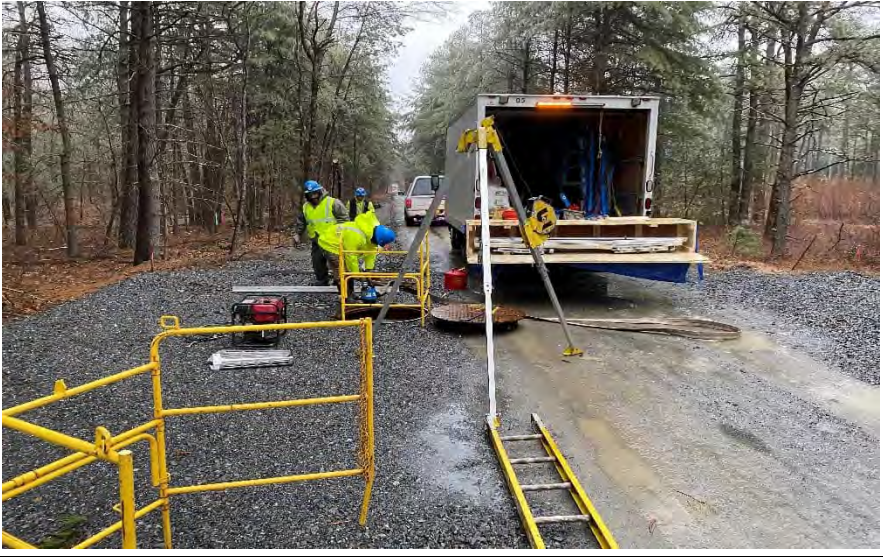
<p>Description:</p> <p>Work area within segment 7, manhole #16 work (racking), dewatering, looking eastward.</p>

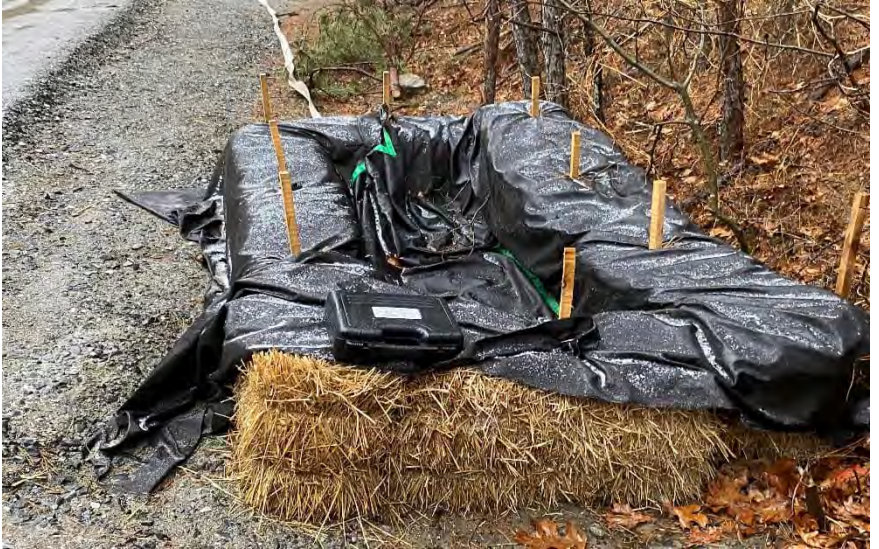
<p>Description:</p> <p>Work area within segment 7, manhole #16 work (racking), dewatering bag/corral, looking westward.</p>

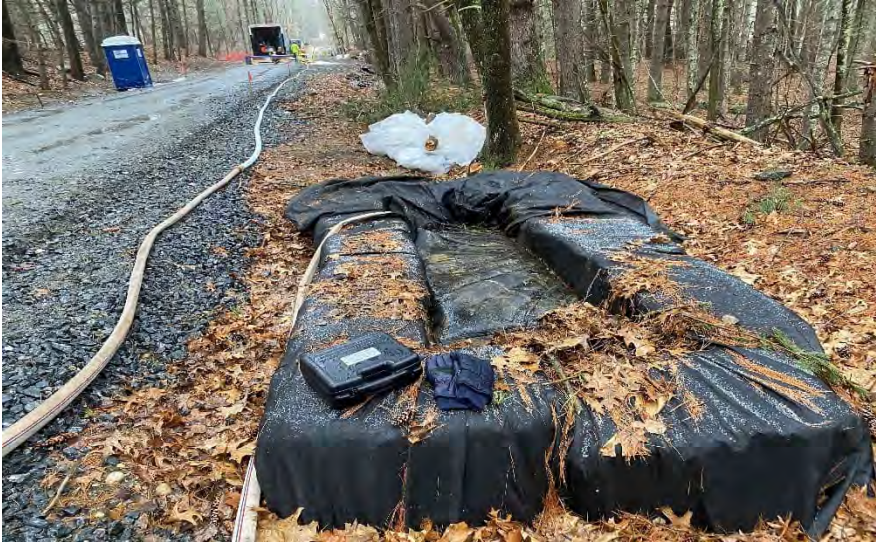
<p>Description:</p> <p>Work area within segment 8, manhole #17 work (racking), dewatering bag/corral, looking westward.</p>

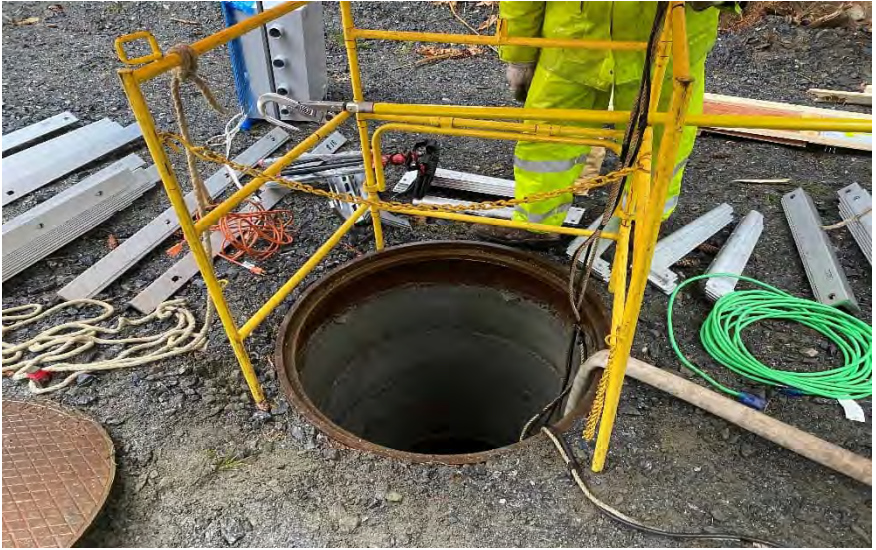
<p>Description:</p> <p>Work area within segment 9, manhole #18 work (racking), dewatering, looking eastward.</p>

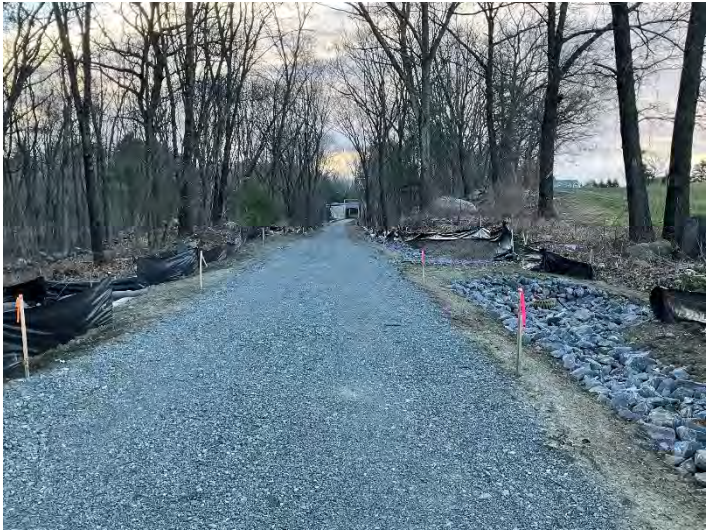
Description: View of drainage structures #5 and 6 in segment 1. Facing east.

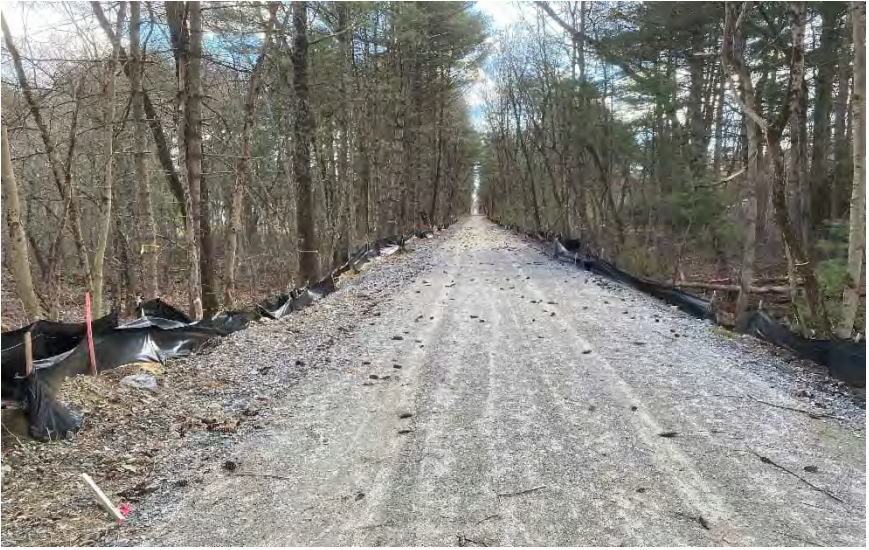
Description:  Work area within segment 11, existing erosion control, looking eastward.

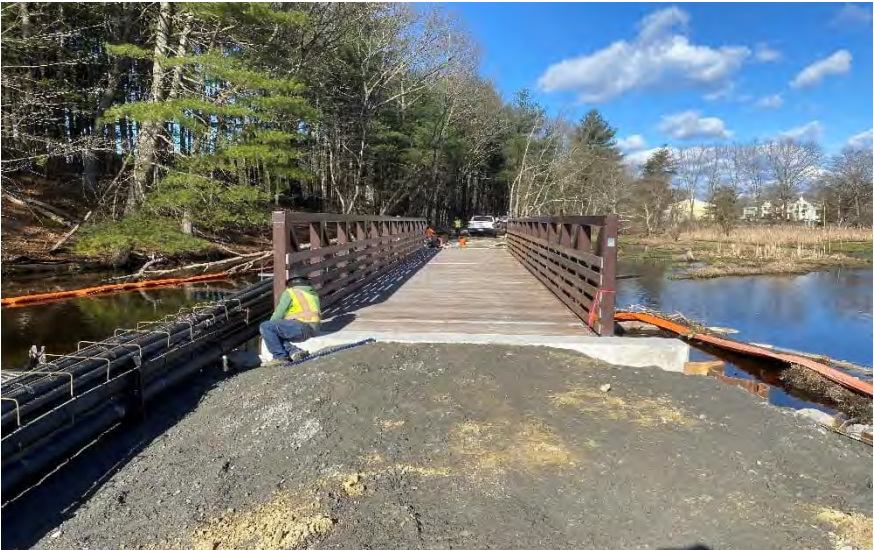
Description:  Work area within segment 14 looking across Hop Brook into segment 13, Bridge 127, existing erosion control, conduit work, looking westward.

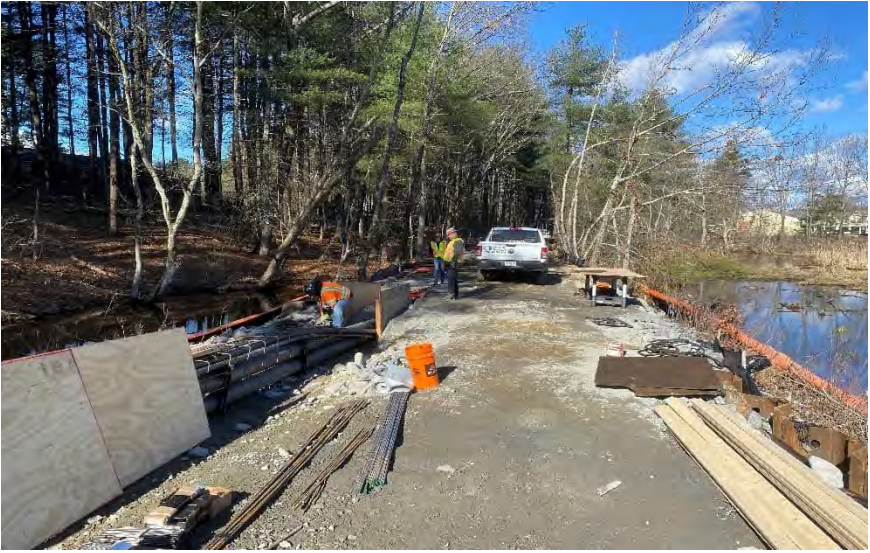
<b>Description:</b>  Work area looking across Hop Brook into segment 13, Bridge 127, existing erosion control, conduit work, looking westward.

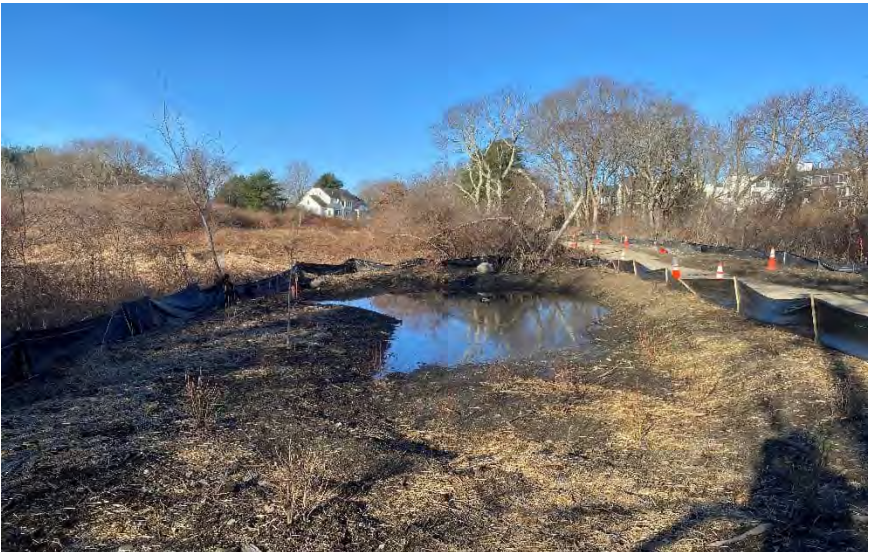
<b>Description:</b>  Wetland replication area within segment 14, existing erosion control, looking eastward.

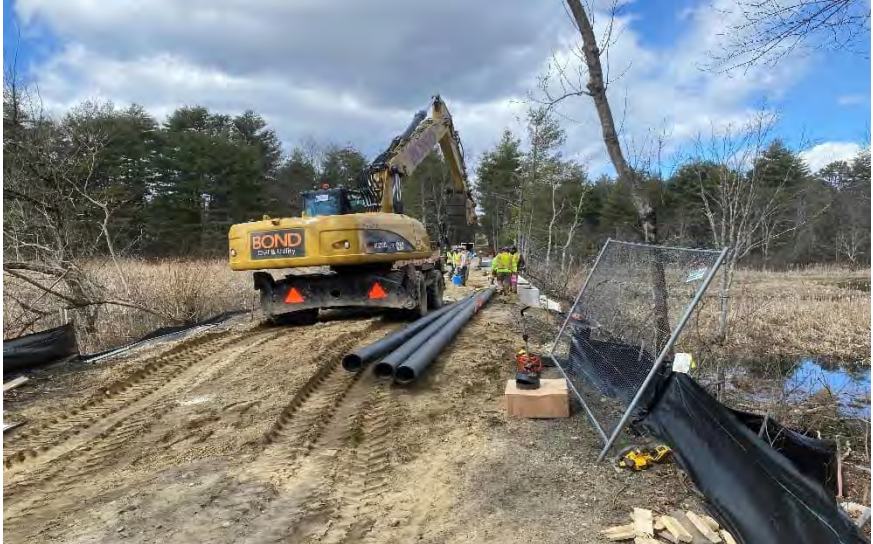
<b>Description:</b>  Work area within segment 8, looking across Hop Brook, Bridge 128, existing erosion control, conduit work, looking westward.

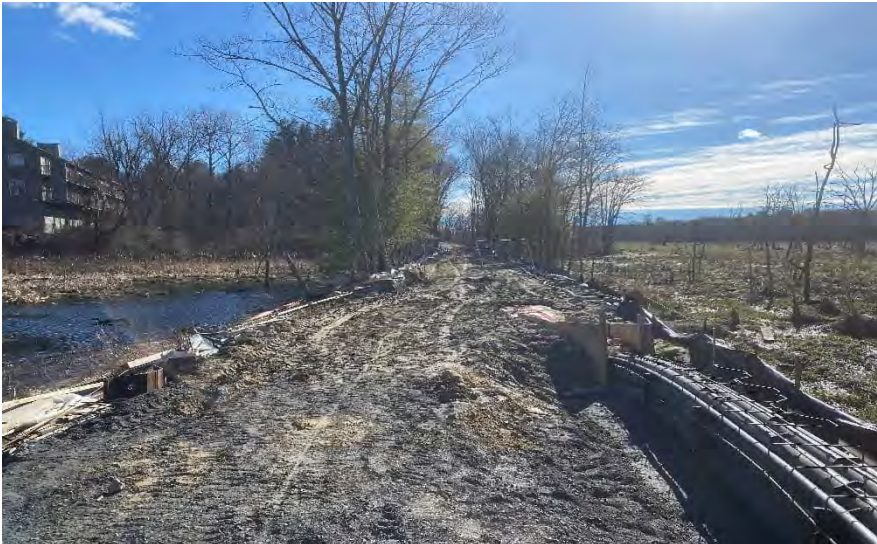
<b>Description:</b>  Work area within segment 14, existing erosion control, looking eastward.

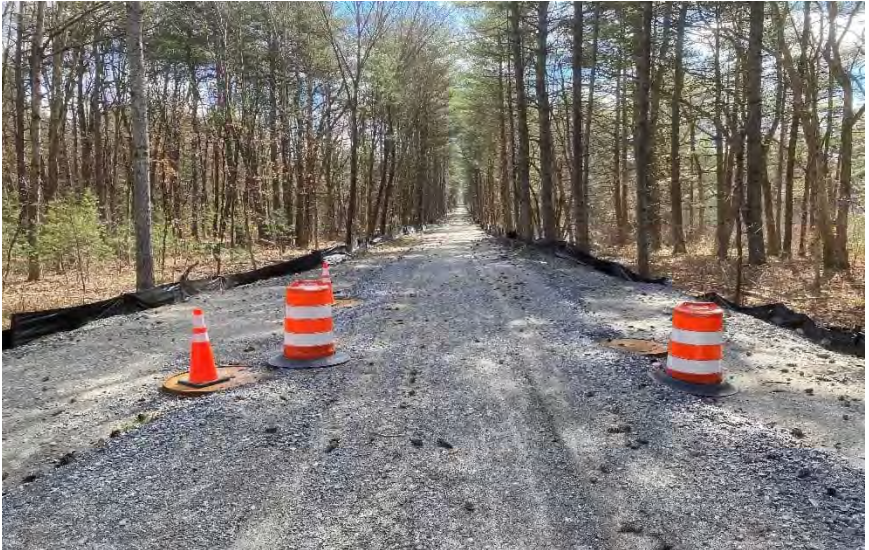
<b>Description:</b>  Work area within segment 10, manhole #20, existing erosion control, looking eastward.
