**Weekly Environmental Compliance Summary**

**Sudbury to Hudson Transmission Reliability Project (USEPA Tracking # MAR1003UW)**

Sudbury, Hudson, and Stow, MA

Week of: March 18, 2024 to March 23, 2024

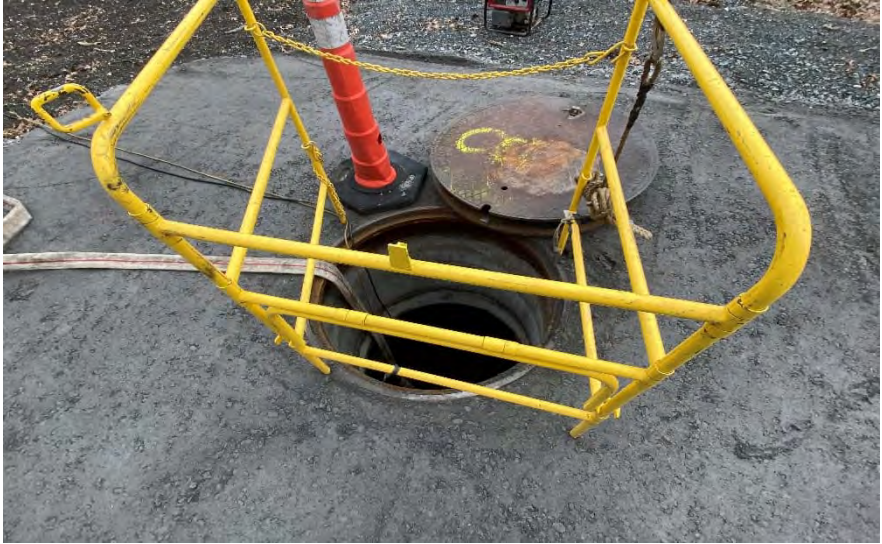
Description: View of area being pumped from manhole #8, segment 3.

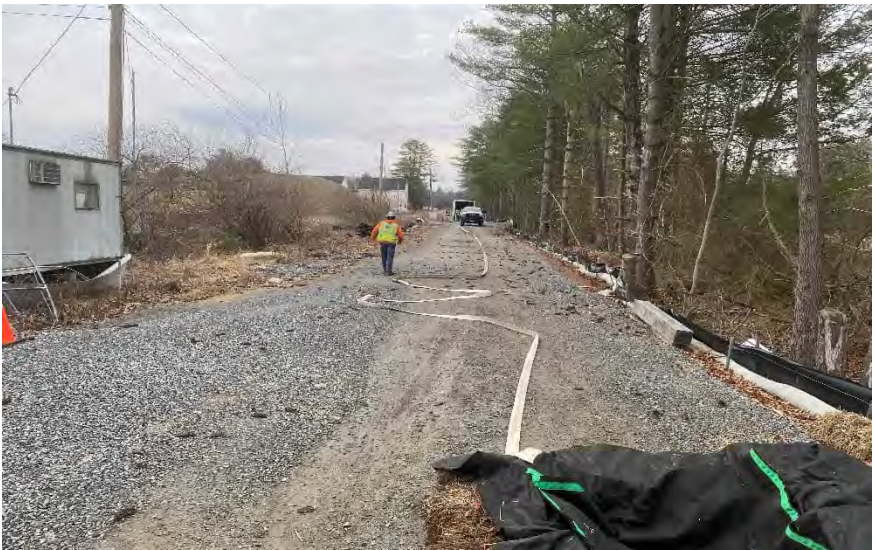
Description: Manhole #8. View of dewatering operation. Looking eastward.

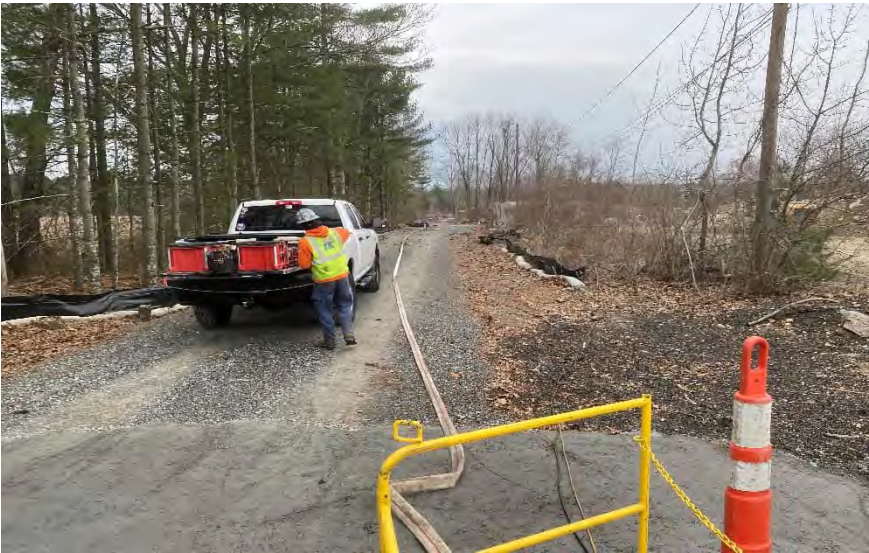
Description: Manhole #8. View of dewatering operation, looking westward.

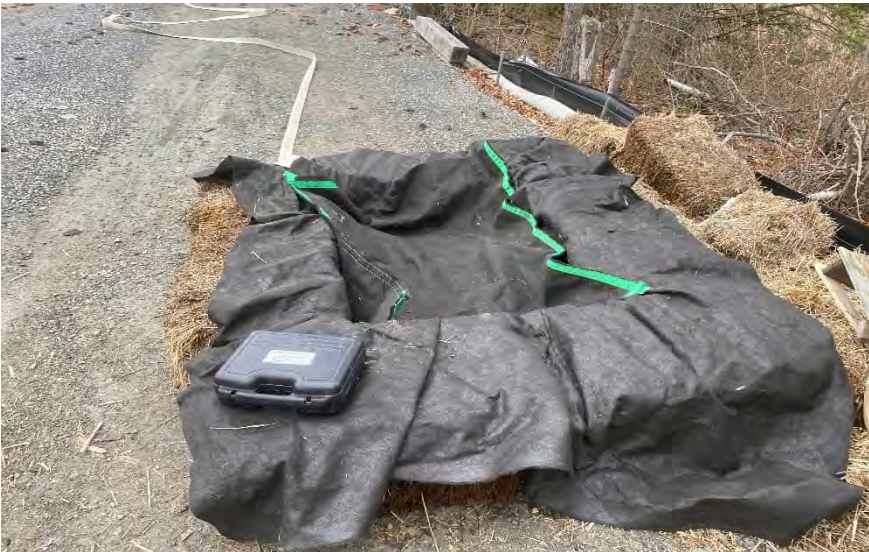
Description: Manhole #8. View of discharge bag/corral, looking eastward. Water from bag/corral discharged to adjacent area.

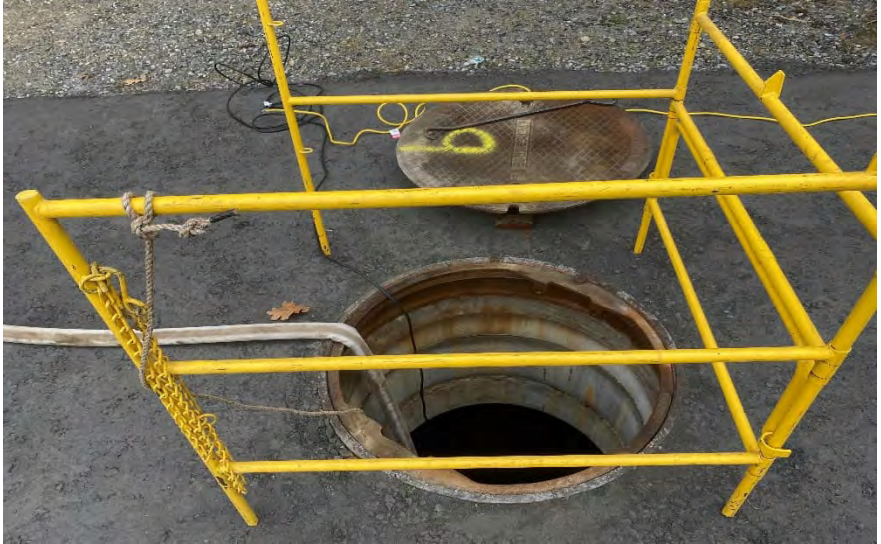
Description: View of area being pumped from manhole #9, segment 3.

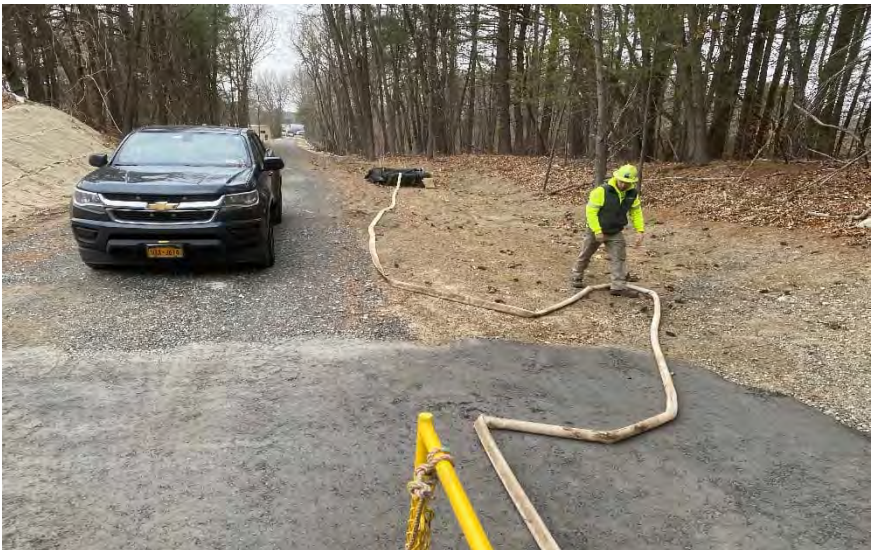
Description: Manhole #9. View of dewatering operation. Looking westward.

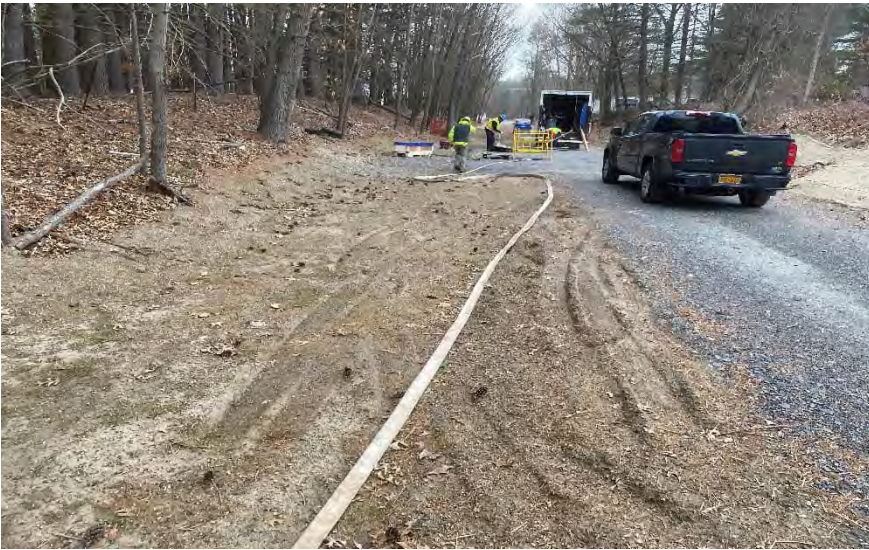
Description: Manhole #9. View of dewatering operation, looking eastward.

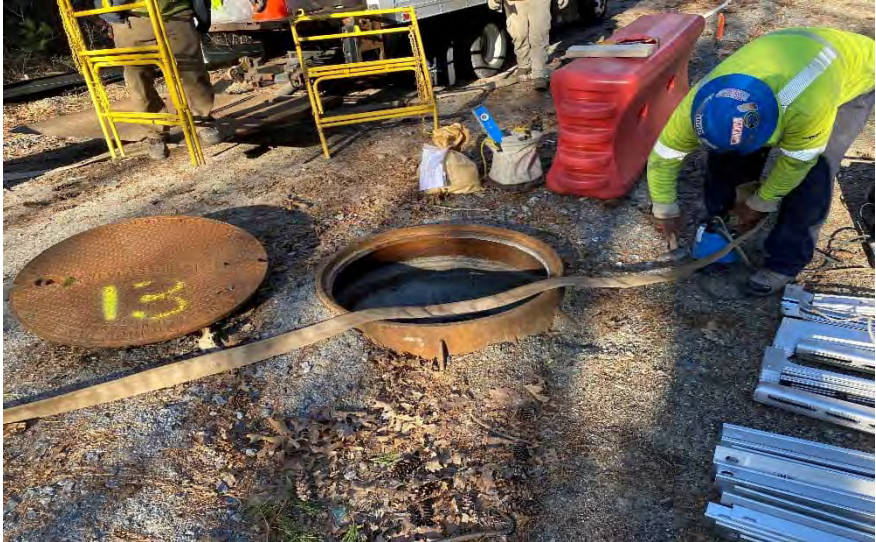
Description: View of area being pumped from manhole #13, segment 5.

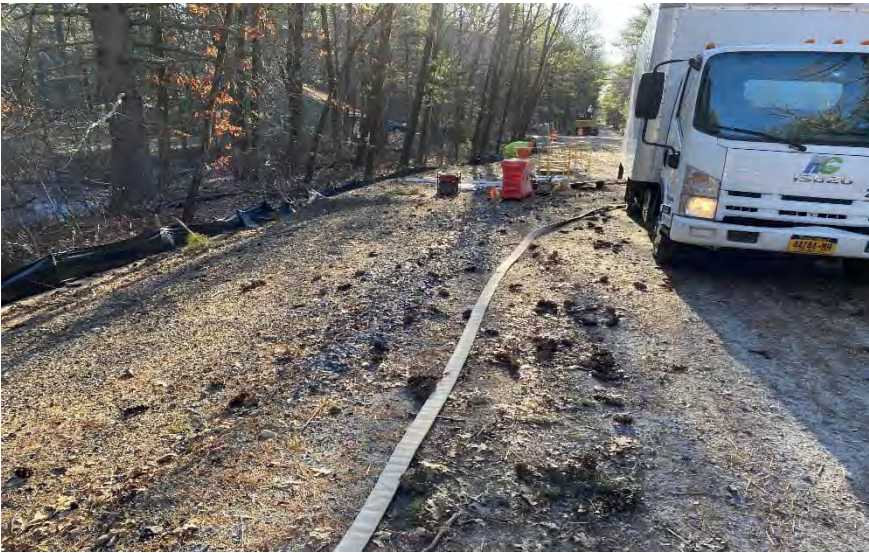
Description: Manhole #13. View of dewatering operation, looking eastward.

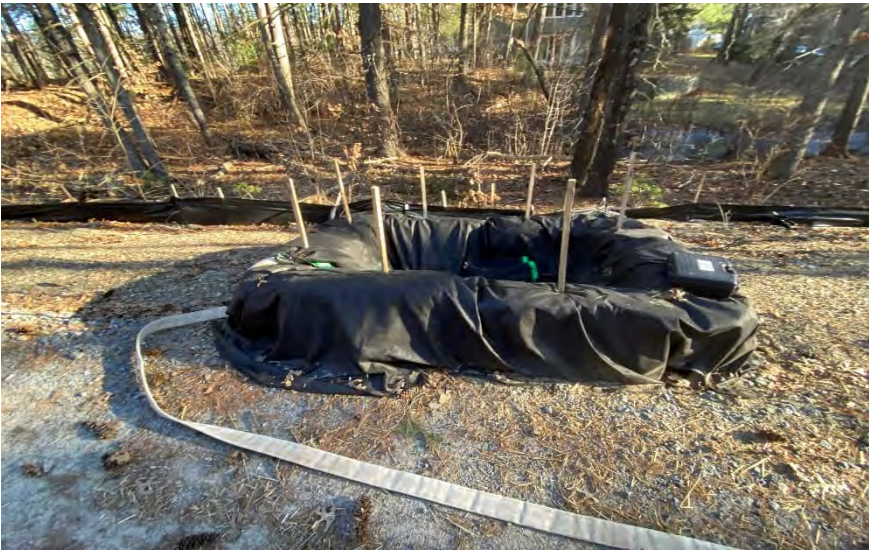
Description: Manhole #13. View of discharge bag/corral, looking eastward. Water from bag/corral discharged to adjacent area.

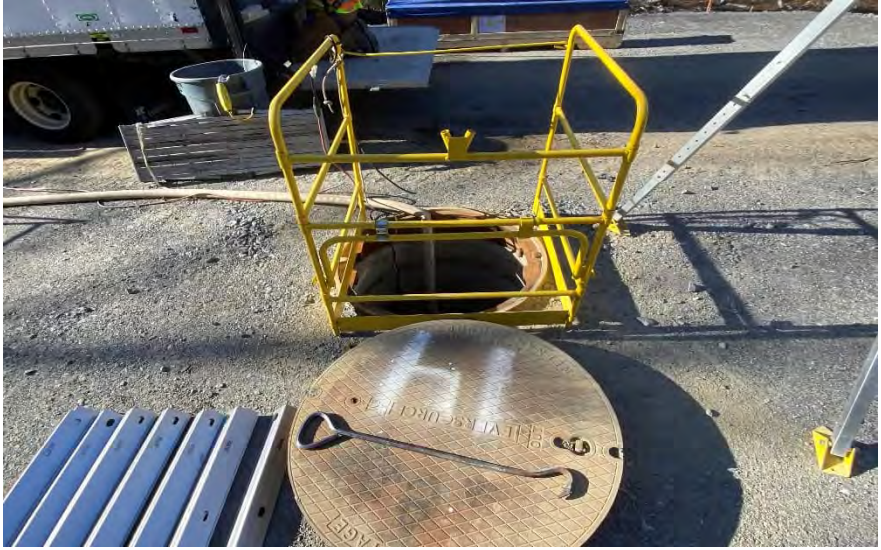
<b>Description:</b> View of area being pumped from manhole #14, segment 6.

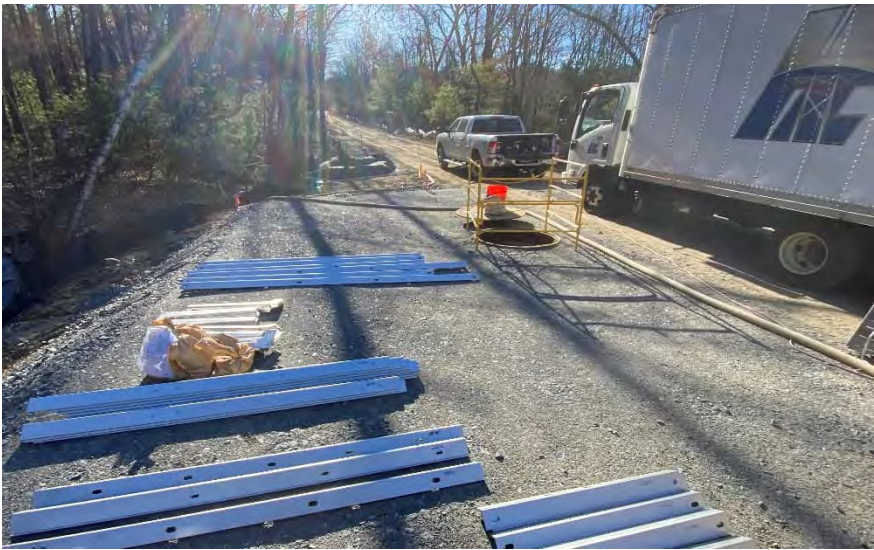
<b>Description:</b> Manhole #14. View of dewatering operation. Looking eastward.

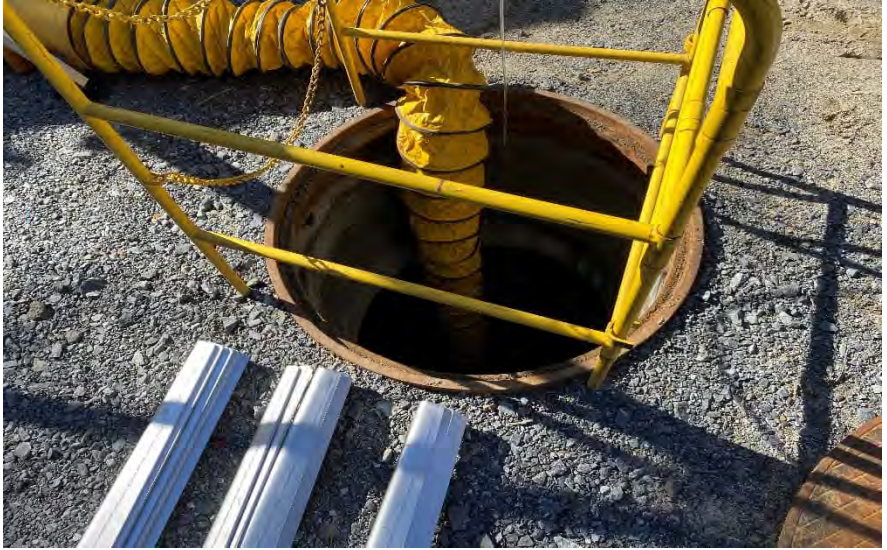
Description: View of area being pumped from manhole #15, segment 7.

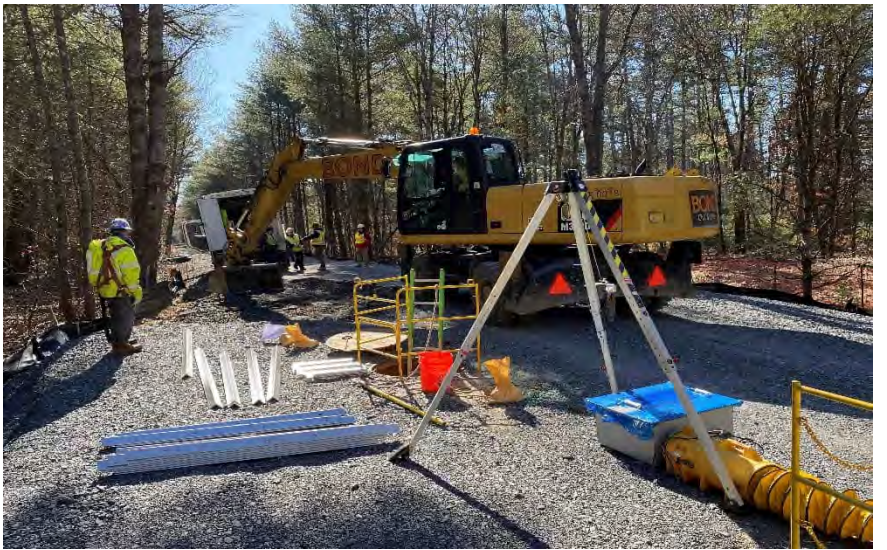
Description: Manhole #15. View of dewatering operation. Looking eastward.

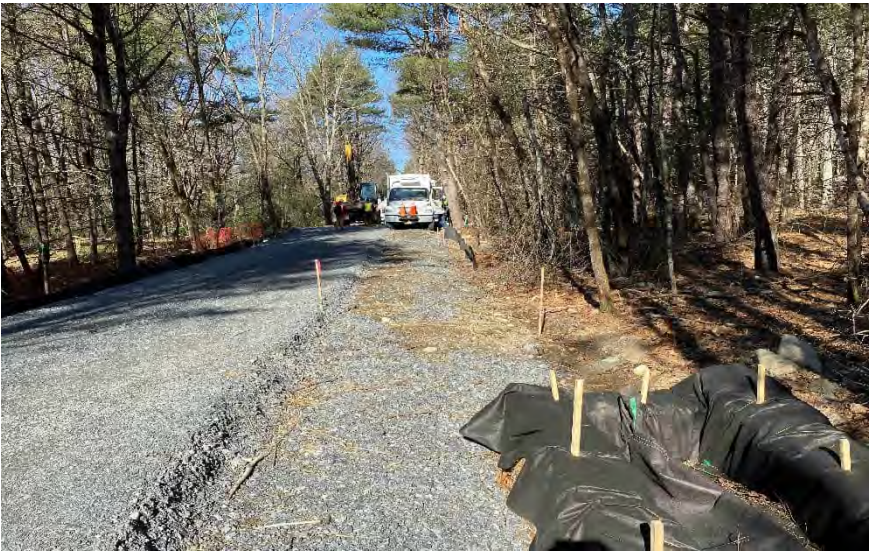
<b>Description:</b> Manhole #15. View of dewatering operation, looking westward.

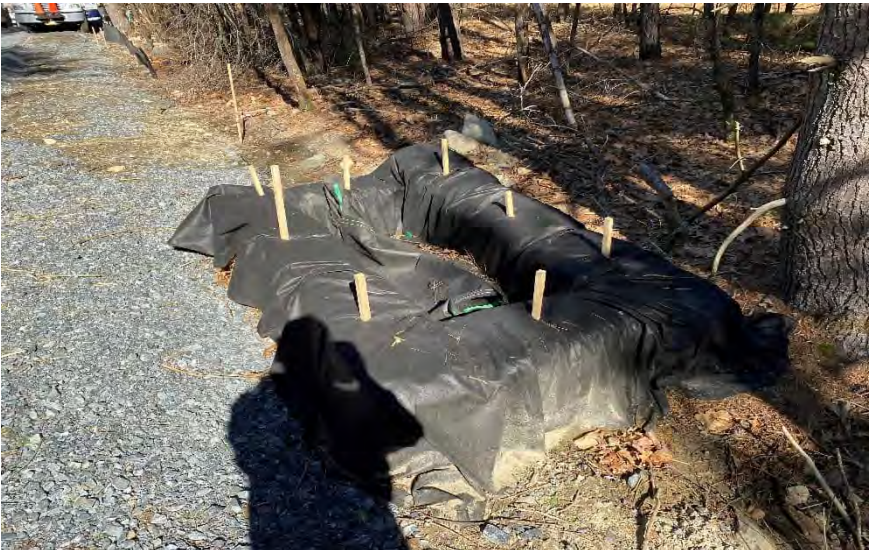
<b>Description:</b> Manhole #15. View of discharge bag/corral, looking westward. Water from bag/corral discharged to adjacent area.

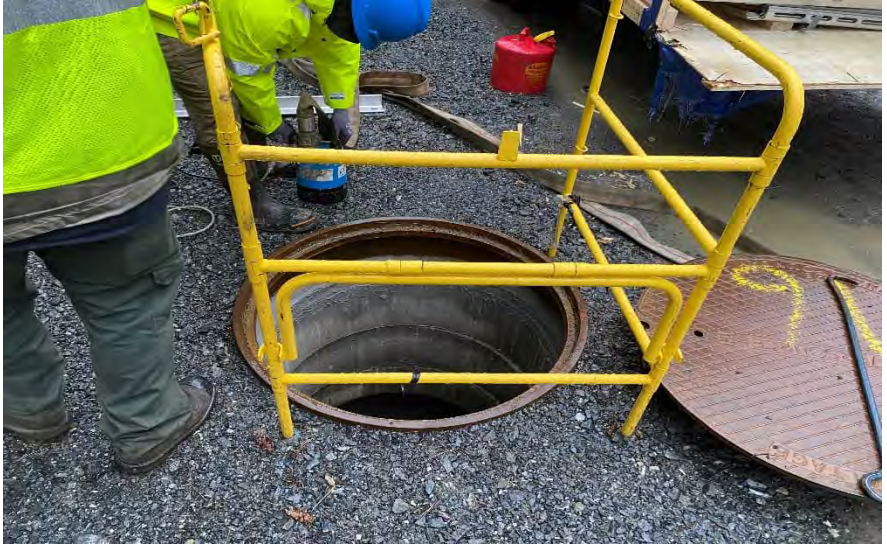
Description: View of area being pumped from manhole #16, segment 7.

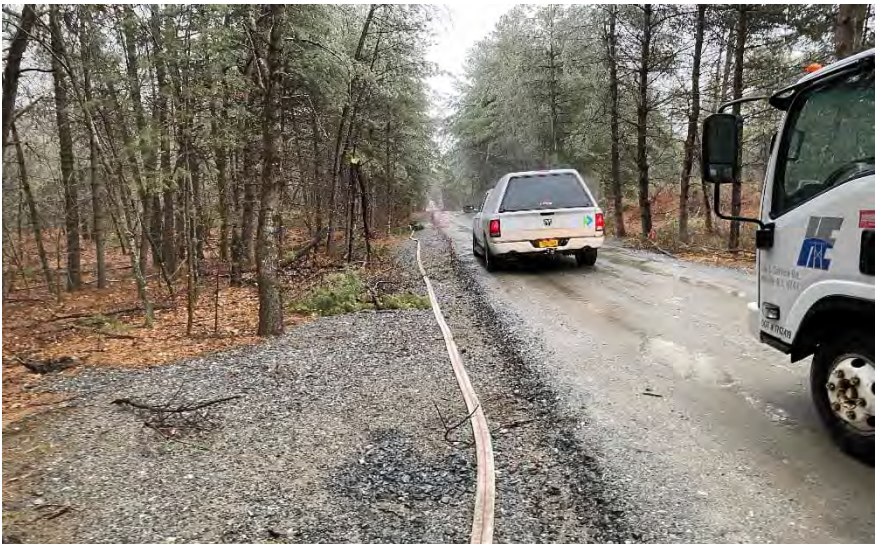
Description: Manhole #16. View of dewatering operation. Looking eastward.

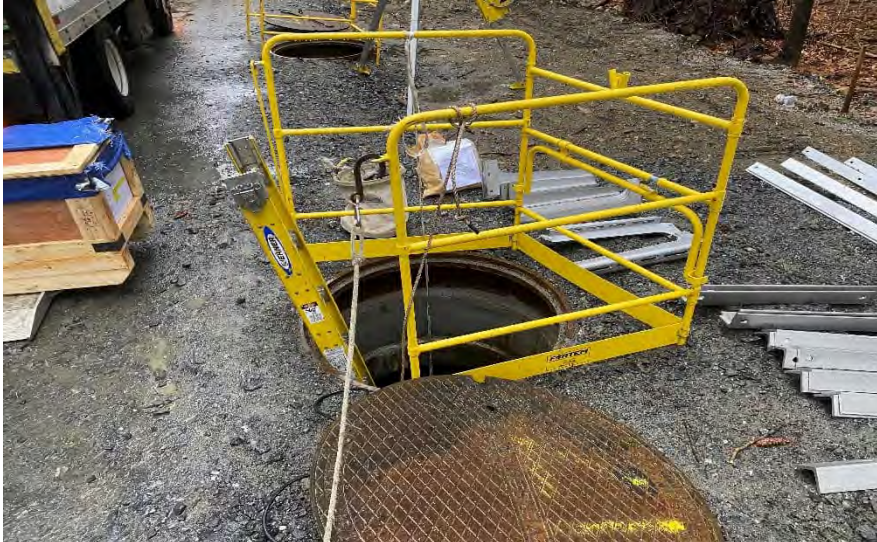
Description: View of area being pumped from manhole #17, segment 8.

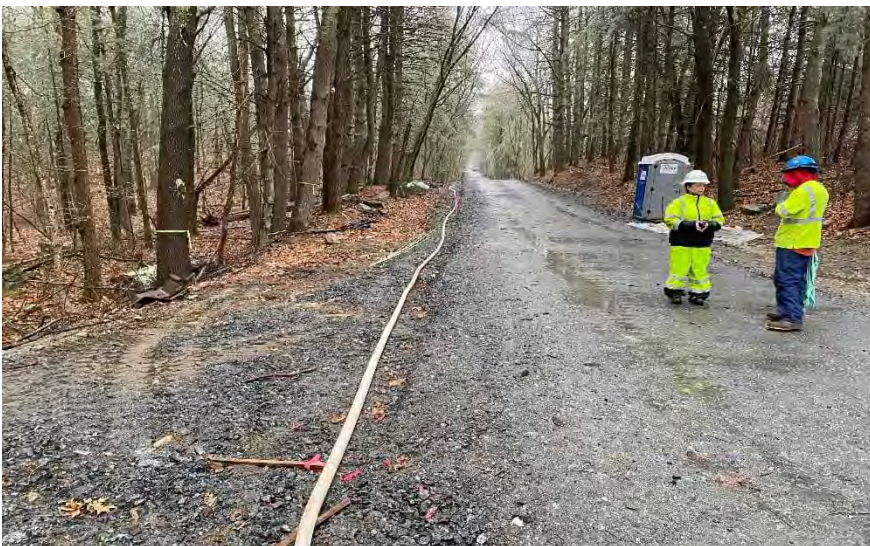
Description: Manhole #17. View of dewatering operation. Looking eastward.

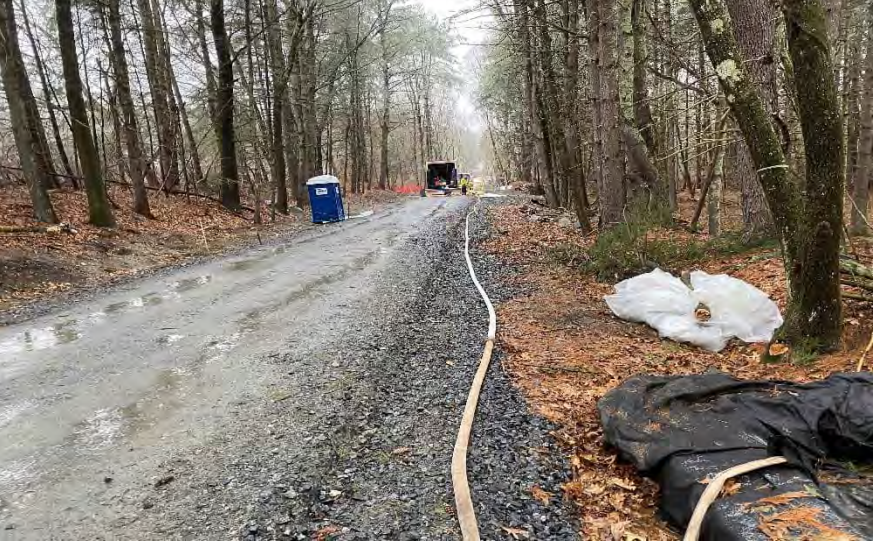
<b>Description:</b> Manhole #17. View of dewatering operation, looking westward.

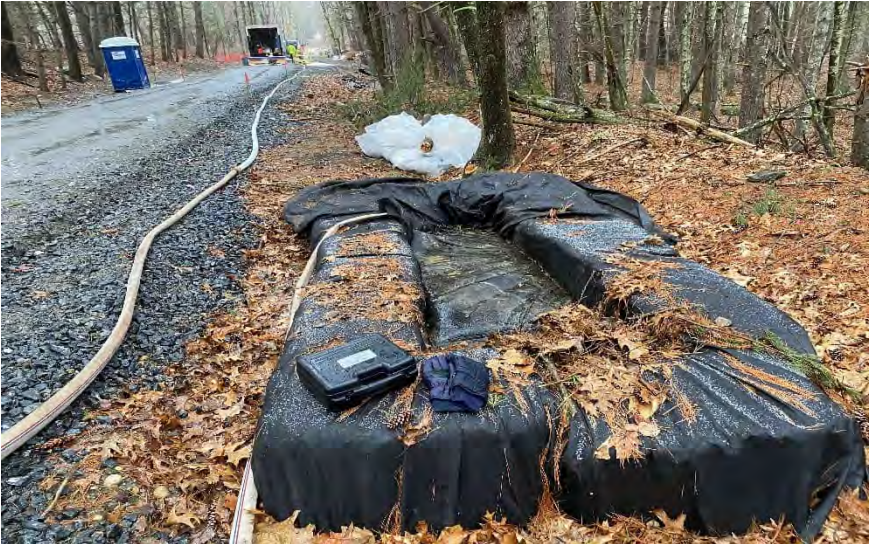
<b>Description:</b> Manhole #17. View of discharge bag/corral, looking westward. Water from bag/corral discharged to adjacent area.

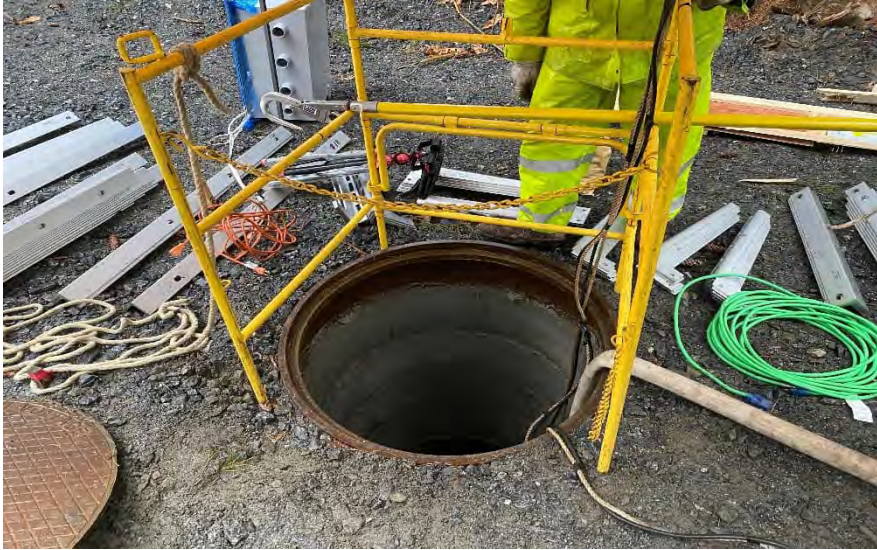
Description: View of area being pumped from manhole #18, segment 9.

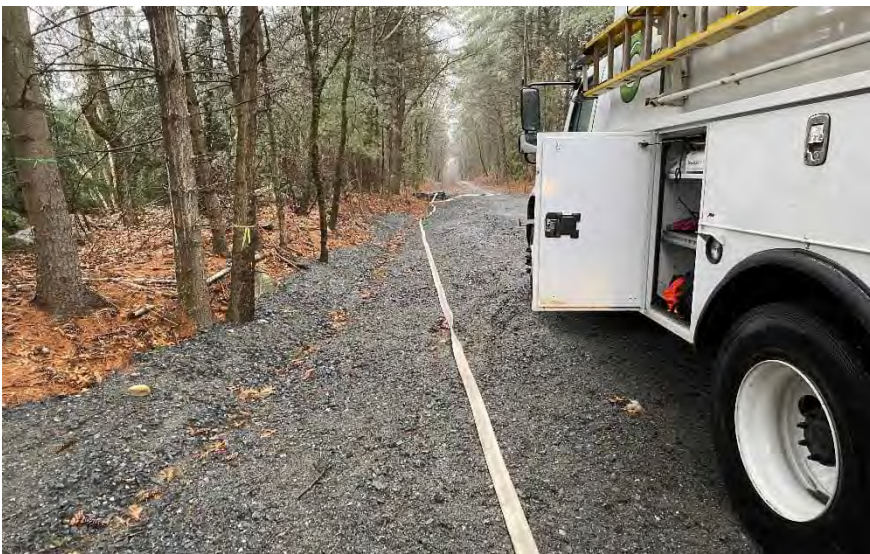
Description: Manhole #18. View of dewatering operation. Looking eastward.

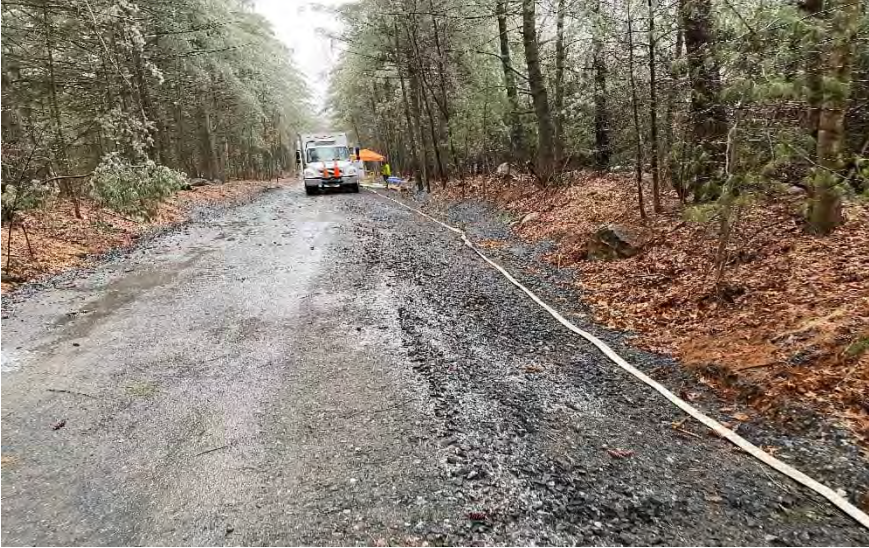
Description: Manhole #18. View of dewatering operation, looking westward.

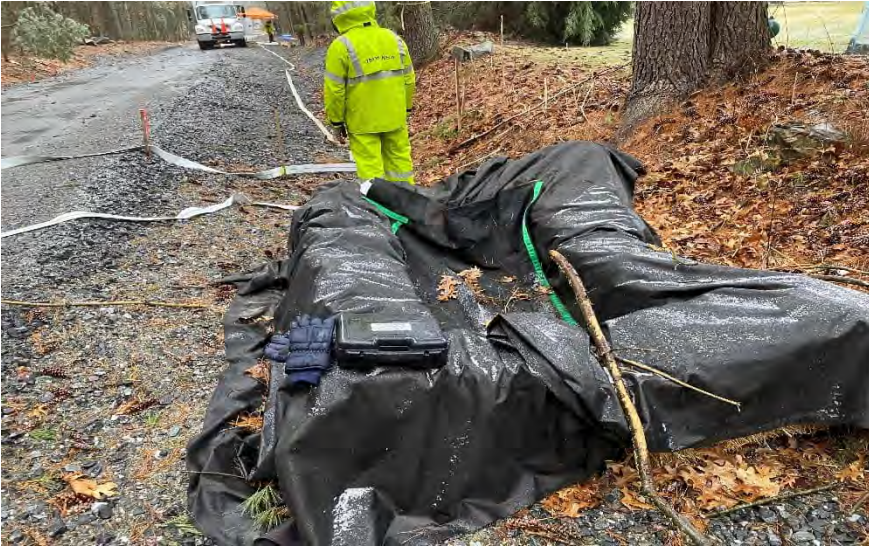
Description: Manhole #18. View of discharge bag/corral, looking westward. Water from bag/corral discharged to adjacent area.
