Weekly Environmental Compliance Summary

Sudbury to Hudson Transmission Reliability Project (USEPA Tracking # MAR1003UW)

Sudbury, Hudson, and Stow, MA

Week of: April 8, 2024 to April 13, 2024

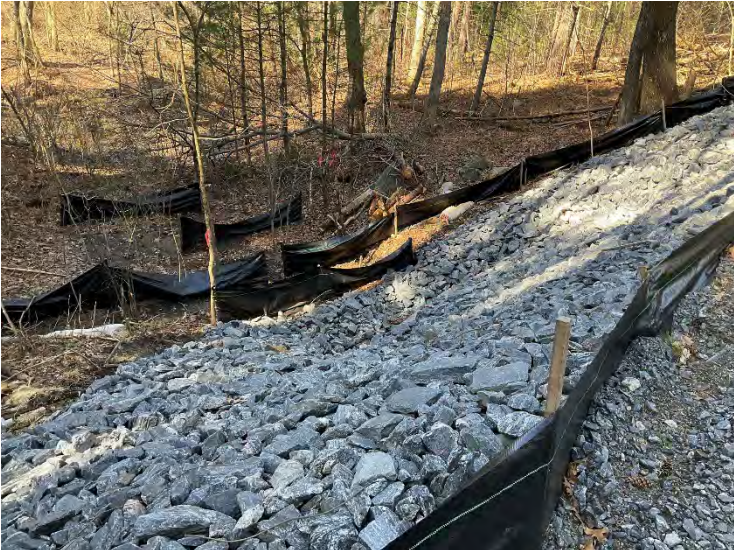
<p>PHOTOGRAPHIC LOG</p>	
<p>Client Name: Eversource</p>		<p>Site Location: Sudbury to Hudson Transmission Reliability Project</p>	<p>Town: Sudbury</p>
<p>Photo No.: 2</p>	<p>Date: 4/09/2024</p>

<p>Description: View of south side/downstream side of repaired culvert in segment 9. Facing southwest.</p>

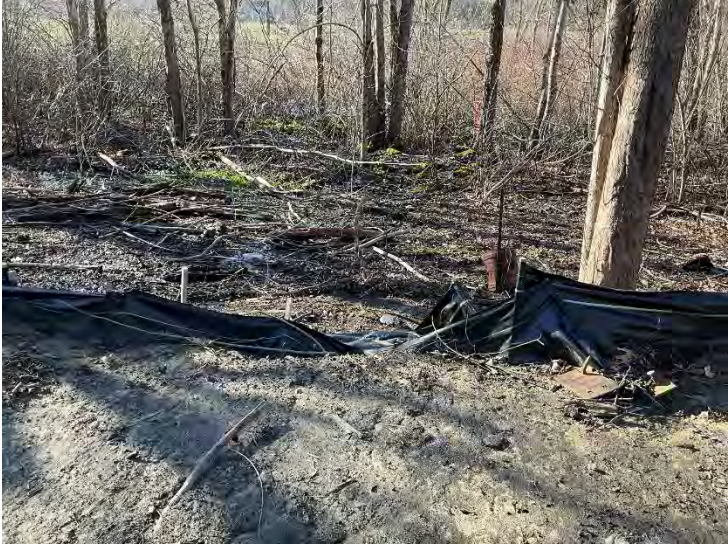
PHOTOGRAPHIC LOG	
Client Name: Eversource		Site Location: Sudbury to Hudson Transmission Reliability Project	Town: Sudbury
Photo No.: 6	Date: 4/09/2024

-Silt fence is in need of repair at Sta. #741 in segment 14 (routine maintenance).

Description: View of silt fence that is in need of repair at Sta. #741 in segment 14. Facing south.

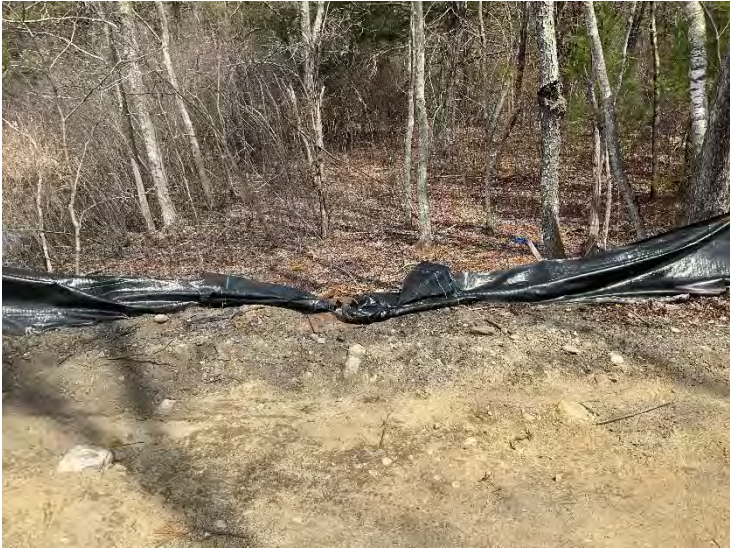
PHOTOGRAPHIC LOG	
Client Name: Eversource		Site Location: Sudbury to Hudson Transmission Reliability Project	Town: Sudbury
Photo No.: 5	Date: 4/10/2024

-Silt fence is in need of repair at Sta. #402 in segment 8 (routine maintenance).

Description: View of silt fence that is in need of repair at Sta. #402 in segment 8. Facing northeast.

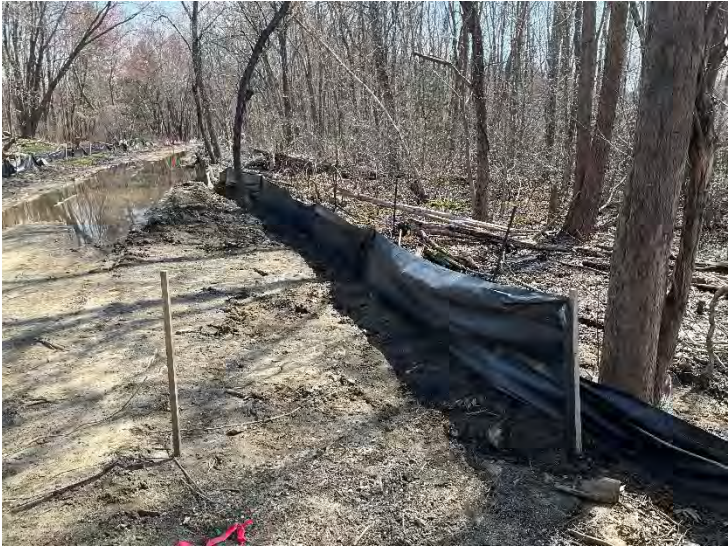
PHOTOGRAPHIC LOG	
Client Name: Eversource		Site Location: Sudbury to Hudson Transmission Reliability Project	Town: Sudbury
Photo No.: 6	Date: 4/10/2024

-Silt fence has been repaired at Sta. #741 in segment 14.

Description: View of repaired silt fence at Sta. #741 in segment 14 completed by Bond 4/10/2024. Facing east.

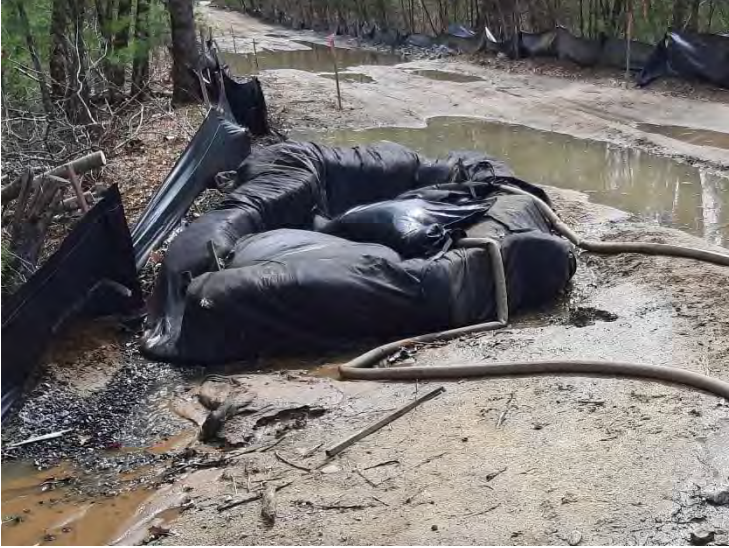
Manhole #14 had significant amounts of accumulated water inside and was dewatered with two pumps simultaneously. Replacement dewatering bags were brought in and used at this location. Additional water poured continuously from the lower conduit on the west side once the water was low enough to expose it. Dewatering was not completed by the time Haugland concluded operations for the day, and the intended work at manhole #14 (halo installation) was not conducted.

<p>Description:</p> <p>Work area within segment 6, manhole #14 dewatering bags/corral, looking eastward. Manhole entirely filled with water prior to dewatering. Significant amounts of water in the ROW prior to dewatering due to rainfall earlier in week.</p>

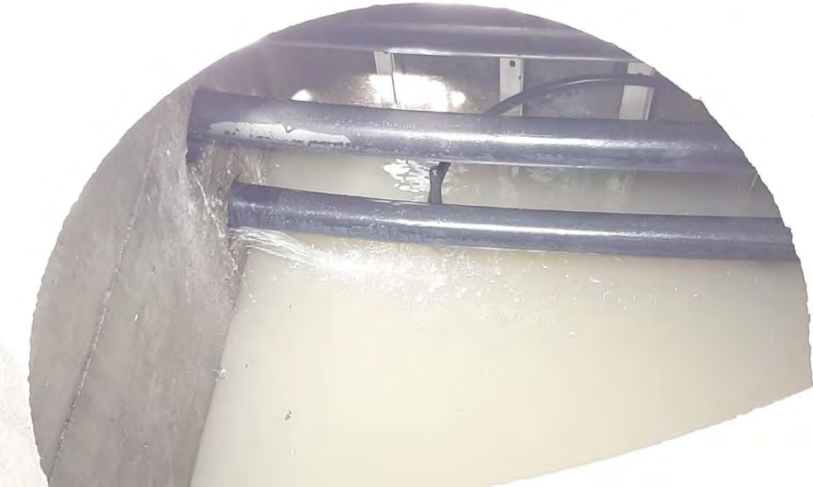
<p>Description:</p> <p>Work area within segment 6, manhole #14 work (intended halo installation), looking into manhole. Steady, continuous flow of water visible from bottom conduit entering west side of manhole. Flow from conduit above it was an inconsistent trickle.</p>

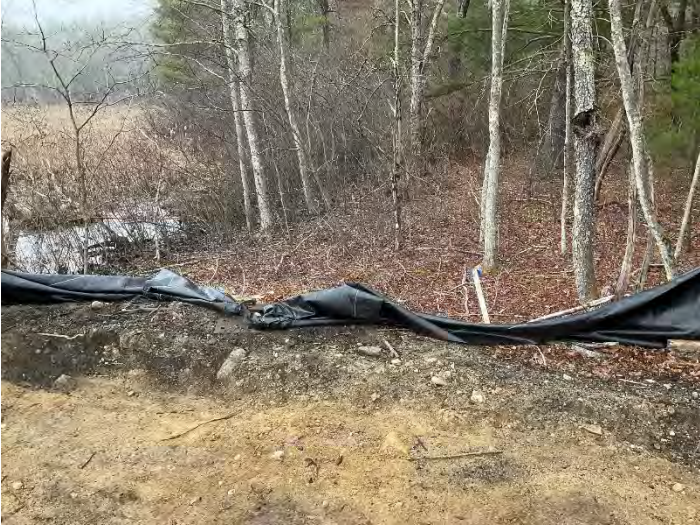
Description: View of damaged silt fence near bridge 128 in segment 8. Repairs are scheduled in this area tomorrow (4/12/2024). Facing north.

-E&S repairs were completed today in segment 14. Additional repairs are needed in various locations. Repairs in segments 7 and 8 are scheduled for tomorrow (4/12/2024). A full punchlist of needed repairs is going to be submitted to project contractors early next week.

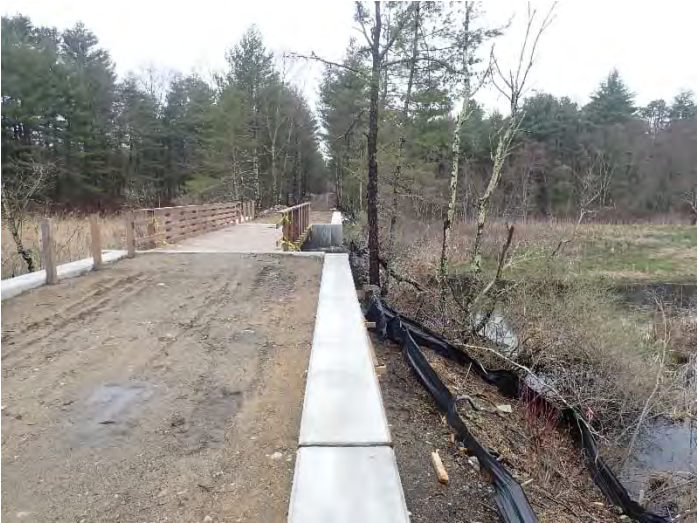
Description: View of the repaired silt fence in segment 8. Facing west.
