Weekly Environmental Compliance Summary

Sudbury to Hudson Transmission Reliability Project (USEPA Tracking # MAR1003UW)

Sudbury, Hudson, and Stow, MA

Week of: May 6, 2024 to May 11, 2024

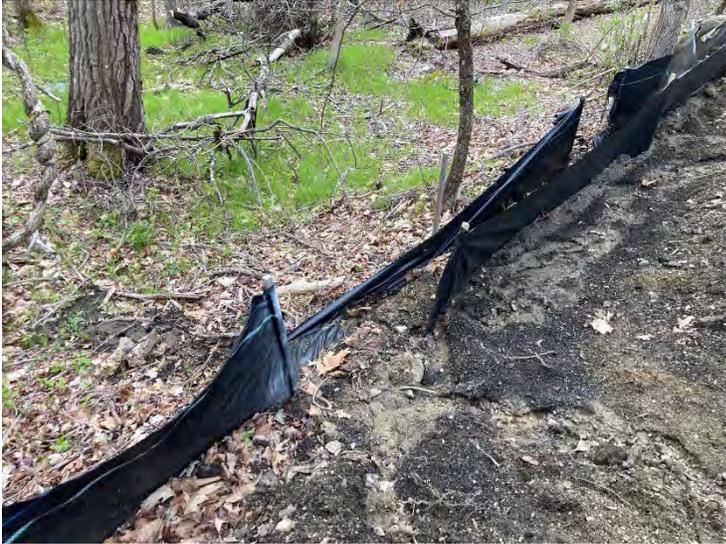
PHOTOGRAPHIC LOG	
Client Name: Eversource		Site Location: Sudbury to Hudson Transmission Reliability Project	Town: Sudbury
Photo No.: 5	Date: 5/06/2024

-Silt fence is in need of repair near Sta. #752 in segment 14.

Description: View of silt fence in need of repair near Sta. #752 in segment 14. Facing southwest.

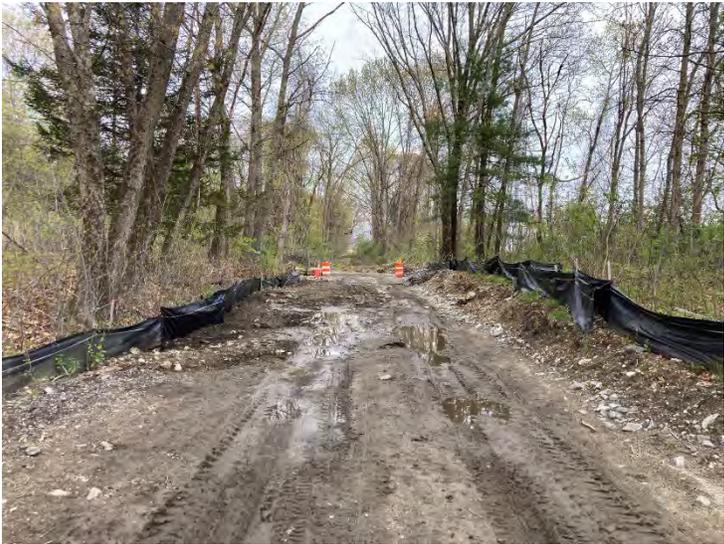
PHOTOGRAPHIC LOG	
Client Name: Eversource		Site Location: Sudbury to Hudson Transmission Reliability Project	Town: Sudbury
Photo No.: 6	Date: 5/06/2024

Description: View of repaired syncopated silt fence at east end of segment 14. Facing east.

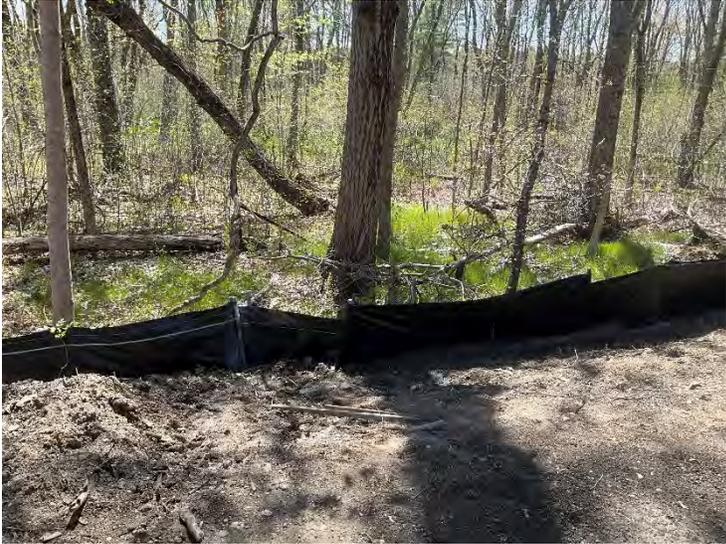
PHOTOGRAPHIC LOG	
Client Name: Eversource		Site Location: Sudbury to Hudson Transmission Reliability Project	Town: Sudbury
Photo No.: 5	Date: 5/07/2024

-Silt fence has been repaired near Sta. #752 in segment 14.

Description: View of repaired silt fence near Sta. #752 in segment 14. Facing south.

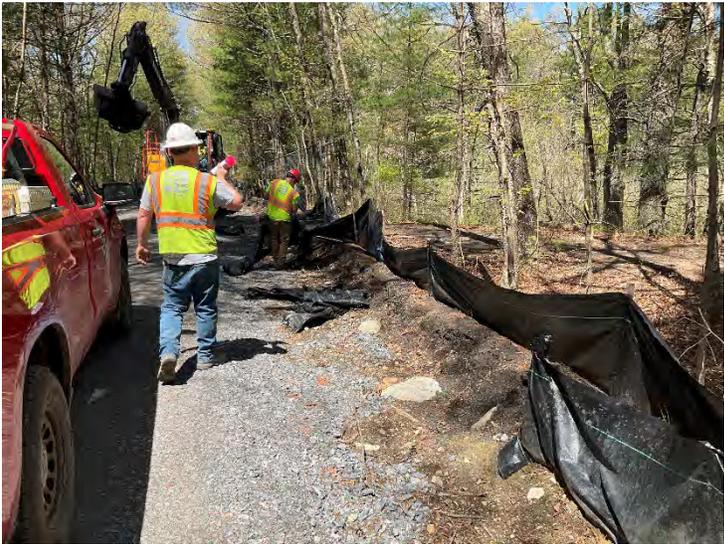
PHOTOGRAPHIC LOG	
Client Name: Eversource		Site Location: Sudbury to Hudson Transmission Reliability Project	Town: Sudbury
Photo No.: 6	Date: 5/07/2024

Description: View of ET&L and MON working in segment 8 repairing silt fencing. Facing northwest.

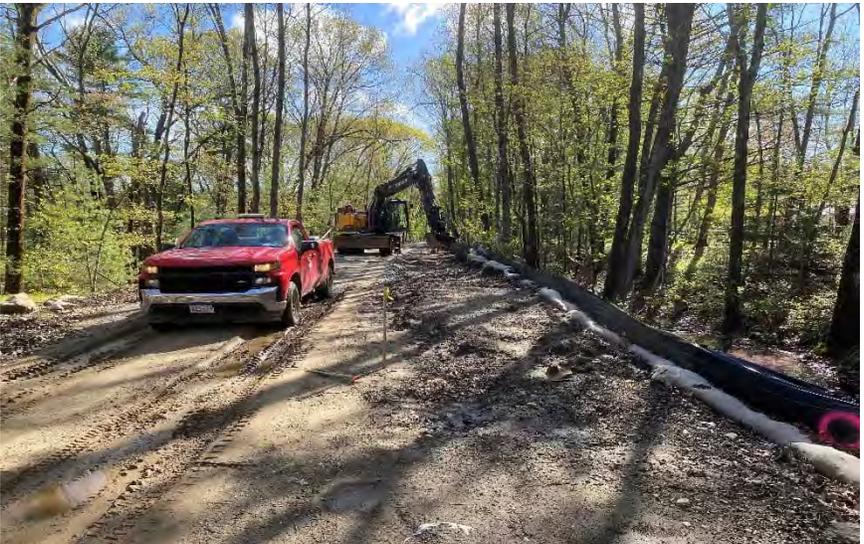
<p>PHOTOGRAPHIC LOG</p>	
<p>Client Name: Eversource</p>		<p>Site Location: Sudbury to Hudson Transmission Reliability Project</p>	<p>Town: Hudson</p>
<p>Photo No.: 4</p>	<p>Date: 5-9-24</p>

<p>Description: Work area within segment 1, erosion controls repair, existing erosion control, looking eastward.</p>

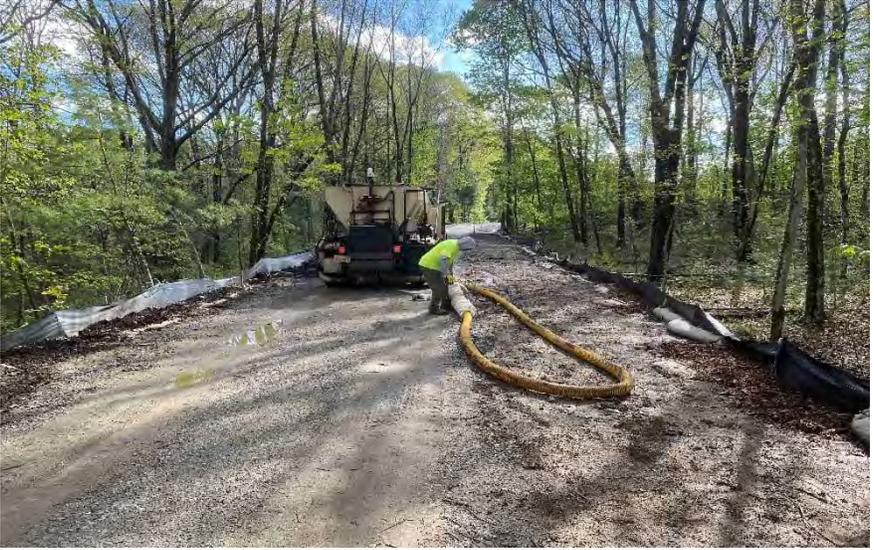
<p align="center">PHOTOGRAPHIC LOG</p>	
<p>Client Name: Eversource</p>		<p>Site Location: Sudbury to Hudson Transmission Reliability Project</p>	<p>Town: Hudson</p>
<p>Photo No.: 5</p>	<p>Date: 5-9-24</p>

<p>Description:</p> <p>Work area within segment 1, erosion controls repair, existing erosion control, looking eastward.</p>

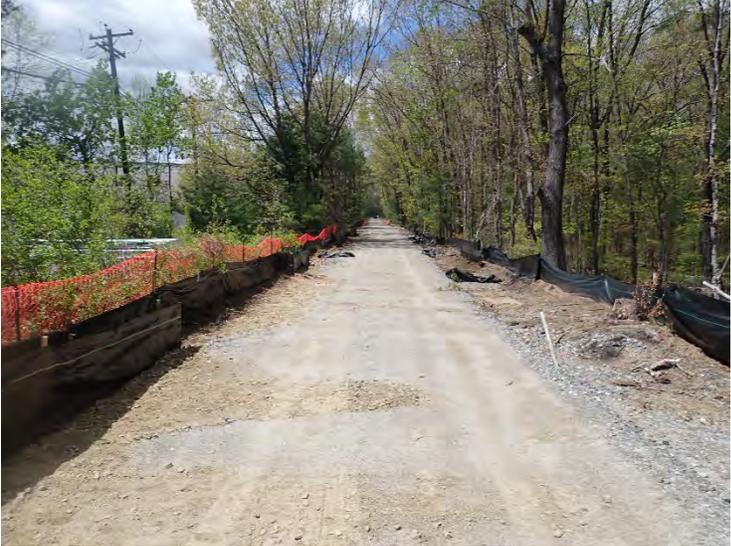
Description: View of repaired erosion controls in segment 11. Facing west.

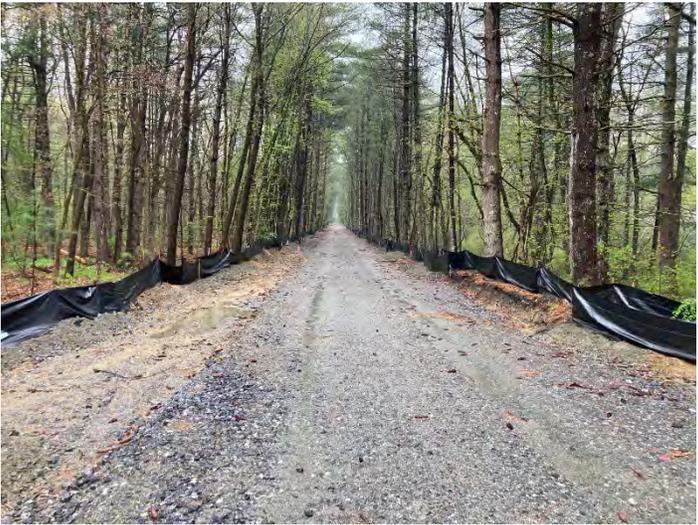
Description: View of syncopated silt fence in segment 10. Silt fence repairs have been completed in this segment. Facing east.

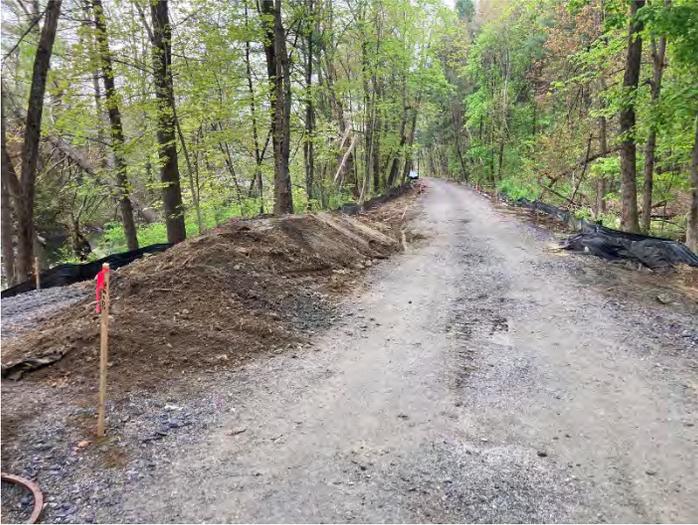
Description: View of stockpile noted near MH #25 in segment 13. Facing east.

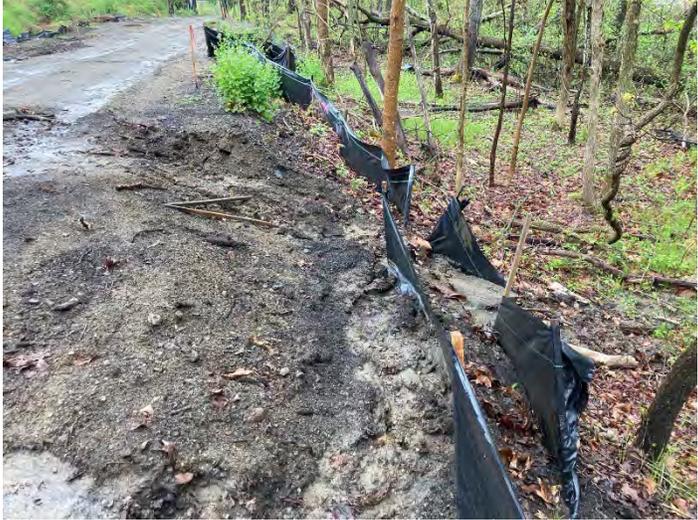
Description: View of silt fence in need of repair near Sta. #752 in segment 14. Facing east.
