**Weekly Environmental Compliance Summary**

**Sudbury to Hudson Transmission Reliability Project (USEPA Tracking # MAR1003UW)**

Sudbury, Hudson, and Stow, MA

Week of: May 20, 2024 to May 24, 2024

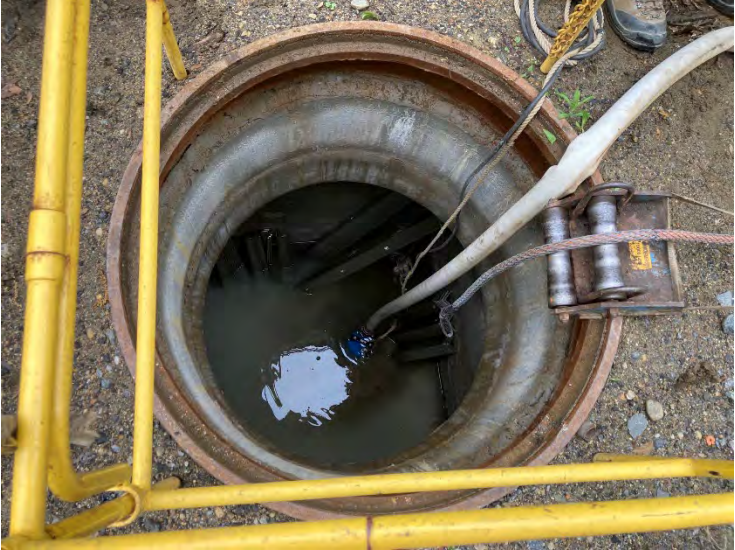
<b>PHOTOGRAPHIC LOG</b>	
Client Name: Eversource		Site Location: Sudbury to Hudson Transmission Reliability Project	Town: Hudson
Photo No.: 3	Date: 5/20/2024

<b>Description:</b> View of pump in MH #6 in segment 1. See additional dewatering inspection report.

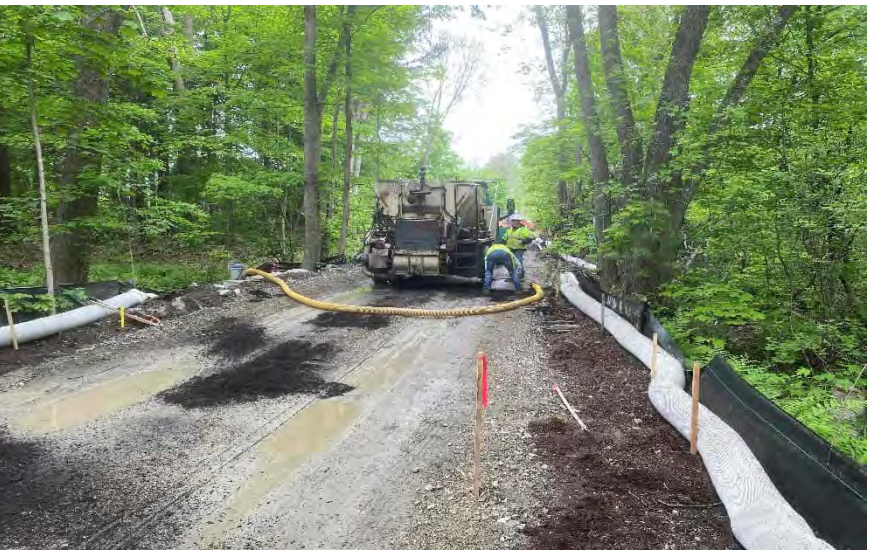
<p align="right">PHOTOGRAPHIC LOG</p>	
<p>Client Name: Eversource</p>		<p>Site Location: Sudbury to Hudson Transmission Reliability Project</p>	<p>Town: Sudbury</p>
<p>Photo No.: 2</p>	<p>Date: 5-20-24</p>

<p>Description:</p> <p>Work area within segment 13, MON repairing erosion control, existing erosion control, looking eastward.</p>

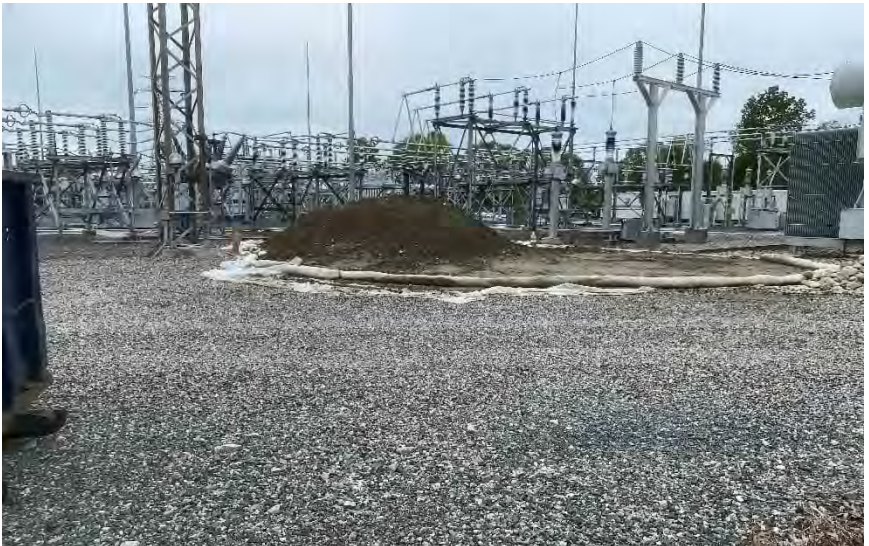
<p align="center">PHOTOGRAPHIC LOG</p>	
<p>Client Name: Eversource</p>		<p>Site Location: Sudbury to Hudson Transmission Reliability Project</p>	<p>Town: Sudbury</p>
<p>Photo No.: 6</p>	<p>Date: 5-20-24</p>

<p>Description:</p> <p>Work area within substation, newly placed spoil pile, existing erosion control (compost tubing), looking southward.</p>

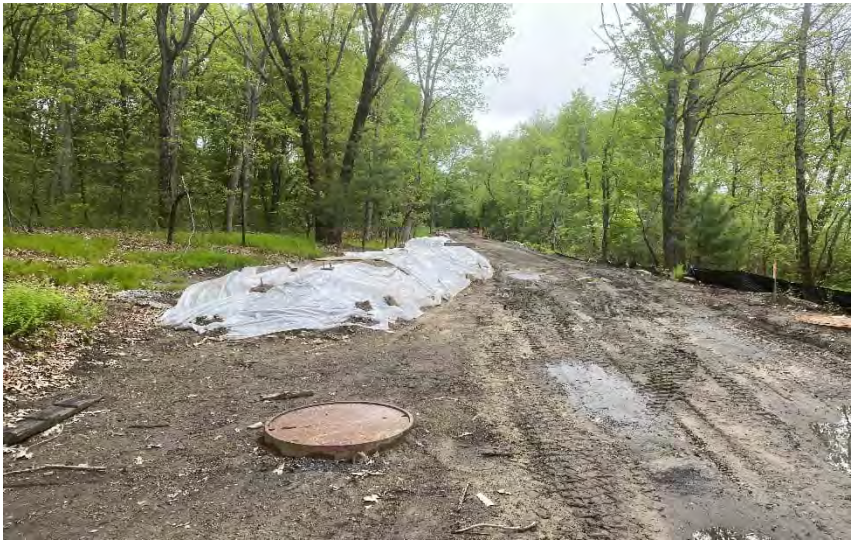
<p align="right">PHOTOGRAPHIC LOG</p>	
<p>Client Name: Eversource</p>		<p>Site Location: Sudbury to Hudson Transmission Reliability Project</p>	<p>Town: Sudbury</p>
<p>Photo No.: 8</p>	<p>Date: 5-20-24</p>

Spoil Berm noted within segment 14, berm created 3-8-24. See photo 8.

<p>Description:</p> <p>Work area within Segment 14, covered spoil berm, existing erosion control, looking eastward.</p>

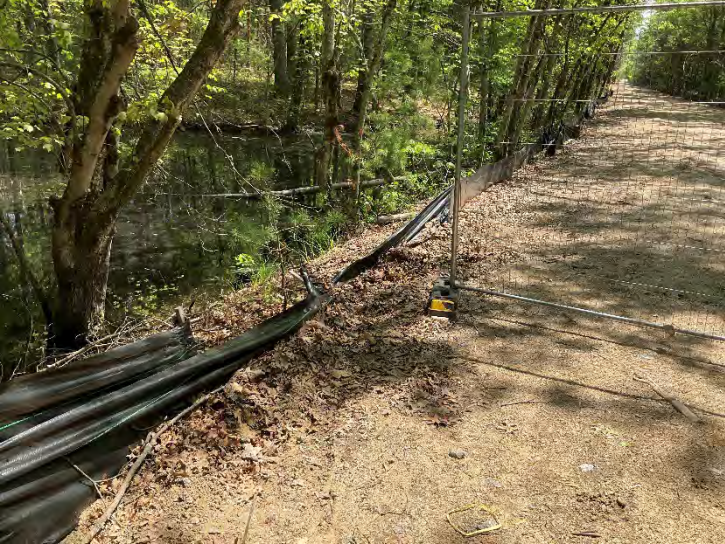
<p align="center"><b>PHOTOGRAPHIC LOG</b></p>	
<p>Client Name: Eversource</p>		<p>Site Location: Sudbury to Hudson Transmission Reliability Project</p>	<p>Town: Hudson</p>
<p>Photo No.: 8</p>	<p>Date: 5-21-24</p>

Silt fencing in need of repairs in segment 6 at station number 338+00.

<p><b>Description:</b></p> <p>View of E&amp;S controls in need of repair by segment 6 entrance at station number 338+00. Facing east.</p>

-A section of the silt fence is damaged, on the northern side of the right-of-way near Segment 6 entrance. Damage appears to have been cause by a bicycle.

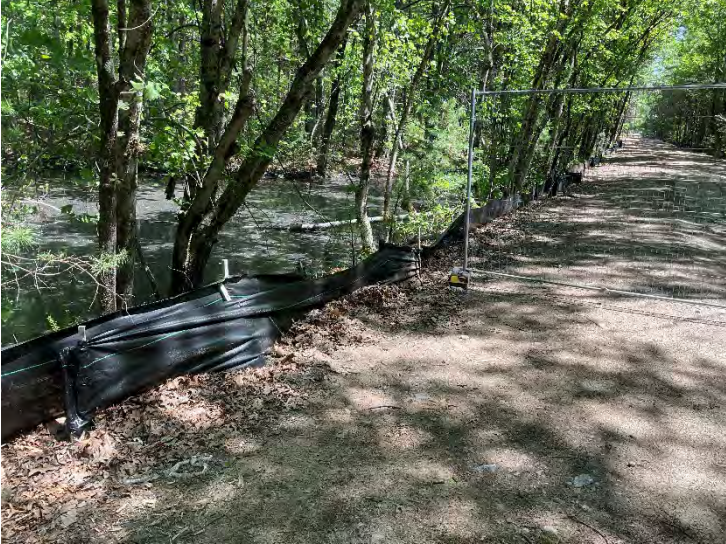
Silt fencing in segment 6 at station number 338-00 has been repaired.

<b>Description:</b> View of repaired E&S controls in segment 6 entrance at station number 338-00. Facing east.

-Previously observed section of the silt fence, on the northern side of entrance to Segment 6, was repaired. Silt fence appeared to have been damaged by bicycles. May need to continue to review the area and repair as needed.

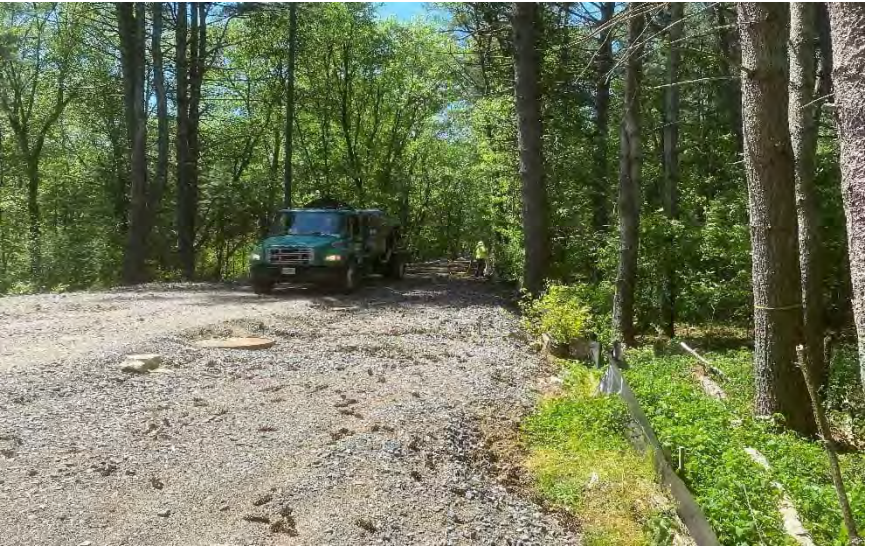
<p>Description:</p> <p>Work area within Segment 9, MON conducting erosion control repairs, existing erosion control, looking westward.</p>

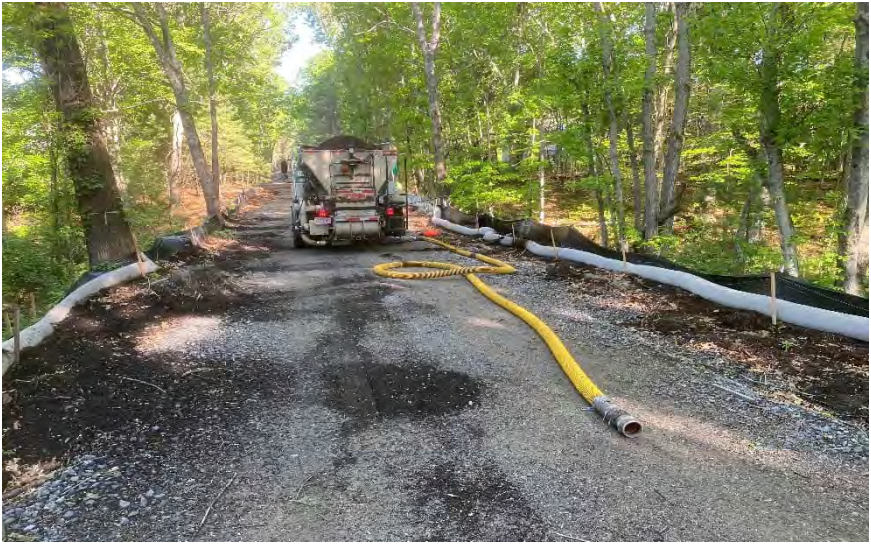
<b>Description:</b>  Work area within Segment 11, MON conducting erosion control repairs, existing erosion control, looking eastward.
