Weekly Environmental Compliance Summary

Sudbury to Hudson Transmission Reliability Project (USEPA Tracking # MAR1003UW)

Sudbury, Hudson, and Stow, MA

Week of: July 29, 2024 to August 3, 2024

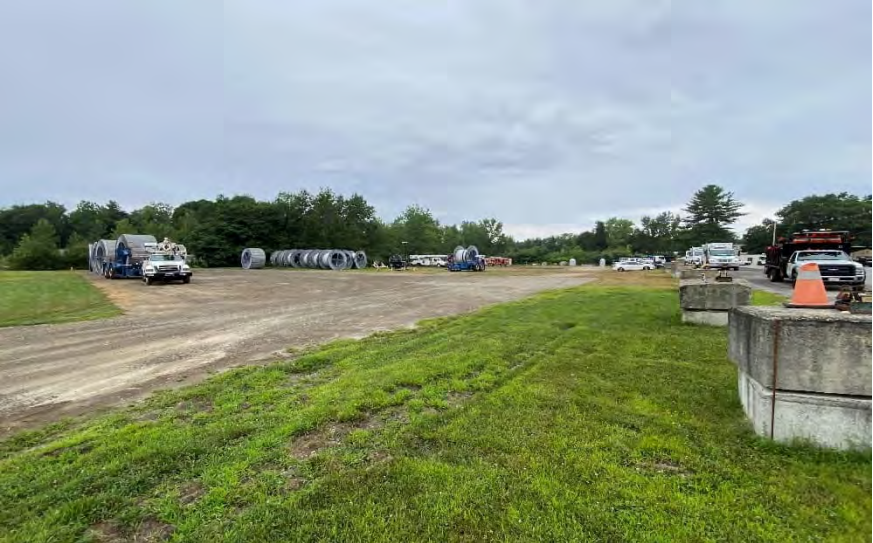
| Photo No.: 1 | Date: 7-29-24 | | |

| Description: Haugland laydown yard, stored wire on reels, looking eastward. | | | |

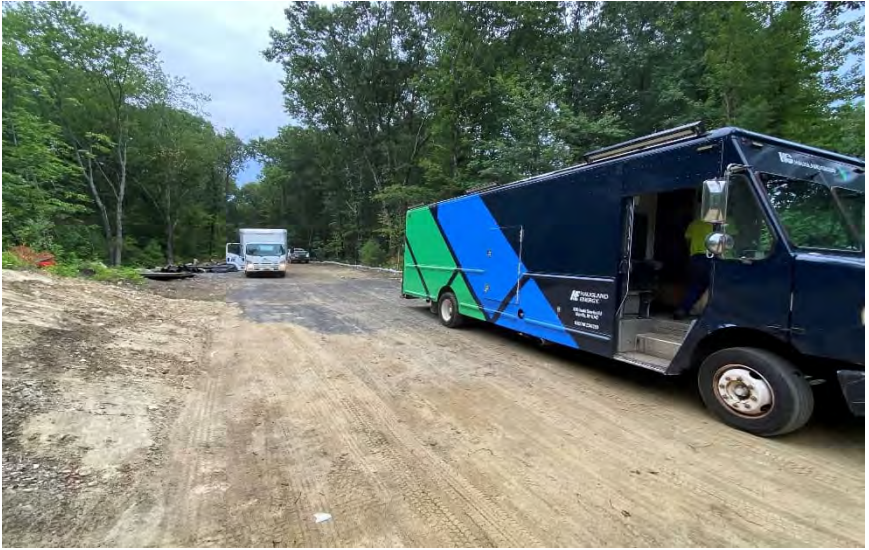
| <p>Photo No.: 3</p> | <p>Date: 7-29-24</p> | | |

| <p>Description:</p> <p>Work area within Segment 1, clipping work, manhole #5, existing erosion control, looking westward.</p> | | | |

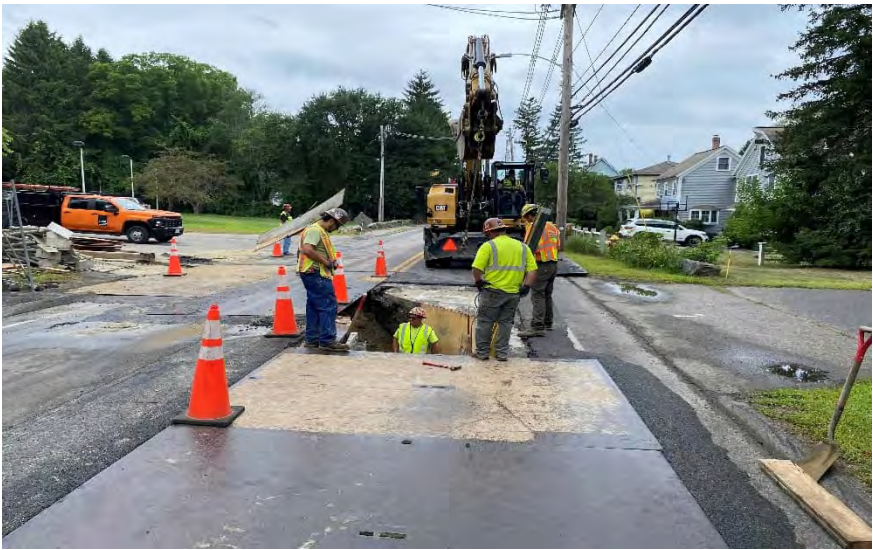
| <p>Photo No.: 4</p> | <p>Date: 7-29-24</p> | | |

| <p>Description:</p> <p>Conduit work near manhole #1, near Hudson Power & Light facility, looking southward.</p> | | | |

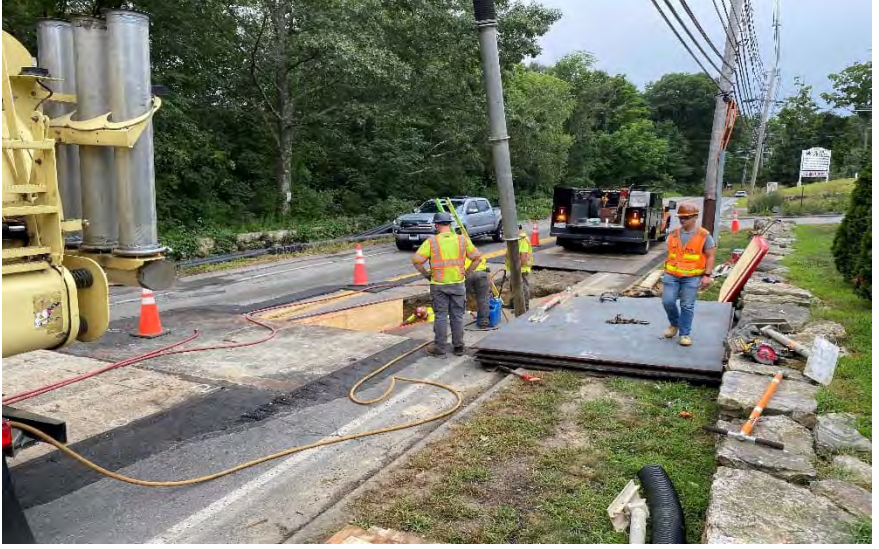
| Photo No.: 5 | Date: 7-29-24 | | |

| Description: Conduit work near manhole #2, near Bonazolli Avenue intersection with Forest Ave., looking southward. | | | |

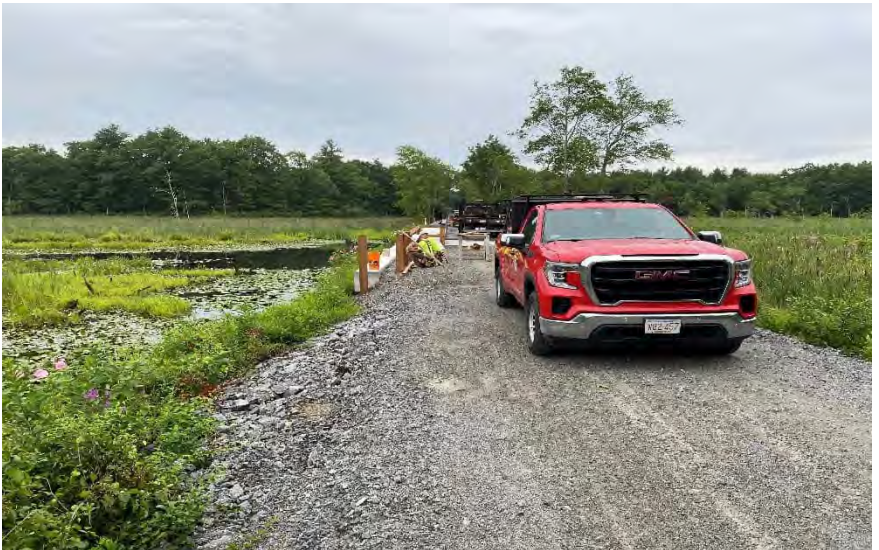
| Photo No.: 6 | Date: 7-29-24 | | |

| Description: Work area within segment 3, Bridge 130, bridge work, existing erosion control, looking westward. | | | |

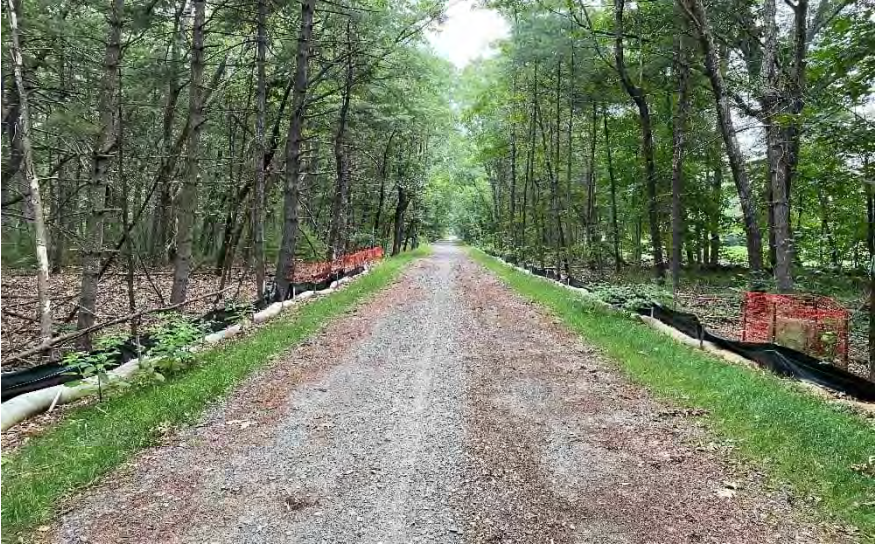
| <p>Photo No.: 7</p> | <p>Date: 7-29-24</p> | | |

| <p>Description:</p> <p>Work area within segment 4, shoulders vegetated, existing erosion control, looking eastward.</p> | | | |

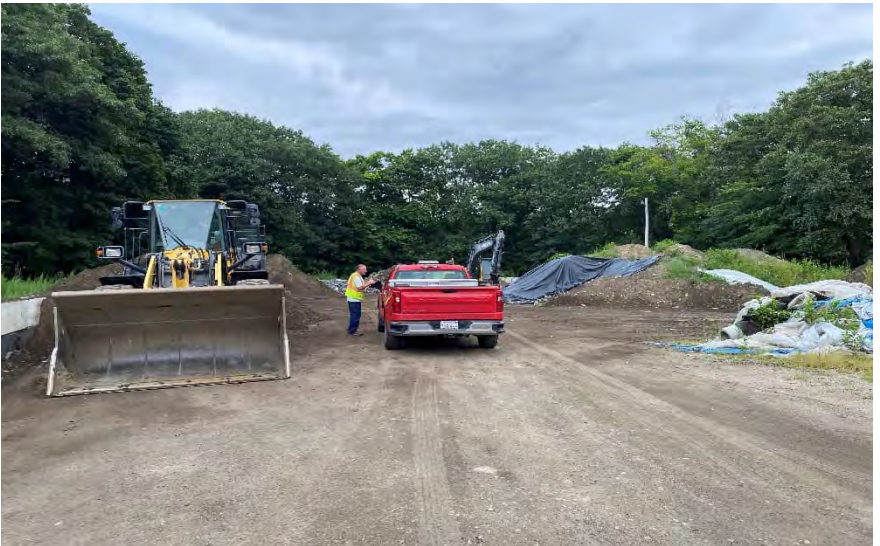
| <p>Photo No.: 8</p> | <p>Date: 7-29-24</p> | | |

| <p>Description:</p> <p>Laydown yard off Stowe Court, spoil pile removal, looking southward</p> | | | |

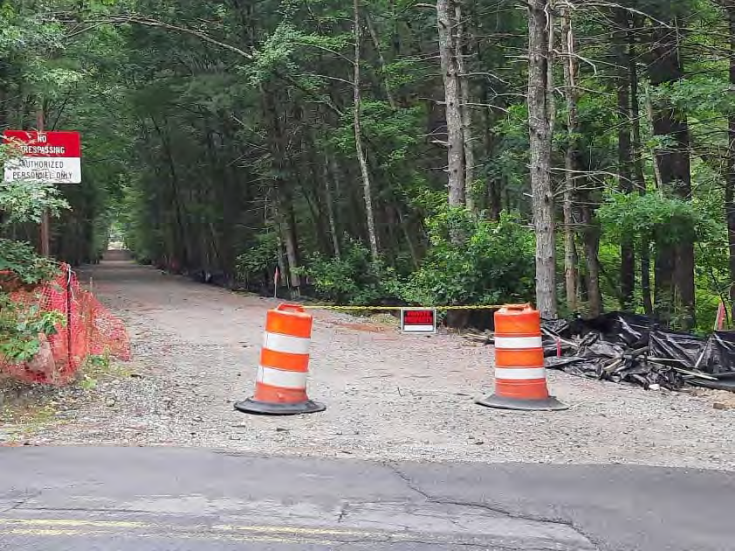
| Photo No.: 7 | Date: 7-29-24 | | |

| Description: Previous work area within Segment 8, no work in this segment today, existing erosion controls, looking westward. | | | |

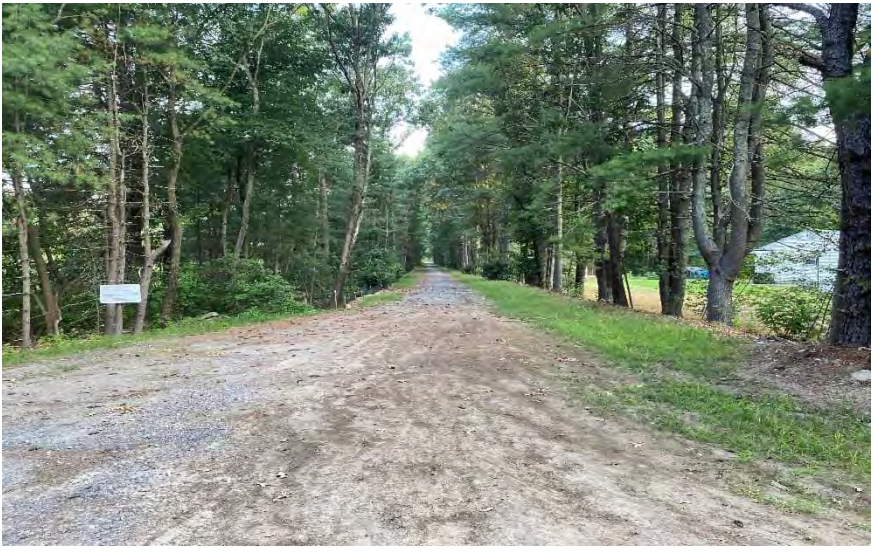
| <p>Photo No.: 2</p> | <p>Date: 7-31-24</p> | | |

| <p>Description:</p> <p>Work area within segment 4, existing erosion control, looking westward.</p> | | | |

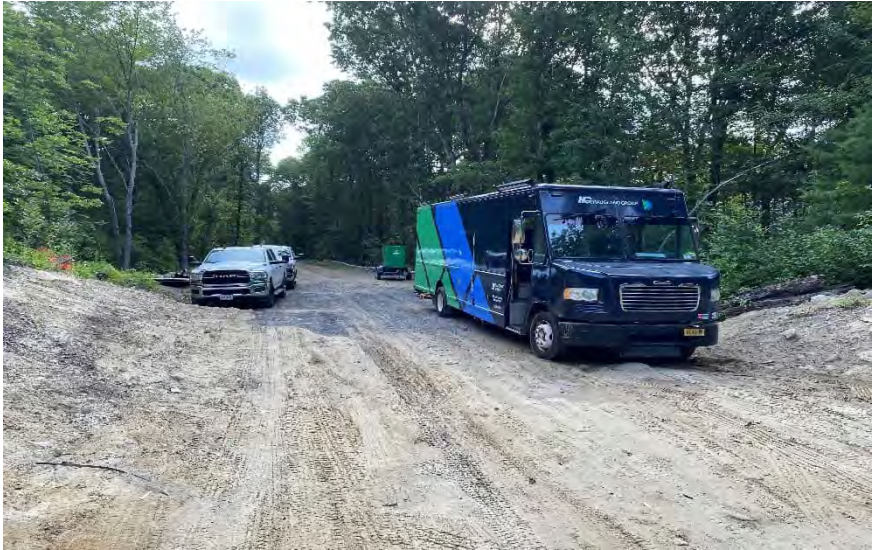
| <p>Photo No.: 3</p> | <p>Date: 7-31-24</p> | | |

| <p>Description:</p> <p>Work area within Segment 1, clipping work, manhole #5, existing erosion control, looking eastward.</p> | | | |

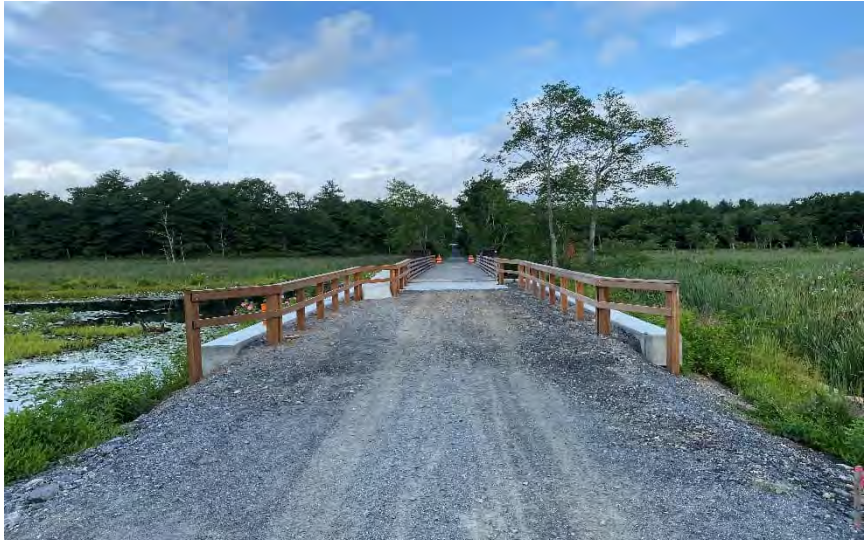
| Photo No.: 6 Date: 7-31-24 | | Town: Hudson | |

| Description: Work area within segment 3, Bridge 130, existing erosion control, looking westward across Fort Meadow Brook. | | | |

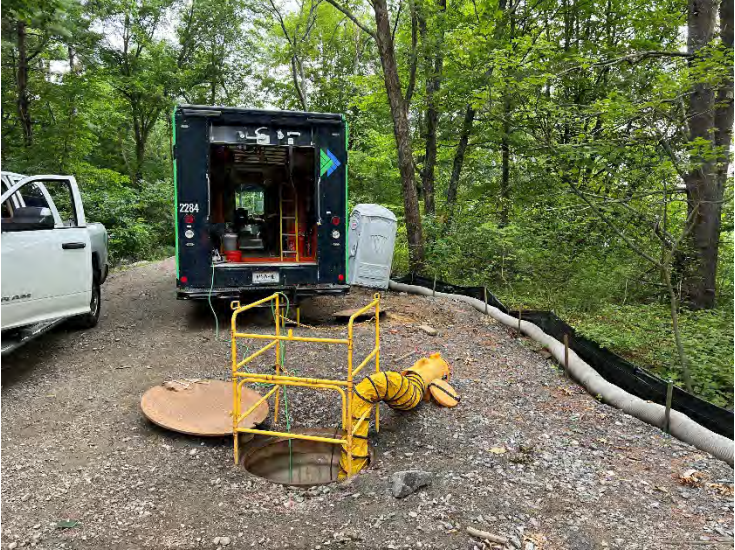
| <p>Photo No.: 3</p> | <p>Date: 7/31/2024</p> | | |

| <p>Description: View of Haugland splicers at MH #25 in segment 13. Facing east.</p> | | | |

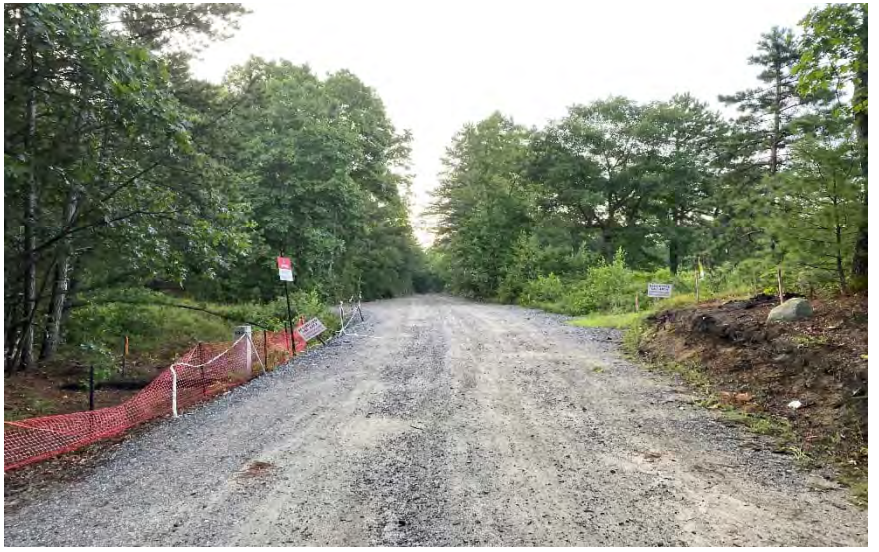
| <p>Photo No.: 6</p> | <p>Date: 8-1-24</p> | | |

| <p>Description:</p> <p>Work area within segment 6, town line area, existing erosion control, looking eastward.</p> | | | |

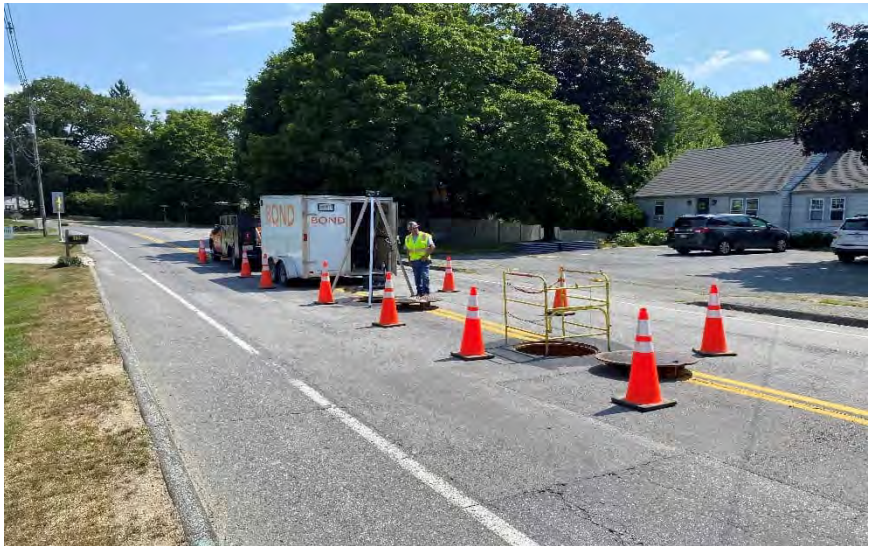
| Photo No.: 8 | Date: 8-1-24 | | |

| Description: Conduit repair work within Forest Avenue, Manhole #3, Forest Avenue, looking northward. | | | |

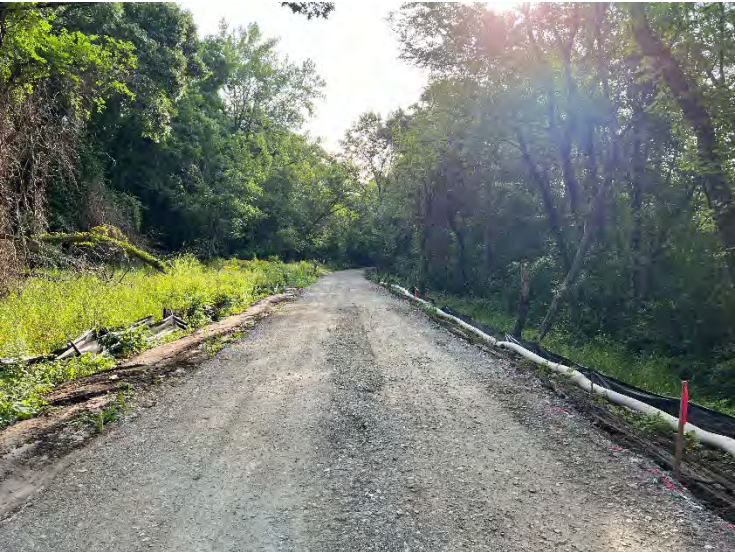
| Photo No.: 2 | Date: 8/1/2024 | | |

| Description: View of E&S controls and subgrading in segment 14. Facing east. | | | |

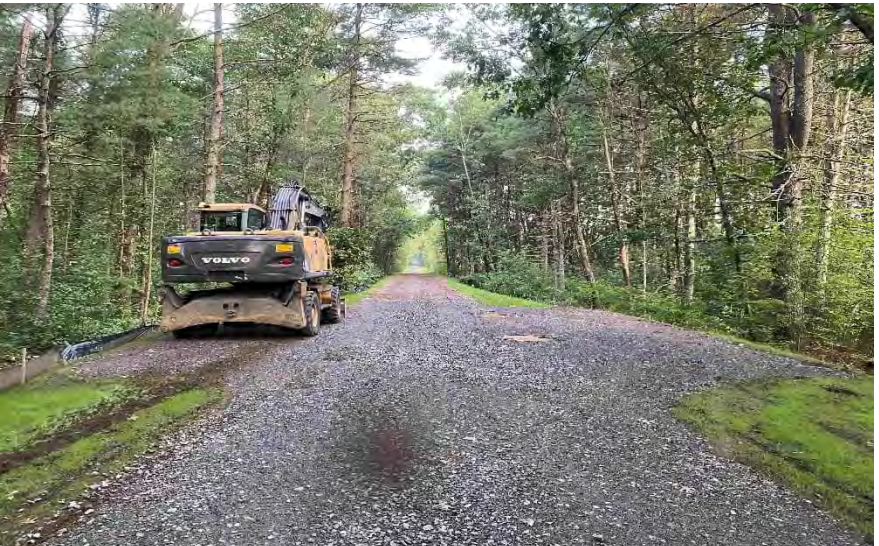
| <p>Photo No.: 6</p> | <p>Date: 8-2-24</p> | | |

| <p>Description:</p> <p>Work area within segment 5, manhole #13, existing erosion control, looking westward.</p> | | | |

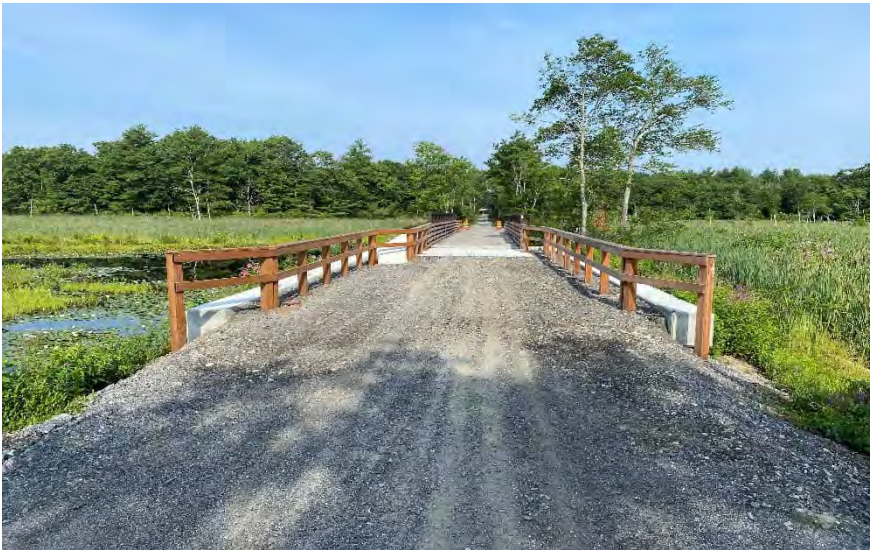
| <p>Photo No.: 8</p> | <p>Date: 8-2-24</p> | | |

| <p>Description:</p> <p>Bridge 130, existing erosion control, looking westward (segment 3 toward segment 2) across Fort Meadow Brook.</p> | | | |

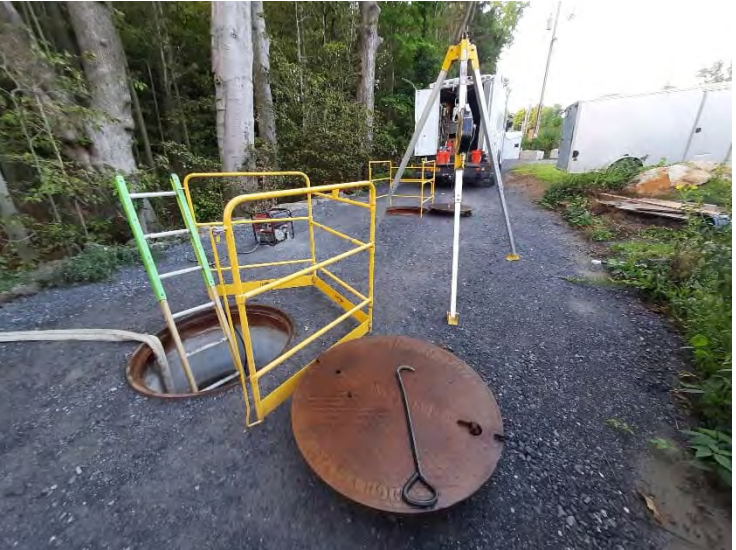
| <p>Photo No.: 1</p> | <p>Date: 8-3-24</p> | | |

| <p>Description:</p> <p>Work area at manhole #1 (near Hudson Light & Power). Haugland attempting to prepare for future cable work, looking southward. Turbidity monitoring conducted during dewatering.</p> | | | |

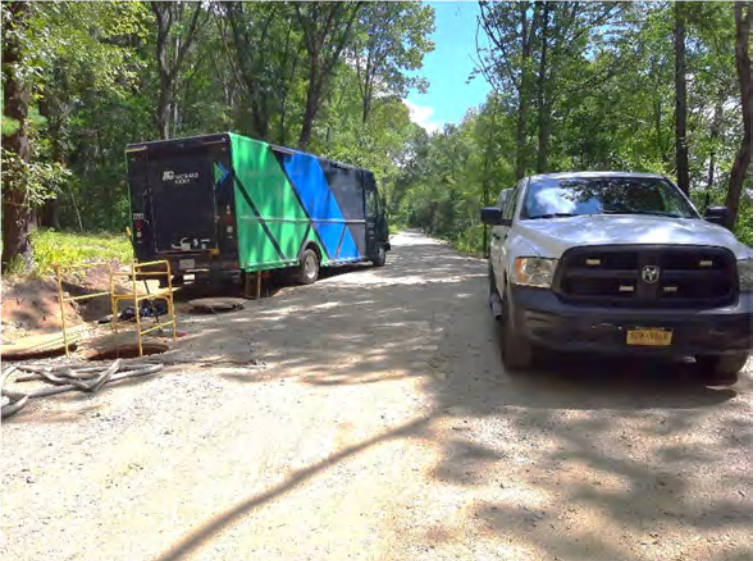
| <p>Photo No.: 4</p> | <p>Date: 8-3-24</p> | | |

| <p>Description:</p> <p>Work area manhole #26 (segment 14), crimping and splicing, looking eastward. Turbidity monitoring conducted during dewatering.</p> | | | |

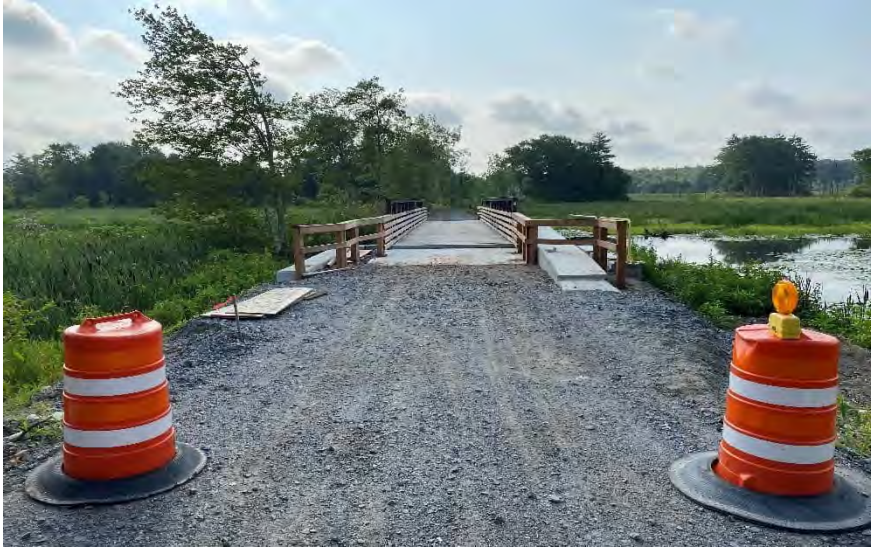
| Photo No.: 5 | Date: 7-30-24 | | |

| Description: Bridge 130 looking over Fort Meadow Brook from segment 2 to segment 3, existing erosion control, looking eastward. | | | |

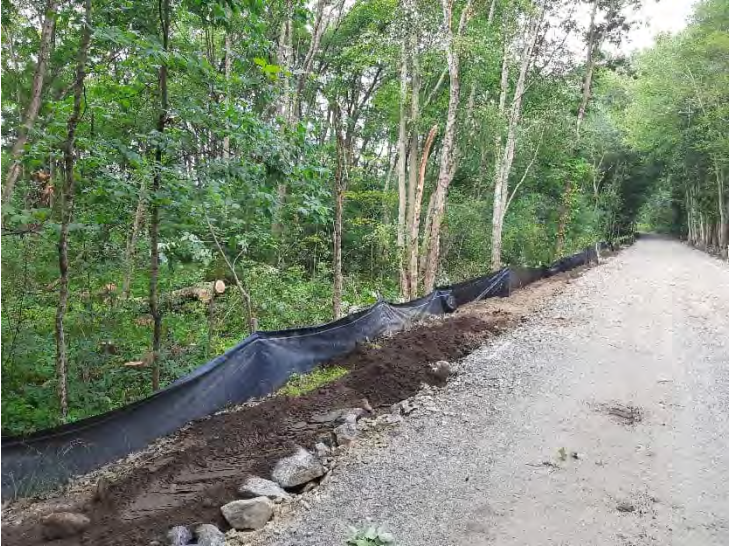
| Photo No.: 5 | Date: 7-30-24 | | |

| Description: Work area within Segment 14, tree removal location and recently repaired silt fence, looking westward. | | | |

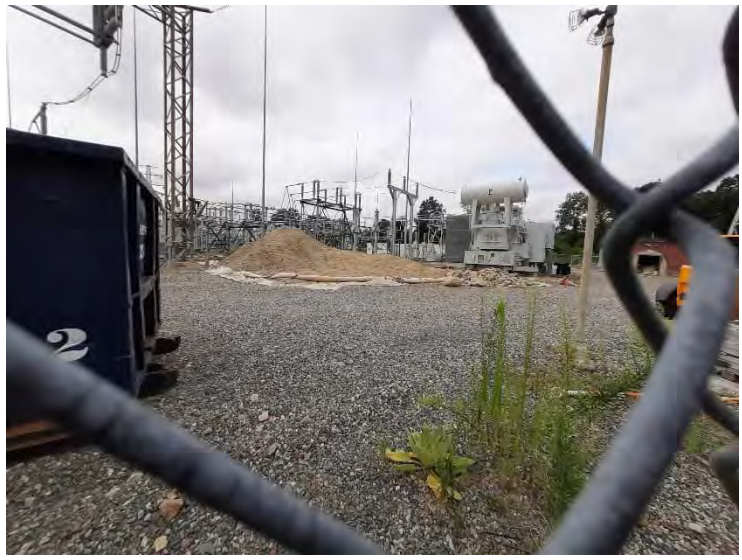
| Photo No.: 8 | Date: 7-30-24 | | |

| Description: Sudbury substation, existing spoils pile and erosion controls, looking southward. | | | |

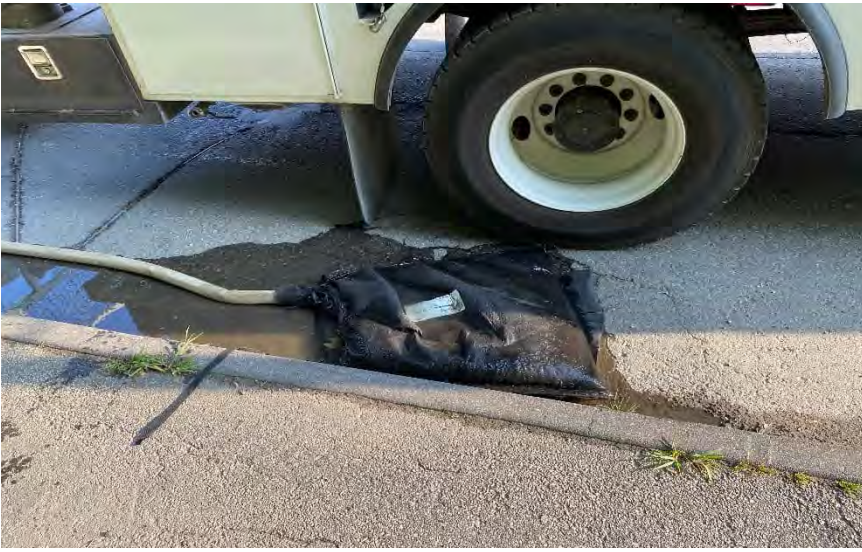
| Photo No.: 4 | Date: 7/30/2024 | | |

| Description: Manhole #2. View of discharge bag. Water from bag discharged to underlying catch basin in Forest Avenue. | | | |

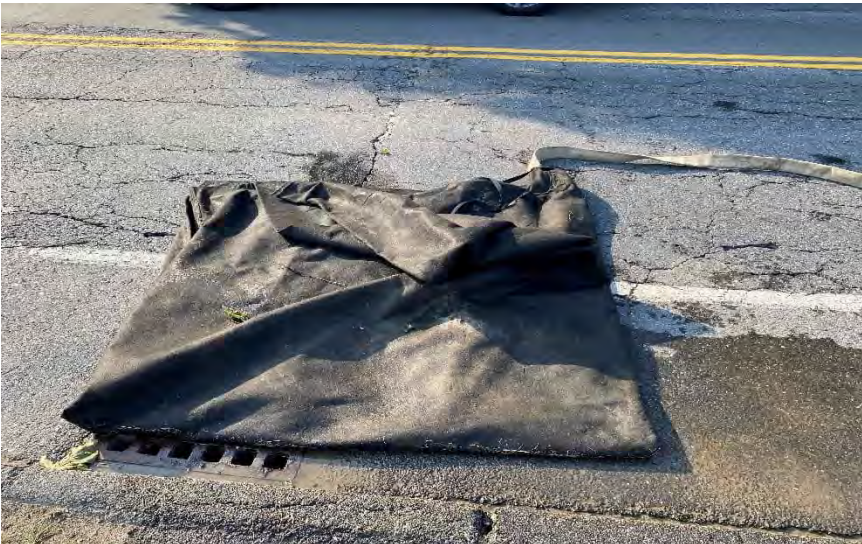
| Photo No.: 4 | Date: 7/30/2024 | | |

| Description: Manhole #3. View of discharge bag. Water from bag discharged to underlying catch basin. | | | |

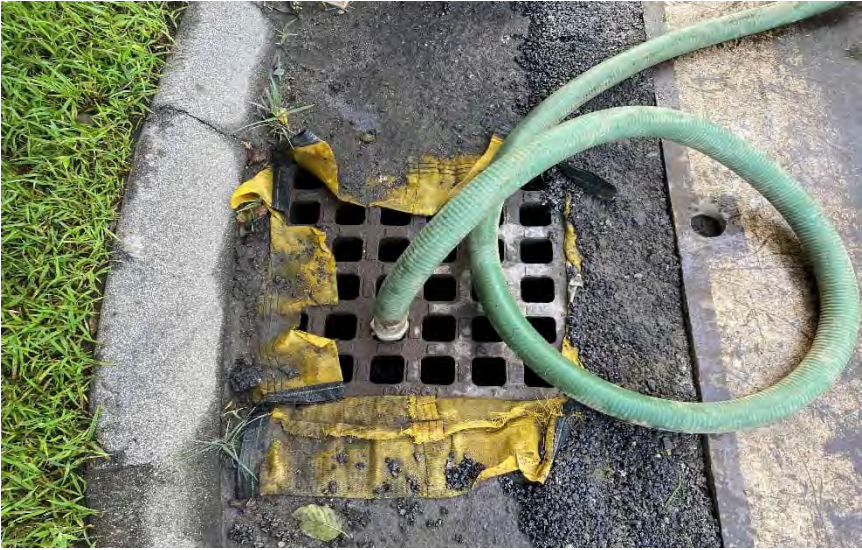
| Photo No.: 4 | Date: 8/1/2024 | | |

| Description: Near manhole #1. View of discharge to catch basin (with catch basin bag). | | | |

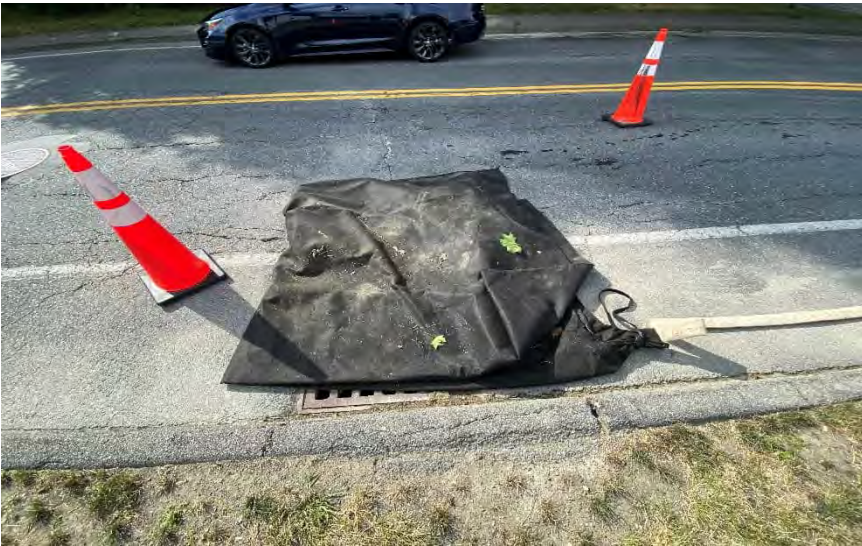
| Photo No.: 4 | Date: 7/31/2024 | | |

| Description: Manhole #3. View of discharge bag. Water from bag discharged to underlying catch basin. | | | |

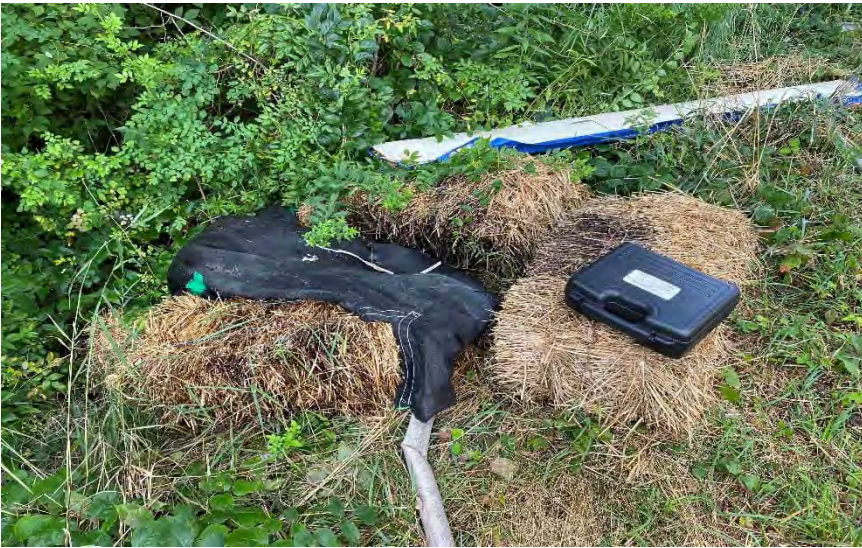
| Photo No.: 4 | Date: 8/2/2024 | | |

| Description: Manhole #4. View of discharge bag/corral. Water from bag/corral discharged to adjacent forested area off Forest Avenue. | | | |
