Weekly Environmental Compliance Summary

Sudbury to Hudson Transmission Reliability Project (USEPA Tracking # MAR1003UW)

Sudbury, Hudson, and Stow, MA

Week of: August 5, 2024 to August 10, 2024

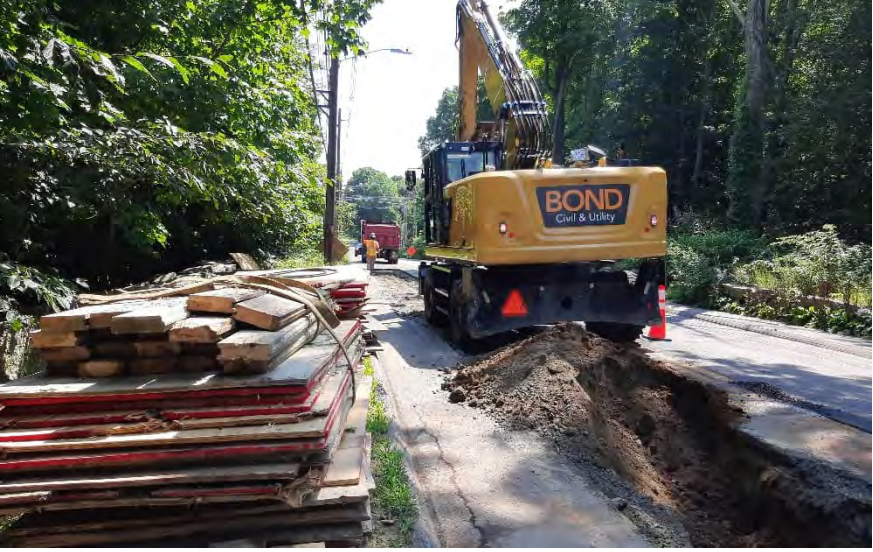
<p align="center">PHOTOGRAPHIC LOG</p>	
<p>Client Name: Eversource</p>		<p>Site Location: Sudbury to Hudson Transmission Reliability Project</p>	<p>Town: Hudson</p>
<p>Photo No.: 1</p>	<p>Date: 8-5-24</p>

<p>Description:</p> <p>Bond conducting conduit work along Forest Ave near manhole #1, near Hudson Light & Power, looking northward.</p>

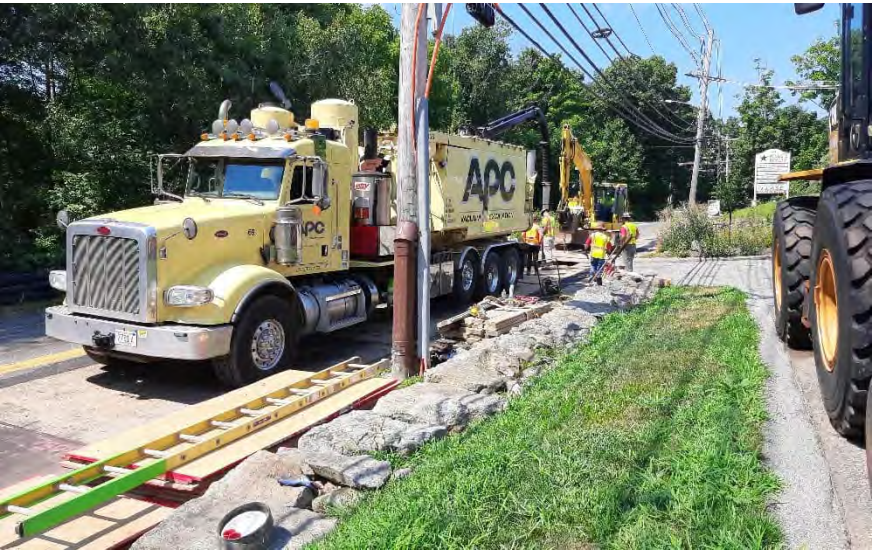
<p align="center">PHOTOGRAPHIC LOG</p>	
<p>Client Name: Eversource</p>		<p>Site Location: Sudbury to Hudson Transmission Reliability Project</p>	<p>Town: Hudson</p>
<p>Photo No.: 2</p>	<p>Date: 8-5-24</p>

<p>Description:</p> <p>Bond conducting conduit work along Forest Ave near manhole #2, near Bonazzoli Avenue intersection with Forest Ave, looking southward.</p>

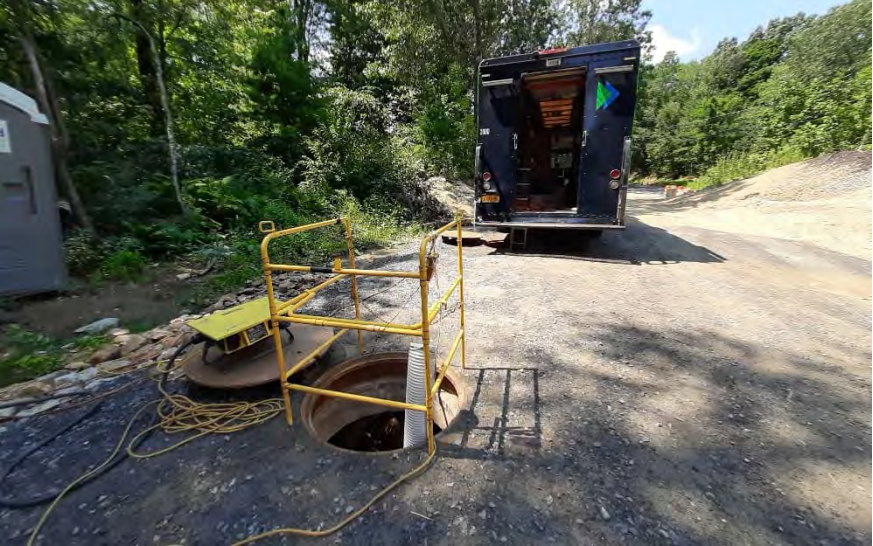
<p>PHOTOGRAPHIC LOG</p>	
<p>Client Name: Eversource</p>		<p>Site Location: Sudbury to Hudson Transmission Reliability Project</p>	<p>Town: Hudson</p>
<p>Photo No.: 3</p>	<p>Date: 8-5-24</p>

<p>Description:</p> <p>Haugland work area within Segment 1, clipping work, manhole #5, looking westward.</p>

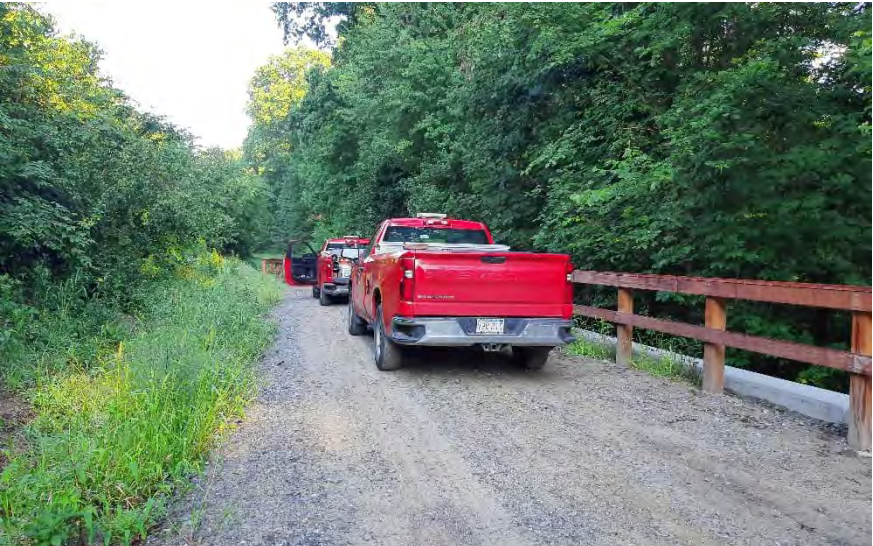
<p>PHOTOGRAPHIC LOG</p>	
<p>Client Name: Eversource</p>		<p>Site Location: Sudbury to Hudson Transmission Reliability Project</p>	<p>Town: Hudson</p>
<p>Photo No.: 4</p>	<p>Date: 8-5-24</p>

<p>Description:</p> <p>ET&L work area within Segment 1, near cattle crossing, looking westward.</p>

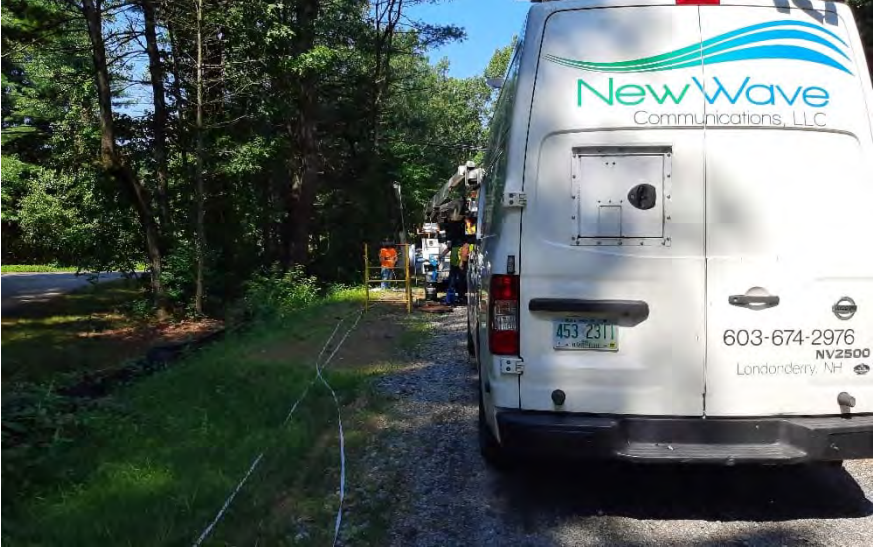
<p align="center">PHOTOGRAPHIC LOG</p>	
<p>Client Name: Eversource</p>		<p>Site Location: Sudbury to Hudson Transmission Reliability Project</p>	<p>Town: Hudson</p>
<p>Photo No.: 5</p>	<p>Date: 8-5-24</p>

<p>Description:</p> <p>New Wave work area within Segment 5, handhole #11, fiber optic cable pulling, looking westward.</p>

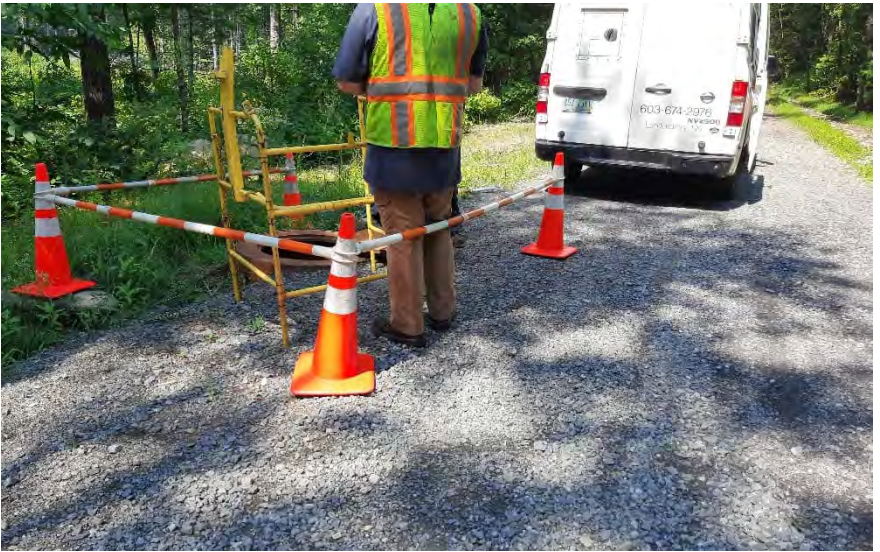
<p align="center">PHOTOGRAPHIC LOG</p>	
<p>Client Name: Eversource</p>		<p>Site Location: Sudbury to Hudson Transmission Reliability Project</p>	<p>Town: Hudson</p>
<p>Photo No.: 6</p>	<p>Date: 8-5-24</p>

<p>Description:</p> <p>New Wave work area within segment 5, handhole #12, monitoring fiber pull towards handhole #11, looking westward.</p>

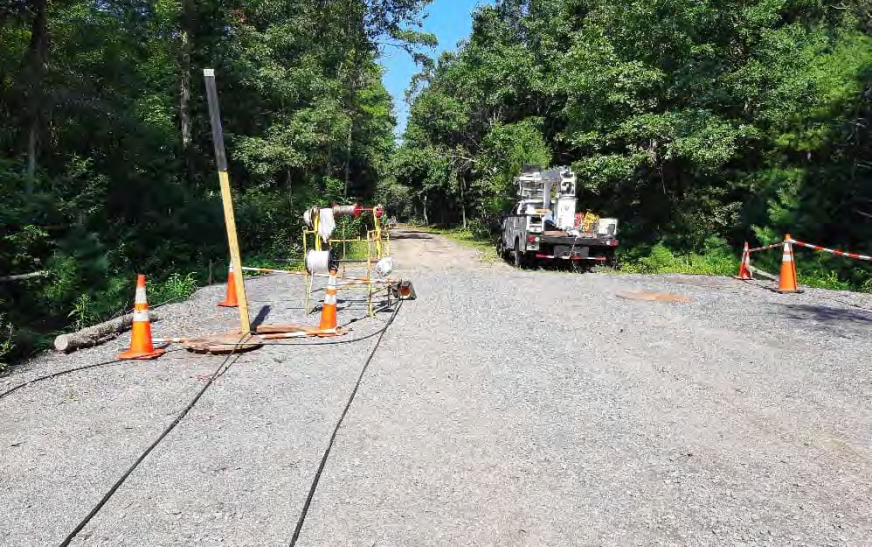
<p align="right">PHOTOGRAPHIC LOG</p>	
Client Name: Eversource		Site Location: Sudbury to Hudson Transmission Reliability Project	Town: Hudson
Photo No.: 7	Date: 8-5-24

Description: New wave work area within Segment 6, handhole #14, feeding cable for fiber optic cable pull, looking westward.

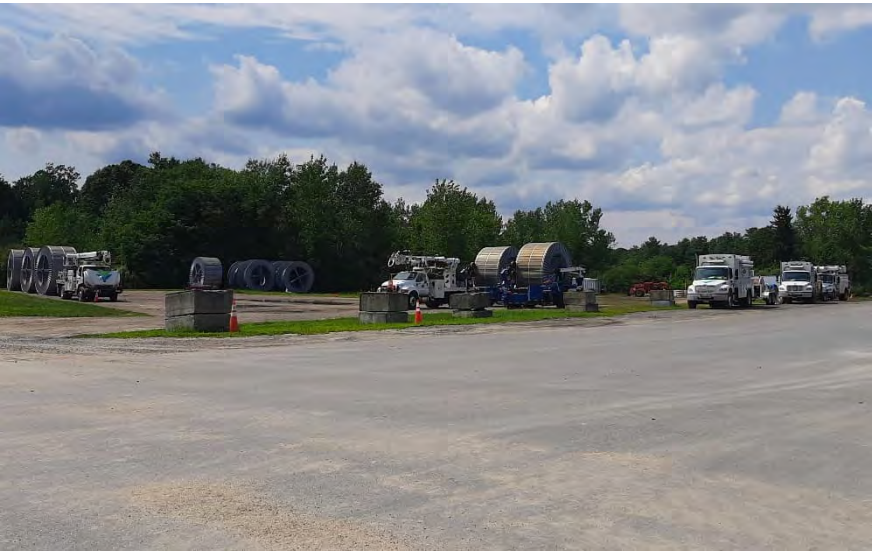
<p align="right">PHOTOGRAPHIC LOG</p>	
Client Name: Eversource		Site Location: Sudbury to Hudson Transmission Reliability Project	Town: Hudson
Photo No.: 8	Date: 8-5-24

Description: Haugland laydown yard, stored wire on reels, loaded Mirks, looking eastward.

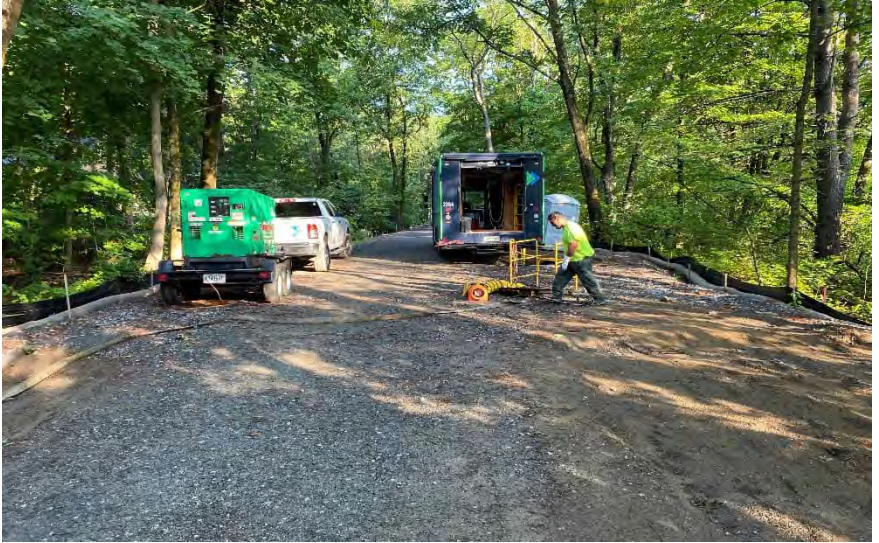
<p align="center">PHOTOGRAPHIC LOG</p>	
<p>Client Name: Eversource</p>		<p>Site Location: Sudbury to Hudson Transmission Reliability Project</p>	<p>Town: Sudbury</p>
<p>Photo No.: 1</p>	<p>Date: 8-5-24</p>

<p>Description:</p> <p>Work area within segment 13, Haugland conducting splicing at manhole #25, existing erosion control, looking westward.</p>

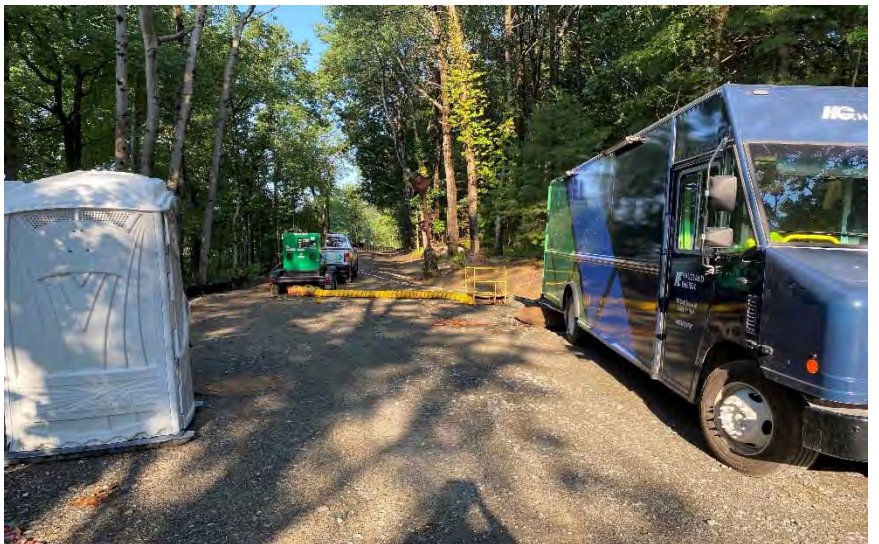
<p align="center">PHOTOGRAPHIC LOG</p>	
<p>Client Name: Eversource</p>		<p>Site Location: Sudbury to Hudson Transmission Reliability Project</p>	<p>Town: Sudbury</p>
<p>Photo No.: 2</p>	<p>Date: 8-5-24</p>

<p>Description:</p> <p>Work area within segment 14, Haugland conducting splicing at manhole #26, existing erosion control, looking westward.</p>

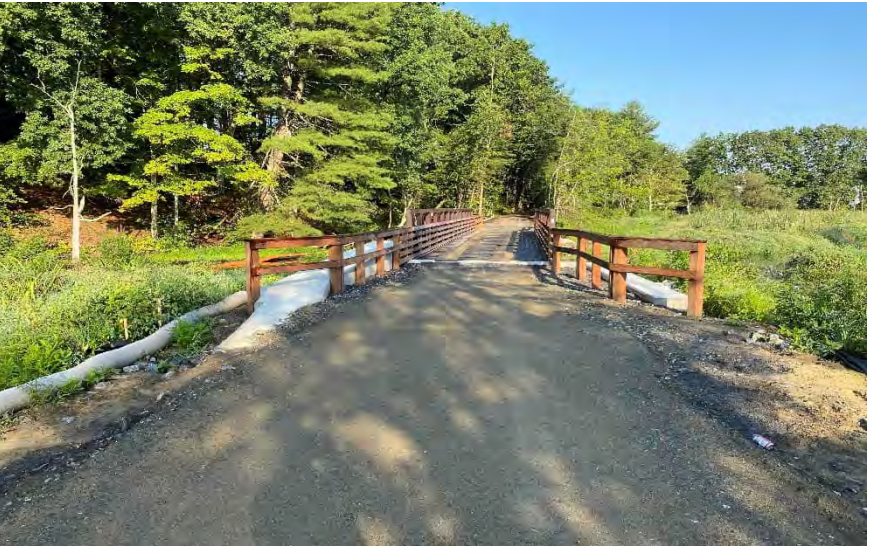
<p align="center">PHOTOGRAPHIC LOG</p>	
<p>Client Name: Eversource</p>		<p>Site Location: Sudbury to Hudson Transmission Reliability Project</p>	<p>Town: Sudbury</p>
<p>Photo No.: 4</p>	<p>Date: 8-5-24</p>

<p>Description:</p> <p>Bridge 127 looking from segment 14 toward segment 13, existing erosion control, looking westward.</p>

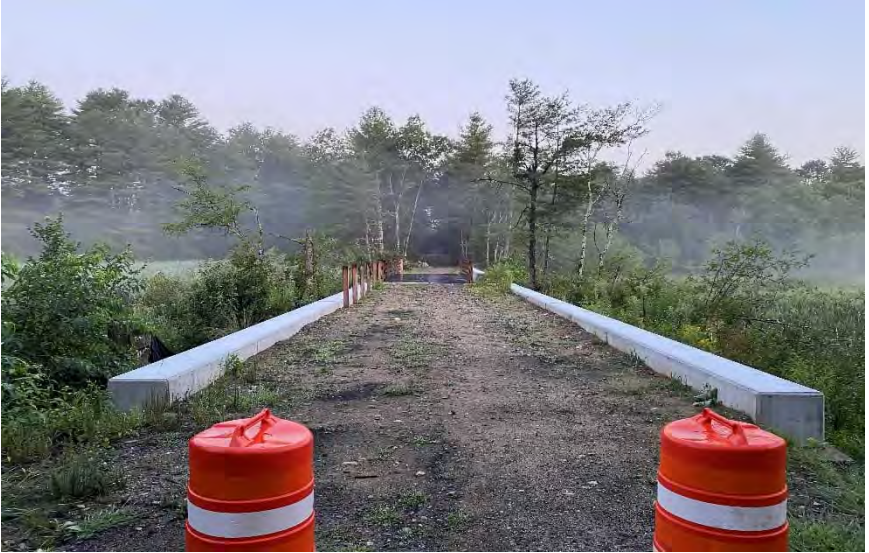
<p>PHOTOGRAPHIC LOG</p>	
<p>Client Name: Eversource</p>		<p>Site Location: Sudbury to Hudson Transmission Reliability Project</p>	<p>Town: Sudbury</p>
<p>Photo No.: 5</p>	<p>Date: 8-5-24</p>

<p>Description:</p> <p>Bridge 128 looking from segment 8 toward segment 7, existing erosion control, looking westward.</p>

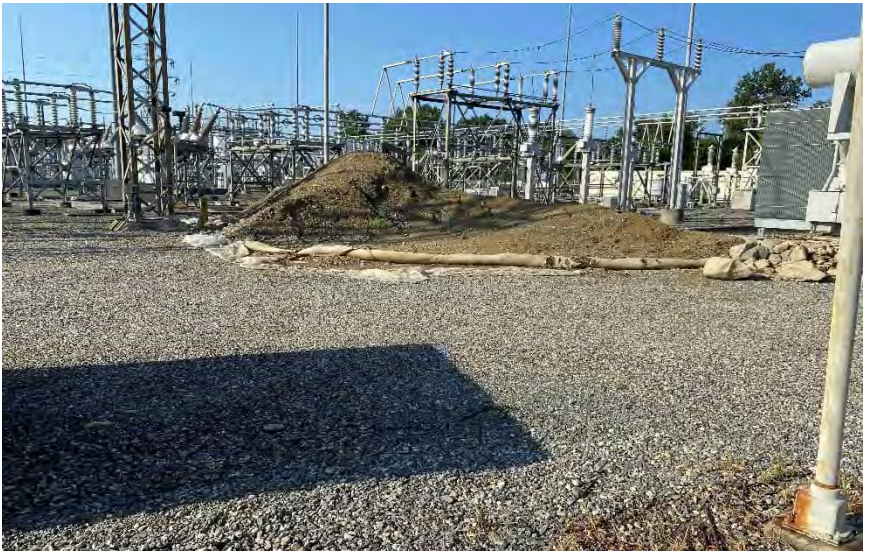
<p>PHOTOGRAPHIC LOG</p>	
<p>Client Name: Eversource</p>		<p>Site Location: Sudbury to Hudson Transmission Reliability Project</p>	<p>Town: Sudbury</p>
<p>Photo No.: 6</p>	<p>Date: 8-5-24</p>

<p>Description:</p> <p>Work area within substation, newly placed spoil pile, existing erosion control (compost tubing), looking southward.</p>

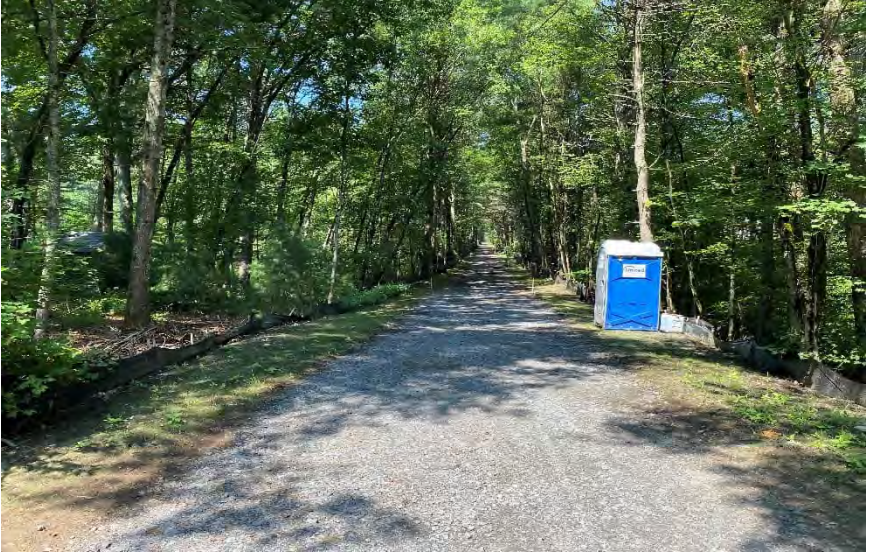
PHOTOGRAPHIC LOG	
Client Name: Eversource		Site Location: Sudbury to Hudson Transmission Reliability Project	Town: Sudbury
Photo No.: 7	Date: 8-5-24

Description: Work area within segment 9, recently placed loam/hydroseeding, existing erosion control, looking westward.

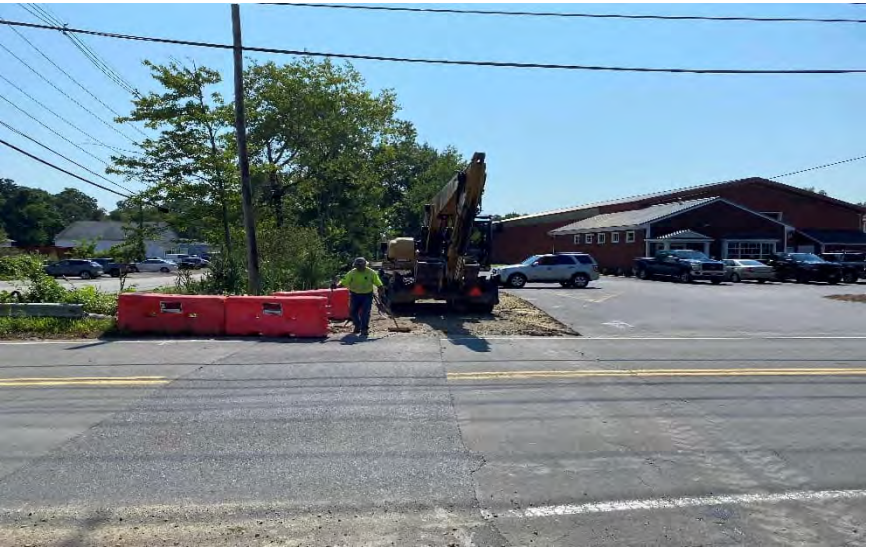
PHOTOGRAPHIC LOG	
Client Name: Eversource		Site Location: Sudbury to Hudson Transmission Reliability Project	Town: Sudbury
Photo No.: 8	Date: 8-5-24

Description: Work area within segment 12, Bond conducting cleanup work, existing erosion control, looking eastward.

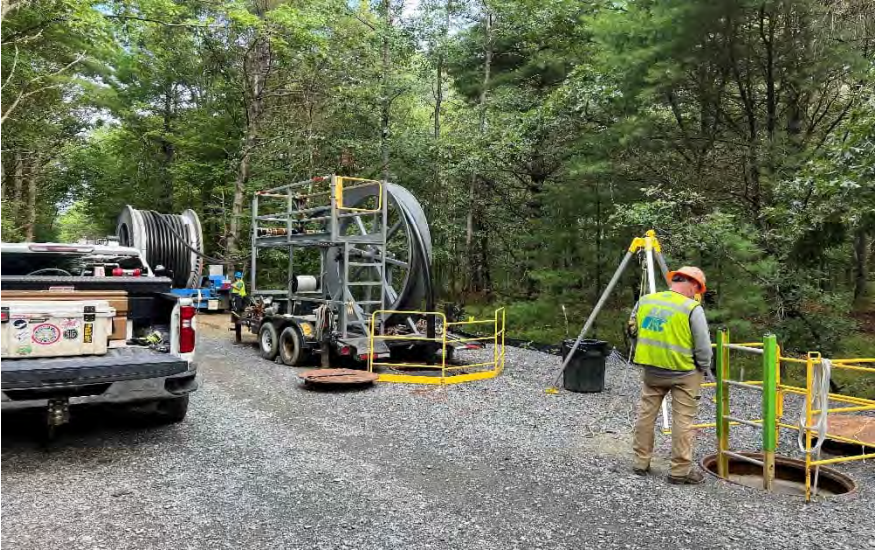
PHOTOGRAPHIC LOG	
Client Name: Eversource		Site Location: Sudbury to Hudson Transmission Reliability Project	Town: Sudbury
Photo No.: 1	Date: 8-8-24

Description: Work area within segment 7, Haugland conducting wire pulling at manhole #15, existing erosion control, looking westward.

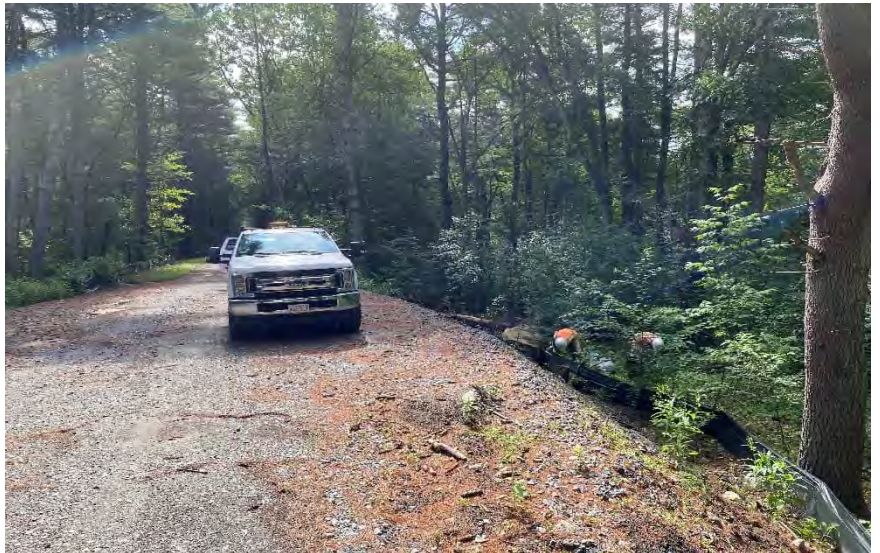
PHOTOGRAPHIC LOG	
Client Name: Eversource		Site Location: Sudbury to Hudson Transmission Reliability Project	Town: Sudbury
Photo No.: 2	Date: 8-8-24

Description: Work area within segment 10, SWCA conducting invasive plant removal, existing erosion control, looking eastward.

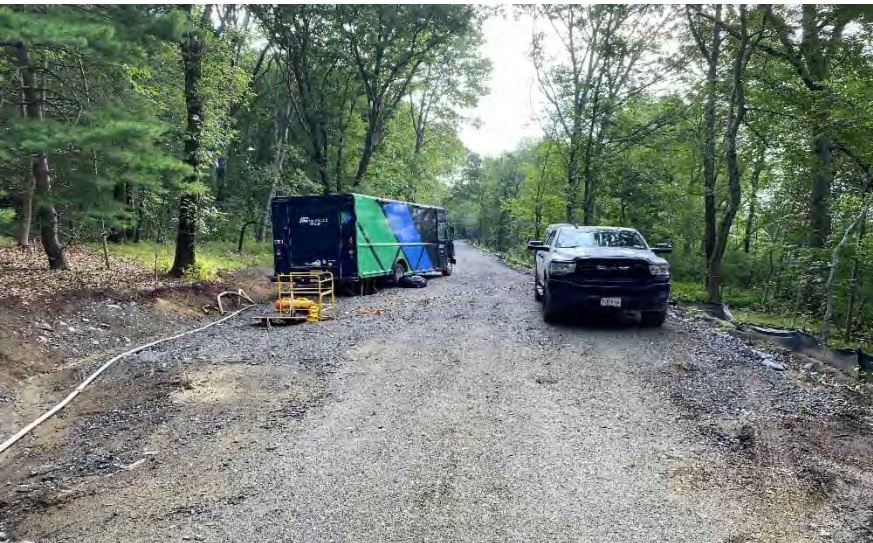
Description: Work area within segment 14, Haugland conducting splicing work at manhole #26, existing erosion control, looking eastward

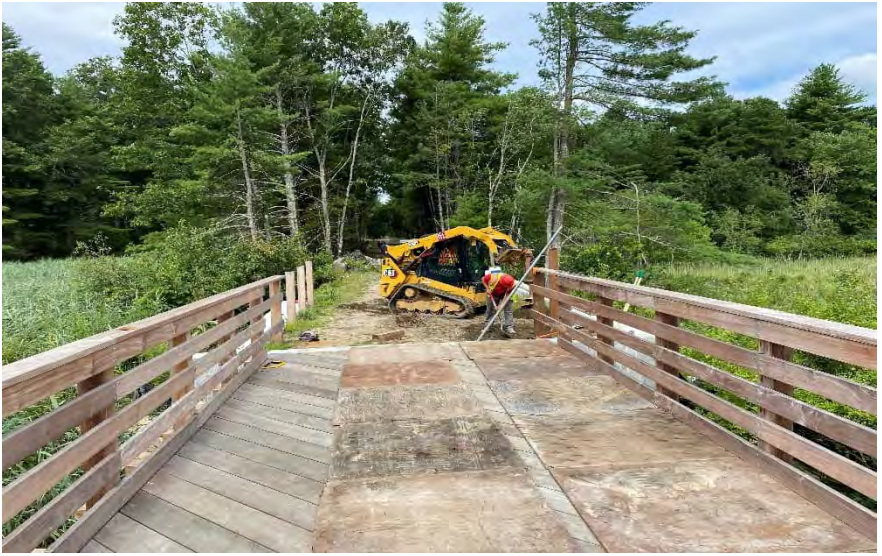
<p>Description:</p> <p>ET&L performing Bridge 128 work within segment 7, existing erosion control, looking westward.</p>

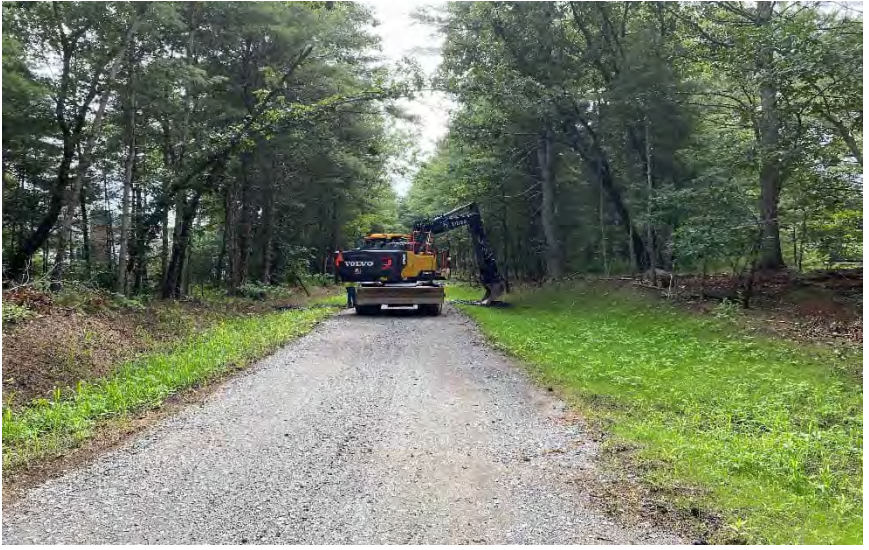
<p>Description:</p> <p>ET&L performing work within segment 9 (adding check dams), existing erosion control, looking eastward.</p>

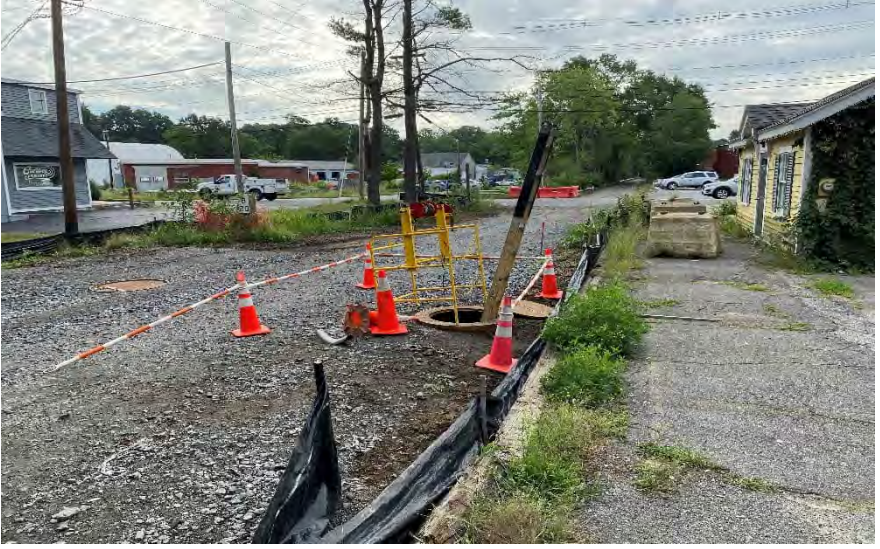
<p>Description:</p> <p>Work area within segment 11, New Wave conducting fiber optics work at handhole #24, existing erosion control, looking eastward.</p>

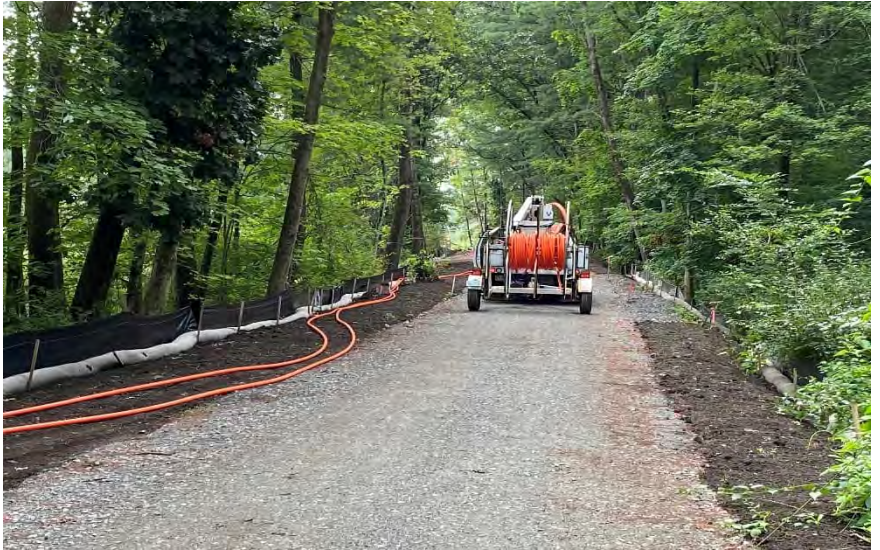
<p>Description:</p> <p>Work area within segment 13, New Wave conducting fiber optics work at handhole #25, existing erosion control, looking eastward</p>

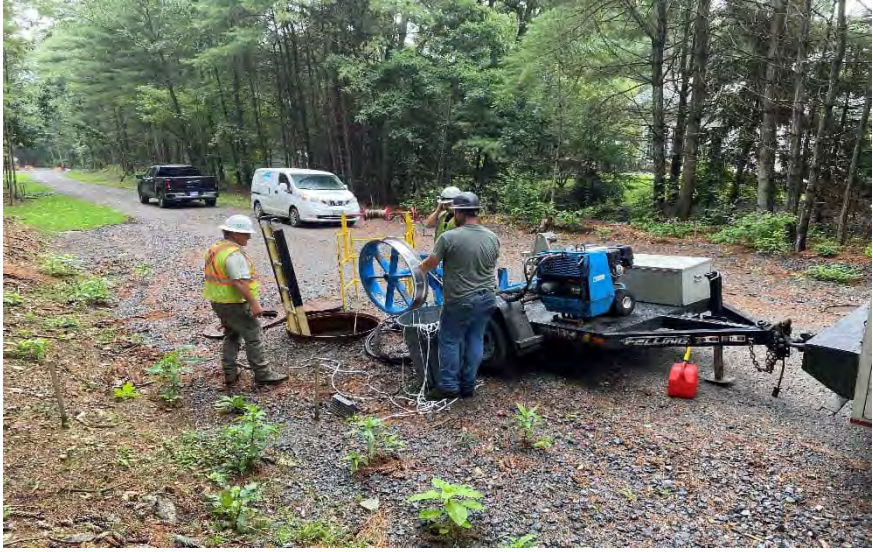
Description: Work area within segment 9, New Wave conducting fiber optic work at manhole #18, existing erosion control, looking westward.

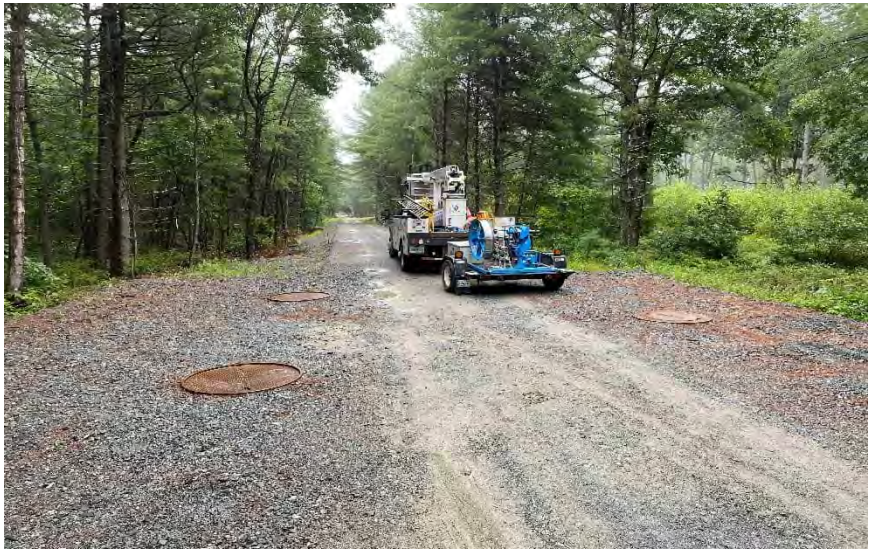
Description: Work area within segment 7, New Wave conducting fiber optic work at manhole #16, existing erosion control, looking westward.

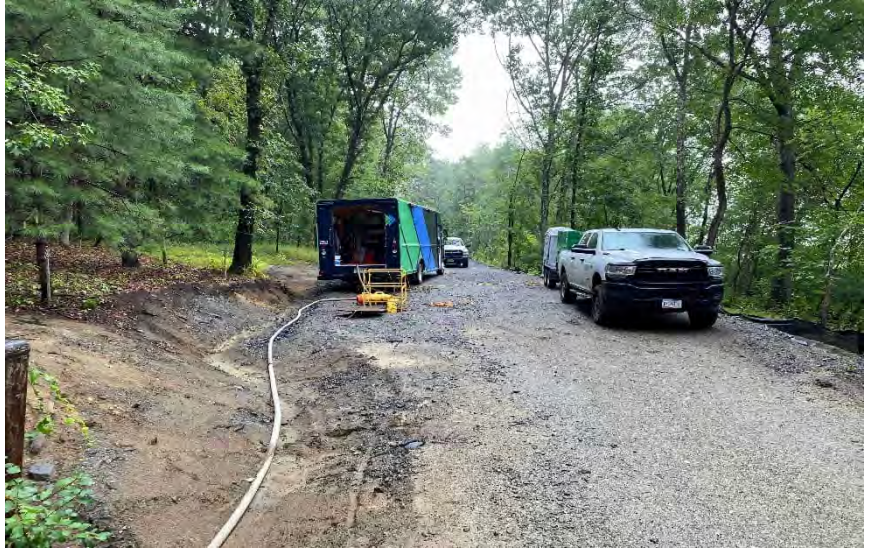
<p>Description:</p> <p>Work area within segment 14, Haugland conducting splicing work at manhole #26, existing erosion control, looking eastward</p>

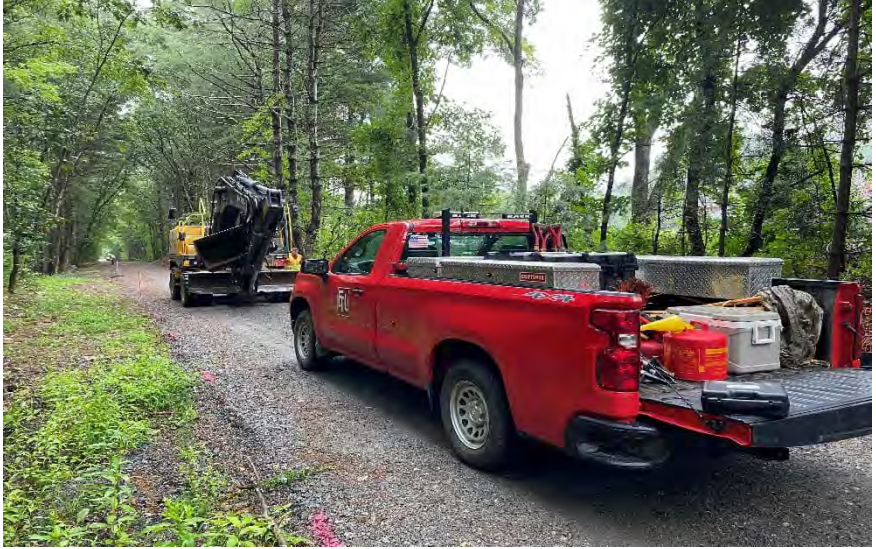
<p>Description:</p> <p>ET&L performing site work within segment 8, existing erosion control, looking westward.</p>

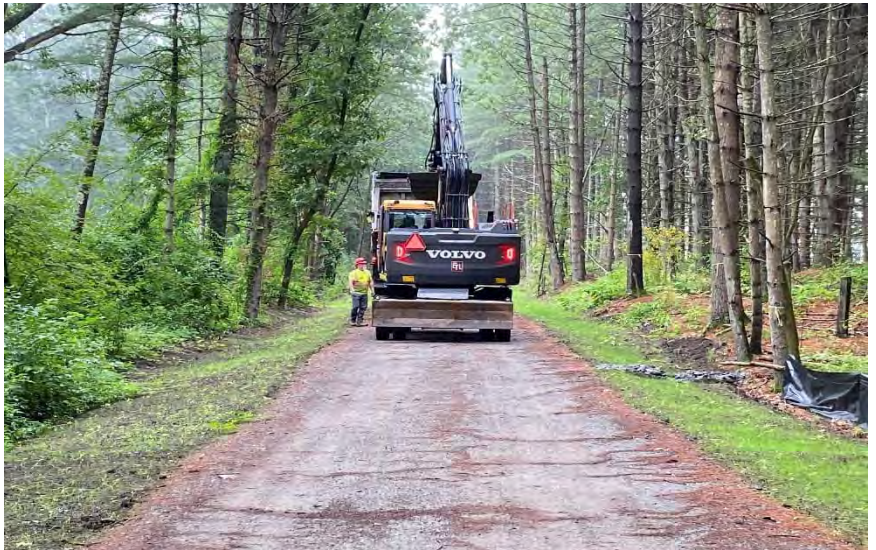
<p>Description:</p> <p>ET&L performing work within segment 11 (adding check dams), existing erosion control, looking westward.</p>

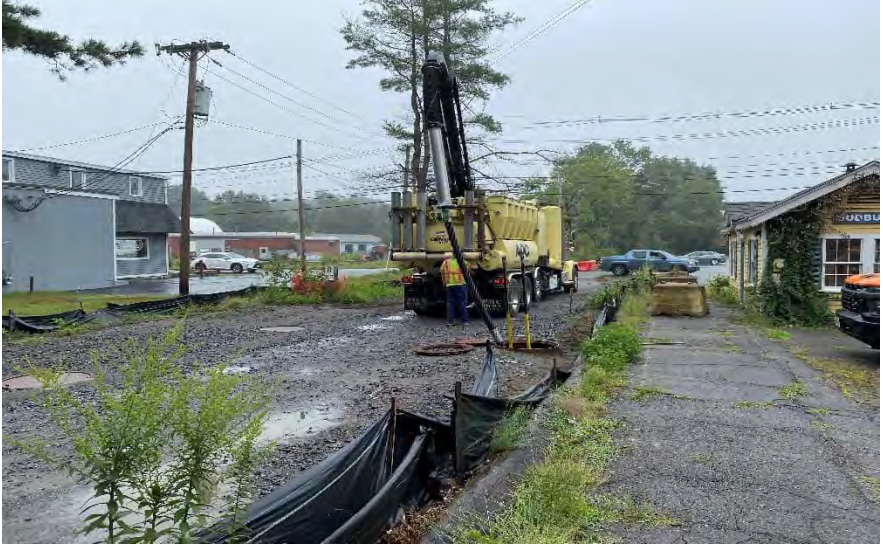
<p>Description:</p> <p>Work area within segment 11, Bond conducting handhole correction work at handhole #24, existing erosion control, looking eastward.</p>

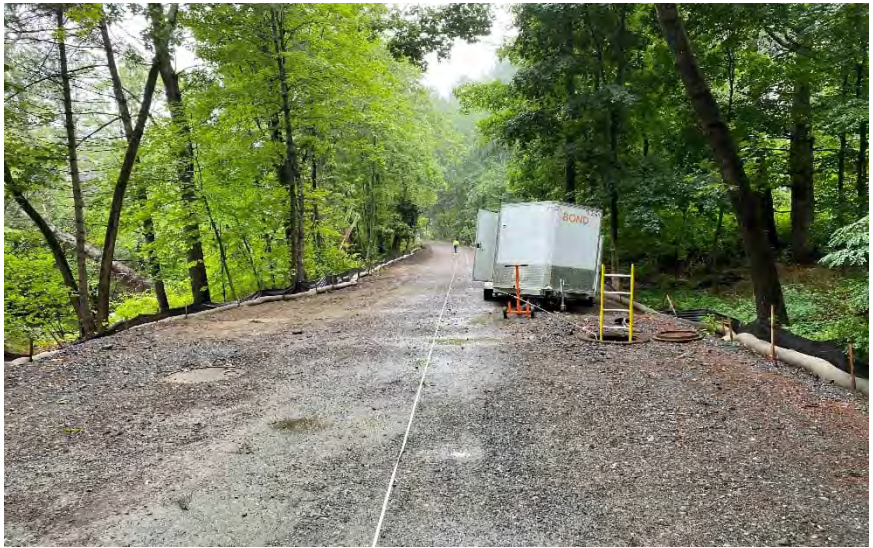
<p>Description:</p> <p>Work area within segment 13, Bond conducting handhole correction work at handhole #25, existing erosion control, looking eastward</p>

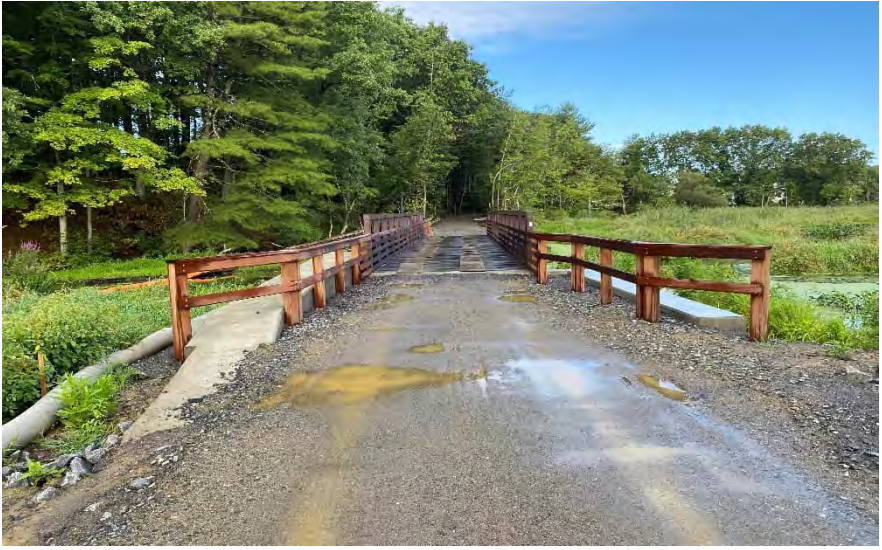
<p>Description:</p> <p>Bridge 127 from segment 14, existing erosion control, looking westward.</p>

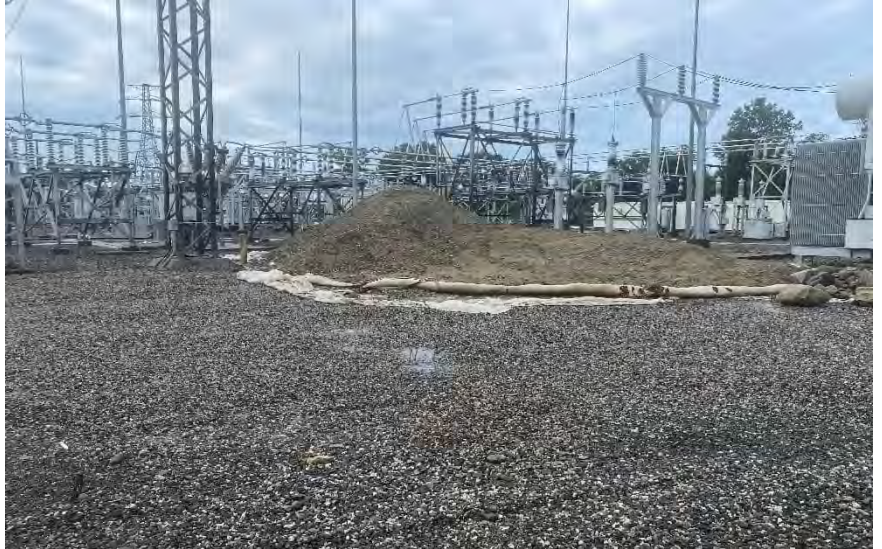
<p>Description:</p> <p>Spoil pile within Sudbury substation surrounded by compost filter tubes, looking southward.</p>

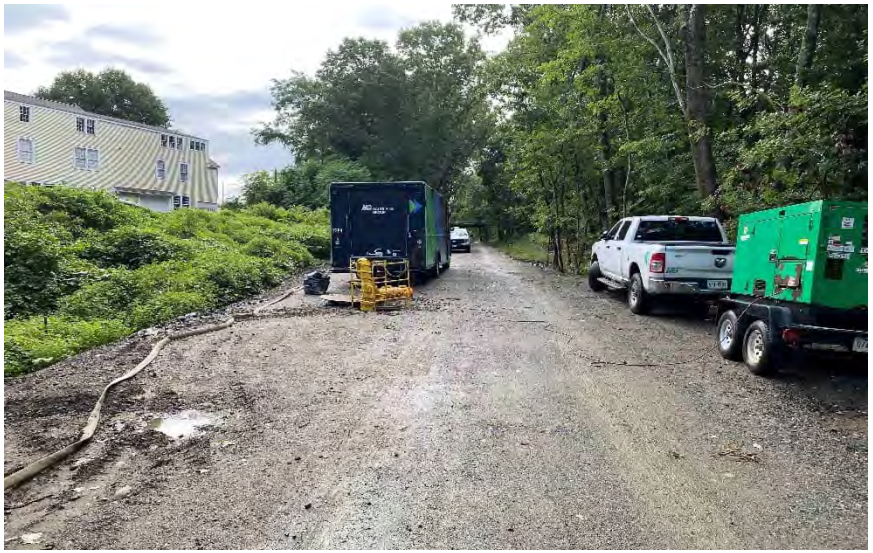
<p>Description:</p> <p>Haugland conducting splicing work at manhole #27 (Segment 14), existing erosion control, looking eastward.</p>

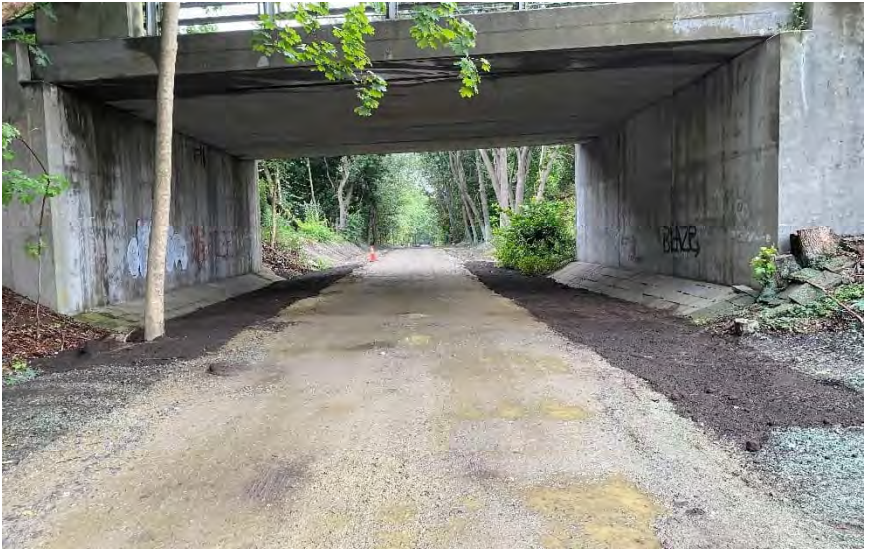
Description: Work area within segment 14, recent loaming under Landham overpass, existing erosion control, looking westward.

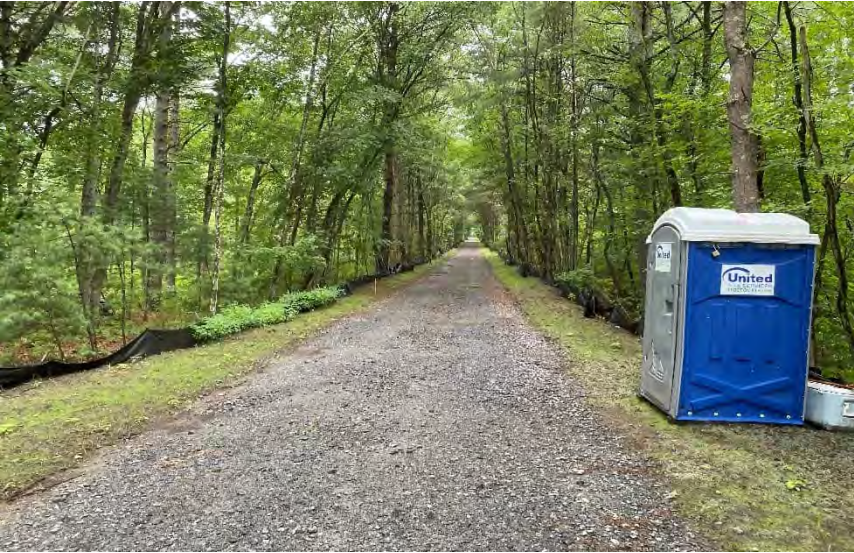
Description: Work area within segment 9 recent loaming/hydroseeding, existing erosion control, looking westward.

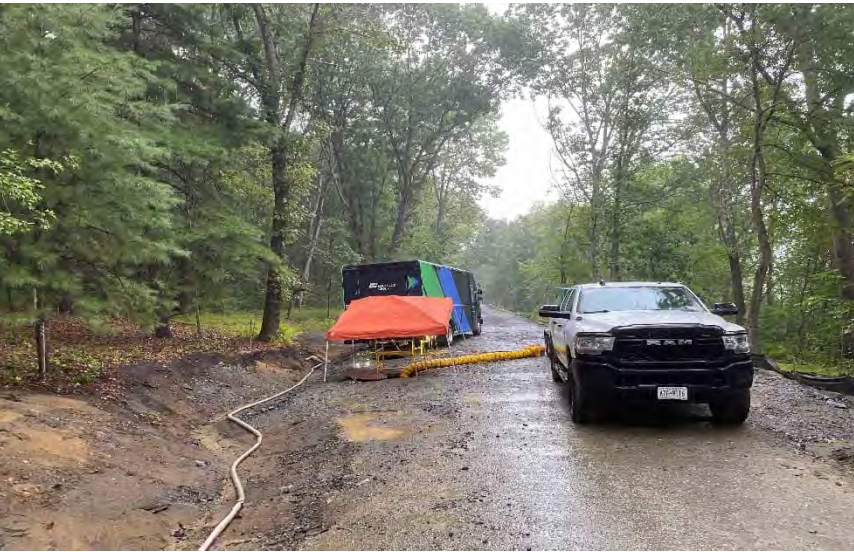
Description: Work area within segment 14 (handhole #26), splicing work, existing erosion control, looking eastward.

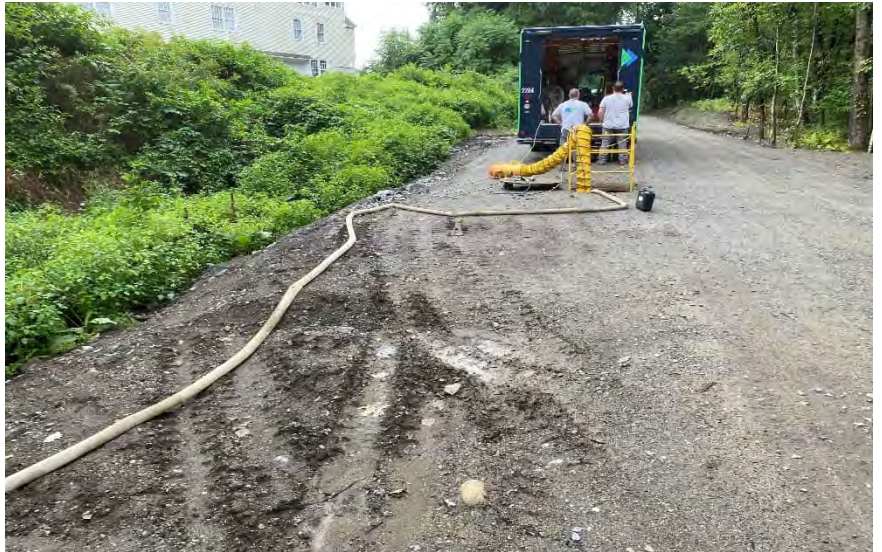
Description: Work area within segment 14 (handhole #27), splicing work, existing erosion control, looking eastward.

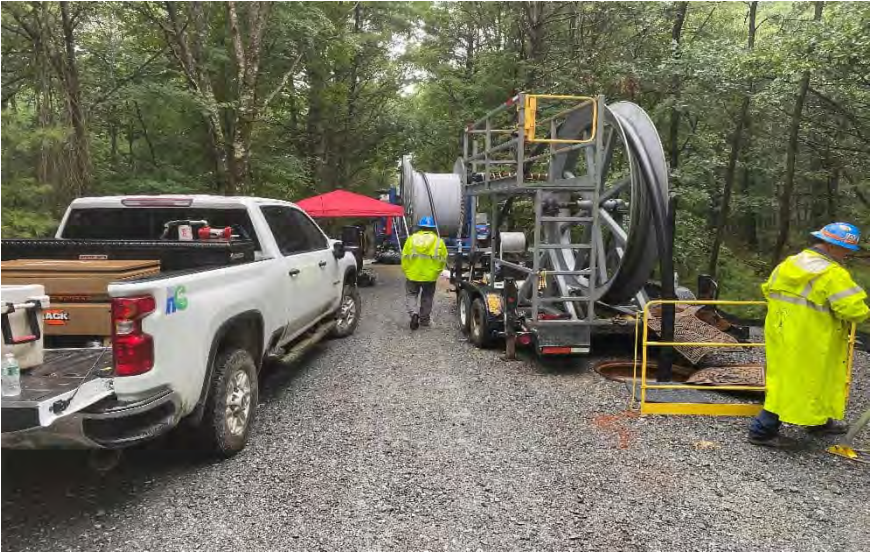
Description: Work area within segment 7, manhole #15 area, wire pulling activity, existing erosion control, looking westward.

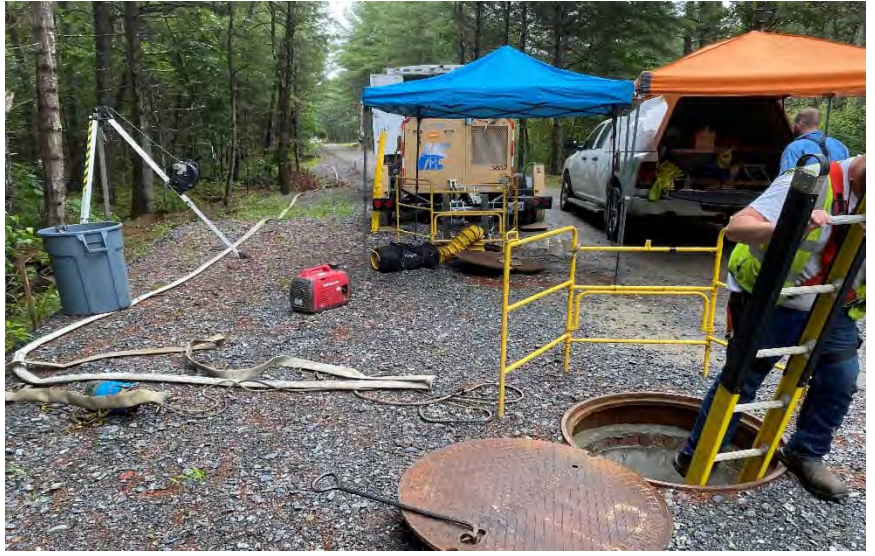
Description: Work area within segment 7, manhole #16 area, wire pulling activity, existing erosion control, looking westward.

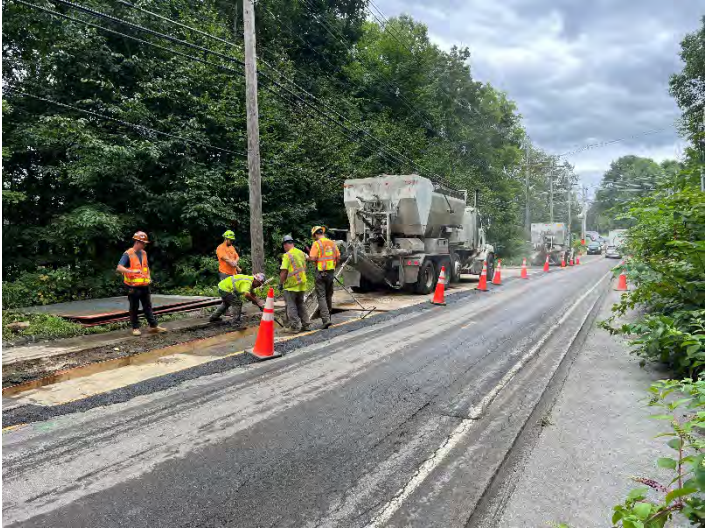
Description: View of Bond work area in Forest Ave by MH #1. Facing northeast.

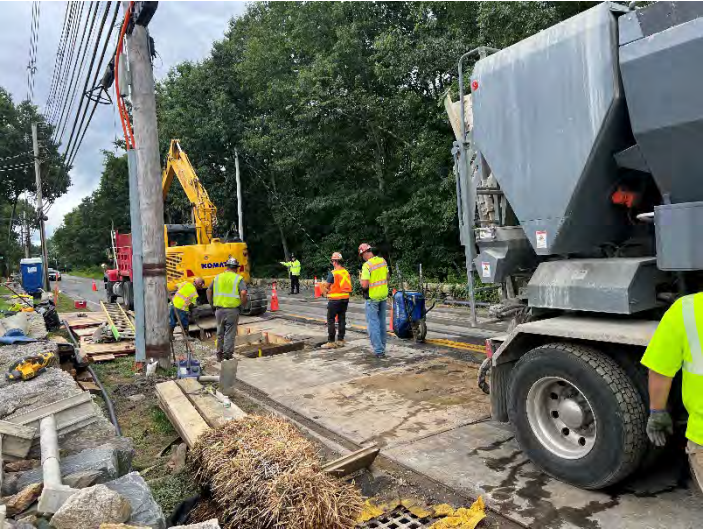
Description: View of Bond work area in Forest Ave by MH #2. See additional attached dewatering report. Facing east.

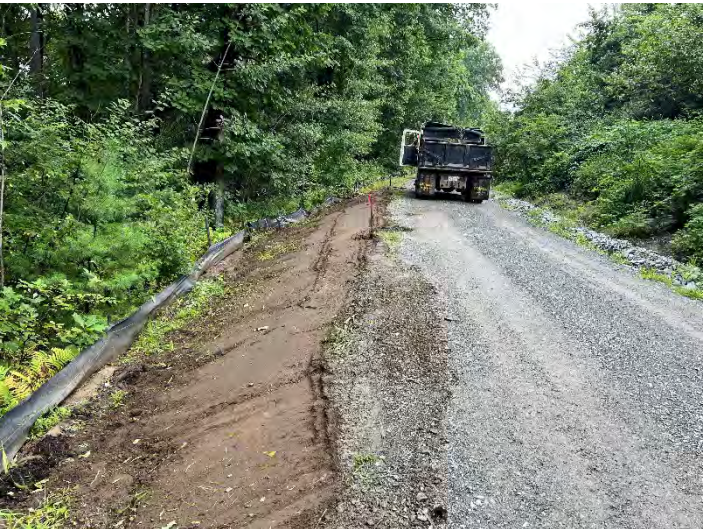
Description: View of ET&L within segment 1 preparing for erosion control repairs. Facing east.

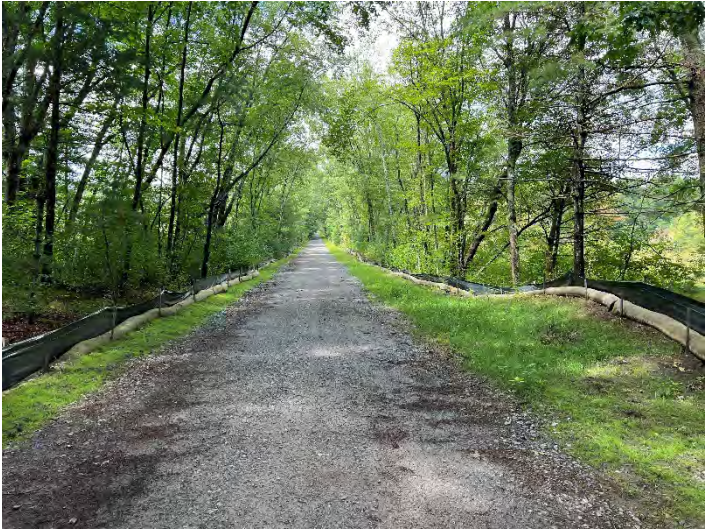
Description: View of E&S controls in segment 5. Facing west.

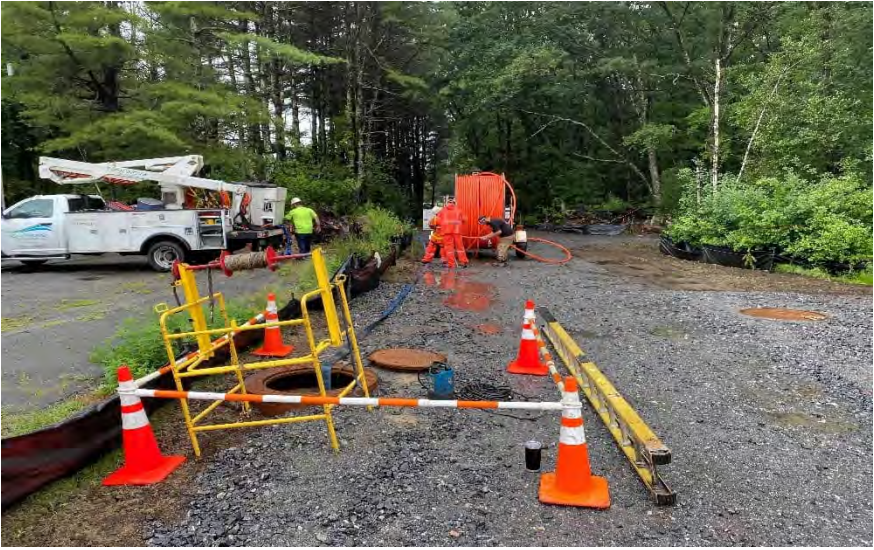
Description: Work area within segment 11, Fiber optic work at handhole #24, existing erosion control, looking westward.
