Weekly Environmental Compliance Summary

Sudbury to Hudson Transmission Reliability Project (USEPA Tracking # MAR1003UW)

Sudbury, Hudson, and Stow, MA

Week of: August 5, 2024 to August 10, 2024

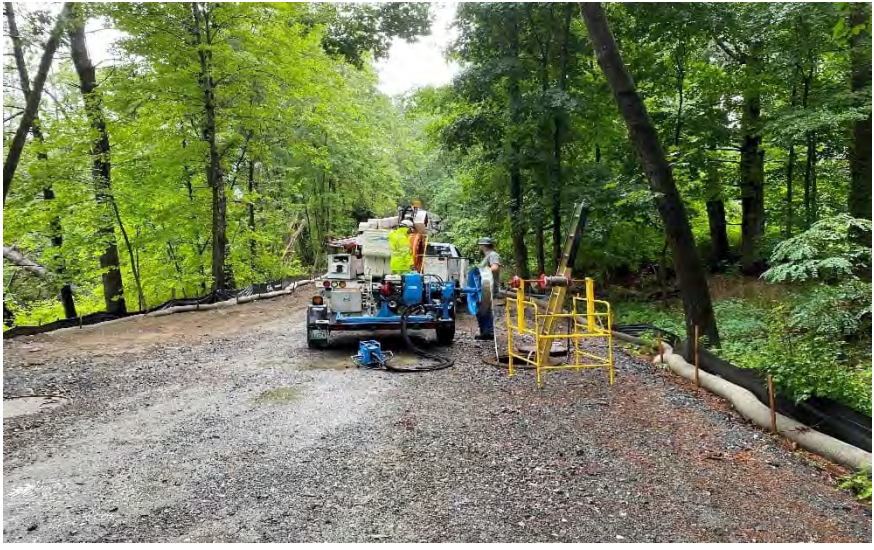
Description: Work area within segment 13, Fiber optic work at handhole #25, existing erosion control, looking eastward.

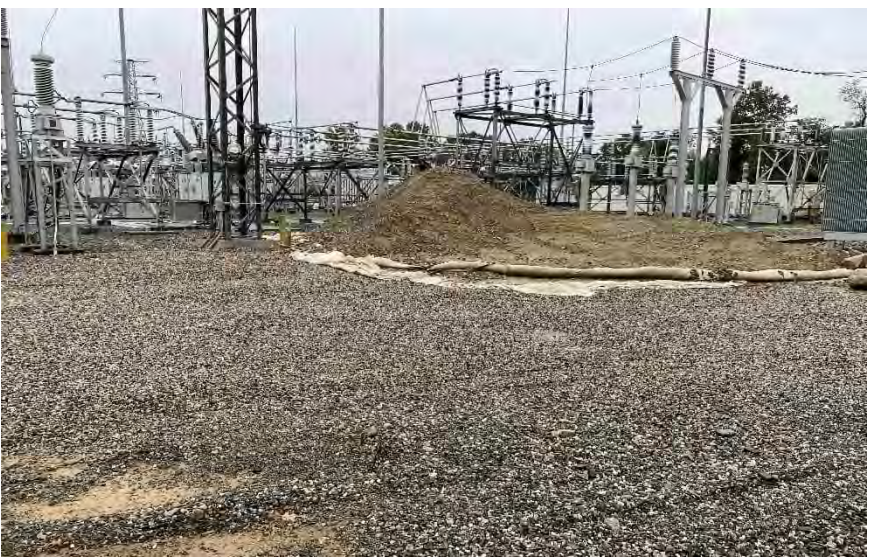
Description: Work area within substation, spoil pile with compost tubes surrounding pile, looking southward.

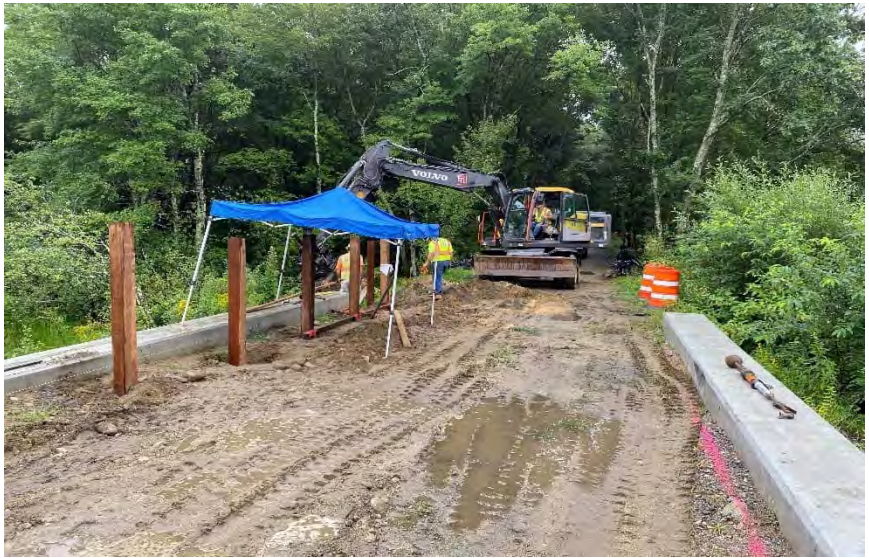
Description: Work area within segment 8 (bridge 128), post/rail work, existing erosion control, looking eastward.

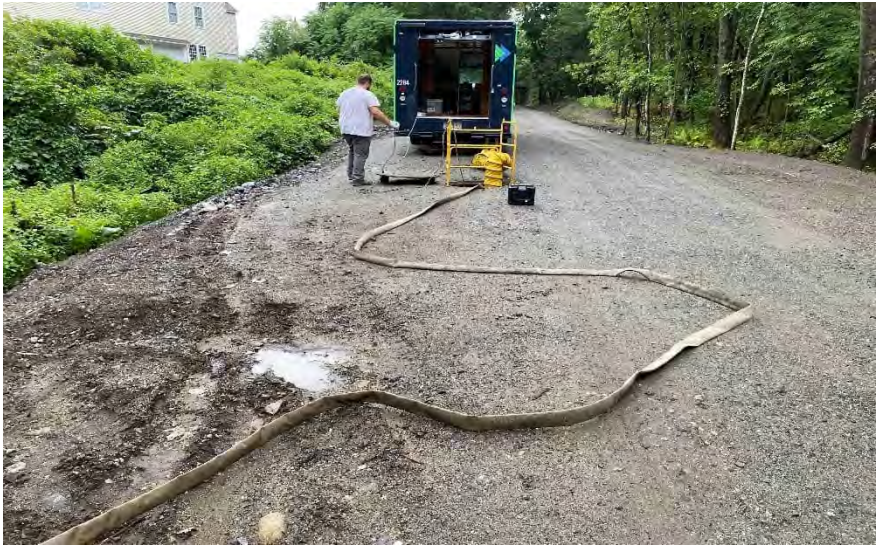
Description: Work area within segment 14 (manhole #27), splicing work, existing erosion control, looking eastward.

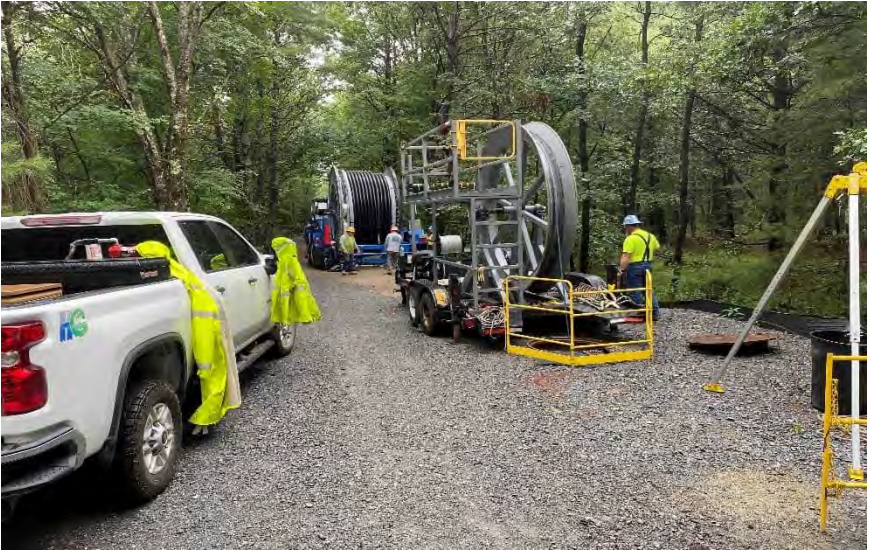
Description: Work area within segment 7, manhole #15 area, wire pulling activity, existing erosion control, looking westward.

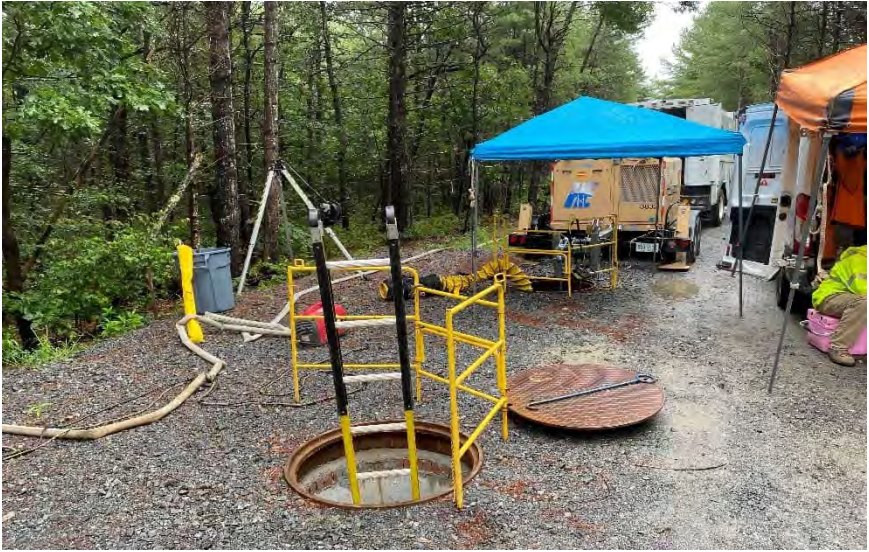
Description: Work area within segment 7, manhole #16 area, wire pulling activity, existing erosion control, looking westward.
