Weekly Environmental Compliance Summary

Sudbury to Hudson Transmission Reliability Project (USEPA Tracking # MAR1003UW)

Sudbury, Hudson, and Stow, MA

Week of: August 12, 2024 to August 17, 2024

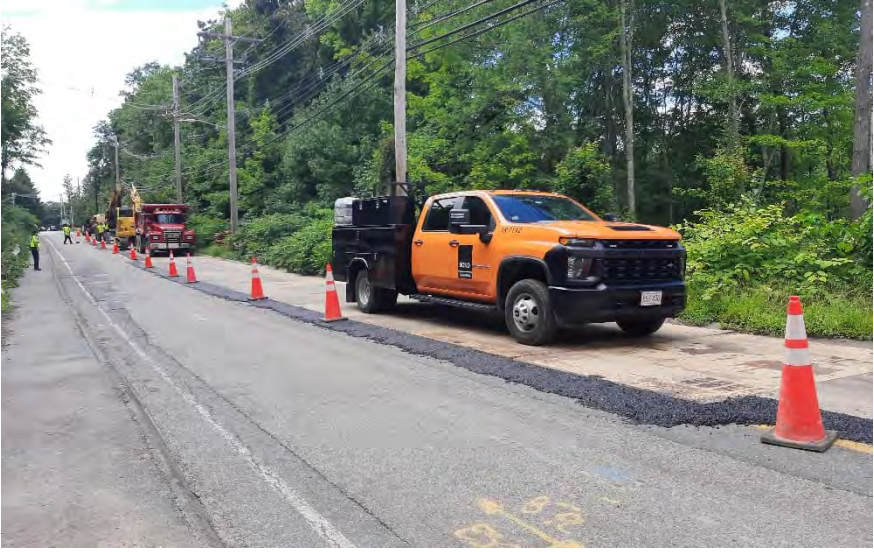
<p>PHOTOGRAPHIC LOG</p>	
<p>Client Name: Eversource</p>		<p>Site Location: Sudbury to Hudson Transmission Reliability Project</p>	<p>Town: Hudson</p>
<p>Photo No.: 1</p>	<p>Date: 8-12-24</p>

<p>Description:</p> <p>Bond conducting conduit work along Forest Ave near manhole #1, near Hudson Light & Power, looking westward.</p>

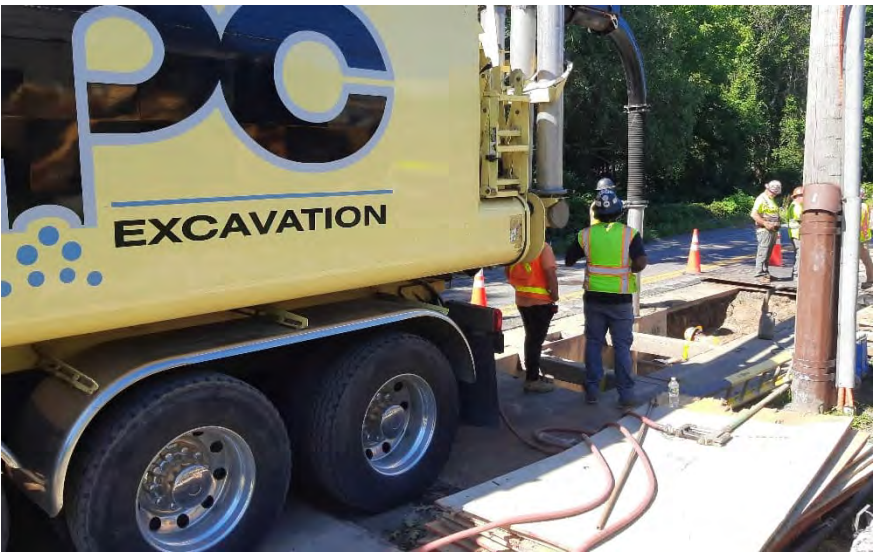
<p>PHOTOGRAPHIC LOG</p>	
<p>Client Name: Eversource</p>		<p>Site Location: Sudbury to Hudson Transmission Reliability Project</p>	<p>Town: Hudson</p>
<p>Photo No.: 2</p>	<p>Date: 8-12-24</p>

<p>Description:</p> <p>Bond conducting conduit work along Forest Ave near manhole #2, near Bonazzoli Avenue intersection with Forest Ave, looking westward.</p>

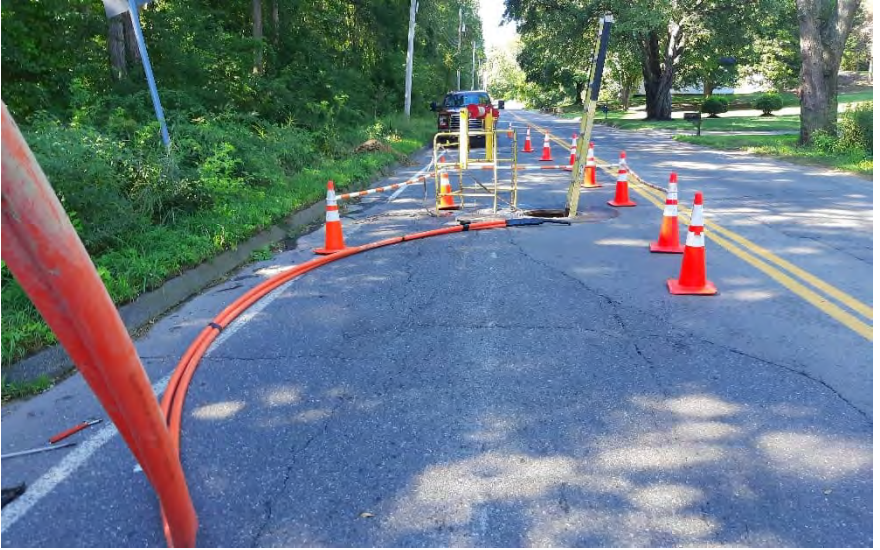
<p align="center">PHOTOGRAPHIC LOG</p>	
<p>Client Name: Eversource</p>		<p>Site Location: Sudbury to Hudson Transmission Reliability Project</p>	<p>Town: Hudson</p>
<p>Photo No.: 4</p>	<p>Date: 8-12-24</p>

<p>Description:</p> <p>New Wave work area at handhole #4, near 156 Forest Ave, pulling inner duct to handhole #3, looking westward.</p>

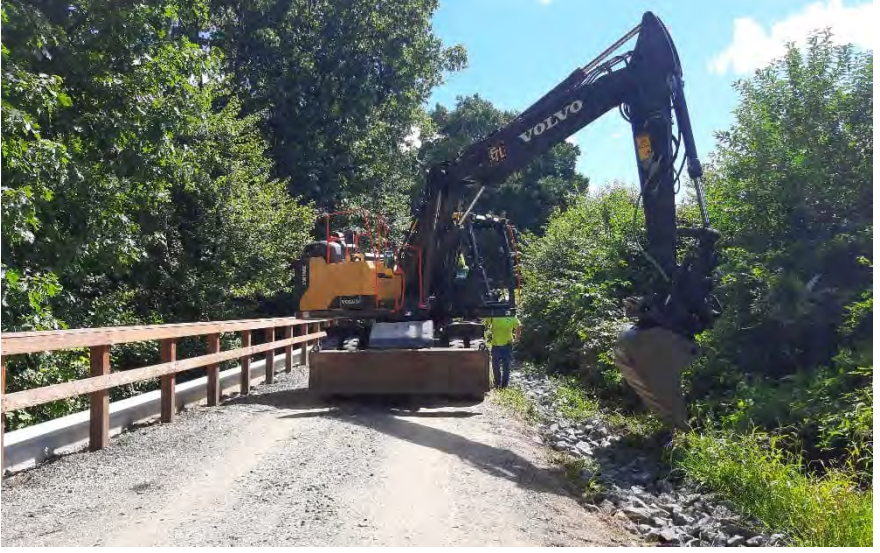
<p>PHOTOGRAPHIC LOG</p>	
<p>Client Name: Eversource</p>		<p>Site Location: Sudbury to Hudson Transmission Reliability Project</p>	<p>Town: Hudson</p>
<p>Photo No.: 5</p>	<p>Date: 8-12-24</p>

<p>Description:</p> <p>ET&L work area within Segment 1, weeding and loaming, looking eastward.</p>

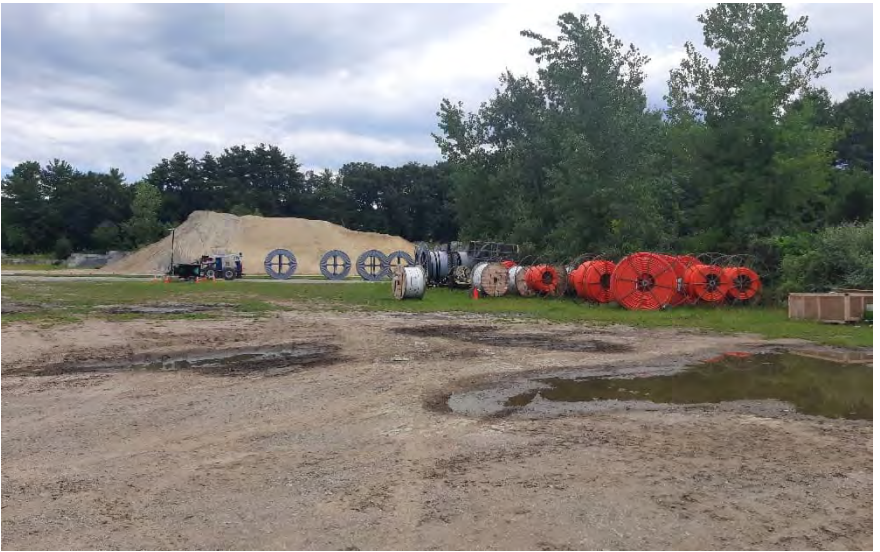
<p>PHOTOGRAPHIC LOG</p>	
<p>Client Name: Eversource</p>		<p>Site Location: Sudbury to Hudson Transmission Reliability Project</p>	<p>Town: Hudson</p>
<p>Photo No.: 6</p>	<p>Date: 8-12-24</p>

<p>Description:</p> <p>Haugland laydown yard, stored wire reels and inner duct reels, looking westward.</p>

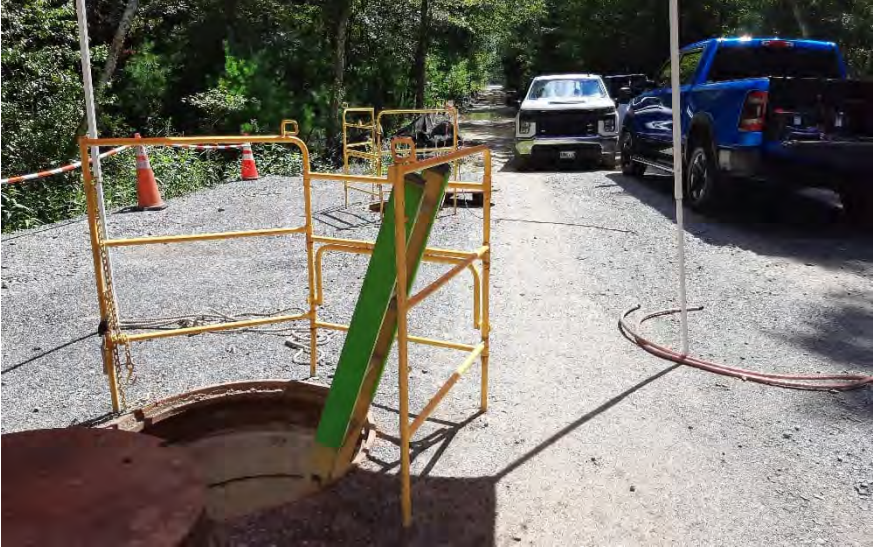
<p>PHOTOGRAPHIC LOG</p>	
<p>Client Name: Eversource</p>		<p>Site Location: Sudbury to Hudson Transmission Reliability Project</p>	<p>Town: Hudson</p>
<p>Photo No.: 7</p>	<p>Date: 8-12-24</p>

<p>Description:</p> <p>Haugland within Segment 6, handhole #14, installing halos, looking eastward.</p>

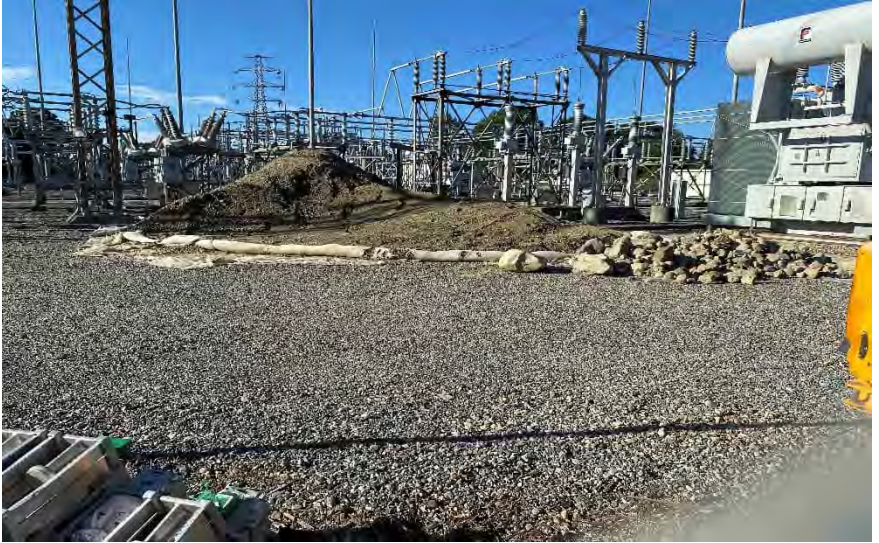
PHOTOGRAPHIC LOG	
Client Name: Eversource		Site Location: Sudbury to Hudson Transmission Reliability Project	Town: Sudbury
Photo No.: 1	Date: 8-12-24

Description: Spoil pile within Sudbury substation surrounded by compost filter tubes, looking southward.

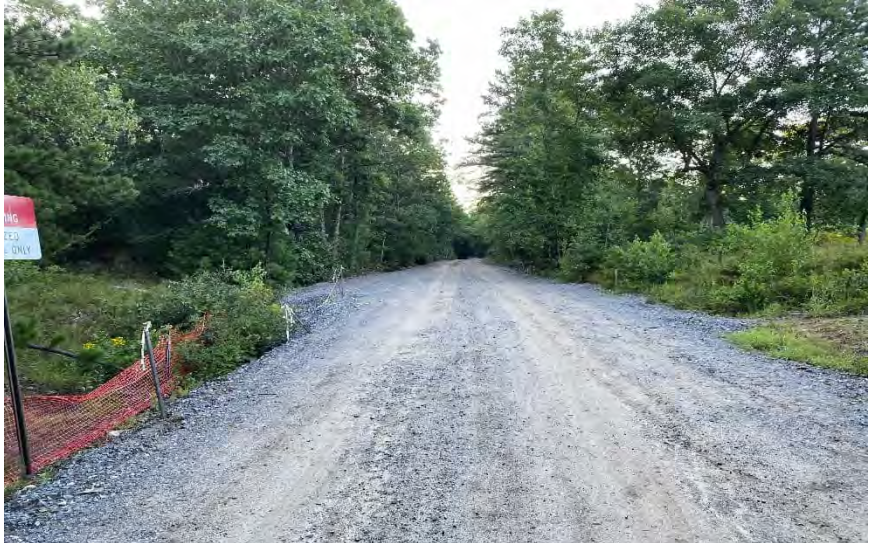
PHOTOGRAPHIC LOG	
Client Name: Eversource		Site Location: Sudbury to Hudson Transmission Reliability Project	Town: Sudbury
Photo No.: 2	Date: 8-12-24

Description: Work area within segment 7, town line area Hudson-Sudbury, existing erosion control, looking eastward.

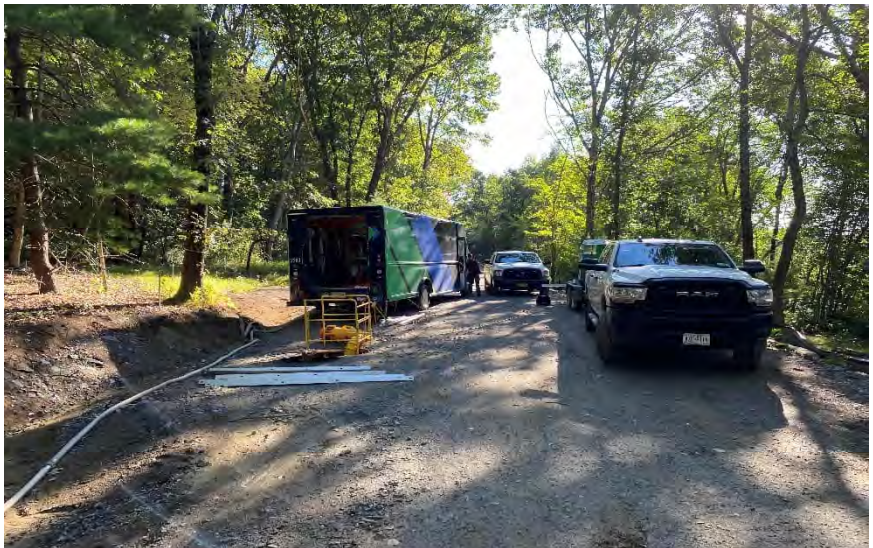
<p>PHOTOGRAPHIC LOG</p>	
<p>Client Name: Eversource</p>		<p>Site Location: Sudbury to Hudson Transmission Reliability Project</p>	<p>Town: Sudbury</p>
<p>Photo No.: 4</p>	<p>Date: 8-12-24</p>

<p>Description: Work area within segment 14, Haugland conducting splicing work at manhole #26, existing erosion control, looking eastward</p>

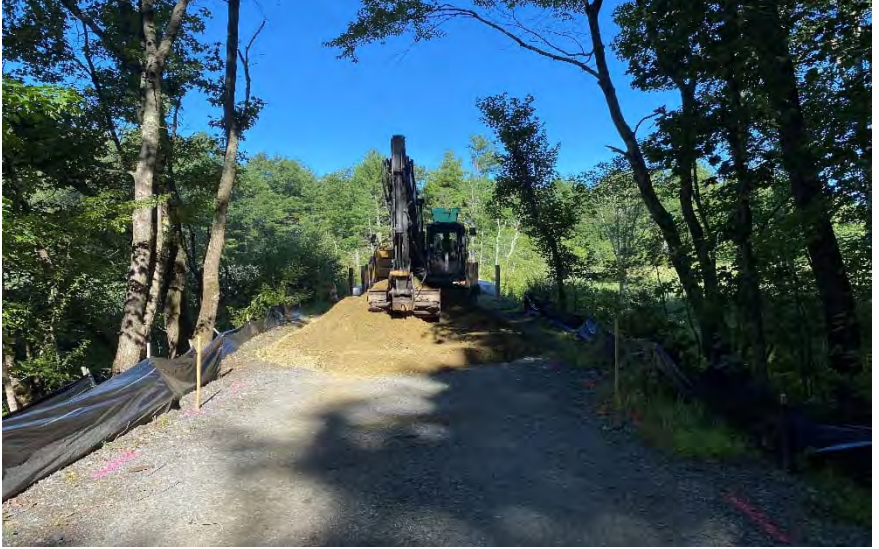
<p>PHOTOGRAPHIC LOG</p>	
<p>Client Name: Eversource</p>		<p>Site Location: Sudbury to Hudson Transmission Reliability Project</p>	<p>Town: Sudbury</p>
<p>Photo No.: 5</p>	<p>Date: 8-12-24</p>

<p>Description:</p> <p>ET&L performing site work within segment 8, Bridge 128 work, existing erosion control, looking westward.</p>

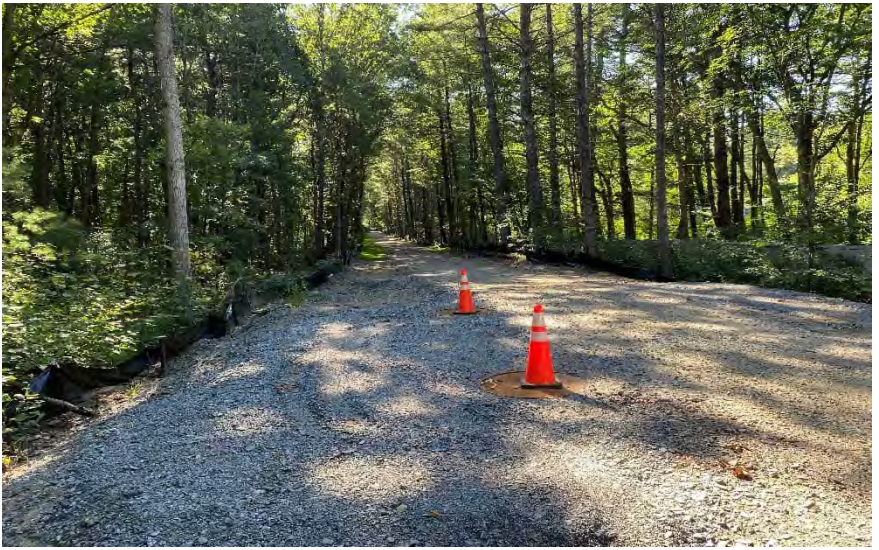
<p>PHOTOGRAPHIC LOG</p>	
<p>Client Name: Eversource</p>		<p>Site Location: Sudbury to Hudson Transmission Reliability Project</p>	<p>Town: Sudbury</p>
<p>Photo No.: 6</p>	<p>Date: 8-12-24</p>

<p>Description:</p> <p>Work area within segment 10, manhole #20, existing erosion control, looking eastward</p>

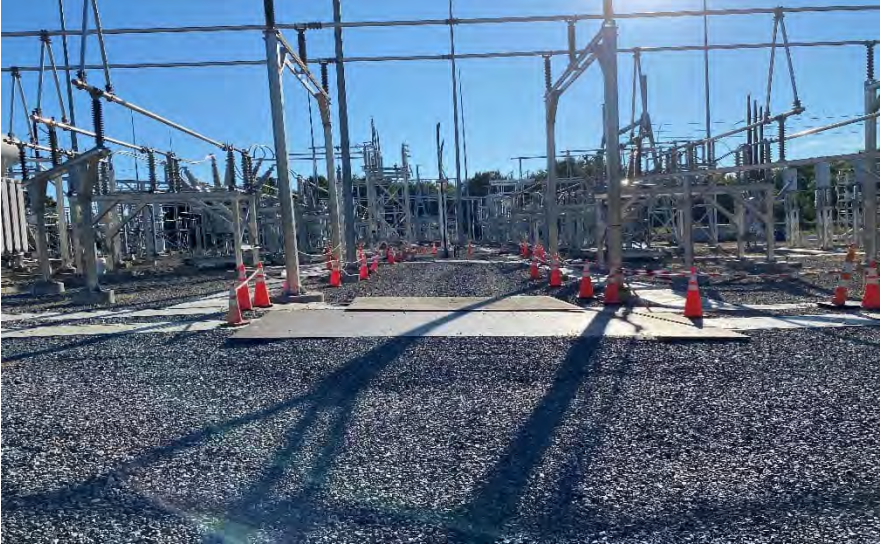
<p>PHOTOGRAPHIC LOG</p>	
<p>Client Name: Eversource</p>		<p>Site Location: Sudbury to Hudson Transmission Reliability Project</p>	<p>Town: Sudbury</p>
<p>Photo No.: 7</p>	<p>Date: 8-12-24</p>

<p>Description:</p> <p>Work area within substation, conduit area, looking eastward.</p>

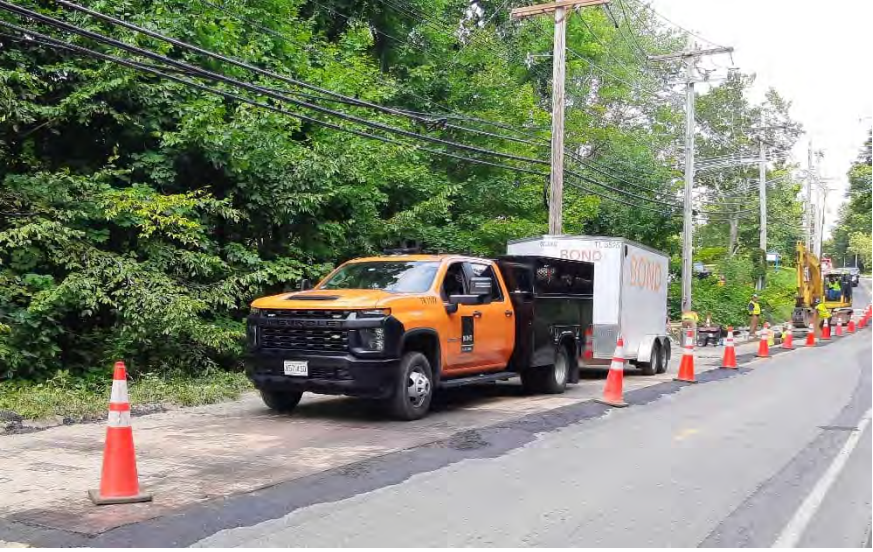
<p>PHOTOGRAPHIC LOG</p>	
<p>Client Name: Eversource</p>		<p>Site Location: Sudbury to Hudson Transmission Reliability Project</p>	<p>Town: Hudson</p>
<p>Photo No.: 1</p>	<p>Date: 8-13-24</p>

<p>Description:</p> <p>Bond conducting conduit work along Forest Ave from manhole #1, near Hudson Light & Power, looking eastward.</p>

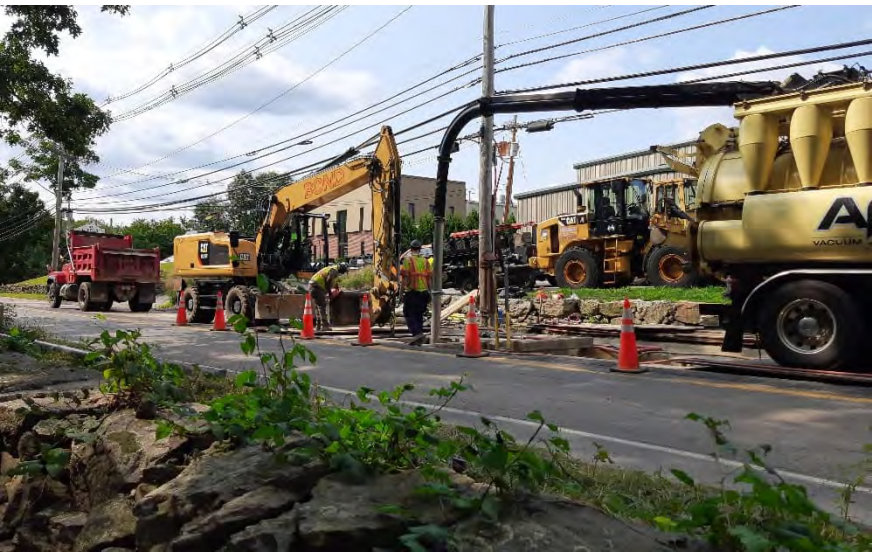
<p>PHOTOGRAPHIC LOG</p>	
<p>Client Name: Eversource</p>		<p>Site Location: Sudbury to Hudson Transmission Reliability Project</p>	<p>Town: Hudson</p>
<p>Photo No.: 2</p>	<p>Date: 8-13-24</p>

<p>Description:</p> <p>Bond conducting conduit work along Forest Ave from manhole #2, near 106 Forest Ave, looking westward.</p>

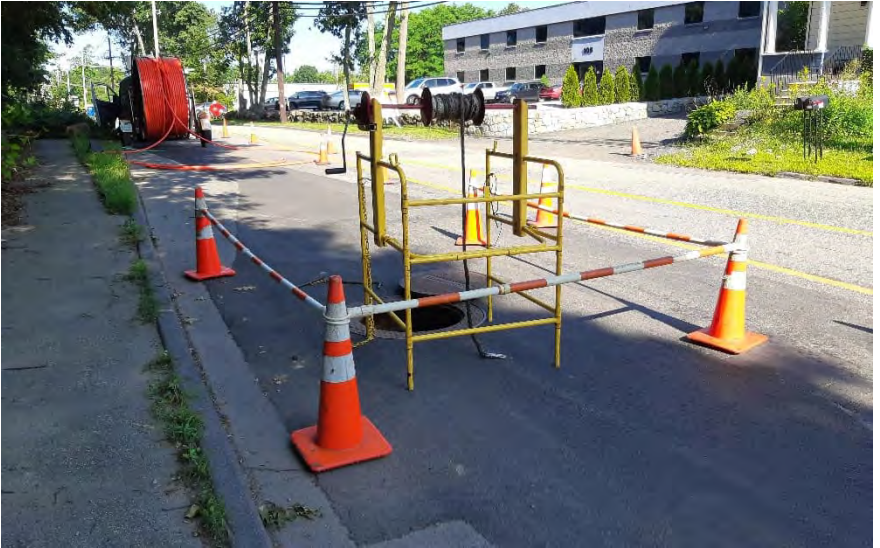
<p align="center">PHOTOGRAPHIC LOG</p>	
<p>Client Name: Eversource</p>		<p>Site Location: Sudbury to Hudson Transmission Reliability Project</p>	<p>Town: Hudson</p>
<p>Photo No.: 3</p>	<p>Date: 8-13-24</p>

<p>Description:</p> <p>New Wave work area at handhole #2, near Forest Ave/Marlboro Street intersection, pulling inner duct from handhole #3, looking westward.</p>

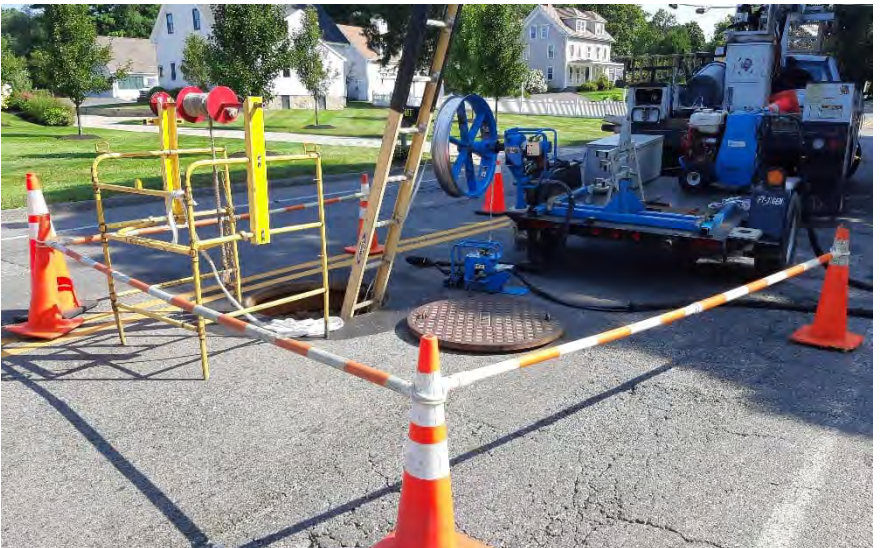
<p align="center">PHOTOGRAPHIC LOG</p>	
<p>Client Name: Eversource</p>		<p>Site Location: Sudbury to Hudson Transmission Reliability Project</p>	<p>Town: Hudson</p>
<p>Photo No.: 4</p>	<p>Date: 8-13-24</p>

<p>Description:</p> <p>New Wave work area at handhole #3, near Forest Ave Elementary, pulling inner duct to handhole #2, looking eastward.</p>

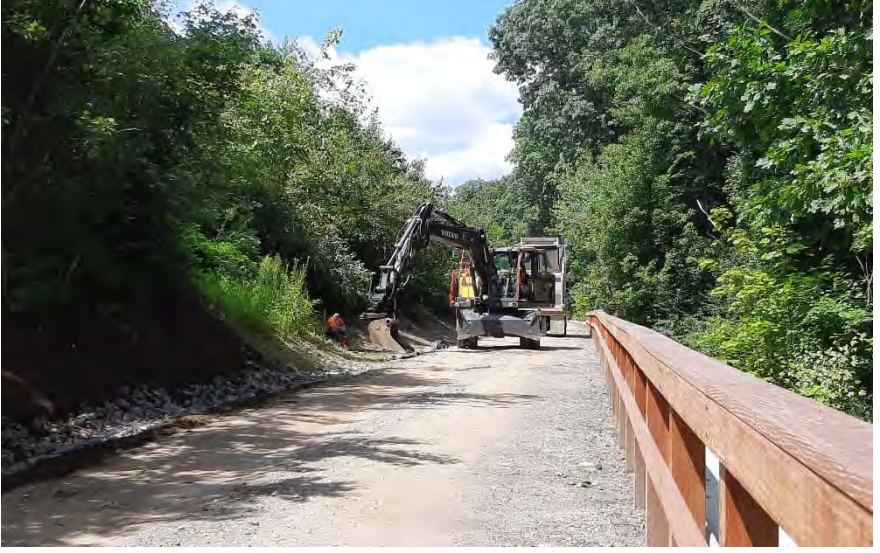
<p>PHOTOGRAPHIC LOG</p>	
<p>Client Name: Eversource</p>		<p>Site Location: Sudbury to Hudson Transmission Reliability Project</p>	<p>Town: Hudson</p>
<p>Photo No.: 5</p>	<p>Date: 8-13-24</p>

<p>Description:</p> <p>ET&L work area within Segment 1, weeding and loaming, looking westward.</p>

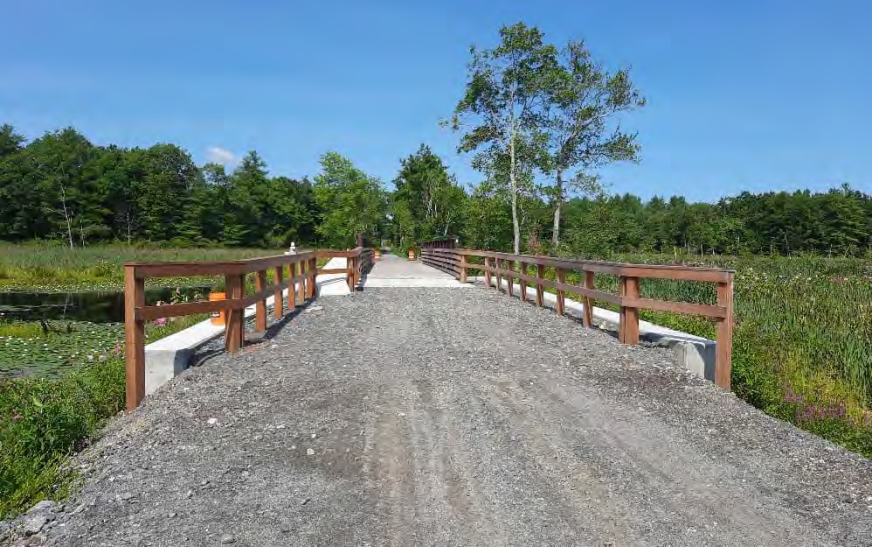
PHOTOGRAPHIC LOG	
Client Name: Eversource		Site Location: Sudbury to Hudson Transmission Reliability Project	Town: Hudson
Photo No.: 7	Date: 8-13-24

Description: Bridge 130 (Segment 3 towards Segment 2), no work in area today, looking westward.

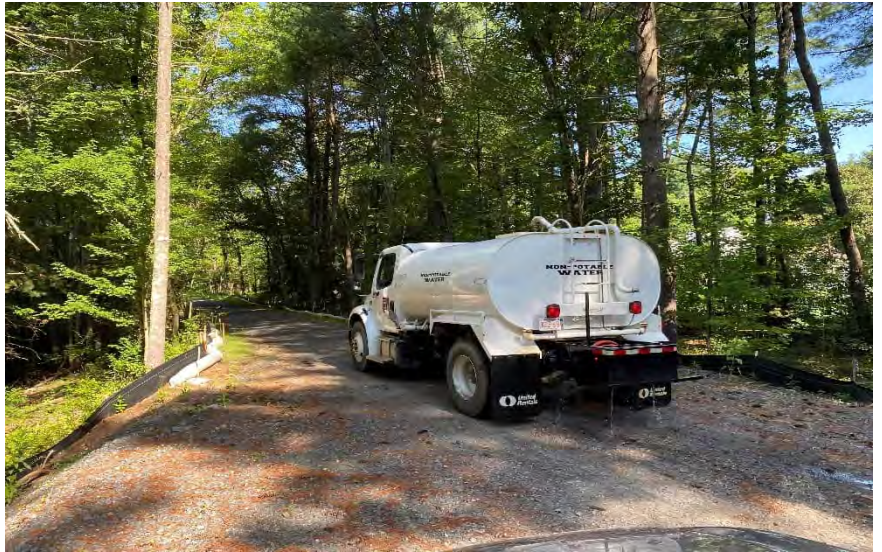
<p>Description:</p> <p>Work area within segment 9, ET&L watering shoulders, existing erosion control, looking westward.</p>

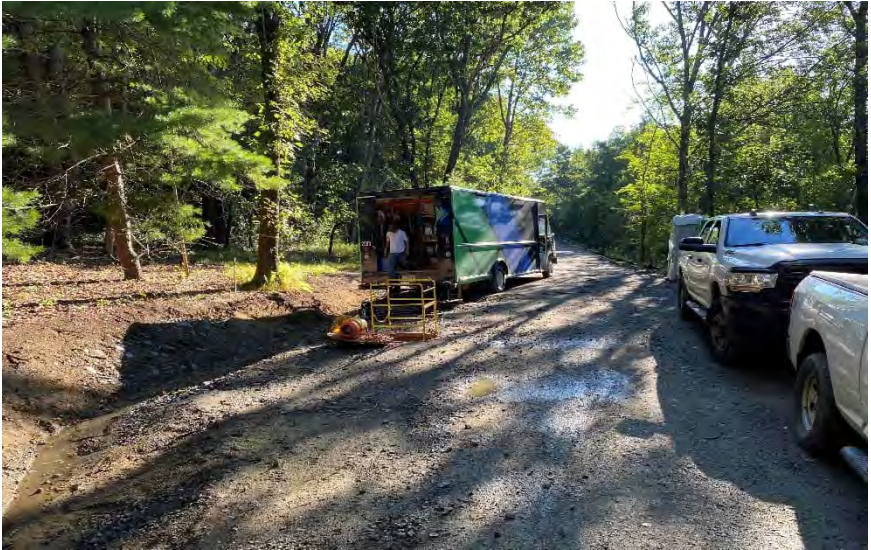
Description: Work area within segment 14, Haugland conducting splicing work at manhole #26, existing erosion control, looking eastward

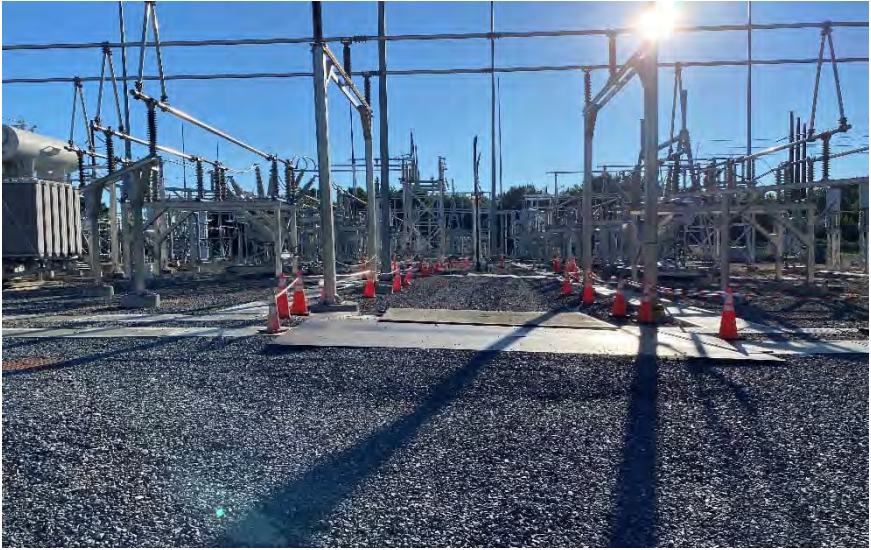
<p>Description: Work area within substation, conduit area, looking eastward.</p>

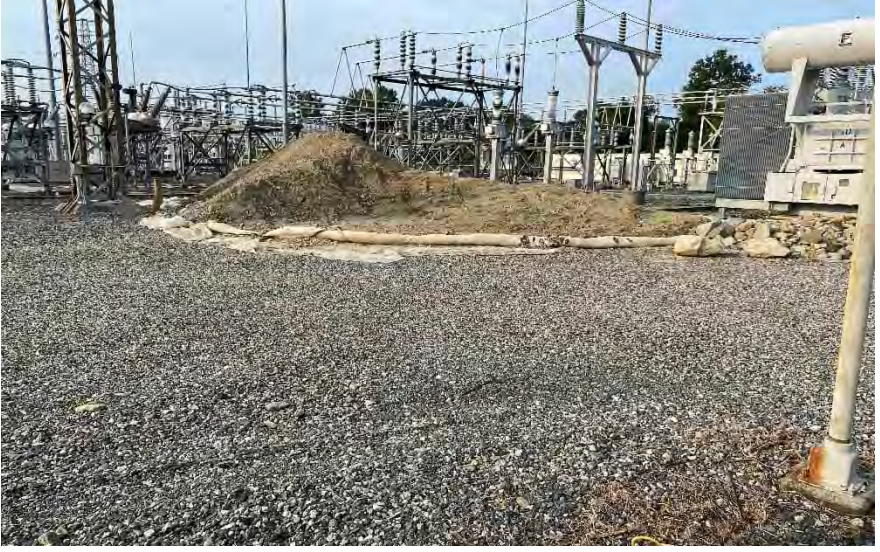
Description: Spoil pile within Sudbury substation surrounded by compost filter tubes, looking southward.

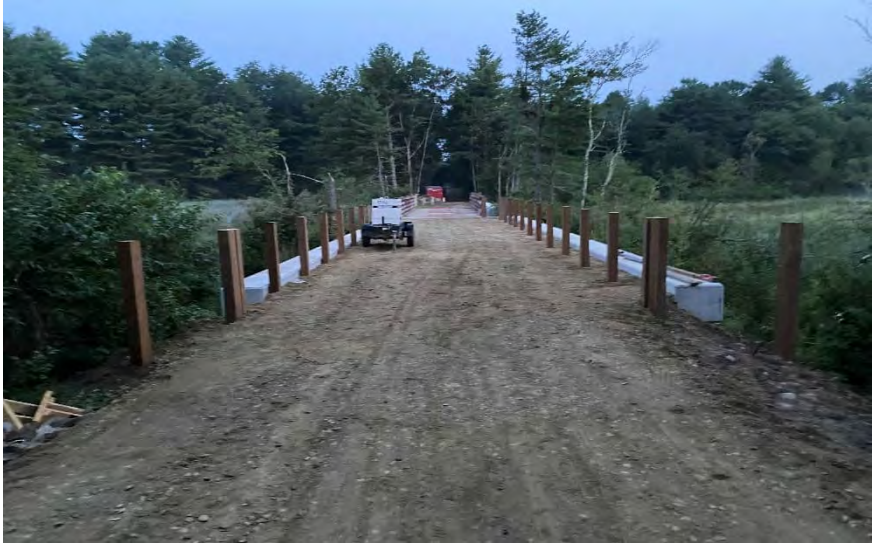
Description: Work area within segment 8, Bridge 128 posts/rails, erosion control, looking westward.

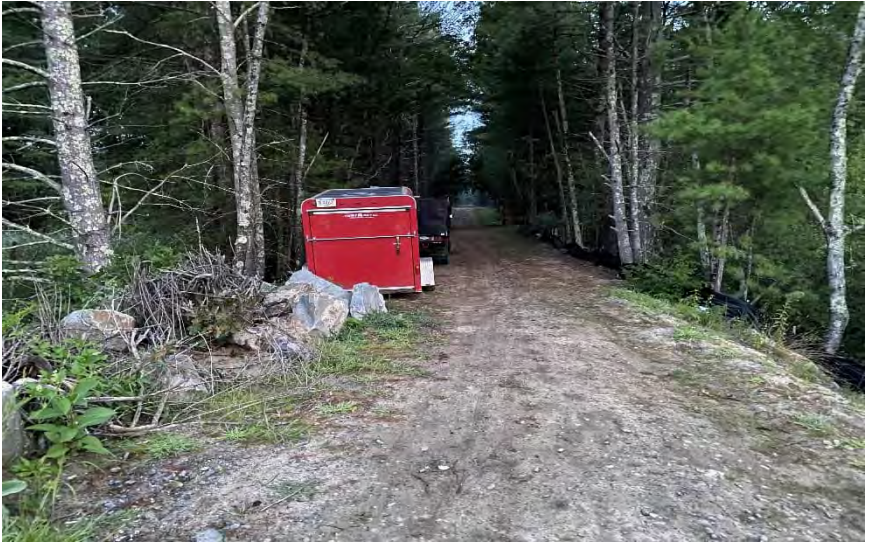
<p>Description:</p> <p>Work area within segment 7, existing erosion control, looking westward.</p>

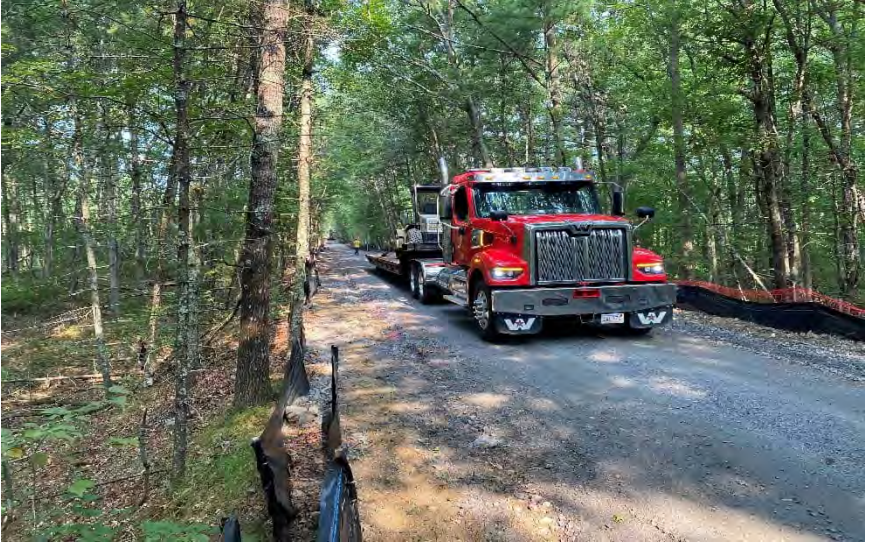
Description: ET&L performing site work within segment 8, existing erosion control, looking westward.

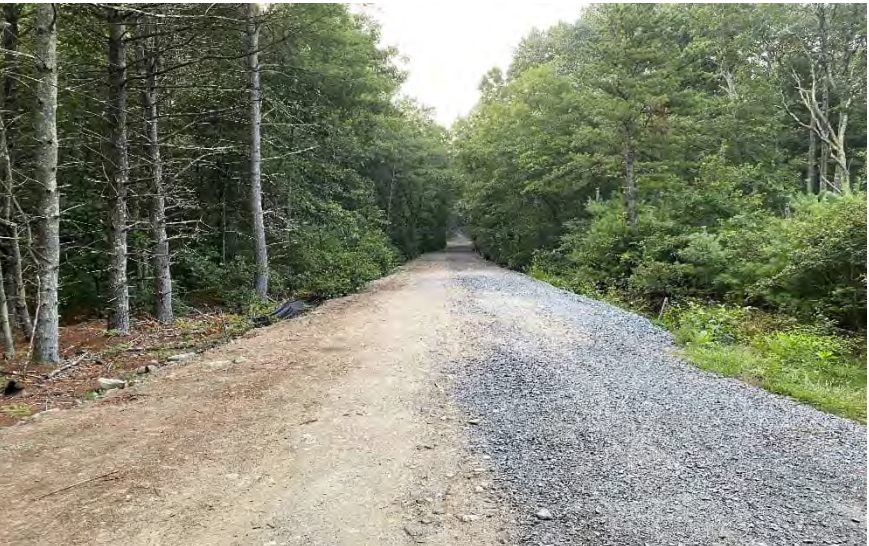
Description: Work area within segment 7, existing erosion control, looking eastward

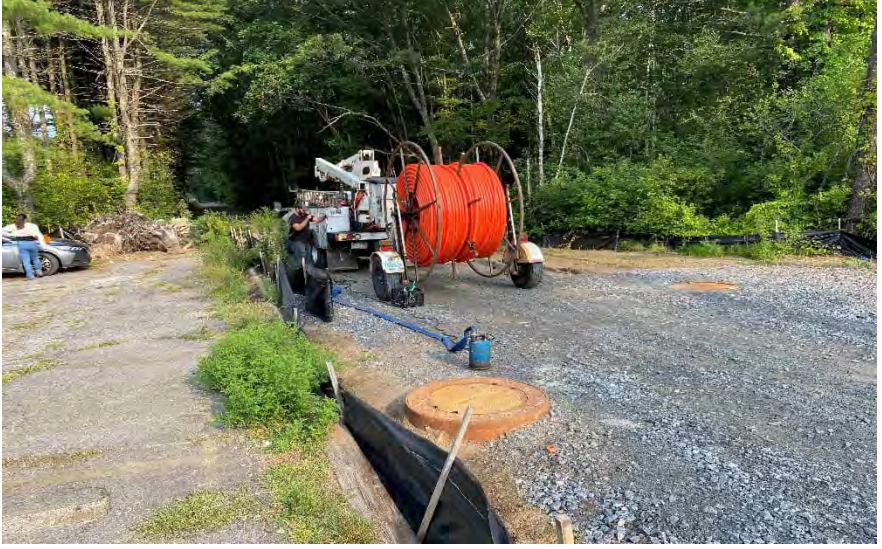
<p>Description:</p> <p>Work area within segment 11, handhole #24 fiber optic work, existing erosion control, looking westward.</p>

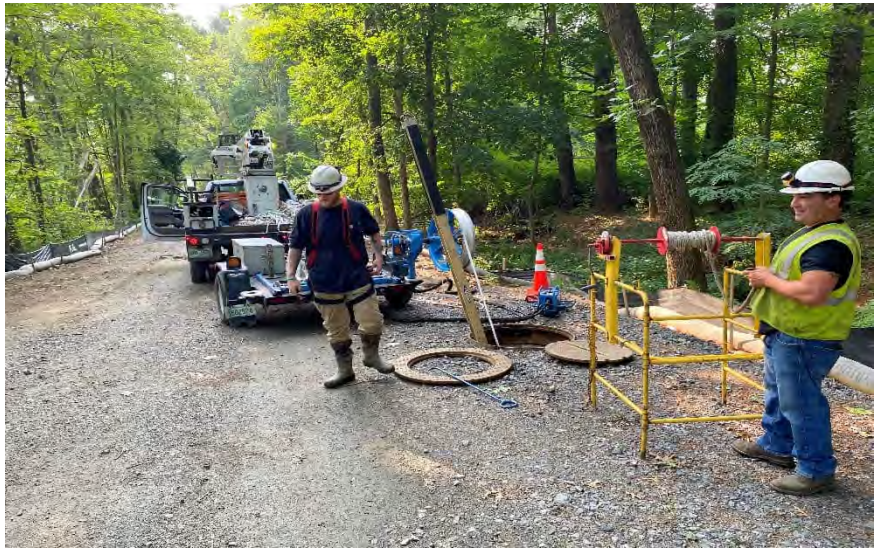
<p>Description:</p> <p>Work area within segment 13, handhole #25 fiber optic work, existing erosion control, looking eastward.</p>

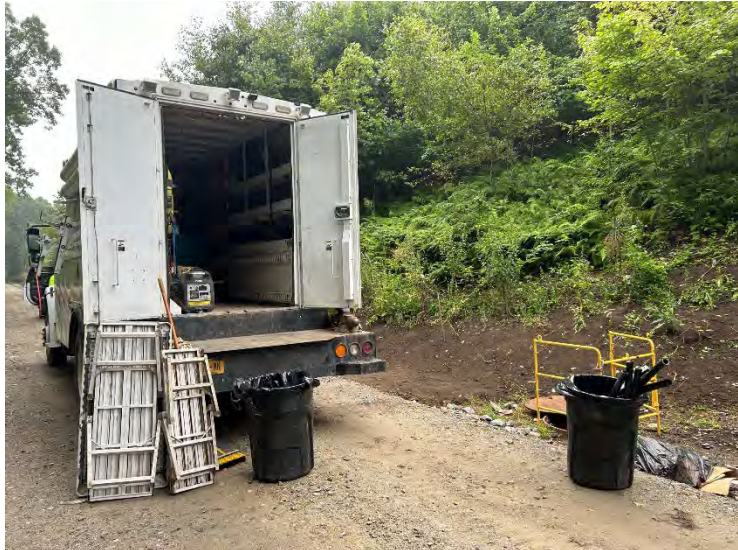
<p>Description: View of Haugland's work area at MH #6 in segment 1. Facing southeast.</p>

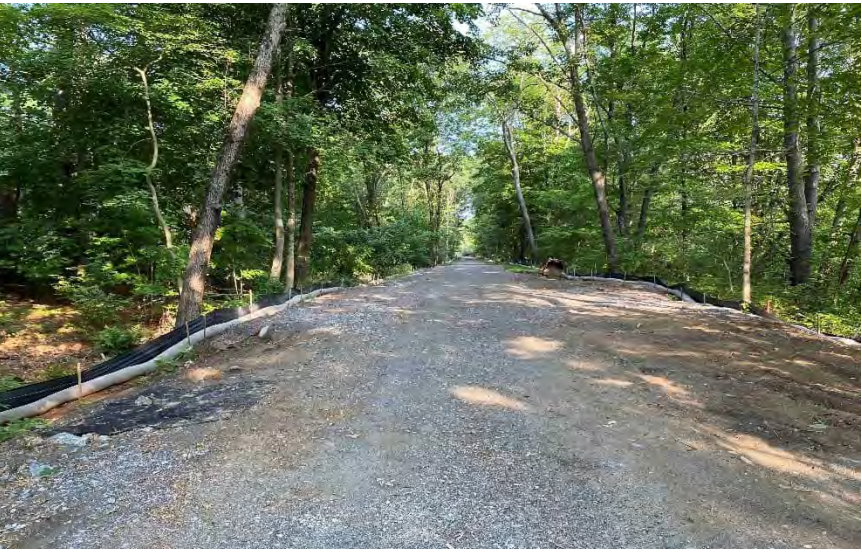
Description: Work area within segment 13 (manhole #25), existing erosion control, looking westward.

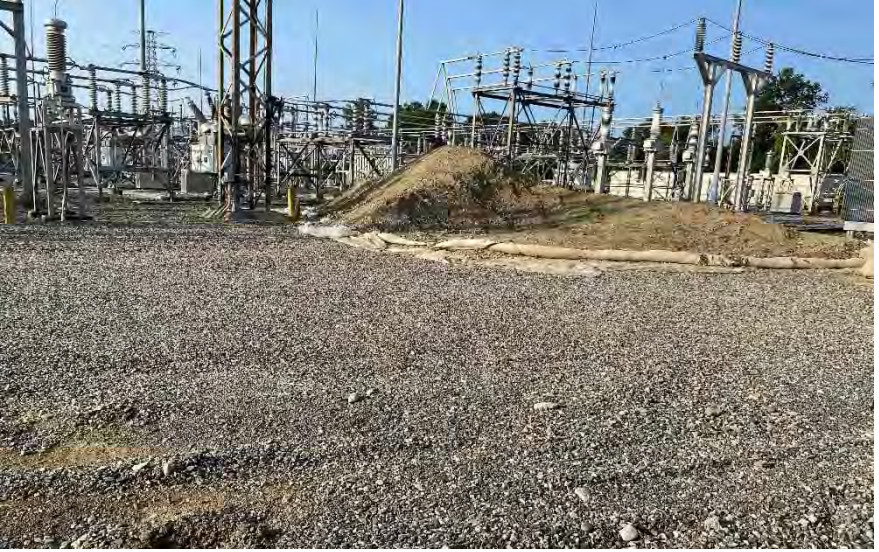
Description: Work area within substation, spoil pile with compost tubes surrounding pile, looking southward.

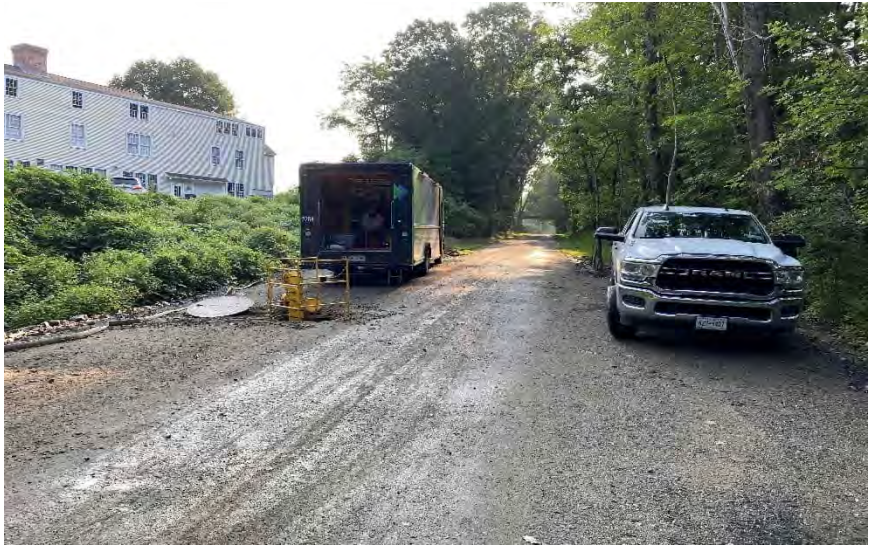
Description: Work area within segment 14 (handhole #27), splicing work, existing erosion control, looking eastward.

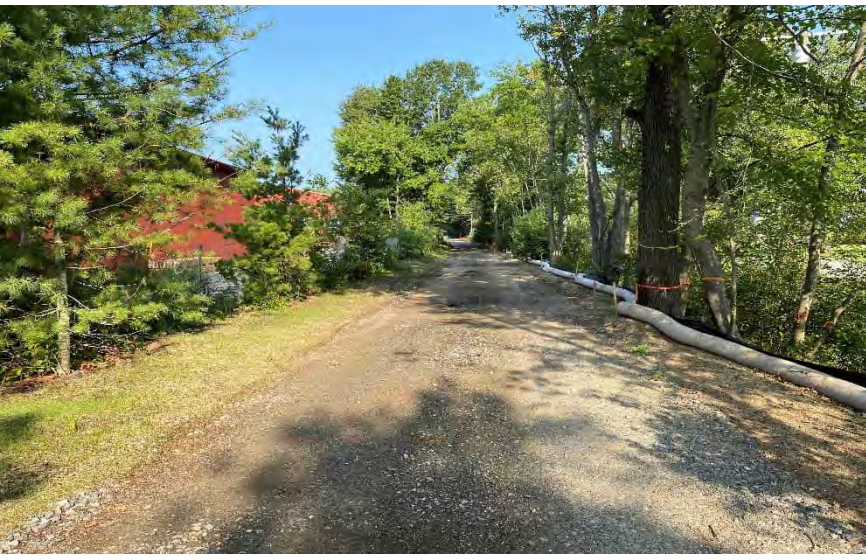
Description: Work area within segment 12, future culvert extension area, trees with orange flagging to be removed, existing erosion control, looking westward.

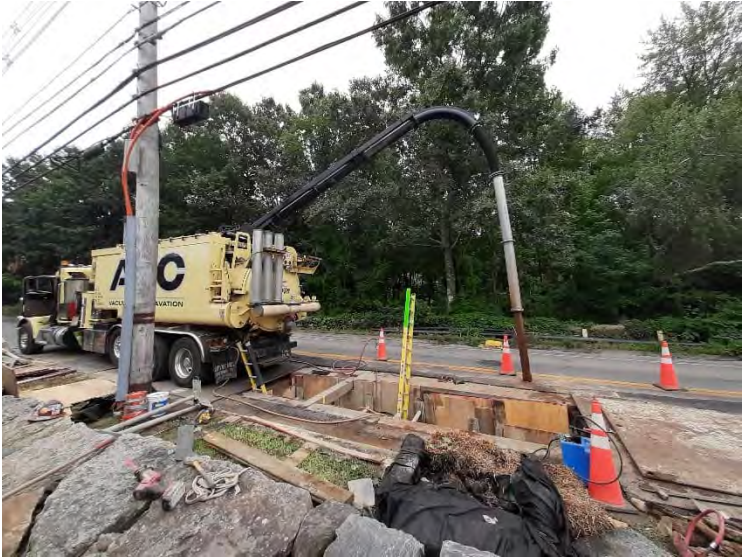
Description: Bond conducting conduit work within Forest Avenue near 106 Forest Ave, extending conduit westward from manhole #2, looking southward.

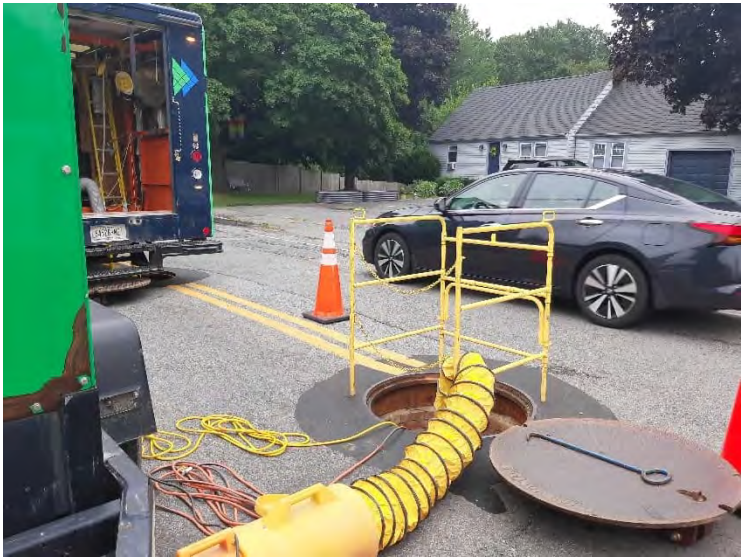
Description: Work area at manhole #3, within segment 1, Haugland crimping and splicing, looking eastward.

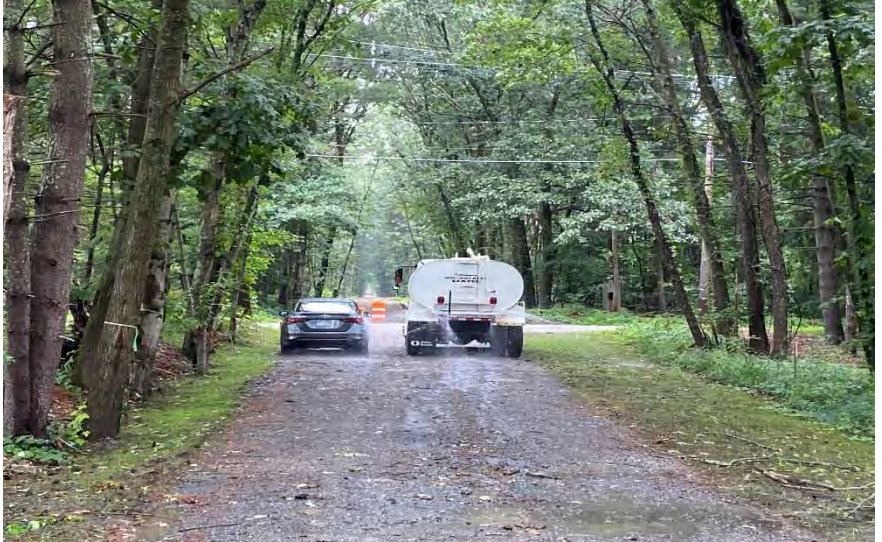
Description: Work area within segment 11, watering of work area shoulders, existing erosion control, looking westward.

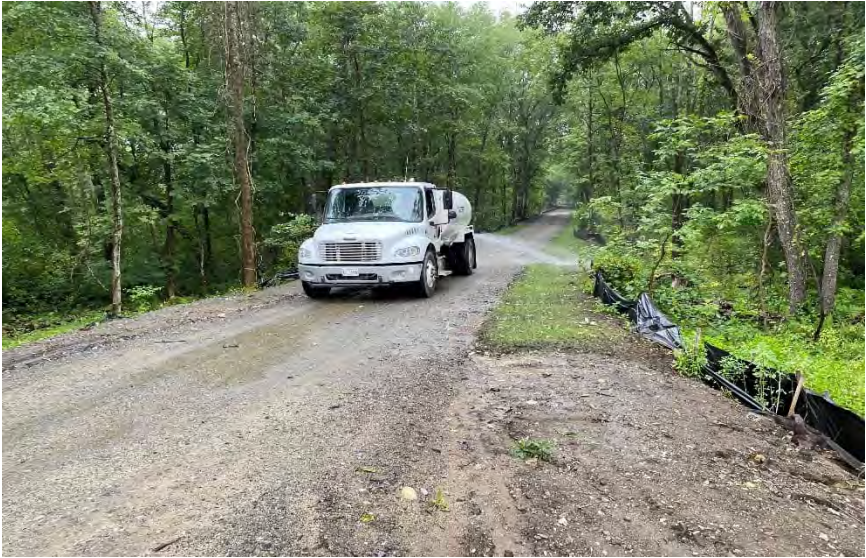
Description: Work area within segment 14, watering of work area shoulders, existing erosion control, looking westward.

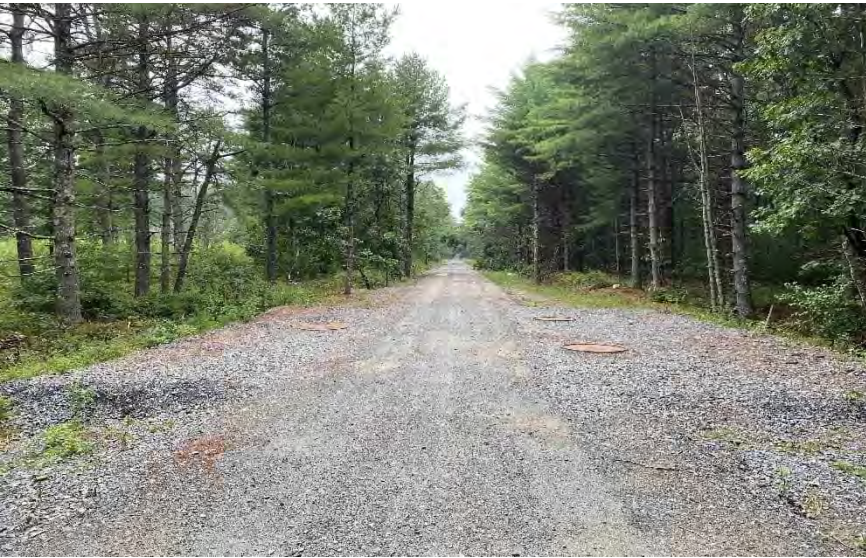
Description: Work area within segment 7 (manhole #16), existing erosion control, looking westward.

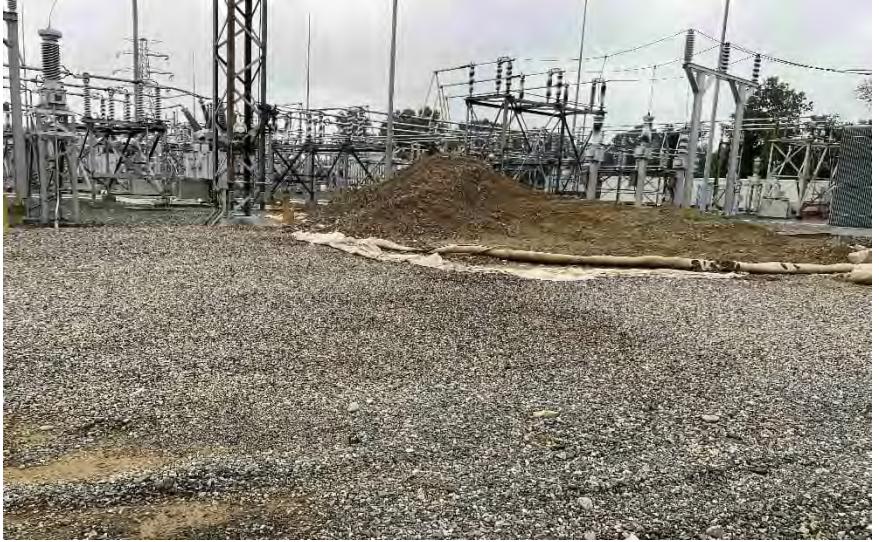
Description: Work area within substation, spoil pile with compost tubes surrounding pile, looking southward.

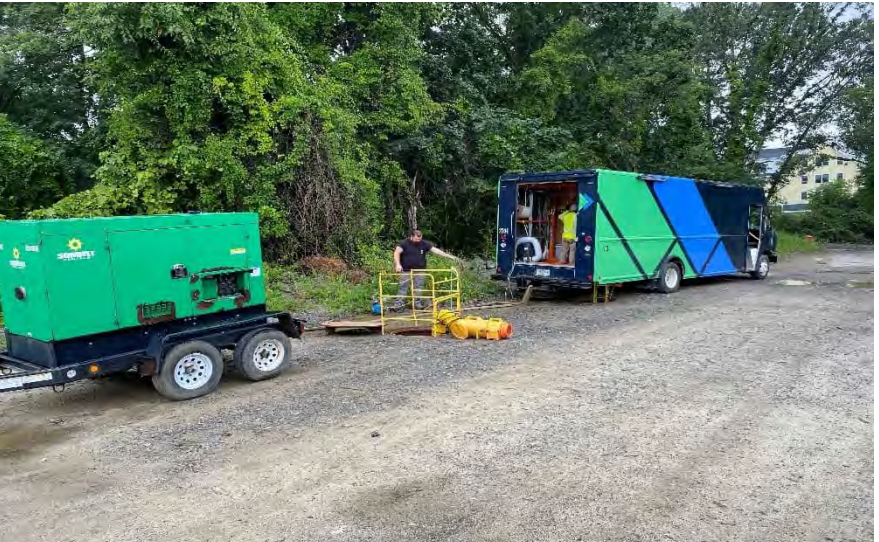
Description: Work area outside substation (handhole #28), splicing work, existing erosion control, looking northward.

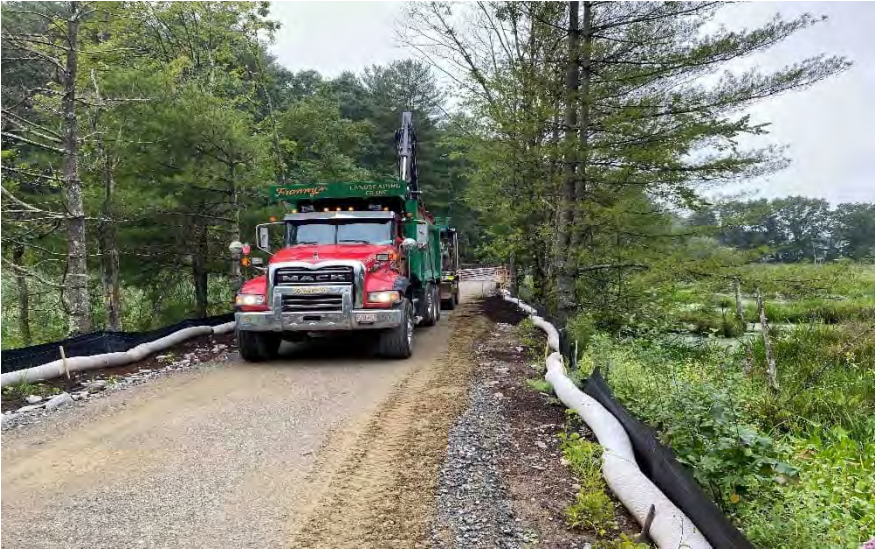
Description: Work area within segment 14, laying down loam, existing erosion control, looking westward.

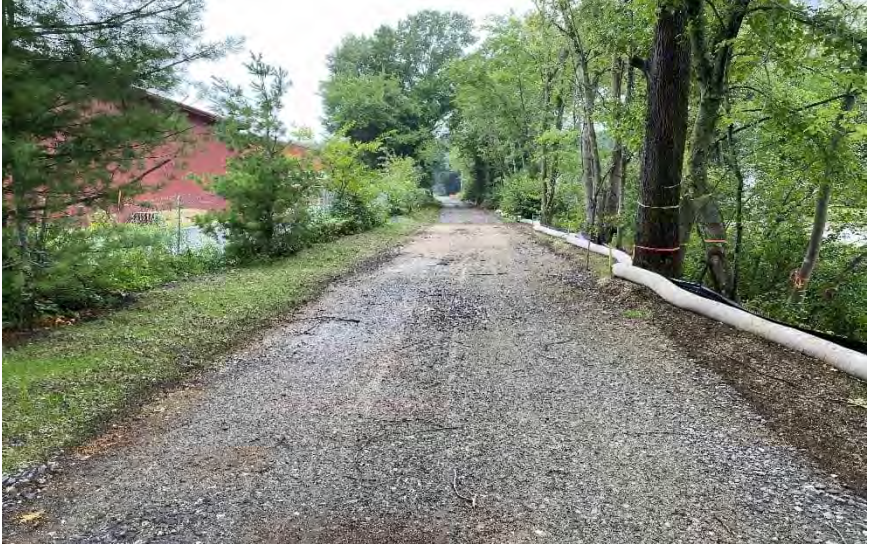
Description: Work area within segment 12, future culvert extension area, trees with orange flagging to be removed, existing erosion control, looking westward.

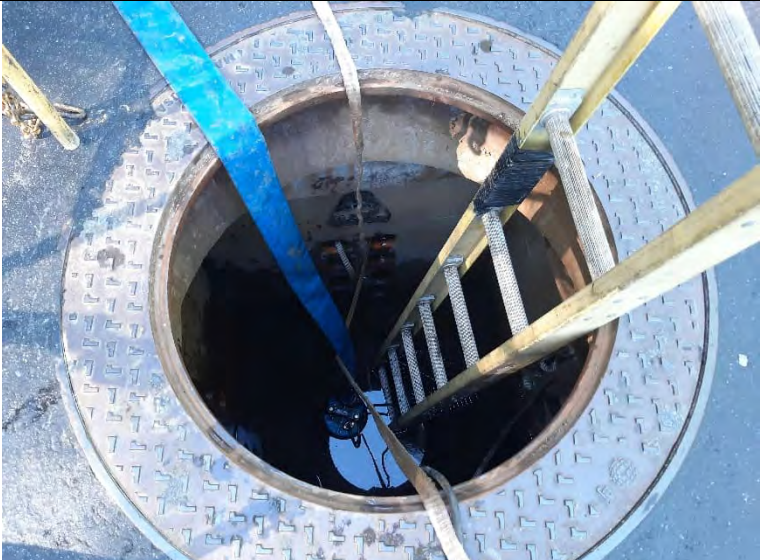
Description: View of handhole #4 (Forest Ave near 156 Forest Ave), area being pumped, looking down.
