Weekly Environmental Compliance Summary

Sudbury to Hudson Transmission Reliability Project (USEPA Tracking # MAR1003UW)

Sudbury, Hudson, and Stow, MA

Week of: August 12, 2024 to August 17, 2024

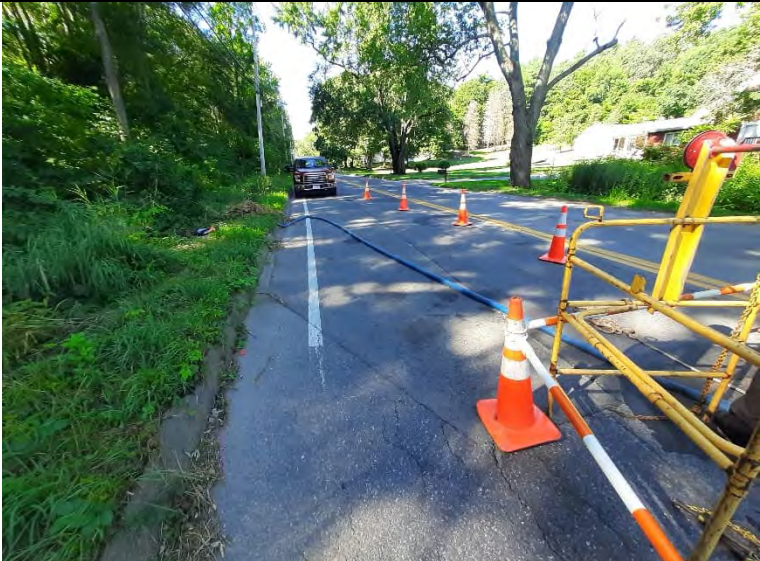
Description: Handhole #4. View of dewatering operation, looking westward.

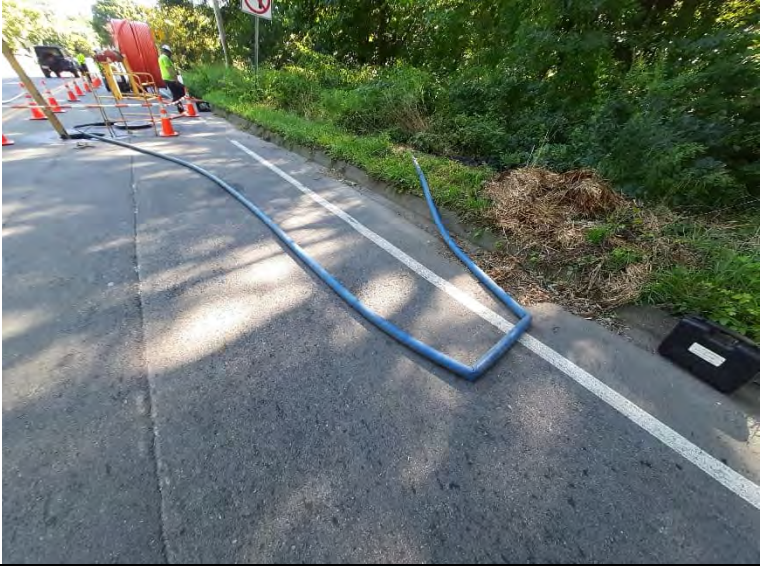
Description: View of dewatering operation for handhole #4, looking eastward.

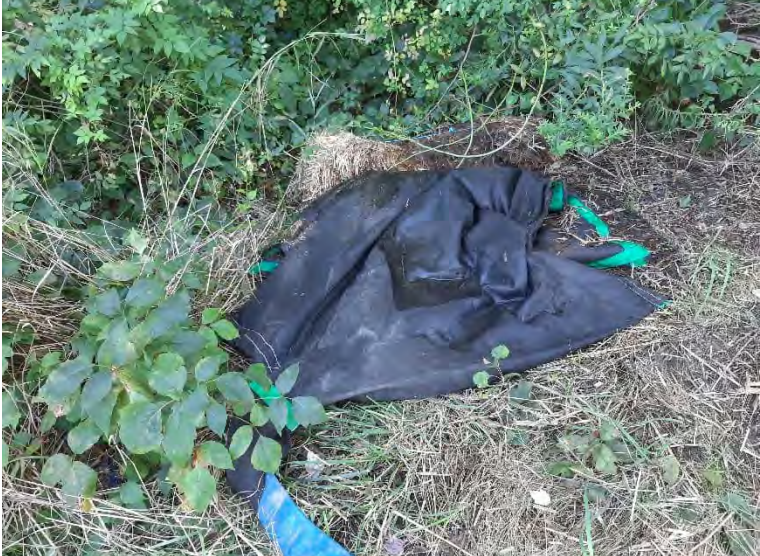
Description: Handhole #4. View of discharge bag/corral, looking southward, corral discharging to low-lying area downhill.

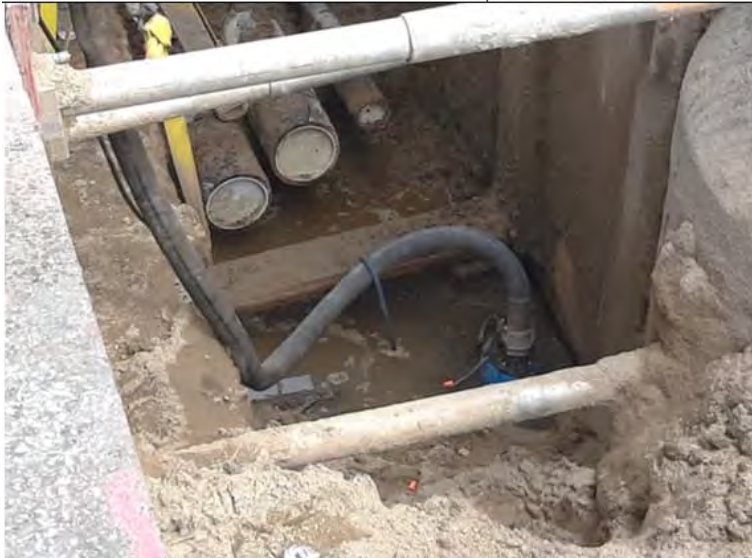
Description: View of Forest Ave trench from MH #2 (near 106 Forest Ave), area being pumped, looking eastward.

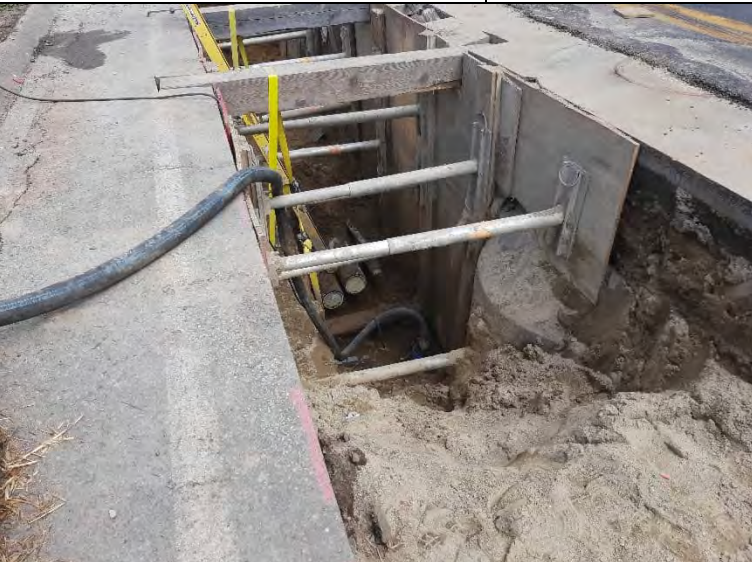
Description: Forest Ave trench from MH #2. View of dewatering operation, looking eastward.

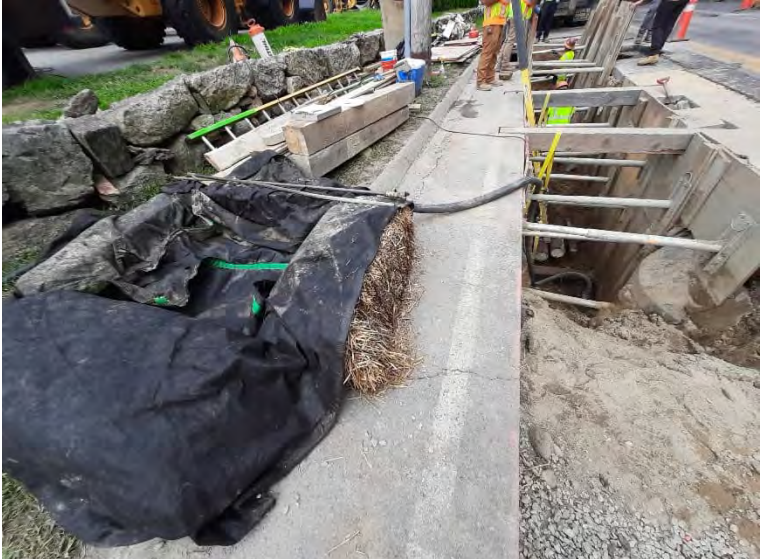
Description: View of dewatering operation for Forest Avenue trench from MH #2, looking eastward.

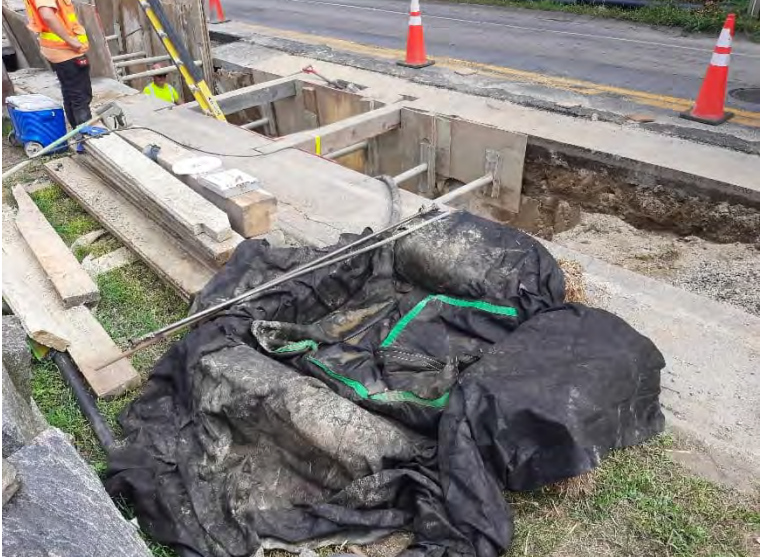
Description: Forest Ave trench from MH #2. View of discharge bag/corral, looking southward, corral discharging to catch basin below corral.

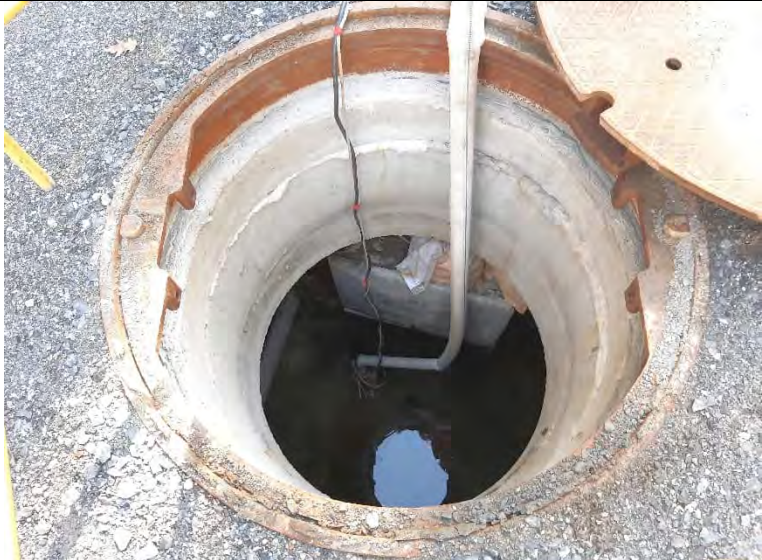
Description: View of Manhole #14 (Segment 6), area being pumped, looking down.

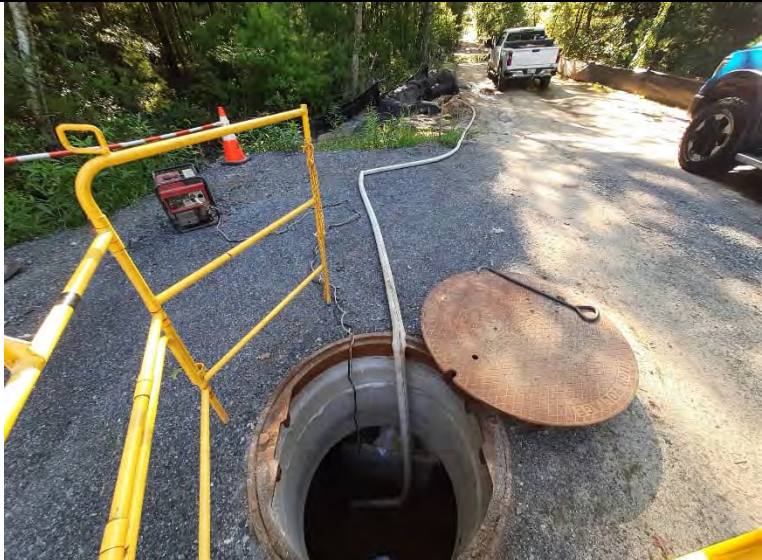
Description: Manhole #14. View of dewatering operation, looking eastward.

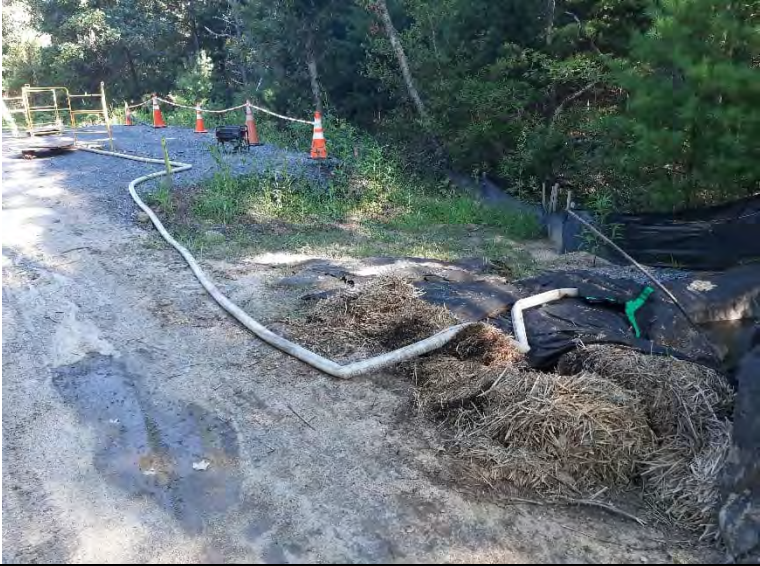
Description: View of dewatering operation for manhole #14, looking westward.

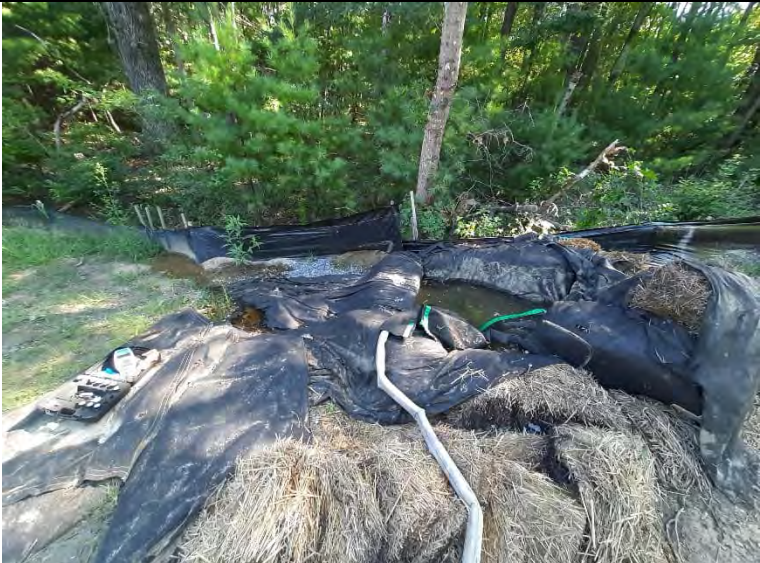
Description: Manhole #14. View of discharge bag/corral, looking northward, corral discharging to adjacent area.

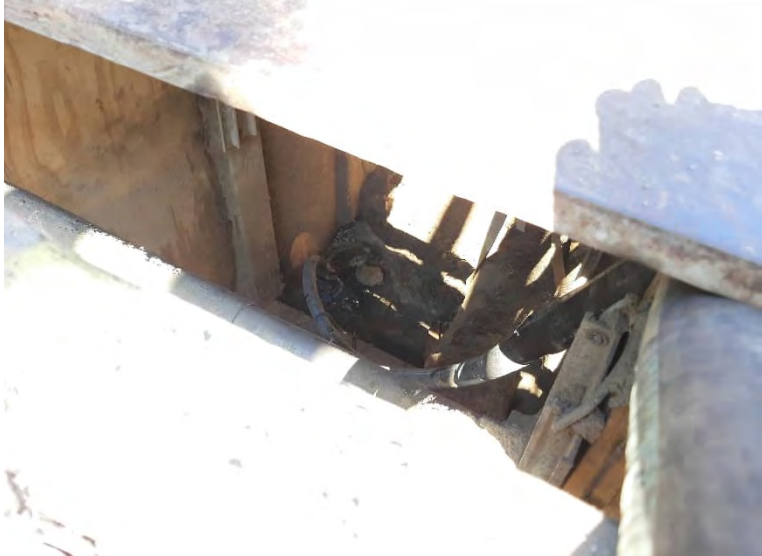
Description: View of Forest Ave trench from Manhole #2 (near 106 Forest Ave), area being pumped, looking down.

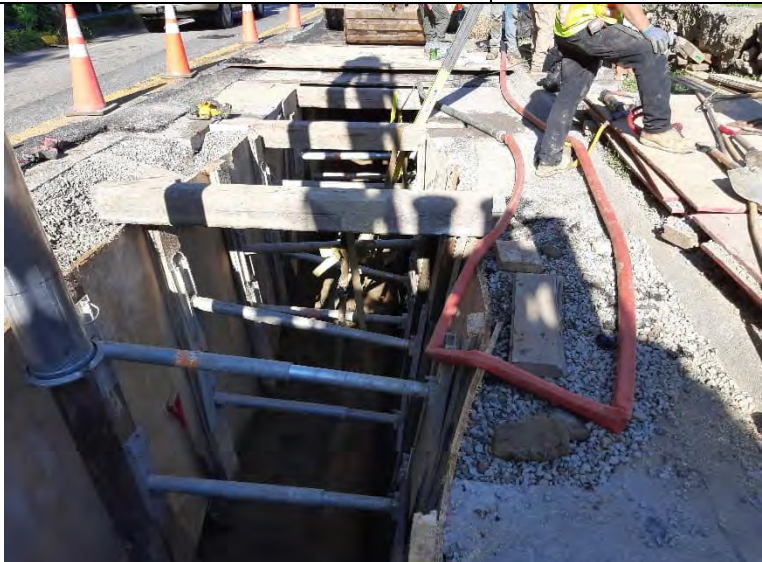
Description: Forest Ave trench from Manhole #2. View of dewatering operation, looking westward.

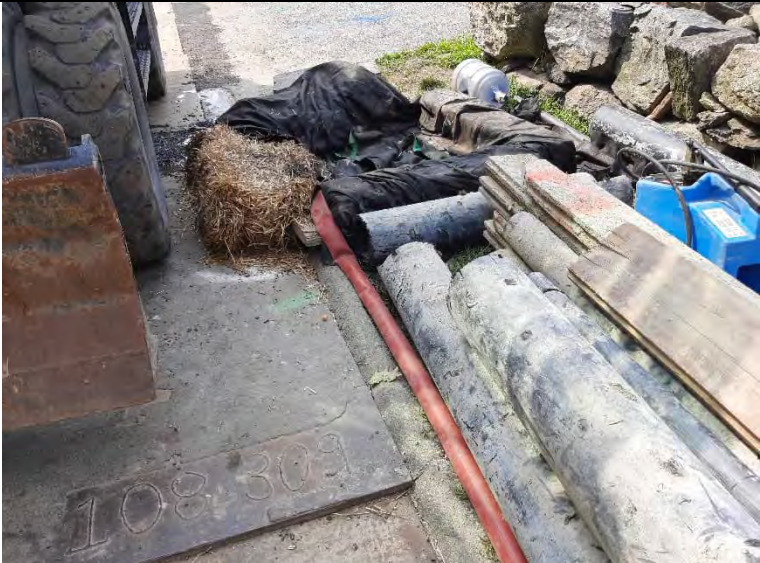
Description: View of dewatering operation for Forest Avenue trench from Manhole #2, looking westward.

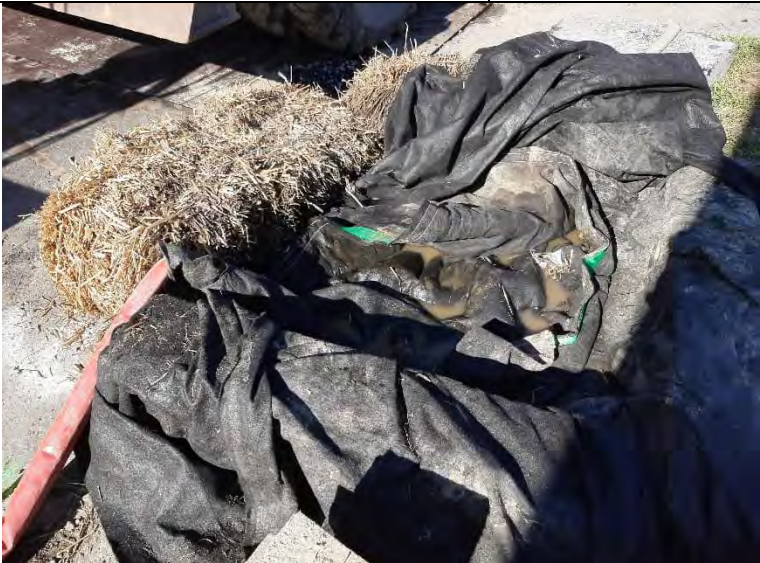
Description: Forest Ave trench from Manhole #2. View of discharge bag/corral, looking westward, corral discharging to catch basin below corral.

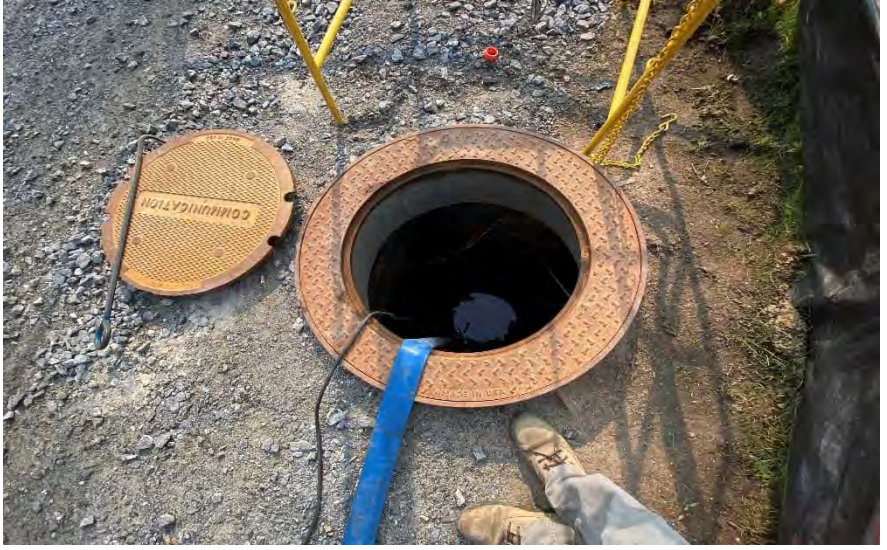
Description: View of area being pumped from handhole #24, segment 11.

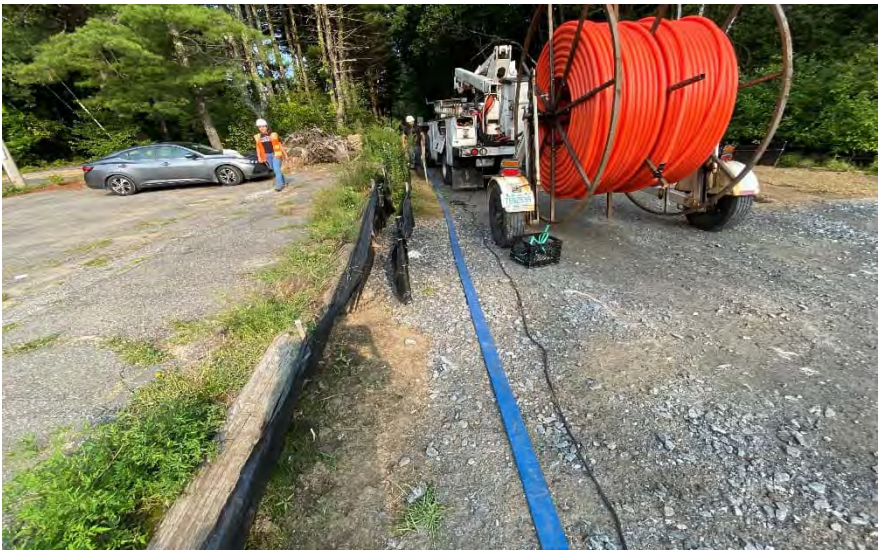
Description: Handhole #24. View of dewatering operation. Looking westward.

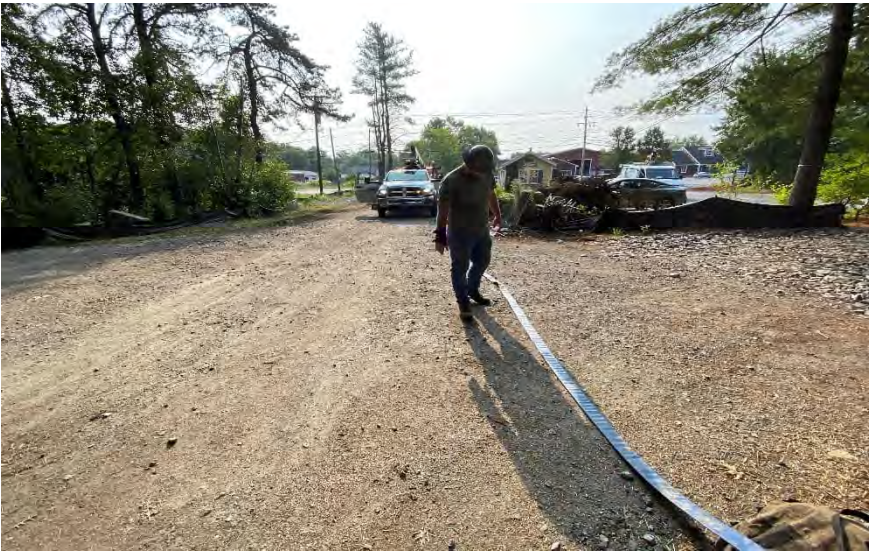
Description: Handhole #24. View of dewatering operation, looking eastward.

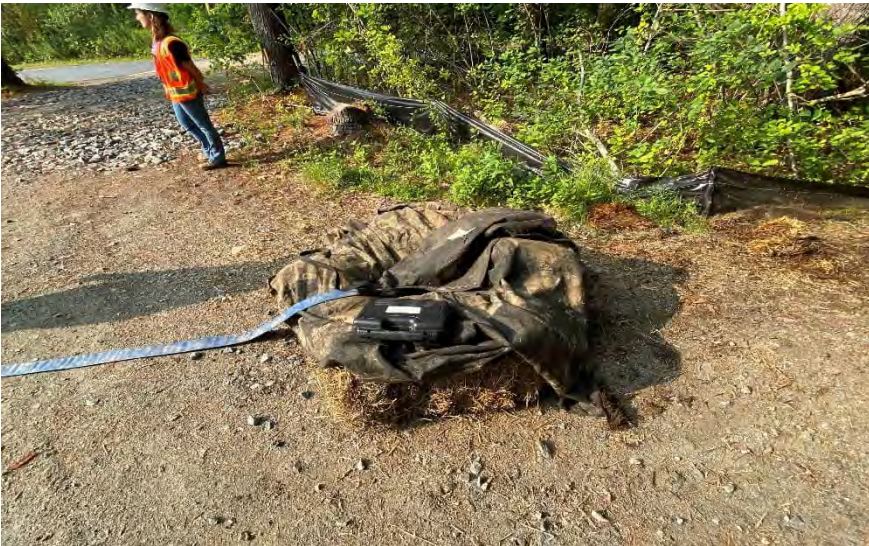
Description: Handhole #24. View of discharge bag/corral, looking westward. Water from bag/corral discharged to adjacent area.

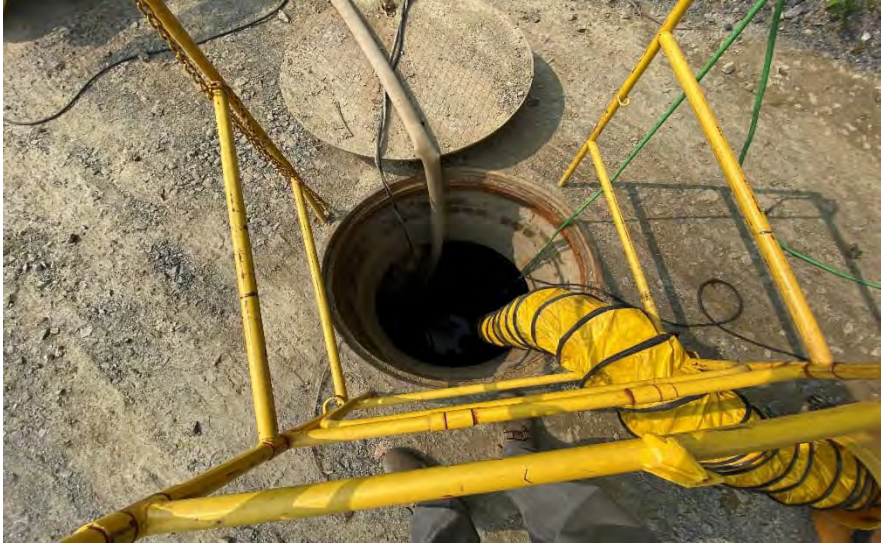
Description: View of area being pumped from manhole #28 outside substation.

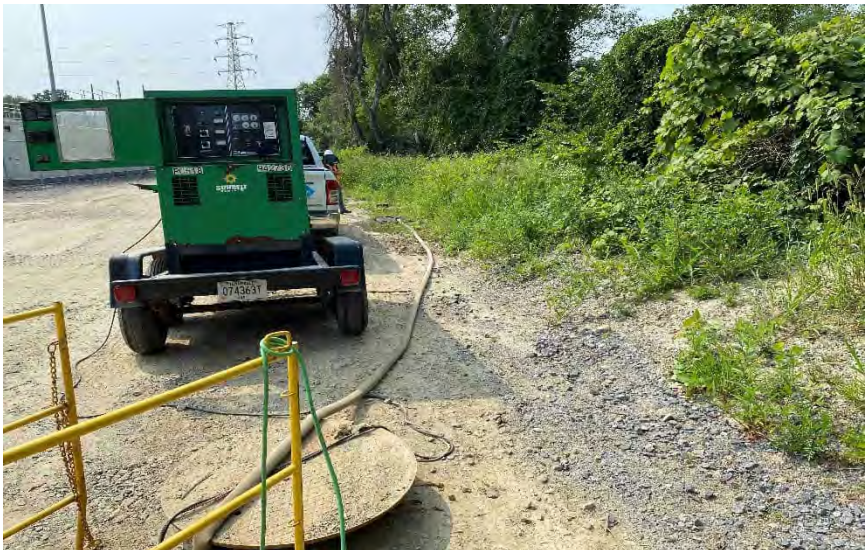
Description: Manhole #28. View of dewatering operation. Looking southward.

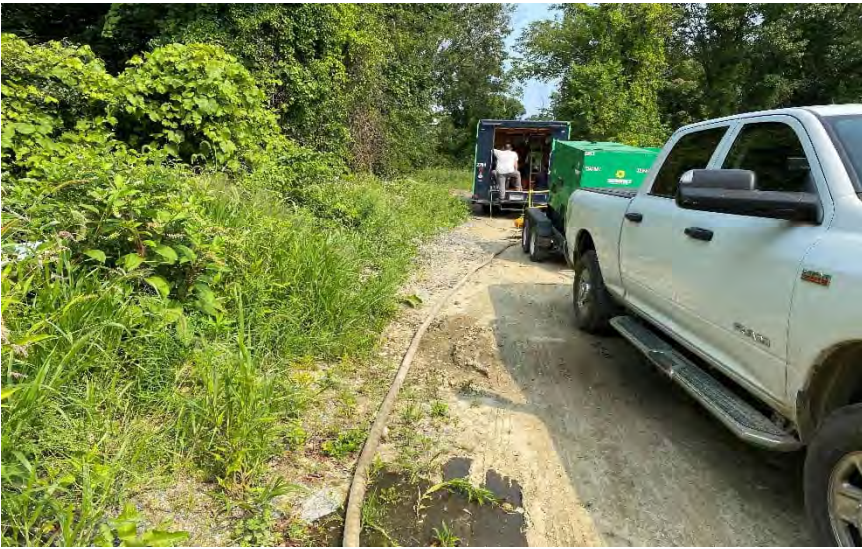
Description: Manhole #28 View of dewatering operation, looking northward.

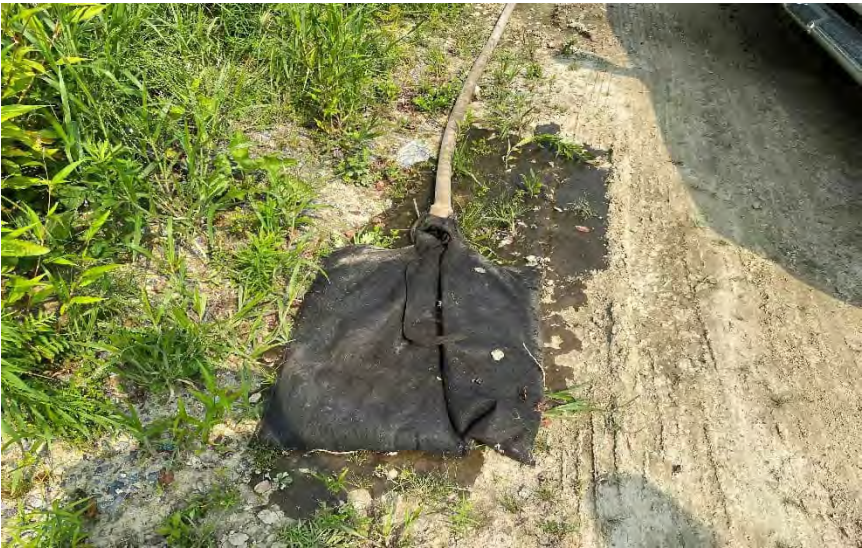
Description: Manhole #28. View of discharge bag. Water from bag discharged to adjacent area.

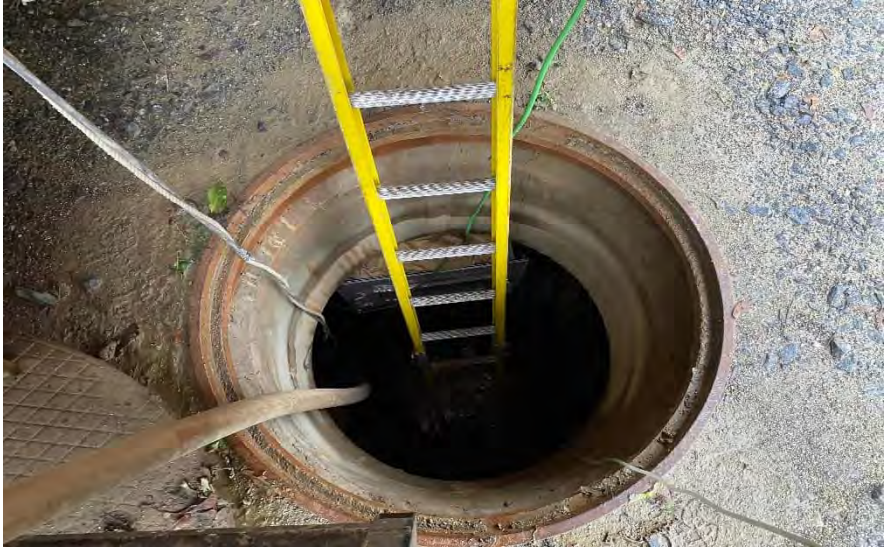
Description: View of area being pumped from manhole #28 outside substation.

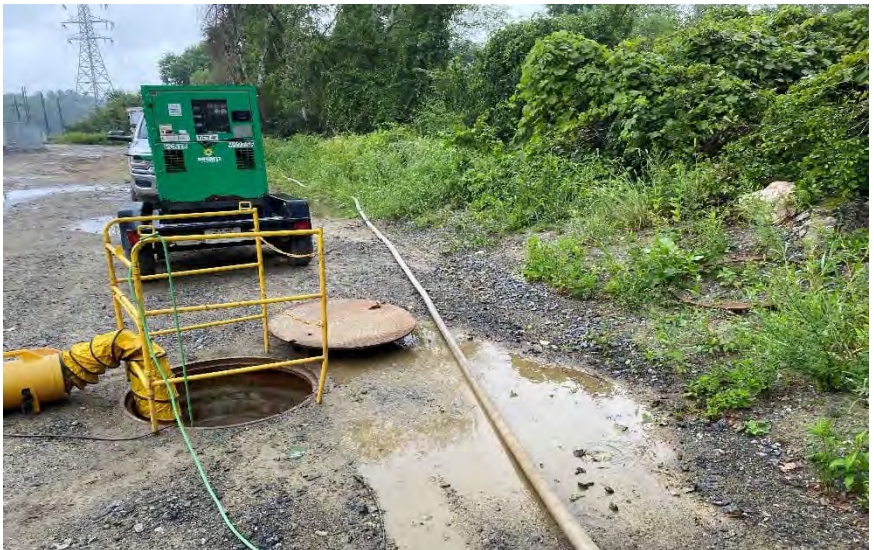
Description: Manhole #28. View of dewatering operation. Looking southward.

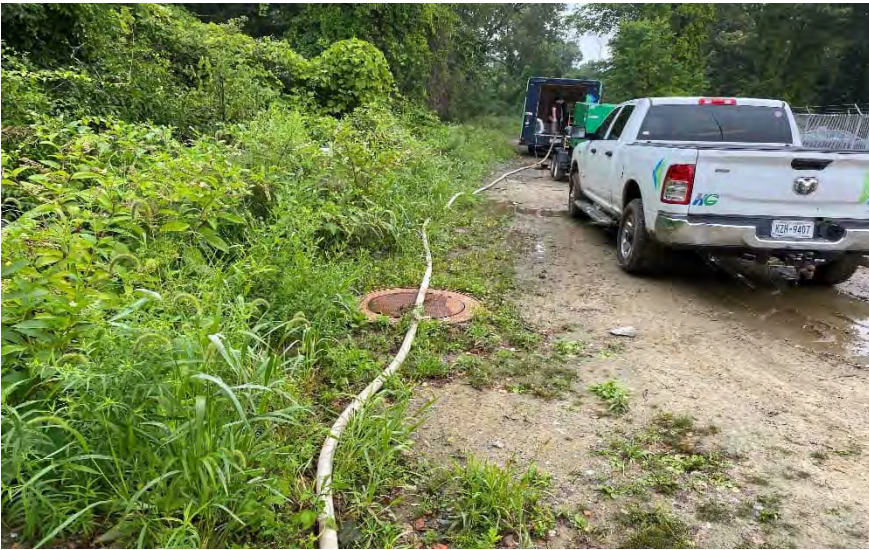
Description: Manhole #28 View of dewatering operation, looking northward.

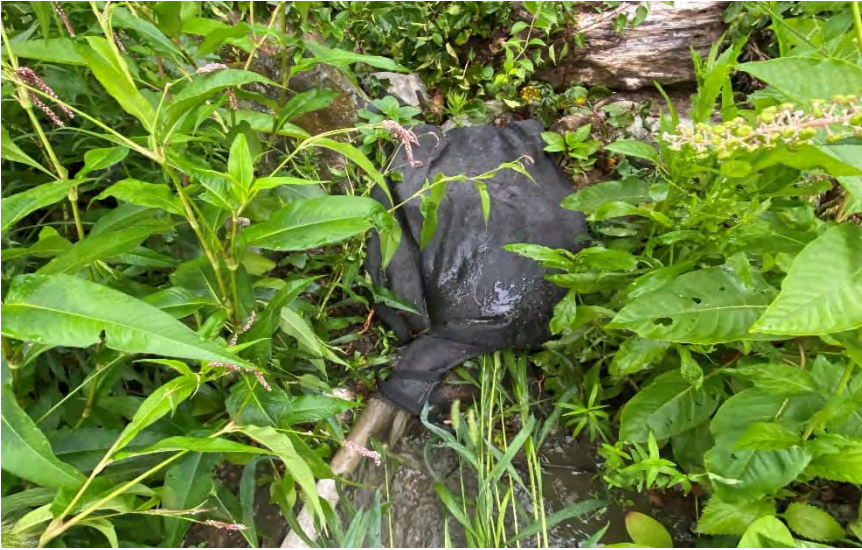
Description: Manhole #28. View of discharge bag. Water from bag discharged to adjacent area.
