**Environmental Monitor Construction Site Inspection Report  
MassDOT Project #608164 Construction Contract # 119678  
EM Report #4**

Project Description: Bruce Freeman Rail Trail Right-of-Way  
Permit Description(s): Order of Conditions (MGL Chapter 131, Section 40 and 310 CMR 10.00, Mass DEP File No. 301-1362); 2022 EPA NPDES General Permit for Discharges from Construction Areas; U.S. Army Corps of Engineers Permit No NAE-2021-01975.

Project Name: Bruce Freeman Rail Trail - Phase 2d - Sudbury  
Date of Inspections: 5/28/2024  
Bi Weekly/ Monthly Period Covered: May Weekly Inspection #4  
Inspector's Name(s): Douglas Beach  
Inspectors' Contact Information: [dbeach@beta-inc.com](mailto:dbeach@beta-inc.com)

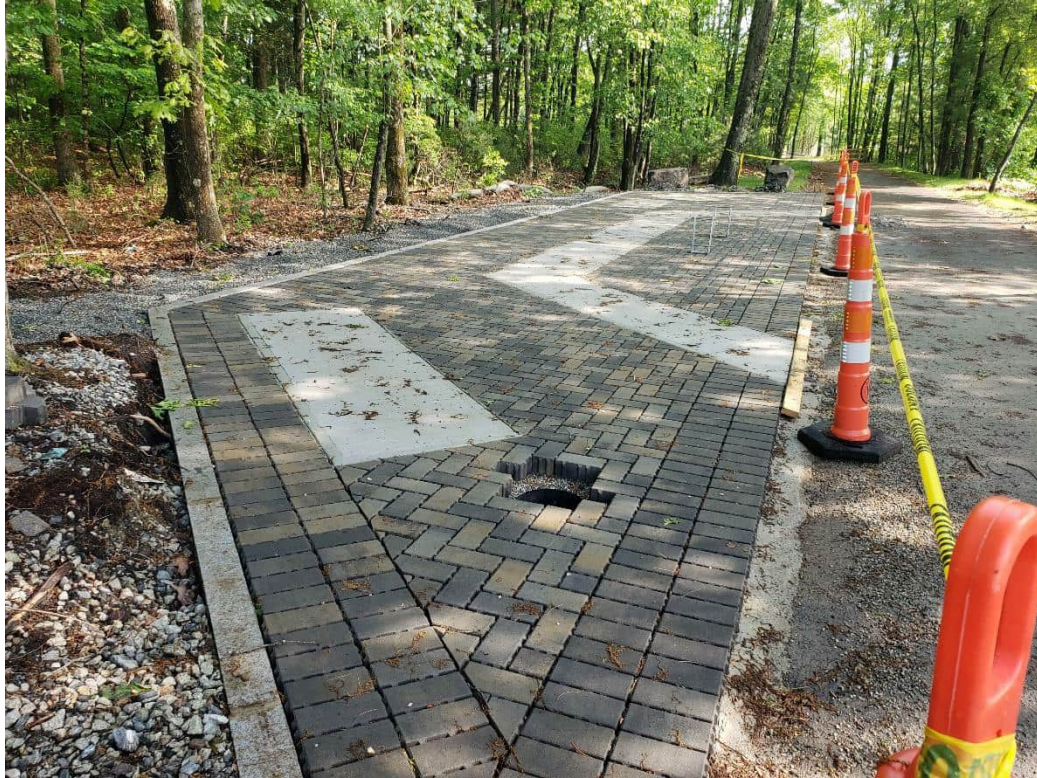
**Photo No. 1**    **Date:**  
5/28/2024

View of the rest area at Station 101+00 following trash removal per Compliance Action Item 29.

29	Trash has been left on the rest area pad at Station 101+00 <b>Priority: Low</b>	5/16/2024	5/23/2024	<b>Resolved 5/28/2024</b> Remove the trash in a proper manner.	5/21/2024 - Observation remains. 5/28/2024 - Trash has been removed.

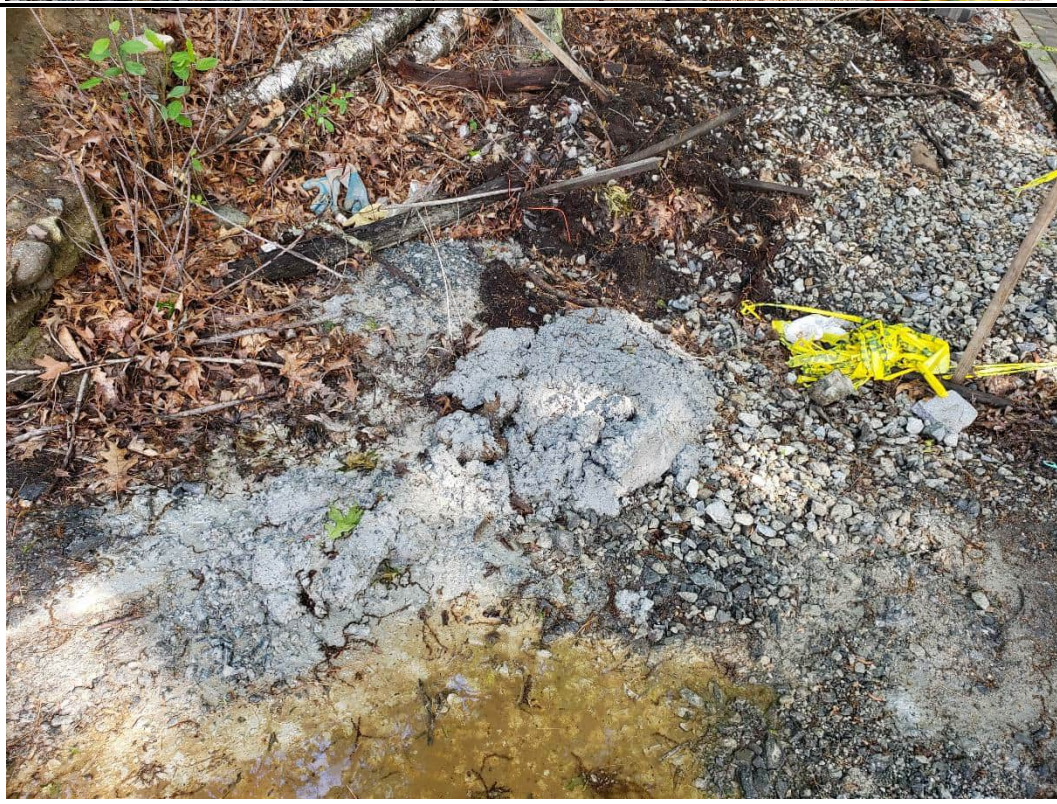
**Photo No. 2**    **Date:**  
5/28/2024

Typical view of dried concrete and cement washout at Station 101+00 per Compliance Action Items 1, 2, 4, 7, 11, 28, 30, 35, 36, 37, 39 and 40.

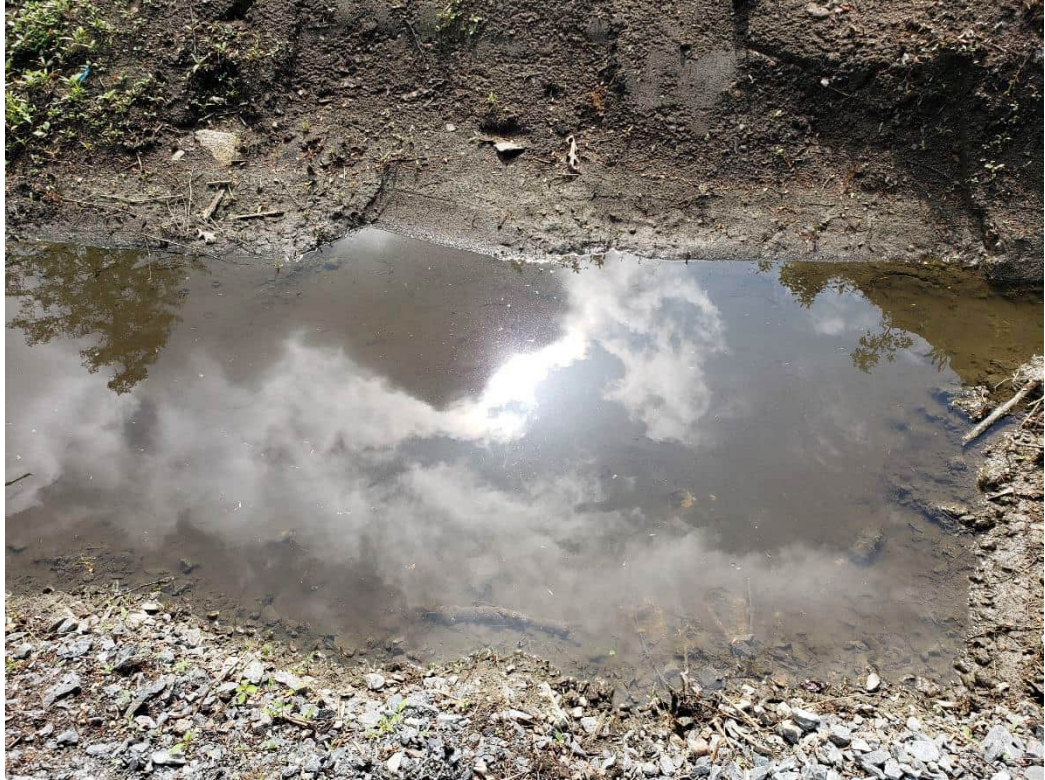
**Photo No. 3**    **Date:** 5/28/2024

View of good water quality within the channel near Stations 167+00 through 172+00 per Compliance Action Item 5.

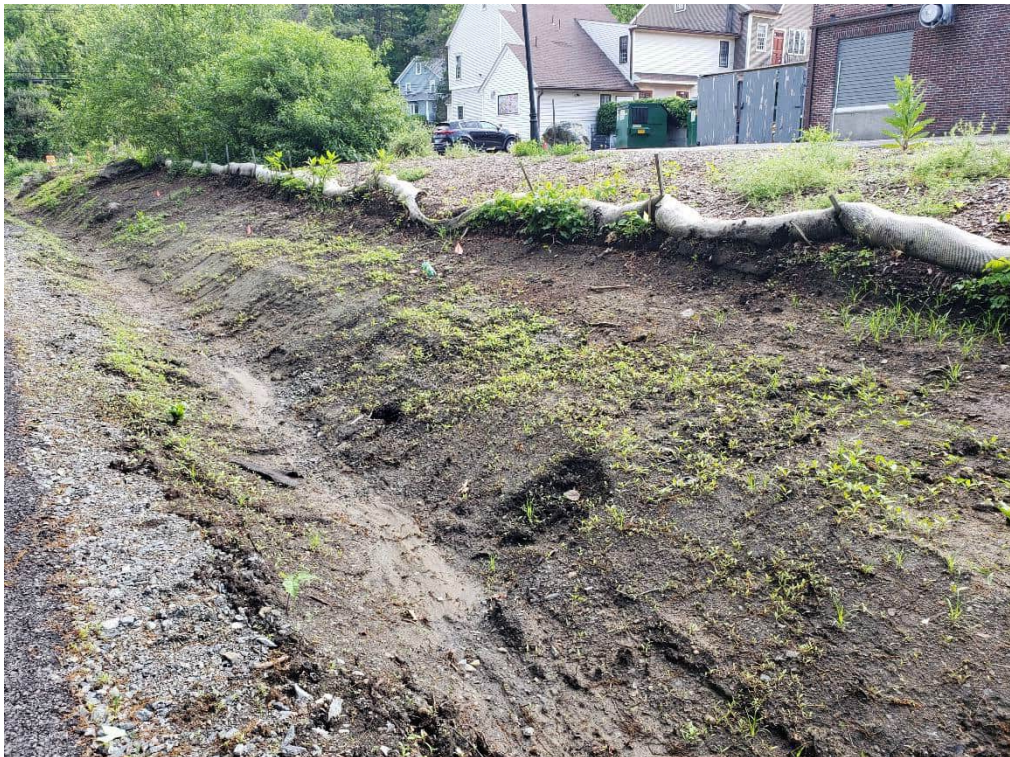
**Photo No. 4**    **Date:** 5/28/2024

6	Exposed sediment slope at Station 172+00 to 175+00 <b>Priority: High</b>	5/8/2024	5/15/2024	Install temporary sediment controls along the slope such as jute netting and/or straw following the application of seed.	5/16/2024 - Observation remains. 5/21/2024 - Observation remains. 5/28/2024 - Partial germination was observed.

View of partial germination along the east side of trail near Stations 172+00 through to 175+00 per Compliance Action Item 6.

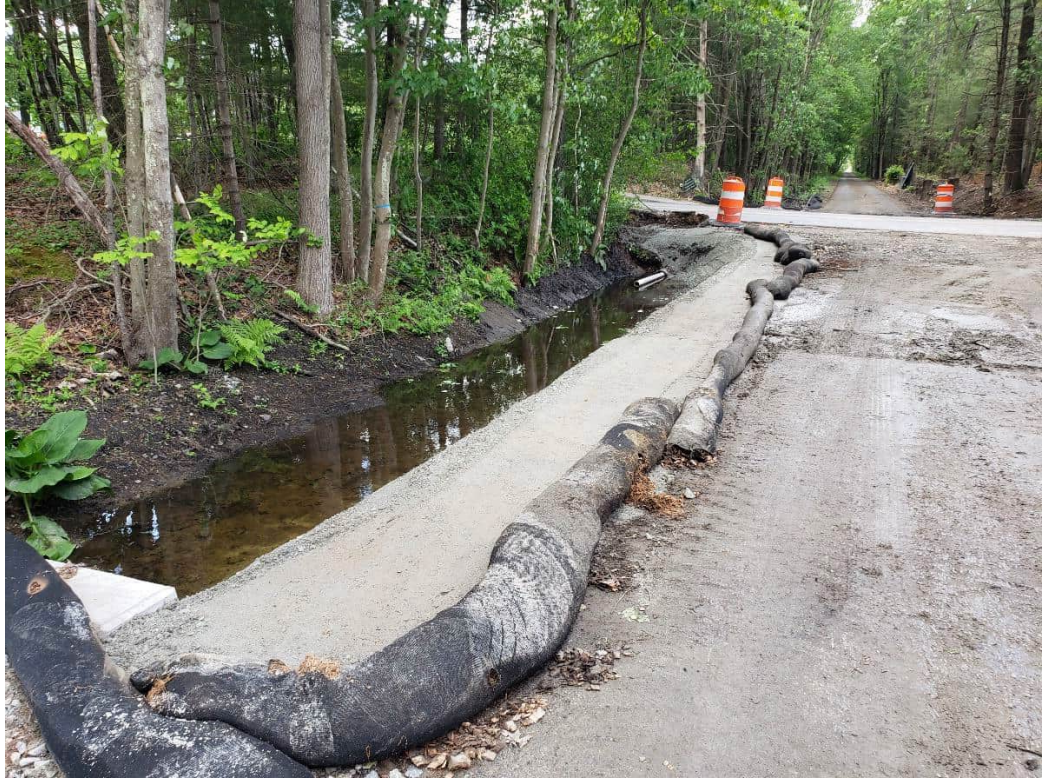
**Photo No. 7**    **Date:** 5/28/2024

Overall Adherence to Environmental Permits	Yes	As noted in Action Items 41 and 42, it appears that work has been conducted beyond the limits of work approved under the Order of Conditions. These areas will require coordination amongst the Project Team to confirm if any restoration is required.

**Description:**  
View of grading of the stream Bank beyond the limits of work at Station 216+00 per Compliance Action Item 41.

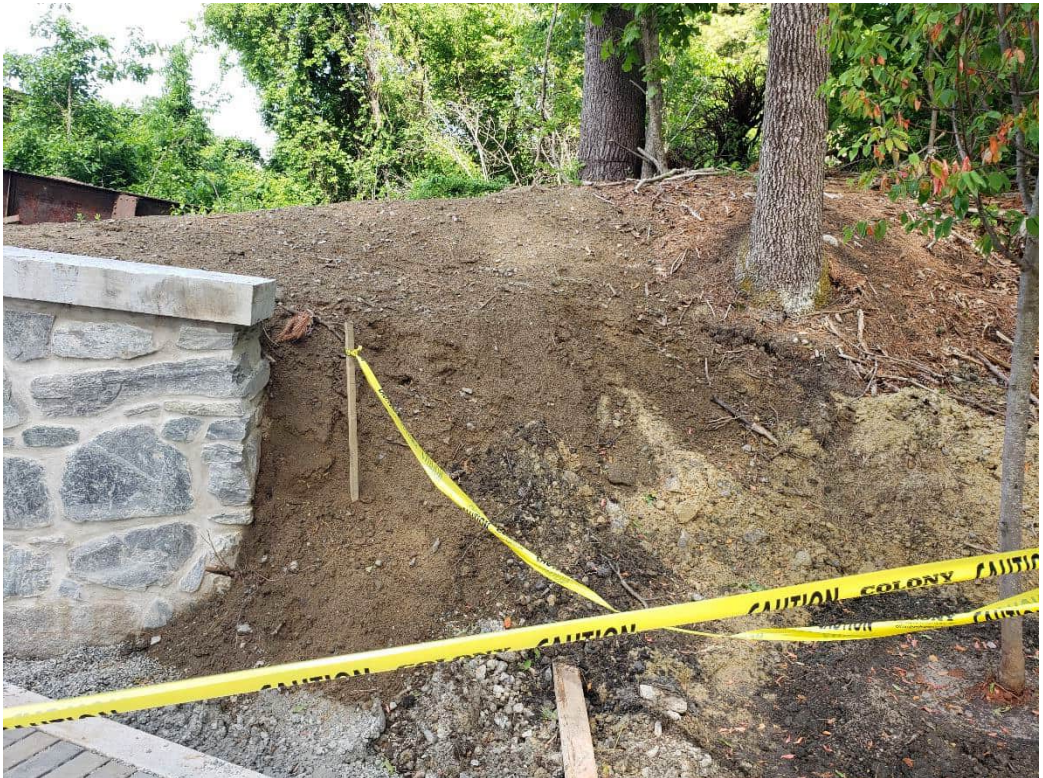
**Photo No. 8**    **Date:** 5/28/2024

35	Concrete pile improperly disposed of at Station 217+45 <b>Priority: Low</b>	5/28/2024	6/4/2024	Remove concrete pile from the area.	
34	Sediment is eroding downhill from behind the cemented stone masonry wall at Station 217+45 <b>Priority: Low</b>	5/28/2024	6/4/2024	Apply seed and temporarily stabilize the soils along the slope with straw, jute netting, etc.	
33	Sediment is eroding downhill and offsite at Station 222+00 through Station 236+00 <b>Priority: High</b>	5/21/2024	5/28/2024	Remove rill erosion and remove over washed material from outside limit of work.	5/28/2024 - Hydroseed has been applied and germination was observed. No new erosion was observed.
32	Soil and organic debris has been placed within the wetland between wetland flagging WF#23-119 and WF#23-118 at Station 224+00 <b>Priority: High</b>	5/21/2024	5/28/2024	Remove all material and provide stabilization of the area with the approved wetland seed mixture. Straw should also be placed for interim stabilization.	5/28/2024 - Observation remains.

**Description:**  
View of exposed soils along a newly constructed masonry wall that require stabilization at Station 217+45 per Compliance Action Item 34.

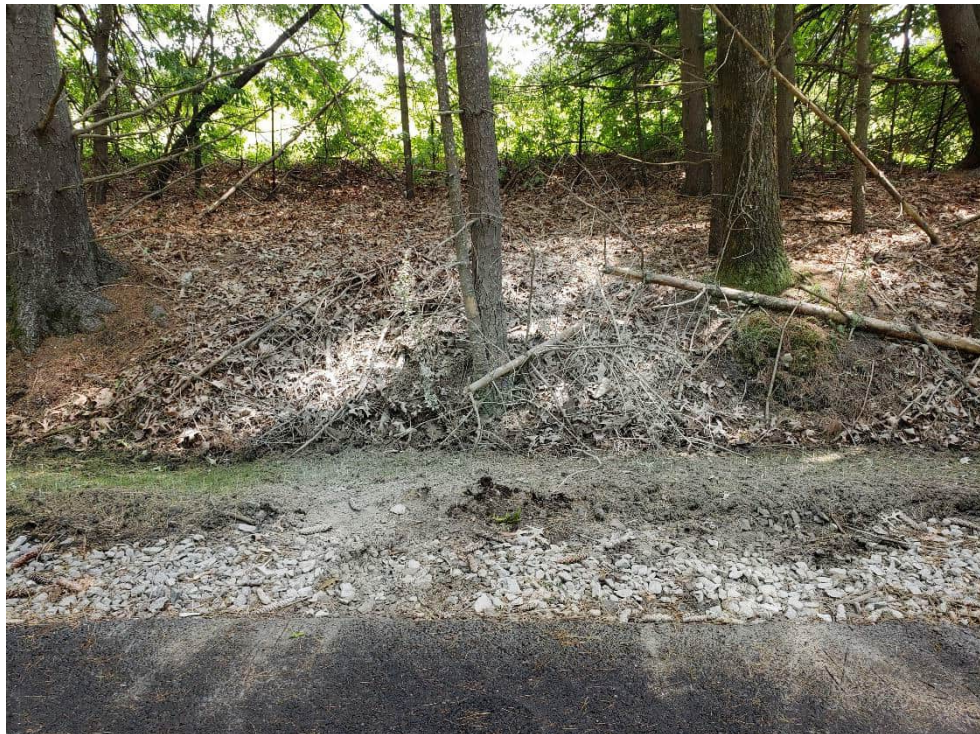
<b>Photo No. 14</b>	<b>Date:</b> 5/28/2024
<b>Direction Photo Taken:</b>  Toward the East	
<b>Description:</b>  View of stone cutting dust that has settled over vegetation at Station 259+00 per Compliance Action Item 38. Follow SWPPP protocols for dust control on site, or update SWPPP to eliminate fugitive dust.
