**Environmental Monitor Construction Site Inspection Report
MassDOT Project #608164 Construction Contract # 119678
EM Report #5**

Project Description: Bruce Freeman Rail Trail Right-of-Way
Permit Description(s): Order of Conditions (MGL Chapter 131, Section 40 and 310 CMR 10.00, Mass DEP File No. 301-1362); 2022 EPA NPDES General Permit for Discharges from Construction Areas; U.S. Army Corps of Engineers Permit No NAE-2021-01975.

Project Name: Bruce Freeman Rail Trail - Phase 2d - Sudbury
Date of Inspections: 5/31/2024
Bi Weekly/ Monthly Period Covered: May Weekly Inspection #5
Inspector's Name(s): Douglas Beach
Inspectors' Contact Information: dbeach@beta-inc.com

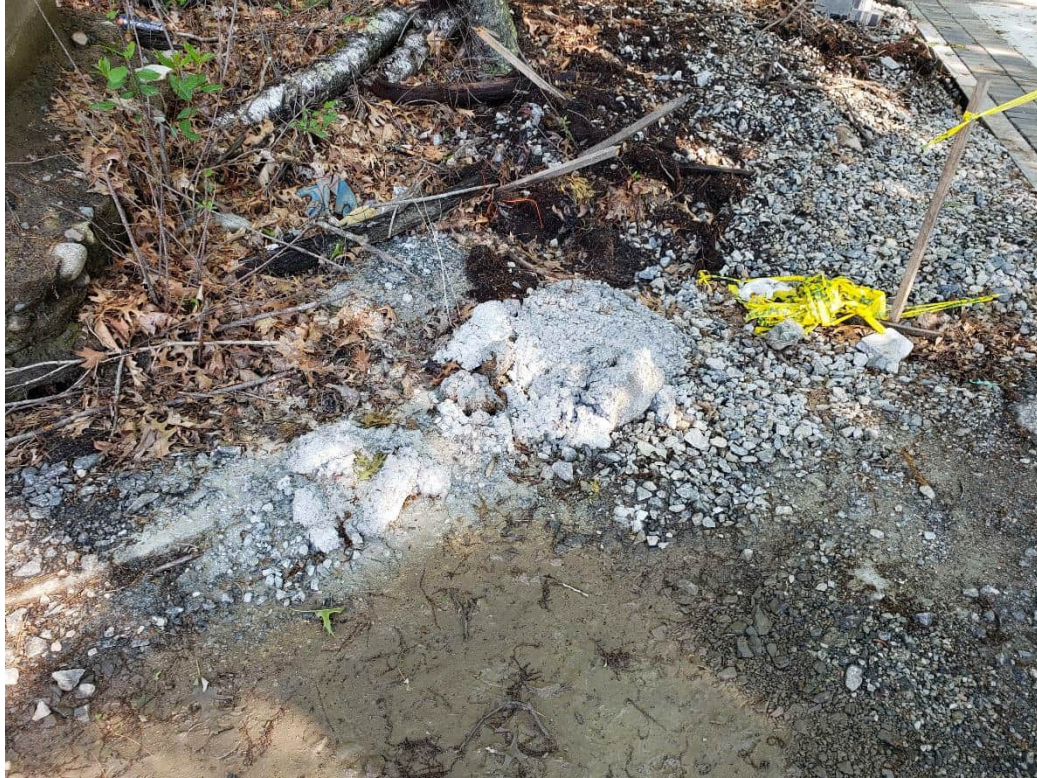
Photo No. 1 **Date:**
5/31/2024

Typical view of dried concrete and cement washout at Station 101+00 per Compliance Action Items 1, 2, 4, 7, 11, 28, 30, 36, 37, 39.

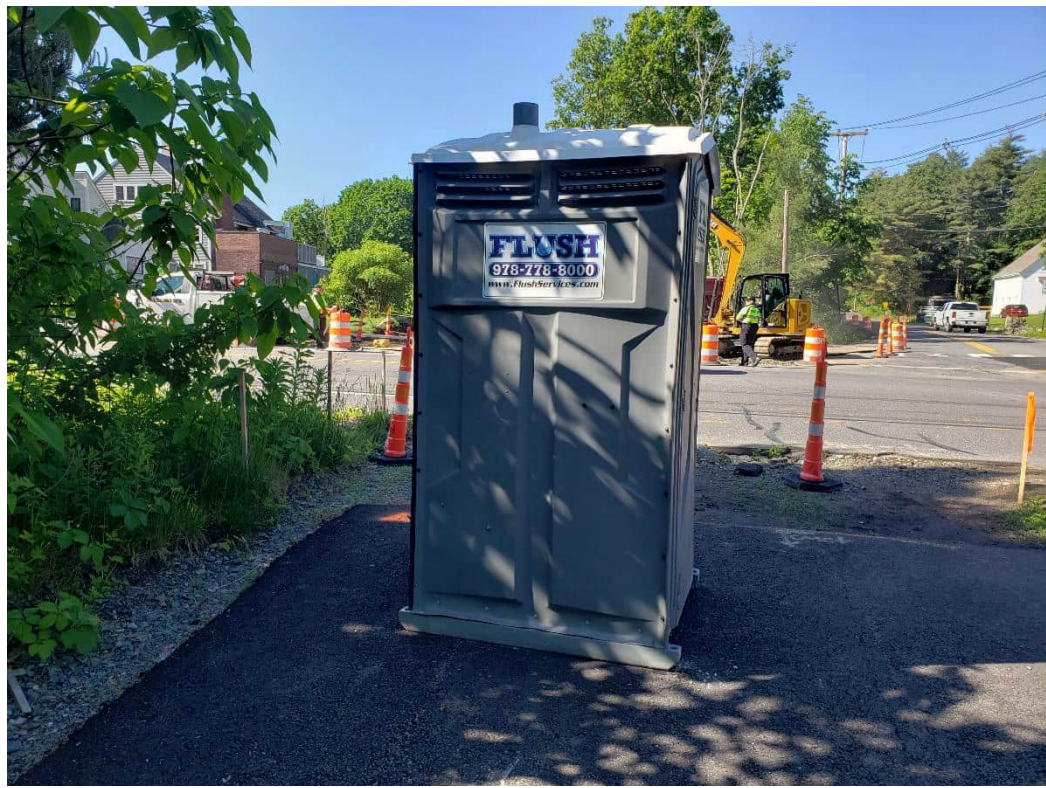
Photo No. 2 **Date:**
5/31/2024

View of a portable restroom installed at Station 176+00

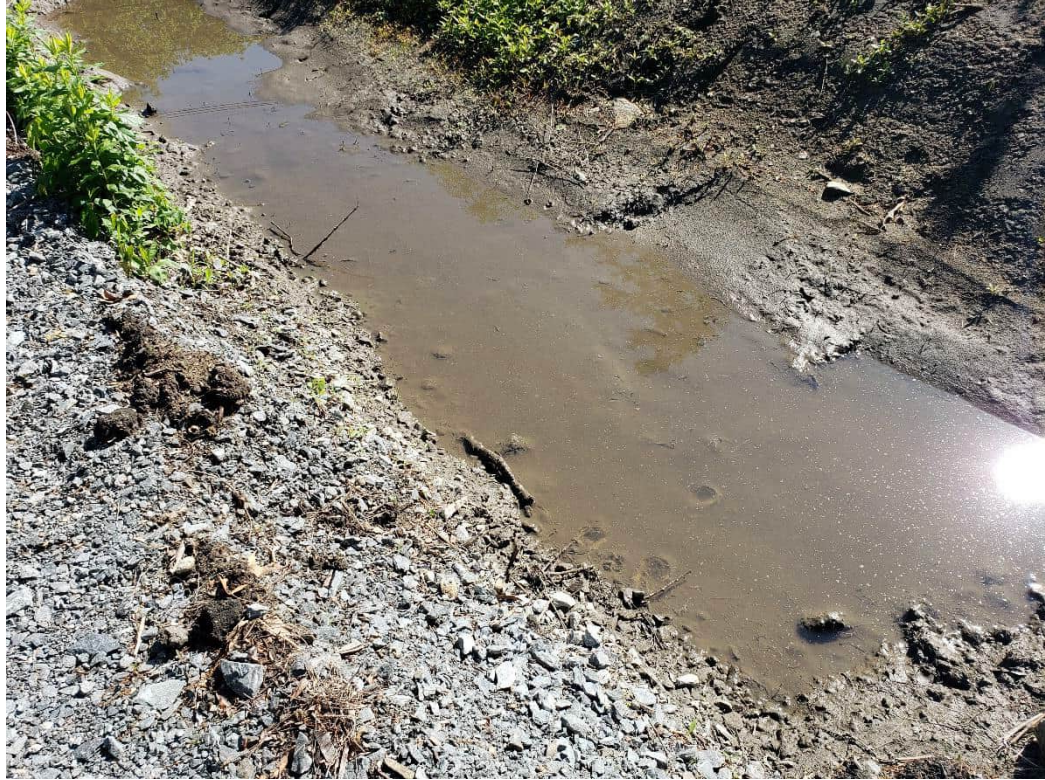
Photo No. 3 **Date:**
5/31/2024

5	Turbid water in swale at Stations 167+00 through 172+00 Priority: High	5/8/2024	5/15/2024	Stabilize all contributing areas to the swale and implement stabilization measures over exposed soils within the swale itself once water recedes. It is recommended that the contractor coordinate with MassDOT on stabilization within the swale, which may require jute netting and seed.	5/16/2024 - Observation remains. 5/21/2024 - Observation remains. 5/28/2024 - Good water quality was observed; however, no stabilization measures have been implemented. 5/31/2024 - Good water quality was present; however, no additional stabilization measures have been installed.
6	Exposed sediment slope at Station 172+00 to 175+00 Priority: High	5/8/2024	5/15/2024	Install temporary sediment controls along the slope such as jute netting and/or straw following the application of seed.	5/16/2024 - Observation remains. 5/21/2024 - Observation remains. 5/28/2024 - Partial germination was observed. 5/31/2024 - See previous update.

View of good water quality within the channel near Stations 167+00 through 172+00 per Compliance Action Item 5.

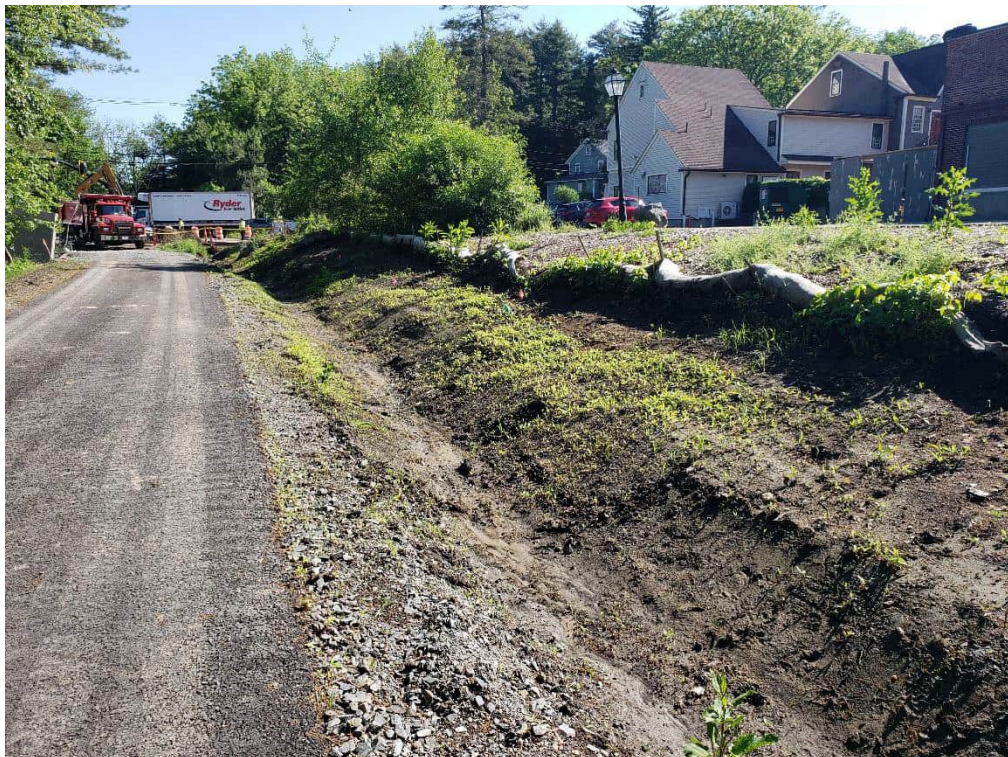
Photo No. 4 **Date:**
5/31/2024

View of partial germination along the east side of trail near Stations 172+00 through to 175+00 per Compliance Action Item 6.

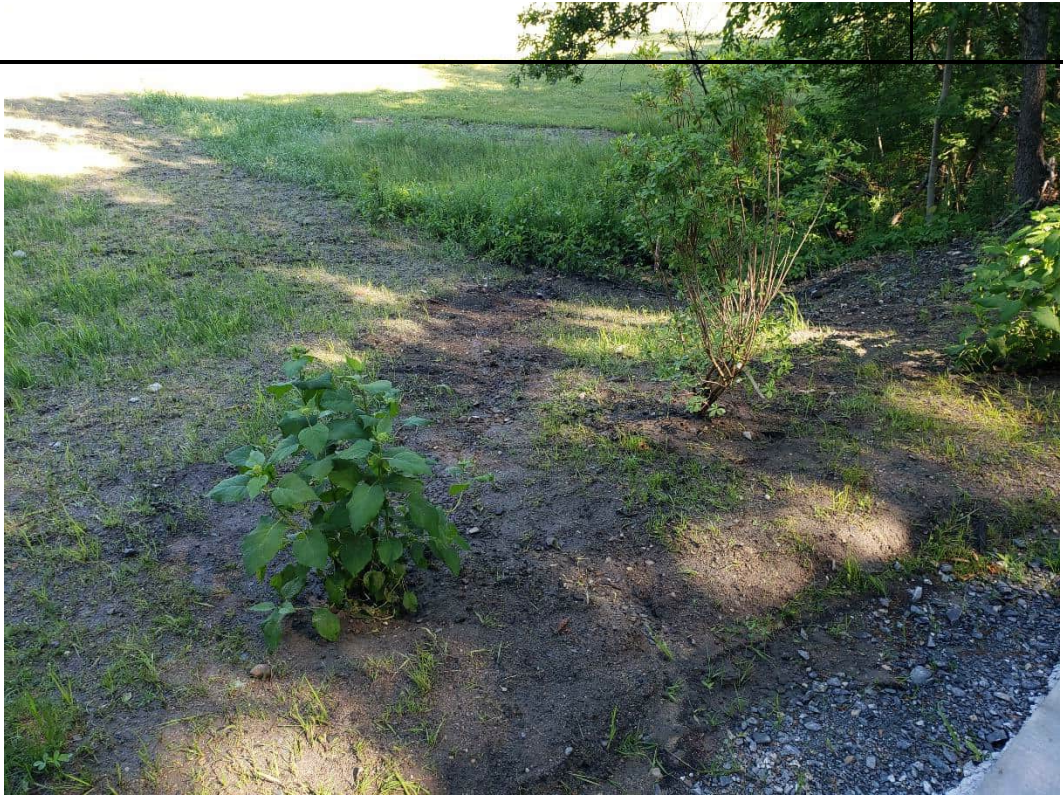
Direction Photo Taken: Toward the Northwest		
Description: View of filled rill erosion and proposed plantings along a slope at the intersection of Stations 184+50 and 1003+00 per Compliance Action Item 9.		
Photo No. 6	Date: 5/31/2024

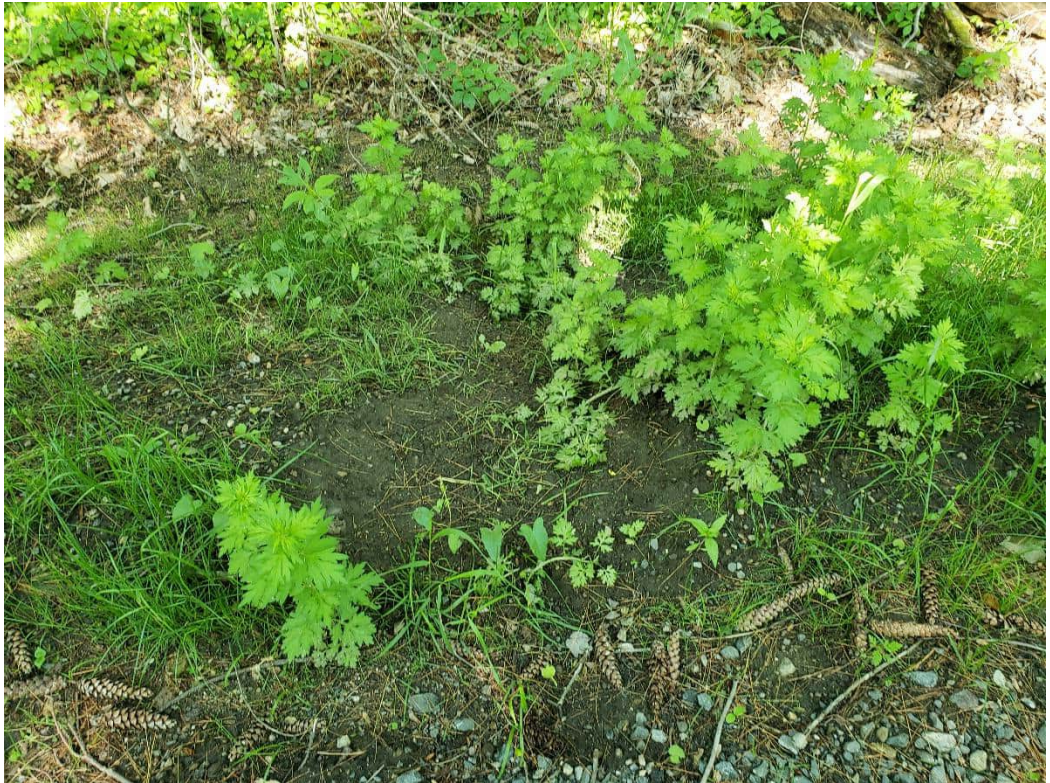
13	Rill erosion is occurring along the west side of the trail at Stations 201+50 to 204+00 Priority: Low	5/8/2024	5/15/2024	Fill in rills and apply seed to stabilize the area. Temporary stabilization measures such as straw and/or jute netting may be required.	5/16/2024 - Observation remains. 5/21/2024 - Observation remains. 5/28/2024 - Rill erosion has not been filled; however, germination was observed. 5/31/2024 - Observation remains.
14	Sediment-laden runoff is being discharged into a stream from the new parking lot at Station 216+50 Priority: High	5/8/2024	5/15/2024	Replace compost filter tubes around the stream and develop a method of redirecting runoff from the parking lot at the source.	5/16/2024 - New compost filter tubes have been installed but were observed to be undermined. In addition, a new earthen slope was observed to be constructed in this area and requires stabilization. 5/21/2024 - No turbidity was observed due to no rain preceding this inspection. However, additional erosion controls should be explored at this location to prevent future discharges. 5/28/2024 - Untreated runoff being discharged from the parking area has not been addressed, and work is occurring along the stream beyond the compost filter tubes. 5/31/2024 - Observation remains.

Direction Photo Taken: Toward the West		
Description: View of typical rill erosion and sediment runoff along the west side of the trail from Station 201+00 through 204+00 per Compliance Action Item 13.

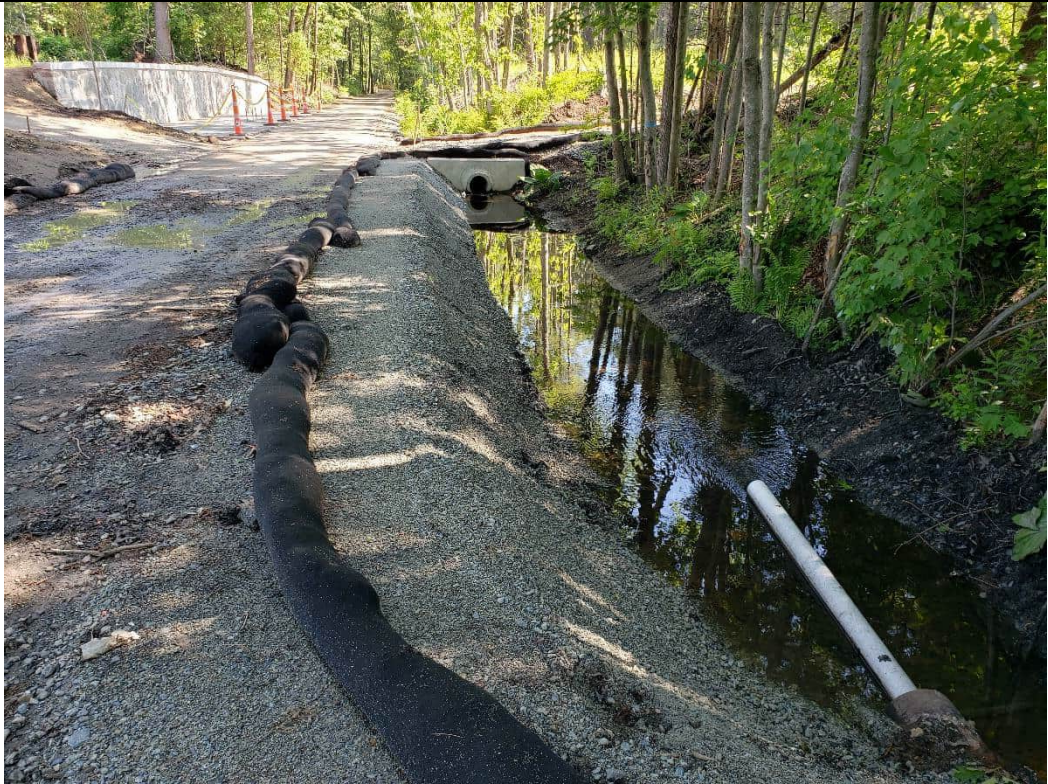
Photo No. 7 **Date:** 5/31/2024

Overall Adherence to Environmental Permits	Yes	As noted in Action Items 41 and 42, it appears that work has been conducted beyond the limits of work approved under the Order of Conditions. These areas will require coordination amongst the Project Team to confirm if any restoration is required.

View of grading of the stream Bank beyond the limits of work at Station 216+00 per Compliance Action Item 41.

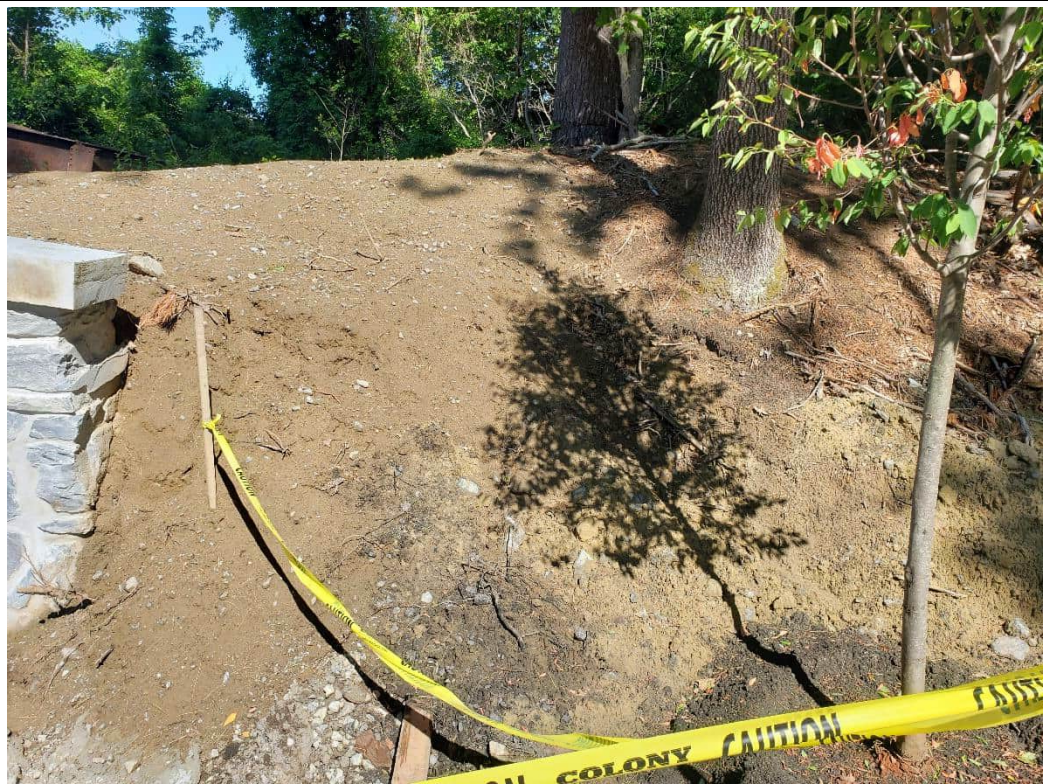
Photo No. 8 **Date:** 5/31/2024

View of exposed soils along a newly constructed masonry wall that require stabilization at Station 217+45 per Compliance Action Item 34.

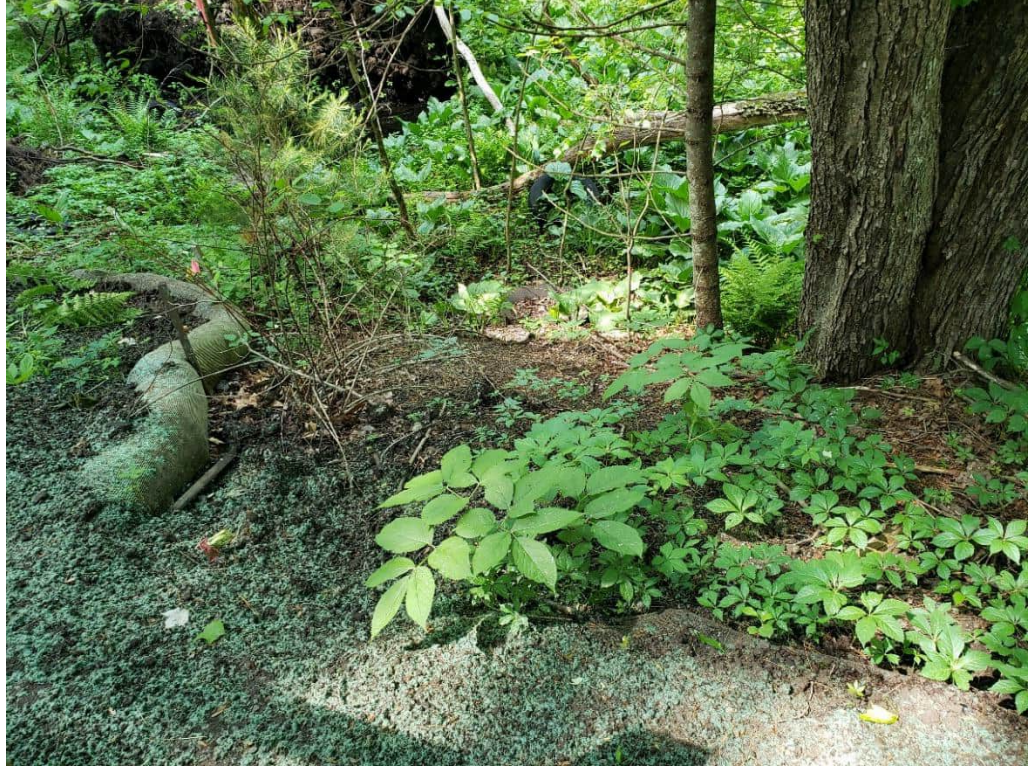
Photo No. 11 **Date:** 5/31/2024

View of washout overtopping compost filter tubes at Station 231+00 per Compliance Action Item 16.

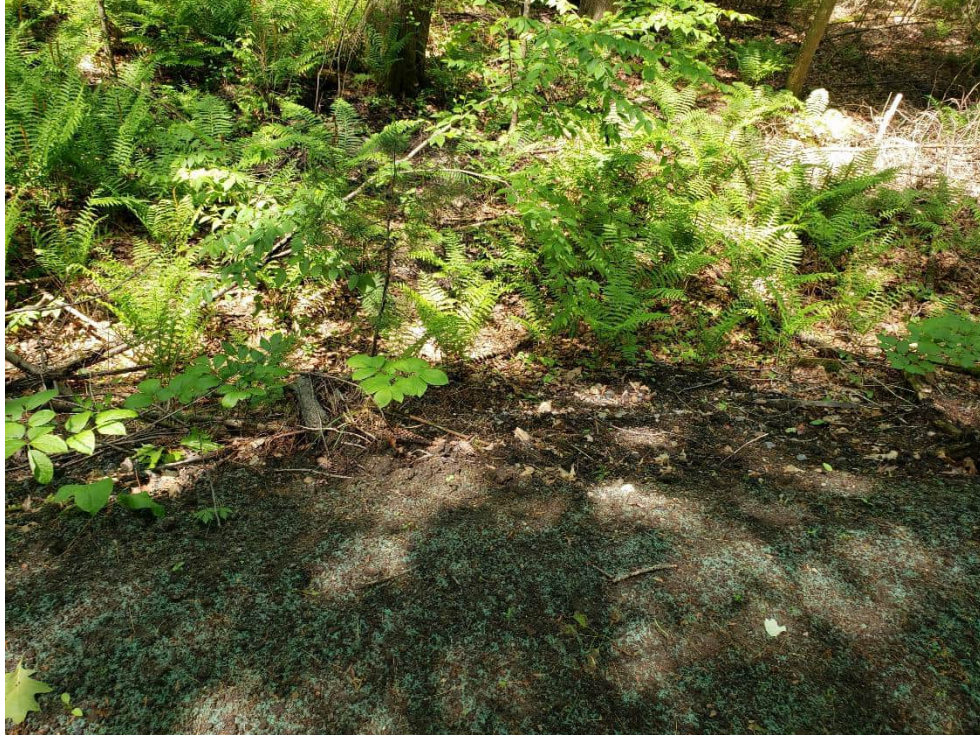
Photo No. 13	Date: 5/31/2024
---------------------	---------------------------

Description: View of washout overtopping compost filter tubes near Stations 238+00 and 241+00 per Compliance Action Item 18.
--

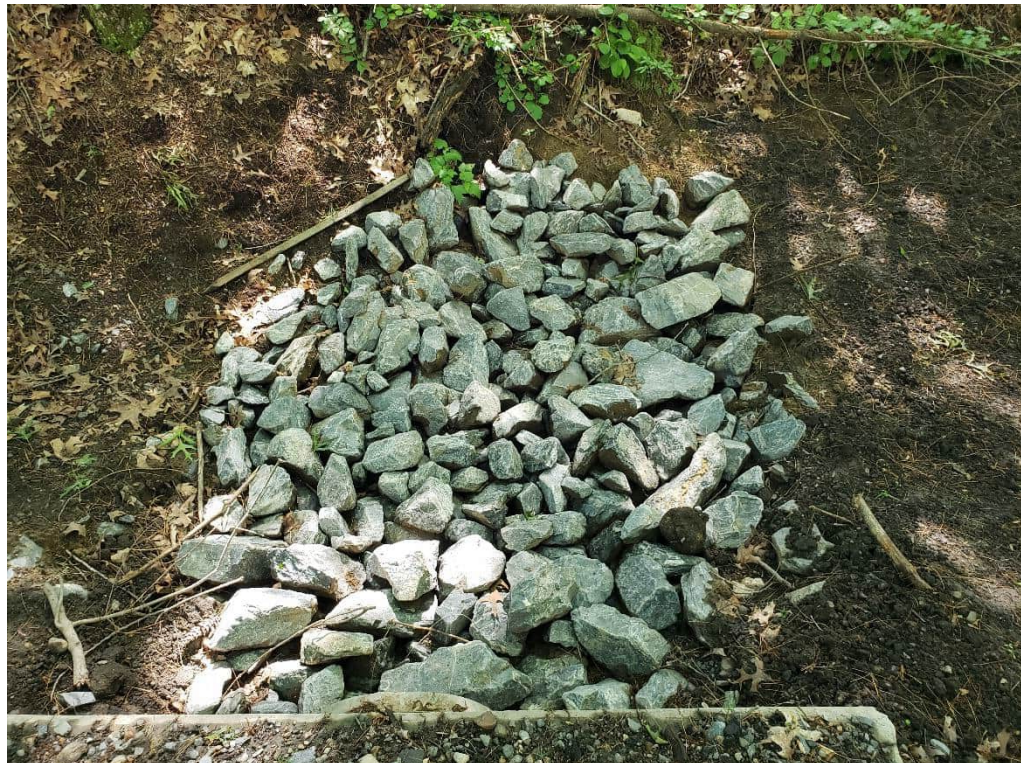
Photo No. 14	Date: 5/31/2024
---------------------	---------------------------

Description: View of the stone for pipe ends at Station 257+00 following removal of accumulated sediment per Compliance Action Item 22.
