Weekly Environmental Compliance Summary

Sudbury to Hudson Transmission Reliability Project (USEPA Tracking # MAR1003UW)

Sudbury, Hudson, and Stow, MA

Week of: August 26, 2024 to August 30, 2024

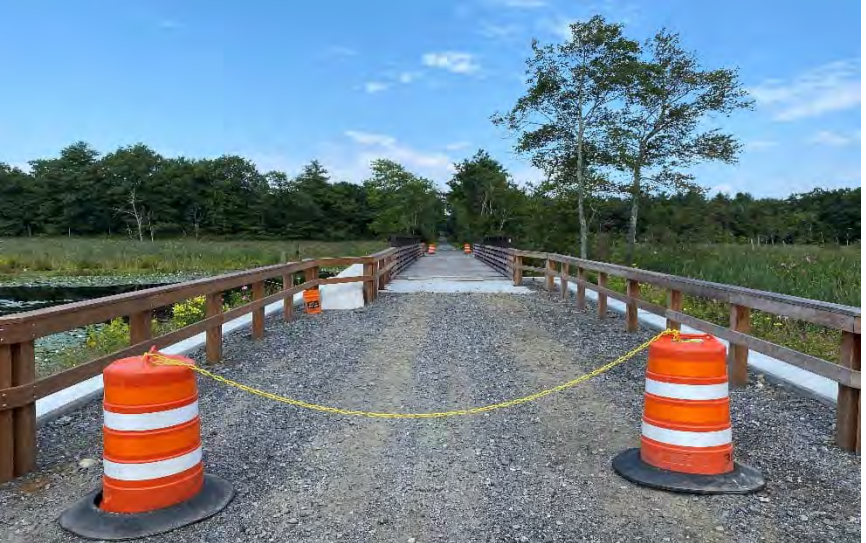
| <p>Photo No.: 1</p> | <p>Date: 8-26-24</p> | | |

| <p>Description:</p> <p>Bridge 130, over Fort Meadow Brook, existing erosion control, looking westward.</p> | | | |

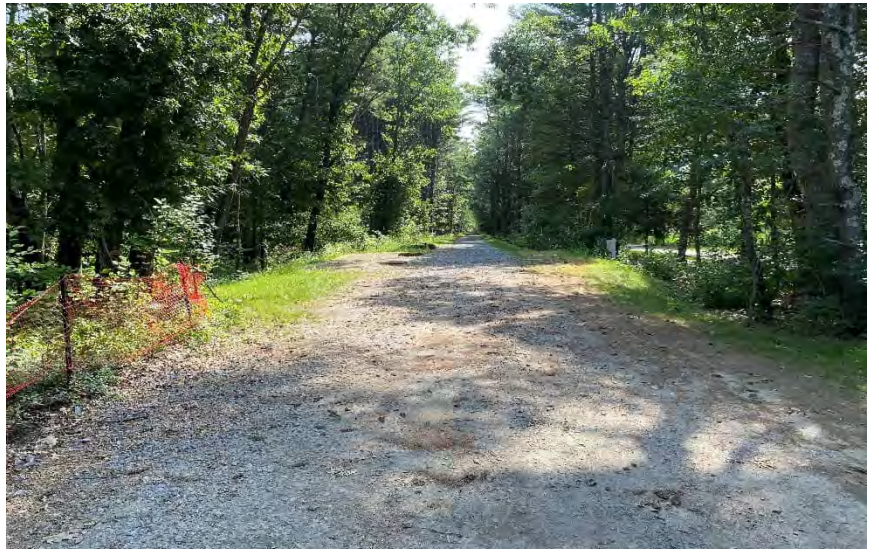
| <p>Photo No.: 6</p> | <p>Date: 8-26-24</p> | | |

| <p>Description:</p> <p>Work area within segment 5, manhole #11, existing erosion control, looking eastward.</p> | | | |

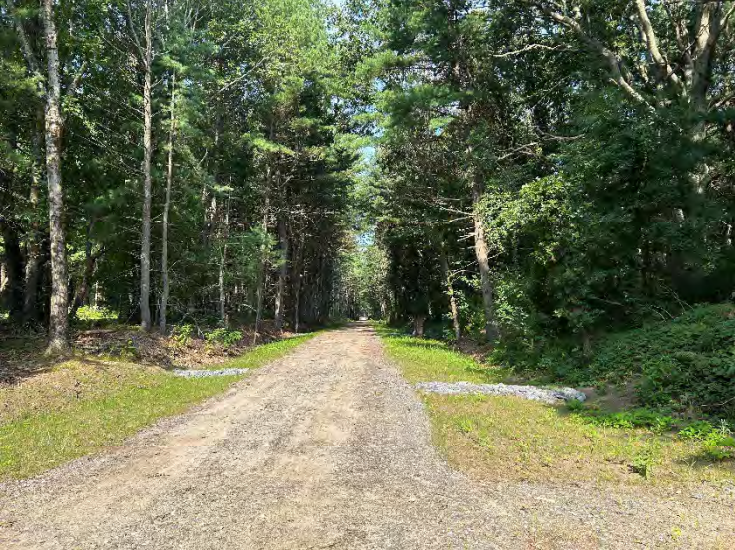
| <p>Photo No.: 4</p> | <p>Date: 8/26/2024</p> | | |

| <p>Description: View of installed rock check dams in segment 11. Facing east.</p> | | | |

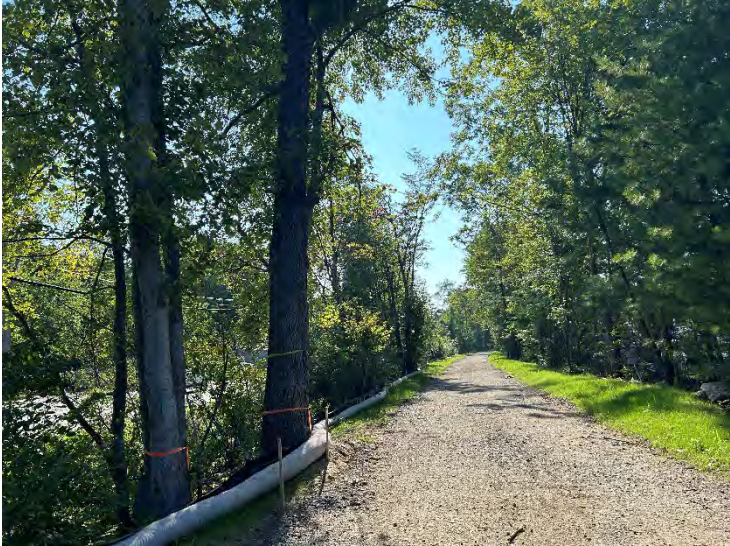
| <p>Photo No.: 5</p> | <p>Date: 8/27/2024</p> | | |

| <p>Description: View of erosion and sediment controls in segment 12. Facing east.</p> | | | |

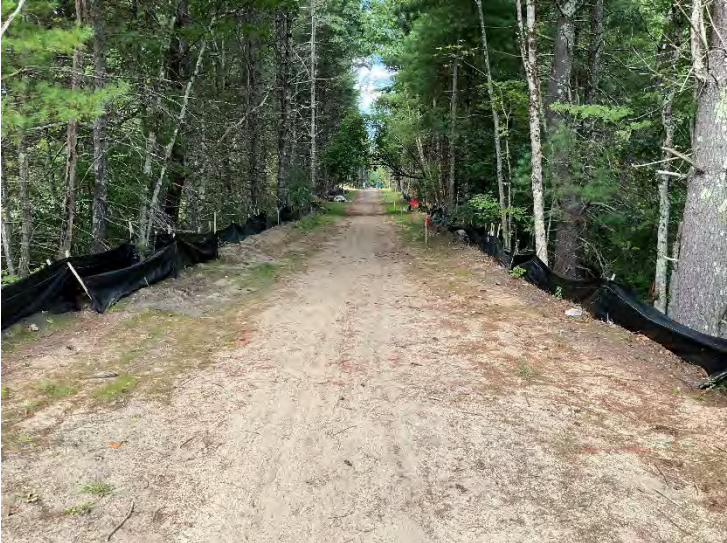
| Photo No.: 6 | Date: 8/30/2024 | | |

| Description: View of E&S controls in segment 7. Facing east. | | | |

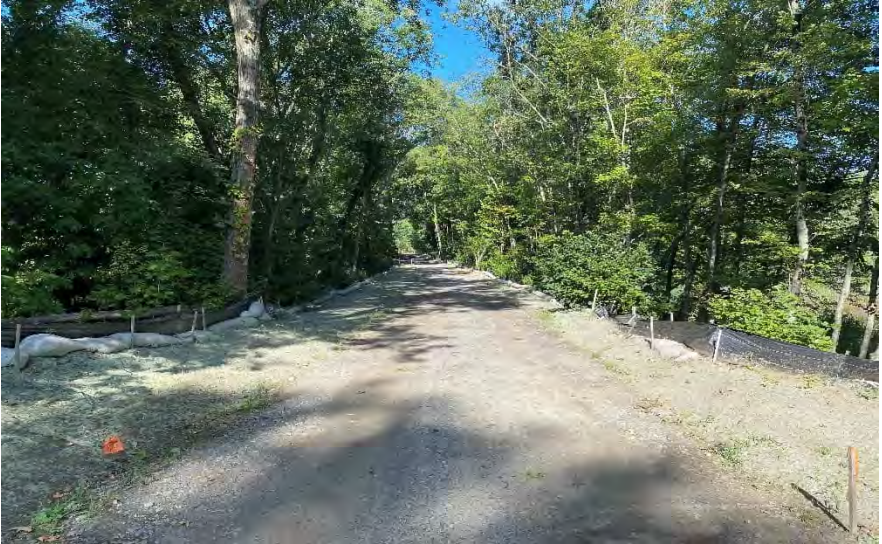
| Photo No.: 5 | Date: 8-29-24 | | |

| Description: Work area within segment 1, recent loaming/hydro seeding, existing erosion control, looking westward. | | | |

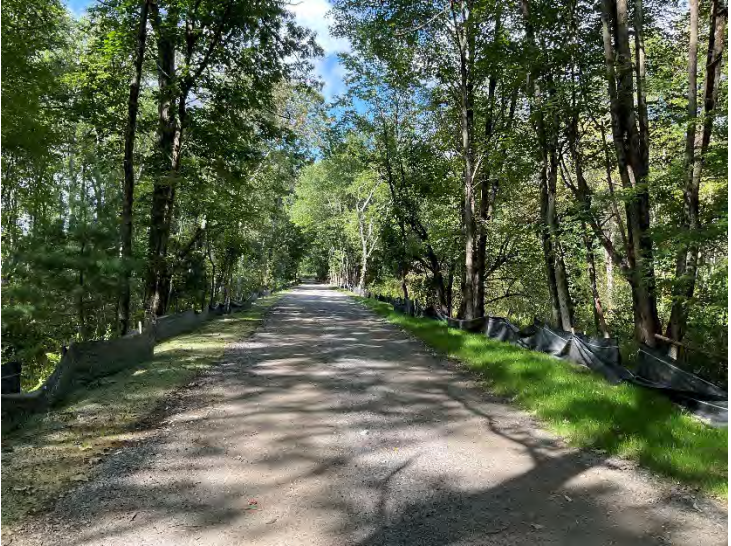
| Photo No.: 8 | Date: 8-29-24 | | |

| Description: View of E&S controls in segment 14. Facing west. | | | |

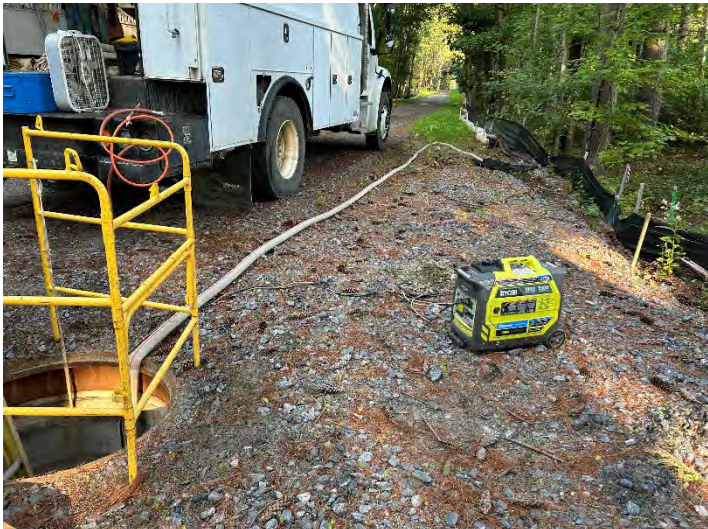
| Photo No.: 4 | Date: 8/27/2024 | | |

| Description: View of dewatering setup and discharge from filter bag. Discharge appeared clear and turbidity reading was below 50 NTUs. Discharge did not appear to reach any jurisdictional resource areas. Facing west. | | | |

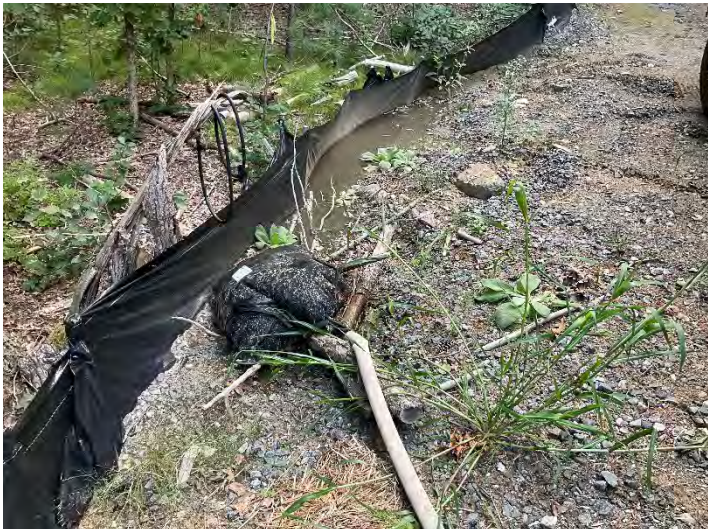
| | | PHOTOGRAPHIC LOG | |
|--|---|--|---|
| Photo No.: 4 | Date: 8/28/2024 | | |

| | | PHOTOGRAPHIC LOG | |
|--|---|--|---|
| Description: View of dewatering setup and discharge from filter bag. Discharge appeared slightly turbid and turbidity reading was above 50 NTUs. Facing east. | | | |

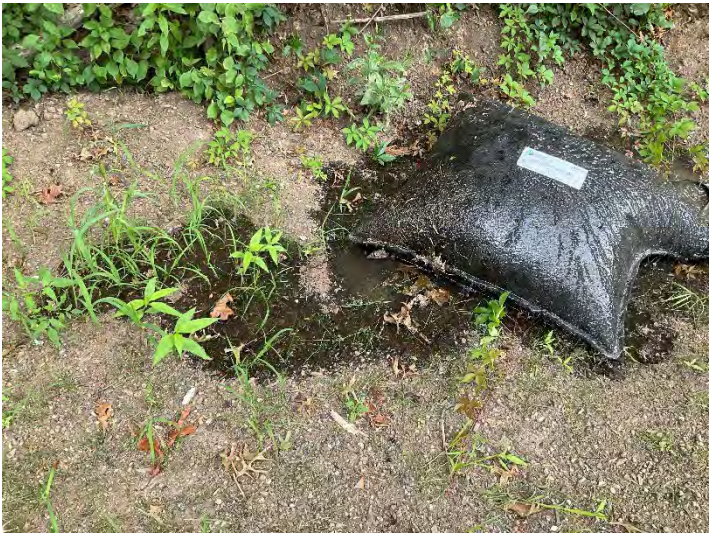
| Photo No.: 4 | Date: 8/29/2024 | | |

| Description: View of discharge from filter bag. Discharge appeared to be mostly clear and turbidity reading was below 50 NTUs. Facing north. | | | |
