Client:			Town of Sudbury
Project Name:		Sudbury-Hudso	n Transmission Reliability
nspector:			Jeffrey Polidor
Project No:			22012F
nspection Date:	9/16/24	Arrival Time:	9:00 AM
Weather:	Clear, 75°F D o	eparture Time:	12:00 PM

Sudbury to Hudson 115kV Underground Transmission Line

Field Report No. 27 page 2

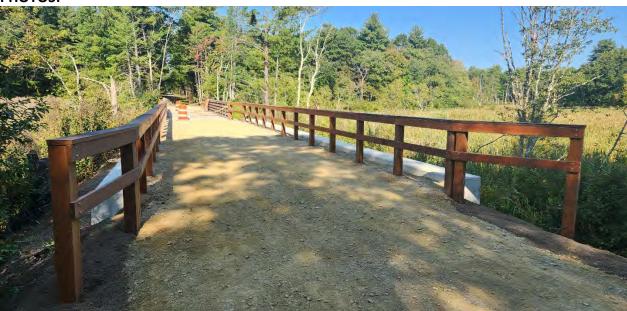
Photo 1: Timber rail post installation is complete at bridge 128. Photo taken on 9/16/24

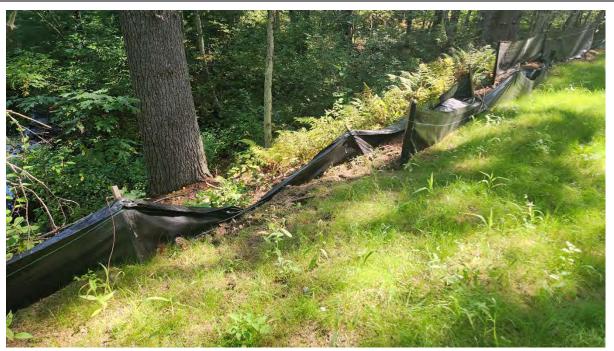
Photo 2: Broken stakes and sagging in the silt fence along segment 9. Photo taken on 9/16/24

1. Repair silt fence and filter tube as noted above.

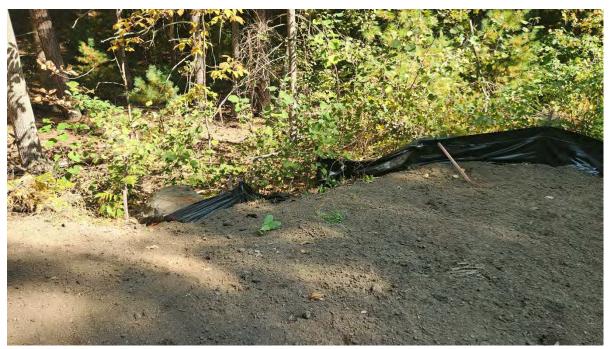
Photo 3: Broken stakes and ripping in the silt fence along segment 10. Photo taken on 9/16/24

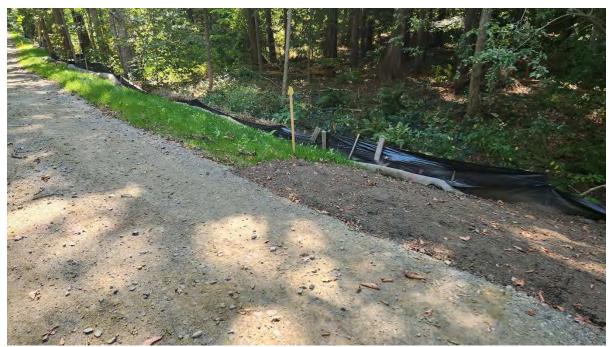
Photo 4: Loam and planting soil installed along segment 13. Photo taken on 9/16/24

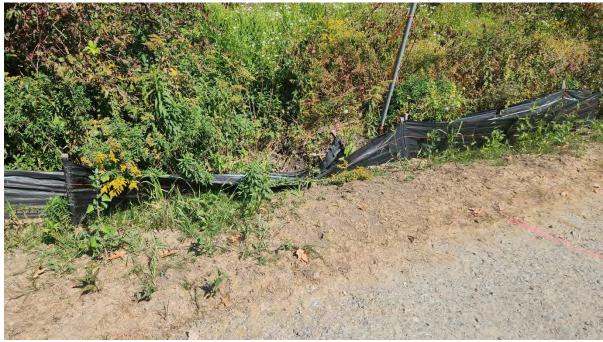
Photo 5: Silt fence ripped along segment 14. Photo taken on 9/16/24.

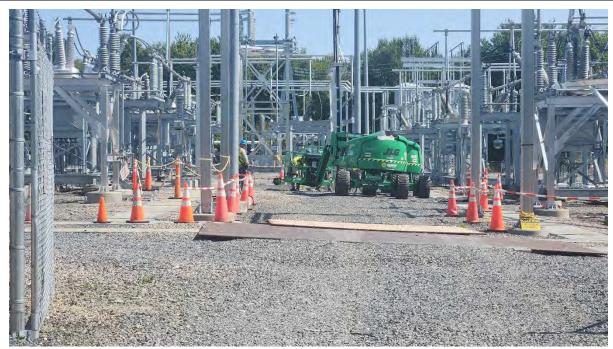
Photo 6: Cable splicing was conducted at the Eversource Substation. Photo taken on 9/16/24.
