**Environmental Monitor Construction Site Inspection Report**  
**MassDOT Project #608164 Construction Contract # 119678**  
**EM Report #21**

Project Description: Bruce Freeman Rail Trail Right-of-Way  
 Permit Description(s): Order of Conditions (MGL Chapter 131, Section 40 and 310 CMR 10.00, Mass DEP File No. 301-1362); 2022 EPA NPDES General Permit for Discharges from Construction Areas; U.S. Army Corps of Engineers Permit No NAE-2021-01975.

Project Name:	Bruce Freeman Rail Trail - Phase 2d - Sudbury
Date of Inspections:	9/3/2024
Bi Weekly/ Monthly Period Covered:	September Weekly Inspection #1
Inspector's Name(s):	Anna Haznar
Inspectors' Contact Information:	ahaznar@beta-inc.com

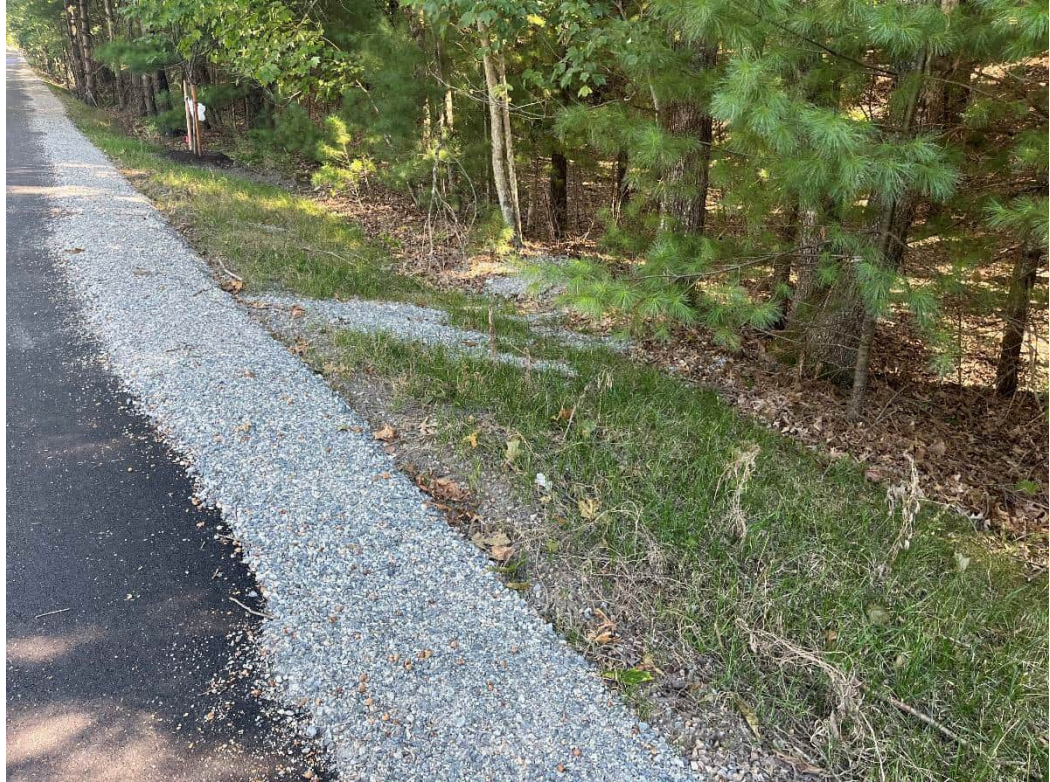
**Photo No. 7**    **Date:**  
9/3/2024

View of a location where crushed stone has migrated off of the shoulders and onto the path at Station 180+00 per Long Term Compliance Action Item 58.

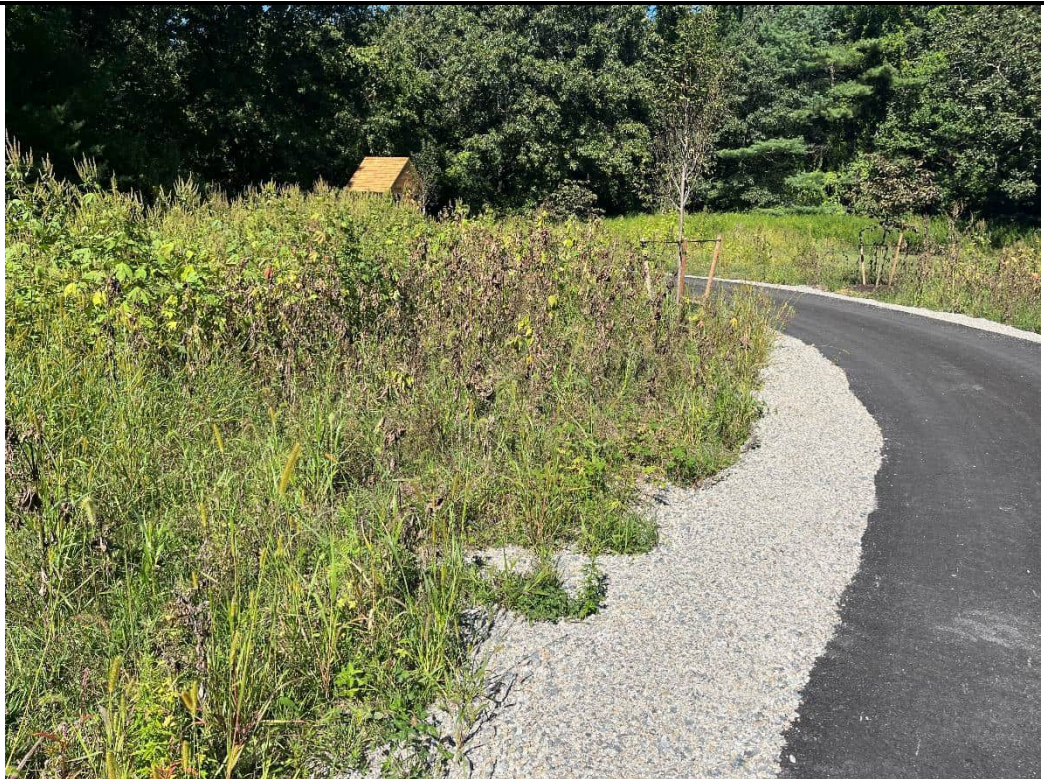
**Photo No. 8**    **Date:**  
9/3/2024

View of a location where Japanese hops require treatment and crushed stone has migrated off of the shoulders at Station 1002+00 per Long Term Compliance Action Item 57 and 58.

57	Japanese hops ( <i>Humulus japonicus</i> ) has been observed throughout the Project and requires removal <b>Priority: High</b>	8/5/2024	8/12/2024	The Contractor should perform varying removal approaches including herbicide treatment and hand pulling to remove the vegetation throughout the Project and reseed areas that are no longer stabilized due to herbicide application.	8/5/2024 - Removal methods, including herbicide work and hand pulling have been observed to remove the plant throughout the Project. 8/7/2024 - Japanese hops and other invasives appear to be wilting due to herbicide application. Multiple areas along the trail appear to have not been treated and seed heads have appeared on some of the plants that were not treated. A second application of herbicide and pulling of plants with seedheads is recommended to ensure spreading does not continue. 8/12/2024 - Herbicide application on the Japanese hops and other invasives was occurring at the time of the inspection. Plants that have been previously treated appear to be dead or wilting. 8/16/2024 - A majority of the Japanese hops were observed as wilting, while some plants do not appear to have been treated (i.e., near Station 1003+00). 8/20/2024 - Multiple areas throughout the Project where herbicide application was performed have been observed as no longer stable due to herbicide killing grass and other vegetation. These areas include but are not limited to Station 137+00 to Station 145+00 and Station 223+00 to Station 240+00. These areas should be reseeded to ensure stabilization. 8/27/2024 - Observation remains. Areas that are no longer stabilized due to herbicide application should be reseeded. There are multiple locations along the path where hops are present with seed heads and should be retreated. 9/3/2024 - Observation remains. Japanese hops that were treated with herbicide appear to be dead. Japanese hops are still present along the path in varying amounts, with a large population with seed heads present near Station 1002+00. Areas that are no longer stabilized due to herbicide application are further discussed in Long Term Compliance Action Item 59.

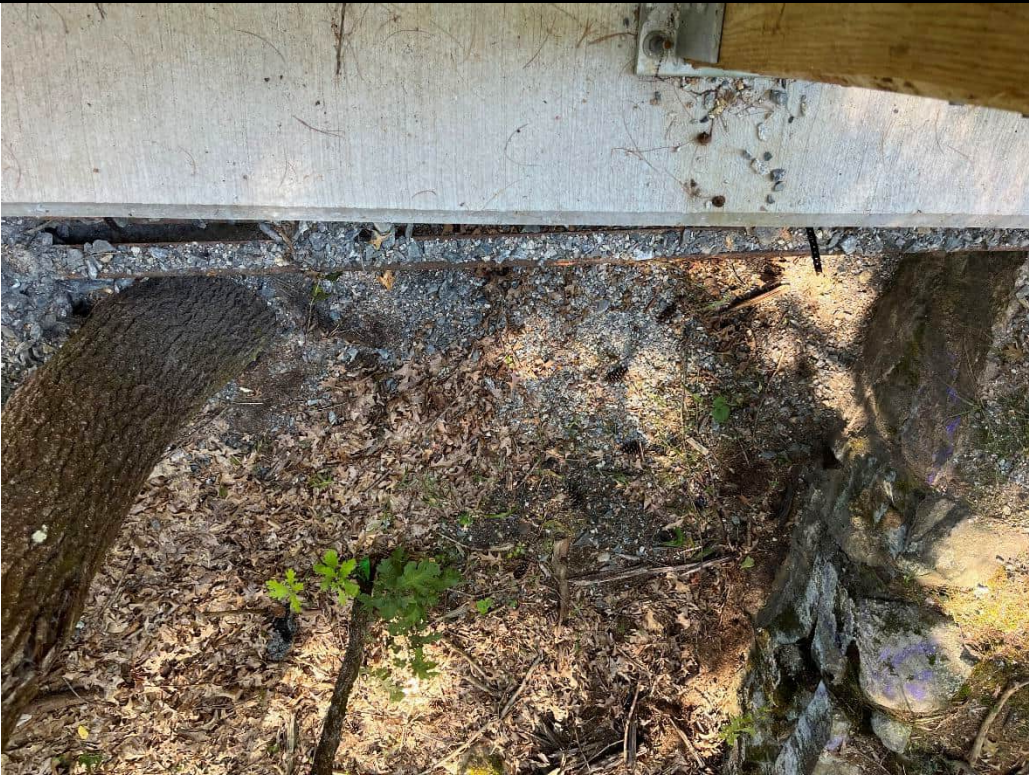
<b>Site Location</b> Bruce Freeman Rail Trail Right-of-Way		<b>BETA Project No.</b> 24.10326.23
<b>Photo No. 9</b>	<b>Date:</b> 9/3/2024

<b>Direction Photo Taken:</b>  Toward the East		
<b>Description:</b>  View of the crushed stone that has discharged into the cattle crossing at Station 190+50 per Long Term Compliance Action Item 58.		
<b>Photo No. 10</b>	<b>Date:</b> 9/3/2024

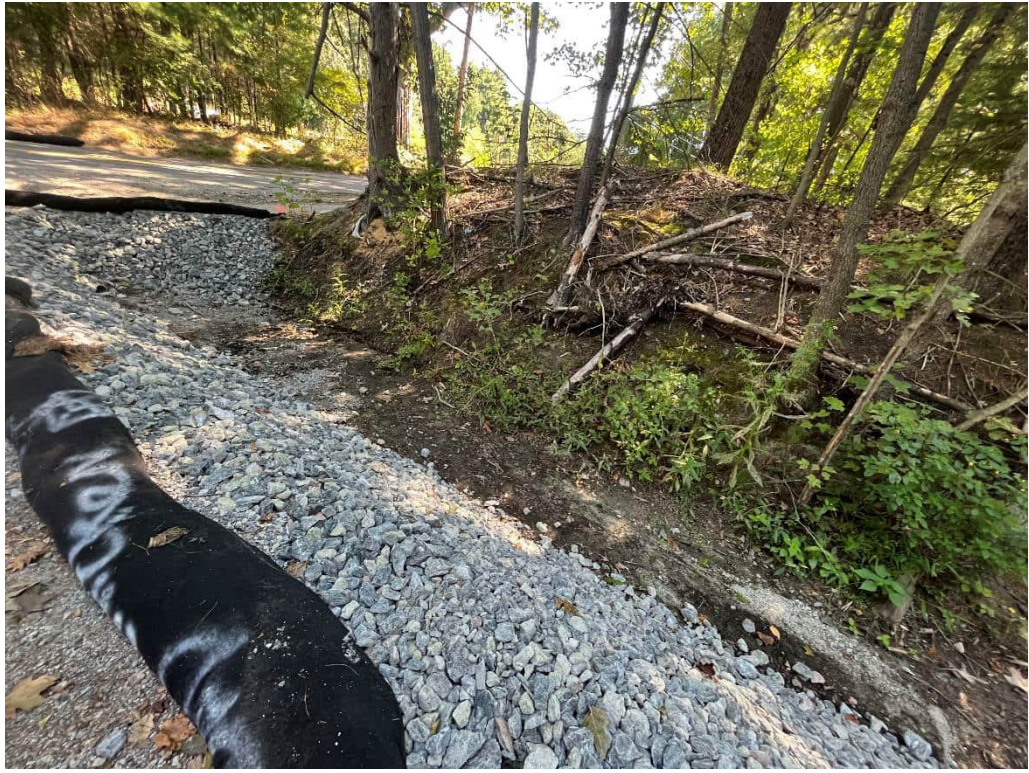
<b>Direction Photo Taken:</b>  Toward the East		
<b>Description:</b>  View of the location where crushed stone has discharged into the streambed at Station 215+00 per Long Term Compliance Action Item 58.

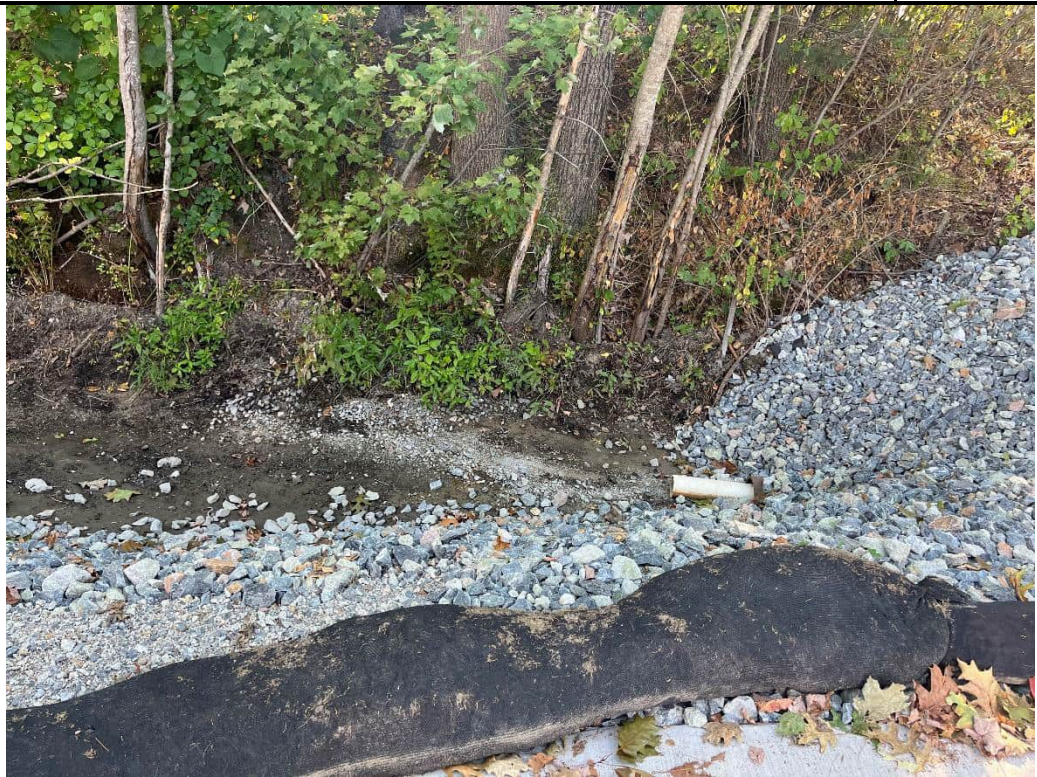
**Photo No. 11**    **Date:**  
9/3/2024

View of another location where crushed stone has discharged into the streambed at Station 216+00 per Long Term Compliance Action Item 58.

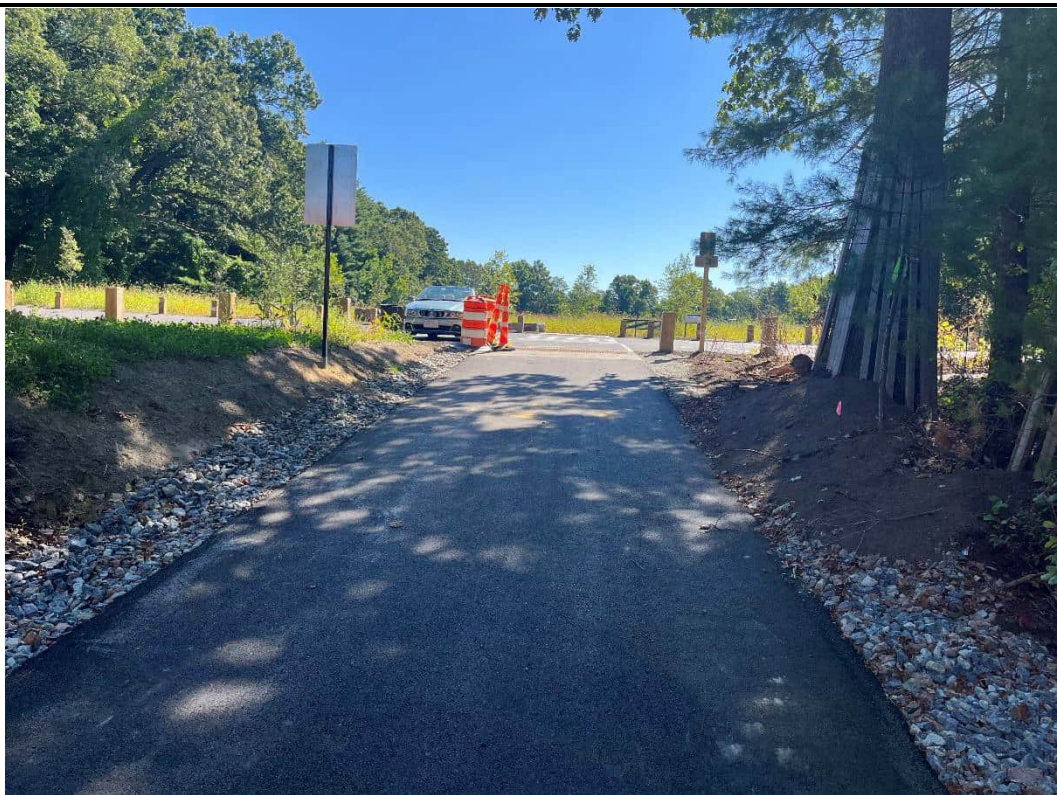
**Photo No. 12**    **Date:**  
9/3/2024

View of the slopes along the driveway to the parking lot that require stabilization near Station 216+50 per Compliance Action Item 52.

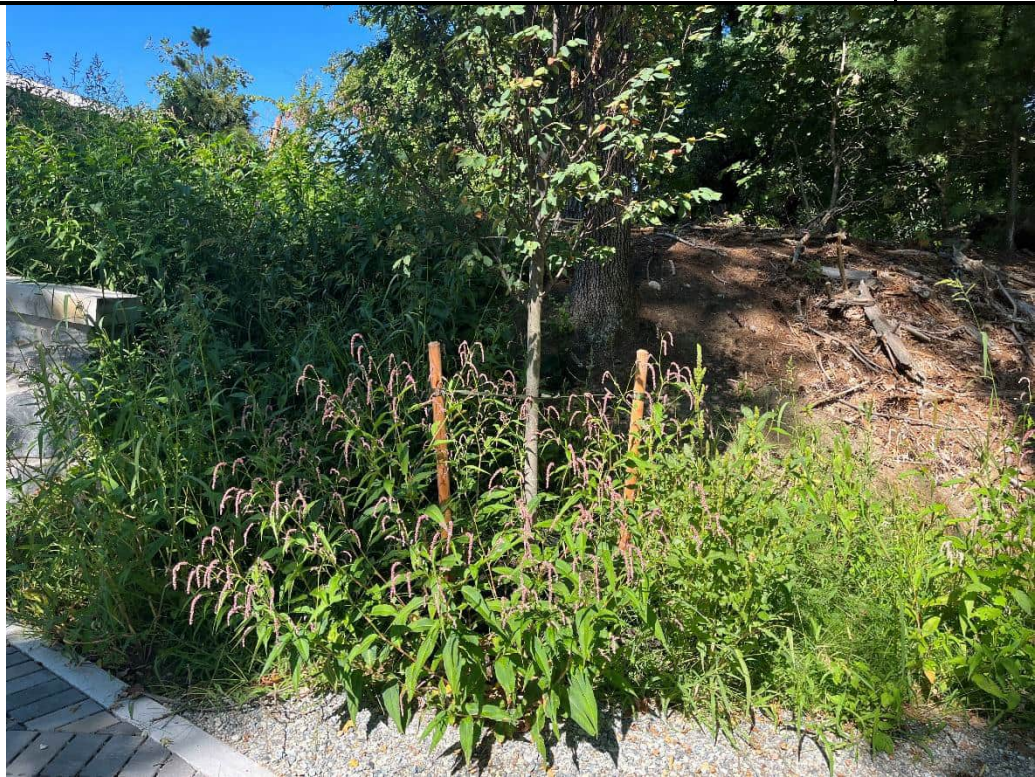
**Photo No. 13**    **Date:**  
9/3/2024

34	Sediment is eroding downhill from behind the cemented stone masonry wall at Station 217+45 <b>Priority: Low</b>	5/28/2024	6/4/2024	Apply seed and temporarily stabilize the soils along the slope with straw, jute netting, etc.	<p>5/31/2024 - Observation remains.  6/7/2024 - Observation remains.  6/14/2024 - Observation remains.  6/17/2024 - Observation remains.  6/24/2024 - Observation remains.  6/27/2024 - Rills were raked, loam was added, and hydroseed was applied.  7/8/2024 - Observation remains. Grass was observed to be germinating at this location. Comment will remain open until stabilization is complete.  7/8/2024 - See previous update.  7/15/2024 - Additional hydroseed is required due to washouts.  7/22/2024 - Observation remains.  7/29/2024 - Observation remains.  8/5/2024 - Observation remains.  8/7/2024 - Regrowth of vegetation has been observed in this area. This item will remain open until the area is fully stabilized.  8/12/2024 - Observation remains. Regrowth has stabilized a portion of this hill; however, reseeding and additional temporary stabilized measures are recommended on the section that is currently unvegetated.  8/16/2024 - Observation remains.  8/20/2024 - Application of the approved seed mixture is required at this location.  8/27/2024 - Observation remains.  9/3/2024 - Vegetation that is present in this location generally consists of lady's thumb smartweed (<i>Persicaria maculosa</i>), a non-native species. Removal of non-native species and application of the approved seed mixture is required at this location.</p>

View of the location where removal of non-native species and application of the approved seed mixture is required along the cemented stone masonry wall at Station 217+45 per Compliance Action Item 34.

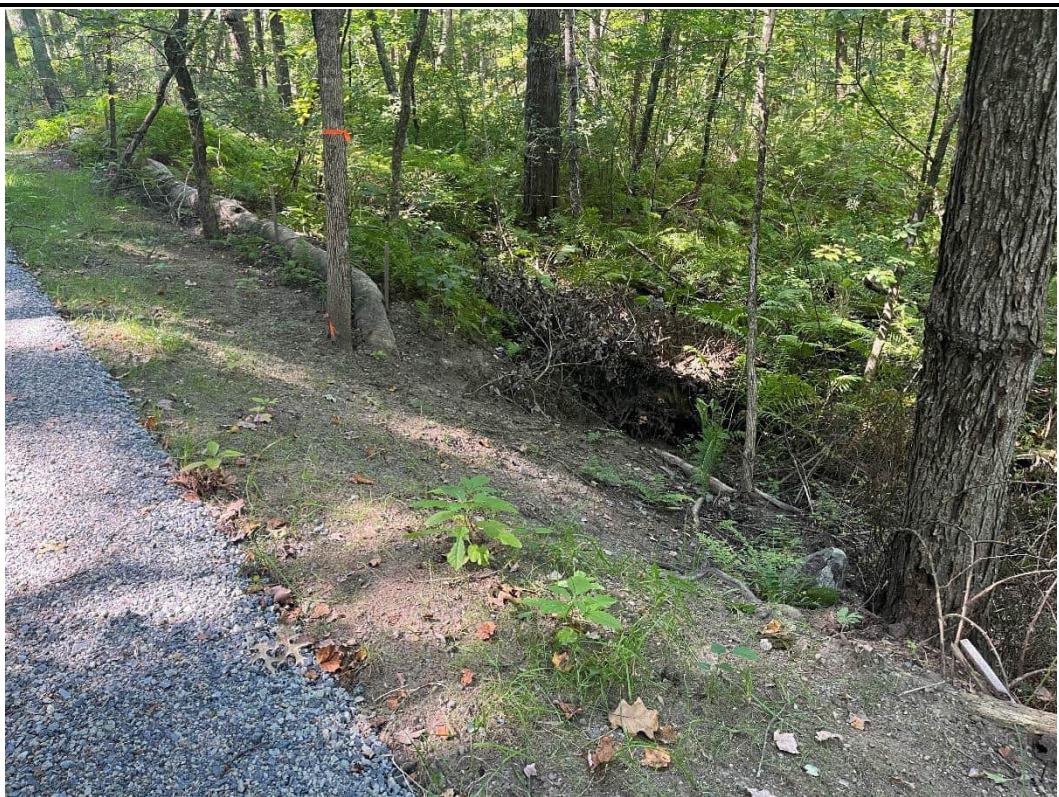
**Photo No. 14**    **Date:**  
9/3/2024

32	<p>Soil and organic debris has been placed within the wetland between wetland flagging WF#23-119 and WF#23-118 at Station 224+00 <b>Priority: High</b></p>	5/21/2024	5/28/2024	<p>Remove all material and provide stabilization of the area with the approved wetland seed mixture. Straw should also be placed for interim stabilization.</p>	<p>5/28/2024 - Observation remains. 5/31/2024 - Observation remains. 6/7/2024 - Observation remains. 6/14/2024 - Observation remains. 6/17/2024 - This area has been hydroseeded multiple times, but the debris should also be removed from the downgradient wetland. 6/24/2024 - Observation remains. 6/27/2024 - Observation remains. The area was hydroseeded again. 7/8/2024 - Germination was observed and the area will be monitored for stabilization. 7/15/2024 - See previous update. 7/22/2024 - Observation remains. 7/29/2024 - Observation remains. 8/5/2024 - Observation remains. 8/7/2024 - Regrowth of vegetation has been observed in this area. This item will remain open until the area is fully stabilized. Debris is still present in wetland and requires removal. 8/12/2024 - Observation remains. 8/16/2024 - Observation remains. 8/20/2024 - Debris is still present within the wetland. 8/27/2024 - Observation remains. 9/3/2024 - Debris is still present in the wetland and slopes upgradient of the wetland require stabilization.</p>

View of the organic debris that has been placed within the wetland and exposed soil that requires stabilization at Station 224+00 per Compliance Action item 32.

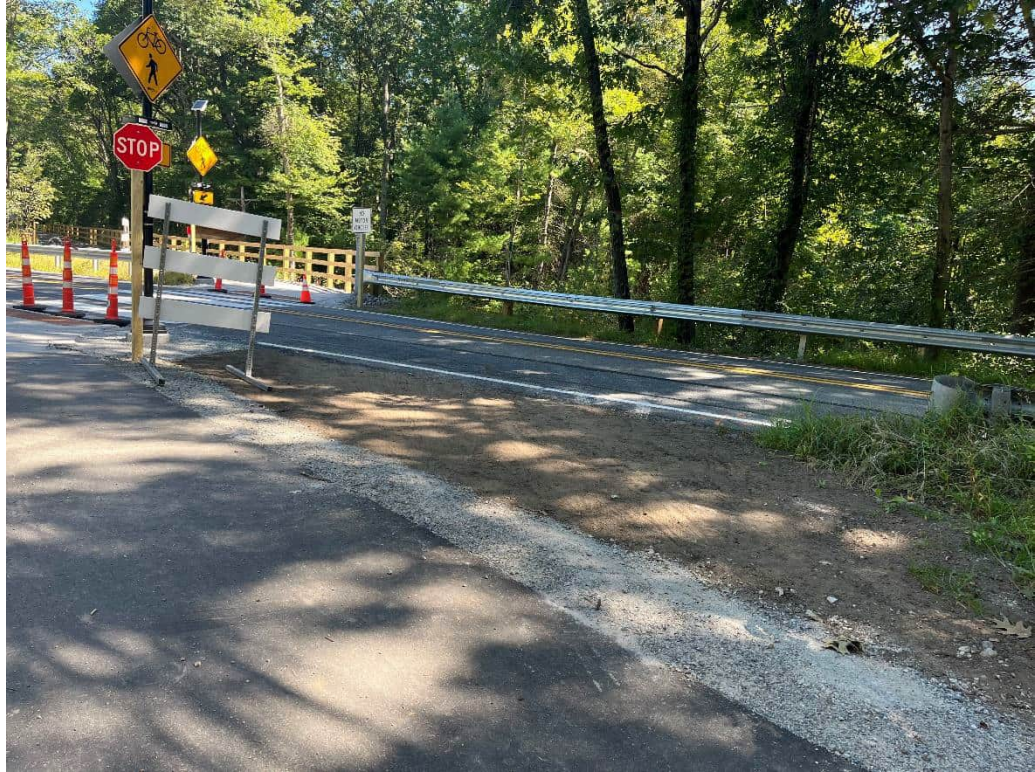
**Photo No. 15**    **Date:** 9/3/2024

56	Concrete requiring removal was observed from the side of the path adjacent to the Pantry Road intersection <b>Priority: High</b>	8/20/2024	<b>Resolved: 9/3/2024</b> 8/27/2024	Remove and properly dispose of concrete	8/27/2024- Observation remains. 9/3/2024 - Concrete has been removed.
Typically, these items require coordination with MassDEP. If so, remove once approval is obtained from MassDEP

View of the location where concrete was removed adjacent to the Pantry Road intersection per Compliance Action Item 56.

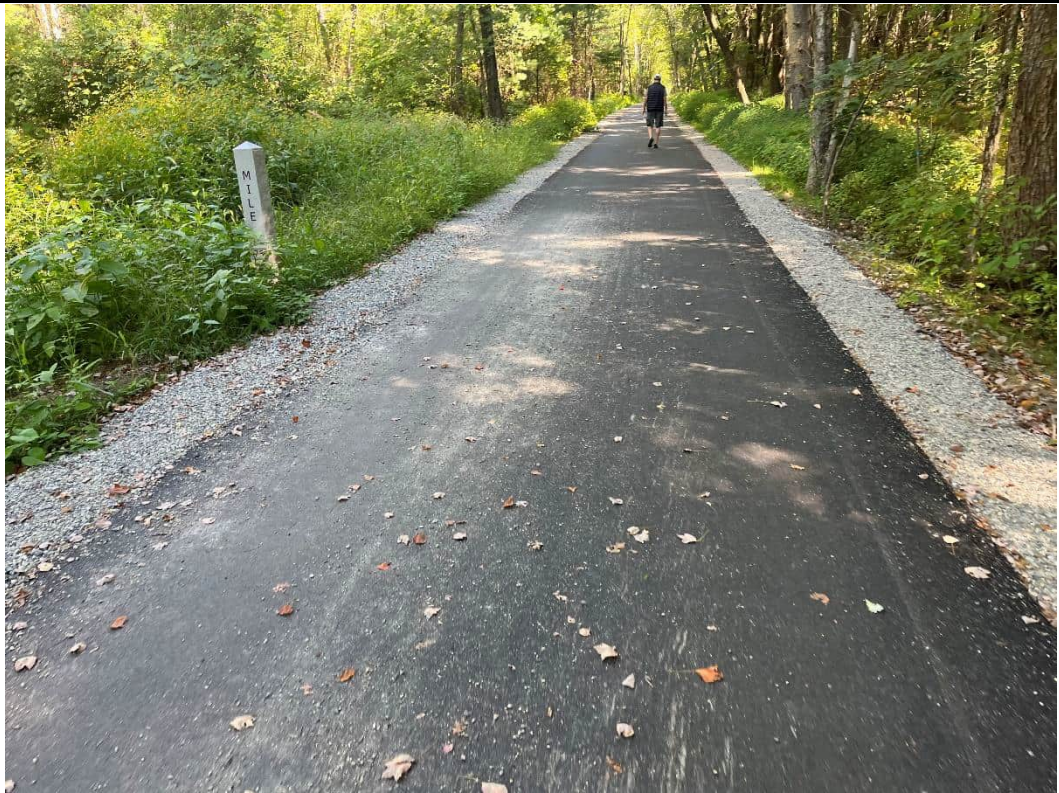
**Photo No. 16**    **Date:** 9/3/2024

View of a location where crushed stone is present on the path at Station 293+00 per Long Term Compliance Action Item 58.

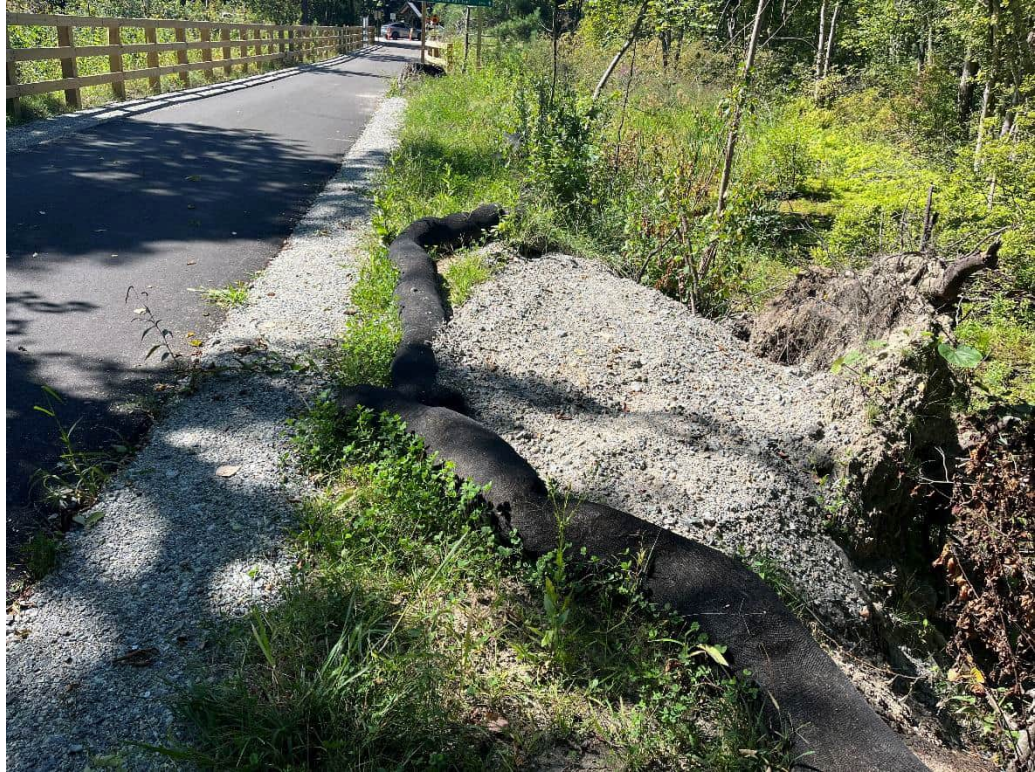
**Photo No. 17**    **Date:** 9/3/2024

View of crushed stone that has been placed on the root system of a fallen tree at Station 310+00 near Bank flag #BF4-108 per Long Term Compliance Action Item.

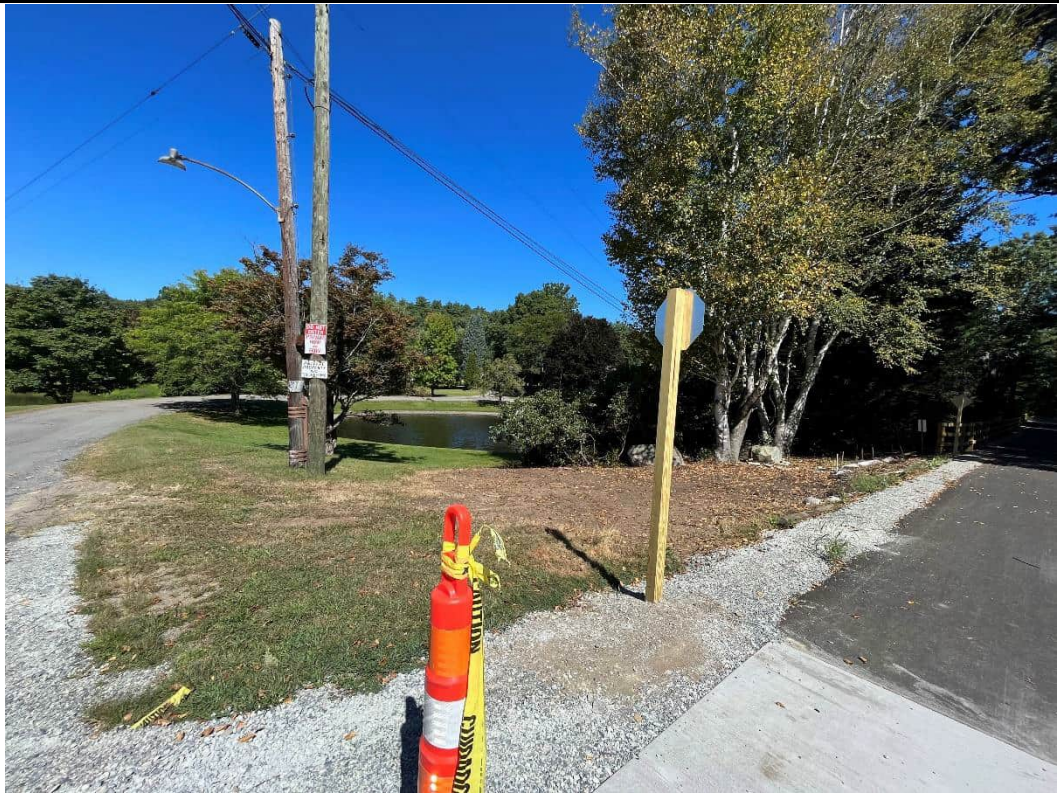
**Photo No. 18**    **Date:** 9/3/2024

View of the location where vegetation has been cleared and exposed soil requires stabilization at Station 320+50 per Long Term Compliance Action Item 58.
