Weekly Environmental Compliance Summary

Sudbury to Hudson Transmission Reliability Project (USEPA Tracking # MAR1003UW)

Week of: September 23, 2024 to September 27, 2024

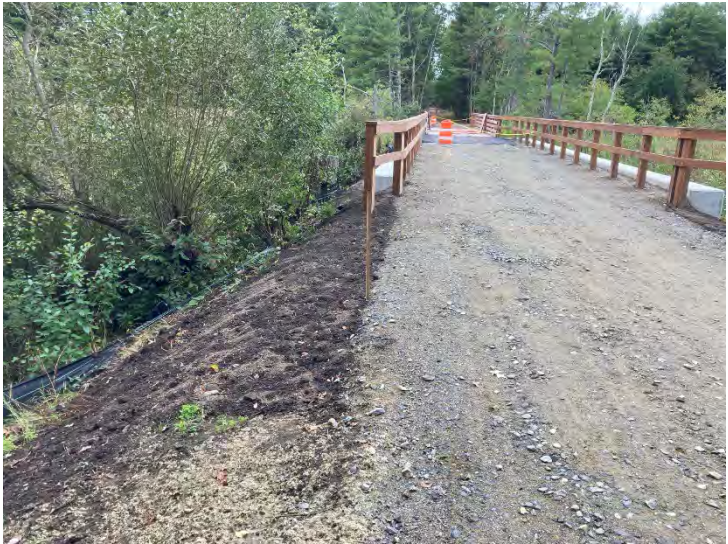
-Silt fence in segment 8 near bridge 128 is damaged and in need of repair.

Description: View of damaged silt fence in segment 8 near bridge 128. Facing west.

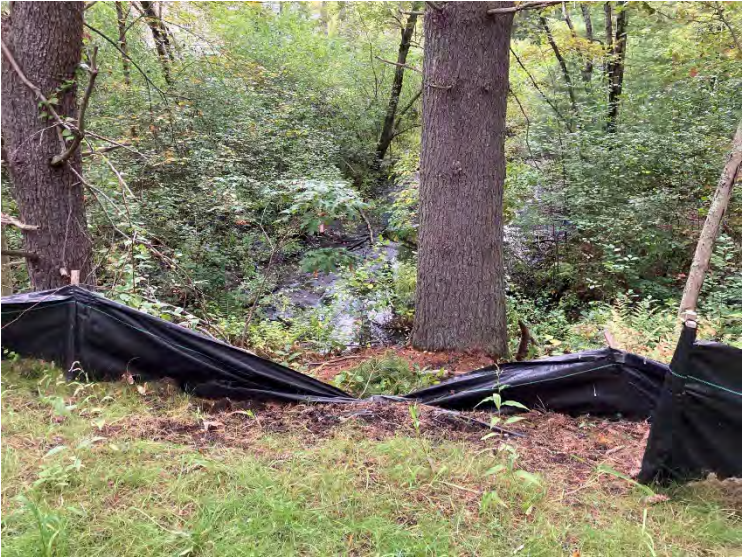
-Silt fence at Sta. #527+50 in segment 9 is damaged and in need of repair.

Description: View of damaged silt fence at Sta. #527+50 in segment 9. Facing north.

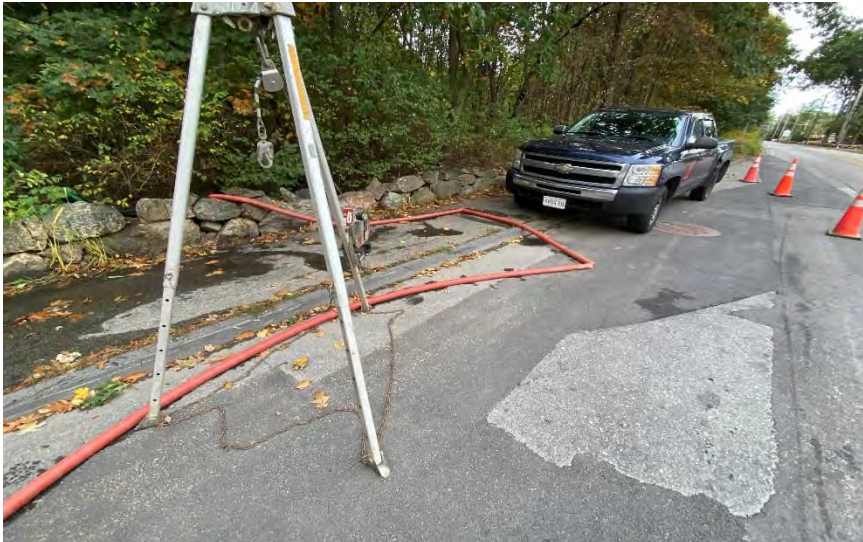
Description: Manhole #2 Forest Avenue. View of dewatering operation. Looking southward.

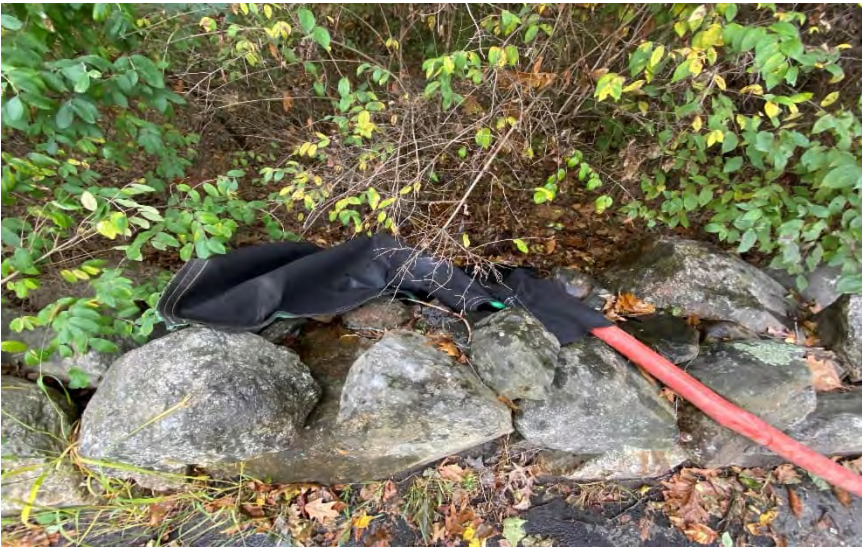
Description: Near Manhole #2 Forest Avenue. View of discharge to bag within adjacent vegetated area. Looking eastward.

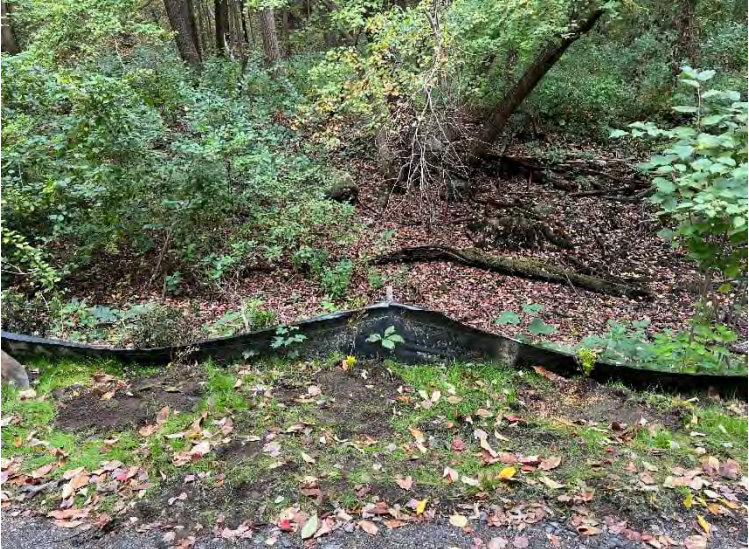
<p>Description: View of 5 GB planted at sta#744+20. Plants were installed in front of silt fencing even though no planting soil was applied due to 3 CA and 7 OC being priorly planted behind the fencing on the vernal pools border. Facing north.</p>

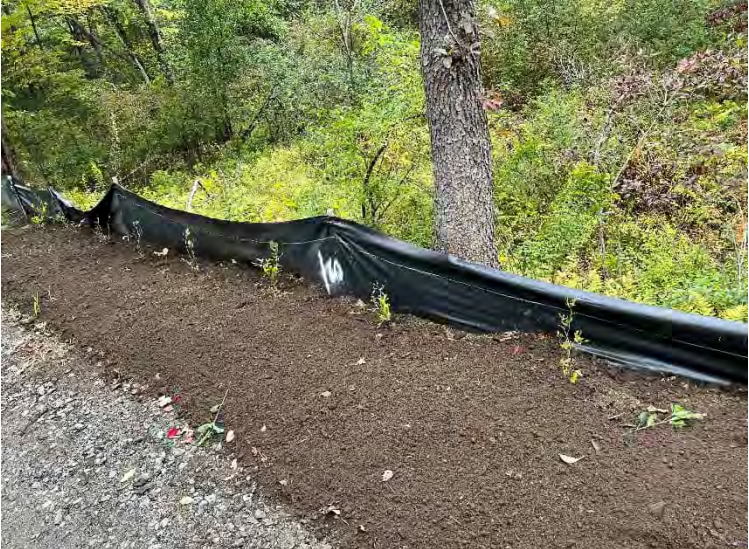
<p>Description: View of installed GB's within northern planting bed of station #748+15 to 748+65. GB's are very small compared to planned but have buds growing. Facing northwest.</p>

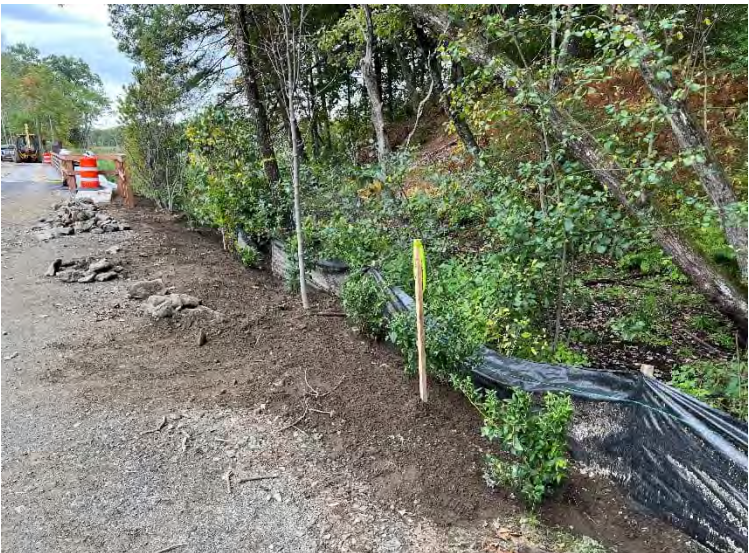
Description: View of installed plants. Stones left on ROW edge to be removed by ET&L after work is finished in this area. Facing east.

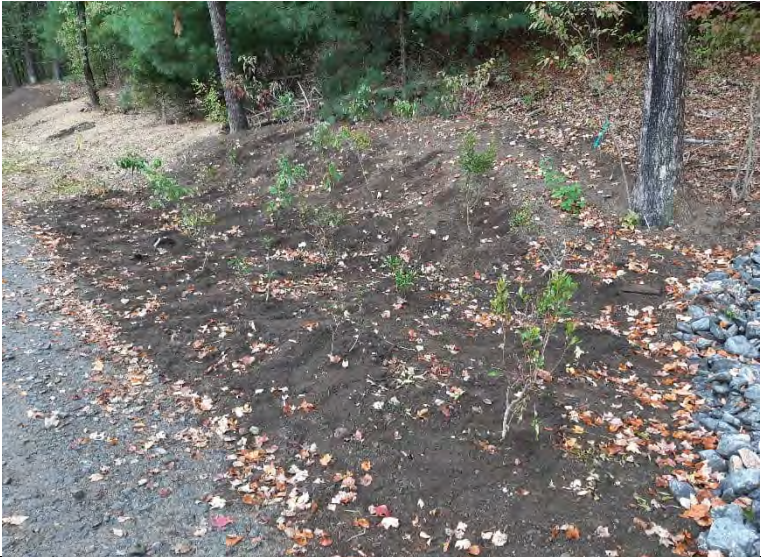
<p>Description: Segment 14, north side, near STA 732 +-00. Recent plantings. Check dam on right not on plans. Looking westward.</p>

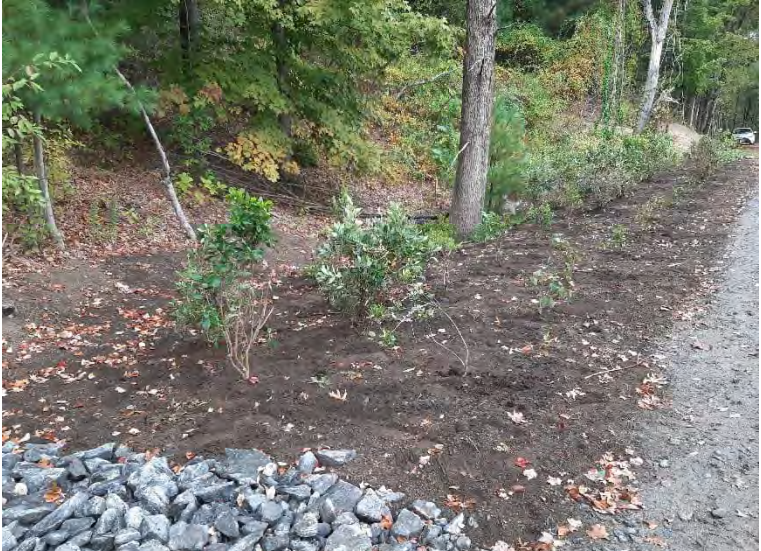
<p>Description: Segment 14, north side, near STA 732 +-00. Recent plantings. Check dam on left not on plans. Looking eastward.</p>

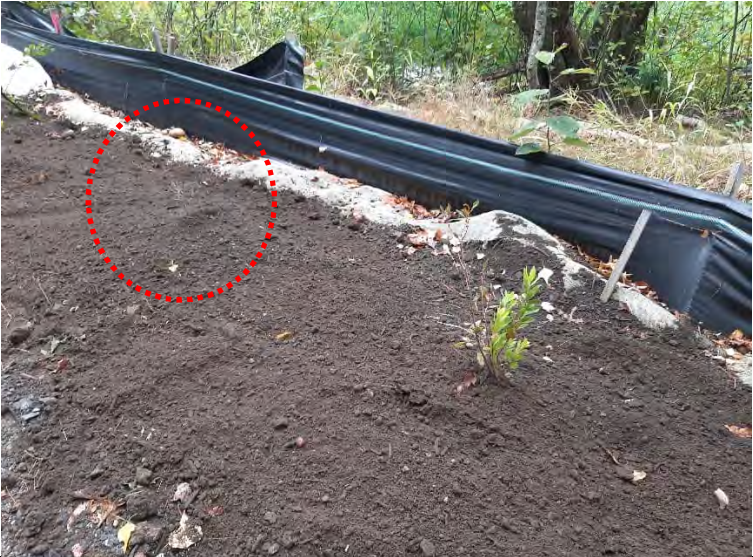
<p>Description:</p> <p>Segment 14, south shoulder, west of Wall 13. Examples of condition of installed huckleberries (GBs). Poor condition GB (left, circled) difficult to see, good condition GB shows new growth. Both noticeably shorter than planned specs. Looking southward.</p>

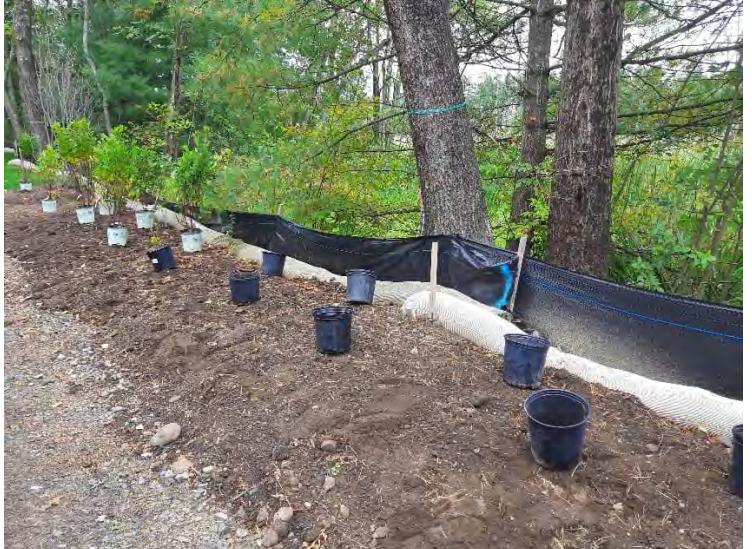
<p>Description: Segment 14, south side, near STA ~728 + 00. MON laying out planting distribution, empty pots for spacing 6 absent huckleberries (GB). Looking eastward.</p>
