**Weekly Environmental Compliance Summary**

**Sudbury to Hudson Transmission Reliability Project (USEPA Tracking # MAR1003UW)**

Sudbury, Hudson, and Stow, MA

Week of: October 7, 2024 to October 11, 2024

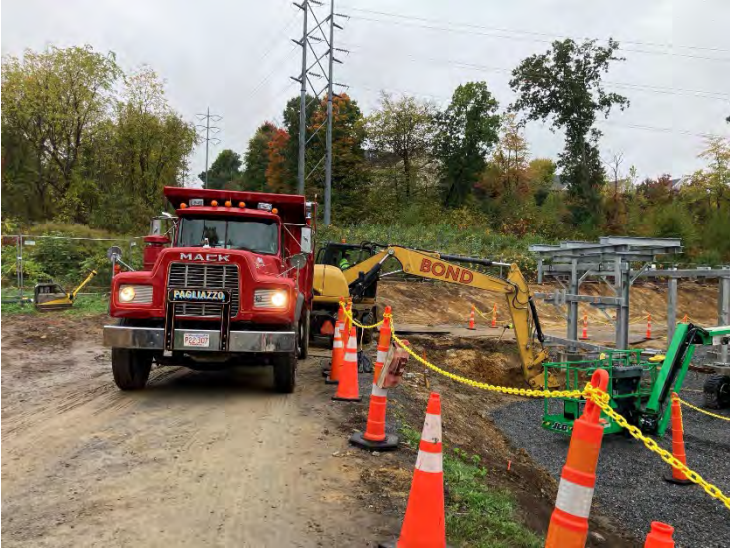
<b>PHOTOGRAPHIC LOG</b>	
Client Name: Eversource		Site Location: Sudbury to Hudson Transmission Reliability Project	Town: Hudson
Photo No.: 1	Date: 10/07/2024

<b>Description:</b> View of Bond working between MH #1 and Hudson Light & Power Substation. See additional dewatering inspection report. Facing south.

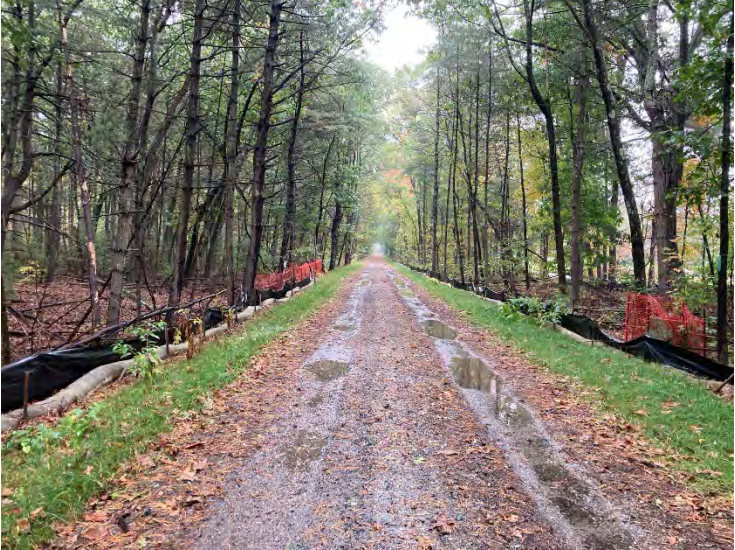
<p><b>PHOTOGRAPHIC LOG</b></p>	
<p>Client Name: Eversource</p>		<p>Site Location: Sudbury to Hudson Transmission Reliability Project</p>	<p>Town: Hudson</p>
<p>Photo No.: 3</p>	<p>Date: 10/07/2024</p>

<p>Description: View of E&amp;S controls in segment 4. Facing east.</p>

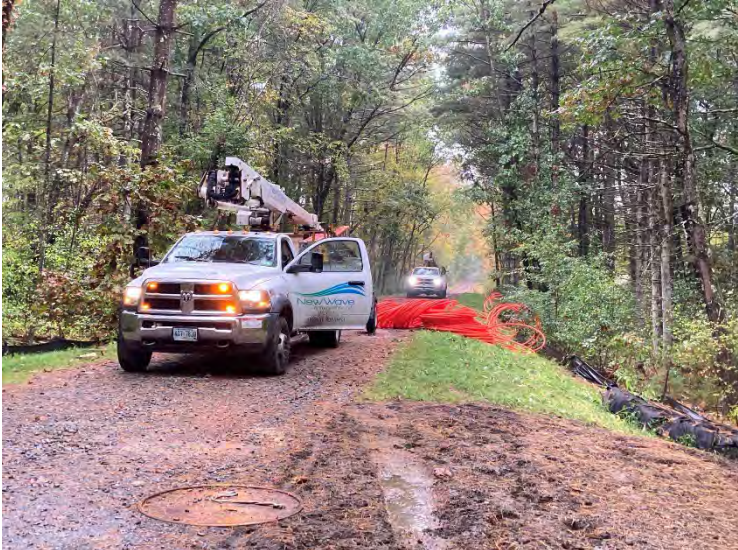
<p><b>PHOTOGRAPHIC LOG</b></p>	
<p>Client Name: Eversource</p>		<p>Site Location: Sudbury to Hudson Transmission Reliability Project</p>	<p>Town: Hudson</p>
<p>Photo No.: 4</p>	<p>Date: 10/07/2024</p>

<p>Description: View of New Wave working near MH #13 in segment 5. Facing west.</p>

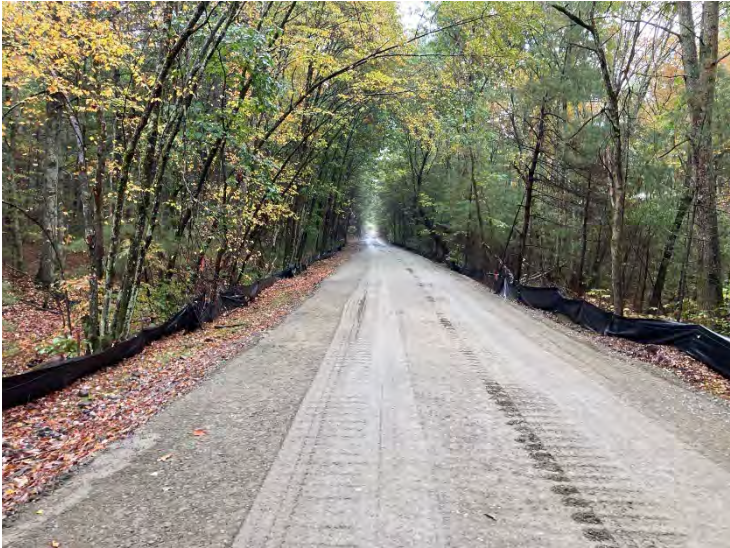
<p><b>PHOTOGRAPHIC LOG</b></p>	
<p>Client Name: Eversource</p>		<p>Site Location: Sudbury to Hudson Transmission Reliability Project</p>	<p>Town: Hudson</p>
<p>Photo No.: 5</p>	<p>Date: 10/07/2024</p>

<p>Description: View of E&amp;S controls and new stone base applied in segment 6. Facing east.</p>

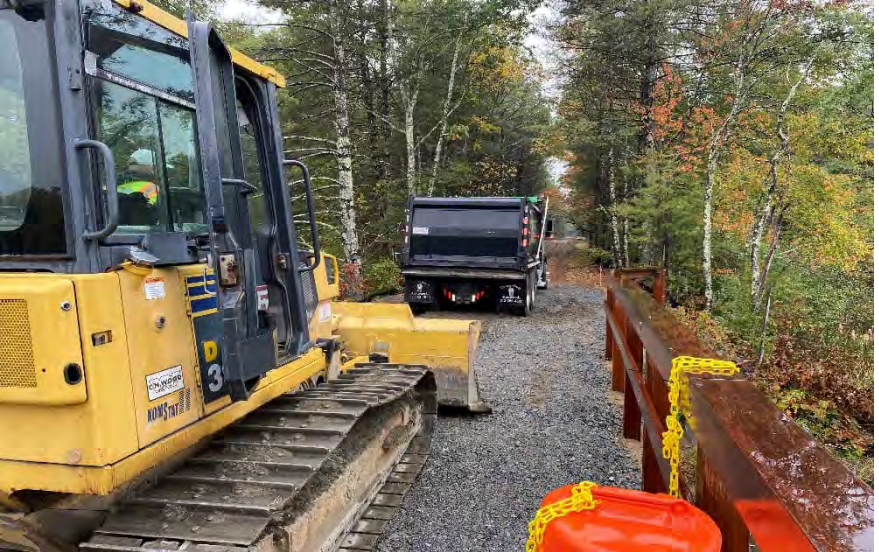
<p align="center">PHOTOGRAPHIC LOG</p>	
<p>Client Name: Eversource</p>		<p>Site Location: Sudbury to Hudson Transmission Reliability Project</p>	<p>Town: Sudbury</p>
<p>Photo No.: 1</p>	<p>Date: 10-07-24</p>

<p>Description:</p> <p>Segment 7 at Bridge 128, ET&amp;L conducting grading work, existing erosion control, looking westward.</p>

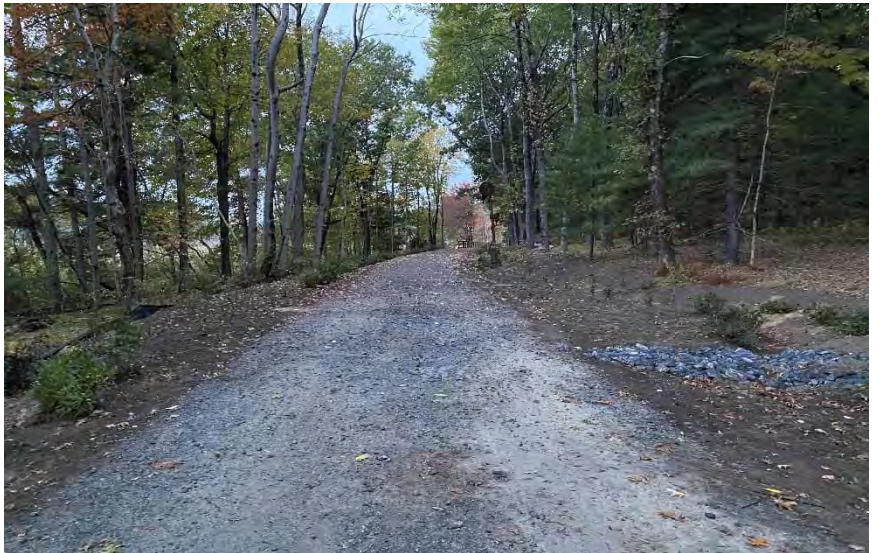
<p align="center">PHOTOGRAPHIC LOG</p>	
<p>Client Name: Eversource</p>		<p>Site Location: Sudbury to Hudson Transmission Reliability Project</p>	<p>Town: Sudbury</p>
<p>Photo No.: 2</p>	<p>Date: 10-07-24</p>

<p>Description:</p> <p>Work area within segment 14 at manhole #26, recently planted area - to be hydro seeded, existing erosion control, looking westward</p>

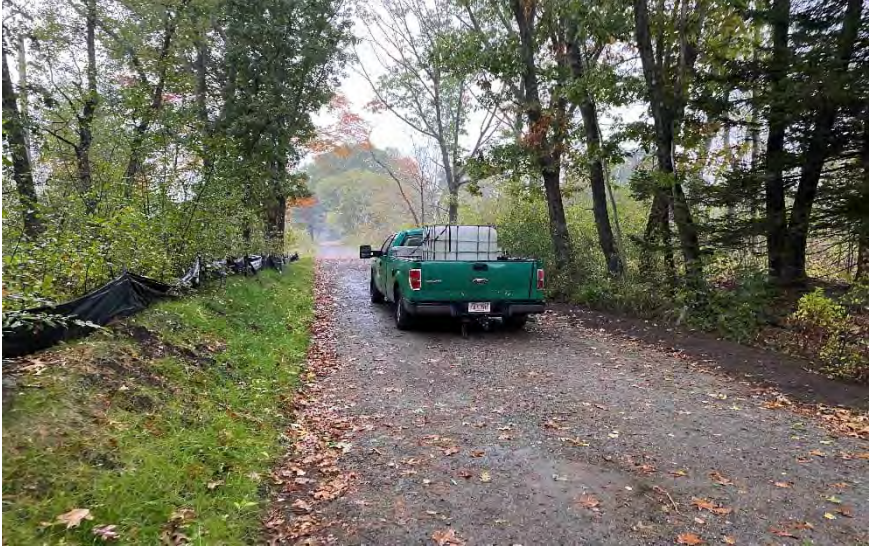
<p>PHOTOGRAPHIC LOG</p>	
<p>Client Name: Eversource</p>		<p>Site Location: Sudbury to Hudson Transmission Reliability Project</p>	<p>Town: Sudbury</p>
<p>Photo No.: 3</p>	<p>Date: 10-07-24</p>

<p>Description:</p> <p>Work area within segment 14 MON watering at recently planted area - to be hydro seeded, existing erosion control, looking westward</p>

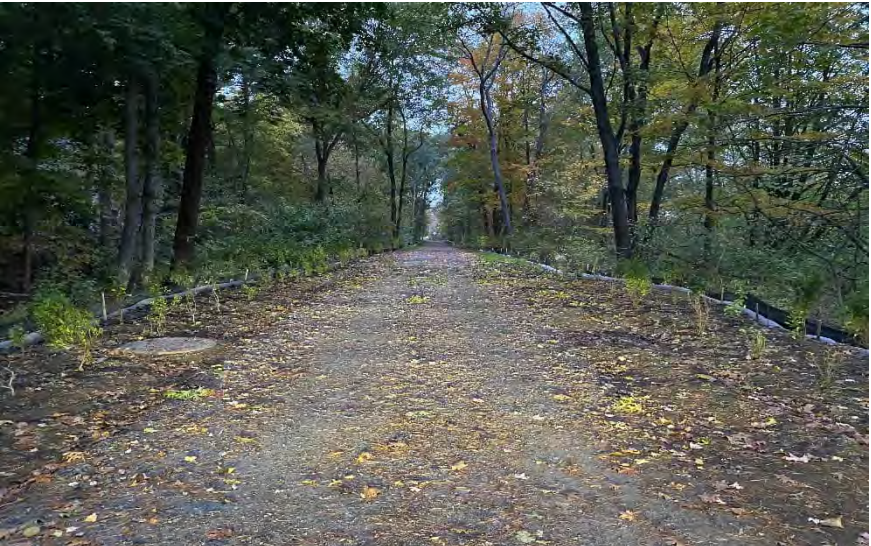
<p>PHOTOGRAPHIC LOG</p>	
<p>Client Name: Eversource</p>		<p>Site Location: Sudbury to Hudson Transmission Reliability Project</p>	<p>Town: Sudbury</p>
<p>Photo No.: 4</p>	<p>Date: 10-07-24</p>

<p>Description:</p> <p>Work area within segment 13 at manhole #25, recently planted area - to be hydro seeded, existing erosion control, looking westward</p>

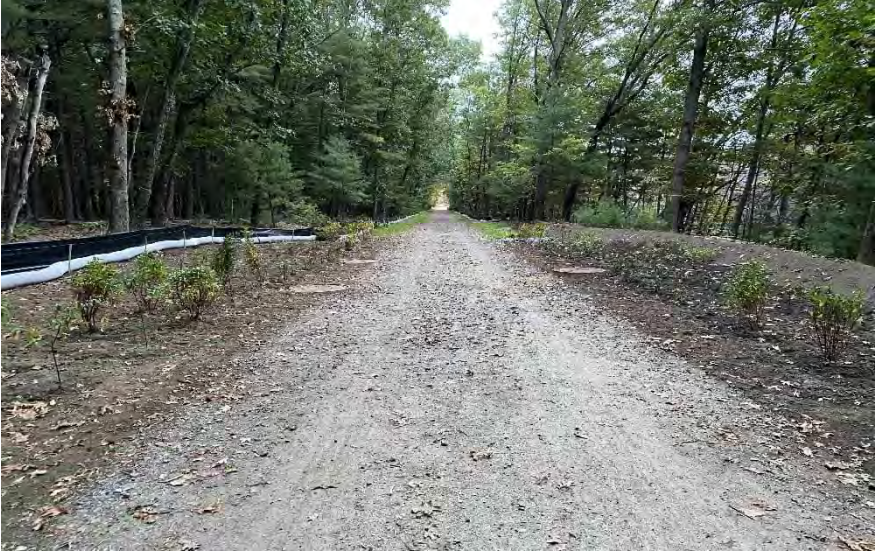
<p align="center">PHOTOGRAPHIC LOG</p>	
<p>Client Name: Eversource</p>		<p>Site Location: Sudbury to Hudson Transmission Reliability Project</p>	<p>Town: Sudbury</p>
<p>Photo No.: 5</p>	<p>Date: 10-07-24</p>

<p>Description:</p> <p>Work area within segment 11 manhole #23, recently planted area - to be hydro seeded, existing erosion control, looking westward.</p>

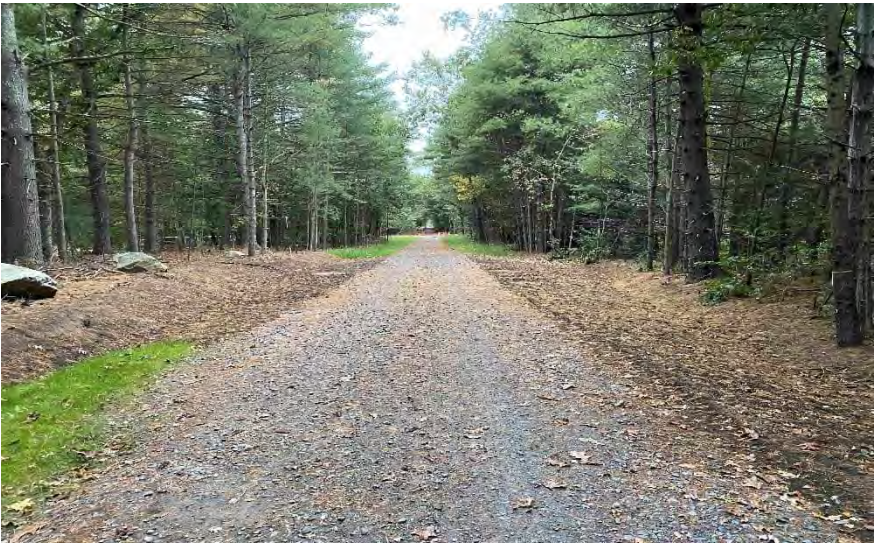
<p align="center">PHOTOGRAPHIC LOG</p>	
<p>Client Name: Eversource</p>		<p>Site Location: Sudbury to Hudson Transmission Reliability Project</p>	<p>Town: Sudbury</p>
<p>Photo No.: 6</p>	<p>Date: 10-07-24</p>

<p>Description:</p> <p>Work area within segment 9 manhole #18, recently planted area - to be hydro seeded, existing erosion control, looking westward.</p>

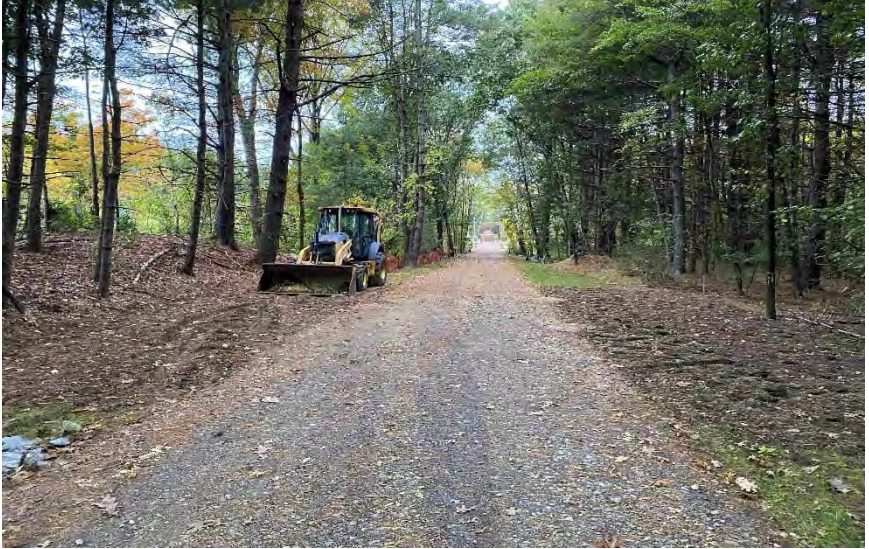
<p>Description:</p> <p>Work area within segment 8 manhole #17, recently planted area - to be hydro seeded, MON equipment staged, existing erosion control, looking westward.</p>

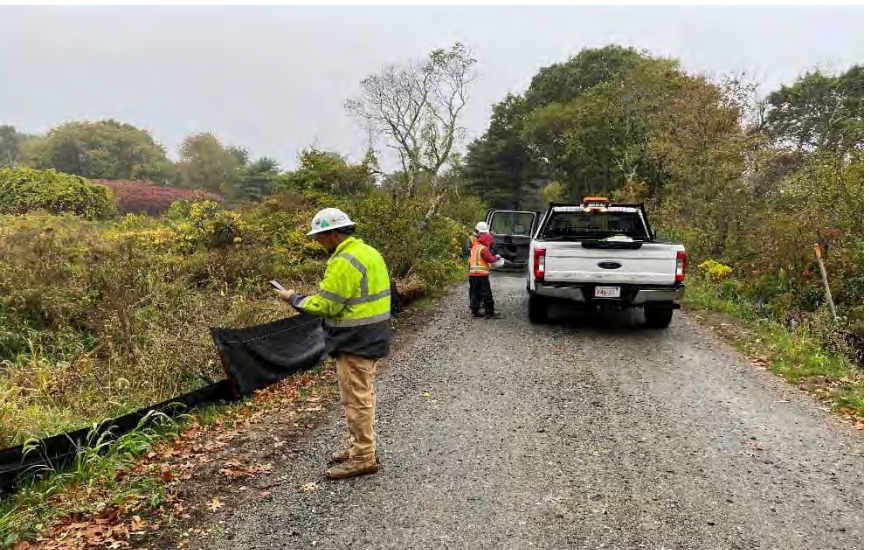
<p>Description:</p> <p>Work area within segment 14 Wetland replication area, SWCA removing non-native species from area, existing erosion control, looking westward.</p>

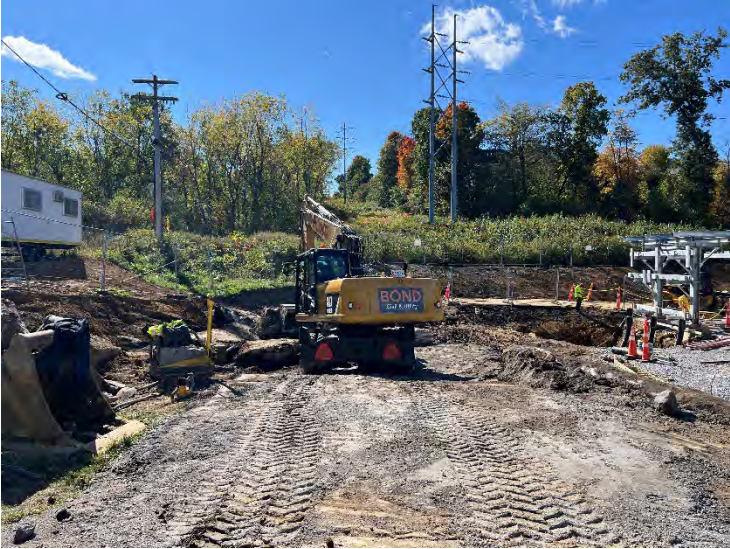
Description: View of Bond working between MH #1 and Hudson Light & Power Substation. See additional dewatering inspection report. Facing south.

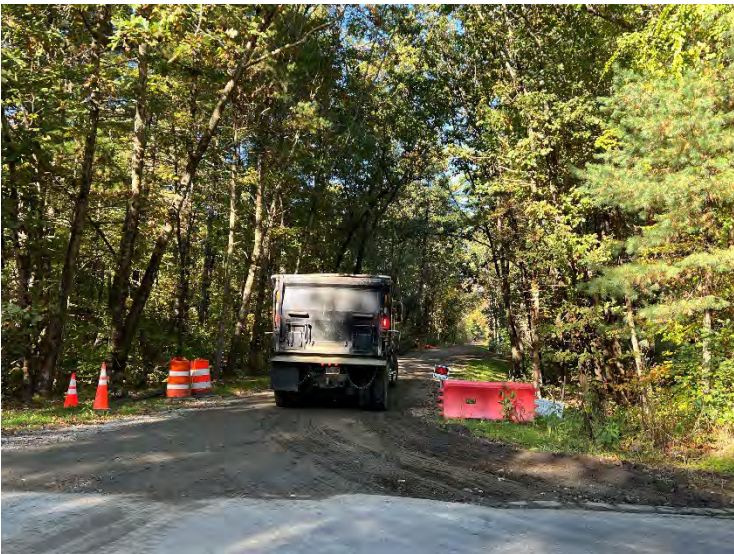
Description: View of loam truck delivery within entrance to segment 5. ET&L applying loam in segment 7 in Sudbury. Facing west.

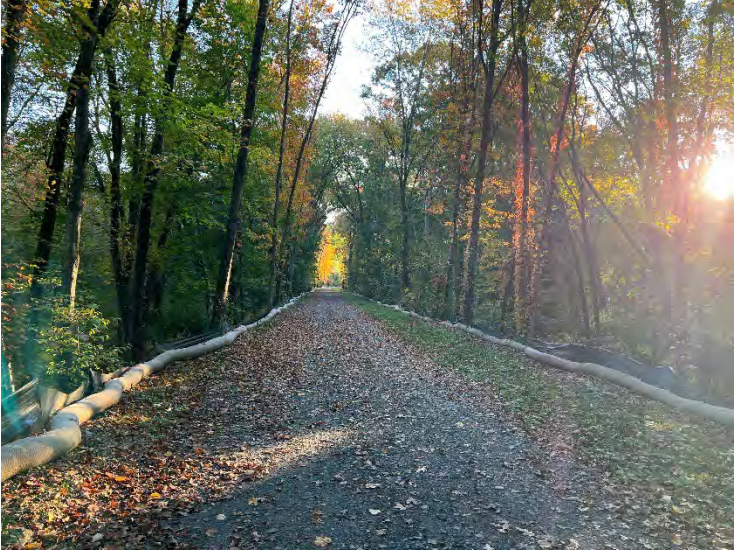
<b>Description:</b> View of E&S controls in segment 1. Facing east.

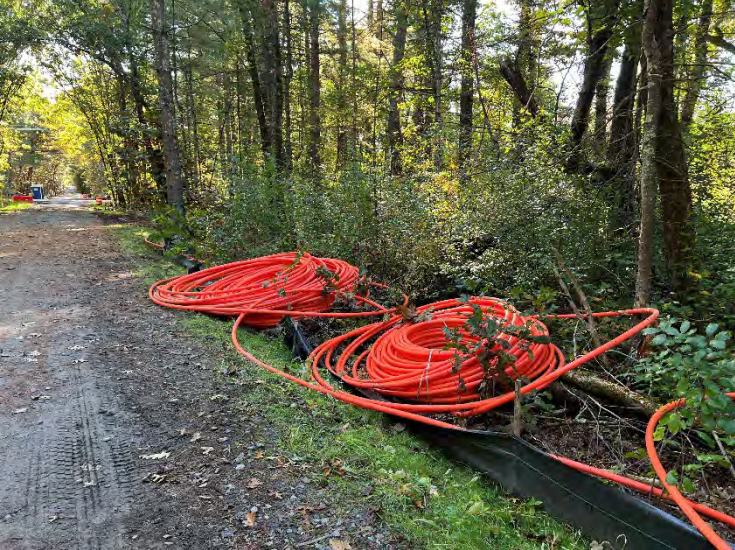
<b>Description:</b> View of New Wave fiber optics inner cable on ROW shoulder in segment 5 near MH #13. Silt fencing may need repairs once cable is removed. Facing east.

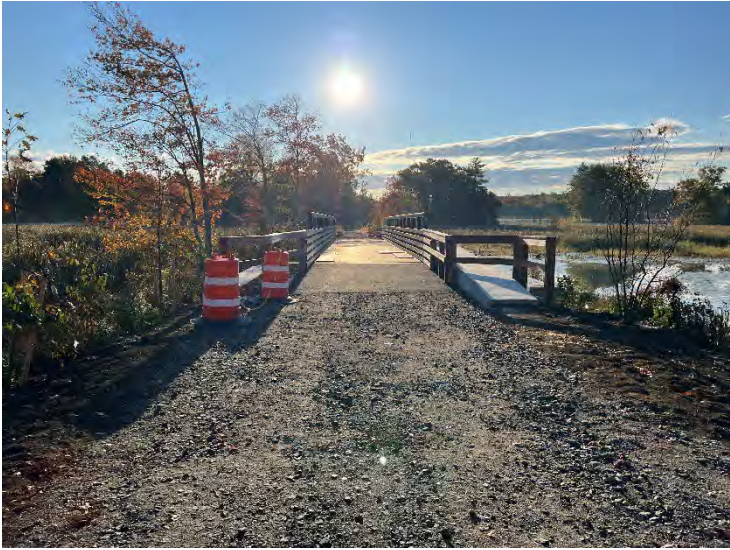
<p>Description: View of Bridge 130. Facing east.</p>

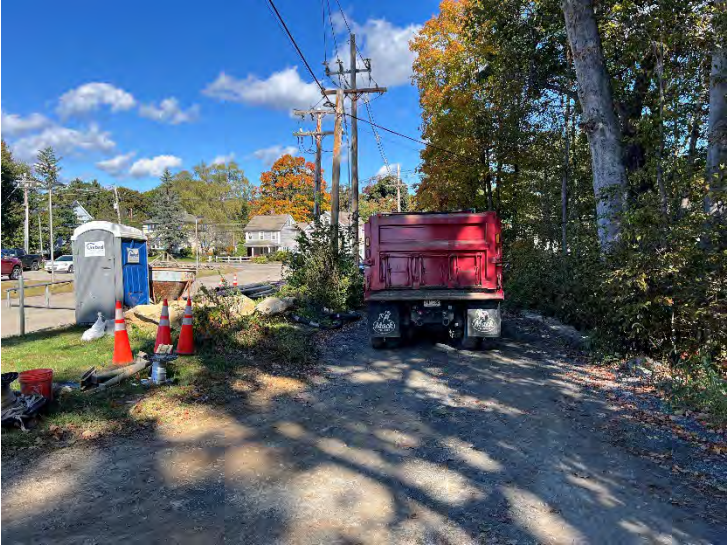
<p>Description: View of work area at MH #1. Truck onsite for loading excavated soils. Facing north.</p>

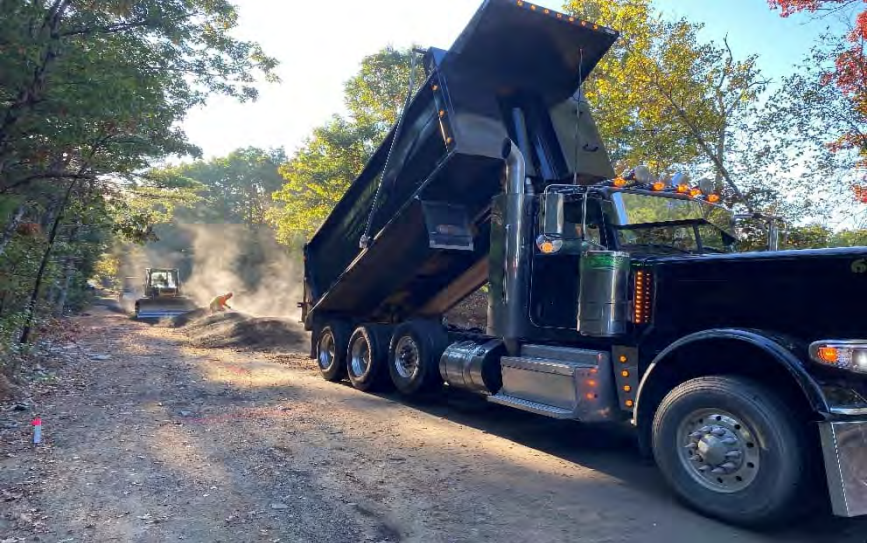
<p>Description:</p> <p>Segment 7, ET&amp;L conducting grading work, existing erosion control, looking eastward.</p>

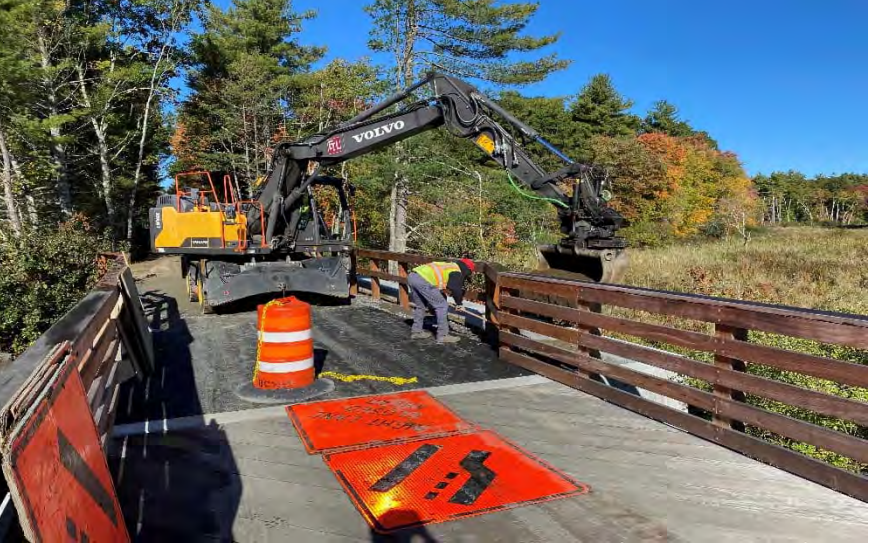
<p>Description:</p> <p>Work area within segment 7 at bridge 128, ET&amp;L adding loam to shoulders prior to plantings, existing erosion control, looking westward</p>

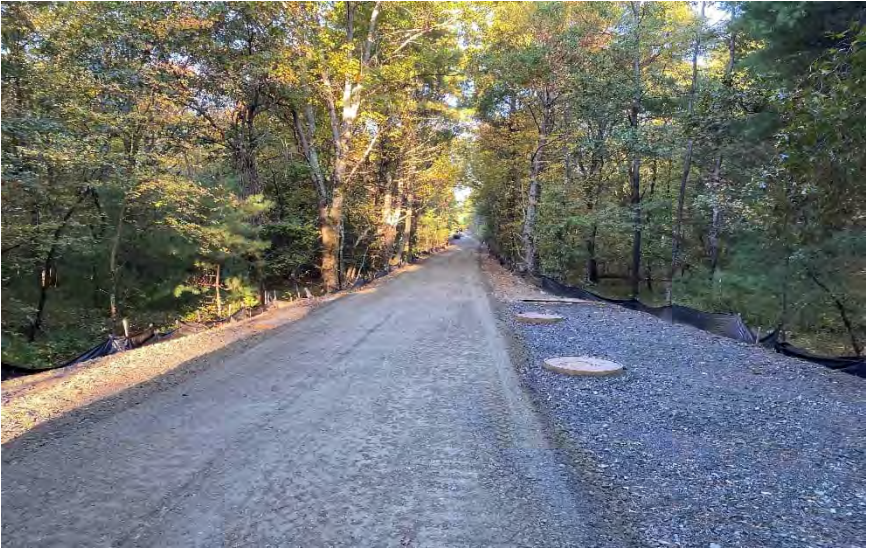
<p>Description:</p> <p>Work area within segment 7 at manhole #15, gravel pad removed prior to adding loam for plantings, existing erosion control, looking westward</p>

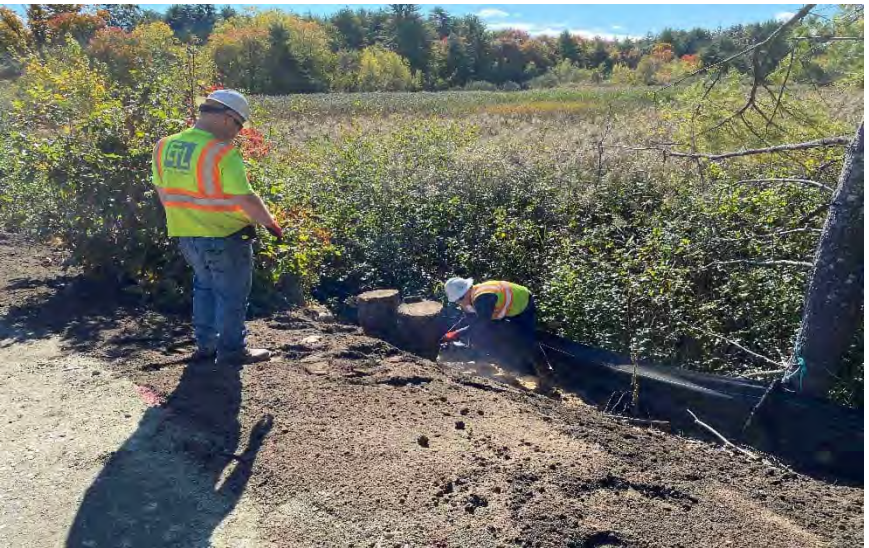
<p>Description:</p> <p>Work area within segment 7 at bridge 128, ET&amp;L flush cutting stumps prior to loaming, existing erosion control, looking southward</p>

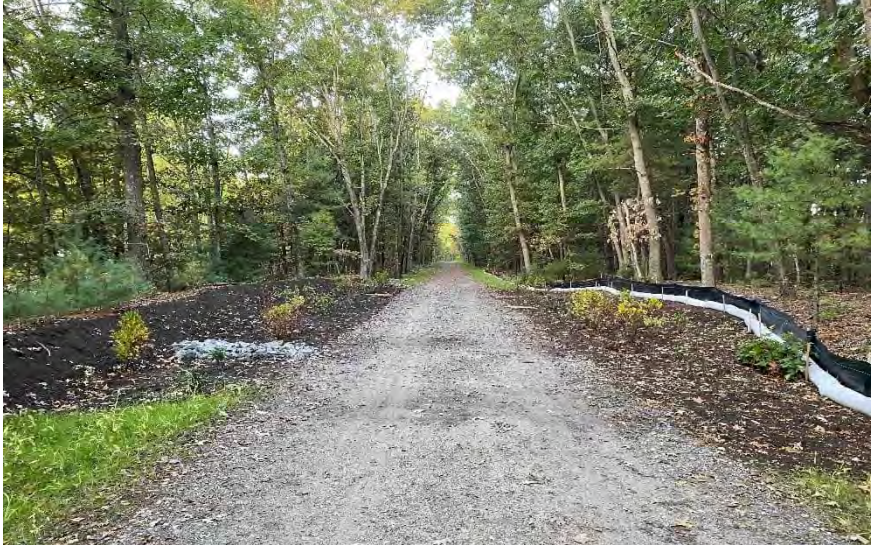
<p>Description:</p> <p>Work area within segment 11 manhole #23, recently planted area - to be hydro seeded, existing erosion control, looking westward.</p>

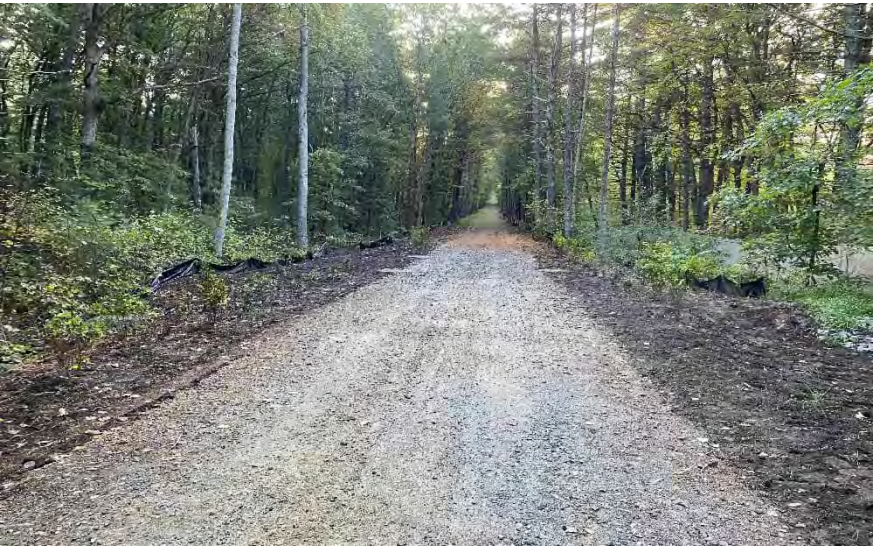
<p>Description:</p> <p>Work area within segment 10 manhole #20, recently planted area - to be hydro seeded, existing erosion control, looking eastward.</p>

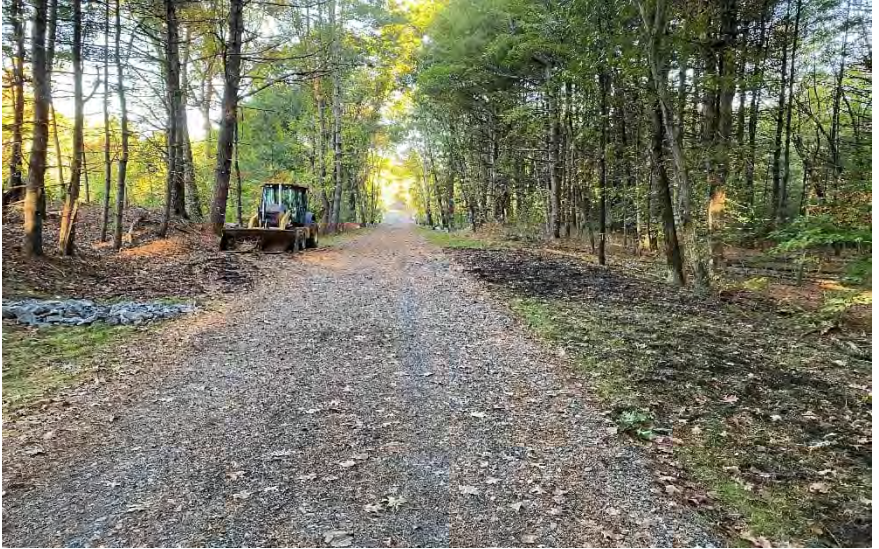
<p>Description:</p> <p>Work area within segment 8 manhole #17, recently planted area - to be hydro seeded, MON equipment staged, existing erosion control, looking westward.</p>

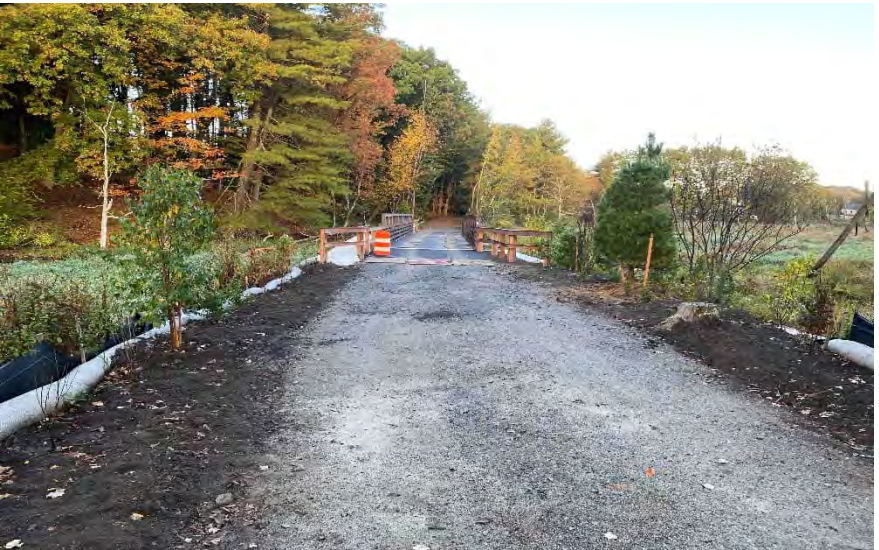
<p>Description:</p> <p>Work area within segment 14, recently planted area near bridge 127- to be hydro seeded, existing erosion control, looking westward.</p>

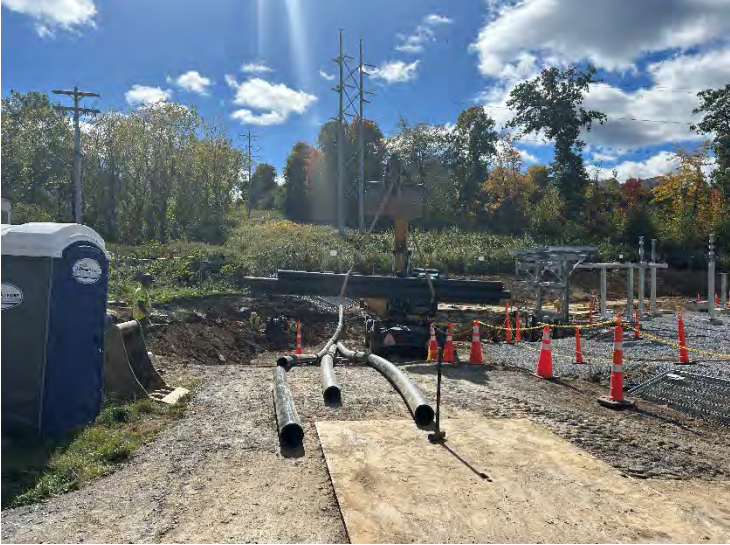
Description: View of Bond working between MH #1 and Hudson Light & Power Substation. Facing south.

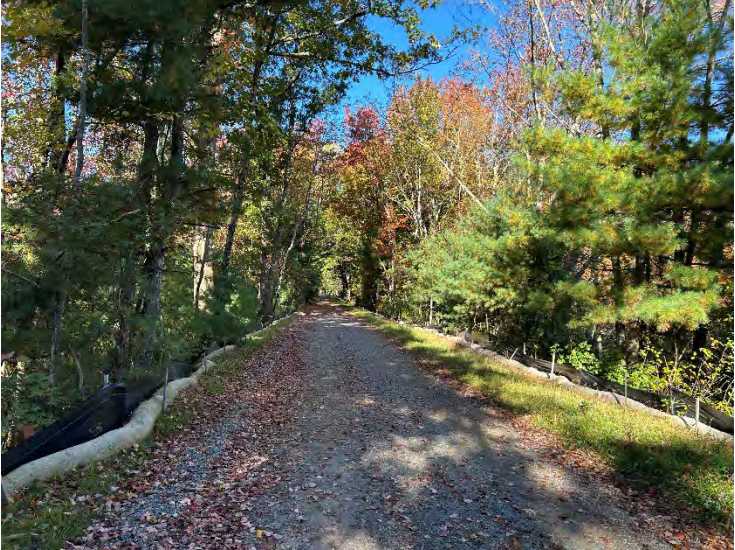
<p>Description: View of E&amp;S controls in segment 5. Facing west.</p>

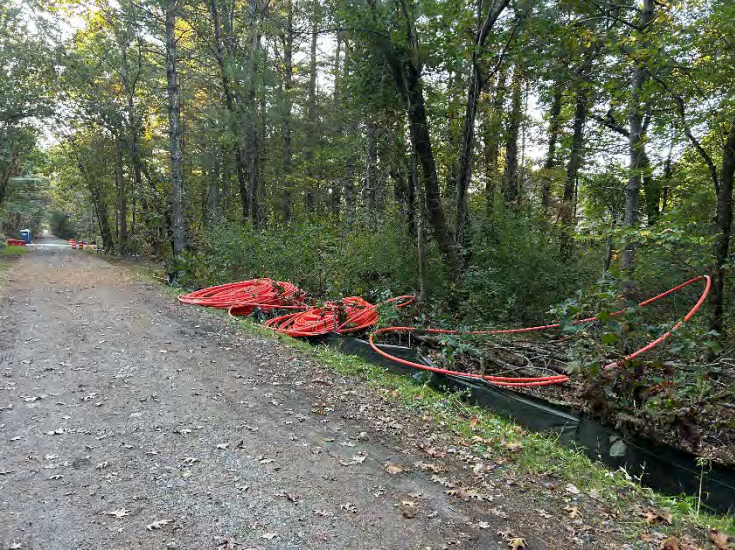
<p>Description: View of New Wave fiber optics inner cable on ROW shoulder in segment 5 near MH #13. Silt fencing may need repairs once cable is removed. Facing east.</p>

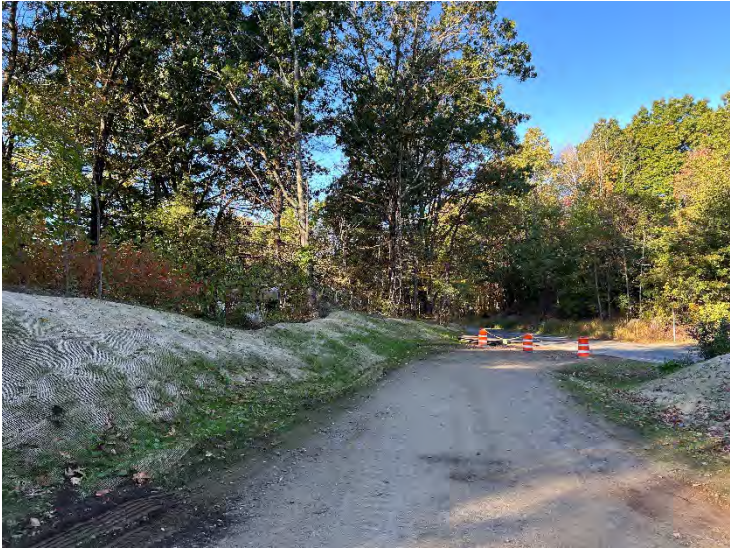
<p>Description: View of erosion control matting at the entrance to segment 1. Facing east.</p>

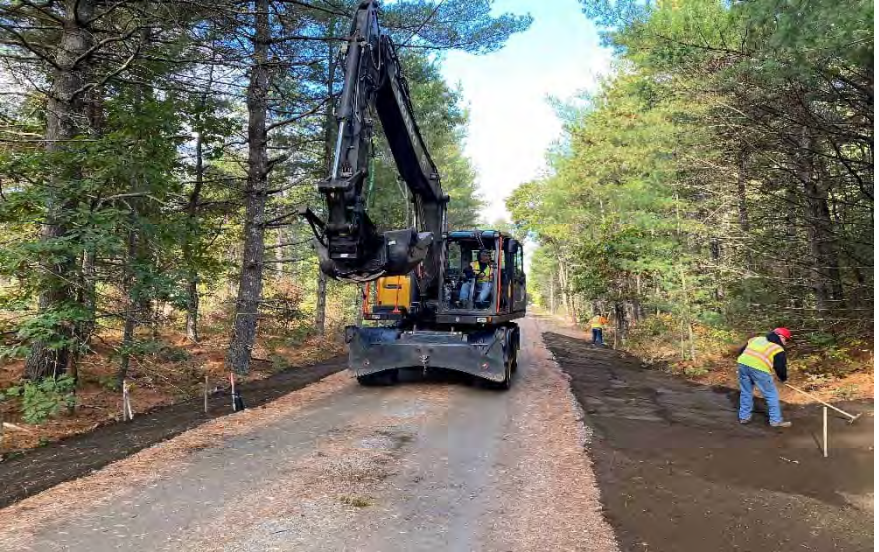
<p>Description:</p> <p>Segment 7, ET&amp;L conducting loaming work, existing erosion control, looking westward.</p>

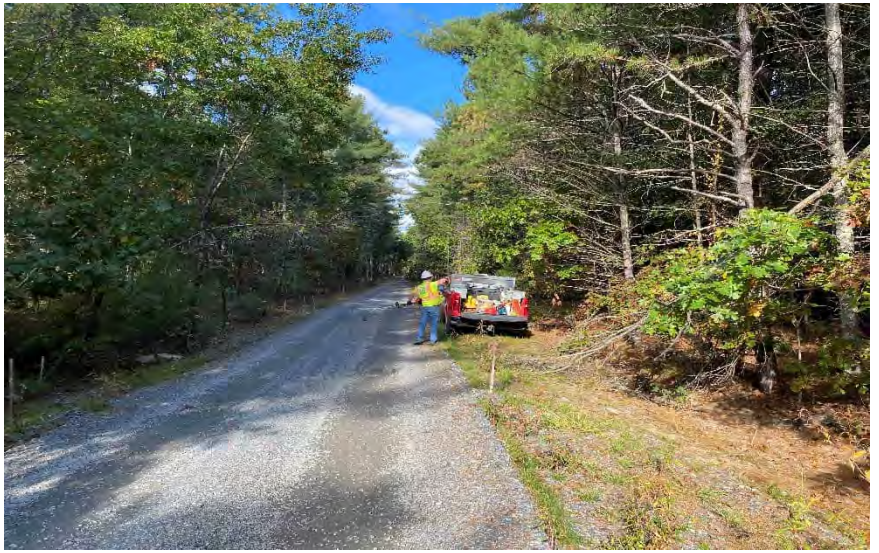
<p>Description:</p> <p>Work area within segment 7, ET&amp;L removing shoulder grasses prior to adding loam, existing erosion control, looking westward</p>

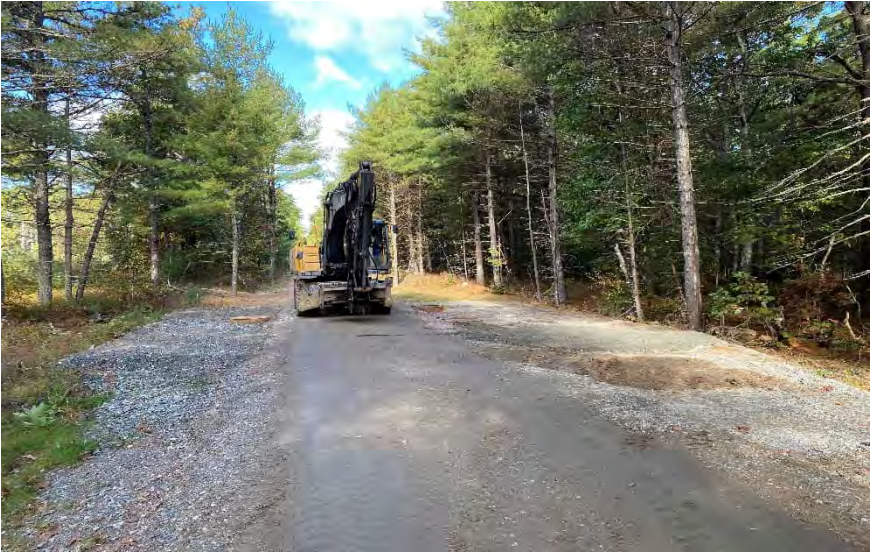
<p>Description:</p> <p>Work area within segment 7 at manhole #16, gravel pad removed prior to adding loam for plantings, existing erosion control, looking westward</p>

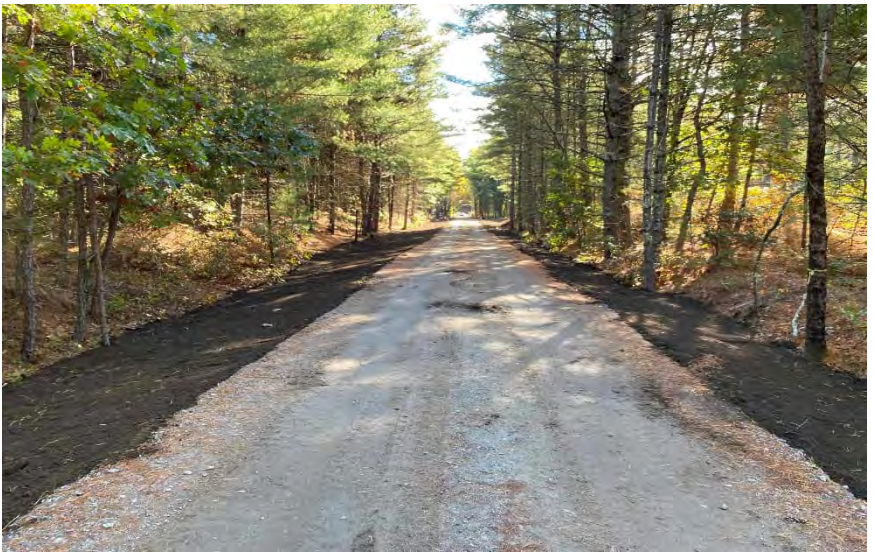
<p>Description:</p> <p>Work area within segment 7, ET&amp;L added loam to shoulders prior to planting, existing erosion control, looking eastward</p>

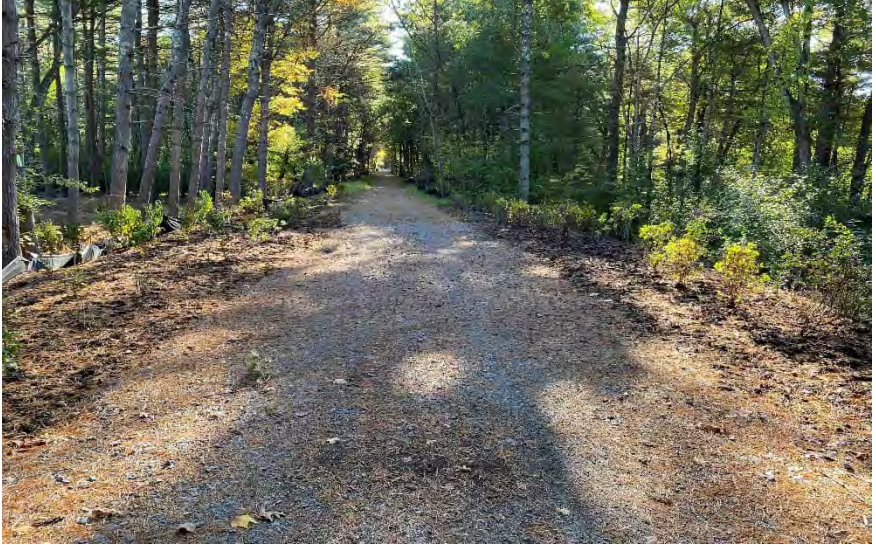
Description:  Work area within segment 9 manhole #19, recently planted area - to be hydro seeded, existing erosion control, looking eastward.

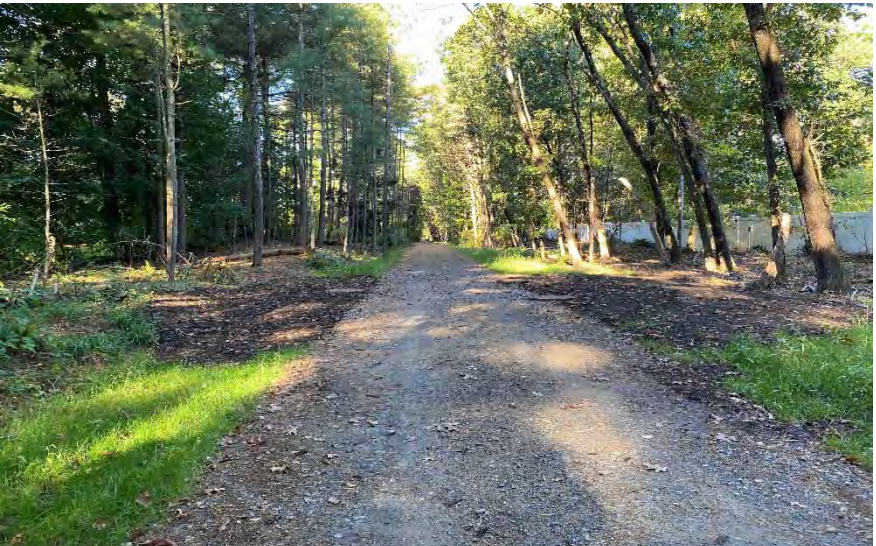
Description:  Work area within segment 10 manhole #21 to be hydro seeded, existing erosion control, looking westward.

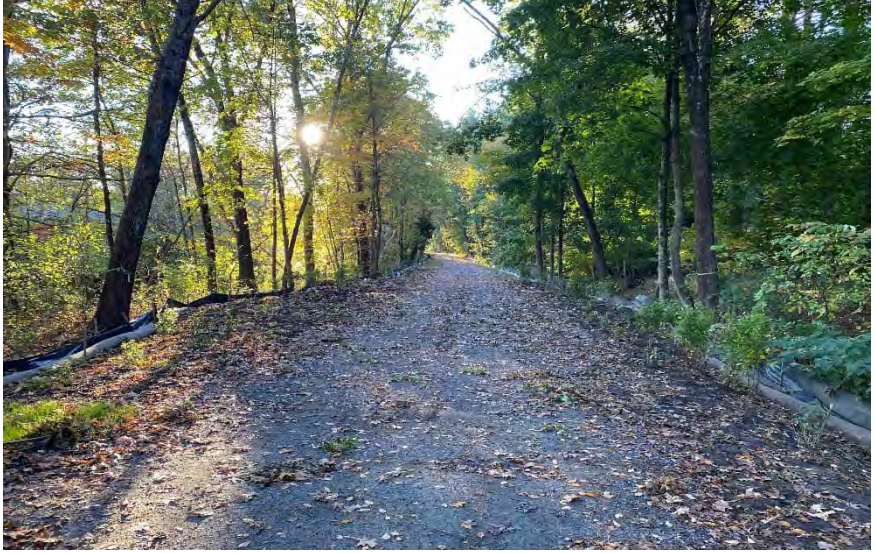
Description:  Work area within segment 14, recently planted area - to be hydro seeded, existing erosion control, looking westward.

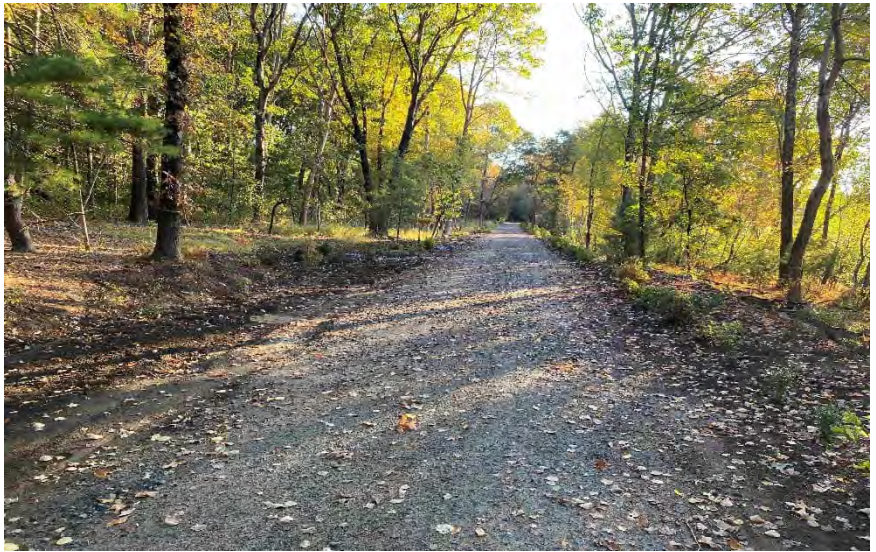
Description:  Work area within segment 14, manhole #26, recently planted area - to be hydro seeded, existing erosion control, looking eastward.

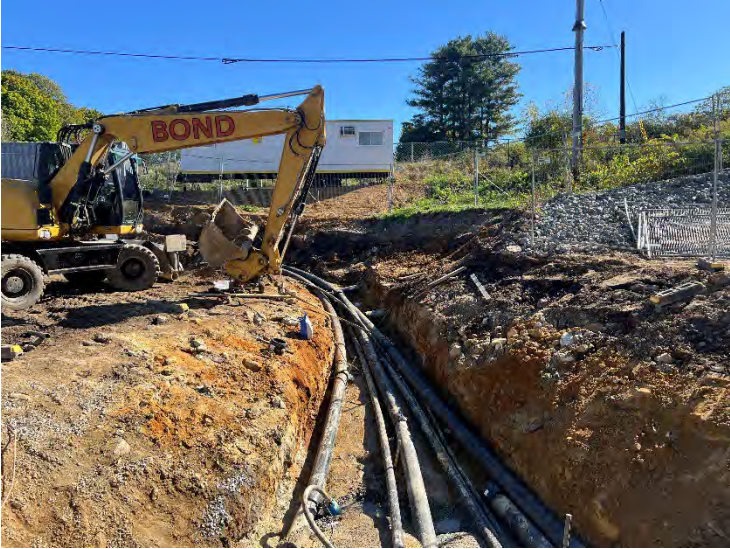
Description: View of Bond installing conduit between MH #1 and Hudson Light & Power Substation. See additional dewatering inspection report. Facing east.

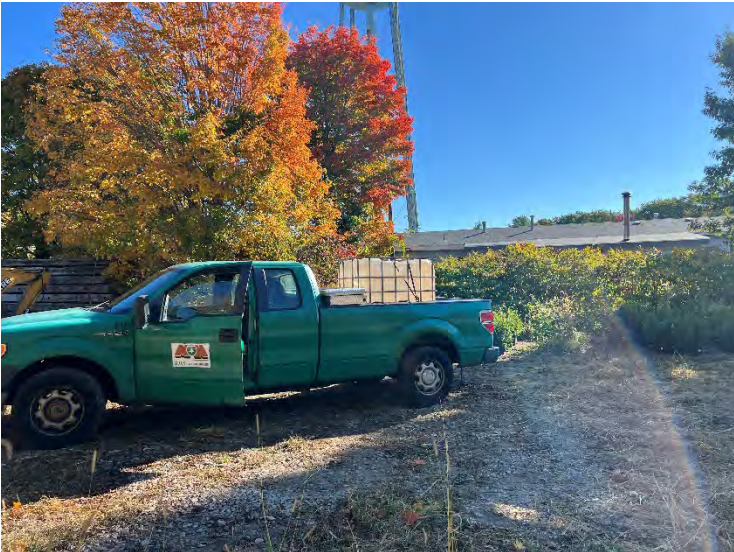
Description: View of MON watering plants located in their laydown yard off of Central Street. Facing east.

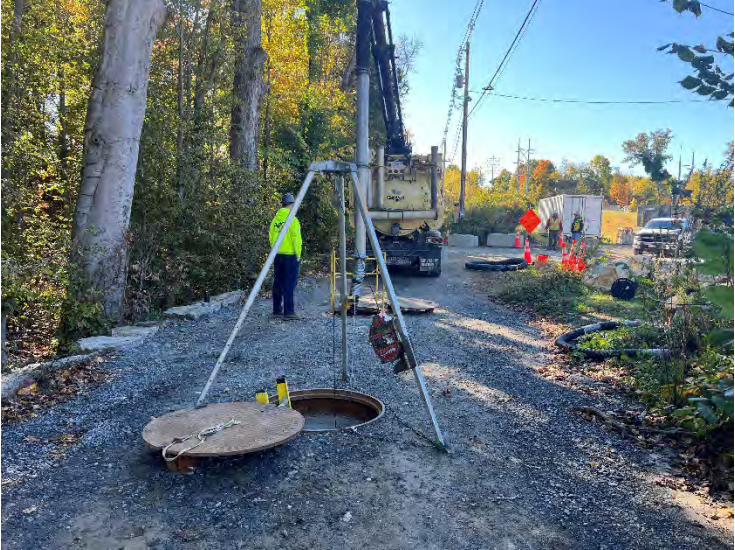
<p>Description: View of vac truck at MH #1 for proofing of conduit. Facing south.</p>

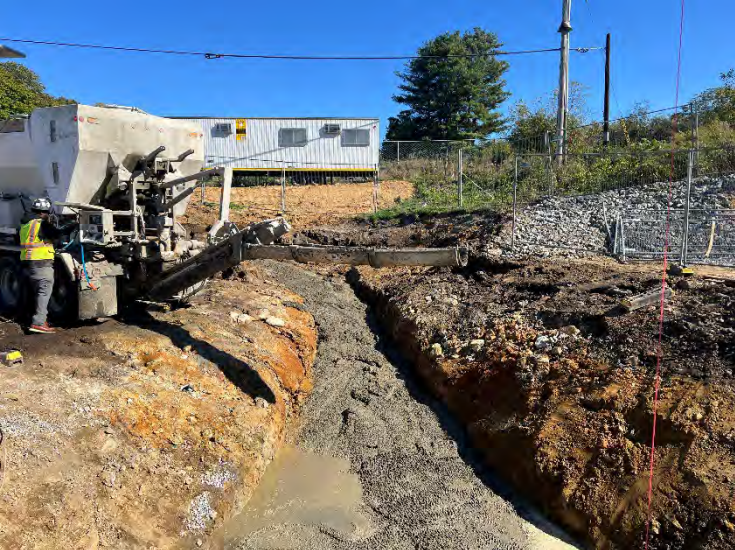
<p>Description: View of trench within Hudson Light &amp; Power property being backfilled with flowable fill. Facing east.</p>

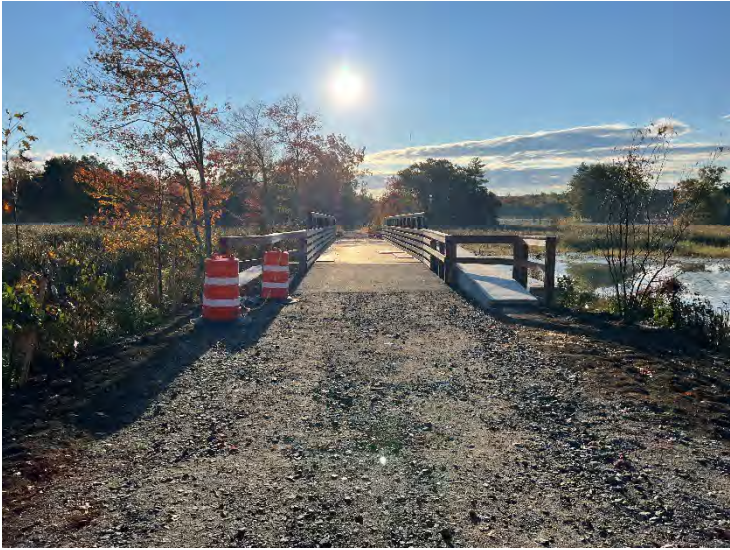
Description: View of Bridge 130. Facing east.

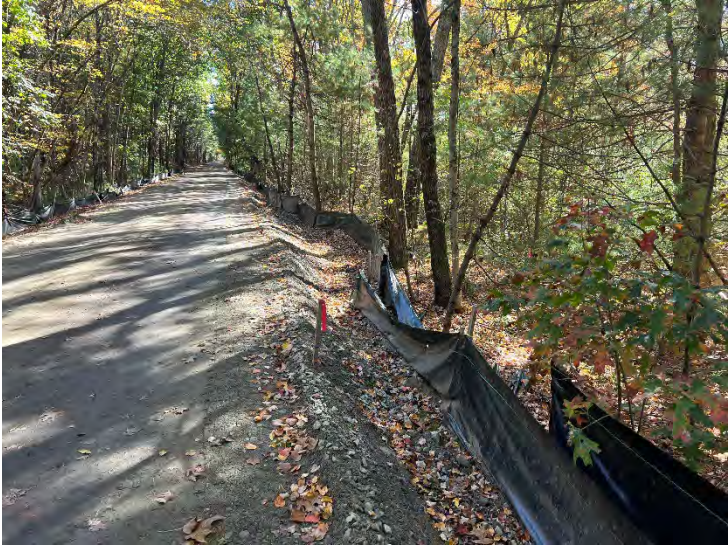
Description: View of E&S controls in segment 6. Facing east.

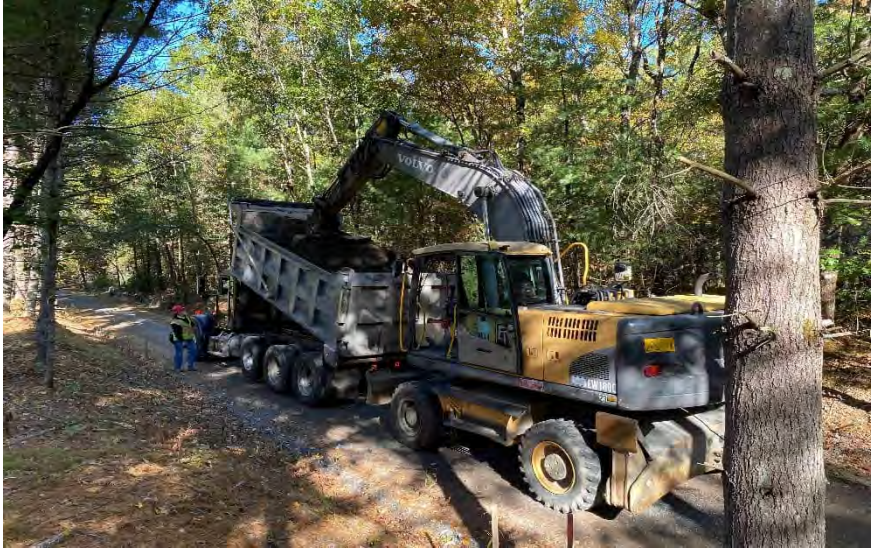
<p>Description:</p> <p>Segment 7, ET&amp;L conducting loaming work, existing erosion control, looking westward.</p>

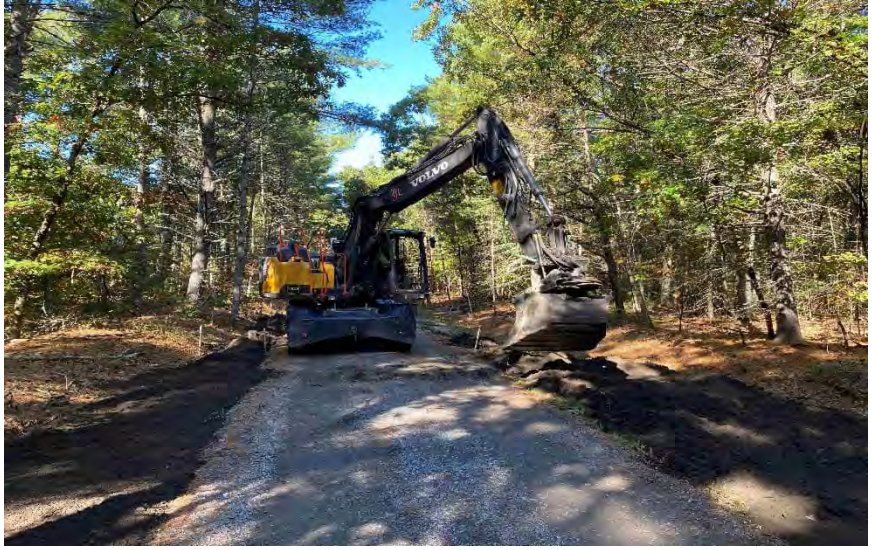
<p>Description:</p> <p>Work area within segment 7, ET&amp;L loaming shoulders, existing erosion control, looking westward</p>
