**Weekly Environmental Compliance Summary**

**Sudbury to Hudson Transmission Reliability Project (USEPA Tracking # MAR1003UW)**

Sudbury, Hudson, and Stow, MA

Week of: October 7, 2024 to October 11, 2024

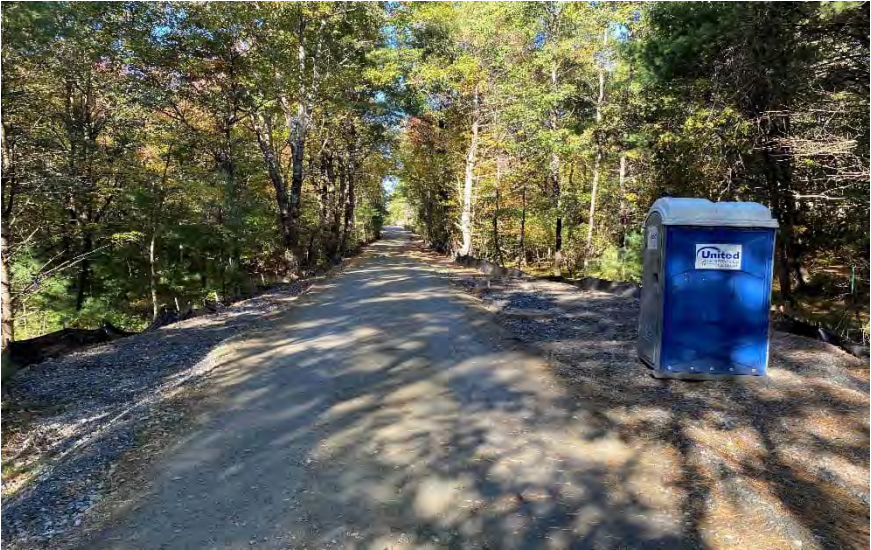
<p>Description:</p> <p>Work area within segment 7 at manhole #15, gravel pad removed prior to adding loam for plantings, existing erosion control, looking westward</p>

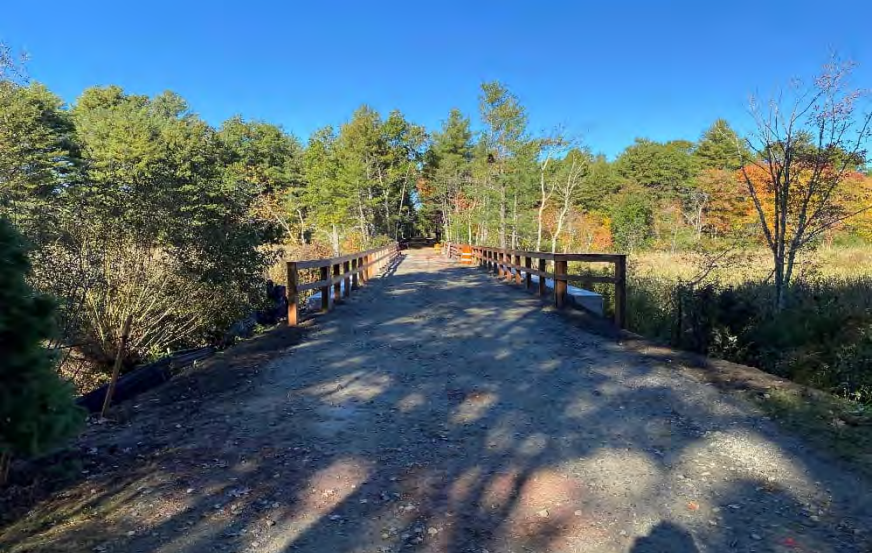
<p>Description:</p> <p>Bridge 128 within segment 8, recently planted area - to be hydro seeded, existing erosion control, looking westward.</p>

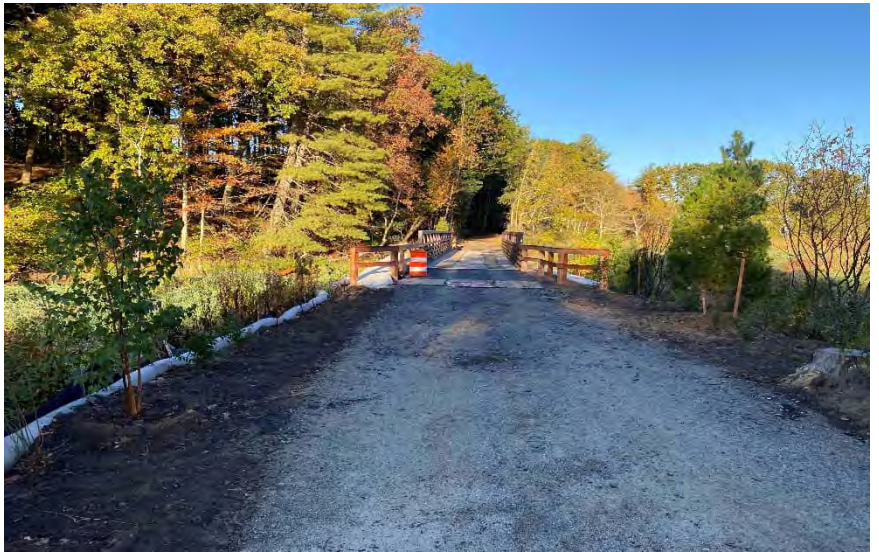
<p>Description:</p> <p>Bridge 127 within segment 14, recently planted area - to be hydro seeded, existing erosion control, looking westward.</p>

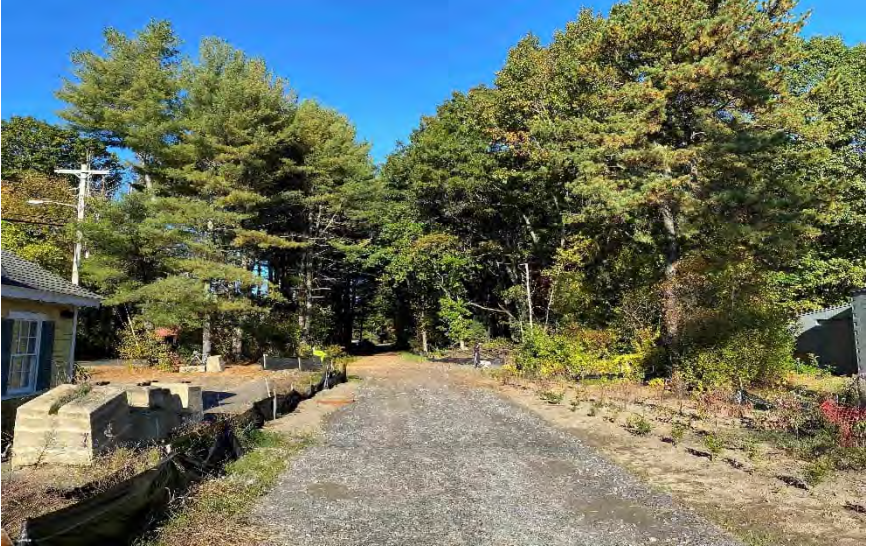
<p>Description:</p> <p>Work area within segment 11 manhole #24, recently planted area - to be hydro seeded, existing erosion control, looking westward.</p>

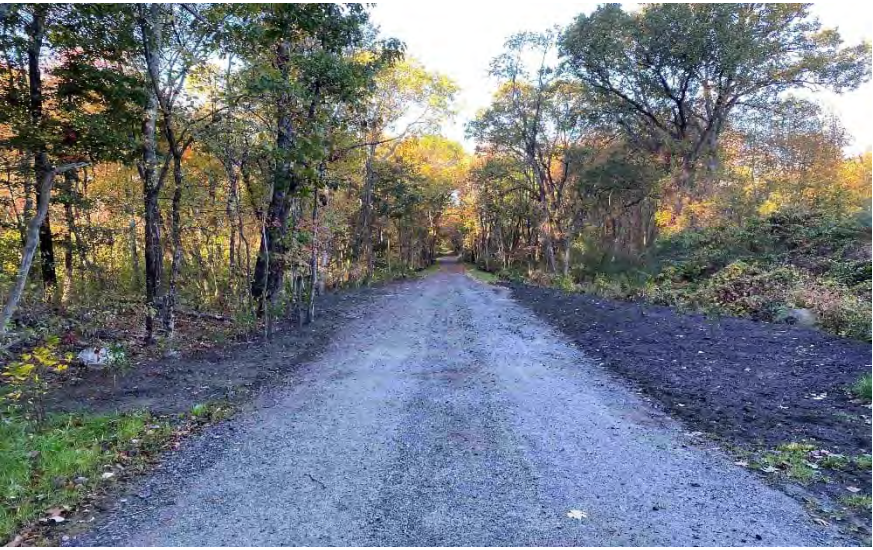
<p>Description:</p> <p>Work area within segment 14, manhole #27, recently planted area - to be hydro seeded, existing erosion control, looking westward.</p>

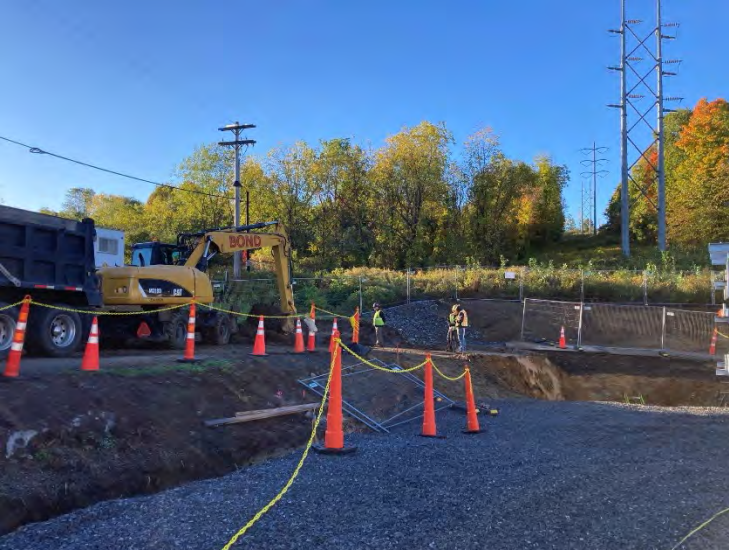
Description: View of Bond working between MH #1 and Hudson Light & Power Substation. See additional dewatering inspection report. Facing southeast.

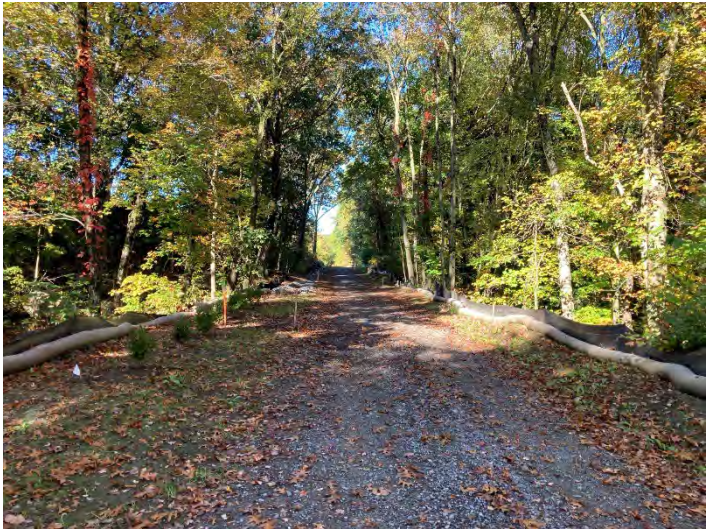
Description: View of E&S controls and new plantings in segment 1. Facing west.

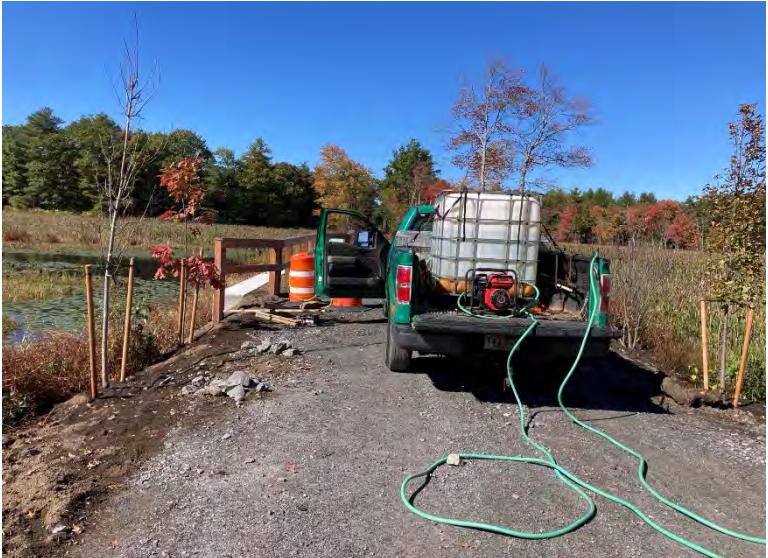
Description: View of MON watering new plantings at bridge 130. Facing west.

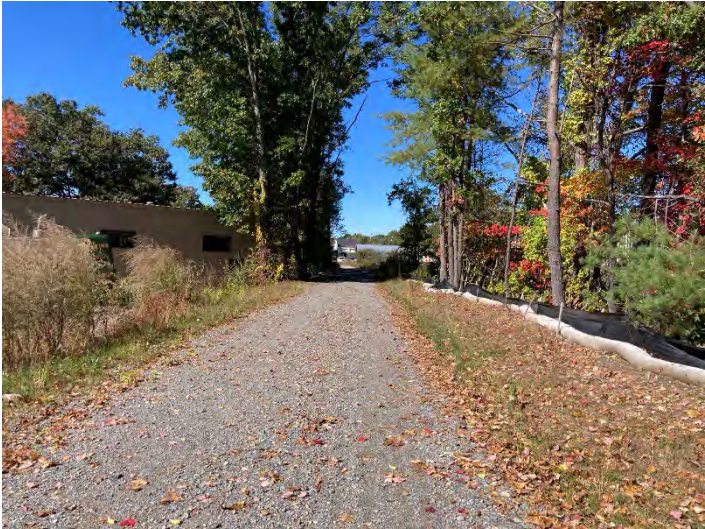
Description: View of E&S controls in segment 3. Facing east.

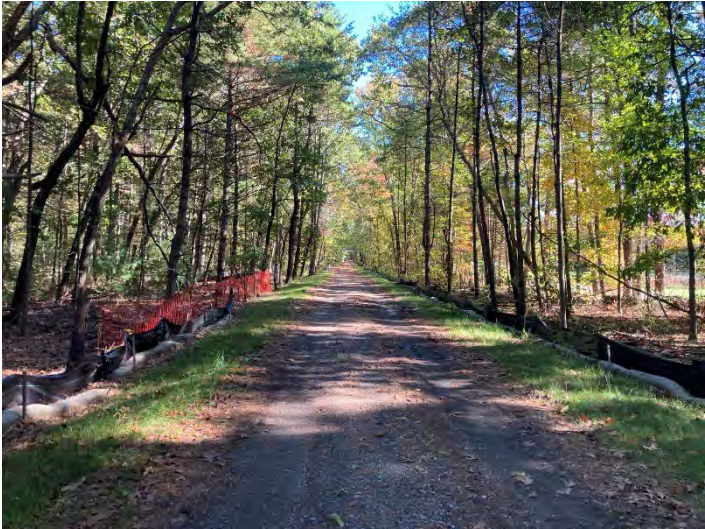
Description: View of E&S controls in segment 4. Facing east.

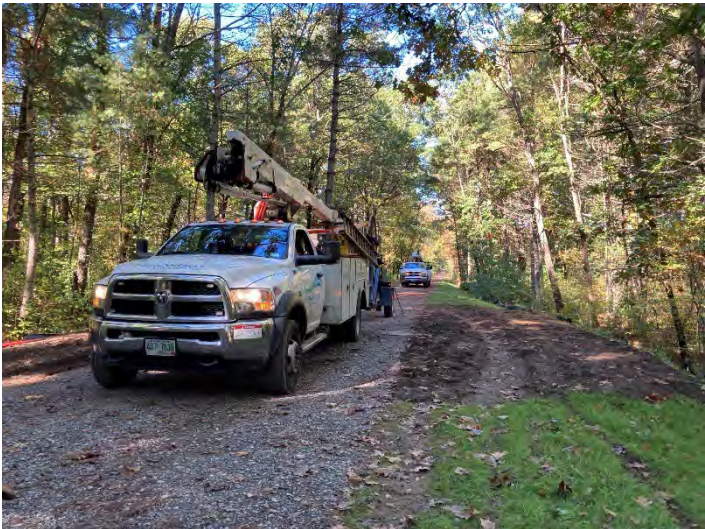
Description: View of New Wave working near MH #13 in segment 5. Facing west.

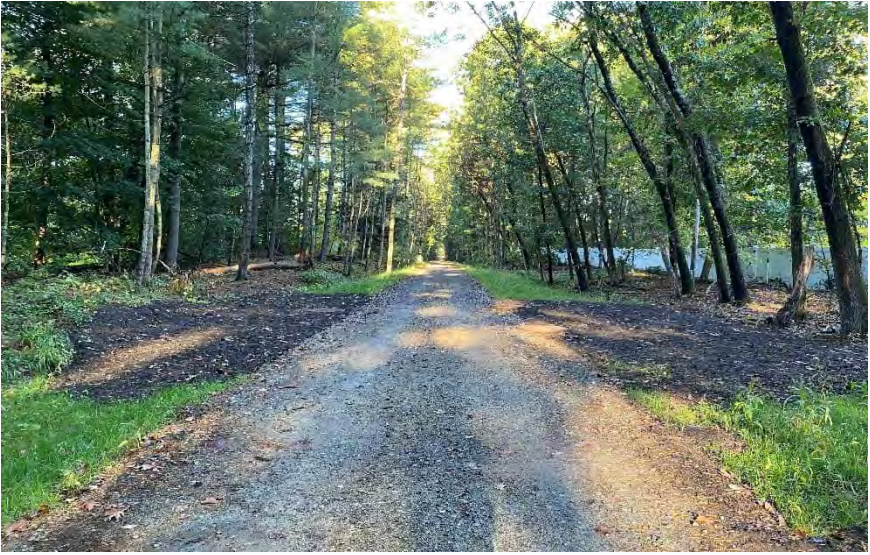
<b>Description:</b>  Work area within segment 10, manhole #21 to be hydroseeded, looking westward.

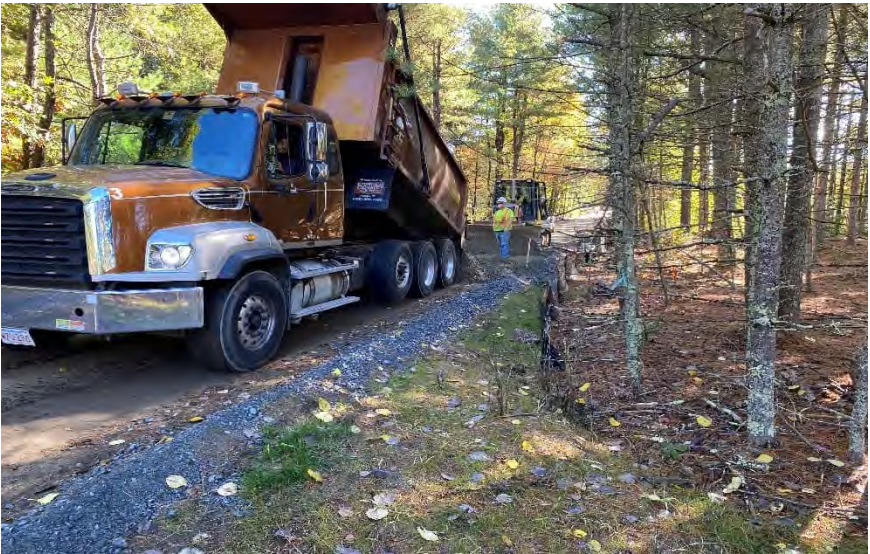
<b>Description:</b>  Work area within segment 7, ET&L grading activities, existing erosion control, looking westward.

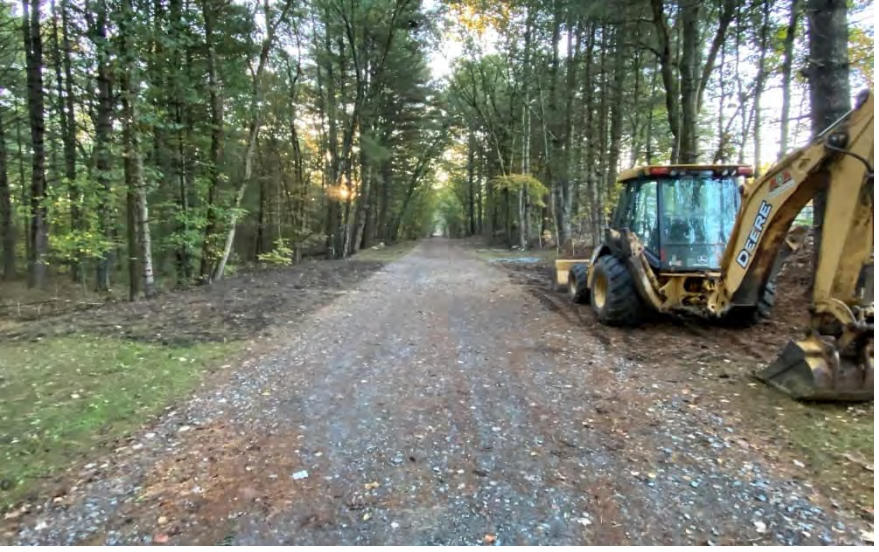
Description:  Work area within segment 8 manhole #17, to be hydro seeded, MON equipment staged, existing erosion control, looking eastward.

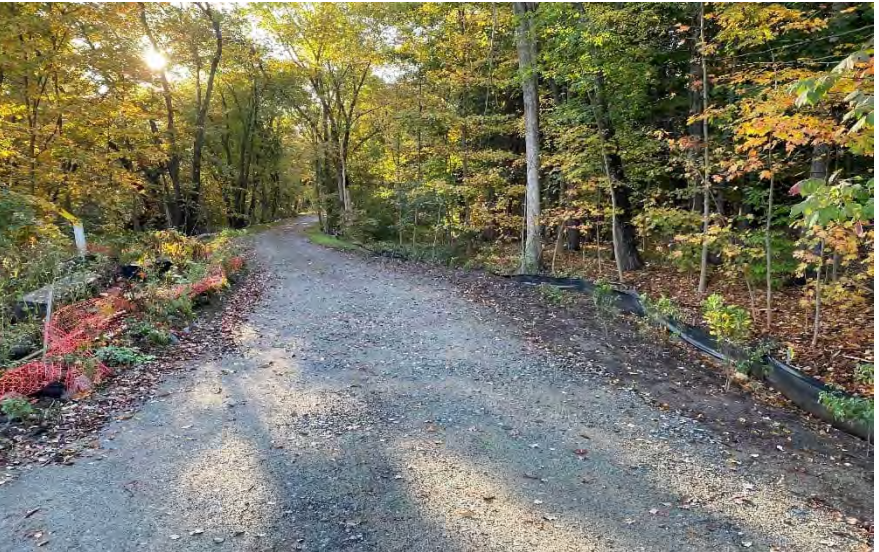
Description:  Work area within segment 13, recently planted area to be hydroseeded, existing erosion control, looking eastward.

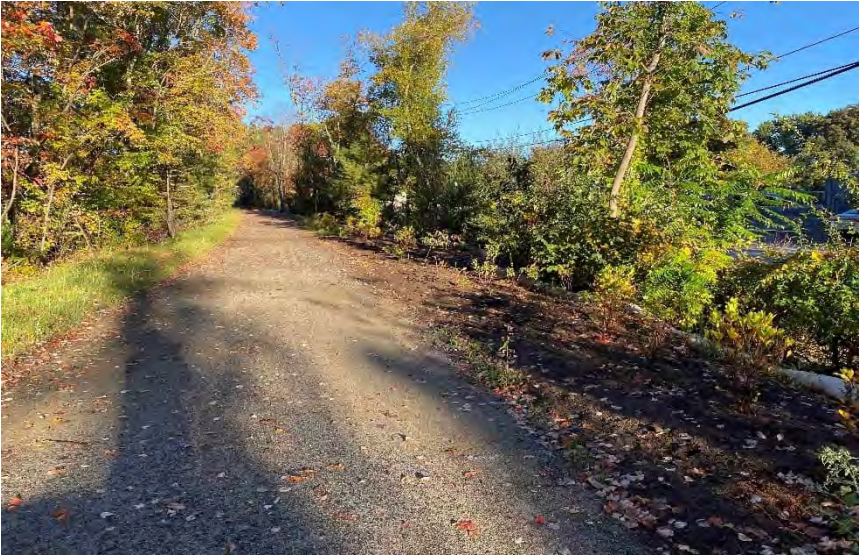
<b>Description:</b>  Work area within segment 12, recently planted area to be hydroseeded, existing erosion control, looking westward.

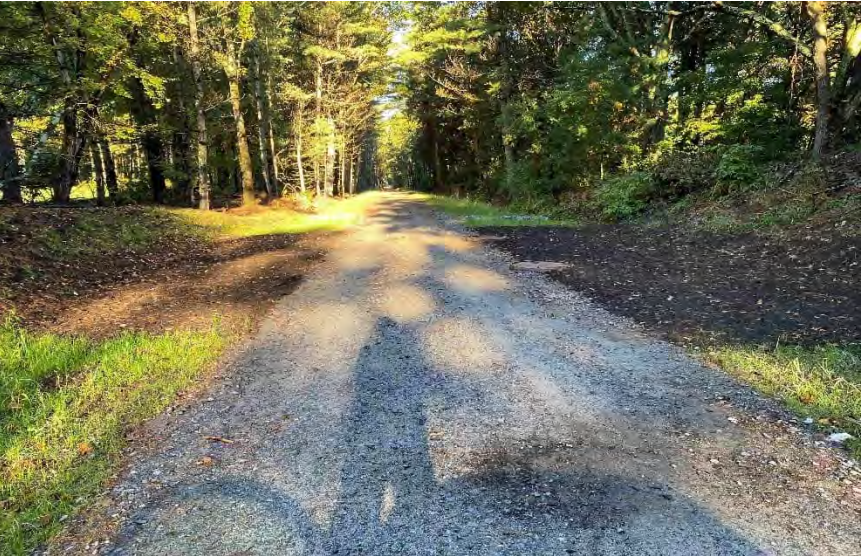
<b>Description:</b>  Work area within segment 11 manhole #22 to be hydro seeded, looking westward.

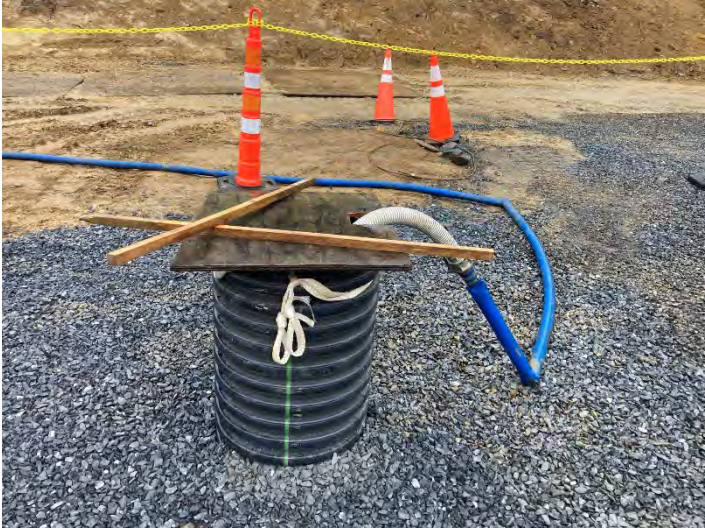
<b>Description:</b> View of sump well within Hudson Light and Power substation, where dewatering discharge was initially sent. Facing south.

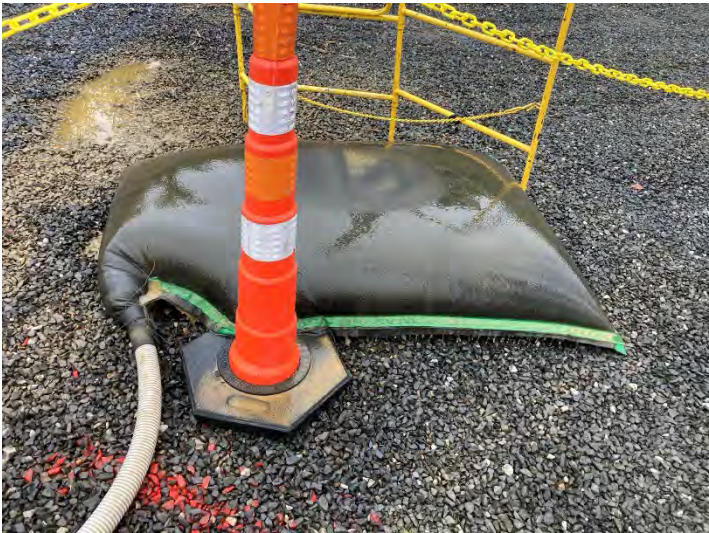
<b>Description:</b> View of dewatering controls in use later in the day. Discharge sent to silt bag west of trench within substation. Discharge appeared to be turbid but was not leaving the Hudson Light & Power property. Turbidity sample was not collected. Facing west.

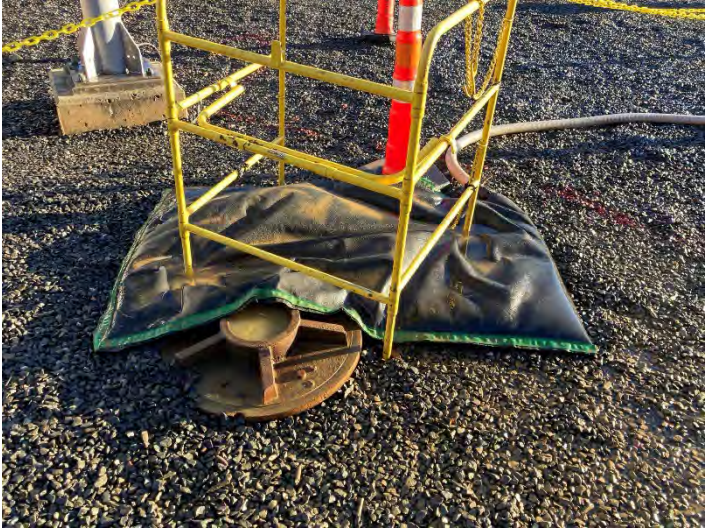
<b>Description:</b> View of dewatering controls. Discharge sent to silt bag west of trench within substation. Discharge appeared mostly clear and was not leaving the Hudson Light & Power property. Turbidity sample was not collected. Facing north.

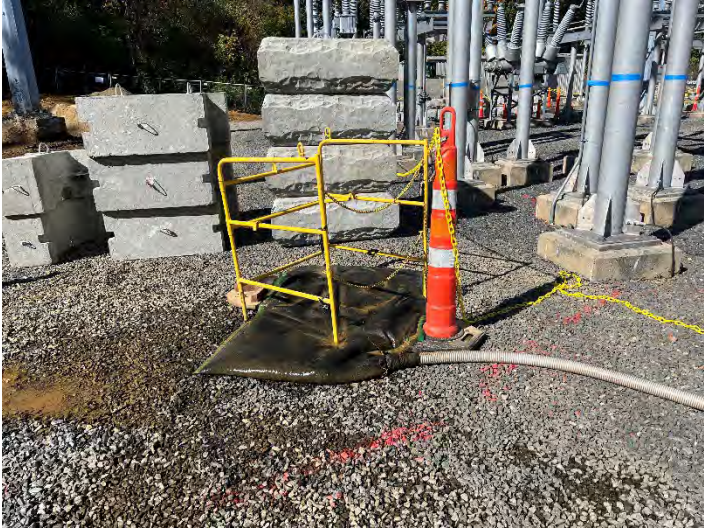
Description: View of dewatering controls (silt bag). Facing west.

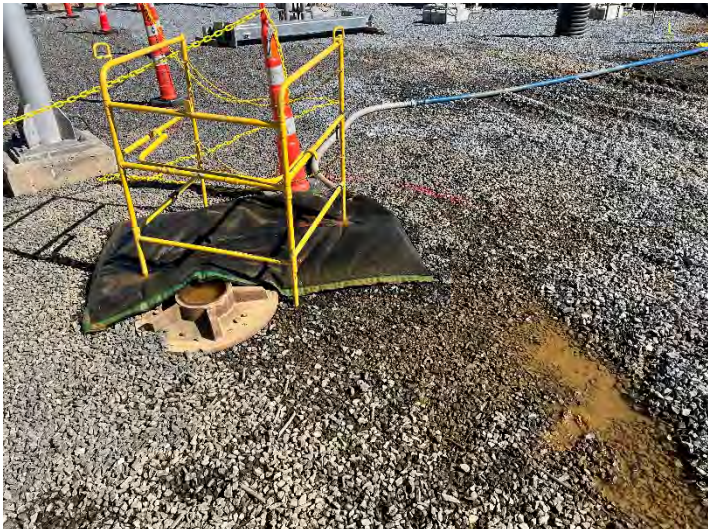
Description: View of discharge from silt bag. Discharge appeared to be mostly clear and did not leave the Hudson Light & Power property. Turbidity sample was not collected. Facing north.

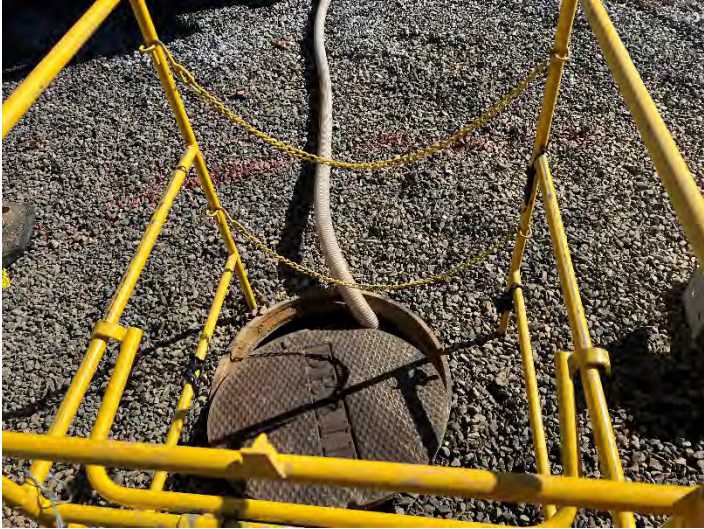
<b>Description:</b> View of dewatering set up to drain. Facing east.

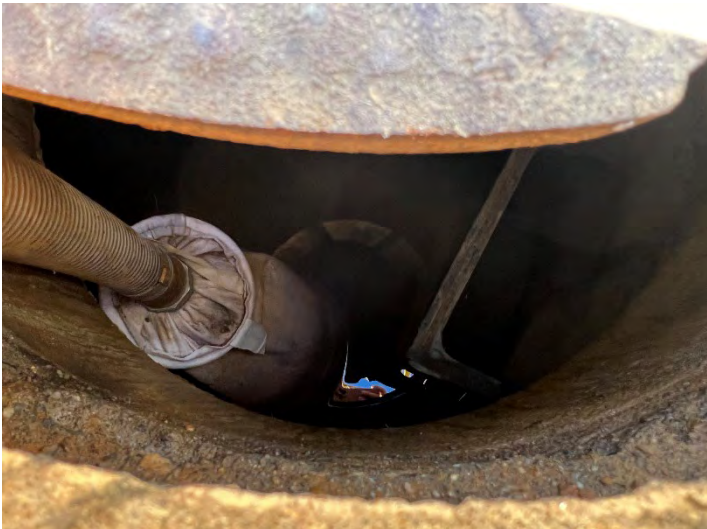
<b>Description:</b> View of dewatering controls (silt bag within drain). Turbidity sample was not collected.
