**Weekly Environmental Compliance Summary**

**Sudbury to Hudson Transmission Reliability Project (USEPA Tracking # MAR1003UW)**

Week of: October 14, 2024 to October 19, 2024

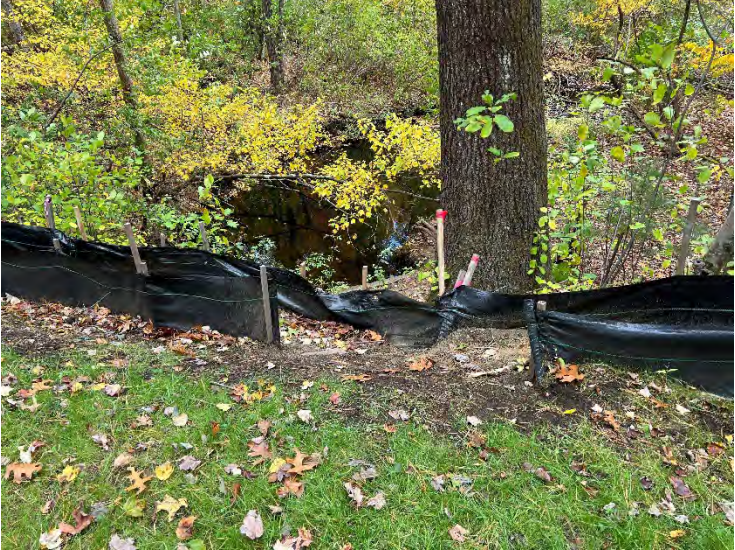
<p><b>PHOTOGRAPHIC LOG</b></p>	
<p>Client Name: Eversource</p>		<p>Site Location: Sudbury to Hudson Transmission Reliability Project</p>	<p>Town: Sudbury</p>
<p>Photo No.: 3</p>	<p>Date: 10/16/2024</p>

<p>Description: View of repairs to silt fencing in segment 10. Facing south.</p>

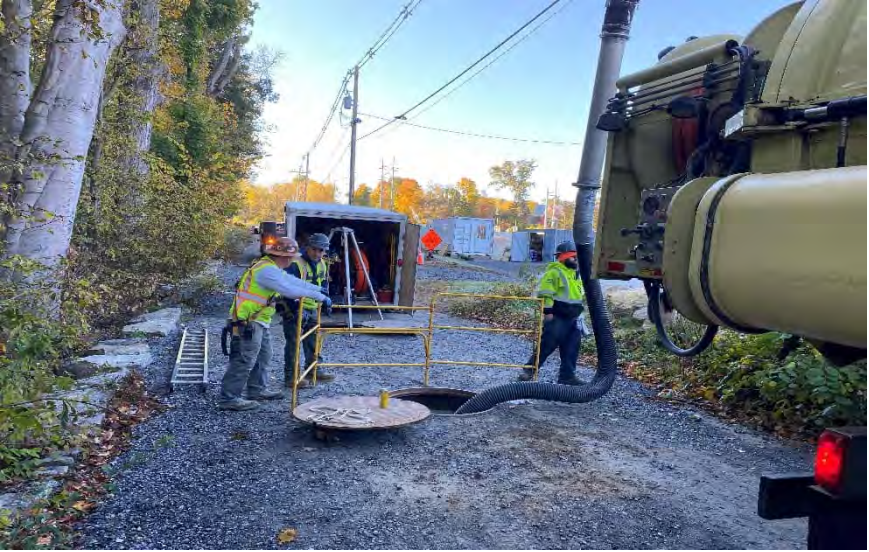
<p align="center"><b>PHOTOGRAPHIC LOG</b></p>	
<p>Client Name: Eversource</p>		<p>Site Location: Sudbury to Hudson Transmission Reliability Project</p>	<p>Town: Hudson</p>
<p>Photo No.: 1</p>	<p>Date: 10-17-24</p>

<p>Description:</p> <p>Work area at manhole #1, Bond conducting exploratory work to repair conduit, looking eastward.</p>

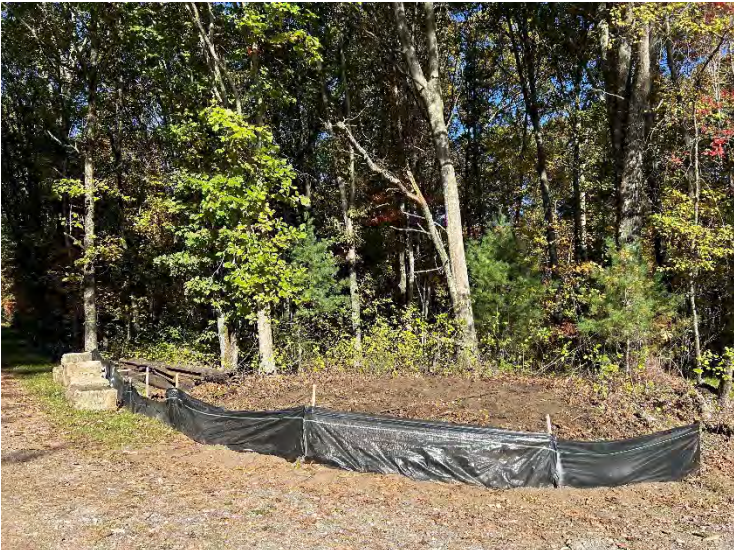
<p>Description: View of repaired silt fence after ET&amp;L completed removal of debris in segment 11. Facing northwest.</p>

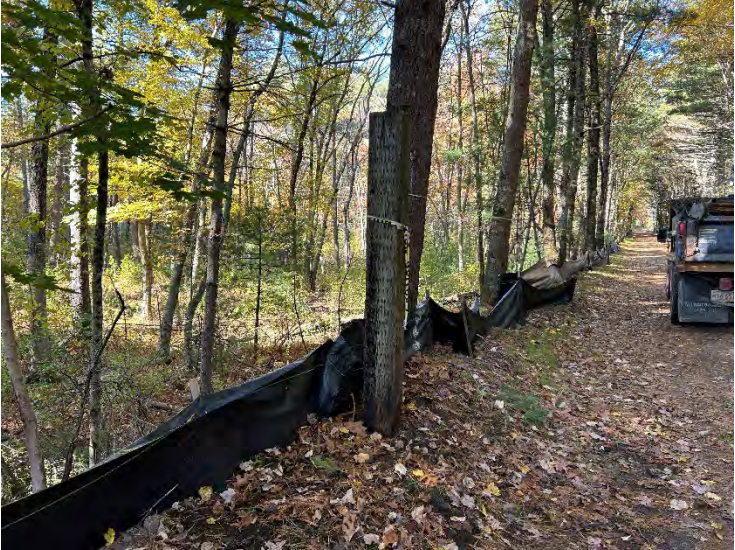
<p>Description: View of reset post and repaired silt fence within segment 8. Facing west.</p>

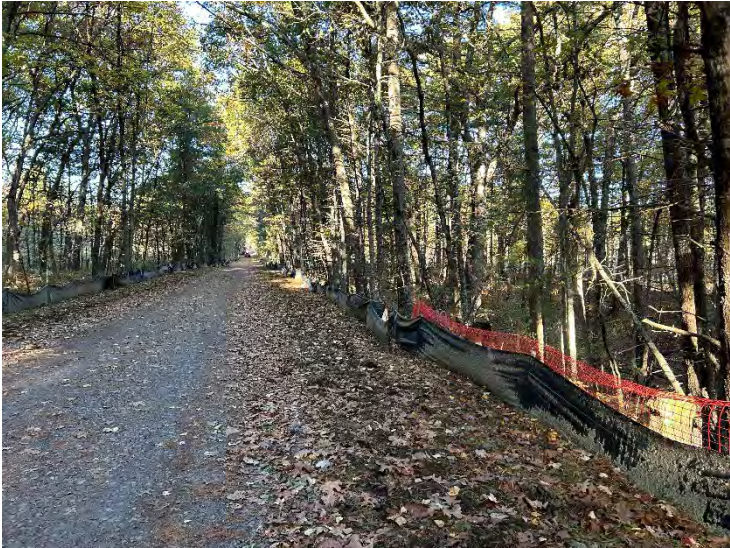
<p>Description: View of E&amp;S controls within segment 8. Controls are in good condition. Facing west.</p>

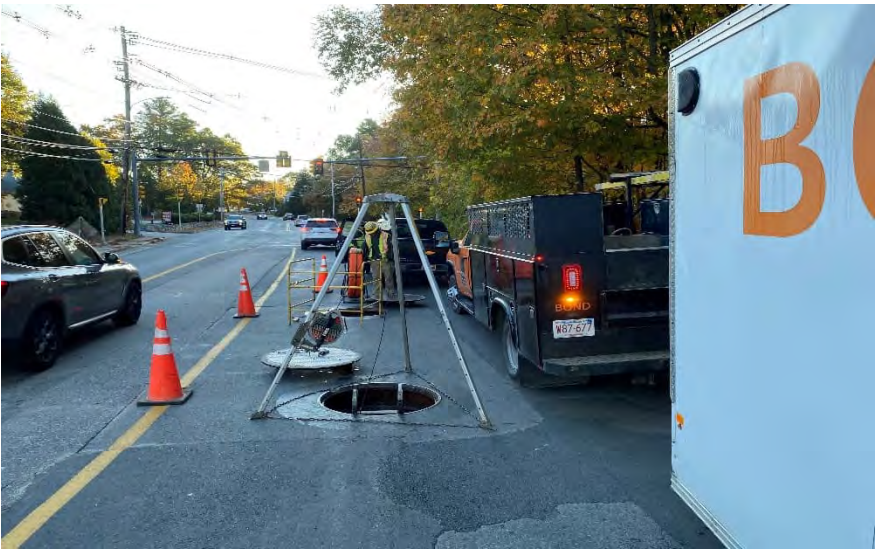
<p>Description:</p> <p>Bond working at manhole #2 to conduct repairs to conduit, looking northward.</p>

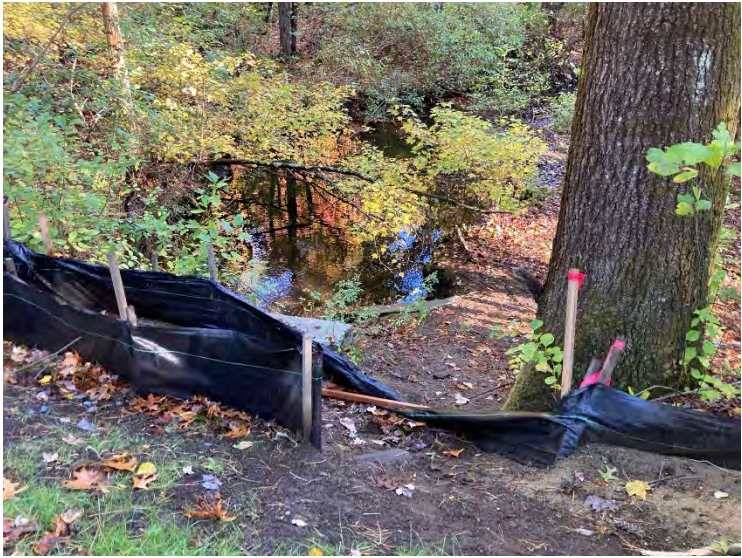
-Silt fence is in need of repair at Dudley Brook culvert in segment 10.

Description: View of damaged silt fence at Dudley Brook culvert in segment 10. Facing north.

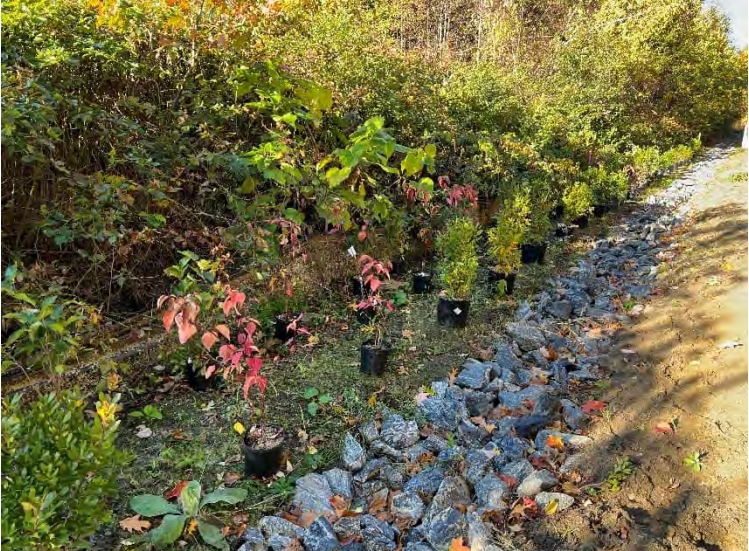
<p>Description: View of plants laid out prior to installation. Plant locations had to be adjusted from plans to fit planting bed. <i>Facing west.</i></p>

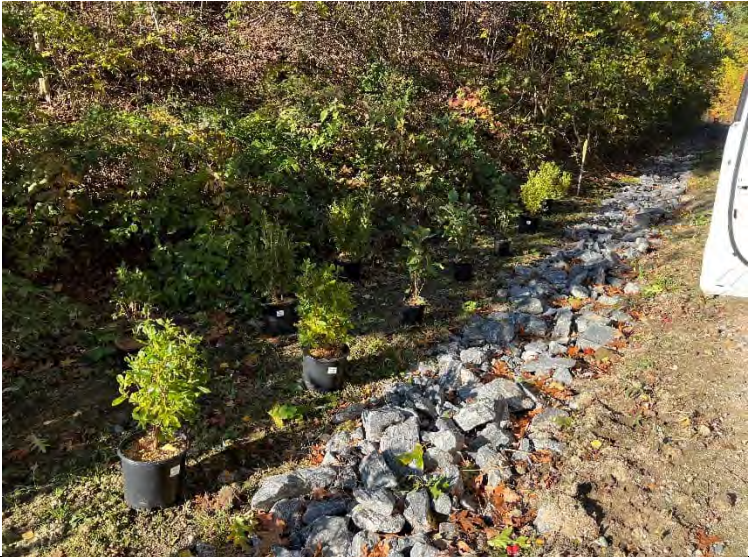
<p>Description: View of the western end of planting bed where the fourth row was shifted to a continuation of the second row due to spacing. <i>Facing west.</i></p>

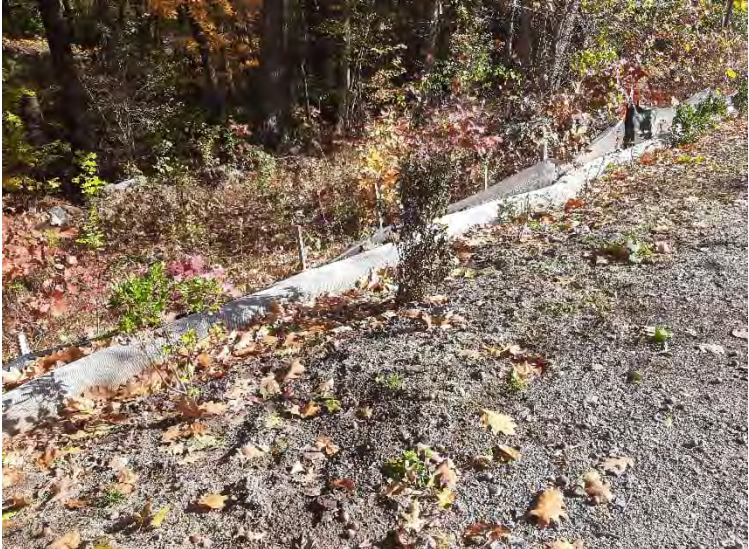
<p>Description: Segment 1, south side, near STA 117+~20. Recently installed alders (CH) between previously installed pepperbushes (CA) and bayberries (MP). Note condition of center-of-photo CA versus CA to the left. Center CA has degraded more since installation than left CA. Looking northeastward.</p>

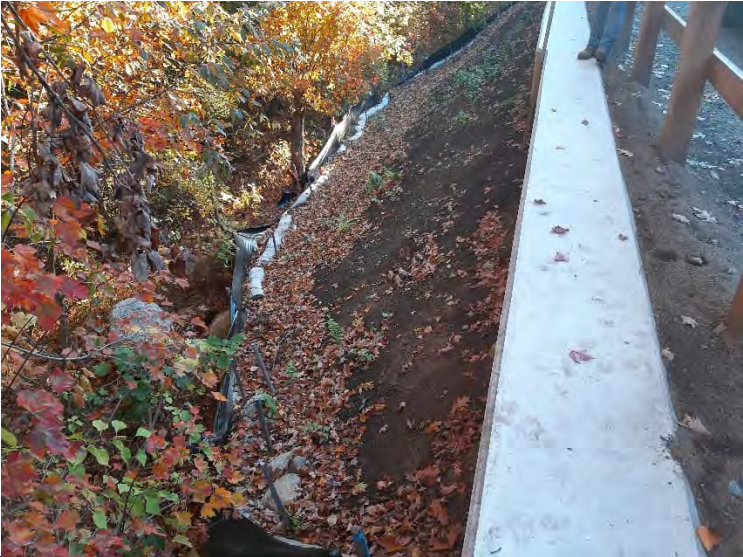
<p>Description: Segment 1, north side, opposite manhole 6 (MH6). Bed prior to plantings. Loam is loose and fairly steep. Drop-off from concrete to bed several feet. Looking eastward.</p>
