Weekly Environmental Compliance Summary

Sudbury to Hudson Transmission Reliability Project (USEPA Tracking # MAR1003UW)

Week of: October 21, 2024 to October 26, 2024

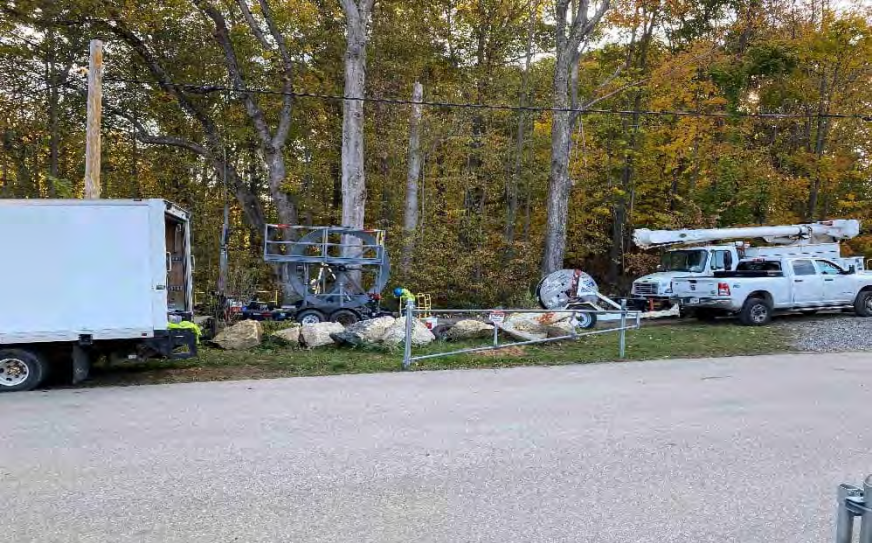
Description: Work area at manhole #1, Haugland conducting wire work to manhole #2, looking northward.

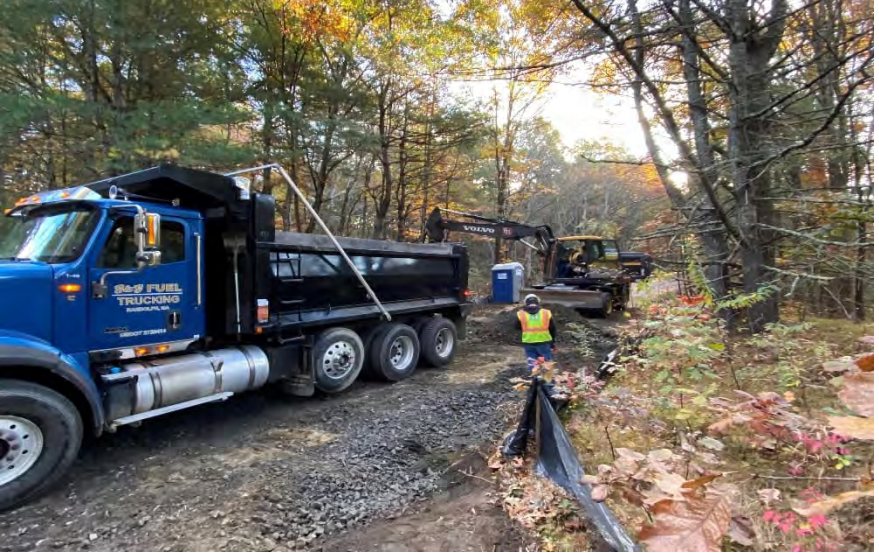
<p>Description:</p> <p>Work area within segment 6, ET&L conducting removal of the construction entrance pad, existing erosion control, looking eastward.</p>

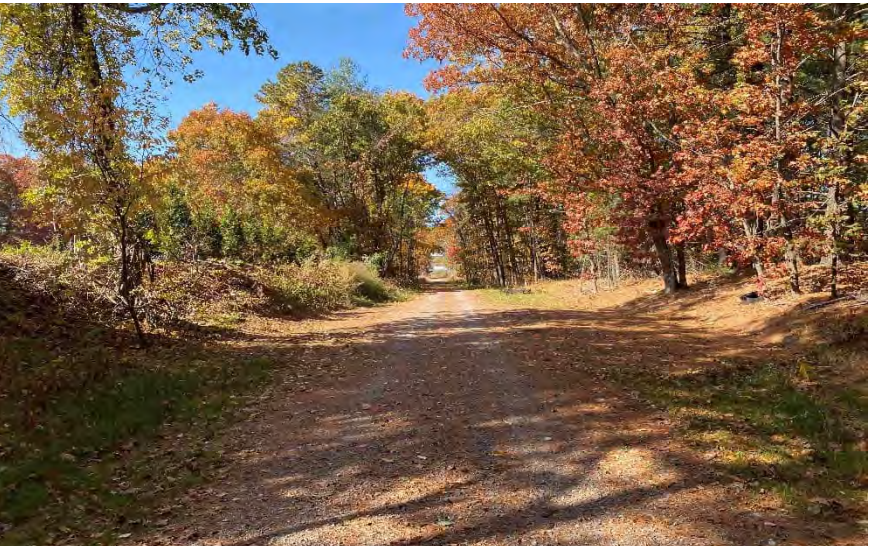
<p>Description:</p> <p>Work area within segment 3, manhole #9, area recently loamed awaiting hydro seeding, looking westward.</p>

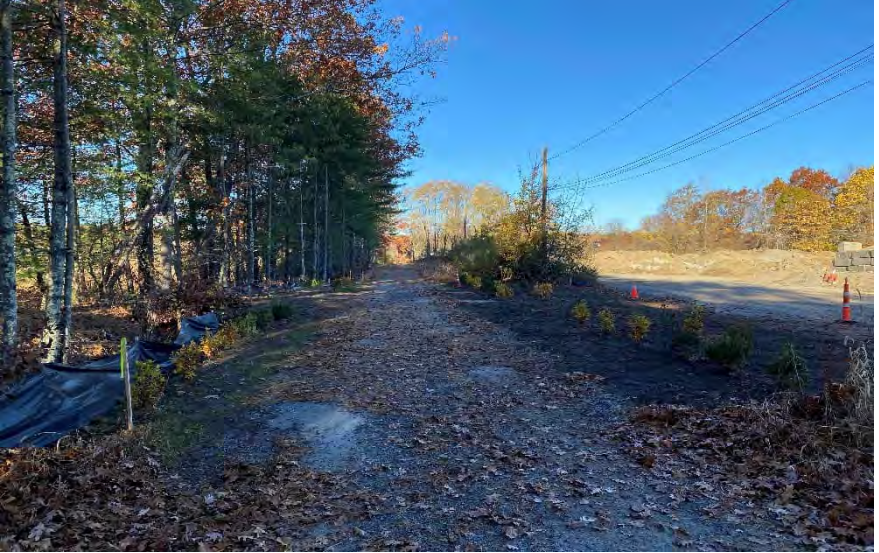
<p>Description:</p> <p>Segment 3, manhole #8 area, recently loamed & planted to be hydroseeded, existing erosion control, looking westward.</p>

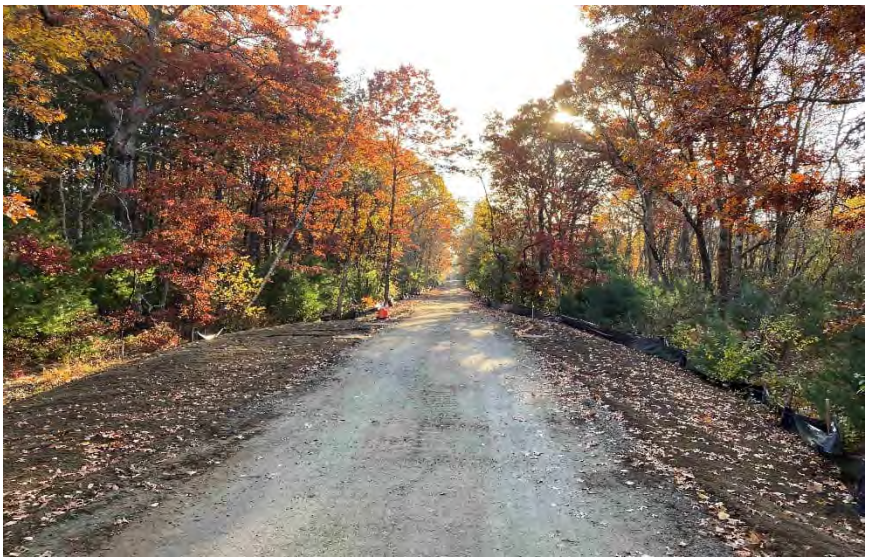
Description: Work area within segment 6, recently loamed areas at manhole #14 prior to hydro seeding, existing erosion control, looking eastward.

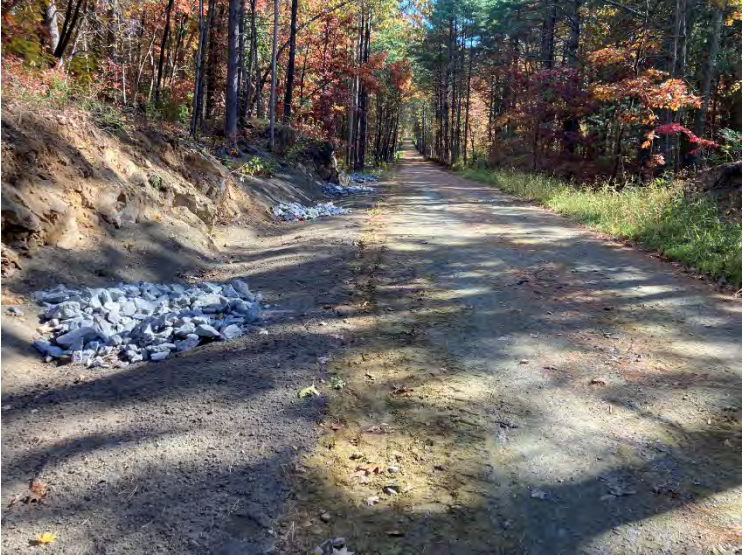
Description: View of new swale installed at west end of segment 10. Facing east.

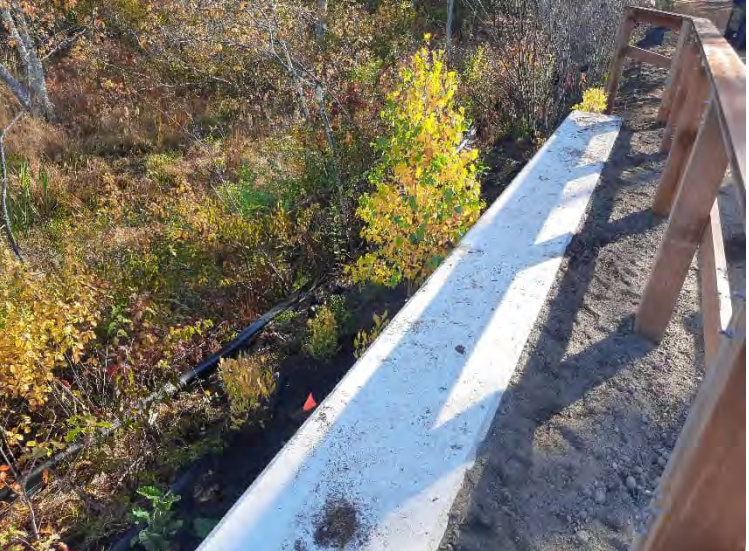
<p>Description: Segment 8, north side, near Bridge 128. Plantings along north side of ROW after shrubs installed. Flags placed for missing trees. Looking eastward.</p>

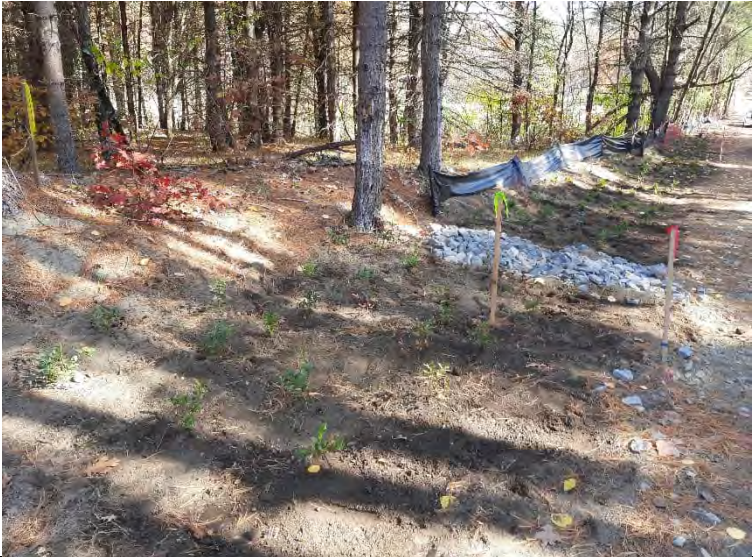
Description: Segment 8, north side, STAs 396 + ~75 to ~398 + 00. Plantings after installation, including ~6-7 foot bed extension for spacing. Pennsylvania sedge (CP) staggered for a more natural look per previous requests. Looking eastward.

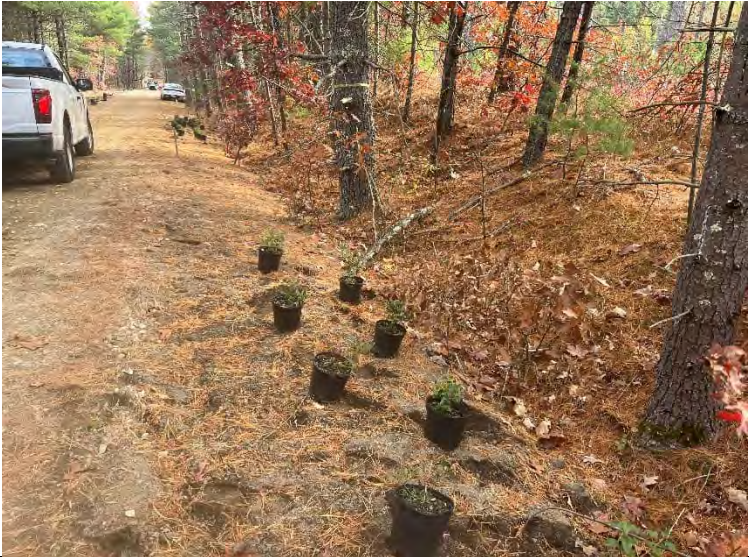
<p>Description: View of plants laid out prior to installation. Partial bed completed; gaps left for remainder of plants to be installed 10/25. Facing west.</p>

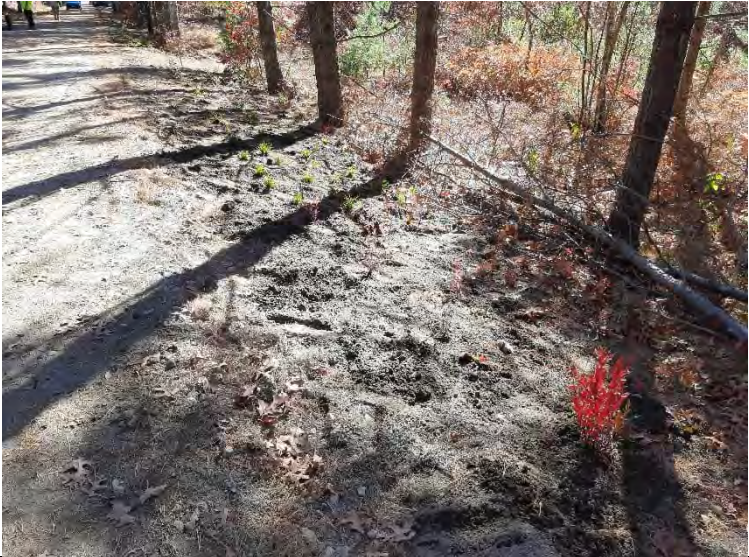
Description: Segment 7, south side, STA 391 + ~00. Installed plantings. Gap for trailhead visible in sunlit area near top left of image. Looking eastward.
