Environmental Monitor Construction Site Inspection Report
MassDOT Project #608164 Construction Contract # 119678
EM Report #29

Project Description: Bruce Freeman Rail Trail Right-of-Way
 Permit Description(s): Order of Conditions (MGL Chapter 131, Section 40 and 310 CMR 10.00, Mass DEP File No. 301-1362); 2022 EPA NPDES General Permit for Discharges from Construction Areas; U.S. Army Corps of Engineers Permit No NAE-2021-01975.

Project Name:	Bruce Freeman Rail Trail - Phase 2d - Sudbury
Date of Inspections:	10/22/2024
Bi Weekly/ Monthly Period Covered:	October Weekly Inspection #4
Inspector's Name(s):	Anna Haznar
Inspectors' Contact Information:	ahaznar@beta-inc.com

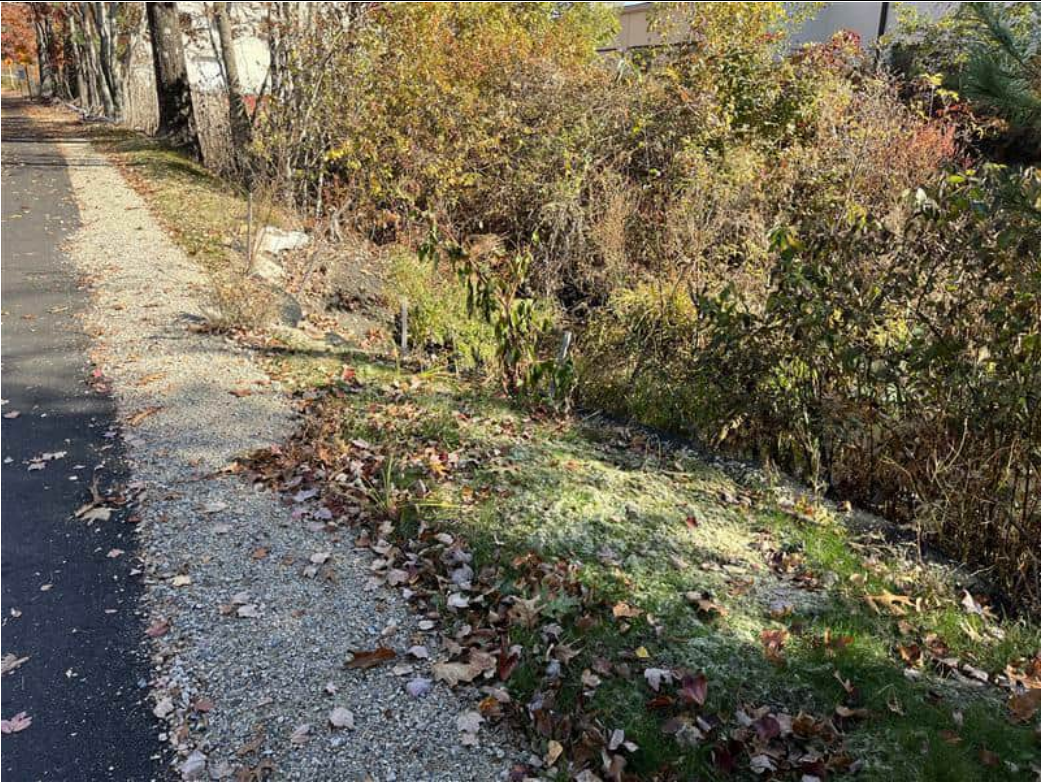
Photo No. 1	Date: 10/22/2024

43	<p>Overtopped compost filter tubes and exposed soils beyond the limits of work at Station 105+00 Priority: High</p>	6/7/2024	6/14/2024	Stabilize the area with the approved seed mixture and provide interim stabilization such as straw mulch.	<p>6/14/2024 - Observation remains. 6/17/2024 - Observation remains. 6/24/2024 - Observation remains. 6/27/2024 - Observation remains. 7/8/2024 - Observation remains. 7/15/2024 - Observation remains. 7/22/2024 - Observation remains. 7/29/2024 - Observation remains. 8/5/2024 - Observation remains. 8/7/2024 - Observation remains. 8/12/2024 - Observation remains. Some material has migrated off of the compost filter tubes due to erosion. 8/16/2024 - Observation remains. 8/20/2024 - Application of the approved seed mixture is required at this location. 8/27/2024 - Observation remains. 9/3/2024 - Observation remains. 9/10/2024 - Observation remains. Application of the approved seed mixture is required at this location. 9/16/2024 - Observation remains. 9/23/2024 - Observation remains. 9/27/2024 - Observation remains. 10/4/2024 - Hydroseed has been applied here; however, the contractor should provide an update on long-term slope stabilization plans. 10/8/2024 - Observation remains. Germination has not been observed. 10/15/2024 - Observation remains. Germination has not been observed. 10/22/2024 - Observation remains. Some germination has been observed but the area is not considered stabilized.</p>

44	Slopes require stabilization / additional seed due to lack of compost filter tubes at 105+00 and 106+00 Priority: High	6/7/2024	6/14/2024	Stabilize the slope with the approved seed mixture and provide interim stabilization such as straw mulch.	<p>6/14/2024 - Observation remains. 6/17/2024 - Observation remains. 6/24/2024 - Observation remains. 6/27/2024 - Observation remains. 7/8/2024 - Observation remains. 7/15/2024 - Observation remains. 7/22/2024 - Observation remains. 7/29/2024 - Regrowth of vegetation has been observed in this area. This item will remain open until the area is fully stabilized. 8/5/2024 - Observation remains. 8/7/2024 - Regrowth of vegetation has been observed but the area is not yet fully stabilized. 8/12/2024 - Observation remains. 8/16/2024 - Observation remains. 8/20/2024 - Application of the approved seed mixture is required at this location. 8/27/2024 - Vegetation has partially stabilized this area; however, seed should be applied. 9/3/2024 - Observation remains. 9/10/2024 - Observation remains. Application of the approved seed mixture is require at this location. 9/16/2024 - Observation remains. 9/23/2024 - Observation remains. Application of the approved seed mixture is require at this location. 9/27/2024 - Observation remains. The contractor reached out and indicated this area was hydroseeded after the inspection occurred. 10/4/2024 - Hydroseed has been applied here and the item will remain open until the area is fully stabilized. 10/8/2024 - Observation remains. Germination has not been observed. 10/15/2024 - Observation remains. Germination has not been observed. 10/22/2024 - Observation remains. Some germination has been observed but the area is not considered stabilized.</p>

Direction Photo Taken: Toward the Northeast		
Description: View of the overtopped compost filter tube beyond the limits of work and the recently applied hydroseed with germination at Station 105+00 per Compliance Action Item 43 and 44.

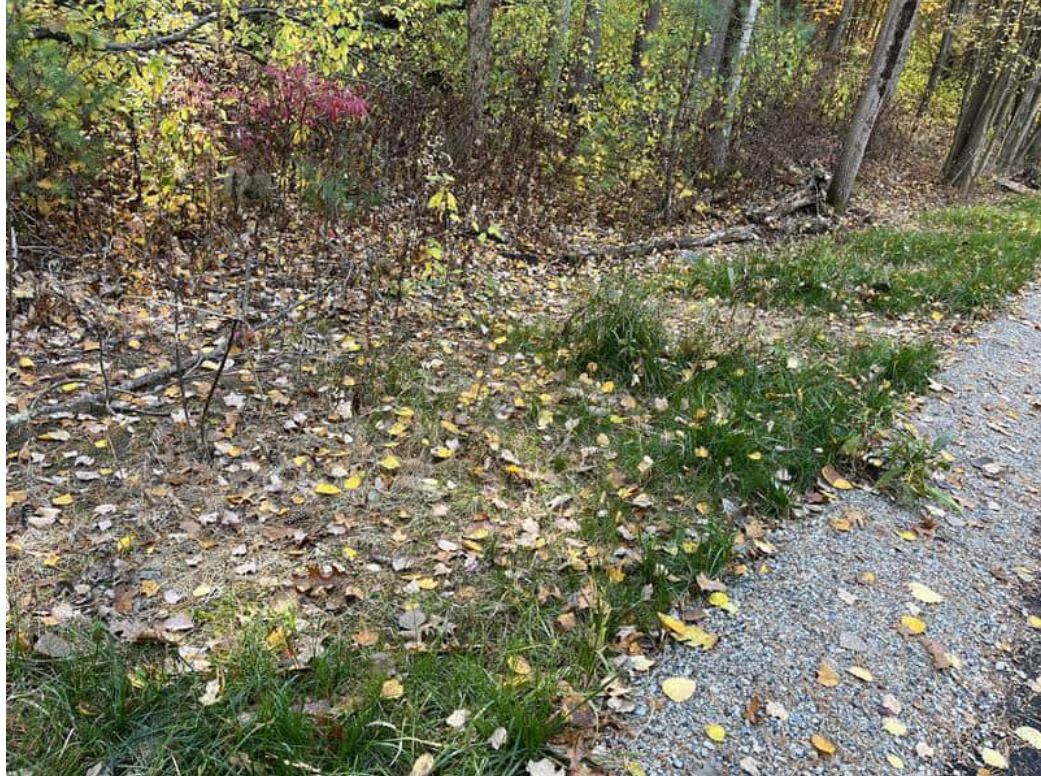
Photo No. 3 **Date:**
10/22/2024

Item	Location/ Description	Observation Date	Resolution Due Date	Recommended/Discussed Resolution	Comments/Updates
59	Multiple locations of exposed soils along the Project corridor require stabilization Priority: High	9/3/2024	9/10/2024	The contactor should apply the approved seed mixture to areas of exposed soils and place straw.	<p>9/3/2024 - Herbicide application caused multiple areas along the path to be no longer stabilized. If thatch is present in these locations the thatch should be removed before seeding occurs. A location near Station 320+50 has been cleared outside of the limit of work and requires stabilization. Other areas along the path where seed did not germinate should be reseeded with the approved seed mix and straw should be placed on the areas of exposed soil.</p> <p>9/10/2024 - Observation remains, see previous update. A few locations along the trail have been hydroseeded but a majority of the locations of exposed soil require seed and stabilization.</p> <p>9/16/2024 - Observation remains. The contactor indicated areas of bare soil will be hydroseeded.</p> <p>9/23/2024 - Observation remains. It does not appear as though any hydroseeding has been done since the last inspection. Areas throughout the trail require removal of thatch and application of seed for stabilization.</p> <p>9/27/2024 - Observation remains. The contractor reached out and indicated all areas of exposed soils south of Hudson Road were hydroseeded after the inspection occurred.</p> <p>10/4/2024 - All areas south of Hudson Road were not seeded using hydroseed; hydroseed was applied in a few locations, but there are still large areas of exposed soil both south and north of Hudson Road that require seeding. Thatch was not removed in any areas before hydroseed was applied. The contractor should provide the tag from the seed mix that was used to the Conservation Commission to ensure that the required native seed mix was used per the design plans. Once vegetation has sufficiently stabilized, this item will be closed.</p> <p>10/8/2024 - Observation remains. See update from 10/4/2024. No additional hydroseed has been applied since the last inspection.</p> <p>10/15/2024 - Observation remains. See update from 10/4/2024. No additional hydroseed has been applied since the last inspection. No germination has been observed in areas where hydroseed was applied.</p> <p>10/22/2024 - Observation remains. See update from 10/4/2024. No additional hydroseed has been applied since the last inspection. Some germination has been observed in a few locations where hydroseed was previously applied.</p>

View of an area that is no longer stabilized due to herbicide application at Station 169+50 per Long Term Compliance Action Item 59.

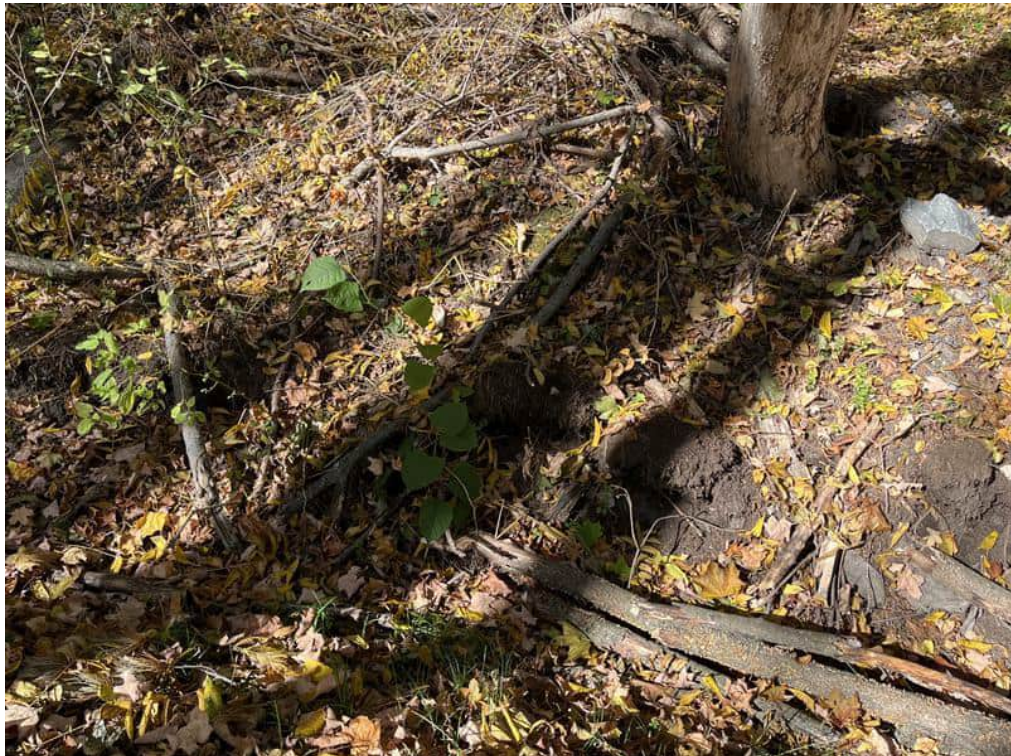
Photo No. 4 **Date:**
10/22/2024

Item	Location/ Description	Observation Date	Resolution Due Date	Recommended Resolution / Resolution Date	Comments/Updates
61	Invasive vegetation including Japanese knotweed (<i>Reynoutria japonica</i>), bittersweet (<i>Celastrus orbiculatus</i>), bush honeysuckle (<i>Lonicera</i> spp.), glossy buckthorn (<i>Frangula alnus</i>) and garlic mustard (<i>Alliaria petiolata</i>) have been observed throughout the path. Priority: High	10/22/2024	10/29/2024	Invasive Species should be removed by manual and/or chemical removal methods	
57-1	Japanese hops (<i>Humulus japonicus</i>) has been observed throughout the Project and requires removal Priority: High	10/22/2024	10/22/2024	The Contractor should manage remaining Japanese hops by hand pulling and the application of herbicide.	10/22/2024 - This Action Item has been reopened due to observations of both dead and living Japanese hops in select locations along the Project, including along Route 117 and within the northernmost extent of the Project. BETA and MassDOT will coordinate further with the Sudbury Conservation Agent to clarify the extents of remaining living vegetation as removal efforts progress.

View of Japanese knotweed that was observed on the side of the right-of-way at Station 170+00 per Compliance Action Item 61.

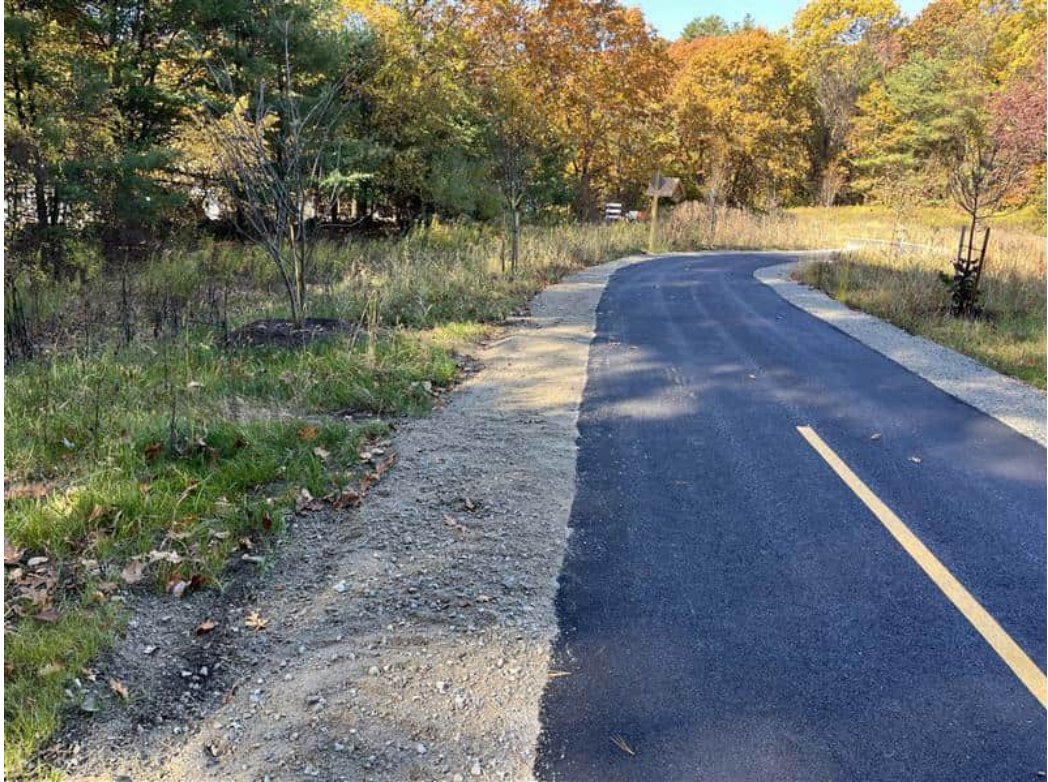
Photo No. 7	Date: 10/22/2024
--------------------	----------------------------

58	Crushed stone used for the dense graded crush stone shoulders has been observed as migrating both onto the path, off the sides of the path, and into the adjacent Resource Areas throughout the Project Priority: High	8/7/2024	8/14/2024	Remove all crushed stone from Resource Areas and develop a plan to cease discharges of stone.	<p>8/12/2024 - Crushed stone is still present in varying amounts throughout the path and on the sides of the path. 8/16/2024 - Observation remains. 8/20/2024 - Crushed stone has been removed from some adjacent resource areas but is still observed as migrating onto and off of the path in multiple locations throughout the Project. 8/27/2024 - Crushed stone has been observed as migrating from the shoulders throughout the path. 9/3/2024 - Crushed stone was observed as migrating both onto the path and off the side of the path in multiple locations. Stone was observed to have discharged to the cattle crossing at Station 190+50 and within the streambed at Station 215+00 to 216+00. Crushed stone was observed to have been placed on the root system of a fallen tree at Station 310+00 near Bank flag #BF4-108. 9/10/2024 - Observation remains. Crushed stone is still present within the cattle crossing, the streambed, and on the root system of the fallen tree. Crushed stone continues to migrate on to and off of the path. 9/16/2024 - Observation remains. The contractor indicated the locations where crushed stone has migrated off the path will be hand removed and crushed stone will be swept off the path prior to the opening of the trail. 9/23/2024 - Observation remains. It does not appear as though crushed stone that has migrated onto or off of the path has been removed in any location along the Project. More crushed stone has migrated onto the path throughout significant portions of the path. 9/27/2024 - Observation remains. Crushed stone is still located on the side of the path and on the path in varying amounts. 10/4/2024 - Crushed stone has been removed from multiple locations along the trail but was still observed on and on the sides of the trail in several locations. 10/8/2024 - Observation remains. Crushed stone is still present in multiple locations on and off the sides of the path. 10/15/2024 - Observation remains. Crushed stone is still present in multiple locations on and off the sides of the path. 10/22/2024 - Observation remains. Crushed stone is still present in multiple locations on and off the sides of the path. The crushed stone shoulders along Station 1000+00 to 1003+00 has been moved back into the shoulders and regraded.</p>

Description: View of crushed stone that has been placed back in the shoulders and regraded at Station 1003+00 per Long Term Compliance Action Item 58.
--

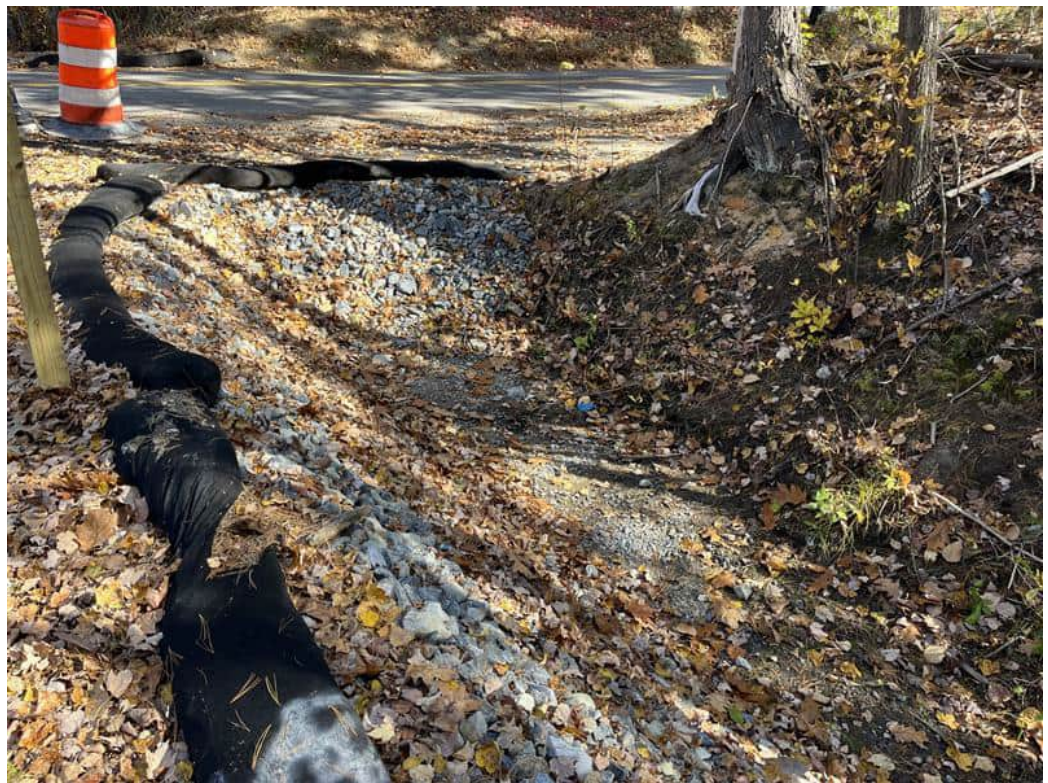
Photo No. 8	Date: 10/22/2024
--------------------	----------------------------

Description: View of the location where crushed stone has discharged into the streambed at Station 215+50 per Long Term Compliance Action Item 59.
--

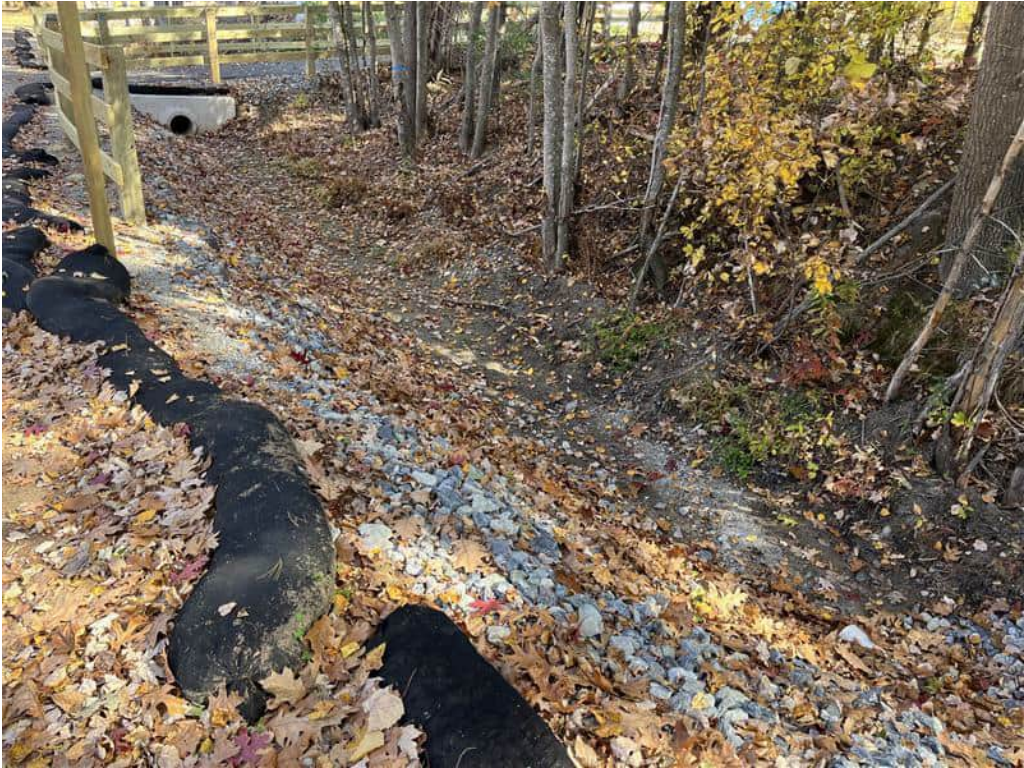
41	Stream Bank has been regraded beyond the limit of work at Station 216+00 Priority: High	5/28/2024	6/4/2024	The Contractor should confirm if this work was permitted by the Conservation Commission, as it does not appear to be a part of the approved plans/impacts. MassDOT should be consulted on next steps regarding notification and potential restoration.	<p>5/31/2024 - Observation remains. 6/7/2024 - Observation remains. 6/14/2024 - Observation remains. 6/17/2024 - Observation remains. 6/24/2024 - Observation remains. 6/27/2024 - Observation remains. 7/8/2024 - Observation remains. 7/15/2024 - This area could not be assessed due to paving operations ongoing during the inspection. 7/22/2024 - Crushed stone and sediment continue to be discharged to the stream between Stations 215+00 and 217+00 due to overtopped and undermined compost filter tubes. 7/29/2024 - Observation remains. 8/5/2024 - Observation remains. 8/7/2024 - Observation remains. 8/12/2024 - Observation remains. Crushed stone is still present in the streambed at this location. 8/16/2024 - Observation remains. 8/20/2024 - Stone has been removed; however, additional alteration to Resource Areas beyond the limit of work continue. 8/27/2024 - Observation remains. 9/3/2024 - Observation remains. 9/10/2024 - Observation remains. Stone has been observed as discharging into the streambed in this location again. 9/16/2024 - Observation remains. 9/23/2024 - Observation remains. Stone is still present within the streambed at this location. 9/27/2024 - Observation remains. 10/4/2024 - Observation remains. 10/8/2024 - Observation remains. 10/15/2024 - Observation remains. Stone is still present within the streambed at this location. 10/22/2024 - Observation remains. Stone is still present within the streambed at this location.</p>

Direction Photo Taken: Toward the North		
Description: View of crushed stone within the streambed and the streambed and the location where the stream bank has been regraded beyond the limits of work at Station 216+00 per Long Term Compliance Action Items 41 and 58.		
Photo No. 10	Date: 10/22/2024

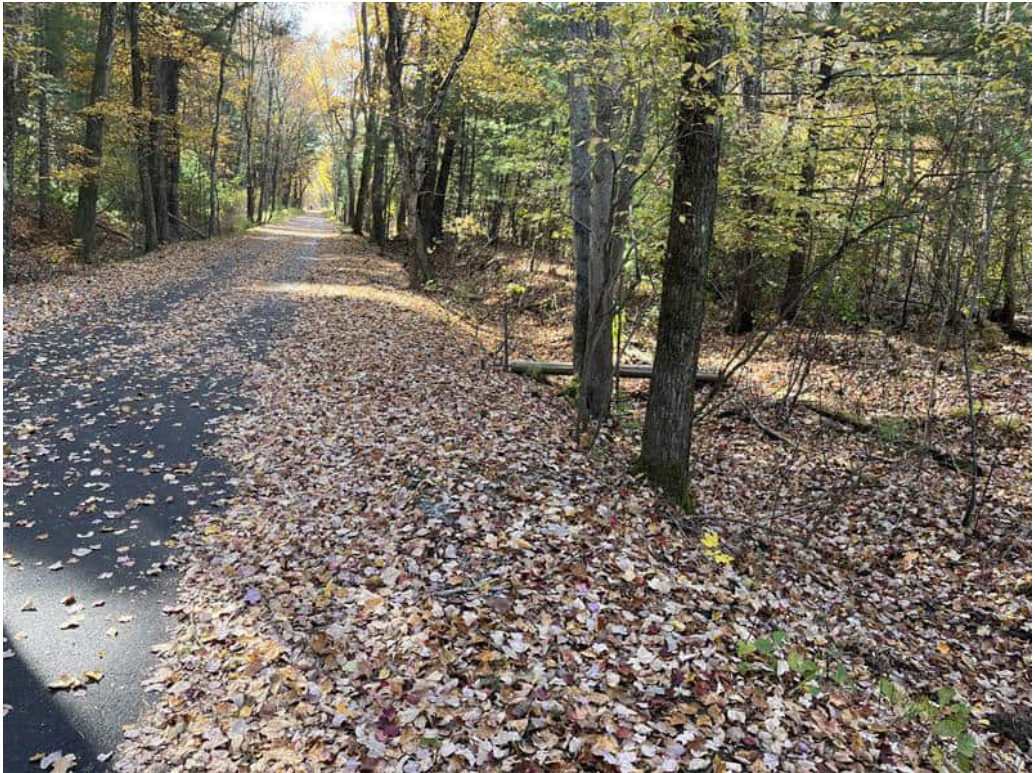
Direction Photo Taken: Toward the North		
Description: View of a location that is no longer stabilized at Station 299+00 per Long Term Compliance Action Item 59. Note that exposed soils are currently covered in leaf litter.

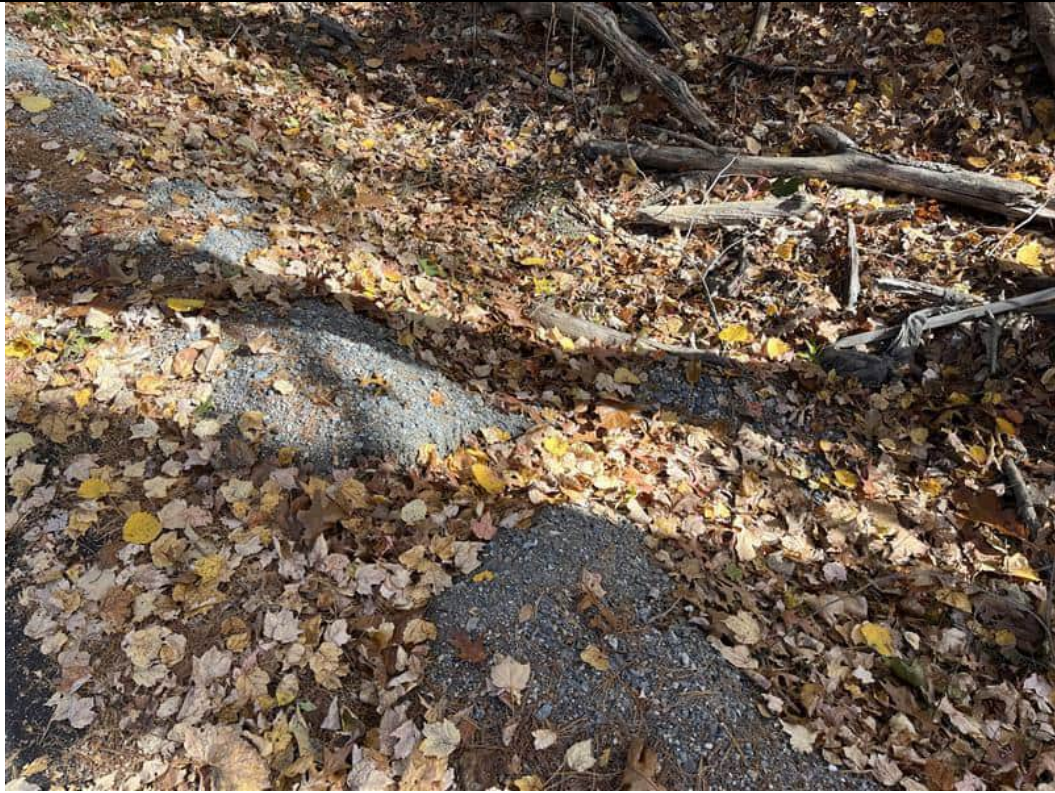
Photo No. 11 **Date:**
10/22/2024

View of crushed stone that requires removal from the swale at Station 303+00 per Long Term Compliance Action Item 58.

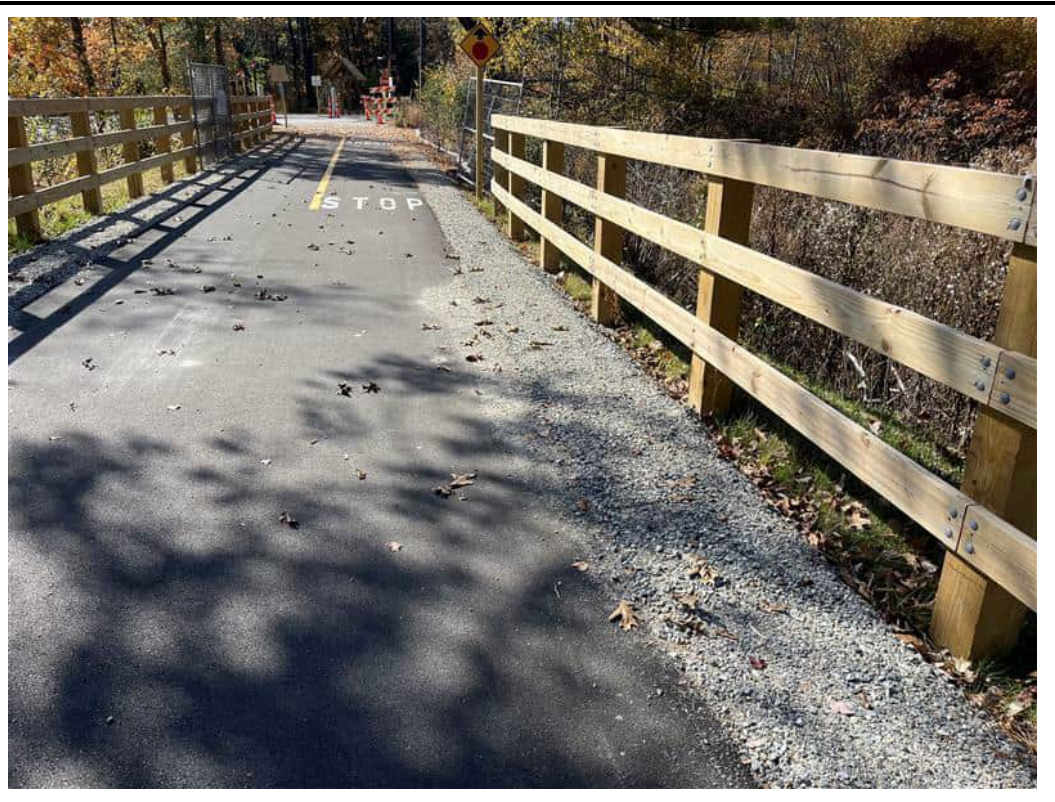
Photo No. 12 **Date:**
10/22/2024

View of a location where crushed stone has migrated on to the path at Station 312+00 per Long Term Compliance Action Item 58.

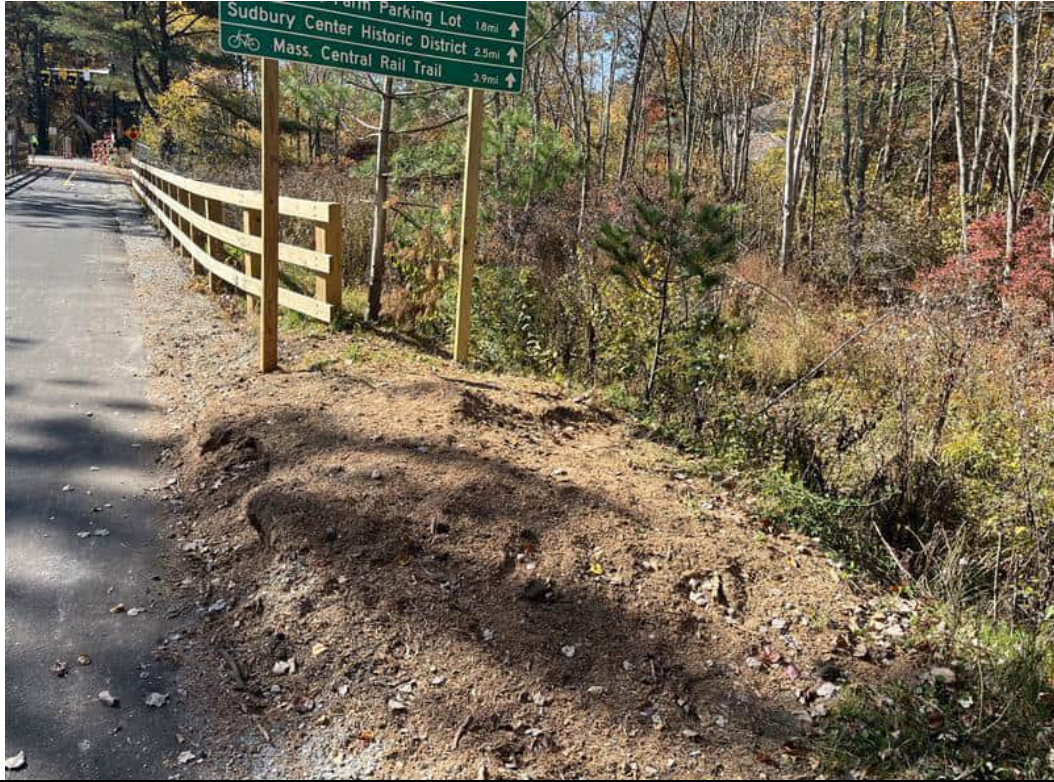
Photo No. 13 **Date:** 10/22/2024

60	Multiple piles of wood shavings were observed along the trail shoulders. In some locations, wood shavings are located directly adjacent to Resource Areas. Priority: High	10/4/2024	10/11/2024	Remove wood shavings from the shoulders.	10/8/2024 - Observation remains. Wood shaving that are in the pile at Station 315+00 were observed as migrating down into the adjacent Resource Areas and require removal. 10/15/2024 - Observation remains. Piles of wood shavings are present in multiple locations throughout the trail and wood shavings are present within the Resource Area adjacent to Station 315+00. 10/22/2024 - Observation remains. See previous update.

Typical view of a pile of wood shavings that requires removal at Station 315+00 per Compliance Action Item 60. This condition was observed in multiple locations along the trail.

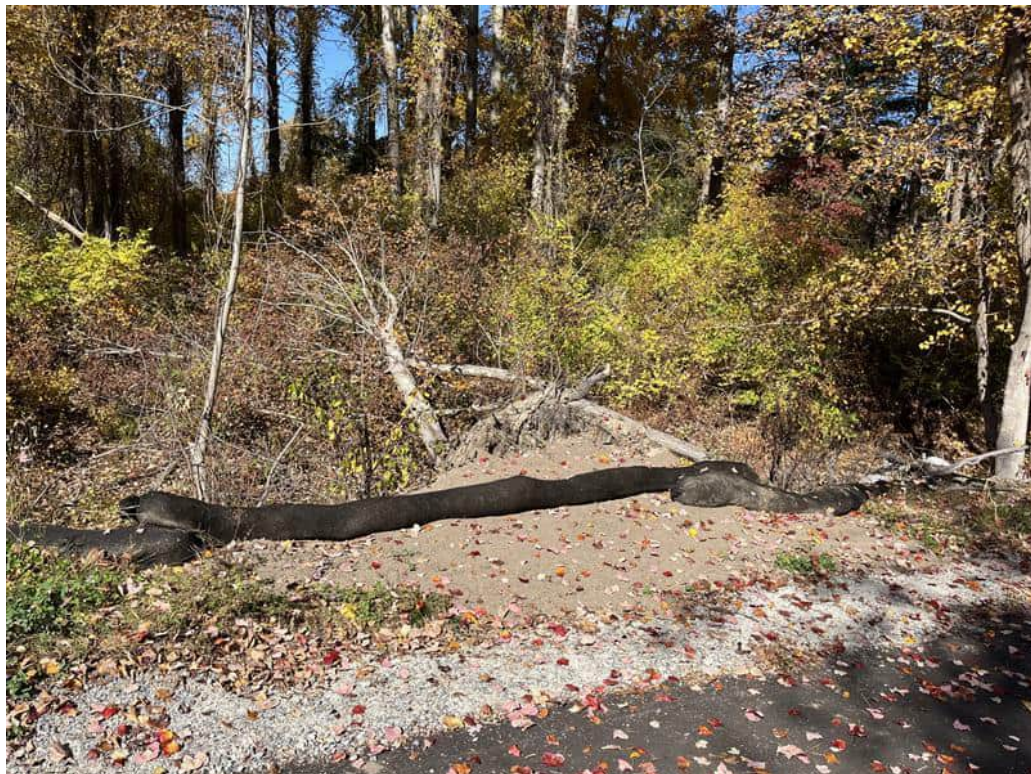
Photo No. 14 **Date:** 10/22/2024

View of recently placed loam that requires stabilization at Station 316+00 per Long Term Compliance Action Item 59.

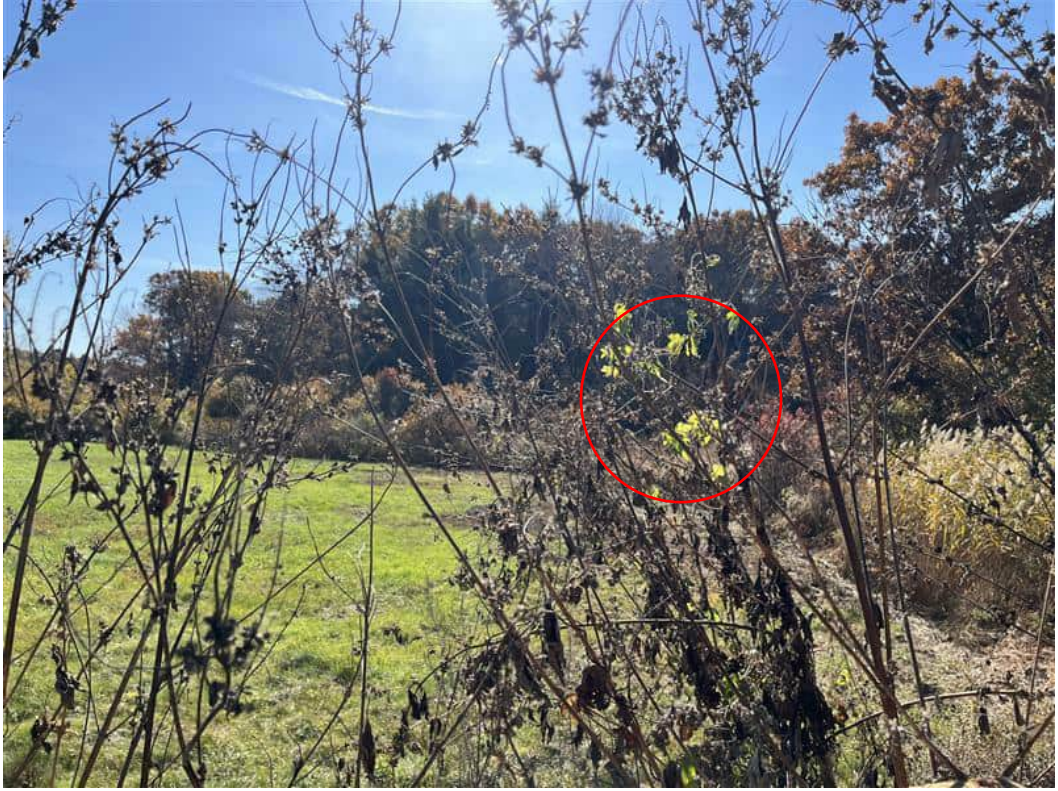
Site Location Bruce Freeman Rail Trail Right-of-Way		BETA Project No. 24.10326.23
Photo No. 15	Date: 10/22/2024

Direction Photo Taken: Toward the South		
Description: View of Japanese hops (green vegetation) that were observed along Route 117 at Station 1103+50 near Davis Field per Compliance Action Item 57-1.
