Weekly Environmental Compliance Summary

Sudbury to Hudson Transmission Reliability Project (USEPA Tracking # MAR1003UW)

Week of: October 28, 2024 to November 2, 2024

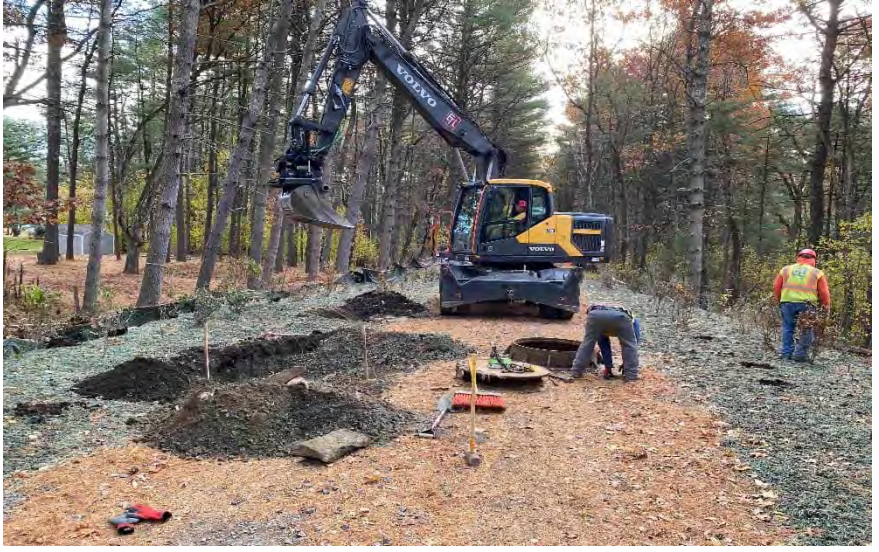
<p align="right">PHOTOGRAPHIC LOG</p>	
<p>Client Name: Eversource</p>		<p>Site Location: Sudbury to Hudson Transmission Reliability Project</p>	<p>Town: Sudbury</p>
<p>Photo No.: 1</p>	<p>Date: 10-28-24</p>

<p>Description:</p> <p>Segment 9, Manhole #19, ET&L conducting frame & cover work, existing erosion control, looking westward.</p>

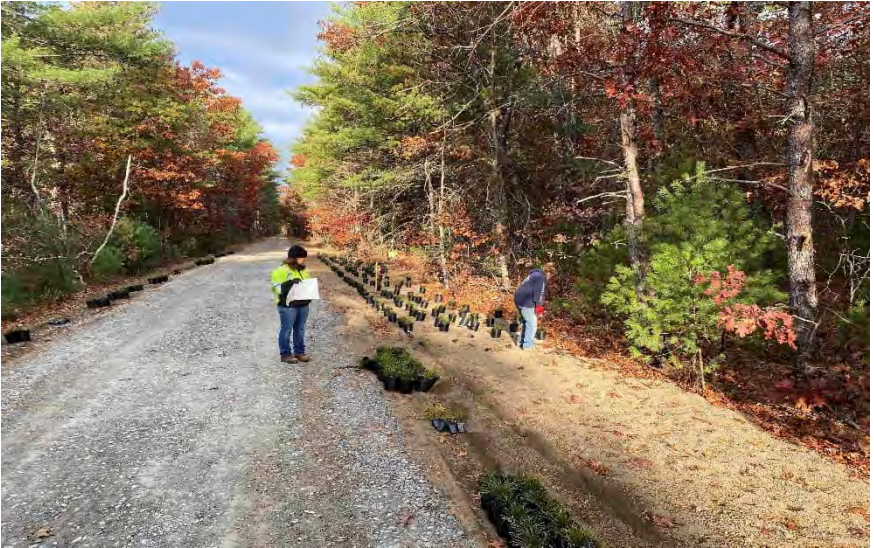
<p>PHOTOGRAPHIC LOG</p>	
<p>Client Name: Eversource</p>		<p>Site Location: Sudbury to Hudson Transmission Reliability Project</p>	<p>Town: Sudbury</p>
<p>Photo No.: 3</p>	<p>Date: 10-28-24</p>

<p>Description:</p> <p>Work area within segment 7 near manhole #15, plantings by MON with plant monitor, looking westward</p>

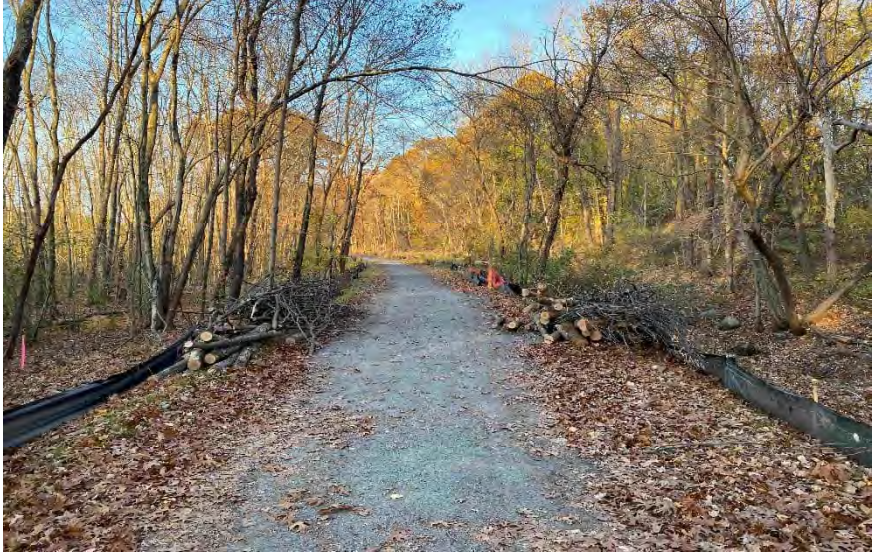
<p>PHOTOGRAPHIC LOG</p>	
<p>Client Name: Eversource</p>		<p>Site Location: Sudbury to Hudson Transmission Reliability Project</p>	<p>Town: Sudbury</p>
<p>Photo No.: 5</p>	<p>Date: 10-28-24</p>

<p>Description:</p> <p>Work area within segment 14, brush left on-site to create new brush piles, existing erosion control, looking westward.</p>

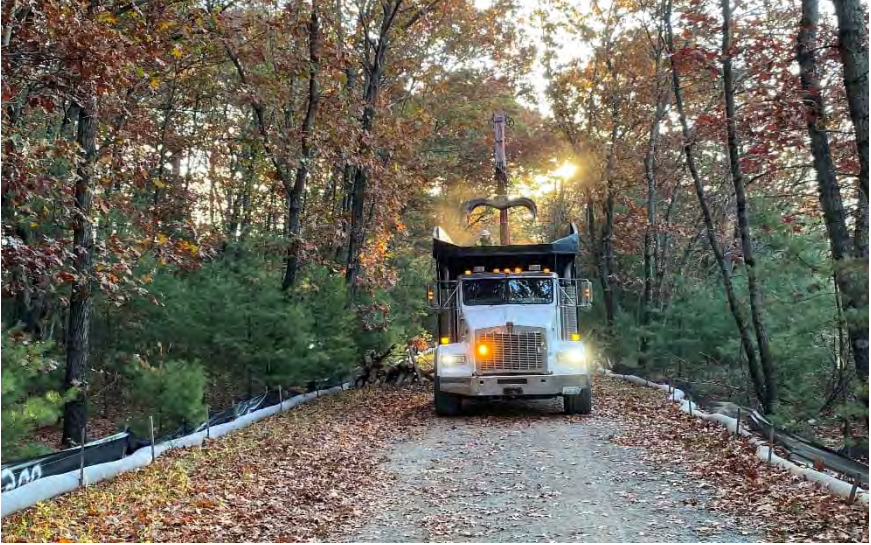
<p>PHOTOGRAPHIC LOG</p>	
<p>Client Name: Eversource</p>		<p>Site Location: Sudbury to Hudson Transmission Reliability Project</p>	<p>Town: Sudbury</p>
<p>Photo No.: 7</p>	<p>Date: 10-28-24</p>

<p>Description:</p> <p>Work area within segment 11, Moosehead delivering brush for creation of brush piles, existing erosion control, looking westward.</p>

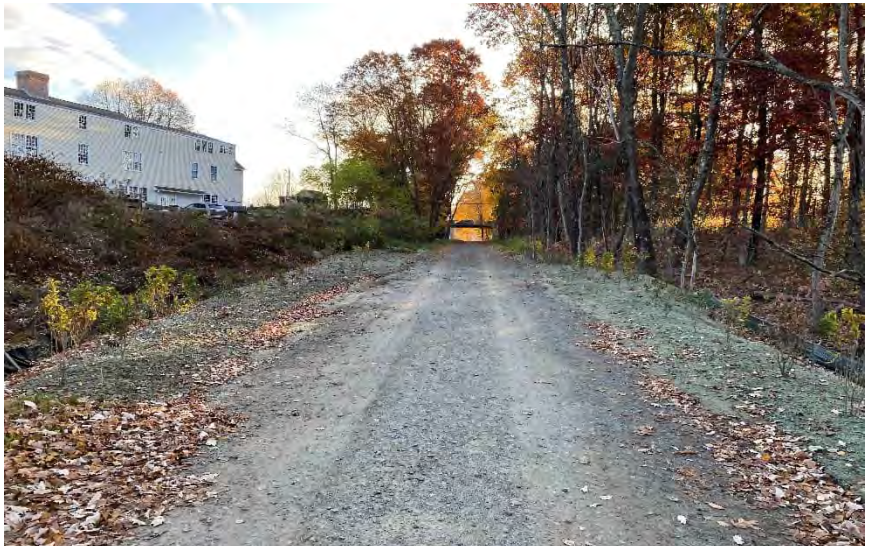
<p>PHOTOGRAPHIC LOG</p>	
<p>Client Name: Eversource</p>		<p>Site Location: Sudbury to Hudson Transmission Reliability Project</p>	<p>Town: Sudbury</p>
<p>Photo No.: 8</p>	<p>Date: 10-28-24</p>

<p>Description:</p> <p>Work area within segment 14, manhole #27, recently planted & hydro seeded, existing erosion control, looking eastward.</p>

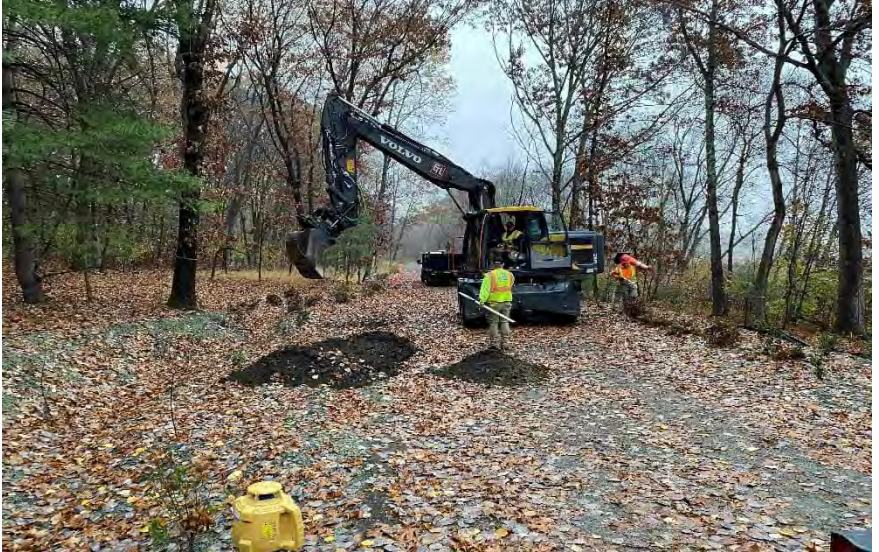
<p>PHOTOGRAPHIC LOG</p>	
Client Name: Eversource		Site Location: Sudbury to Hudson Transmission Reliability Project	Town: Sudbury
Photo No.: 1	Date: 10-30-24

<p>Description:</p> <p>Segment 14, Manhole #26, ET&L conducting frame & cover work, existing erosion control, looking eastward.</p>

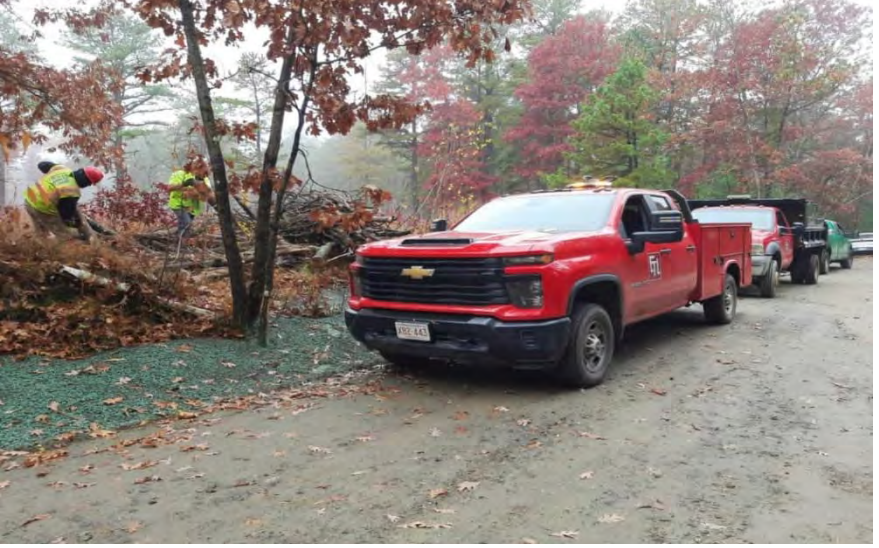
<p>PHOTOGRAPHIC LOG</p>	
Client Name: Eversource		Site Location: Sudbury to Hudson Transmission Reliability Project	Town: Sudbury
Photo No.: 2	Date: 10-30-24

<p>Description:</p> <p>Work area within segment 7, ET&L overseeing MON delivering brush material for future brush pile, existing erosion control, looking westward. Photo courtesy of Mary Toner (AECOM).</p>

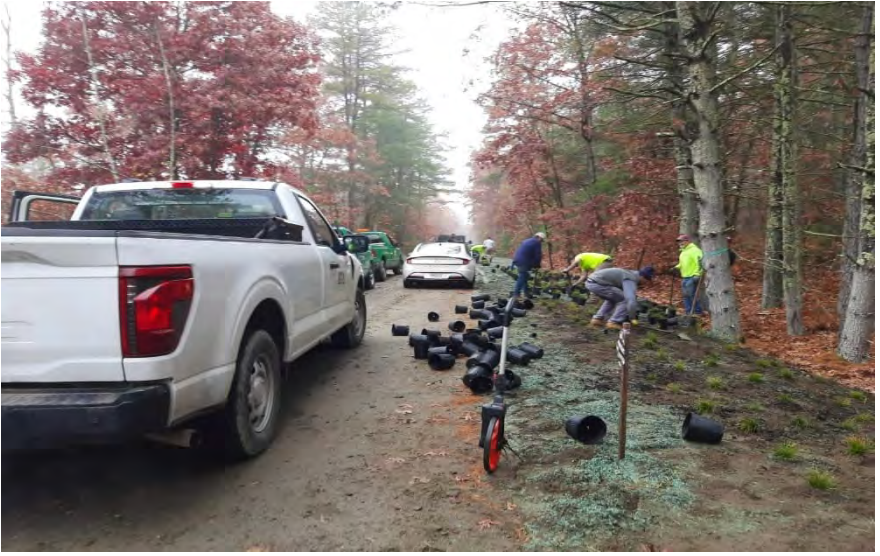
<p>PHOTOGRAPHIC LOG</p>	
<p>Client Name: Eversource</p>		<p>Site Location: Sudbury to Hudson Transmission Reliability Project</p>	<p>Town: Sudbury</p>
<p>Photo No.: 3</p>	<p>Date: 10-30-24</p>

<p>Description:</p> <p>Work area within segment 7, plantings by MON with plant monitor, looking westward. Photo courtesy of Mary Toner (AECOM).</p>

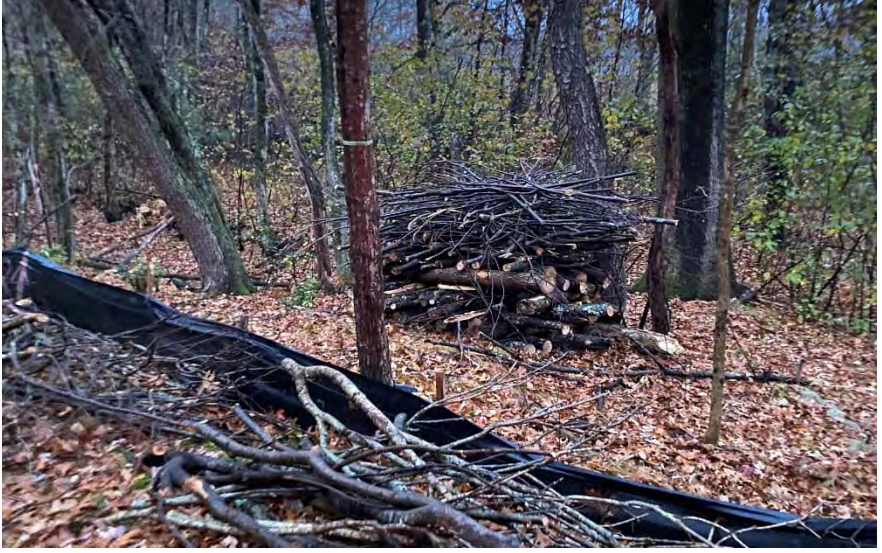
<p>PHOTOGRAPHIC LOG</p>	
<p>Client Name: Eversource</p>		<p>Site Location: Sudbury to Hudson Transmission Reliability Project</p>	<p>Town: Sudbury</p>
<p>Photo No.: 5</p>	<p>Date: 10-30-24</p>

<p>Description:</p> <p>Work area within segment 14, recently completed brush pile, existing erosion control, looking northward.</p>

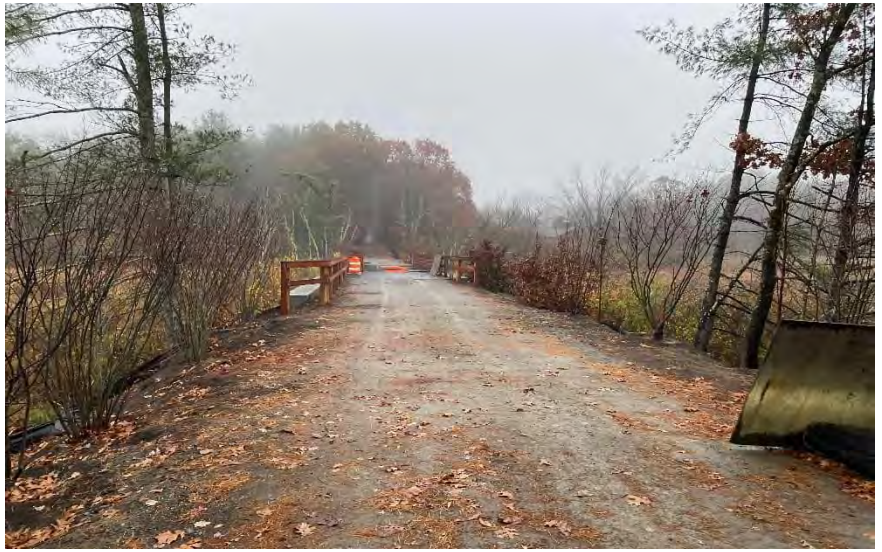
<p>PHOTOGRAPHIC LOG</p>	
<p>Client Name: Eversource</p>		<p>Site Location: Sudbury to Hudson Transmission Reliability Project</p>	<p>Town: Sudbury</p>
<p>Photo No.: 6</p>	<p>Date: 10-30-24</p>

<p>Description:</p> <p>Segment 8, Bridge 128, recently planted & hydro seeded, existing erosion control, looking westward.</p>

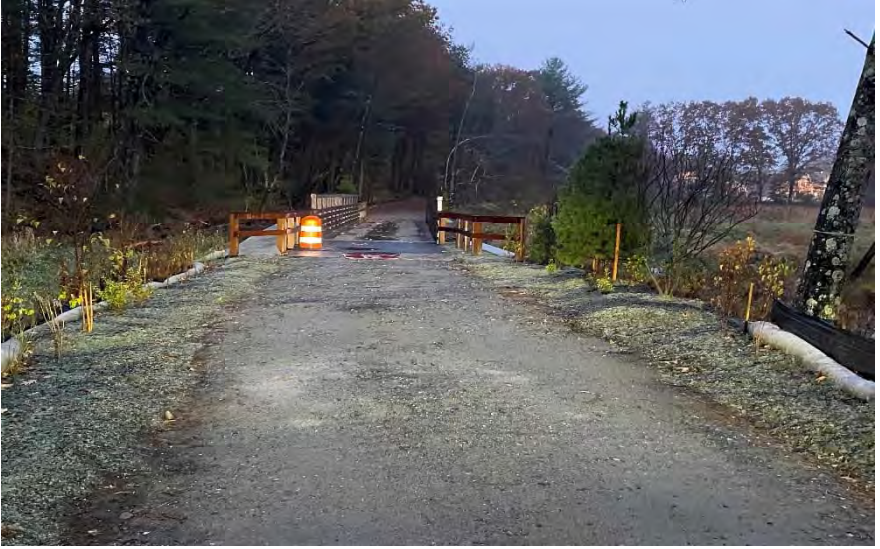
<p>PHOTOGRAPHIC LOG</p>	
<p>Client Name: Eversource</p>		<p>Site Location: Sudbury to Hudson Transmission Reliability Project</p>	<p>Town: Sudbury</p>
<p>Photo No.: 7</p>	<p>Date: 10-30-24</p>

<p>Description:</p> <p>Segment 14, Bridge 127, recently planted & hydro seeded, existing erosion control, looking westward.</p>

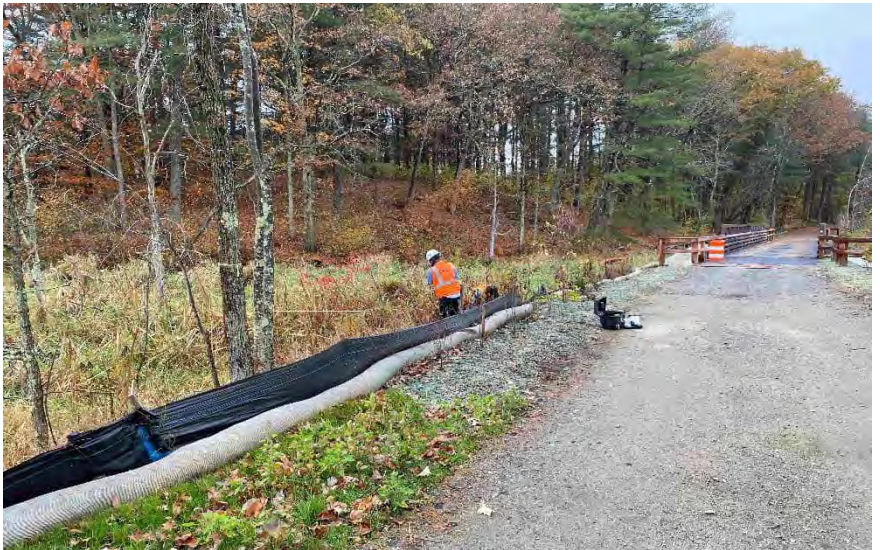
<p>PHOTOGRAPHIC LOG</p>	
<p>Client Name: Eversource</p>		<p>Site Location: Sudbury to Hudson Transmission Reliability Project</p>	<p>Town: Sudbury</p>
<p>Photo No.: 8</p>	<p>Date: 10-30-24</p>

<p>Description:</p> <p>Work area within segment 14, Bridge 127, SWCA removing invasive species, existing erosion control, looking westward.</p>

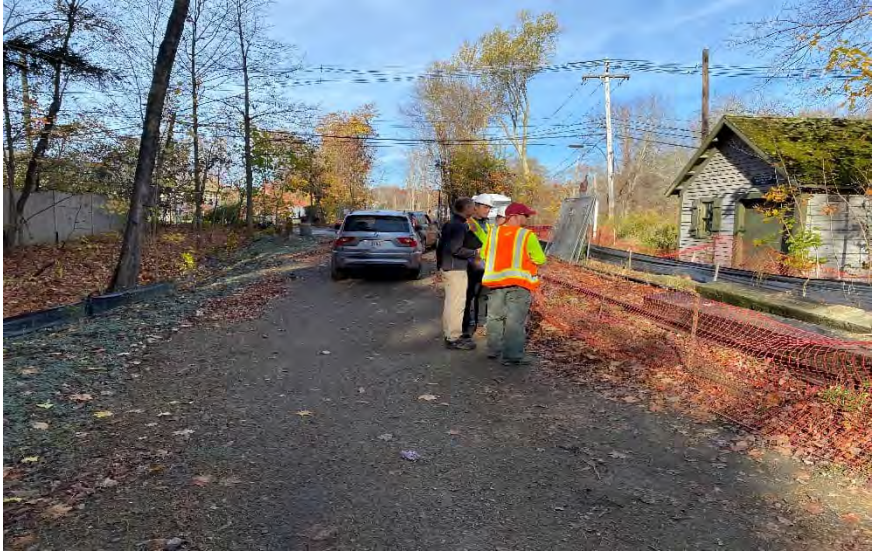
<p align="center">PHOTOGRAPHIC LOG</p>	
<p>Client Name: Eversource</p>		<p>Site Location: Sudbury to Hudson Transmission Reliability Project</p>	<p>Town: Sudbury</p>
<p>Photo No.: 1</p>	<p>Date: 10-31-24</p>

<p>Description:</p> <p>Segment 13, Cultural review with Chronicle Heritage & DCR, existing erosion control, looking westward.</p>

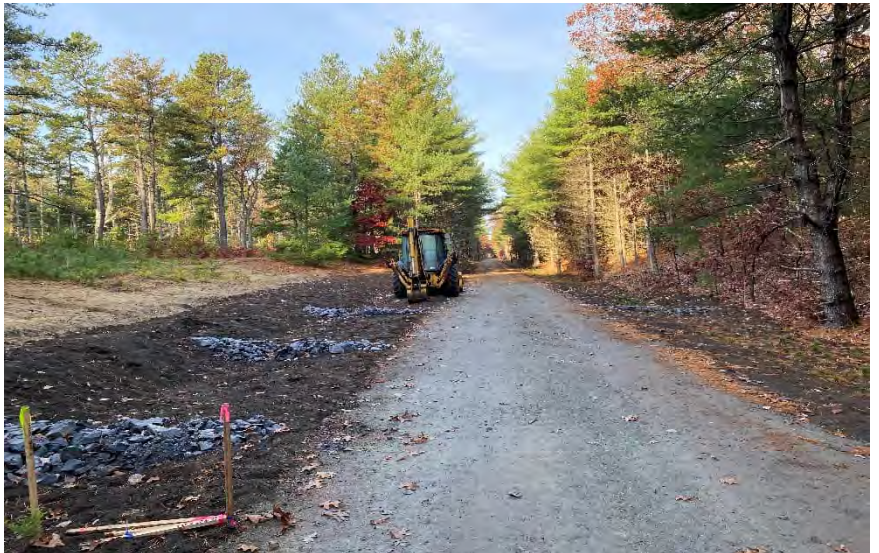
<p align="center">PHOTOGRAPHIC LOG</p>	
<p>Client Name: Eversource</p>		<p>Site Location: Sudbury to Hudson Transmission Reliability Project</p>	<p>Town: Sudbury</p>
<p>Photo No.: 2</p>	<p>Date: 10-31-24</p>

<p>Description:</p> <p>Work area within segment 7, MON equipment staged, area to be hydroseeded, existing erosion control, looking westward.</p>

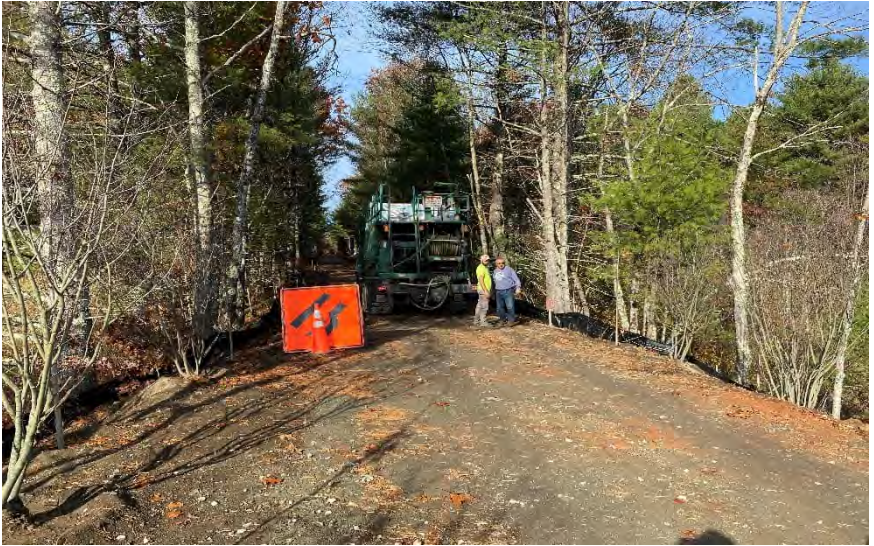
<p align="center">PHOTOGRAPHIC LOG</p>	
<p>Client Name: Eversource</p>		<p>Site Location: Sudbury to Hudson Transmission Reliability Project</p>	<p>Town: Sudbury</p>
<p>Photo No.: 3</p>	<p>Date: 10-31-24</p>

<p>Description:</p> <p>Work area within segment 7, hydroseeding by MON near bridge 128 westward, existing erosion control, looking westward.</p>

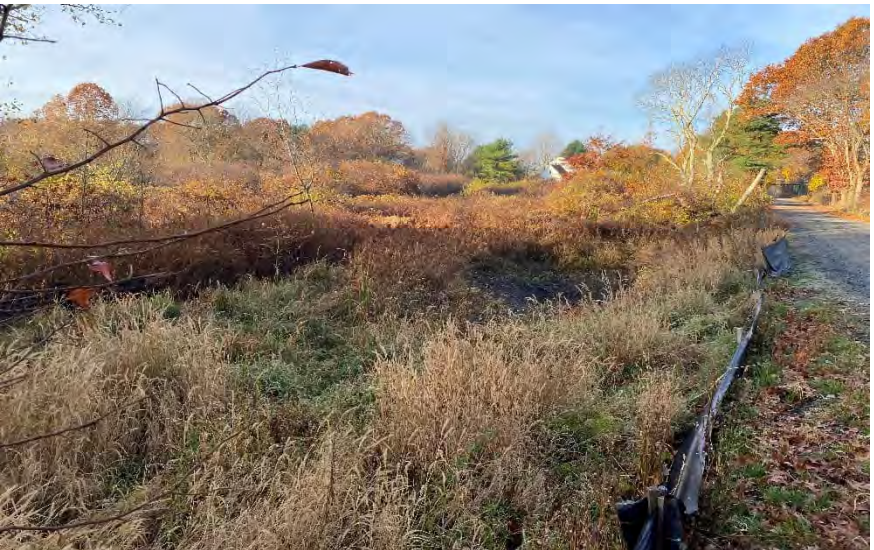
<p>Description:</p> <p>Wetland replication area within segment 14, existing erosion control, looking westward</p>

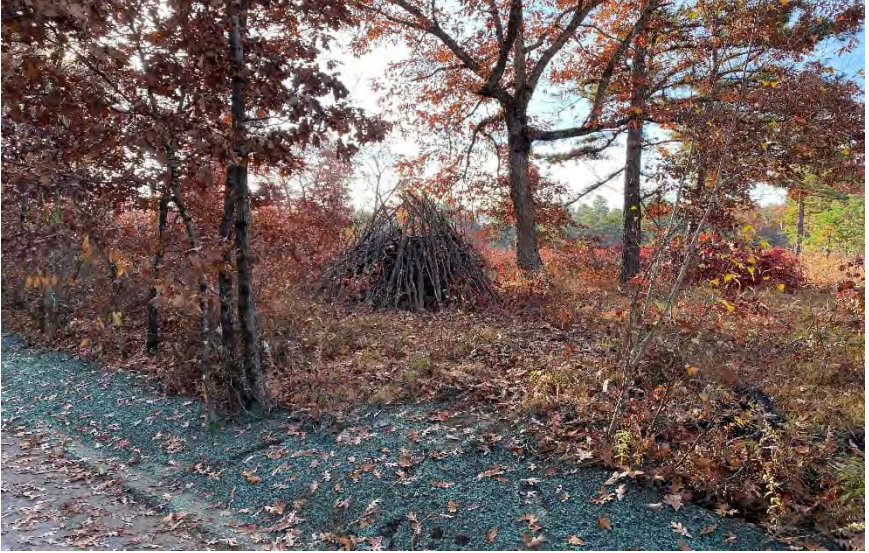
<p>Description:</p> <p>Work area within segment 7, recently completed brush pile, existing erosion control, looking southward.</p>

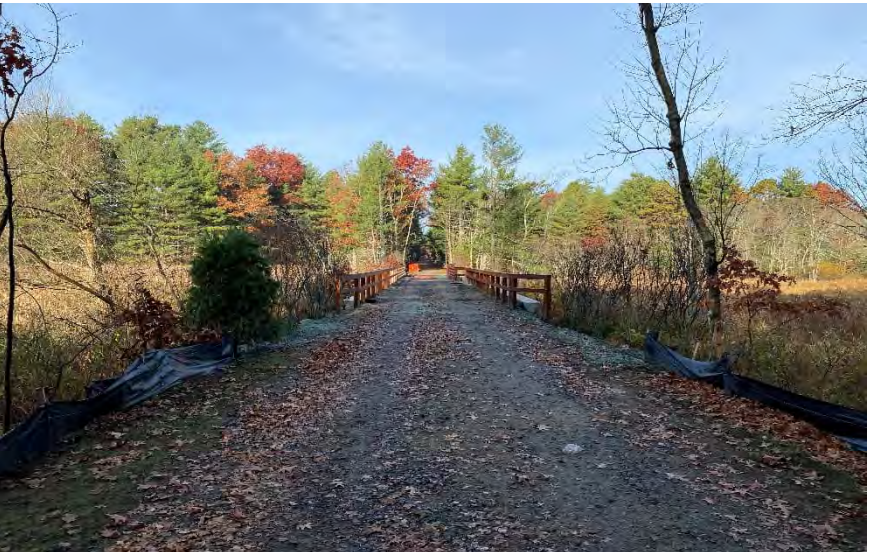
<p>Description:</p> <p>Segment 8, Bridge 128, recently planted & hydro seeded, existing erosion control, looking westward.</p>

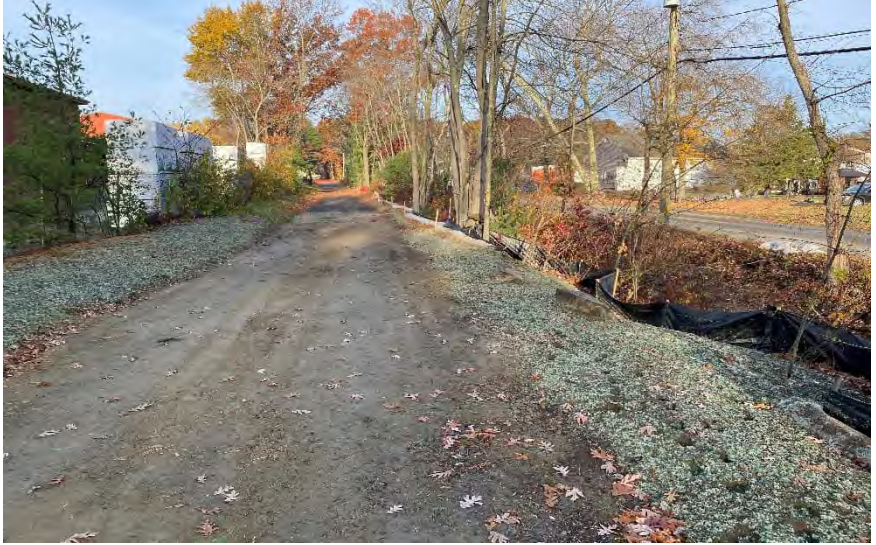
<p>Description:</p> <p>Segment 12, culvert extension area, recently planted & hydro seeded, existing erosion control, looking westward.</p>

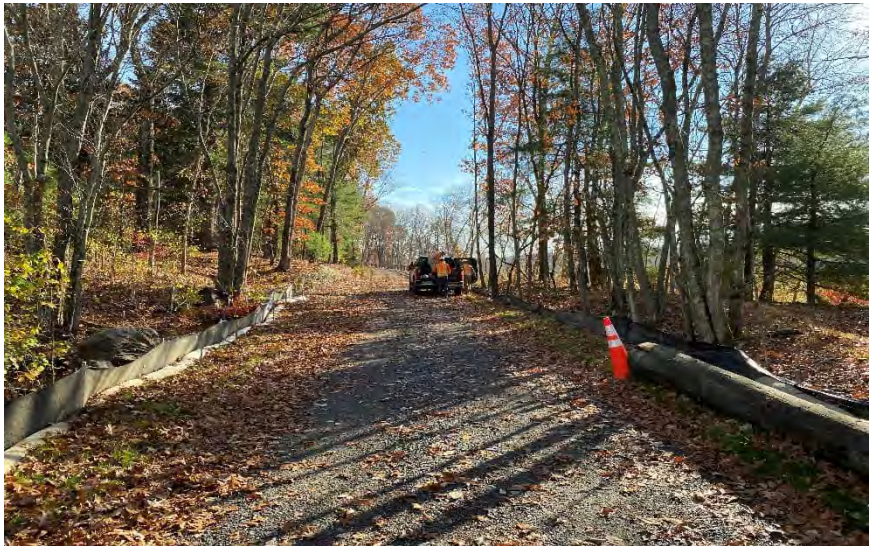
<p>Description:</p> <p>Work area within segment 14, SWCA removing invasive species, existing erosion control, looking eastward.</p>

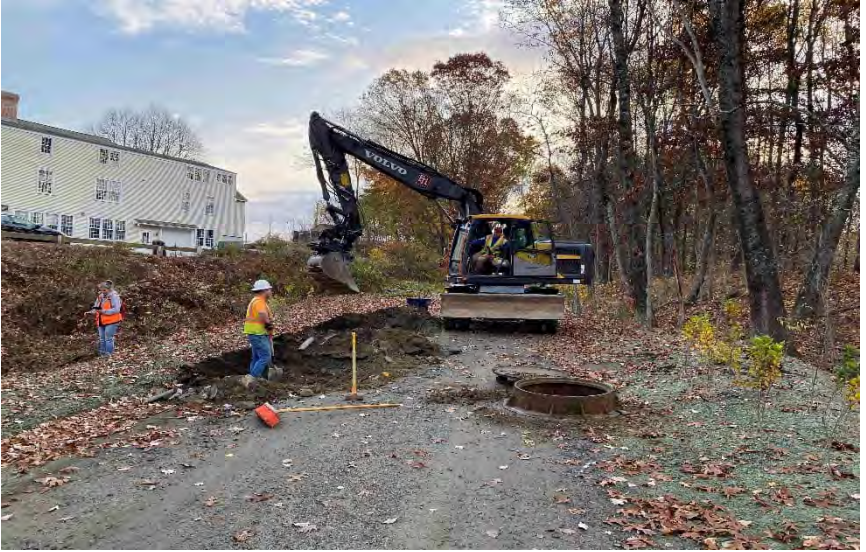
<p>Description:</p> <p>Segment 14, ET&L conducting frame/cover work, existing erosion control, looking eastward.</p>

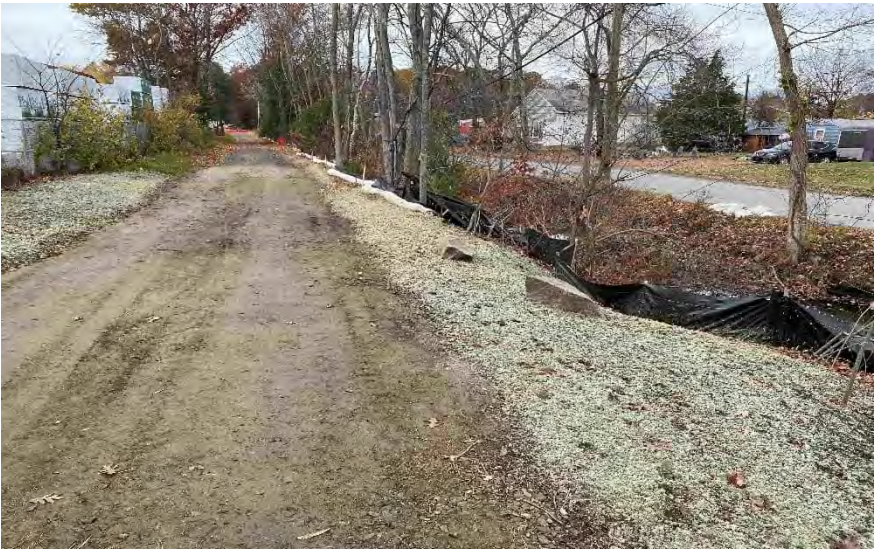
<p>Description:</p> <p>Work area within segment 12, recent hydroseeding at area of culvert extension, existing erosion control, looking westward.</p>

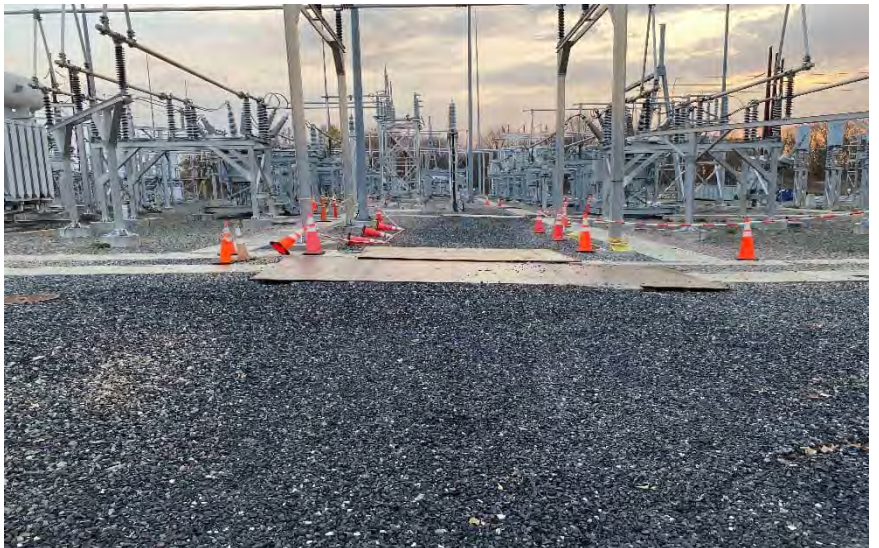
<p>Description:</p> <p>Sudbury substation, termination point of project, looking eastward</p>

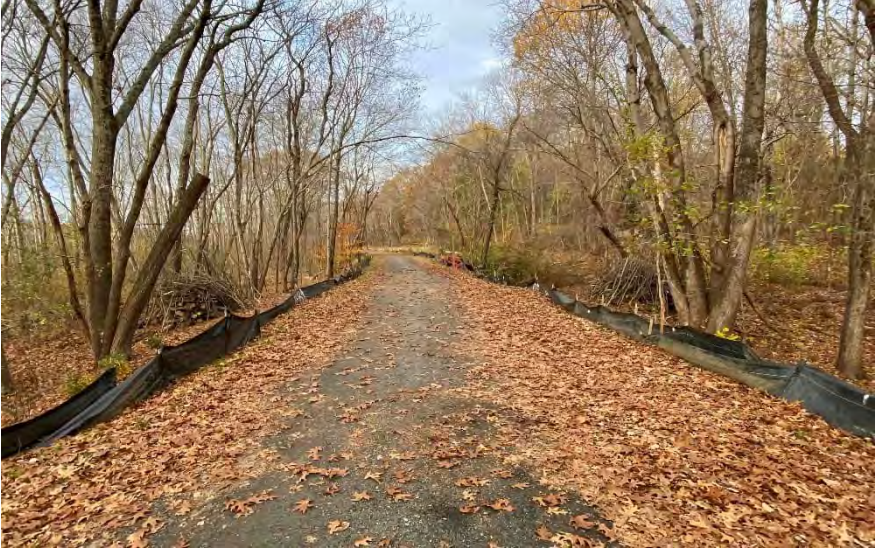
Description: Work area within segment 14, recently completed brush piles – both sides of work area, existing erosion control, looking westward.

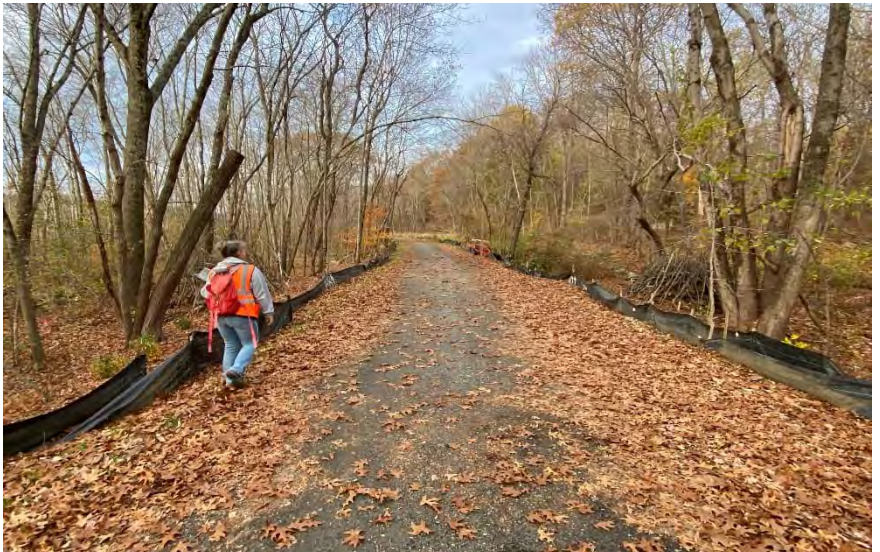
Description: Segment 14, SWCA conducting GPS work surveying erosion control, existing erosion control, looking westward.

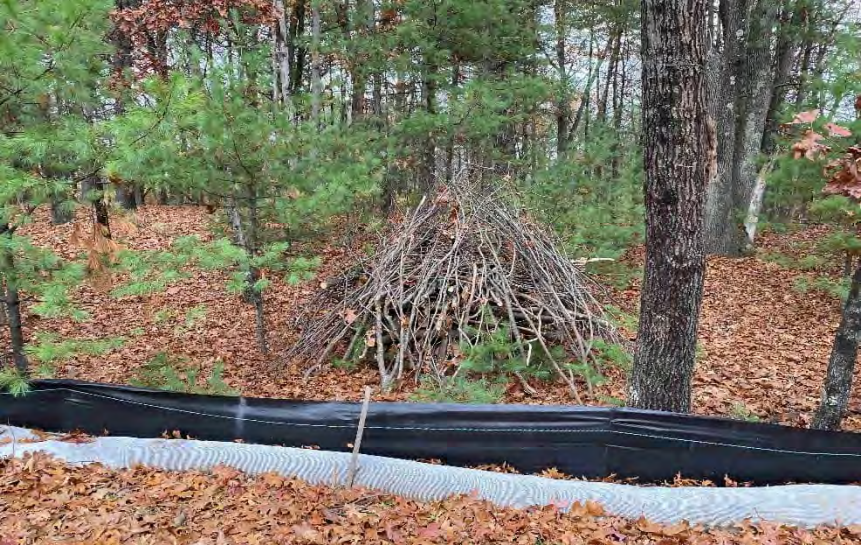
<p>Description:</p> <p>Segment 11, recently placed brush pile, existing erosion control, looking eastward.</p>

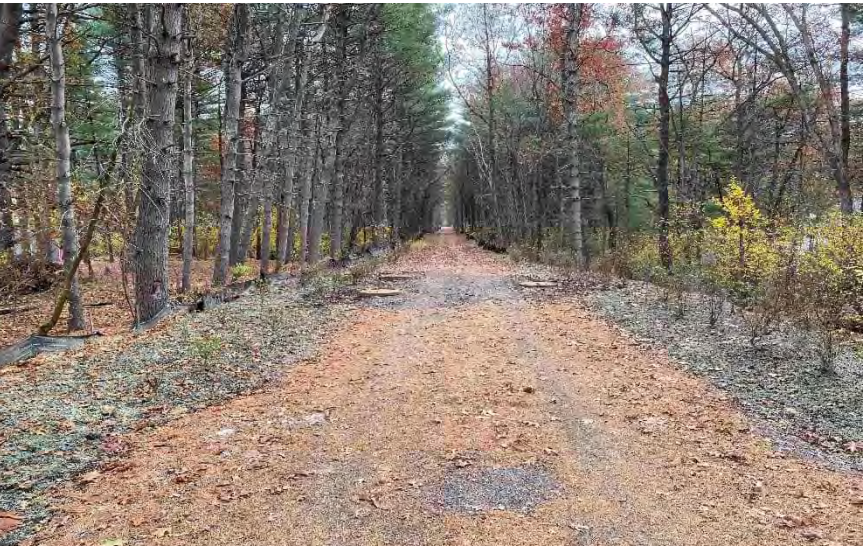
<p>Description:</p> <p>Work area within segment 9, segment #19, area recently planted & hydroseeded, existing erosion control, looking westward.</p>

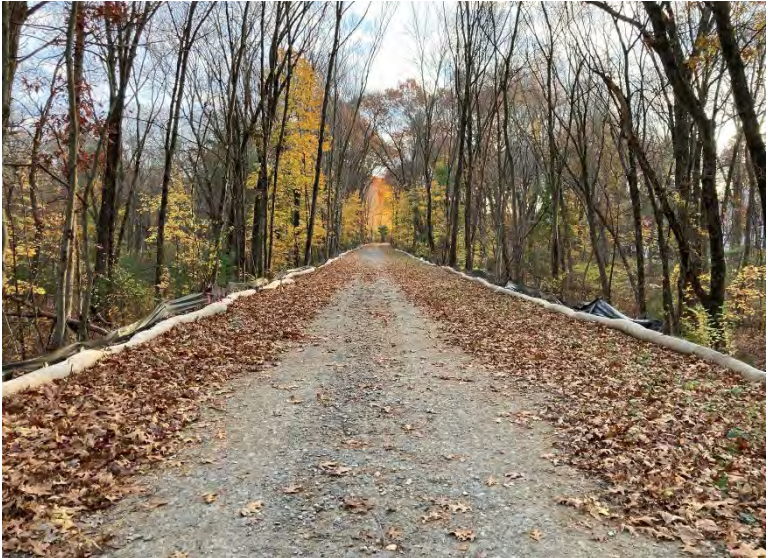
Description: View of E&S controls in segment 1. Facing east.

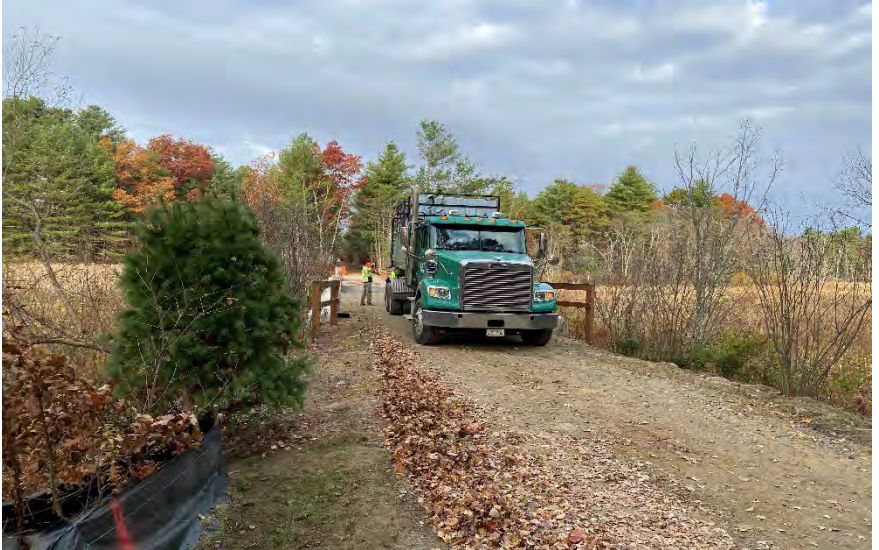
Description: Work area within segment 8, MON hydroseeding at bridge 128 (segment 8 side), existing erosion control, looking westward.

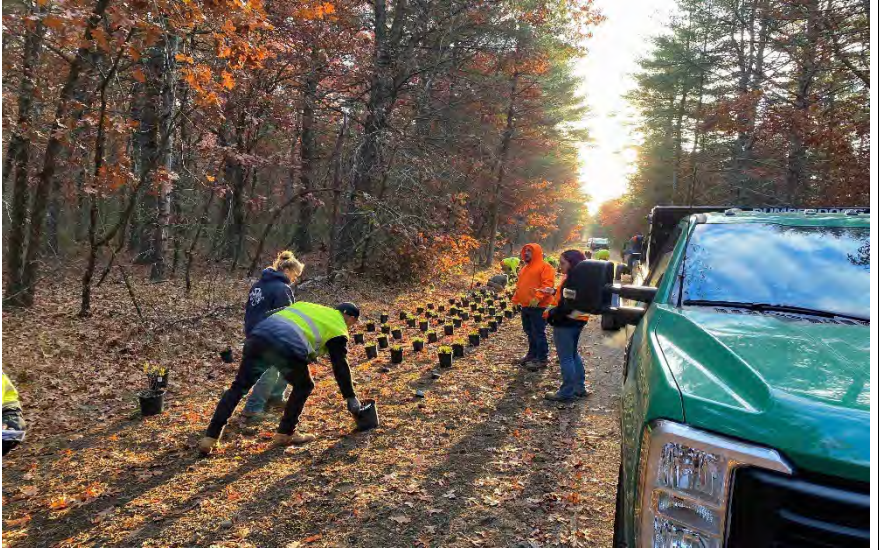
Description: Work area within segment 7, MON planting, existing erosion control, looking eastward.

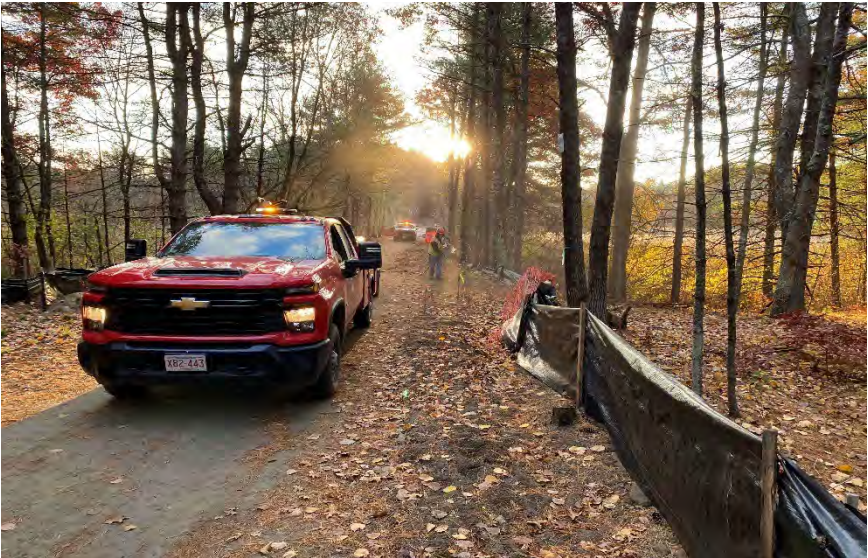
Description: Work area within segment 7, ET&L removing leaves prior to hydroseeding, existing erosion control, looking eastward.

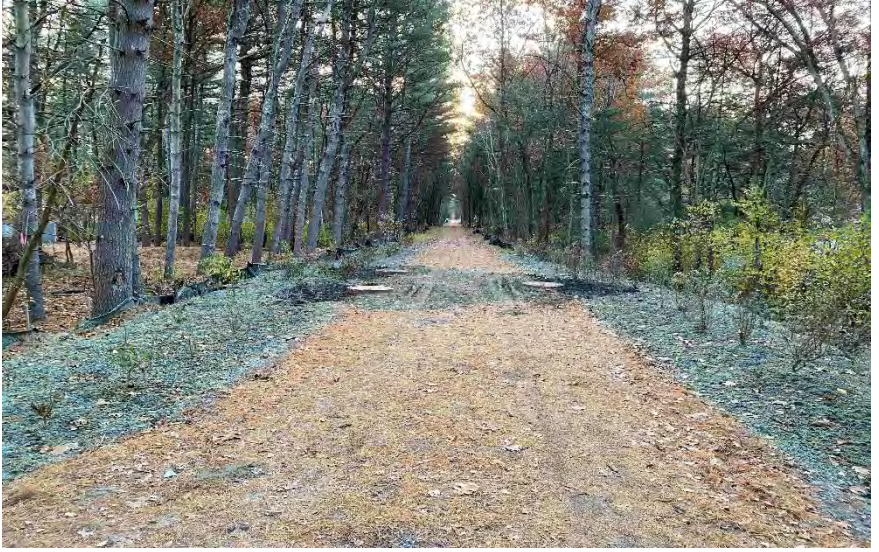
Description: Work area within segment 9 manhole #19, area recently planted & hydroseeded, existing erosion control, looking eastward.

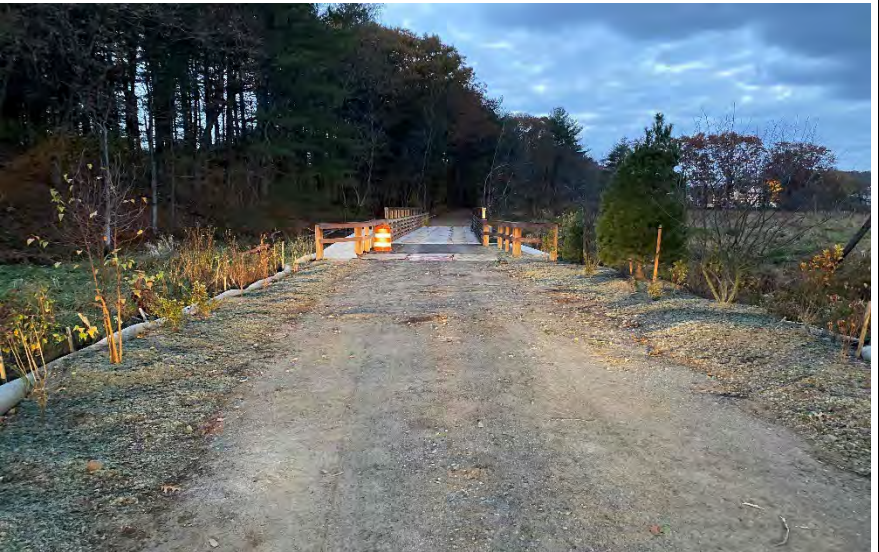
Description: Work area within segment 14, Bridge 127 area recently planted and hydroseeded, existing erosion control, looking westward.

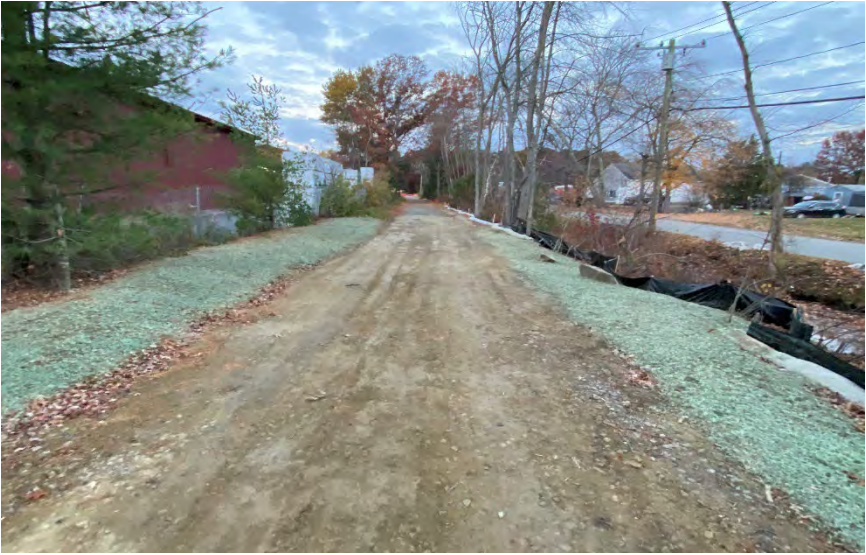
Description: Work area within segment 12, recently hydroseeded area at culvert extension area, existing erosion control, looking westward.

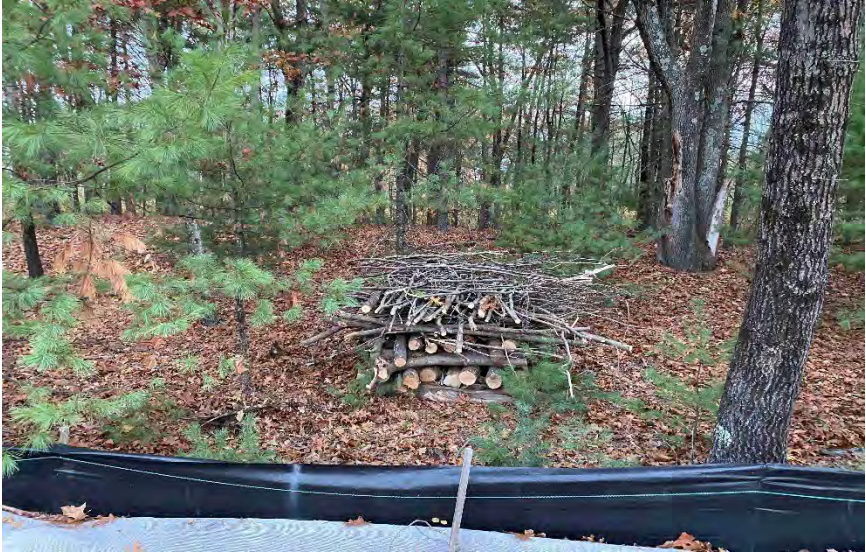
Description: Work area within segment 11 recently built brush pile, existing erosion control, looking southward.

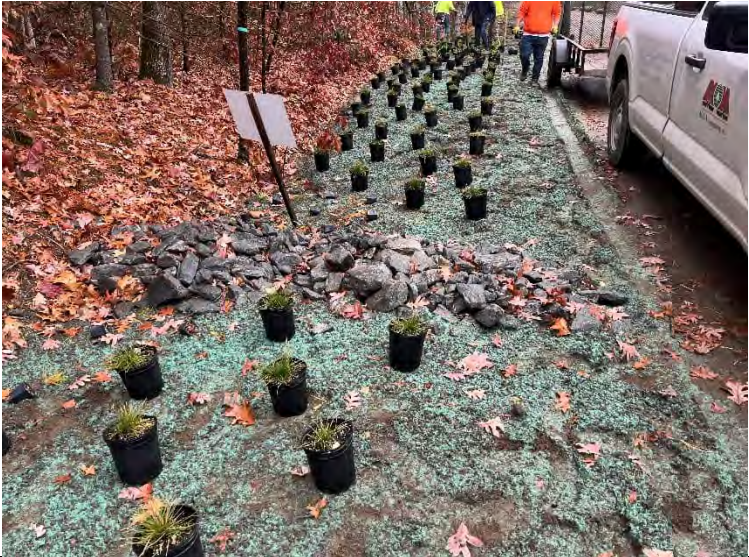
<p>Description: View of unmapped rock check dam at Sta#364+00. Majority of the 99 CS installed east of check dam. Gap was left at the western end of northern bed between Sta#364+00 to #366+00 for CS placement. Facing east.</p>

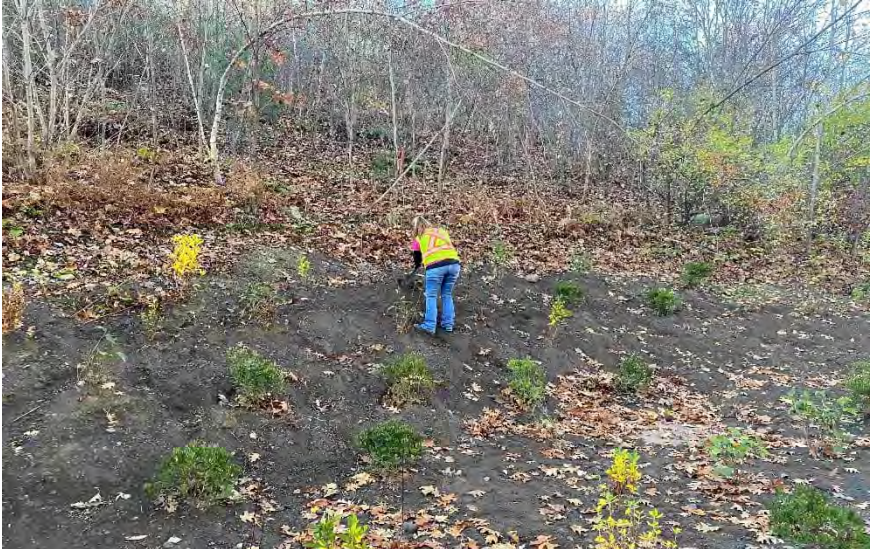
Description: Segment 1. MON replacing one CA near manhole #6. Looking westward.
