Weekly Environmental Compliance Summary

Sudbury to Hudson Transmission Reliability Project (USEPA Tracking # MAR1003UW)

Week of: November 11, 2024 to November 17, 2024

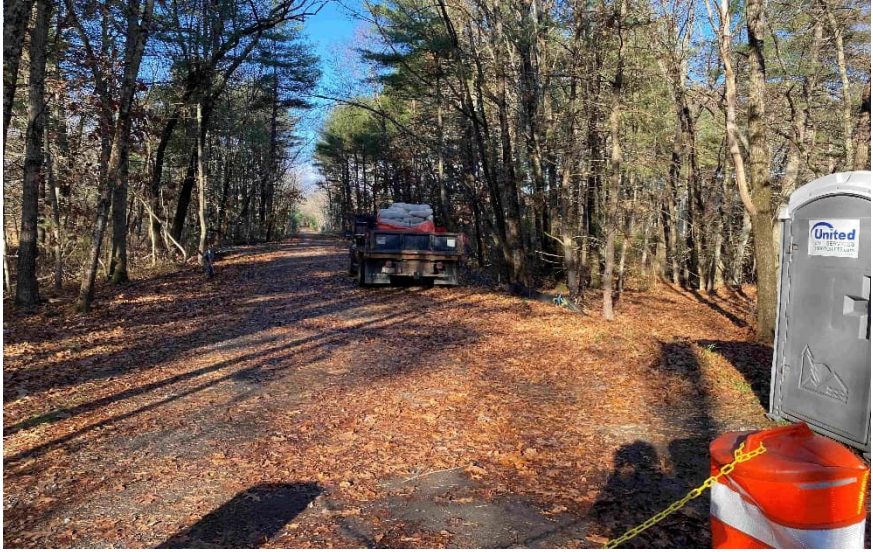
<p align="center">PHOTOGRAPHIC LOG</p>	
<p>Client Name: Eversource</p>		<p>Site Location: Sudbury to Hudson Transmission Reliability Project</p>	<p>Town: Hudson</p>
<p>Photo No.: 1</p>	<p>Date: 11-11-24</p>

<p>Description:</p> <p>Work area within segment 5, ET&L equipment staged, existing erosion control, looking westward.</p>

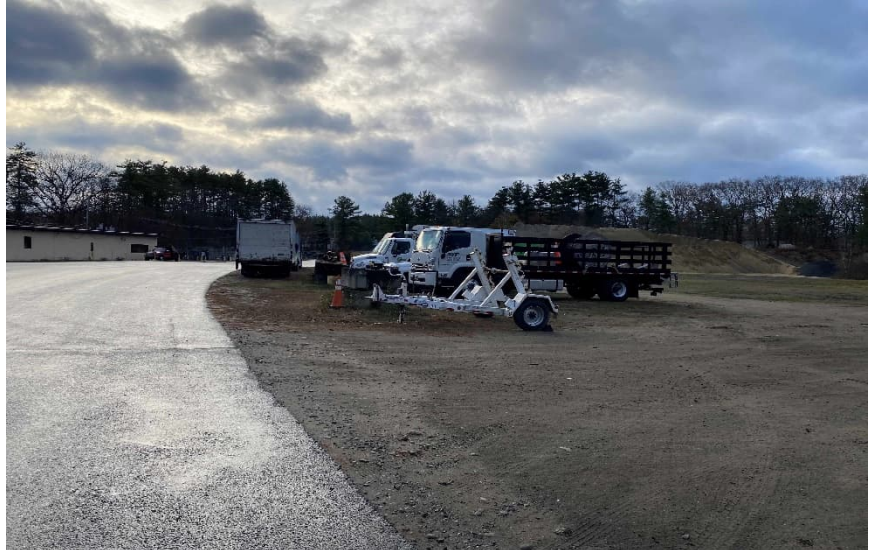
<p align="center">PHOTOGRAPHIC LOG</p>	
<p>Client Name: Eversource</p>		<p>Site Location: Sudbury to Hudson Transmission Reliability Project</p>	<p>Town: Hudson</p>
<p>Photo No.: 2</p>	<p>Date: 11-11-24</p>

<p>Description:</p> <p>Haugland laydown yard, mirk ready to deploy to the field, looking westward.</p>

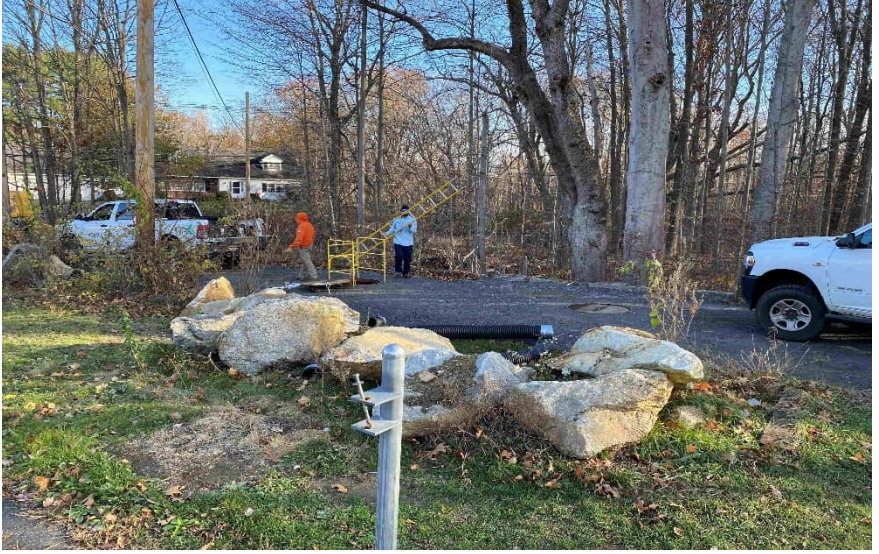
<p>PHOTOGRAPHIC LOG</p>	
Client Name: Eversource		Site Location: Sudbury to Hudson Transmission Reliability Project	Town: Hudson
Photo No.: 3	Date: 11-11-24

Description: Haugland conducting work within manhole #1, looking northward.

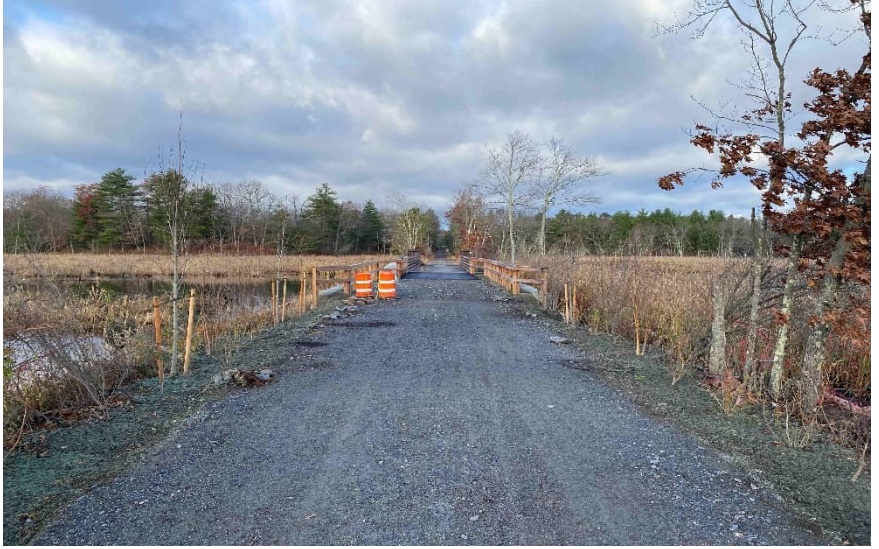
<p>PHOTOGRAPHIC LOG</p>	
<p>Client Name: Eversource</p>		<p>Site Location: Sudbury to Hudson Transmission Reliability Project</p>	<p>Town: Hudson</p>
<p>Photo No.: 5</p>	<p>Date: 11-11-24</p>

<p>Description:</p> <p>Bridge 130 segment 3, recent plantings & hydroseeding, existing erosion control, looking westward.</p>

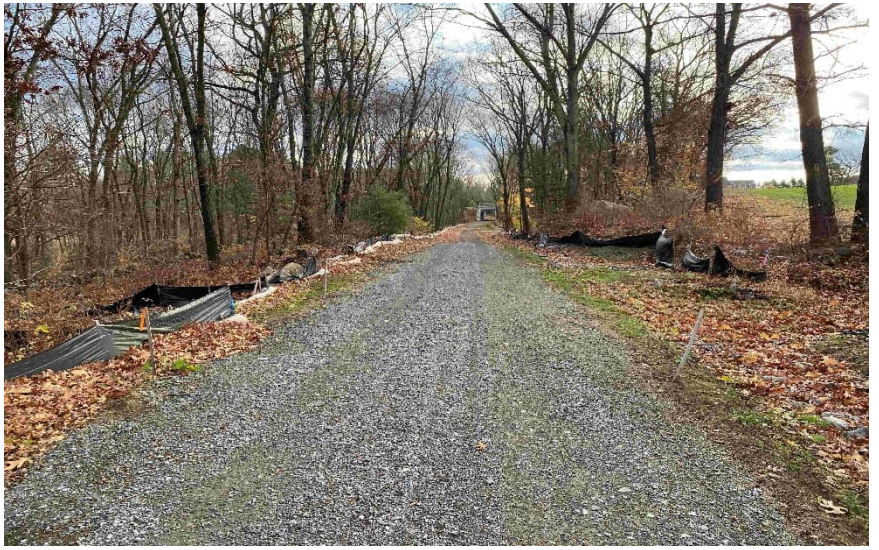
<p>PHOTOGRAPHIC LOG</p>	
<p>Client Name: Eversource</p>		<p>Site Location: Sudbury to Hudson Transmission Reliability Project</p>	<p>Town: Stow</p>
<p>Photo No.: 6</p>	<p>Date: 11-11-24</p>

<p>Description:</p> <p>Work area within segment 1, existing erosion control, looking eastward.</p>

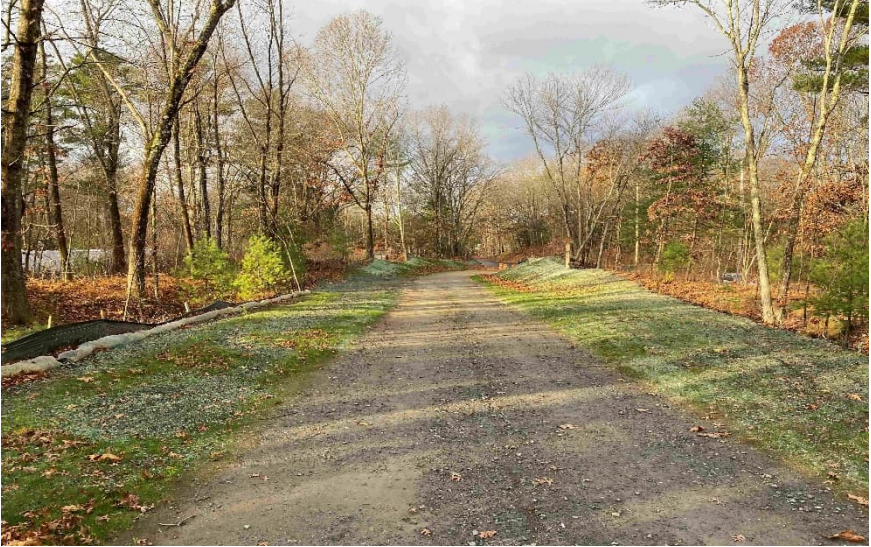
<p>PHOTOGRAPHIC LOG</p>	
<p>Client Name: Eversource</p>		<p>Site Location: Sudbury to Hudson Transmission Reliability Project</p>	<p>Town: Hudson</p>
<p>Photo No.: 7</p>	<p>Date: 11-11-24</p>

<p>Description:</p> <p>Segment 1 (Wilkins Road ahead), recent hydroseeding, existing erosion control, looking westward.</p>

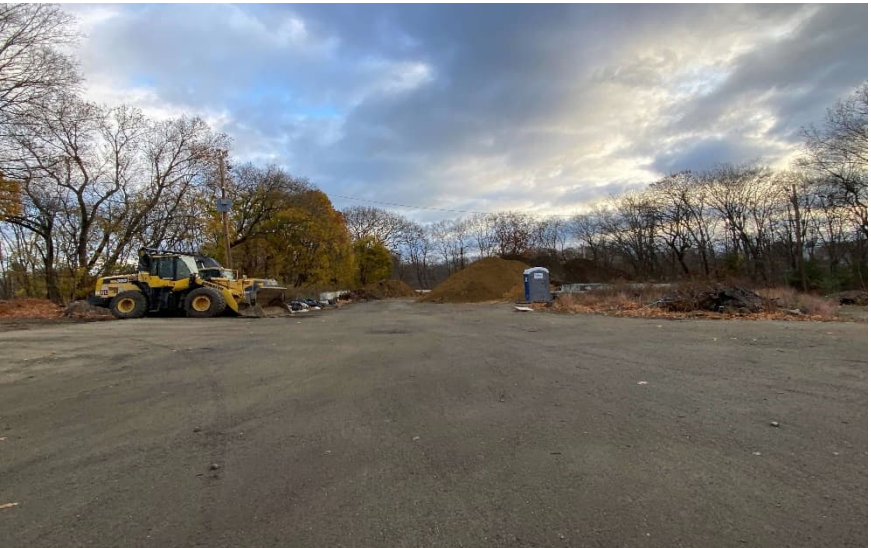
<p>PHOTOGRAPHIC LOG</p>	
<p>Client Name: Eversource</p>		<p>Site Location: Sudbury to Hudson Transmission Reliability Project</p>	<p>Town: Hudson</p>
<p>Photo No.: 8</p>	<p>Date: 11-11-24</p>

<p>Description:</p> <p>Stowe Court laydown yard, looking southward.</p>

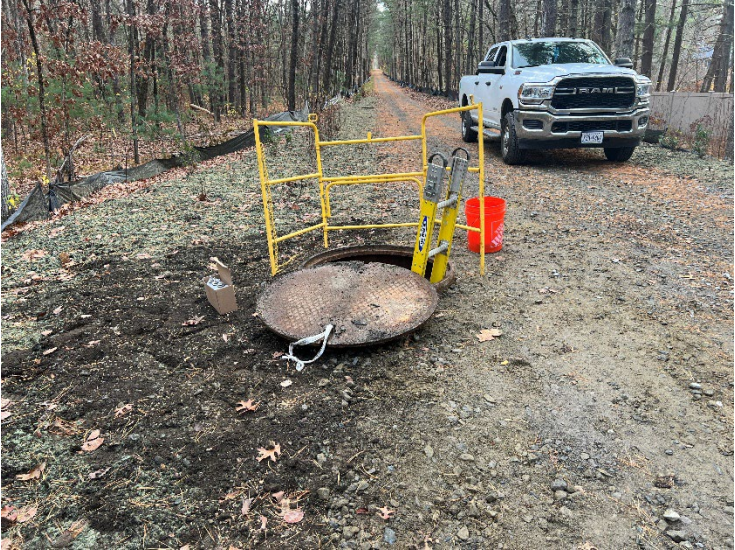
<p>PHOTOGRAPHIC LOG</p>	
<p>Client Name: Eversource</p>		<p>Site Location: Sudbury to Hudson Transmission Reliability Project</p>	<p>Town: Sudbury</p>
<p>Photo No.: 3</p>	<p>Date: 11/11/2024</p>

<p>Description: View of Haugland crew at MH#20 in segment 10. Facing east.</p>

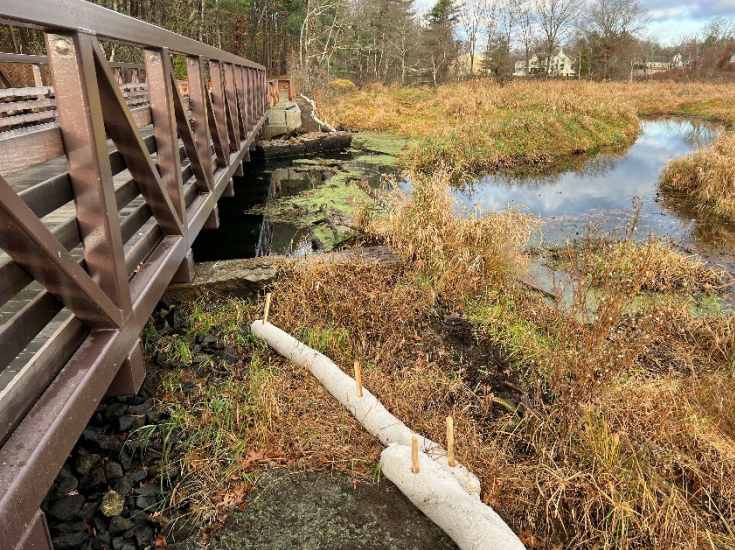
<p>PHOTOGRAPHIC LOG</p>	
<p>Client Name: Eversource</p>		<p>Site Location: Sudbury to Hudson Transmission Reliability Project</p>	<p>Town: Sudbury</p>
<p>Photo No.: 4</p>	<p>Date: 11/11/2024</p>

<p>Description: View of Bridge 127 in segments 13/14. Floating turbidity curtain has been removed and compost filter tubes added along slope. Facing west.</p>

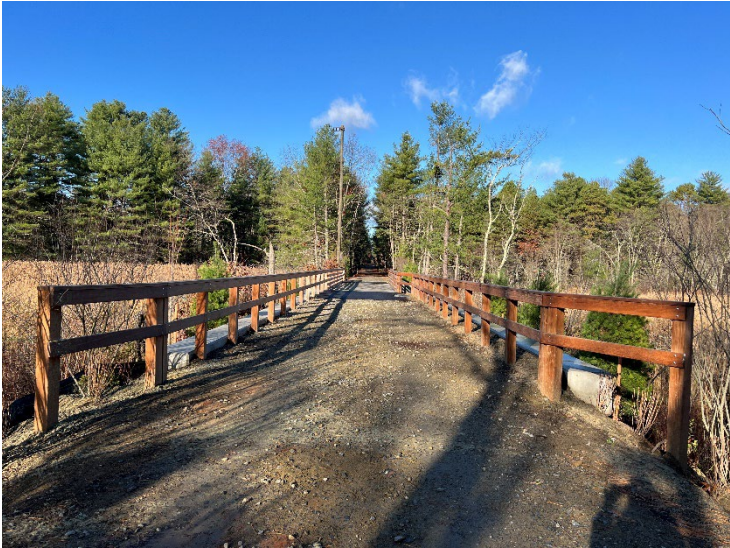
PHOTOGRAPHIC LOG	
Client Name: Eversource		Site Location: Sudbury to Hudson Transmission Reliability Project	Town: Sudbury
Photo No.: 5	Date: 11/11/2024

Description: View of Bridge 128. Osprey platform pole installed west of the bridge. Facing west.

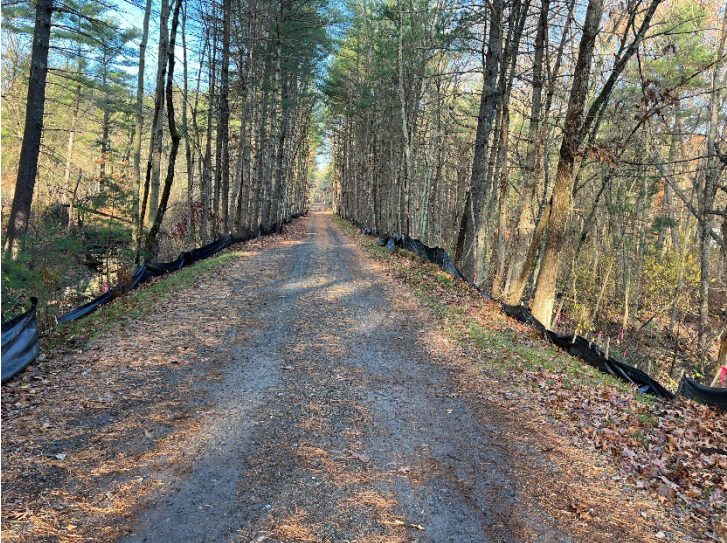
PHOTOGRAPHIC LOG	
Client Name: Eversource		Site Location: Sudbury to Hudson Transmission Reliability Project	Town: Sudbury
Photo No.: 6	Date: 11/11/2024

Description: View of E&S controls in segment 10. Facing west.

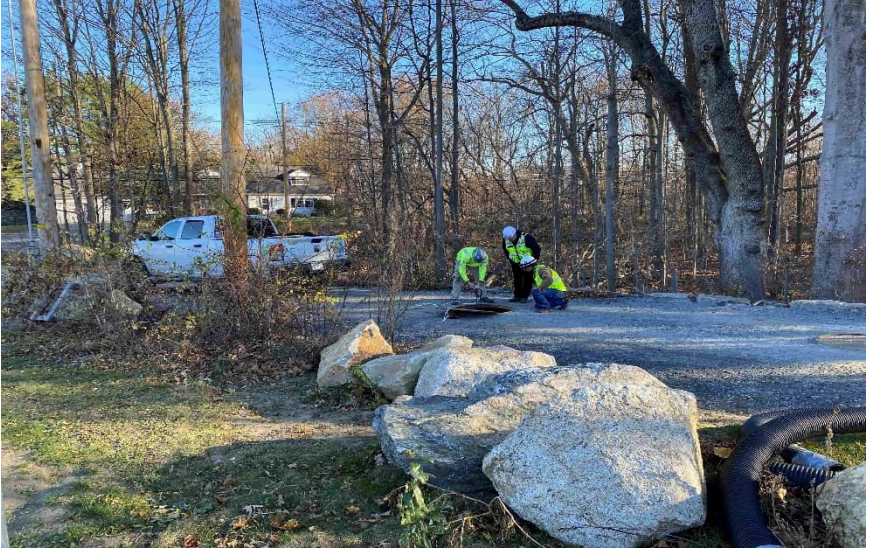
<p>PHOTOGRAPHIC LOG</p>	
<p>Client Name: Eversource</p>		<p>Site Location: Sudbury to Hudson Transmission Reliability Project</p>	<p>Town: Hudson</p>
<p>Photo No.: 1</p>	<p>Date: 11-13-24</p>

<p>Description:</p> <p>Haugland conducting testing work at manhole #1, looking westward.</p>

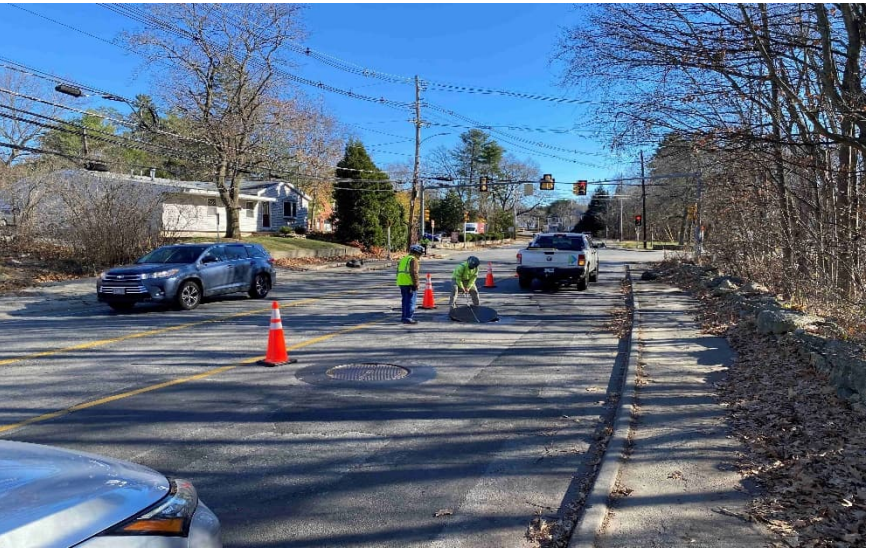
<p>PHOTOGRAPHIC LOG</p>	
<p>Client Name: Eversource</p>		<p>Site Location: Sudbury to Hudson Transmission Reliability Project</p>	<p>Town: Hudson</p>
<p>Photo No.: 2</p>	<p>Date: 11-13-24</p>

<p>Description:</p> <p>Haugland conducting testing work at manhole #2, looking northward.</p>

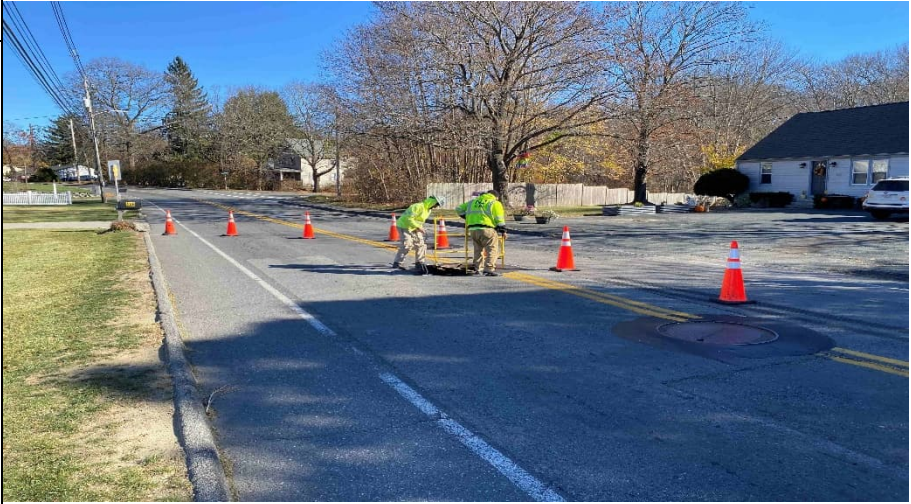
<p>PHOTOGRAPHIC LOG</p>	
<p>Client Name: Eversource</p>		<p>Site Location: Sudbury to Hudson Transmission Reliability Project</p>	<p>Town: Hudson</p>
<p>Photo No.: 3</p>	<p>Date: 11-13-24</p>

<p>Description:</p> <p>Haugland conducting testing work at manhole #3, looking northward.</p>

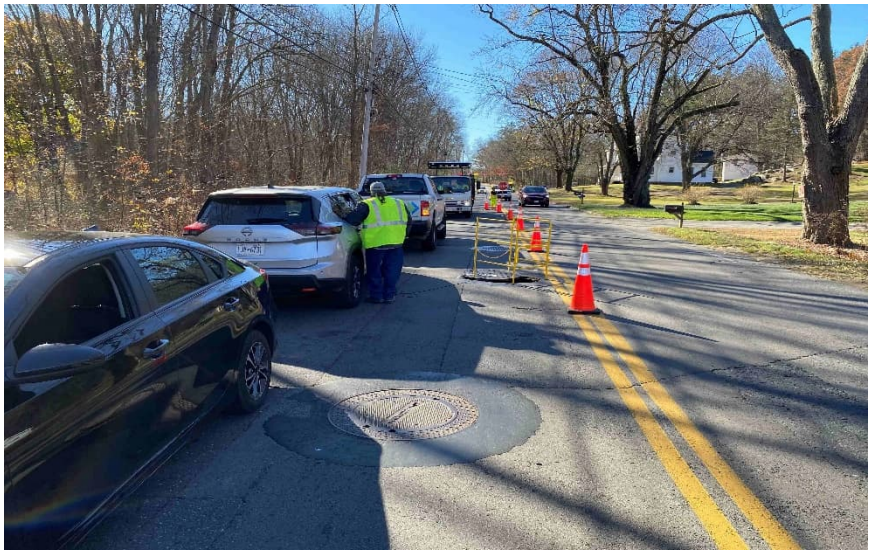
<p>PHOTOGRAPHIC LOG</p>	
<p>Client Name: Eversource</p>		<p>Site Location: Sudbury to Hudson Transmission Reliability Project</p>	<p>Town: Hudson</p>
<p>Photo No.: 4</p>	<p>Date: 11-13-24</p>

<p>Description:</p> <p>Haugland conducting testing work at manhole #4, looking southward.</p>

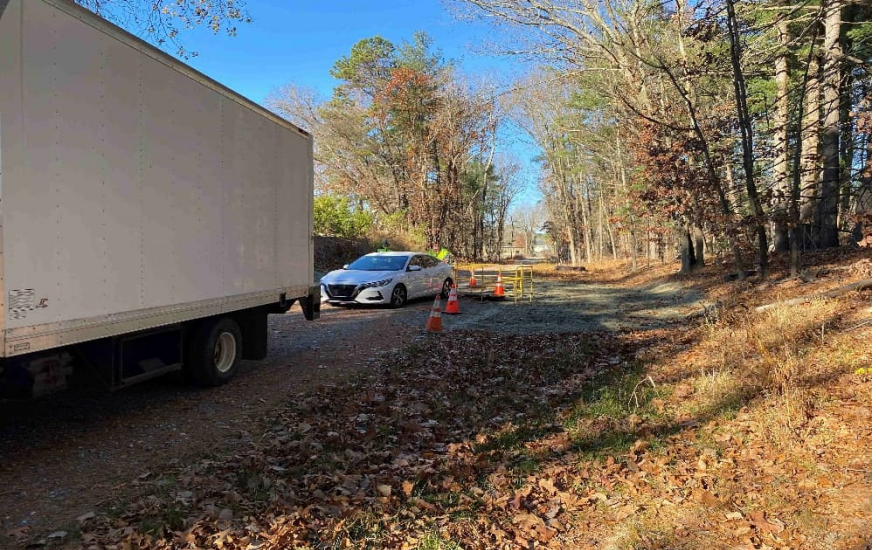
<p>PHOTOGRAPHIC LOG</p>	
<p>Client Name: Eversource</p>		<p>Site Location: Sudbury to Hudson Transmission Reliability Project</p>	<p>Town: Stow</p>
<p>Photo No.: 6</p>	<p>Date: 11-13-24</p>

<p>Description:</p> <p>Haugland conducting testing work at manhole #9, looking westward.</p>

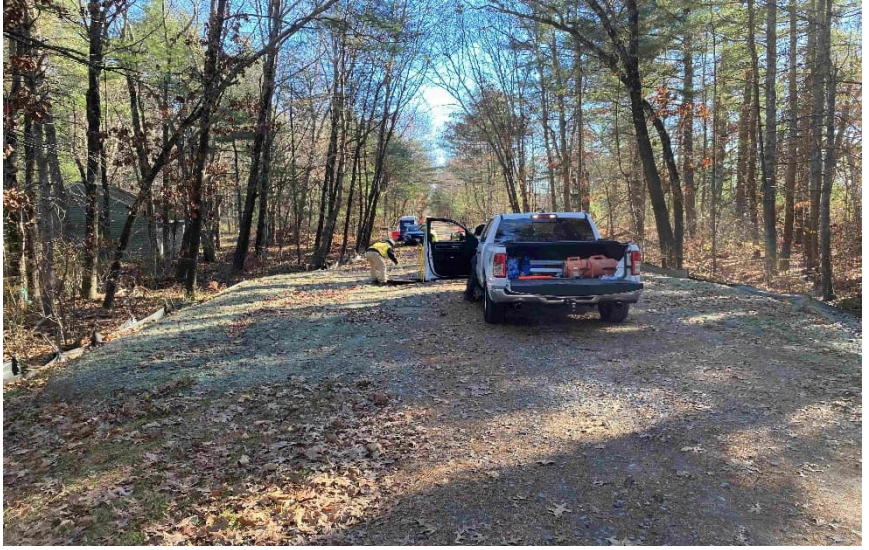
<p>PHOTOGRAPHIC LOG</p>	
<p>Client Name: Eversource</p>		<p>Site Location: Sudbury to Hudson Transmission Reliability Project</p>	<p>Town: Hudson</p>
<p>Photo No.: 8</p>	<p>Date: 11-13-24</p>

<p>Description:</p> <p>Haugland conducting testing work at manhole #13, looking westward.</p>

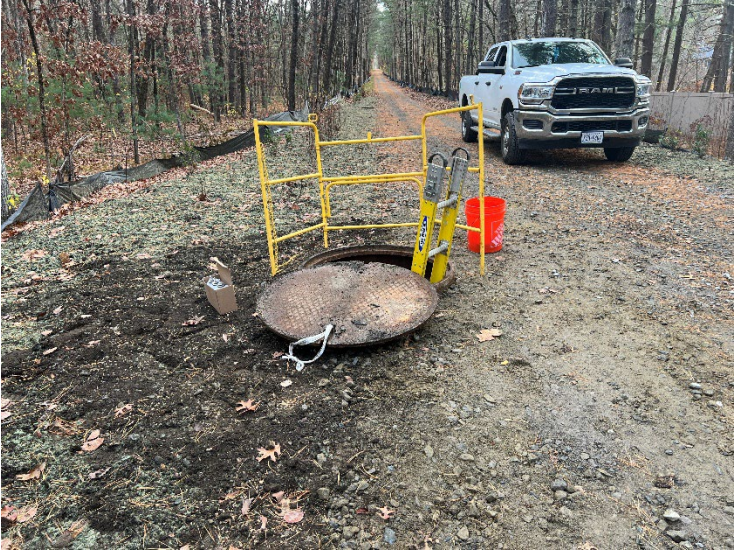
PHOTOGRAPHIC LOG	
Client Name: Eversource		Site Location: Sudbury to Hudson Transmission Reliability Project	Town: Sudbury
Photo No.: 3	Date: 11/13/2024

Description: View of Haugland crew at MH#20 in segment 10. Facing east.

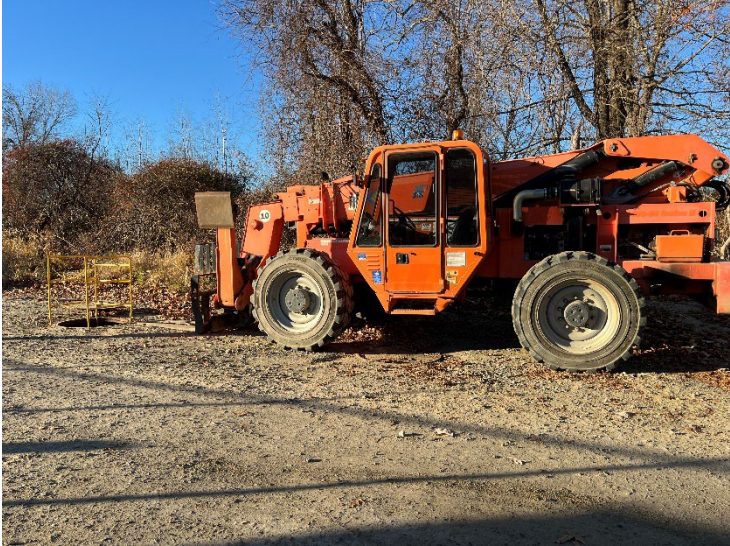
PHOTOGRAPHIC LOG	
Client Name: Eversource		Site Location: Sudbury to Hudson Transmission Reliability Project	Town: Sudbury
Photo No.: 5	Date: 11/13/2024

Description: View of MH#28. Facing west.

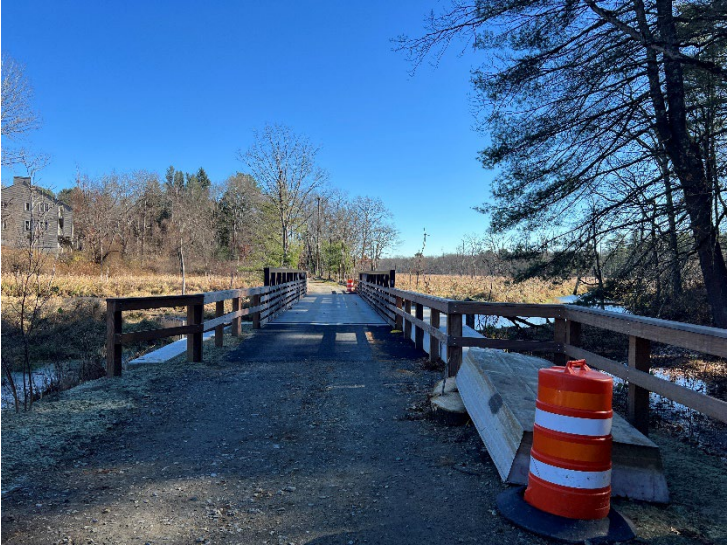
PHOTOGRAPHIC LOG	
Client Name: Eversource		Site Location: Sudbury to Hudson Transmission Reliability Project	Town: Sudbury
Photo No.: 6	Date: 11/13/2024

Description: View of Bridge 127. Facing east.

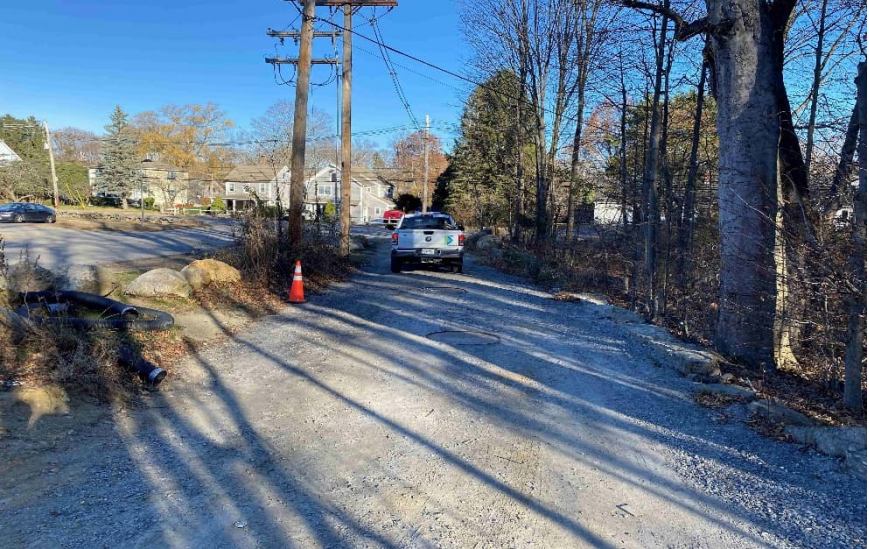
<p>PHOTOGRAPHIC LOG</p>	
<p>Client Name: Eversource</p>		<p>Site Location: Sudbury to Hudson Transmission Reliability Project</p>	<p>Town: Hudson</p>
<p>Photo No.: 1</p>	<p>Date: 11-14-24</p>

<p>Description:</p> <p>Haugland conducting testing work at manhole #1, looking westward.</p>

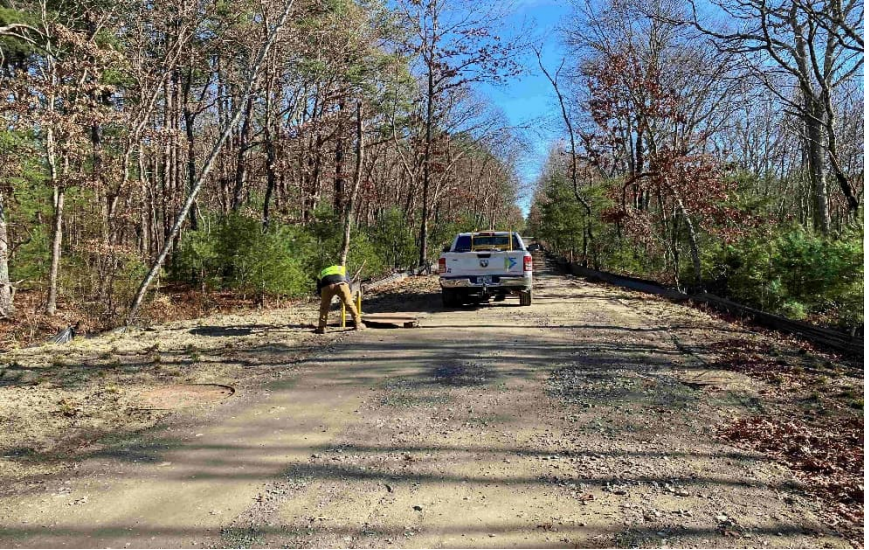
<p>PHOTOGRAPHIC LOG</p>	
<p>Client Name: Eversource</p>		<p>Site Location: Sudbury to Hudson Transmission Reliability Project</p>	<p>Town: Hudson</p>
<p>Photo No.: 4</p>	<p>Date: 11-14-24</p>

<p>Description:</p> <p>Haugland conducting testing work at manhole #14, looking eastward.</p>

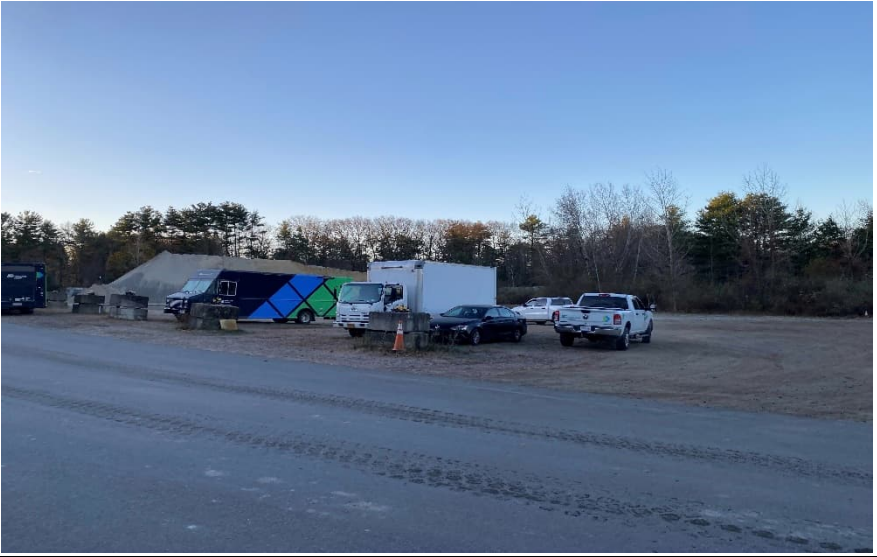
<p>PHOTOGRAPHIC LOG</p>	
<p>Client Name: Eversource</p>		<p>Site Location: Sudbury to Hudson Transmission Reliability Project</p>	<p>Town: Hudson</p>
<p>Photo No.: 5</p>	<p>Date: 11-14-24</p>

<p>Description: Haugland laydown yard, looking westward.</p>

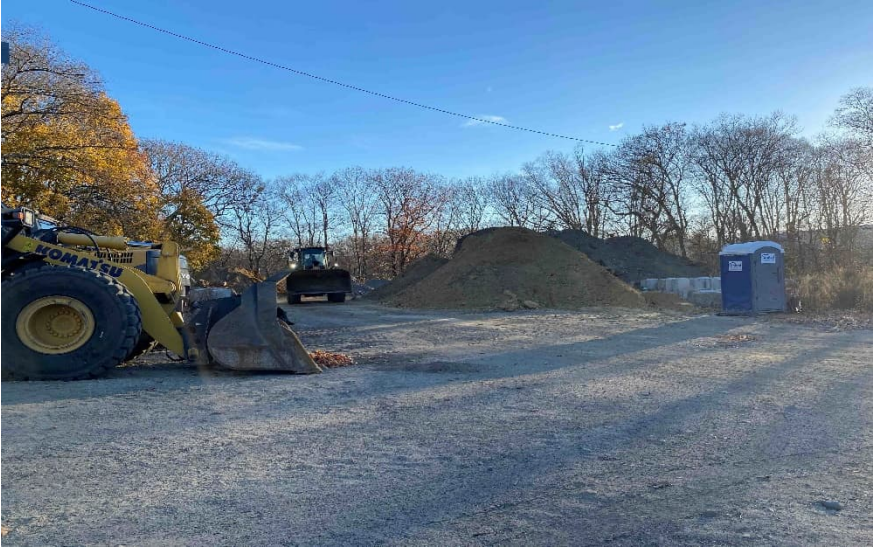
<p>PHOTOGRAPHIC LOG</p>	
<p>Client Name: Eversource</p>		<p>Site Location: Sudbury to Hudson Transmission Reliability Project</p>	<p>Town: Stow</p>
<p>Photo No.: 6</p>	<p>Date: 11-14-24</p>

<p>Description: Stowe Court laydown yard, Bond working within, looking southward.</p>

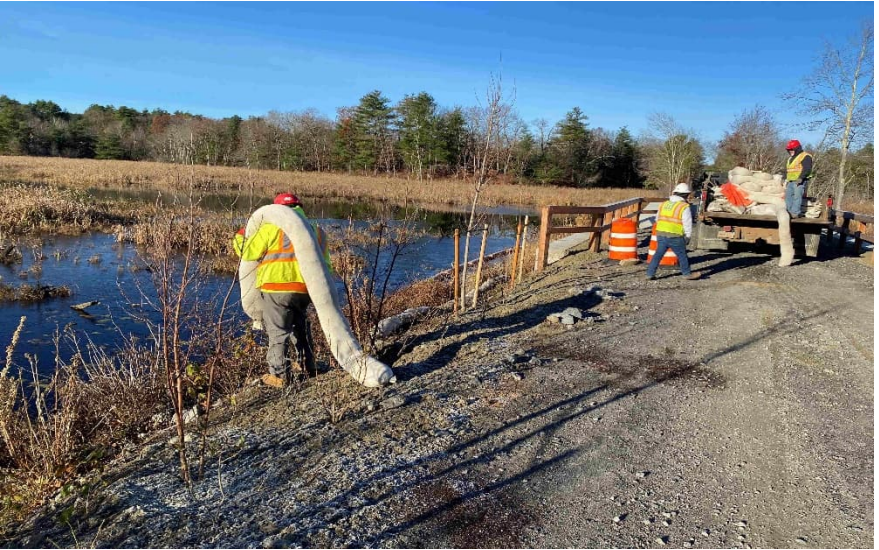
<p align="center">PHOTOGRAPHIC LOG</p>	
<p>Client Name: Eversource</p>		<p>Site Location: Sudbury to Hudson Transmission Reliability Project</p>	<p>Town: Hudson</p>
<p>Photo No.: 7</p>	<p>Date: 11-14-24</p>

<p>Description:</p> <p>ET&L placing compost tubes at bridge 130, existing erosion control, looking westward.</p>

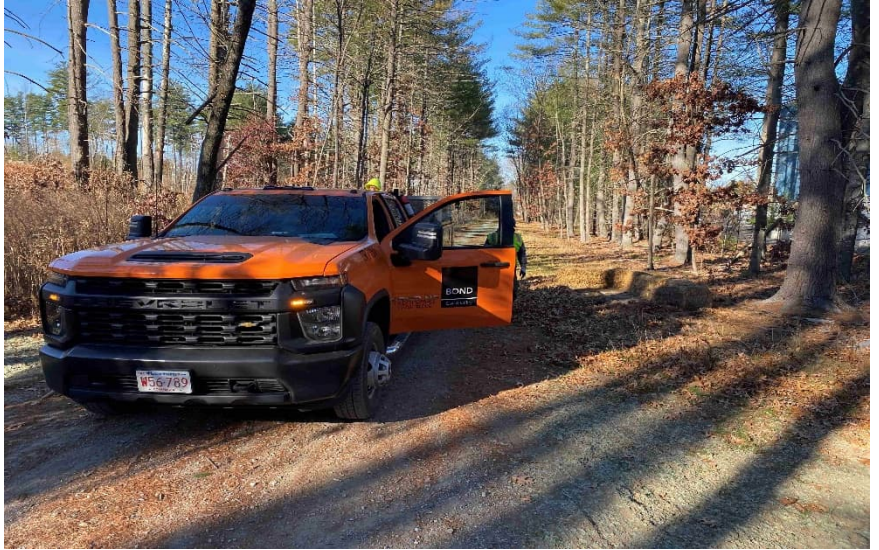
<p align="center">PHOTOGRAPHIC LOG</p>	
<p>Client Name: Eversource</p>		<p>Site Location: Sudbury to Hudson Transmission Reliability Project</p>	<p>Town: Hudson</p>
<p>Photo No.: 8</p>	<p>Date: 11-14-24</p>

<p>Description:</p> <p>Bond conducting cleanup work within segment 4 at manhole #10, looking westward.</p>

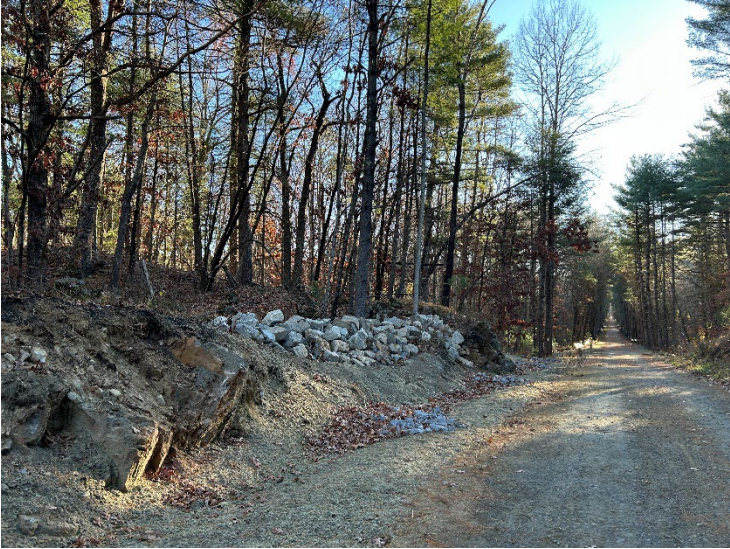
PHOTOGRAPHIC LOG	
Client Name: Eversource		Site Location: Sudbury to Hudson Transmission Reliability Project	Town: Sudbury
Photo No.: 1	Date: 11/14/2024

Description: View of rock pile and hydroseeded ROW shoulder in segment 10. Facing east.

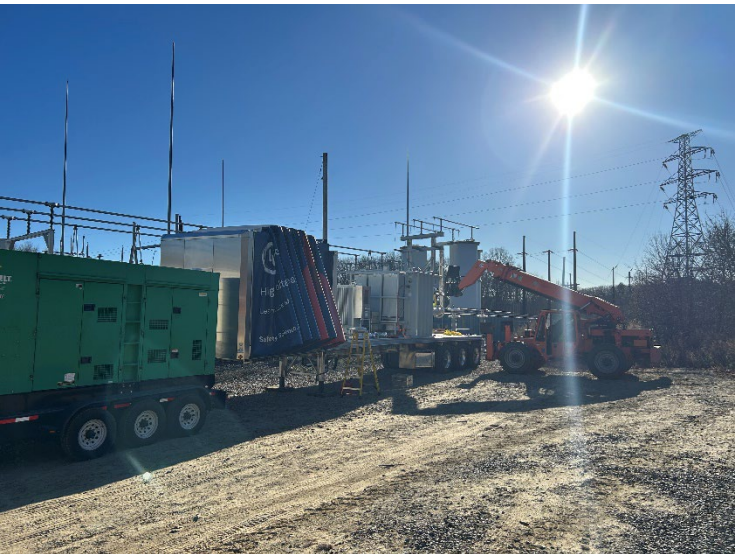
PHOTOGRAPHIC LOG	
Client Name: Eversource		Site Location: Sudbury to Hudson Transmission Reliability Project	Town: Sudbury
Photo No.: 2	Date: 11/14/2024

Description: View of Haugland working at the Sudbury substation. Facing southeast.

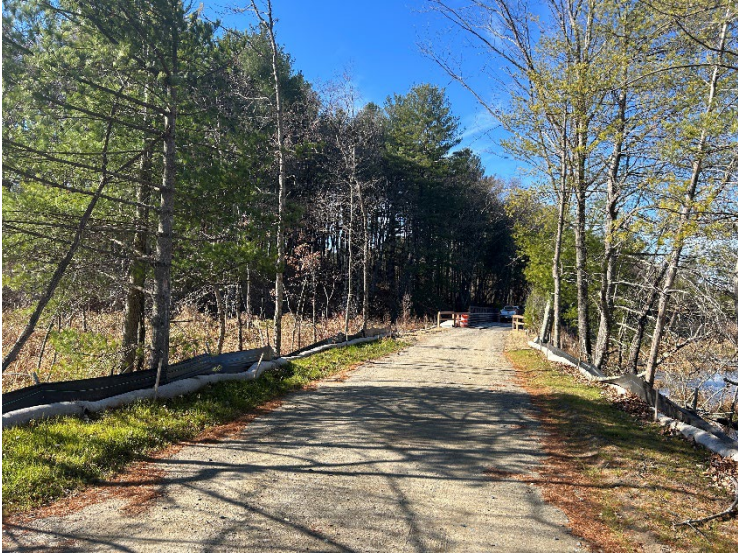
<p>Description: View of erosion controls east of bridge 127 in segment 14. Facing west.</p>

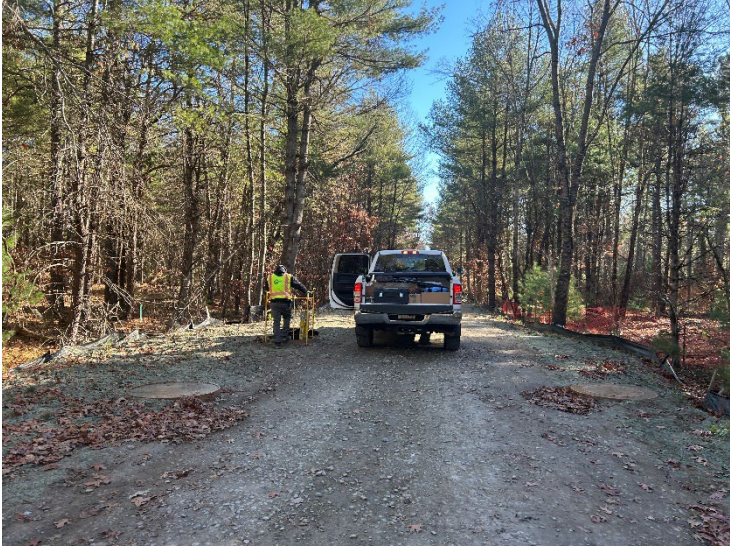
Description: View of Haugland working at MH 15 in segment 7. Facing east.

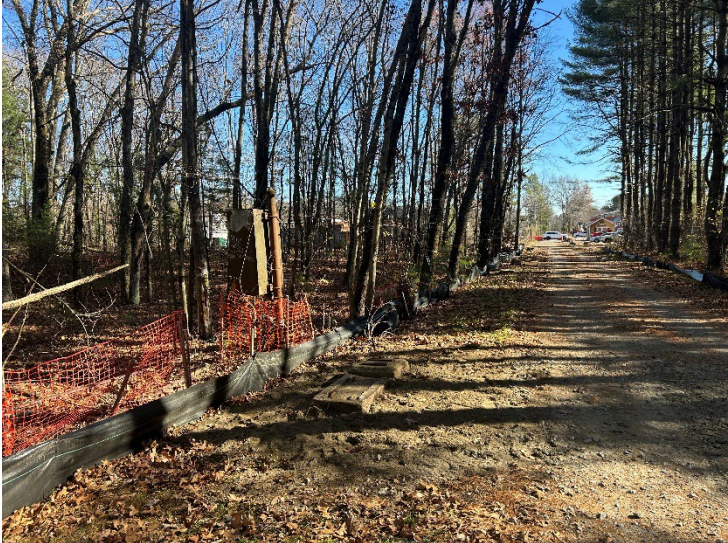
Description: View of reset historical artifacts in segment 11. Facing east.

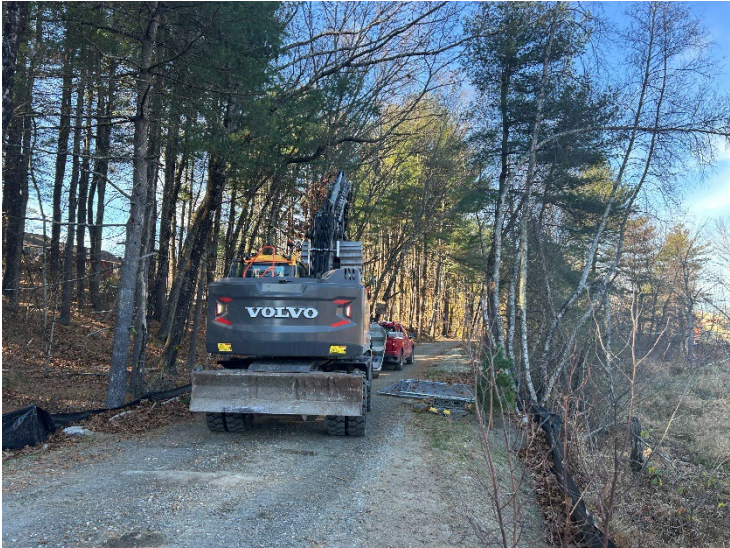
Description: View of ET&L removing row boat from bridge 127 in segment 13. Facing west.

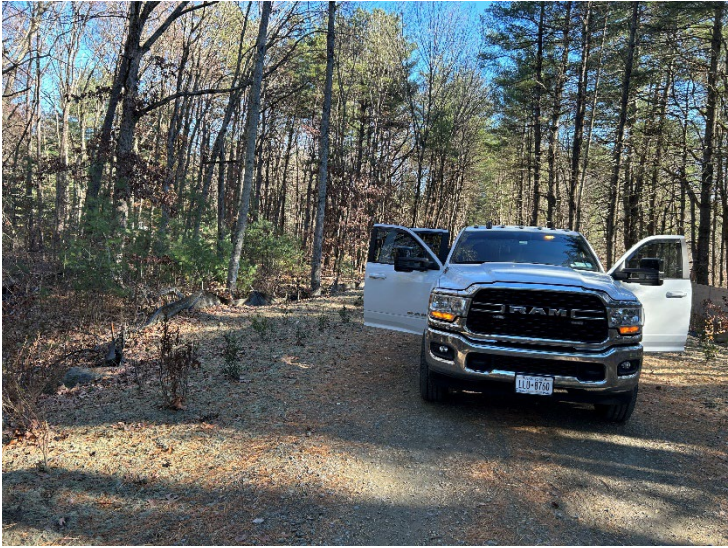
Description: View of Haugland working in MH 20 in segment 10. Facing east.

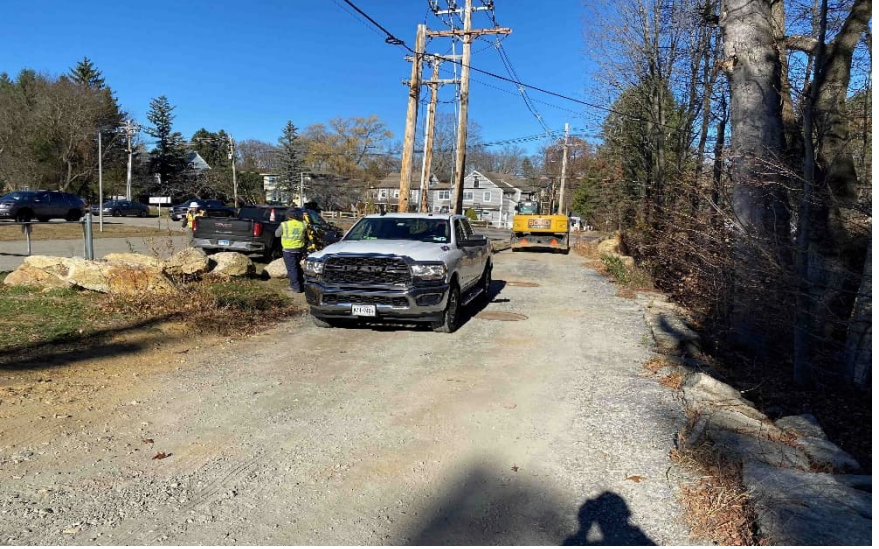
<p>Description:</p> <p>Haugland conducting testing work at manhole #1, looking westward.</p>

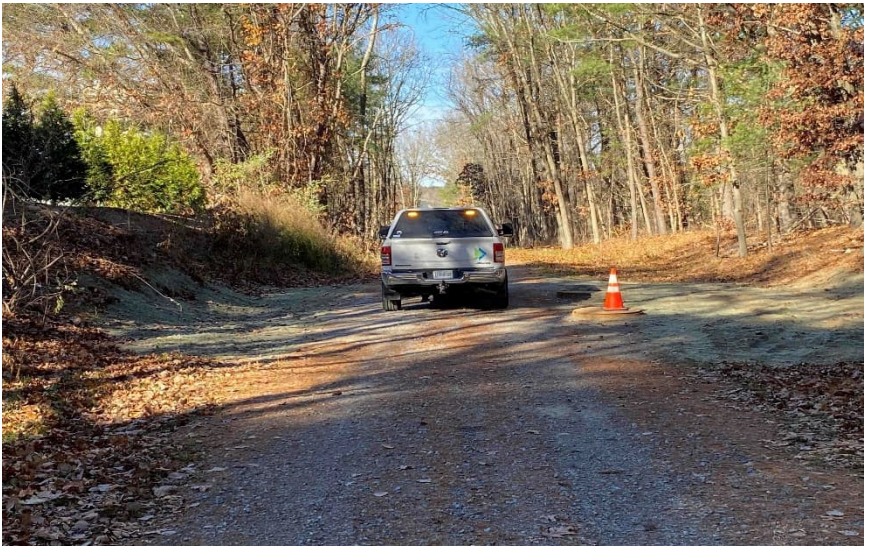
<p>Description:</p> <p>Haugland conducting testing work at manhole #9, looking northward.</p>

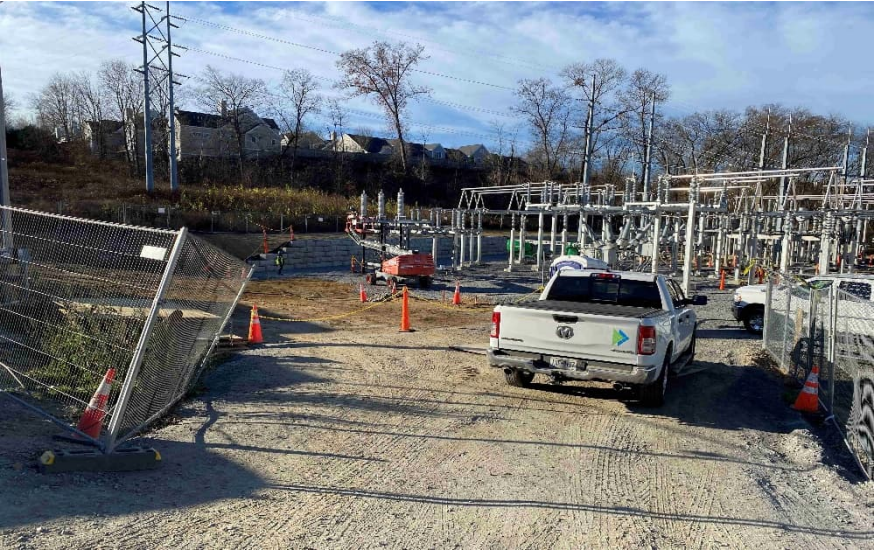
<p>Description:</p> <p>Haugland conducting testing work at Hudson substation, looking southward.</p>

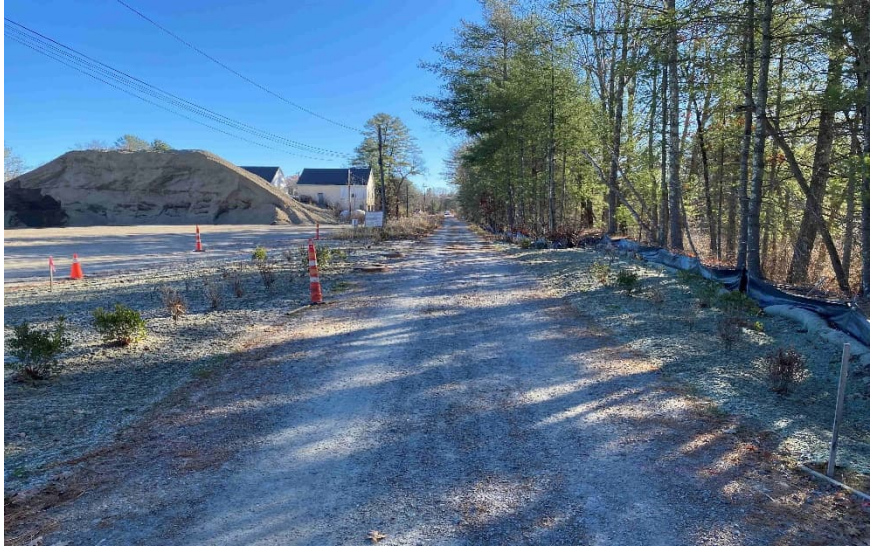
<p>Description:</p> <p>Work area within segment #3, manhole #8, existing erosion control, looking eastward.</p>

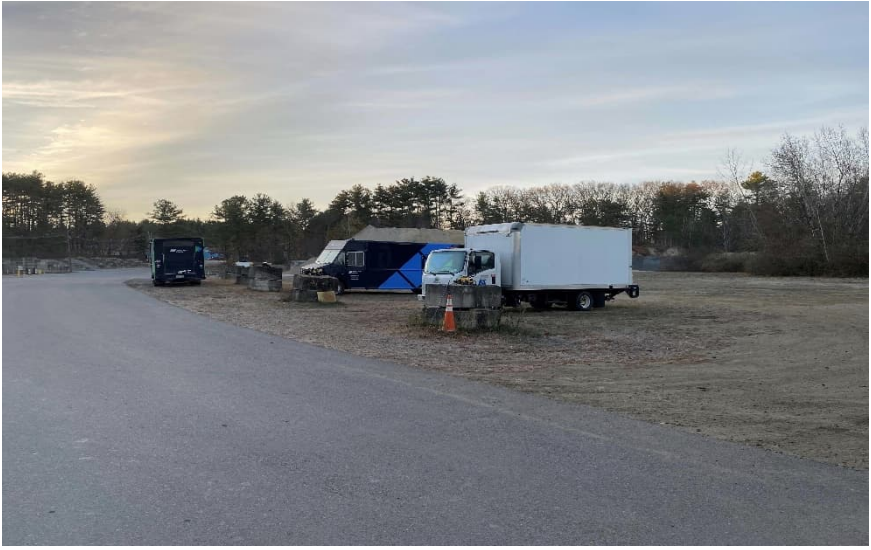
<p>Description: Haugland laydown yard, looking westward.</p>

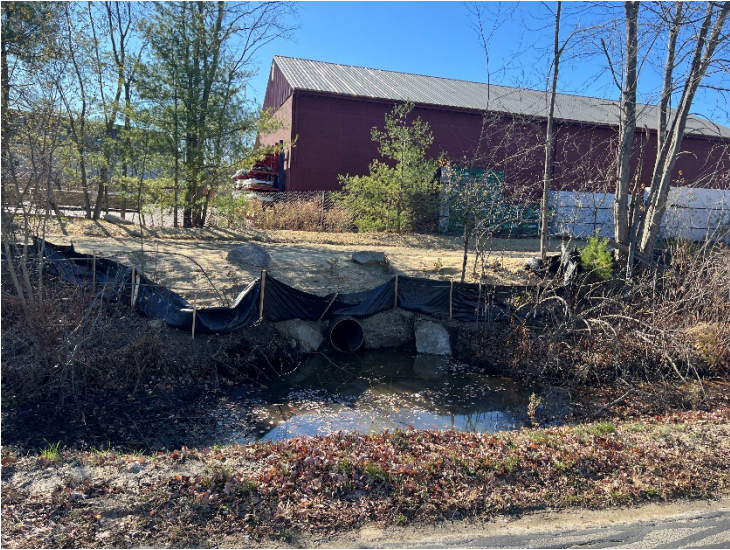
Description: View of culvert extension area within segment 12. Sandbags have been removed. Facing north.

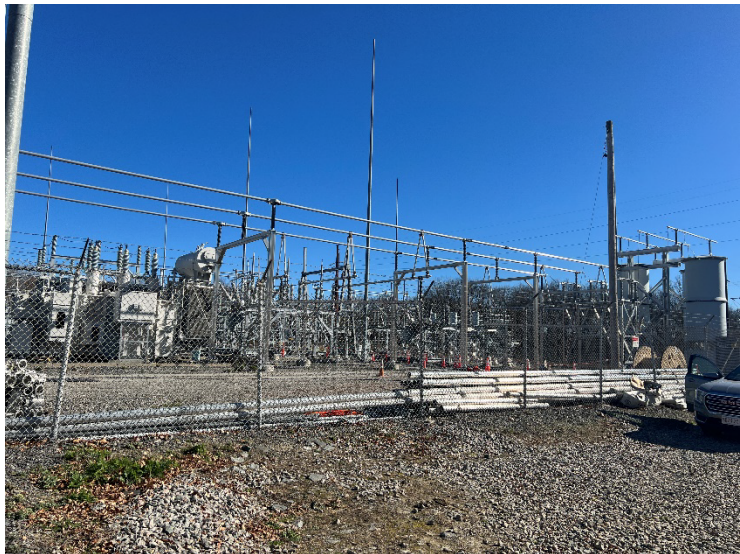
Description: View of Sudbury Substation. Facing west.

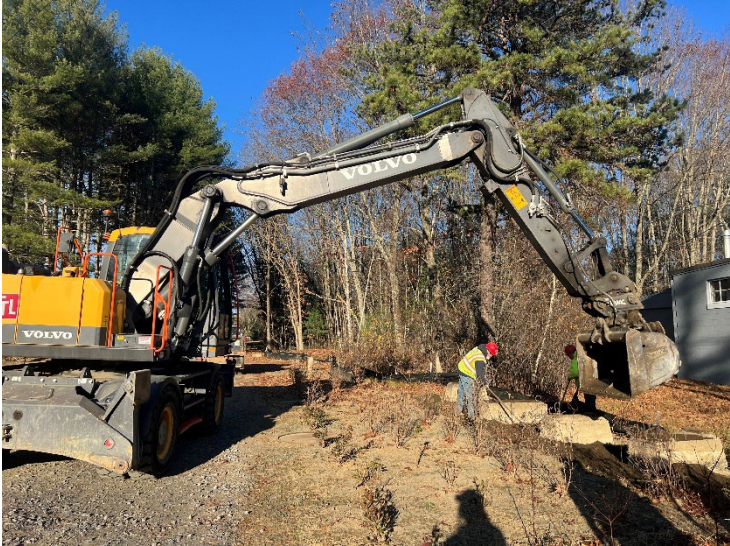
Description: View of ET&L applying top soil around installed historical artifacts in segment 11. Facing west.

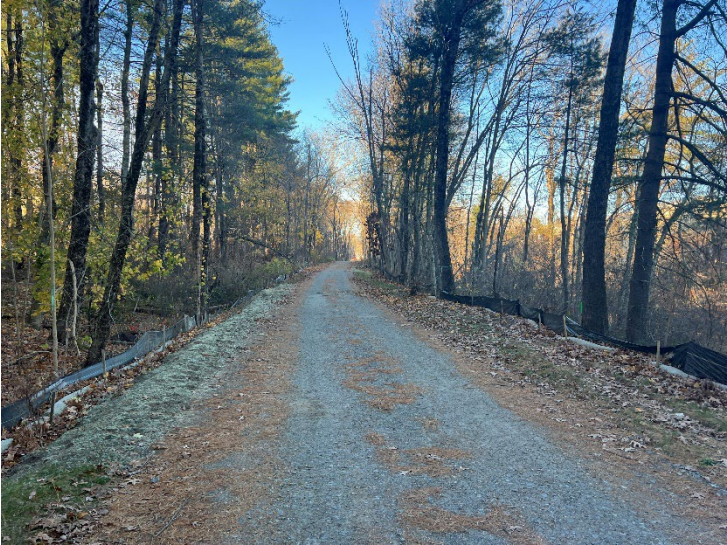
Description: View of E&S controls in segment 13. Facing west.

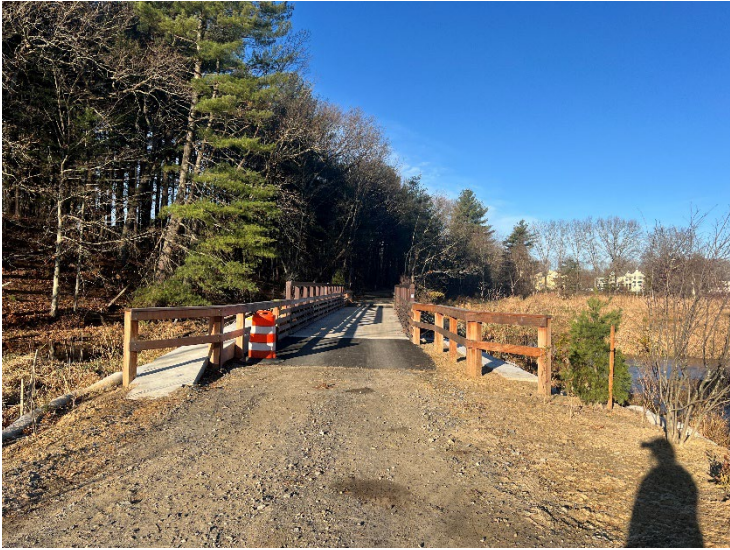
Description: View of Bridge 127. Facing west.

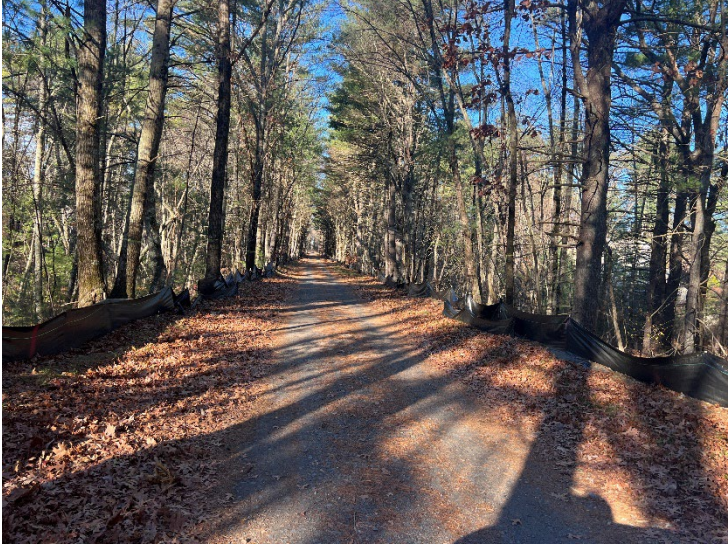
Description: View of E&S controls in segment 9. Facing west.

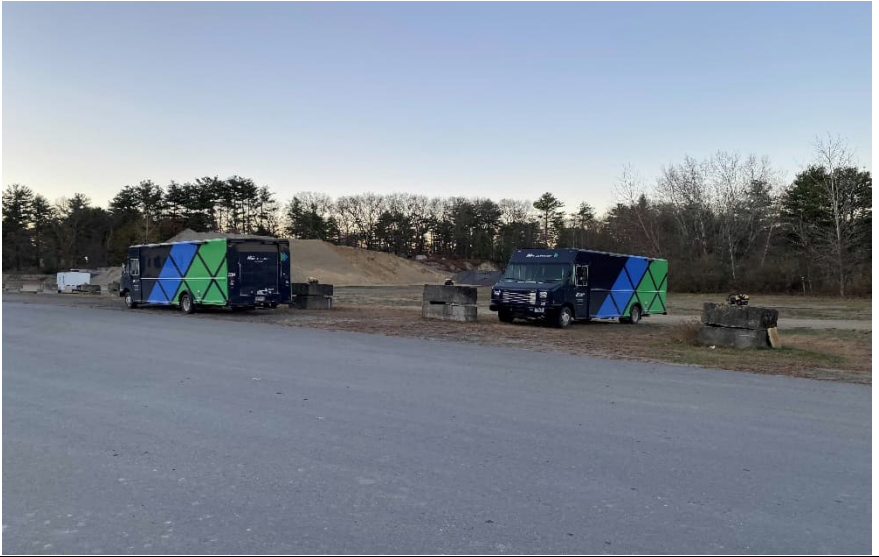
<p>Description:</p> <p>Haugland laydown yard, looking westward.</p>

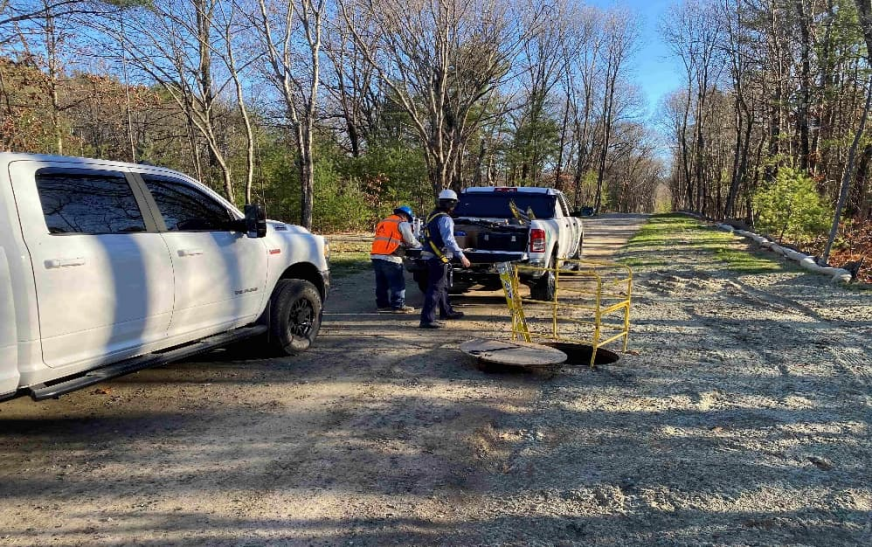
<p>Description:</p> <p>Haugland conducting testing work at manhole #5, looking eastward.</p>
