Weekly Environmental Compliance Summary

Sudbury to Hudson Transmission Reliability Project (USEPA Tracking # MAR1003UW)

Week of: November 11, 2024 to November 17, 2024

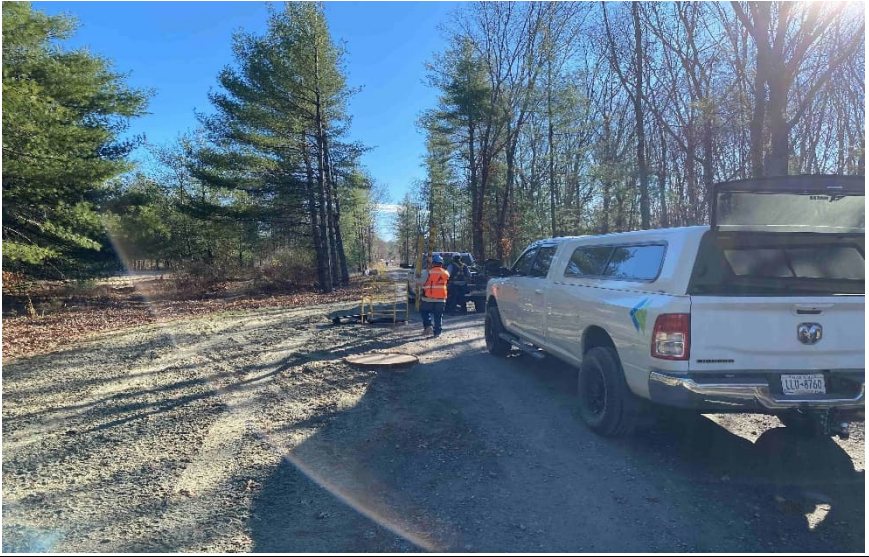
<p>Description:</p> <p>Haugland conducting testing-prep work at manhole #7, looking eastward.</p>

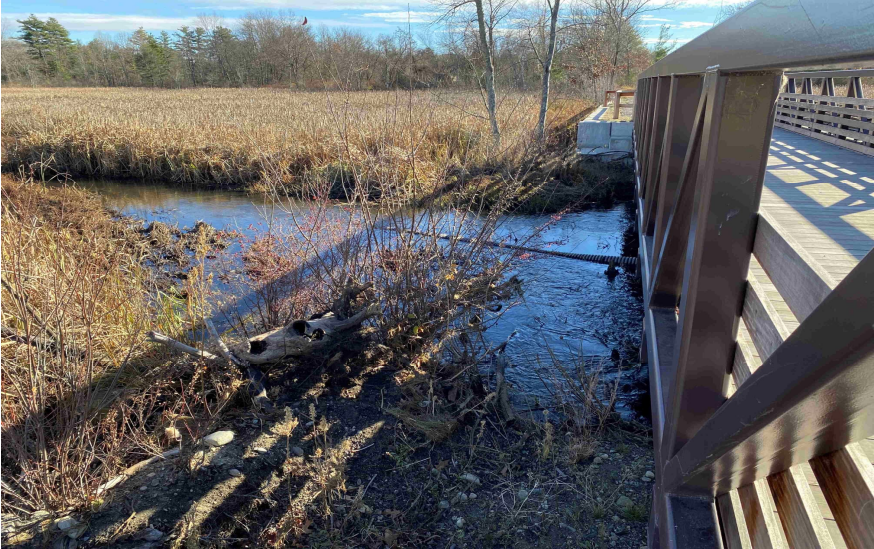
<p>Description:</p> <p>Bridge 130, floating curtain recently removed, looking eastward.</p>

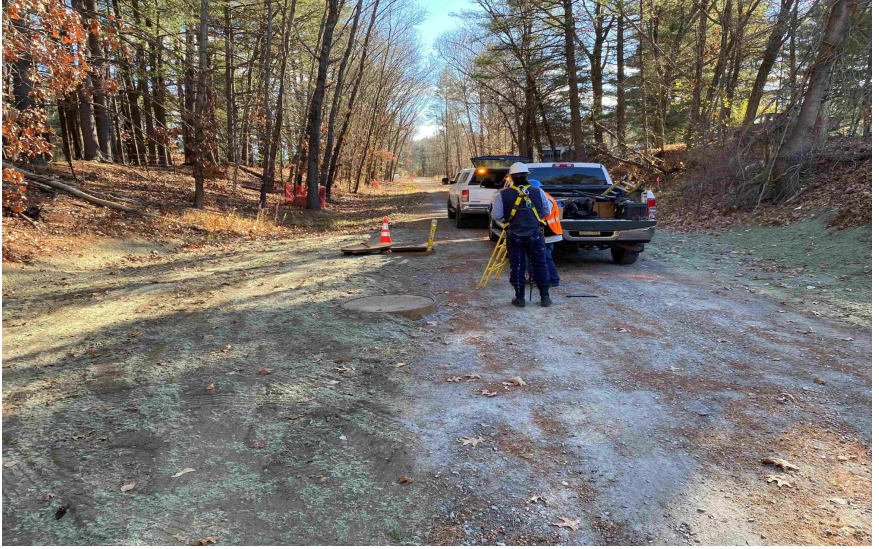
Description: Haugland conducting testing work at manhole #9, looking eastward.

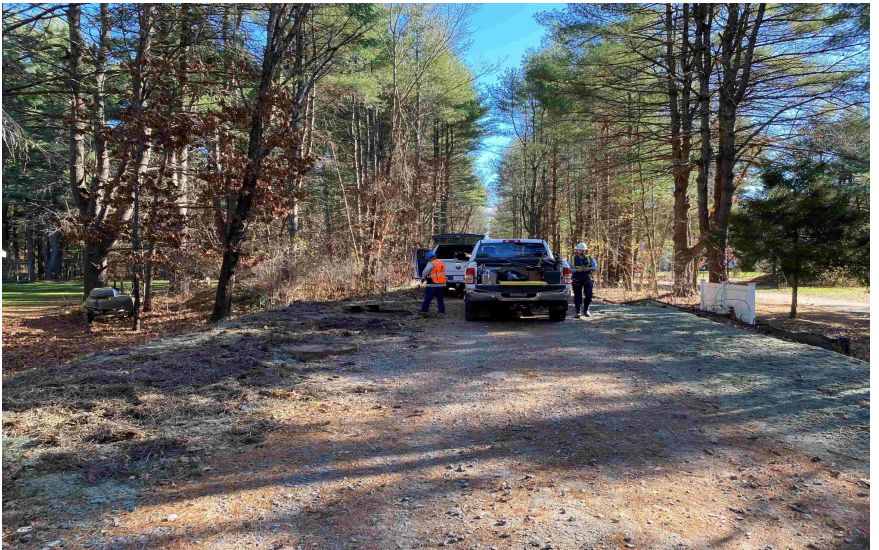
Description: Haugland conducting testing work at manhole #11, looking eastward.

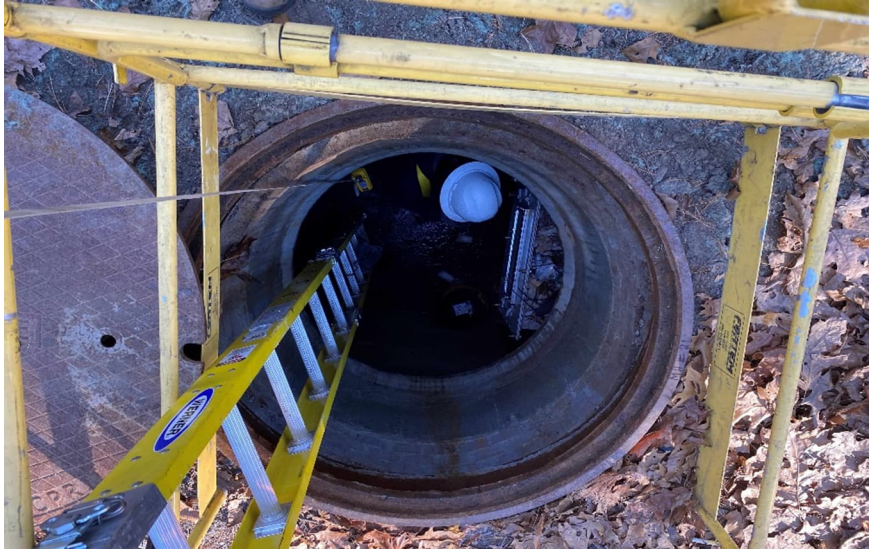
<p>Description:</p> <p>Haugland conducting testing work at manhole #21 (down in manhole), looking eastward.</p>

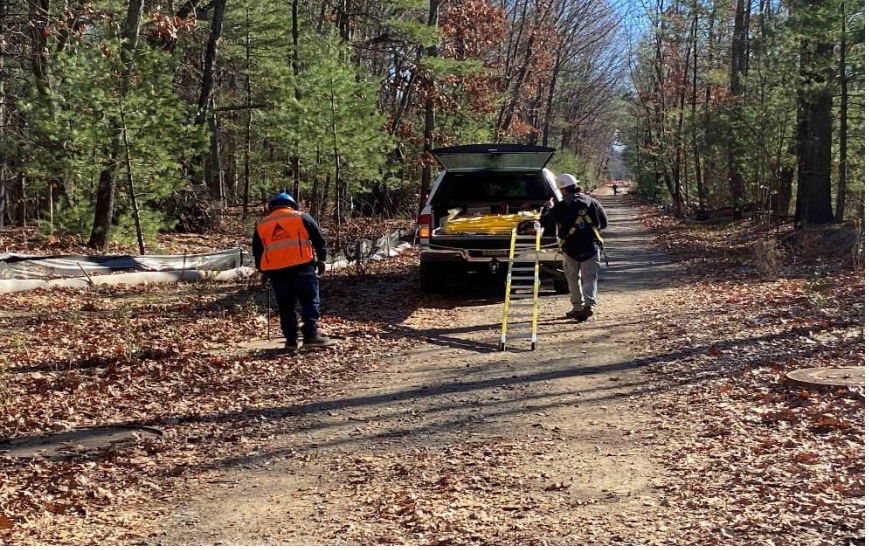
<p>Description:</p> <p>Haugland conducting testing-prep work at manhole #23, looking eastward.</p>

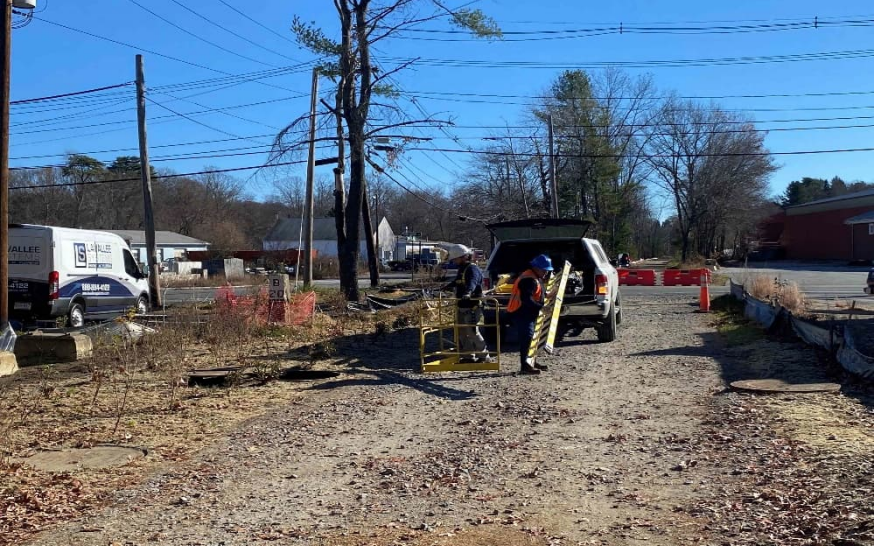
<p>Description:</p> <p>Haugland conducting testing work at manhole #24, looking eastward.</p>

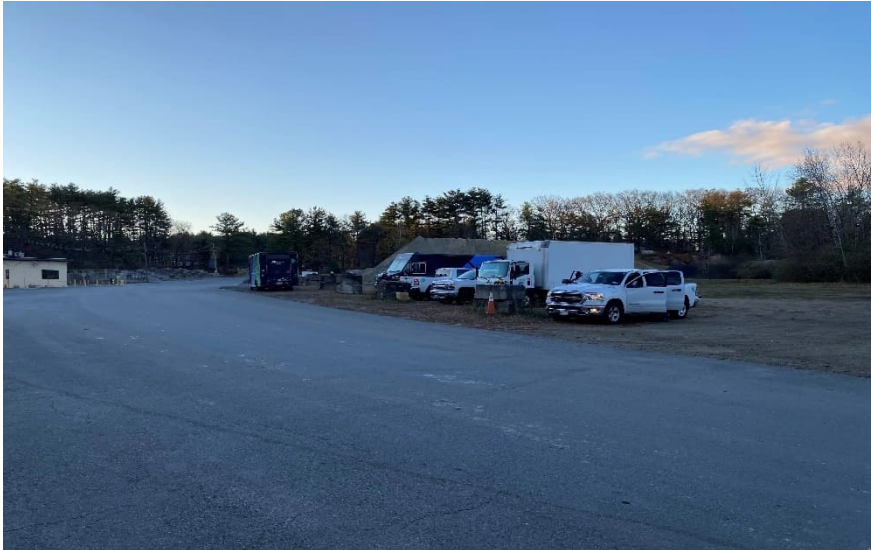
Description: Haugland laydown yard, stored wire on reels, looking westward.

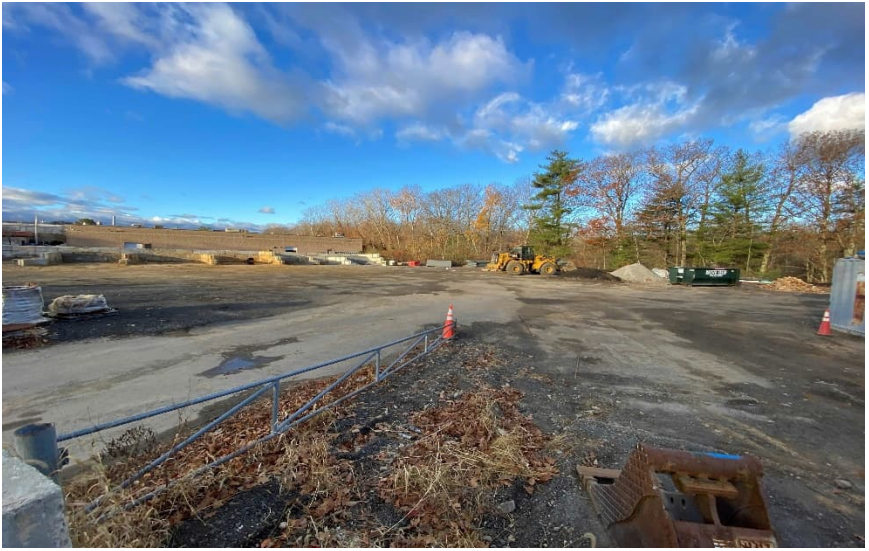
Description: Bonazzoli laydown yard, Bond working here, looking westward.

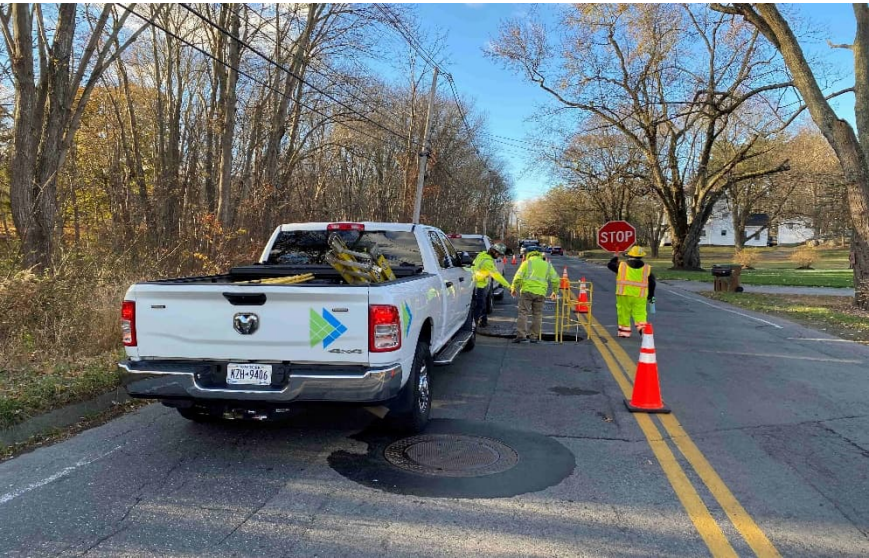
Description: Haugland working within Forest Avenue at manhole #4 conducting testing work, looking southward.

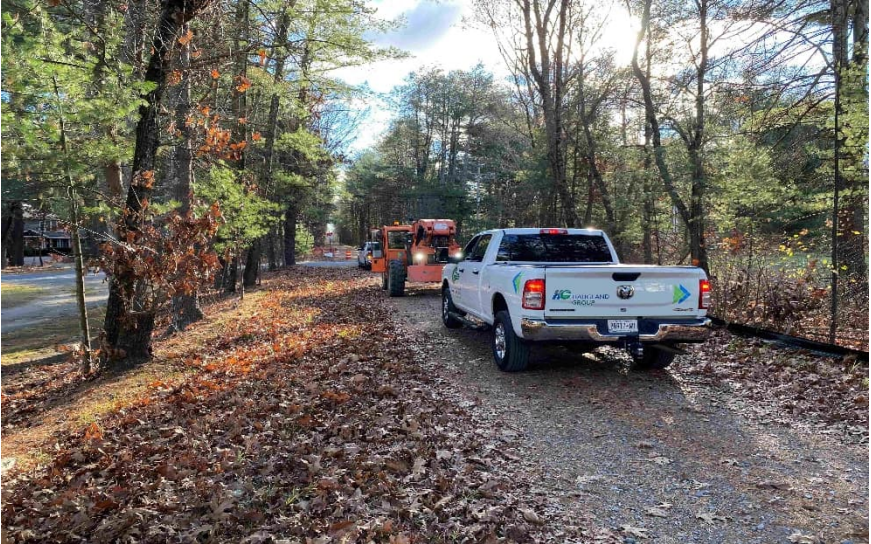
Description: Haugland passing through segment 4, existing erosion control, looking eastward.

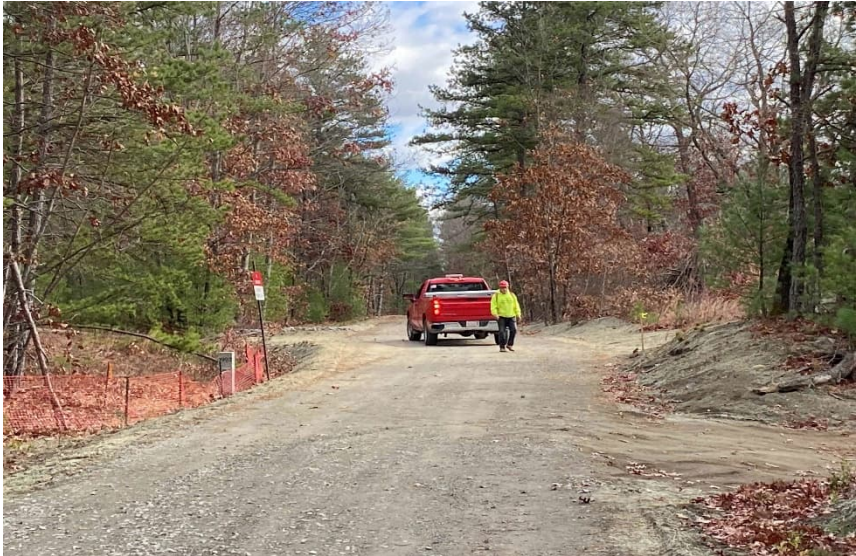
Description: Work area within segment 6, ET&L conducting cleanup work, existing erosion control, looking eastward.

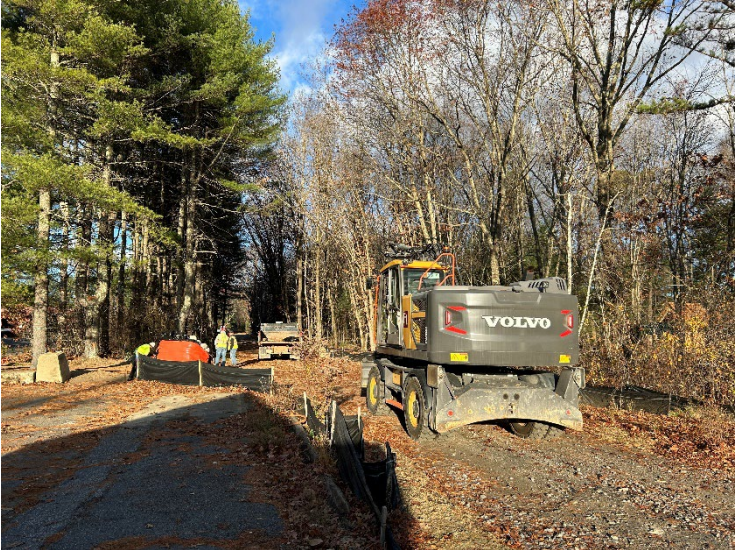
Description: View of ET&L removing stumps in segment 11. Facing west.

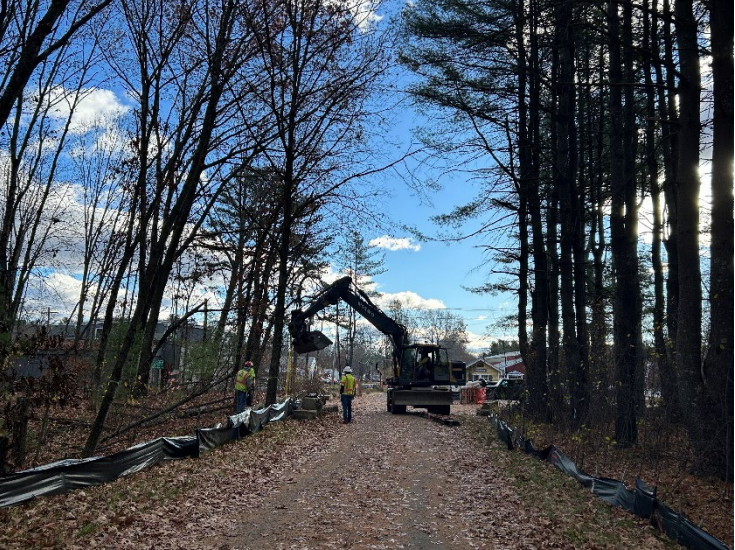
Description: View of ET&L resetting historical artifacts in segment 11. Facing east.

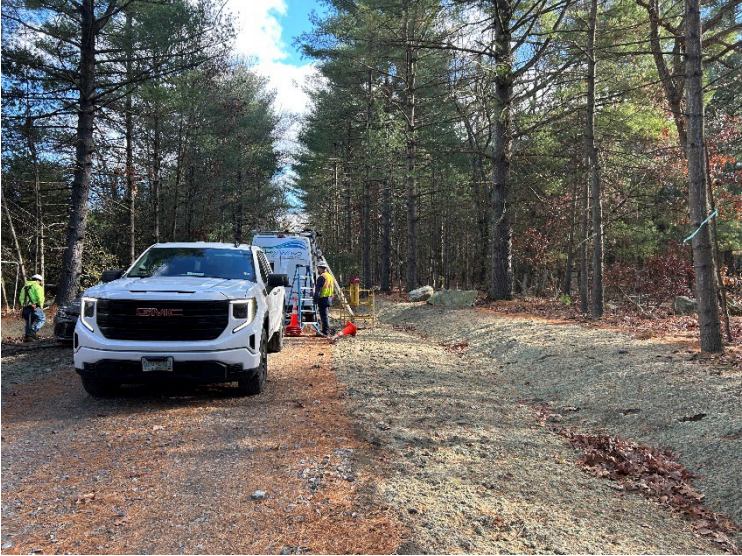
Description: View of New Wave working in handhole #19 within segment 9. Facing east.

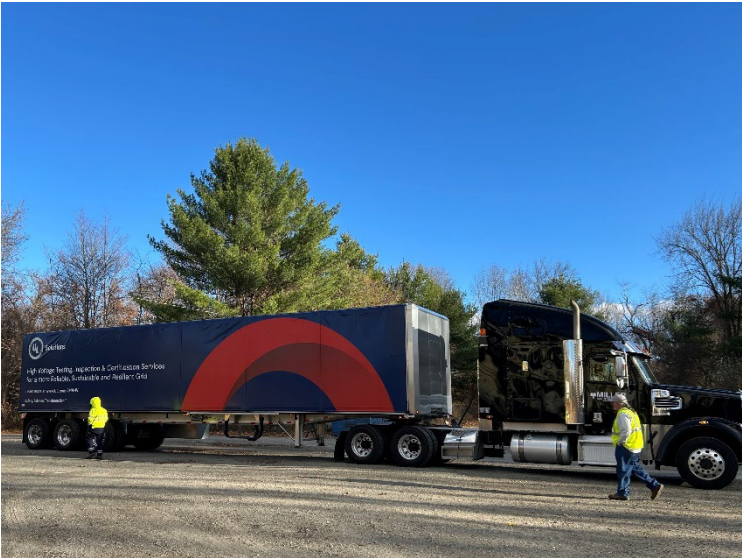
Description: View of testing trailer arriving at Sudbury substation. Facing east.

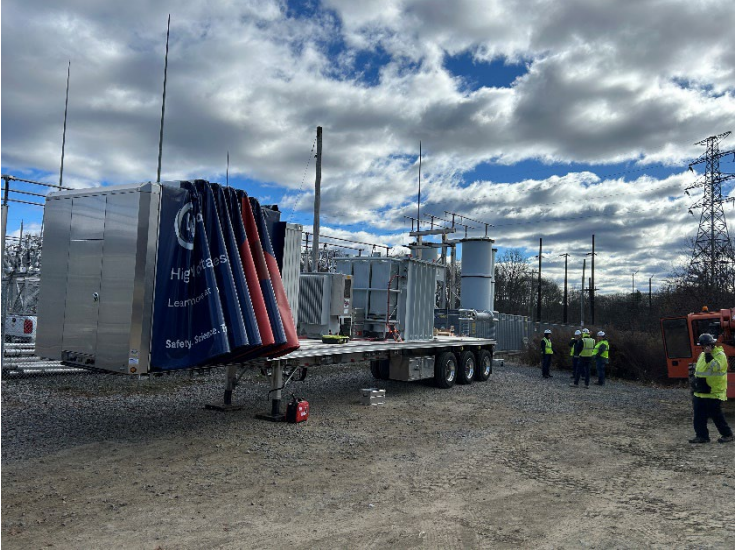
Description: View of testing trailer set up at Sudbury substation. Facing southeast.

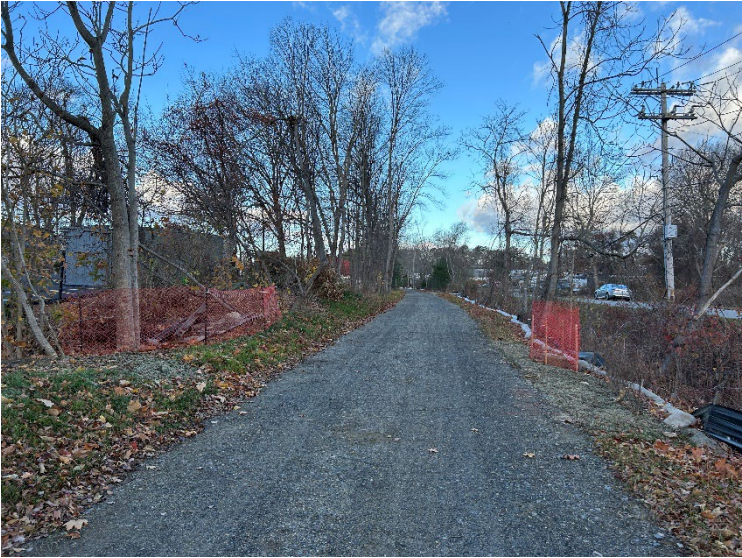
Description: View of erosion controls and construction fencing within segment 12. Facing west.

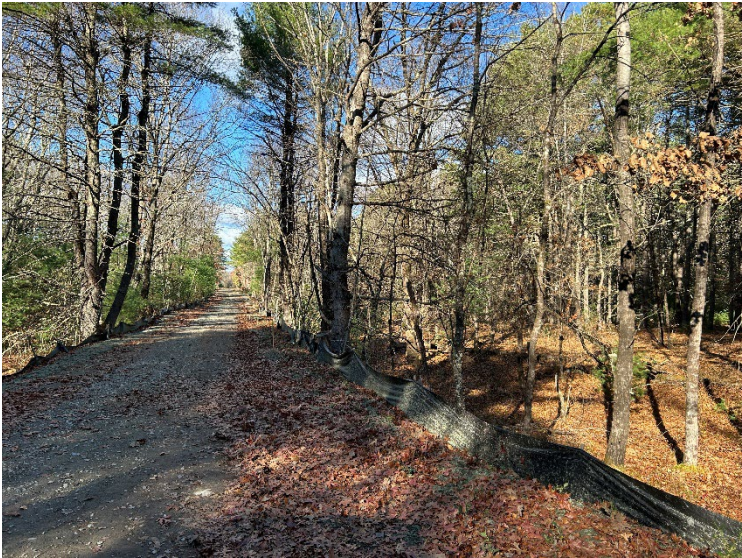
Description: View of silt fence within segment 7. Facing west.
