Environmental Monitor Construction Site Inspection Report
MassDOT Project #608164 Construction Contract # 119678
EM Report #32

Project Description: Bruce Freeman Rail Trail Right-of-Way
 Permit Description(s): Order of Conditions (MGL Chapter 131, Section 40 and 310 CMR 10.00, Mass DEP File No. 301-1362); 2022 EPA NPDES General Permit for Discharges from Construction Areas; U.S. Army Corps of Engineers Permit No NAE-2021-01975.

Project Name:	Bruce Freeman Rail Trail - Phase 2d - Sudbury
Date of Inspections:	11/19/2024
Bi Weekly/ Monthly Period Covered:	November Weekly Inspection #3
Inspector's Name(s):	Anna Haznar
Inspectors' Contact Information:	ahaznar@beta-inc.com

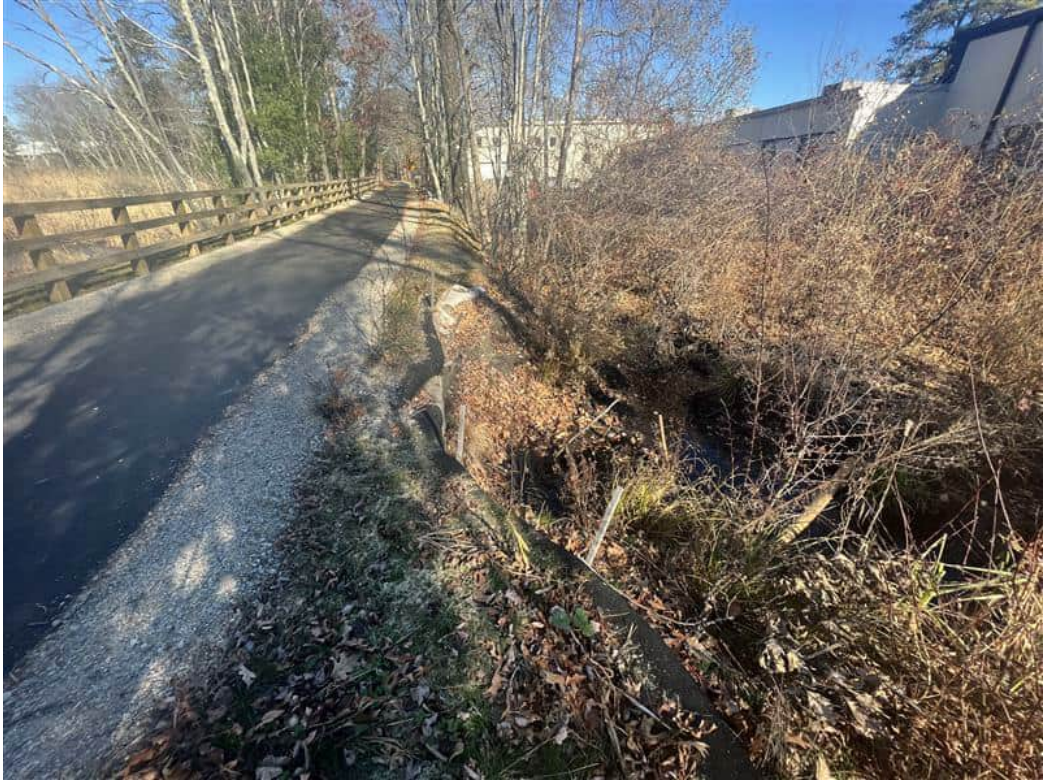
Site Location Bruce Freeman Rail Trail Right-of-Way		BETA Project No. 24.10326.23
Photo No. 1	Date: 11/19/2024

43	<p>Overtopped compost filter tubes and exposed soils beyond the limits of work at Station 105+00 Priority: High</p>	6/7/2024	6/14/2024	<p>Stabilize the area with the approved seed mixture and provide interim stabilization such as straw mulch.</p>	<p>6/14/2024 - Observation remains. 6/17/2024 - Observation remains. 6/24/2024 - Observation remains. 6/27/2024 - Observation remains. 7/8/2024 - Observation remains. 7/15/2024 - Observation remains. 7/22/2024 - Observation remains. 7/29/2024 - Observation remains. 8/5/2024 - Observation remains. 8/7/2024 - Observation remains. 8/12/2024 - Observation remains. Some material has migrated off of the compost filter tubes due to erosion. 8/16/2024 - Observation remains. 8/20/2024 - Application of the approved seed mixture is required at this location. 8/27/2024 - Observation remains. 9/3/2024 - Observation remains. 9/10/2024 - Observation remains. Application of the approved seed mixture is required at this location. 9/16/2024 - Observation remains. 9/23/2024 - Observation remains. 9/27/2024 - Observation remains. 10/4/2024 - Hydroseed has been applied here; however, the contractor should provide an update on long-term slope stabilization plans. 10/8/2024 - Observation remains. Germination has not been observed. 10/15/2024 - Observation remains. Germination has not been observed. 10/22/2024 - Observation remains. Some germination has been observed but the area is not considered stabilized. 10/29/2024 - Observation remains. No further germination has been observed since the last inspection. 11/5/2024 - Observation remains. Some germination has been observed but the area is not considered stabilized. 11/12/2024 - Observation remains. Seed has stabilized the area. 11/19/2024 - The area adjacent to the path has become stabilized; however, exposed soil is still present next to the culvert past the limit of work.</p>

Direction Photo Taken: Toward the Northeast		
Description: View of the overtopped compost filter tube beyond the limits of work at Station 105+00 per Compliance Action Item 43.		
Photo No. 2	Date: 11/19/2024

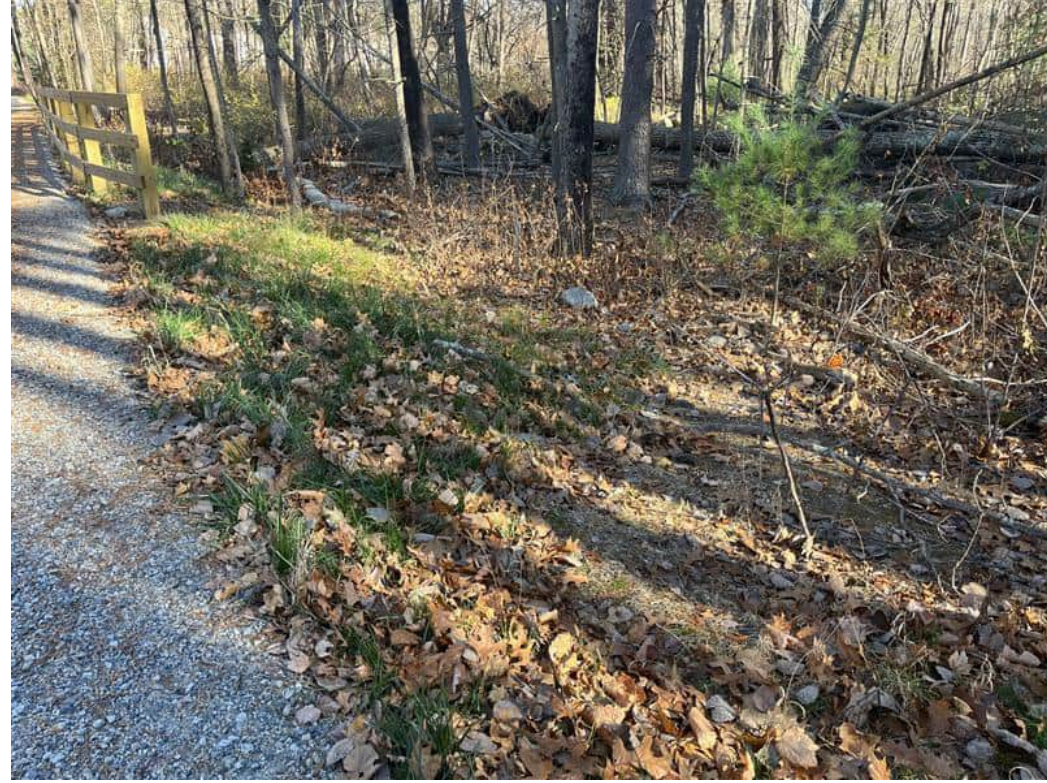
Item	Location/ Description	Observation Date	Resolution Due Date	Recommended/Discussed Resolution	Comments/Updates
59	Multiple locations of exposed soils along the Project corridor require stabilization Priority: High	9/3/2024	9/10/2024	The contractor should apply the approved seed mixture to areas of exposed soils and place straw.	<p>9/3/2024 - Herbicide application caused multiple areas along the path to be no longer stabilized. If thatch is present in these locations the thatch should be removed before seeding occurs. A location near Station 320+50 has been cleared outside of the limit of work and requires stabilization. Other areas along the path where seed did not germinate should be reseeded with the approved seed mix and straw should be placed on the areas of exposed soil.</p> <p>9/10/2024 - Observation remains, see previous update. A few locations along the trail have been hydroseeded but a majority of the locations of exposed soil require seed and stabilization.</p> <p>9/16/2024 - Observation remains. The contractor indicated areas of bare soil will be hydroseeded.</p> <p>9/23/2024 - Observation remains. It does not appear as though any hydroseeding has been done since the last inspection. Areas throughout the trail require removal of thatch and application of seed for stabilization.</p> <p>9/27/2024 - Observation remains. The contractor reached out and indicated all areas of exposed soils south of Hudson Road were hydroseeded after the inspection occurred.</p> <p>10/4/2024 - All areas south of Hudson Road were not seeded using hydroseed; hydroseed was applied in a few locations, but there are still large areas of exposed soil both south and north of Hudson Road that require seeding. Thatch was not removed in any areas before hydroseed was applied. The contractor should provide the tag from the seed mix that was used to the Conservation Commission to ensure that the required native seed mix was used per the design plans. Once vegetation has sufficiently stabilized, this item will be closed.</p> <p>10/8/2024 - Observation remains. See update from 10/4/2024. No additional hydroseed has been applied since the last inspection.</p> <p>10/15/2024 - Observation remains. See update from 10/4/2024. No additional hydroseed has been applied since the last inspection. No germination has been observed in areas where hydroseed was applied.</p> <p>10/22/2024 - Observation remains. See update from 10/4/2024. No additional hydroseed has been applied since the last inspection. Some germination has been observed in a few locations where hydroseed was previously applied.</p> <p>10/29/2024 - Observation remains. No additional hydroseed has been applied since the last inspection. If additional hydroseed is applied leaf litter and thatch should be removed so the seed can make contact with the soil. See update from 10/4/2024.</p> <p>11/5/2024 - Seed and erosion control blankets have been applied to part of the slope at Station 217+45 and seed has been applied to the exposed soil around a newly installed interpretive sign at Station 181+75. The contractor should provide the tag from the seed mix that was used to the Conservation Commission to ensure that the required native seed mix was used per the design plans. Exposed soil with little to no vegetation is still present throughout the trail.</p> <p>11/12/2024 - Observation remains. Loam and seed have been placed on an areas where crushed stone had migrated off of the path at 181+00. No additional hydroseed has been applied.</p> <p>11/19/2024 - Observation remains. Hydroseed has been applied to multiple locations along the path; however, multiple locations of exposed soil were still observed. The contractor should provide the tag from the seed mix that was used to the Conservation Commission to ensure native seed mix was used per the design plan. Seeded areas will continue to be monitored to ensure stabilization occurs before the action item is closed.</p>

Direction Photo Taken: Toward the North		
Description: View of a location at Station 166+00 that is no longer stabilized due to herbicide application per Long Term Compliance Action Item 59.

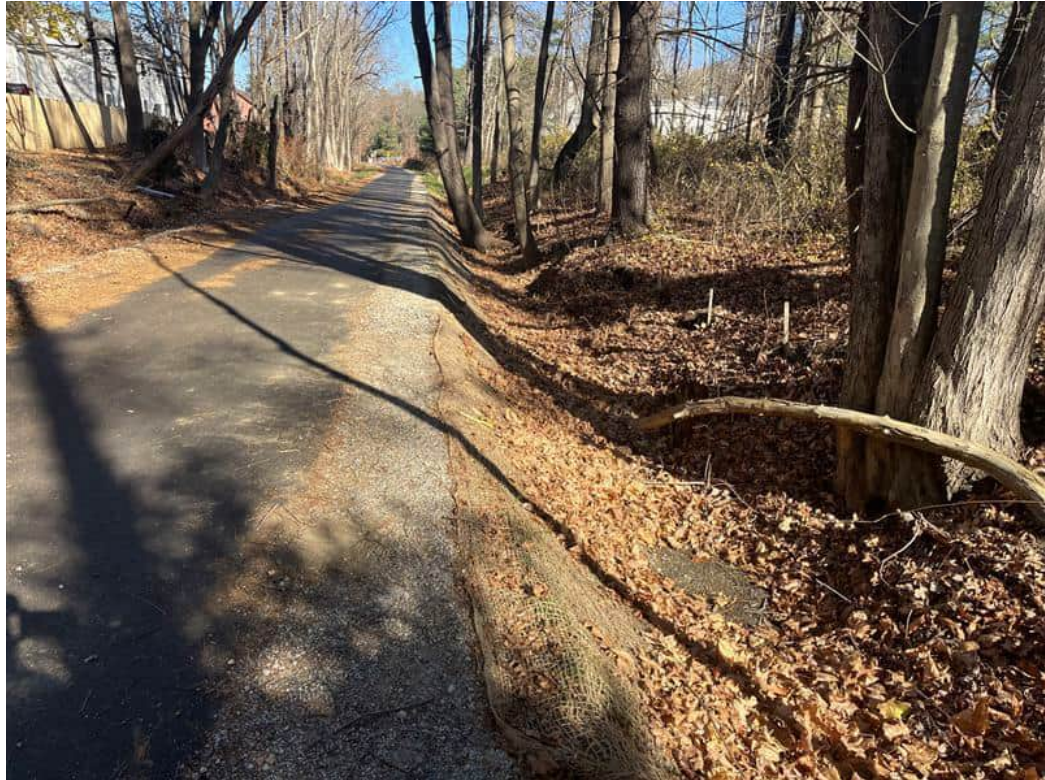
Photo No. 3 **Date:**
11/19/2024

View of an erosion control blanket and seed that were installed at Station 170+00 with no new germination.

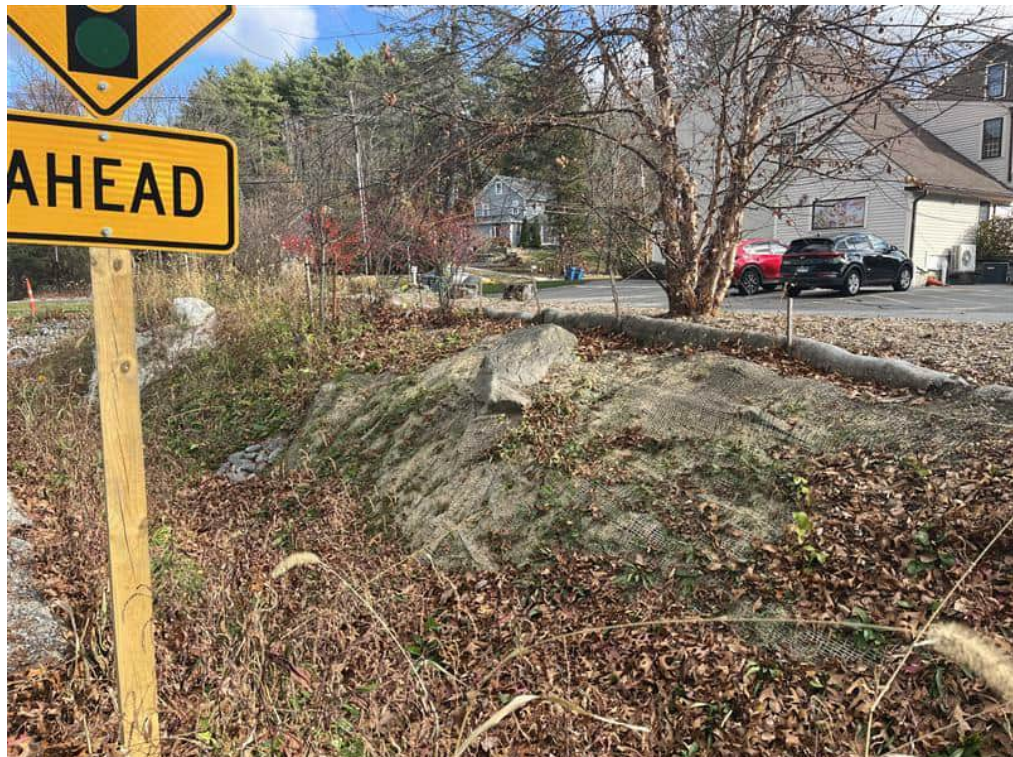
Photo No. 4 **Date:**
11/19/2024

6	Exposed sediment slope at Station 172+00 to 175+00 Priority: High	5/8/2024	5/15/2024	Install temporary sediment controls along the slope such as jute netting and/or straw following the application of seed.	<p>5/16/2024 - Observation remains.</p> <p>5/21/2024 - Observation remains.</p> <p>5/28/2024 - Partial germination was observed.</p> <p>5/31/2024 - See previous update.</p> <p>6/7/2024 - Further earthwork has occurred and soils require stabilization.</p> <p>6/14/2024 - Observation remains.</p> <p>6/17/2024 - Observation remains.</p> <p>6/24/2024 - Observation remains.</p> <p>6/27/2024 - The area has been regraded and loam has been spread. New trees have been planted upgradient of the swale. Stabilization is still required.</p> <p>7/8/2024 - Jute netting has been installed over the applied seed, and the area will be monitored for germination.</p> <p>7/15/2024 - See previous update.</p> <p>7/22/2024 - Observation remains.</p> <p>7/29/2024 - Observation remains.</p> <p>8/5/2024 - Observation remains.</p> <p>8/7/2024 - Regrowth of vegetation was observed in this location. This item will remain open until stabilization has been completed.</p> <p>8/12/2024 - Observation remains.</p> <p>8/16/2024 - Observation remains.</p> <p>8/20/2024 - Application of the approved seed mixture is required at this location.</p> <p>8/27/2024 - Observation remains.</p> <p>9/3/2024 - Vegetation that is present in this location generally consists of lady's thumb smartweed, a non-native species. Removal of non-native species and application of the approved seed mixture is required at this location.</p> <p>9/16/2024 - See previous update.</p> <p>9/23/2024 - Observation remains. See 9/3/2024 update.</p> <p>9/27/2024 - Observation remains. The contractor reached out hydroseed has been applied to this area.</p> <p>10/4/2024 - Hydroseed has been applied to this area; the hydroseed was observed to have been applied over the erosion control blanket that is located in this area. Once vegetation has sufficiently stabilized this area the item will be closed. The contractor should provide the tag from the seed mix that was used to the Conservation Commission to ensure that the required native seed mix was used per the design plans.</p> <p>10/8/2024 - Observation remains. See update from 10/4/2024.</p> <p>10/15/2024 - Observation remains. See update from 10/4/2024.</p> <p>10/22/2024 - Observation remains. See update from 10/4/2024.</p> <p>10/29/2024 - Observation remains. No germination has been observed in this location since the application of hydroseed. See update from 10/4/2024.</p> <p>11/5/2024 - Observation remains. Some germination has been observed but the area is not considered stabilized.</p> <p>11/12/2024 - Observation remains.</p> <p>11/19/2024 - Germination has been observed in this location but it has not fully stabilized.</p>

View of hydroseed with some germination along slopes at Station 172+00 to 175+00 per Compliance Action Item 6.

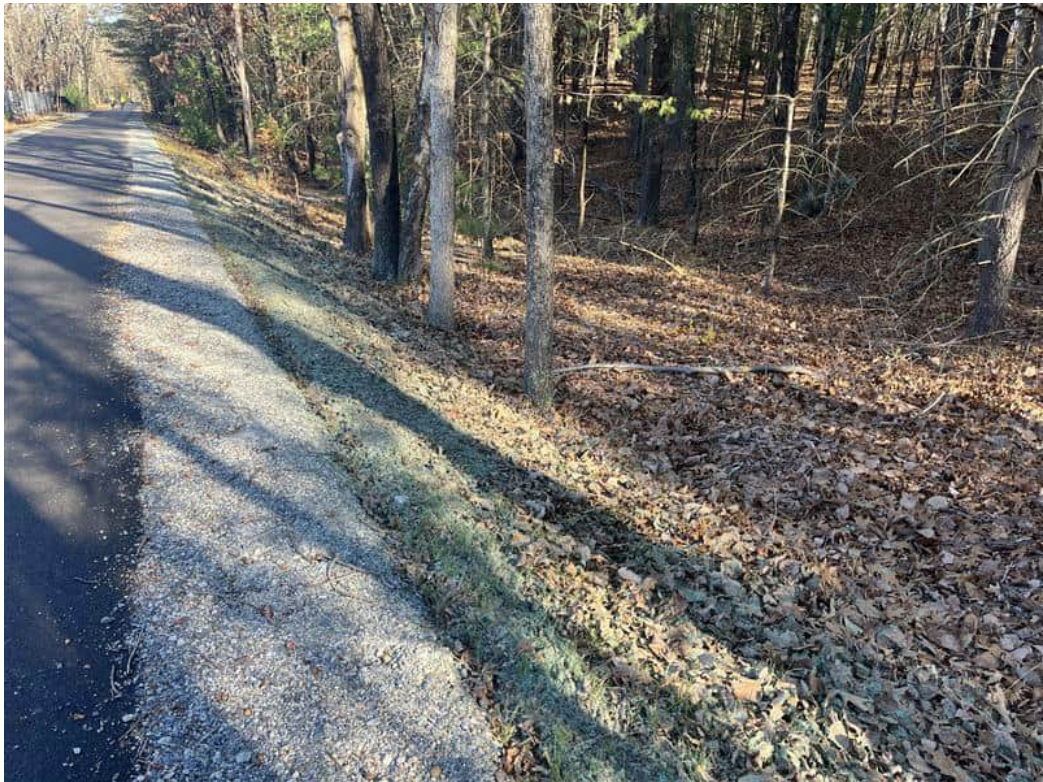
Site Location Bruce Freeman Rail Trail Right-of-Way		BETA Project No. 24.10326.23
Photo No. 5	Date: 11/19/2024	 
Direction Photo Taken: Toward the Northwest		
Description: View of another location of exposed soil due to herbicide application at Station 178+50 per Compliance Action Item 59.		
Photo No. 6	Date: 11/19/2024

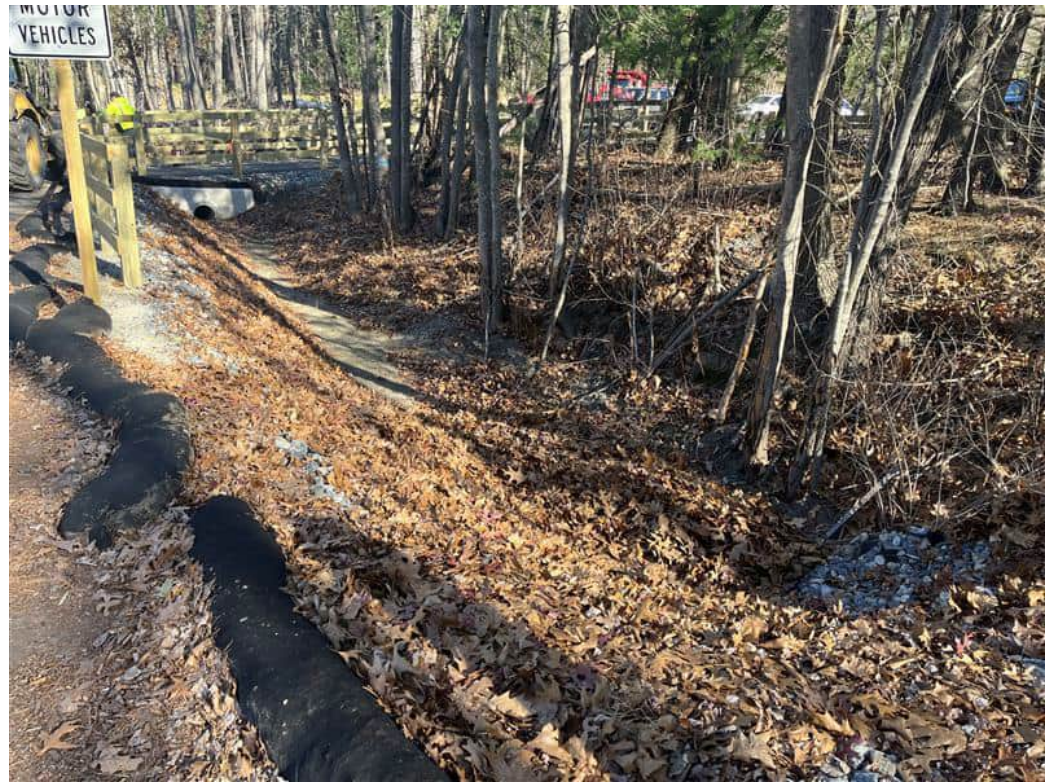
Photo No. 7 **Date:**
11/19/2024

58	<p>Crushed stone used for the dense graded crush stone shoulders has been observed as migrating both onto the path, off the sides of the path, and into the adjacent Resource Areas throughout the Project</p> <p>Priority: High</p>	8/7/2024	8/14/2024	<p>Remove all crushed stone from Resource Areas and develop a plan to cease discharges of stone.</p>	<p>8/12/2024 - Crushed stone is still present in varying amounts throughout the path and on the sides of the path.</p> <p>8/16/2024 - Observation remains.</p> <p>8/20/2024 - Crushed stone has been removed from some adjacent resource areas but is still observed as migrating onto and off of the path in multiple locations throughout the Project.</p> <p>8/27/2024 - Crushed stone has been observed as migrating from the shoulders throughout the path.</p> <p>9/3/2024 - Crushed stone was observed as migrating both onto the path and off the side of the path in multiple locations. Stone was observed to have discharged to the cattle crossing at Station 190+50 and within the streambed at Station 215+00 to 216+00. Crushed stone was observed to have been placed on the root system of a fallen tree at Station 310+00 near Bank flag #BF4-108.</p> <p>9/10/2024 - Observation remains. Crushed stone is still present within the cattle crossing, the streambed, and on the root system of the fallen tree. Crushed stone continues to migrate on to and off of the path.</p> <p>9/16/2024 - Observation remains. The contractor indicated the locations where crushed stone has migrated off the path will be hand removed and crushed stone will be swept off the path prior to the opening of the trail.</p> <p>9/23/2024 - Observation remains. It does not appear as though crushed stone that has migrated onto or off of the path has been removed in any location along the Project. More crushed stone has migrated onto the path throughout significant portions of the path.</p> <p>9/27/2024 - Observation remains. Crushed stone is still located on the side of the path and on the path in varying amounts.</p> <p>10/4/2024 - Crushed stone has been removed from multiple locations along the trail but was still observed on and on the sides of the trail in several locations.</p> <p>10/8/2024 - Observation remains. Crushed stone is still present in multiple locations on and off the sides of the path.</p> <p>10/15/2024 - Observation remains. Crushed stone is still present in multiple locations on and off the sides of the path.</p> <p>10/22/2024 - Observation remains. Crushed stone is still present in multiple locations on and off the sides of the path. The crushed stone shoulders along Station 1000+00 to 1003+00 has been moved back into the shoulders and regraded.</p> <p>10/29/2024 - Observation remains. Crushed stone is still present in multiple locations on and off the sides of the path.</p> <p>11/5/2024 - Observation remains. See previous update.</p> <p>11/12/2024 - Observation remains. Crushed stone is still present on the side of the path in multiple locations, within the streambed and drainage swale and within the cattle crossing at Station 190+50.</p> <p>11/19/2024 - Crushed stone was removed from the cattle crossing at Station 190+50. Further removal of stone is required in multiple locations along the path that are currently covered with leaf litter.</p>

View of crushed stone within the streambed at Station 215+00 per Long Term Compliance Action Item 58.

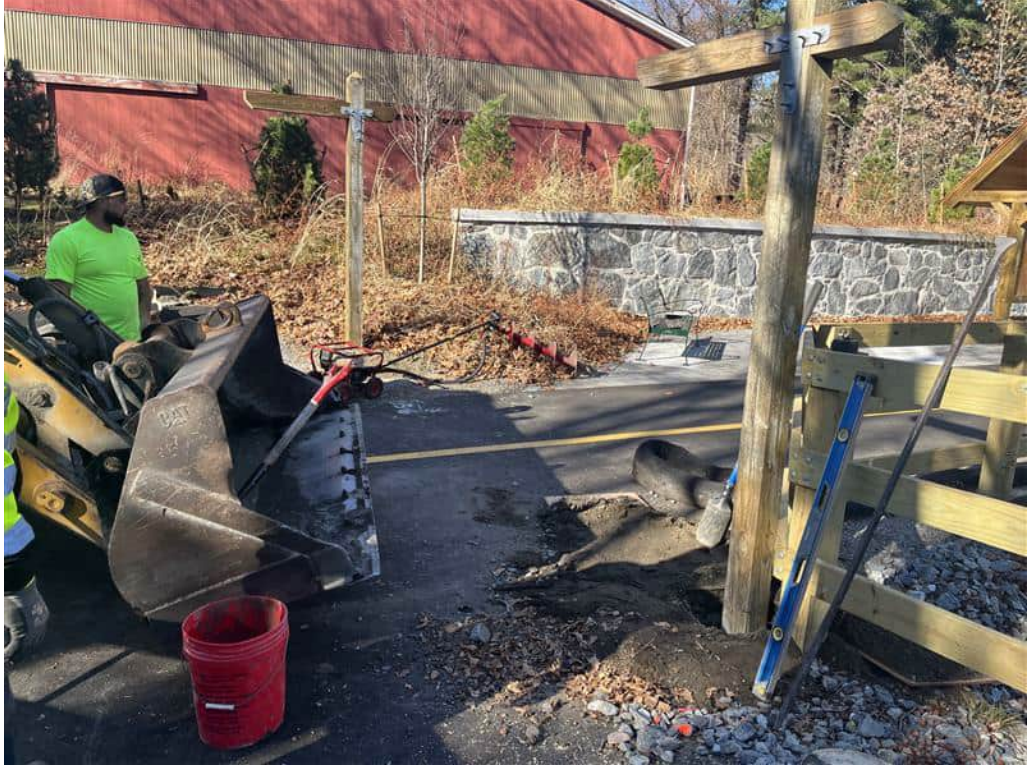
Photo No. 8 **Date:**
11/19/2024

41	Stream Bank has been regraded beyond the limit of work at Station 216+00 Priority: High	5/28/2024	6/4/2024	The Contractor should confirm if this work was permitted by the Conservation Commission, as it does not appear to be a part of the approved plans/impacts. MassDOT should be consulted on next steps regarding notification and potential restoration.	<p>5/31/2024 - Observation remains. 6/7/2024 - Observation remains. 6/14/2024 - Observation remains. 6/17/2024 - Observation remains. 6/24/2024 - Observation remains. 6/27/2024 - Observation remains. 7/8/2024 - Observation remains. 7/15/2024 - This area could not be assessed due to paving operations ongoing during the inspection. 7/22/2024 - Crushed stone and sediment continue to be discharged to the stream between Stations 215+00 and 217+00 due to overtopped and undermined compost filter tubes. 7/29/2024 - Observation remains. 8/5/2024 - Observation remains. 8/7/2024 - Observation remains. 8/12/2024 - Observation remains. Crushed stone is still present in the streambed at this location. 8/16/2024 - Observation remains. 8/20/2024 - Stone has been removed; however, additional alteration to Resource Areas beyond the limit of work continue. 8/27/2024 - Observation remains. 9/3/2024 - Observation remains. 9/10/2024 - Observation remains. Stone has been observed as discharging into the streambed in this location again. 9/16/2024 - Observation remains. 9/23/2024 - Observation remains. Stone is still present within the streambed at this location. 9/27/2024 - Observation remains. 10/4/2024 - Observation remains. 10/8/2024 - Observation remains. 10/15/2024 - Observation remains. Stone is still present within the streambed at this location. 10/22/2024 - Observation remains. Stone is still present within the streambed at this location. 10/29/2024 - Observation remains. Stone is still present within the streambed at this location. 11/5/2024 - Observation remains. The PVC pipe that was installed at this location was observed to be covered with stone and is no longer visible near Station 215+00. Stone is still present within the streambed at this location. 11/12/2024 - Observation remains. The streambed in this location is covered with leaf litter. See previous update. 11/19/2024 - Observation remains. As discussed with the Conservation Agent in the field, further coordination between the Town and MassDOT will be required to clean/repair the culvert, as the degraded condition of the culvert prompted the contractor to armor the stream banks. Further coordination will also be required for restoration of banks.</p>

View of crushed stone within the streambed and the location where the stream bank has been regraded beyond the limits of work at Station 216+00 per Long Term Compliance Action Item 41.
