Weekly Environmental Compliance Summary

Sudbury to Hudson Transmission Reliability Project (USEPA Tracking # MAR1003UW)

Week of: November 18, 2024 to November 22, 2024

CONSTRUCTION MONITORING REPORT

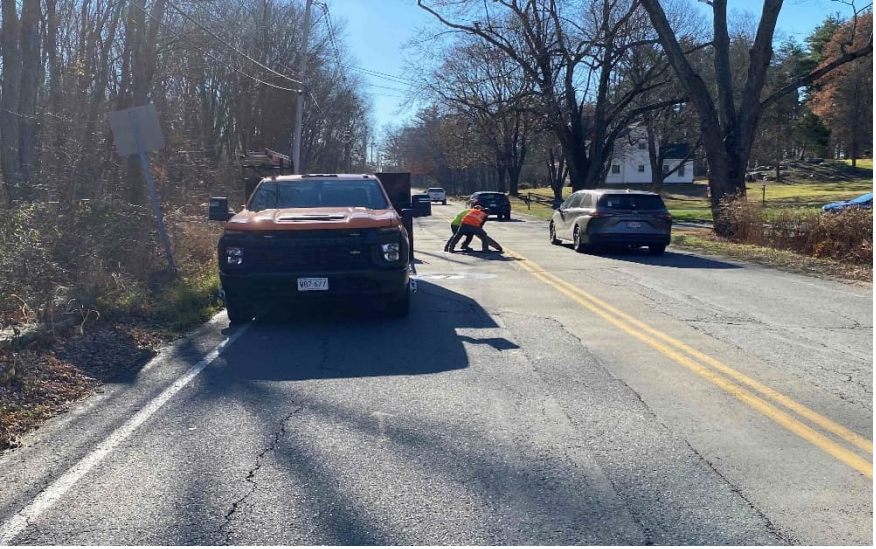
<p>PHOTOGRAPHIC LOG</p>	
<p>Client Name: Eversource</p>		<p>Site Location: Sudbury to Hudson Transmission Reliability Project</p>	<p>Town: Hudson</p>
<p>Photo No.: 8</p>	<p>Date: 11-18-24</p>

<p>Description:</p> <p>Bond conducting manhole cover replacement work at manhole #4, looking southward.</p>

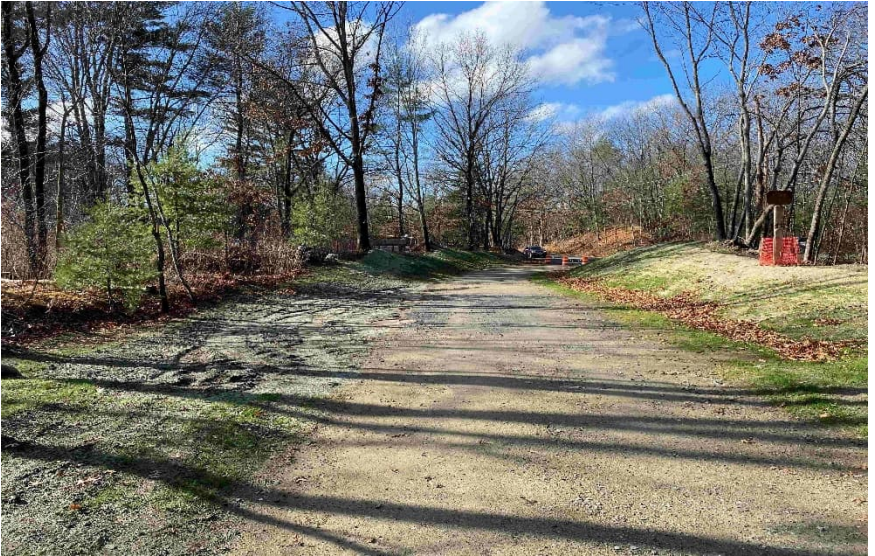
Description: Work area within segment 1, manhole #5, area recently hydro seeded & jute netting applied to slopes, existing erosion control, looking westward.

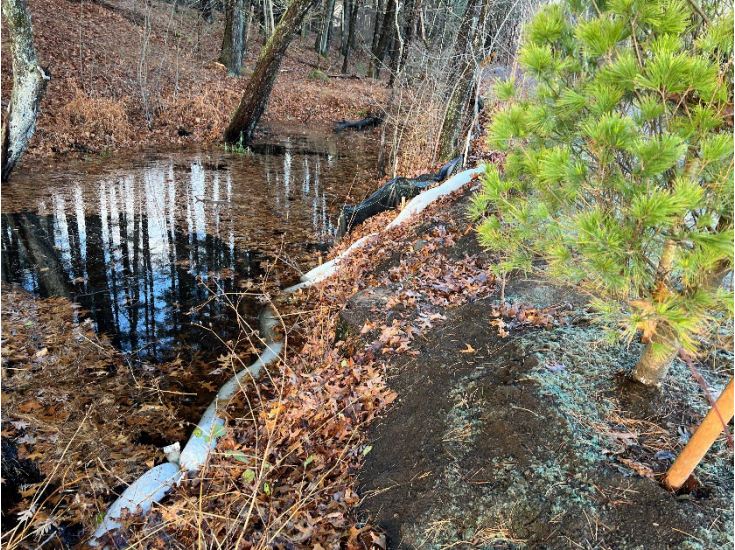
Description: View of newly installed filter tubes in segment 13 along southern side of Bridge 127. Portions of filter tubes are submerged. Facing west.

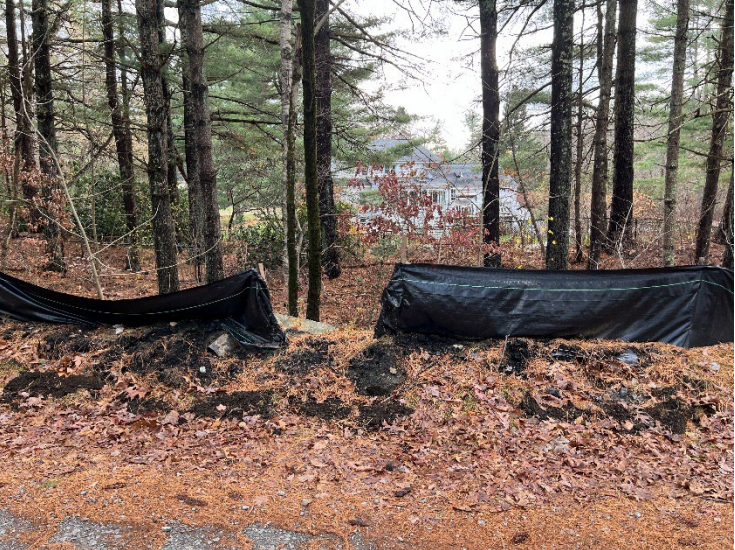
Description: View of syncopated silt fencing in need of repairs in segment 9 east of MH #19. Facing south.
