Weekly Environmental Compliance Summary

Sudbury to Hudson Transmission Reliability Project (USEPA Tracking # MAR1003UW)

Week of: November 25, 2024 to November 29, 2024

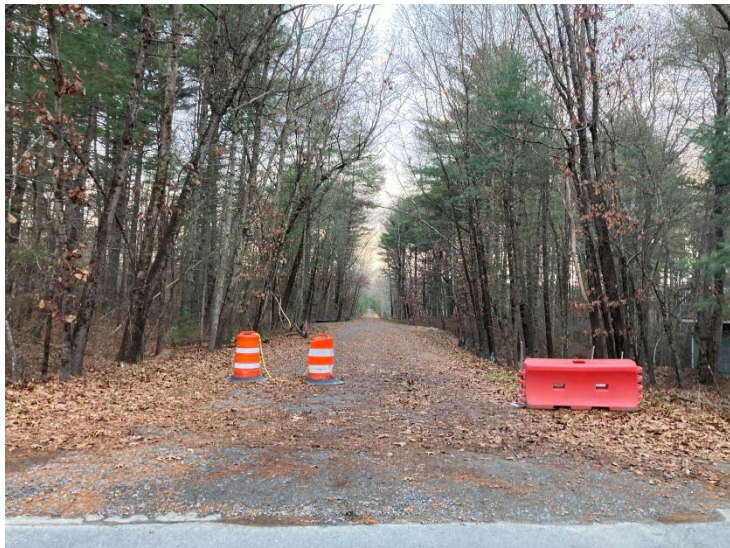
PHOTOGRAPHIC LOG	
Client Name: Eversource		Site Location: Sudbury to Hudson Transmission Reliability Project	Town: Hudson
Photo No.: 2	Date: 11/26/2024

Description: View of entrance to segment 5 off White Pond Rd. ET&L truck previously located here has been removed. Facing west.

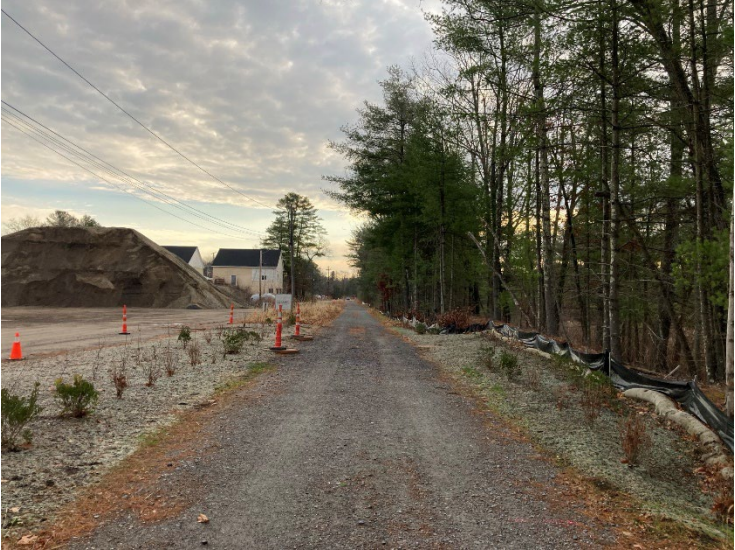
PHOTOGRAPHIC LOG	
Client Name: Eversource		Site Location: Sudbury to Hudson Transmission Reliability Project	Town: Hudson
Photo No.: 3	Date: 11/26/2024

Description: View of E&S controls and plantings at MH #8 in segment 3. Facing east.

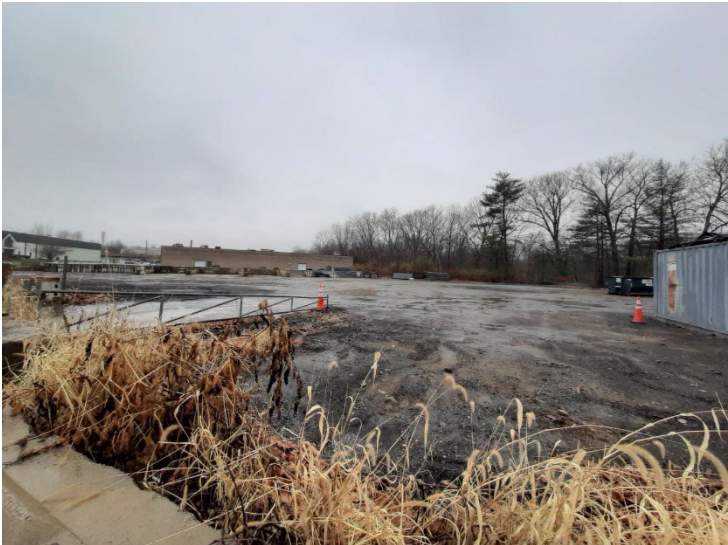
<p>PHOTOGRAPHIC LOG</p>	
<p>Client Name: Eversource</p>		<p>Site Location: Sudbury to Hudson Transmission Reliability Project</p>	<p>Town: Hudson</p>
<p>Photo No.: 6</p>	<p>Date: 11/26/2024</p>

<p>Description: View of Bonazzoli laydown yard. No activities observed at time of inspection. Facing southwest.</p>

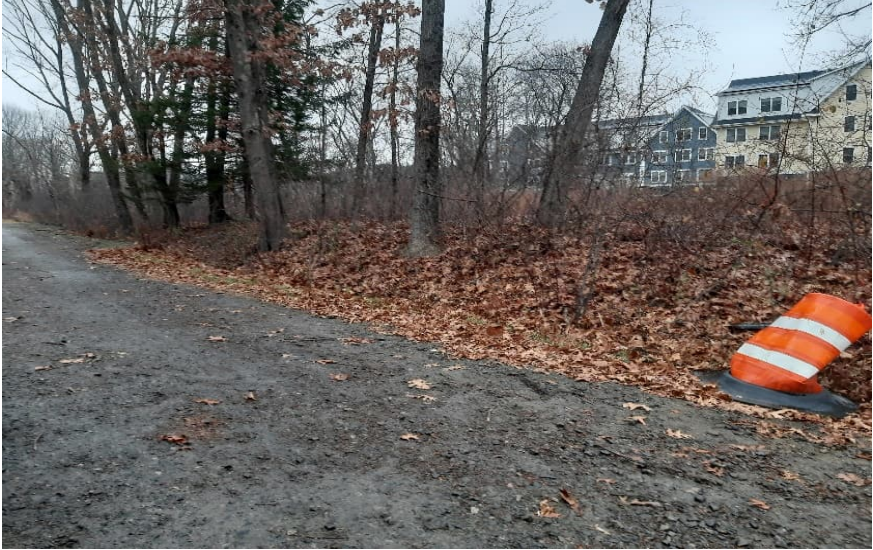
PHOTOGRAPHIC LOG	
Client Name: Eversource		Site Location: Sudbury to Hudson Transmission Reliability Project	Town: Sudbury
Photo No.: 1	Date: 11-26-24

Description: Segment 14, north side, example of area of erosion control removal previous day, looking westward.

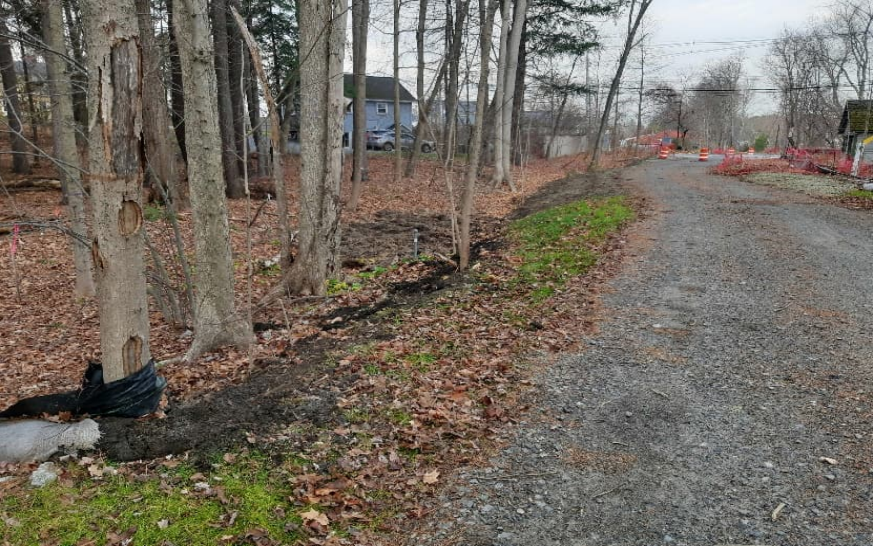
PHOTOGRAPHIC LOG	
Client Name: Eversource		Site Location: Sudbury to Hudson Transmission Reliability Project	Town: Sudbury
Photo No.: 2	Date: 11-26-24

Description: Work area within segment 13, example of area of erosion control removal previous day, existing hydroseed, looking westward.

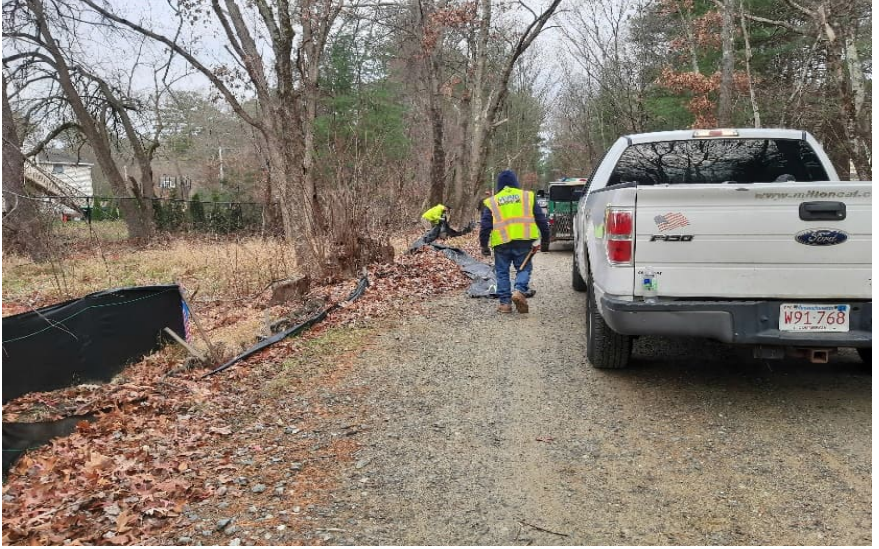
<p>PHOTOGRAPHIC LOG</p>	
<p>Client Name: Eversource</p>		<p>Site Location: Sudbury to Hudson Transmission Reliability Project</p>	<p>Town: Sudbury</p>
<p>Photo No.: 3</p>	<p>Date: 11-26-24</p>

<p>Description:</p> <p>Work area within segment 11, MON removing marked erosion controls, looking westward.</p>

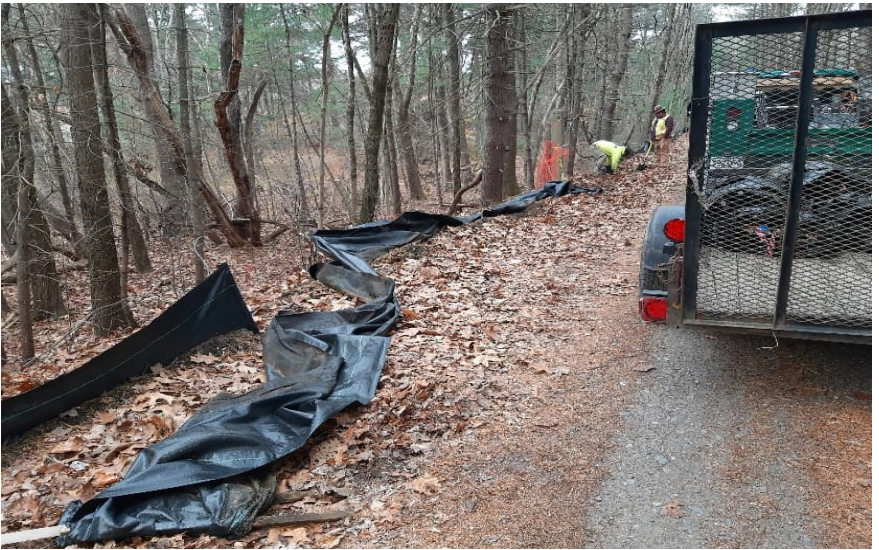
<p>PHOTOGRAPHIC LOG</p>	
<p>Client Name: Eversource</p>		<p>Site Location: Sudbury to Hudson Transmission Reliability Project</p>	<p>Town: Sudbury</p>
<p>Photo No.: 4</p>	<p>Date: 11-26-24</p>

<p>Description:</p> <p>Segment 10, MON removing marked erosion controls, looking westward.</p>

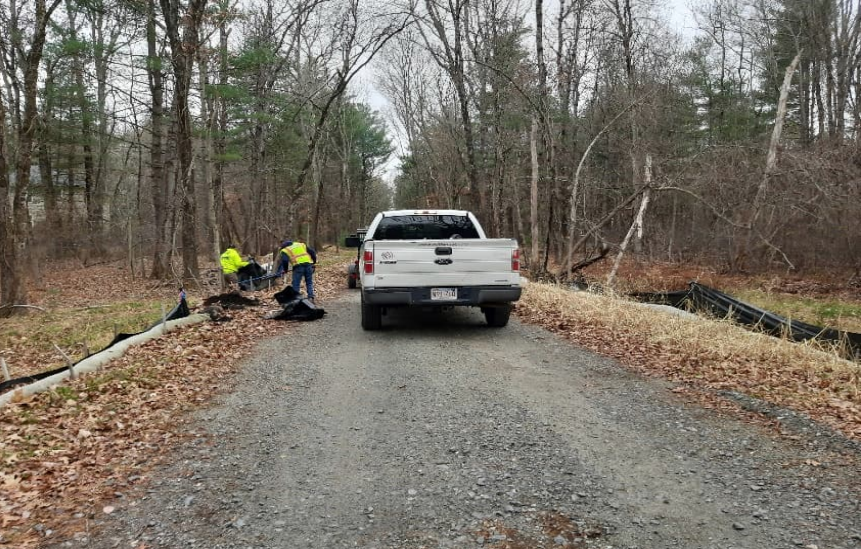
<p>PHOTOGRAPHIC LOG</p>	
<p>Client Name: Eversource</p>		<p>Site Location: Sudbury to Hudson Transmission Reliability Project</p>	<p>Town: Sudbury</p>
<p>Photo No.: 6</p>	<p>Date: 11-26-24</p>

<p>Description:</p> <p>Segment 9, MON removing marked erosion controls, looking westward.</p>

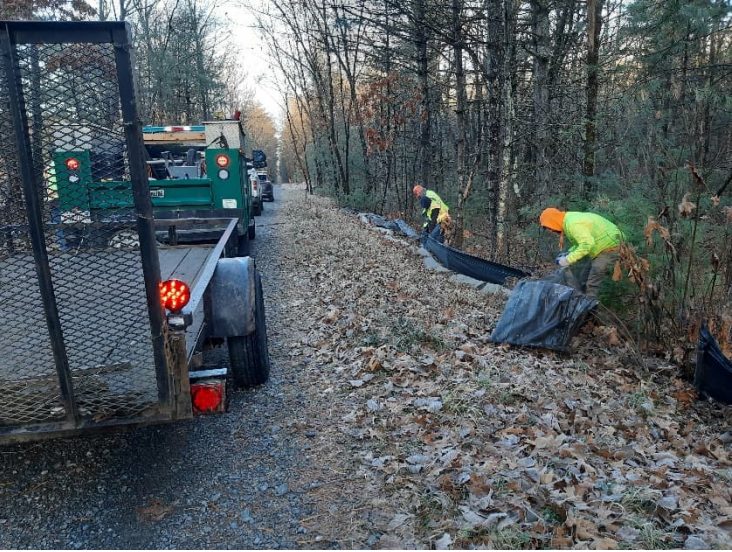
<p align="center">PHOTOGRAPHIC LOG</p>	
<p>Client Name: Eversource</p>		<p>Site Location: Sudbury to Hudson Transmission Reliability Project</p>	<p>Town: Hudson</p>
<p>Photo No.: 1</p>	<p>Date: 11-27-24</p>

<p>Description:</p> <p>Segment 5, MON removing marked erosion controls, continuing westward from end point yesterday. Looking westward.</p>

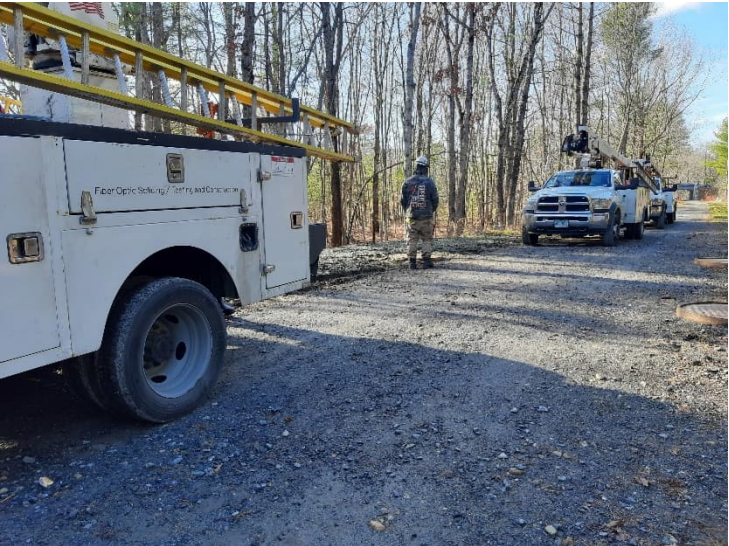
<p align="right">PHOTOGRAPHIC LOG</p>	
<p>Client Name: Eversource</p>		<p>Site Location: Sudbury to Hudson Transmission Reliability Project</p>	<p>Town: Hudson</p>
<p>Photo No.: 4</p>	<p>Date: 11-27-24</p>

<p>Description:</p> <p>Segment 2, HH #7, New Wave putting fiber optic cable in slack bags. Looking westward.</p>

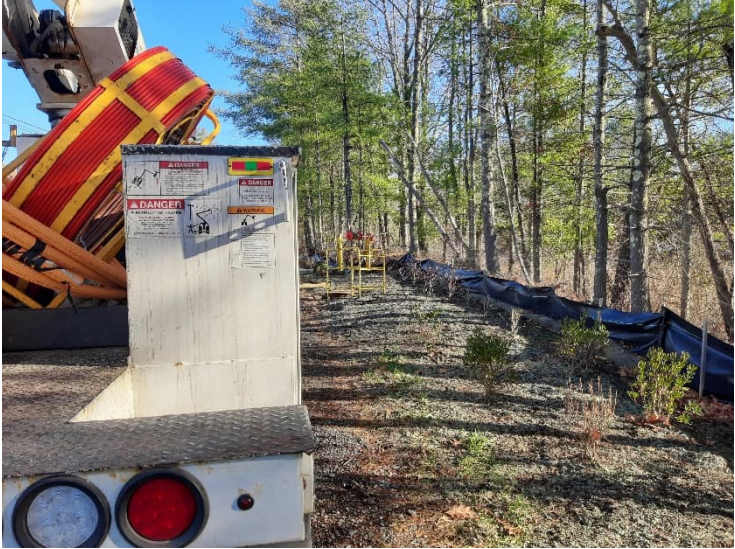
<p>PHOTOGRAPHIC LOG</p>	
<p>Client Name: Eversource</p>		<p>Site Location: Sudbury to Hudson Transmission Reliability Project</p>	<p>Town: Hudson</p>
<p>Photo No.: 5</p>	<p>Date: 11-27-24</p>

<p>Description:</p> <p>Segment 3, HH #8, New Wave putting fiber optic cable in slack bags. Looking westward.</p>

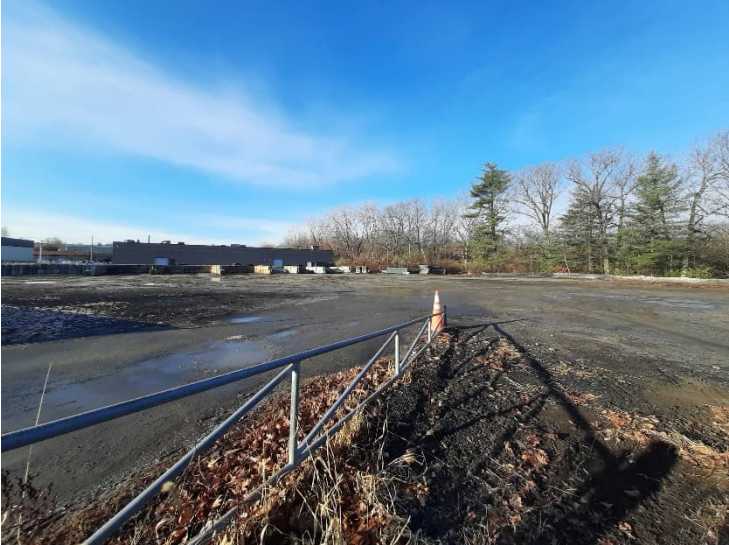
PHOTOGRAPHIC LOG	
Client Name: Eversource		Site Location: Sudbury to Hudson Transmission Reliability Project	Town: Hudson
Photo No.: 7	Date: 11-27-24

Description: Bonazzoli laydown yard, no activity observed, majority of Bond equipment demobilized, dumpster present yesterday removed. Looking westward.

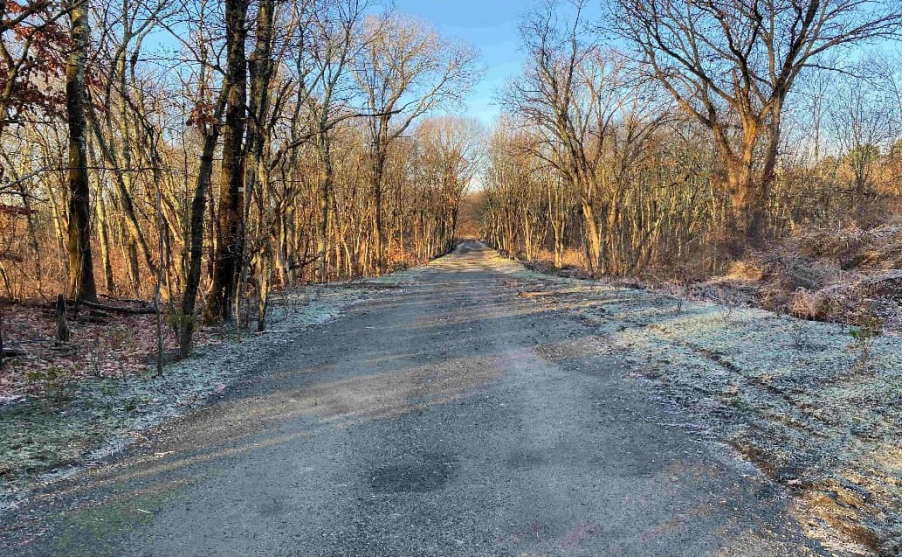
<p>PHOTOGRAPHIC LOG</p>	
<p>Client Name: Eversource</p>		<p>Site Location: Sudbury to Hudson Transmission Reliability Project</p>	<p>Town: Sudbury</p>
<p>Photo No.: 2</p>	<p>Date: 11-27-24</p>

<p>Description:</p> <p>Work area within segment 14, manhole #27, area recently planted & hydroseeded, existing erosion control, looking westward.</p>

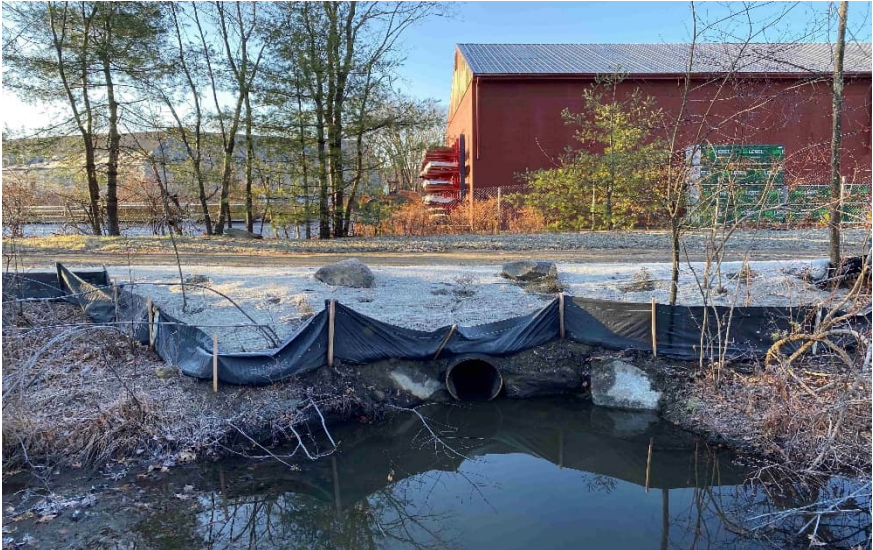
<p align="center">PHOTOGRAPHIC LOG</p>	
<p>Client Name: Eversource</p>		<p>Site Location: Sudbury to Hudson Transmission Reliability Project</p>	<p>Town: Sudbury</p>
<p>Photo No.: 3</p>	<p>Date: 11-27-24</p>

<p>Description:</p> <p>Work area within segment 12, culvert extension area, existing erosion control, looking westward.</p>

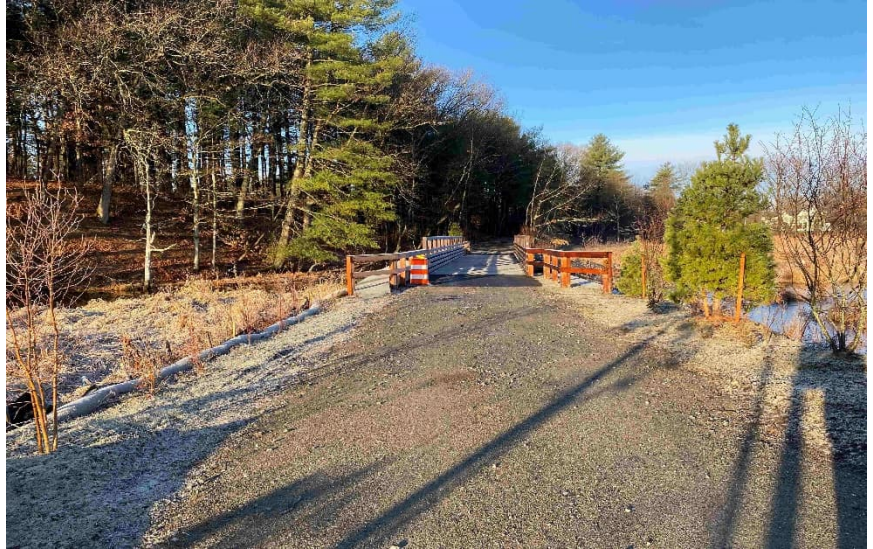
<p align="center">PHOTOGRAPHIC LOG</p>	
<p>Client Name: Eversource</p>		<p>Site Location: Sudbury to Hudson Transmission Reliability Project</p>	<p>Town: Sudbury</p>
<p>Photo No.: 4</p>	<p>Date: 11-27-24</p>

<p>Description:</p> <p>Work area within segment 14, Bridge 127, recently planted & hydroseeded, existing erosion control, looking westward.</p>

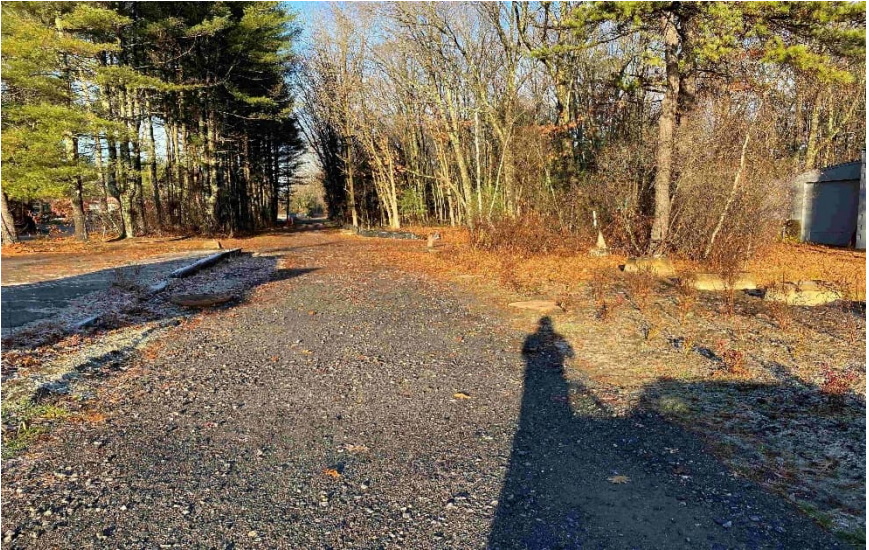
<p>PHOTOGRAPHIC LOG</p>	
<p>Client Name: Eversource</p>		<p>Site Location: Sudbury to Hudson Transmission Reliability Project</p>	<p>Town: Sudbury</p>
<p>Photo No.: 5</p>	<p>Date: 11-27-24</p>

<p>Description:</p> <p>Work area within segment 11, manhole #24, area recently planted & hydroseeded, erosion control recently removed from this area, looking westward.</p>

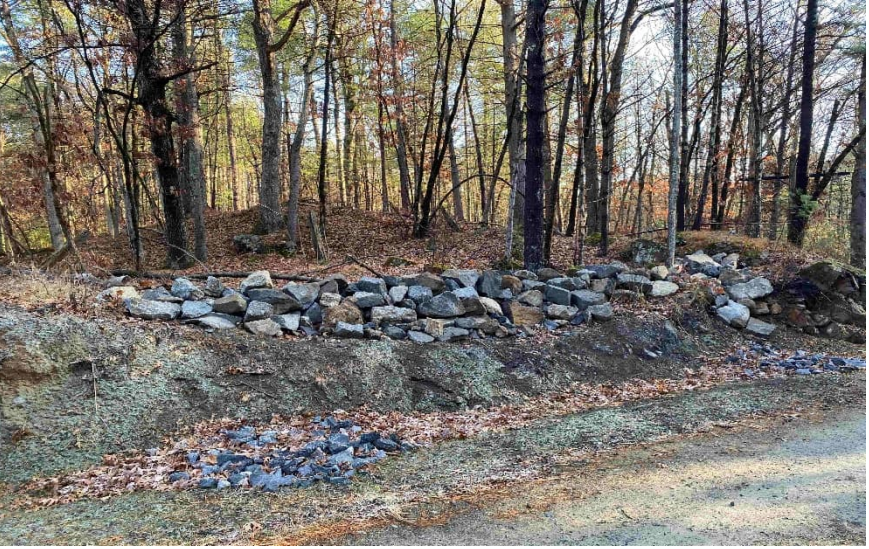
<p>PHOTOGRAPHIC LOG</p>	
<p>Client Name: Eversource</p>		<p>Site Location: Sudbury to Hudson Transmission Reliability Project</p>	<p>Town: Sudbury</p>
<p>Photo No.: 6</p>	<p>Date: 11-27-24</p>

<p>Description:</p> <p>Work area within segment 10, wildlife habitat feature recently added (rock pile), looking northward.</p>

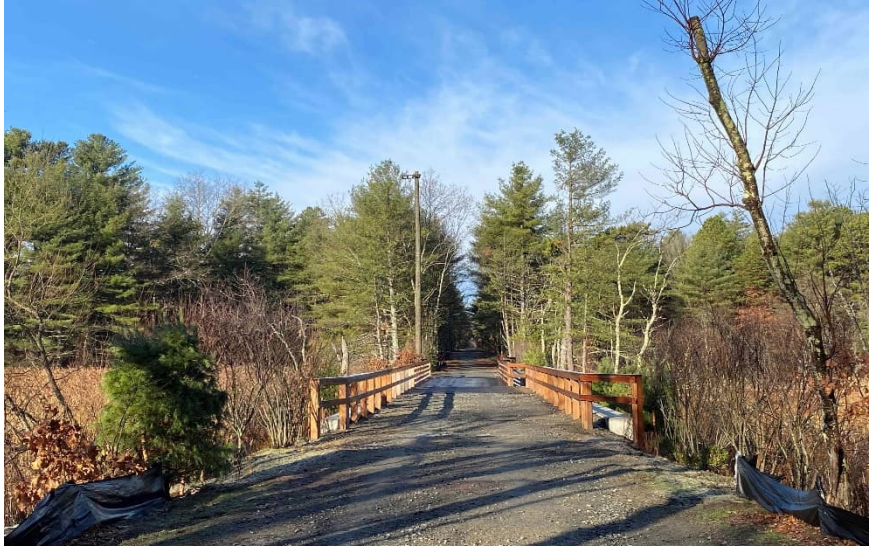
<p>PHOTOGRAPHIC LOG</p>	
<p>Client Name: Eversource</p>		<p>Site Location: Sudbury to Hudson Transmission Reliability Project</p>	<p>Town: Sudbury</p>
<p>Photo No.: 8</p>	<p>Date: 11-27-24</p>

<p>Description:</p> <p>Work area within segments 8/7, Bridge 128, Osprey platform left background, existing erosion control, looking westward.</p>

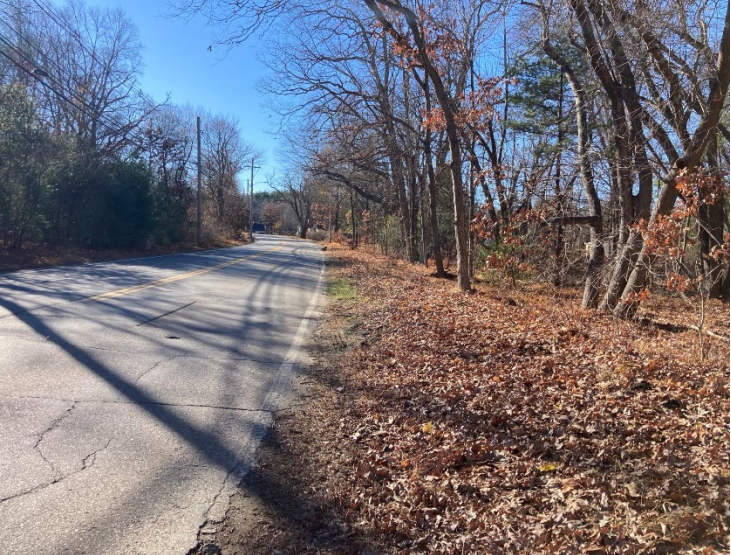
PHOTOGRAPHIC LOG	
Client Name: Eversource		Site Location: Sudbury to Hudson Transmission Reliability Project	Town: Hudson
Photo No.: 1	Date: 11-25-2024

Description: View of Wilkins St. Silt fence has been removed at this location. Facing south.

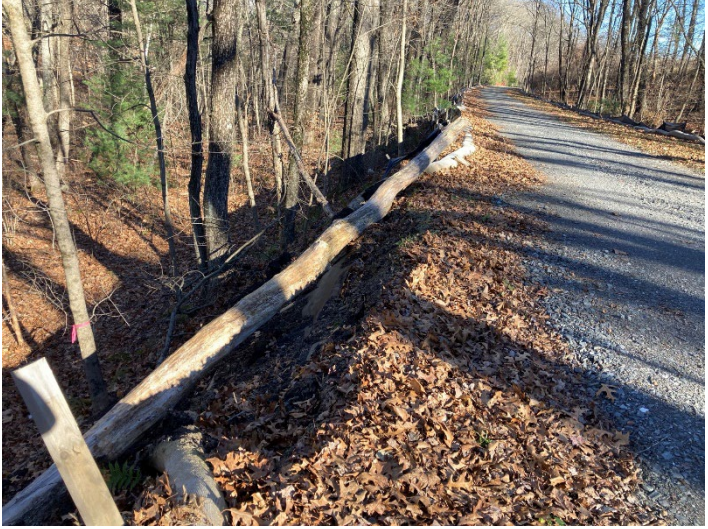
PHOTOGRAPHIC LOG	
Client Name: Eversource		Site Location: Sudbury to Hudson Transmission Reliability Project	Town: Hudson
Photo No.: 2	Date: 11-25-2024

-Tree has fallen at west end of segment 1 and damaged E&S controls. Site wide silt fence repairs are anticipated to take place in the next couple of weeks.

Description: View of damaged E&S controls where tree has fallen at west end of segment 1. Facing east.

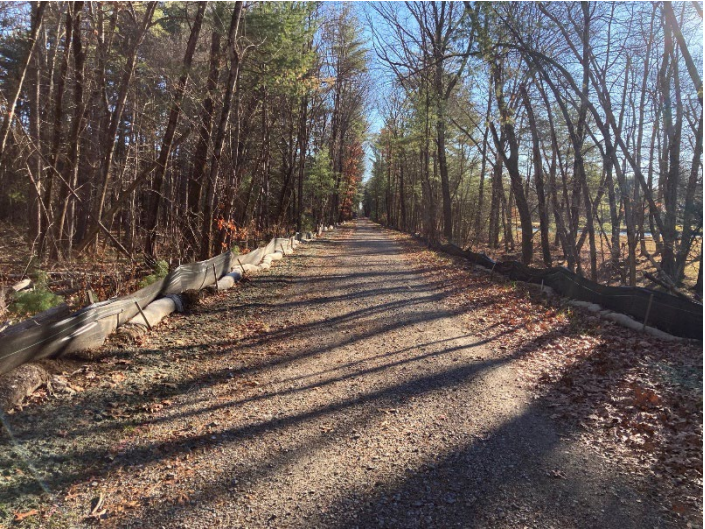
Epsilon ASSOCIATES INC.		PHOTOGRAPHIC LOG	
Client Name: Eversource		Site Location: Sudbury to Hudson Transmission Reliability Project	Town: Hudson
Photo No.: 4	Date: 11-25-2024

Description: View of E&S controls in segment 4. Facing east.

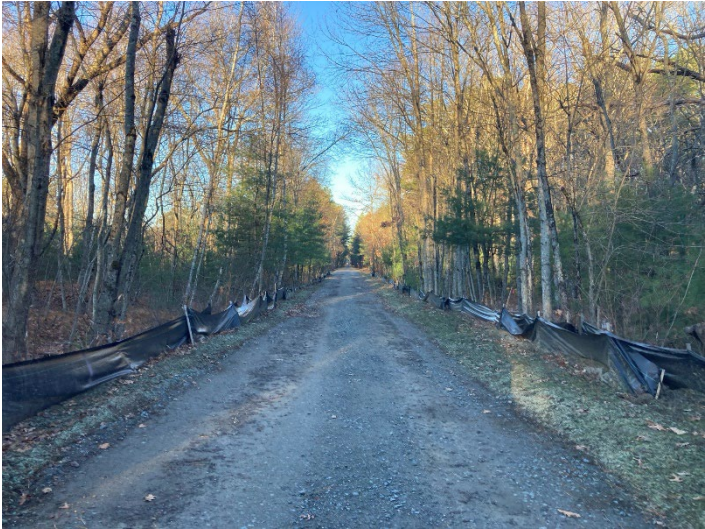
Epsilon ASSOCIATES INC.		PHOTOGRAPHIC LOG	
Client Name: Eversource		Site Location: Sudbury to Hudson Transmission Reliability Project	Town: Hudson
Photo No.: 6	Date: 11-25-2024

Description: View of E&S controls in segment 6. Facing west.

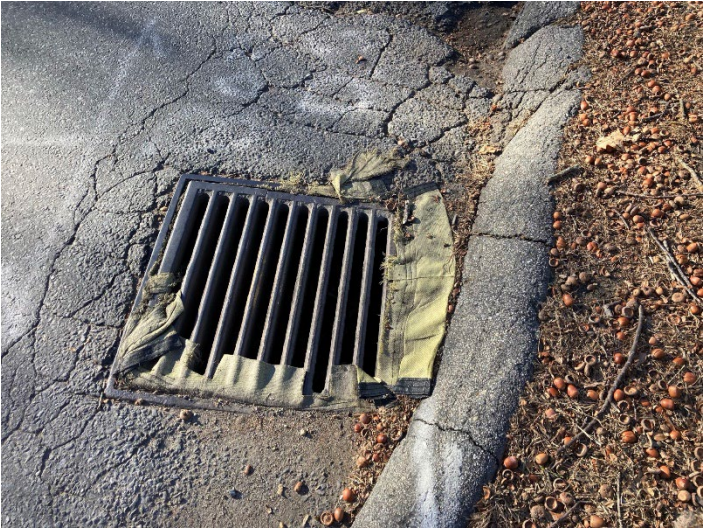
Epsilon ASSOCIATES INC.		PHOTOGRAPHIC LOG	
Client Name: Eversource		Site Location: Sudbury to Hudson Transmission Reliability Project	Town: Hudson
Photo No.: 7	Date: 11-25-2024

Description: View of silt sack inlet protection that remains installed at intersection of Forest Ave and Bonazzoli Ave. All silt sacks should be removed now that construction activities are complete.

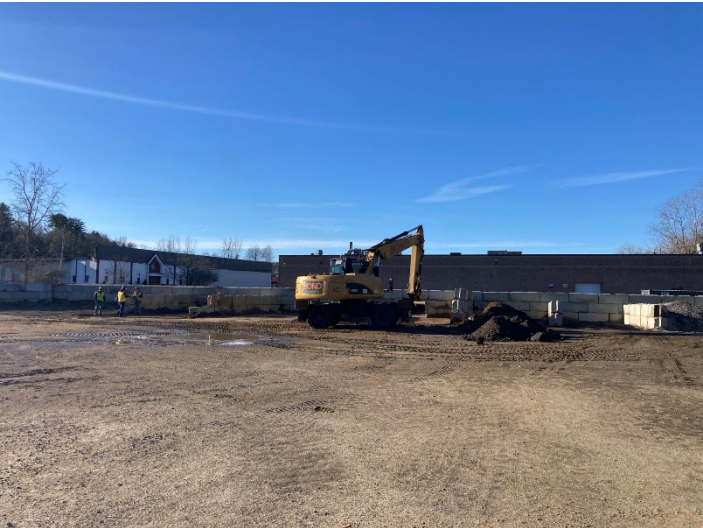
Epsilon ASSOCIATES INC.		PHOTOGRAPHIC LOG	
Client Name: Eversource		Site Location: Sudbury to Hudson Transmission Reliability Project	Town: Hudson
Photo No.: 8	Date: 11-25-2024

Description: View of Bond's clean-up activities at Bonazzoli laydown yard. Facing southwest.

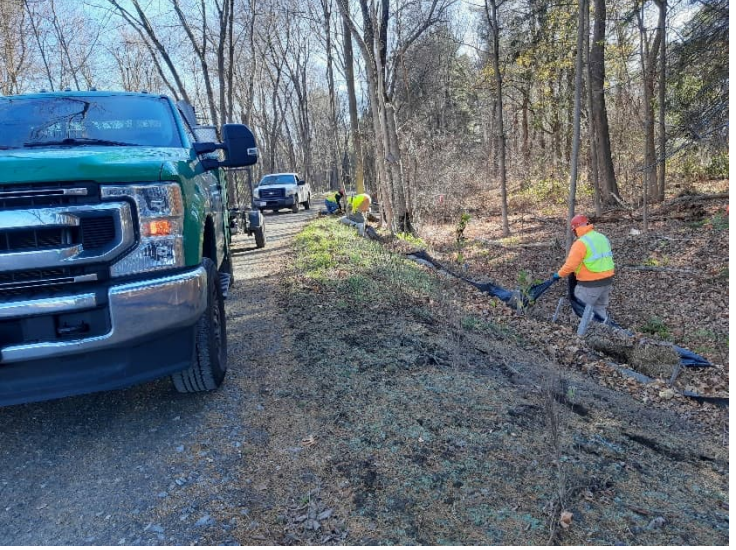
PHOTOGRAPHIC LOG	
Client Name: Eversource		Site Location: Sudbury to Hudson Transmission Reliability Project	Town: Sudbury
Photo No.: 2	Date: 11-25-24

Description: Work area within segment 13, MON removing marked erosion controls, prior plantings noted, looking eastward.

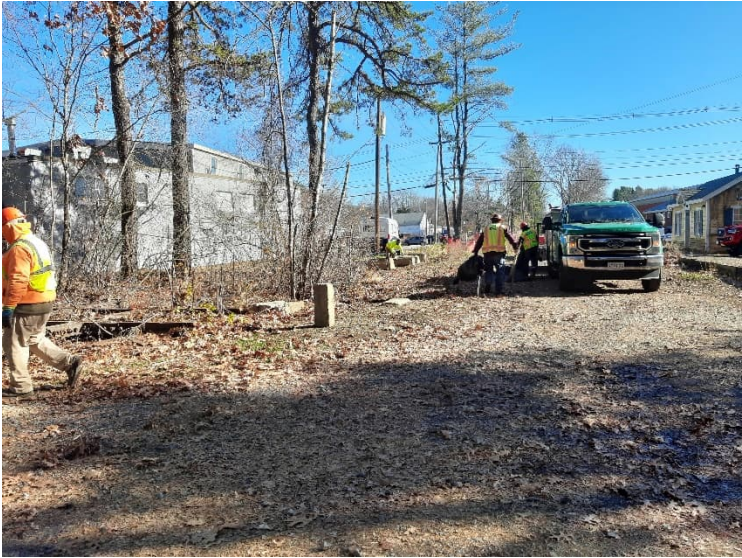
PHOTOGRAPHIC LOG	
Client Name: Eversource		Site Location: Sudbury to Hudson Transmission Reliability Project	Town: Sudbury
Photo No.: 3	Date: 11-25-24

Description: Work area within segment 11, MON removing marked erosion controls, looking eastward.

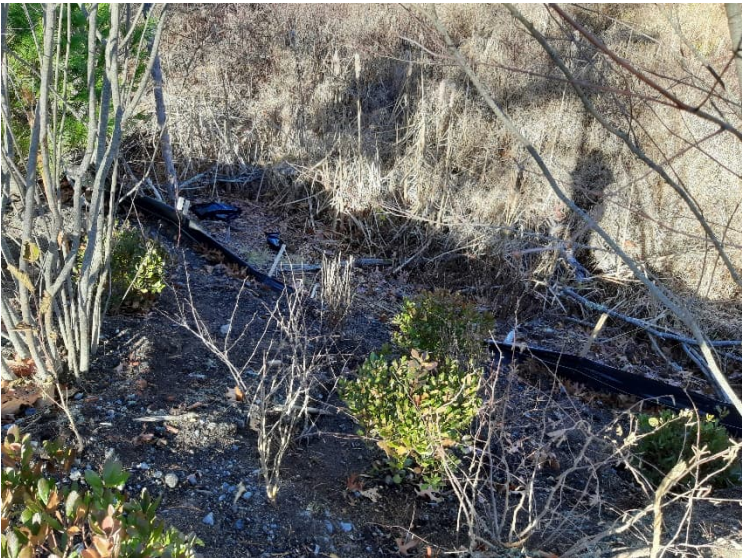
PHOTOGRAPHIC LOG	
Client Name: Eversource		Site Location: Sudbury to Hudson Transmission Reliability Project	Town: Sudbury
Photo No.: 4	Date: 11-25-24

Description: Work area within Segment 7, northwest side of Bridge 128, accumulated soil along silt fence. Sitewide silt fence maintenance pending. Looking northwestward.

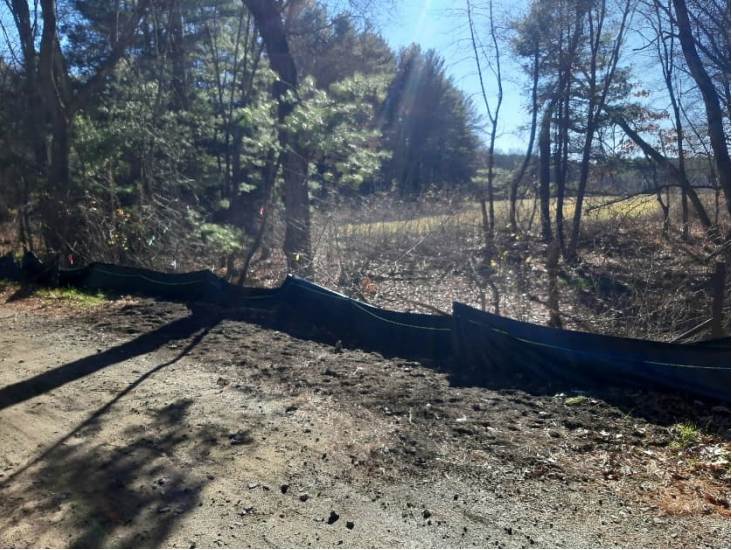
PHOTOGRAPHIC LOG	
Client Name: Eversource		Site Location: Sudbury to Hudson Transmission Reliability Project	Town: Sudbury
Photo No.: 5	Date: 11-25-24

Description: Work area within Segment 11, south shoulder, ~300' east of Horse Pond Road, patch of bare soil at stump removal location. A similar patch is present on north side of ROW. Hydroseeding to resume in Spring 2025. Looking southeastward.
