Weekly Environmental Compliance Summary

Sudbury to Hudson Transmission Reliability Project (USEPA Tracking # MAR1003UW)

Week of: December 2, 2024 to December 7, 2024

CONSTRUCTION MONITORING REPORT

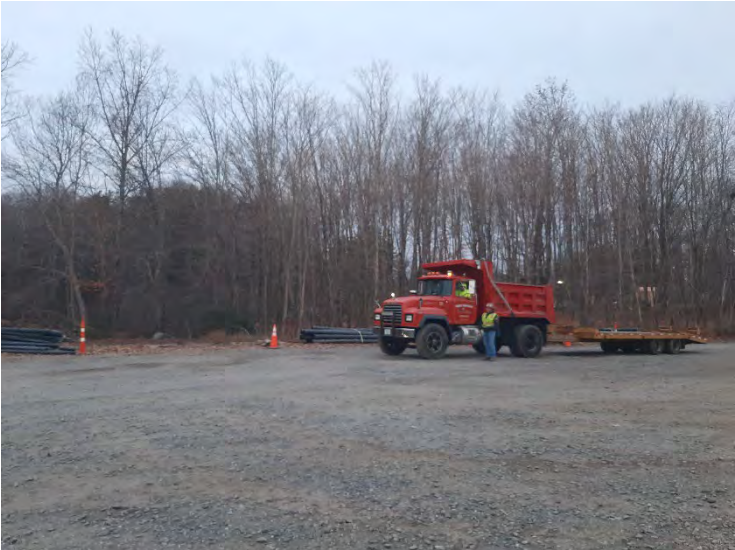
<p>Description:</p> <p>188 Central Street, Bond removing equipment, remaining conduit bundles, looking westward.</p>

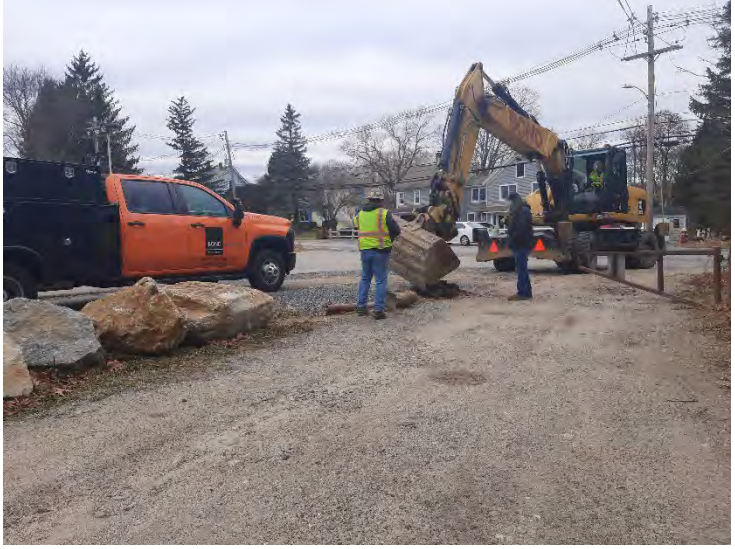
<p>Description:</p> <p>Hudson Light & Power, near Manhole #1 (MH1), Bond repairing damaged post, looking northward.</p>

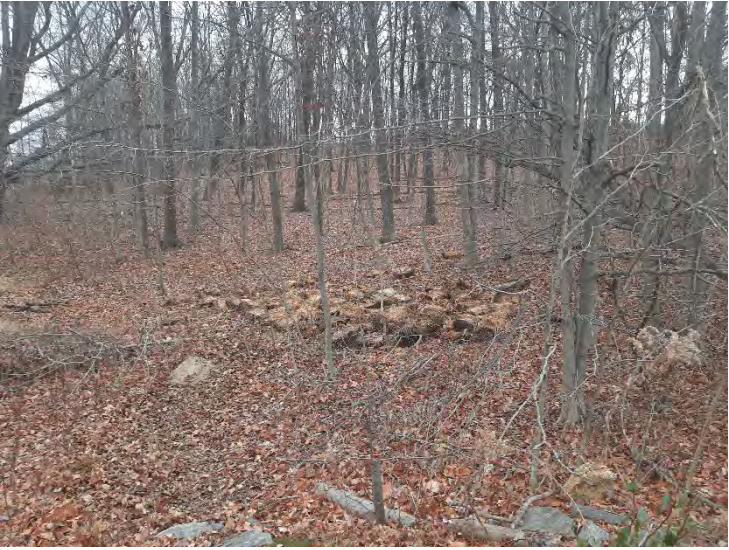
<p>Description:</p> <p>Hudson Light & Power, adjacent to MH1, former MH1 dewatering corral following deconstruction, looking eastward.</p>

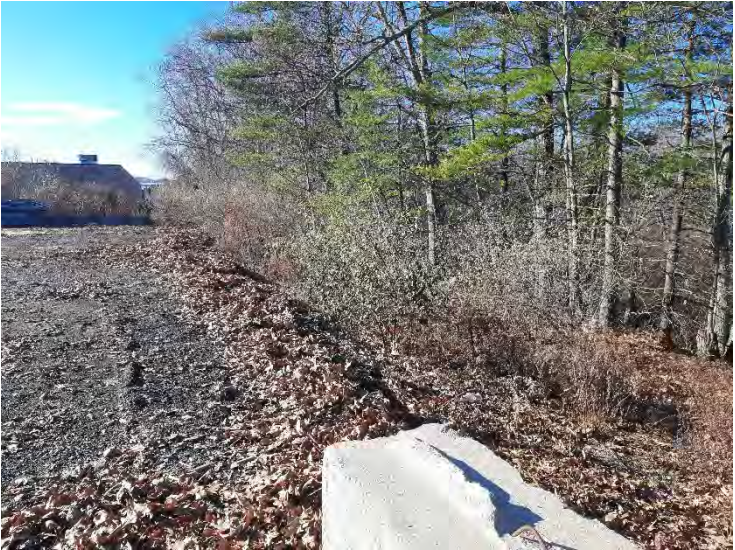
<p>Description:</p> <p>Former Bonazzoli Ave laydown yard, post silt fence removal, laydown yard closed out. Looking southward.</p>

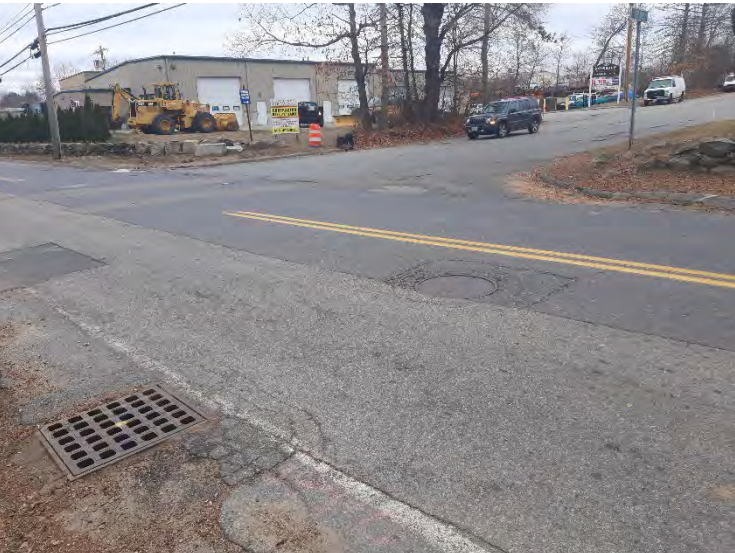
<p>Description:</p> <p>Forest Ave, between MH1 and MH2 at intersection with Bonazzoli Ave, storm drains after silt sack removal, looking northward.</p>

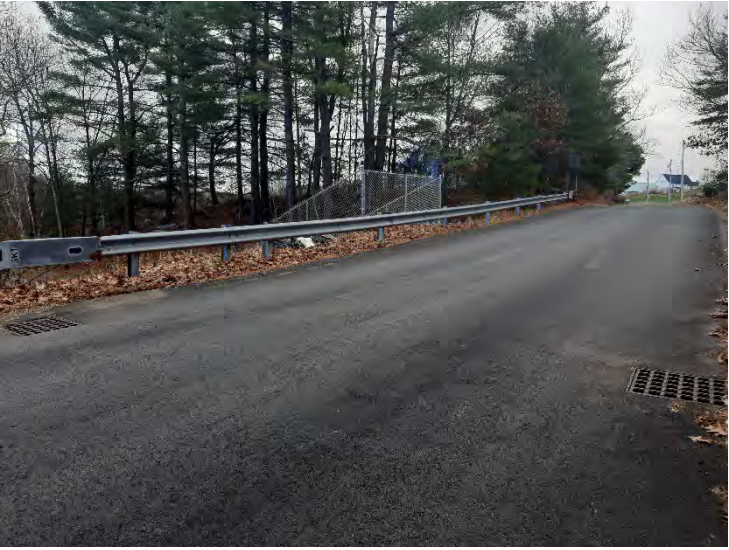
Description: Chestnut Ave over ROW, adjacent to Segment 1/Segment 2 boundary, storm drains after silt sack removal, looking northward.

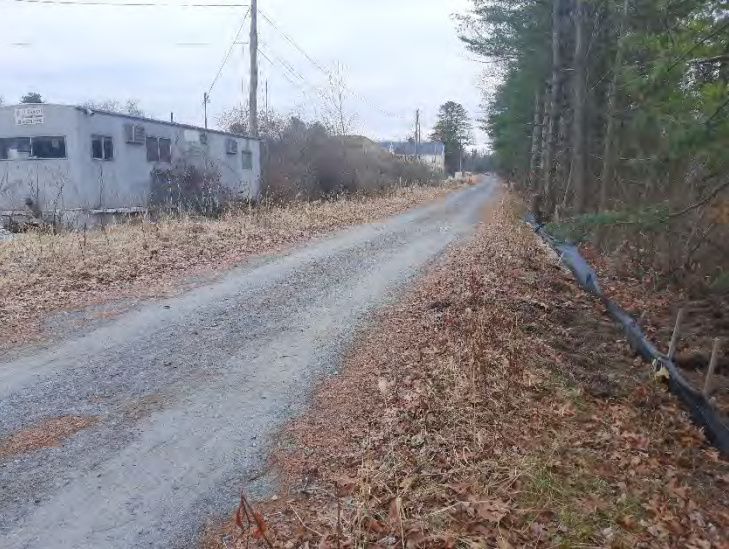
Description: Segment 3, near MH8, former location of MH8 dewatering corral following removal, existing erosion controls. Looking eastward.

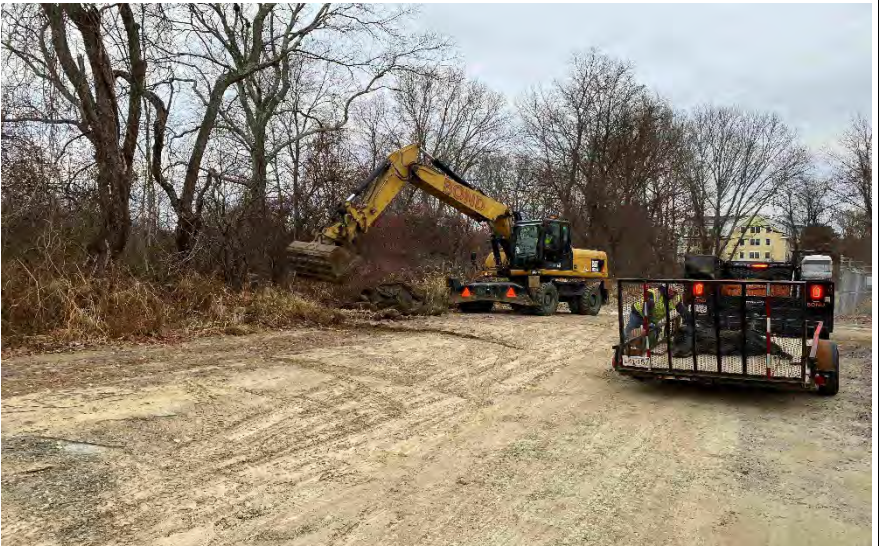
Description: Bond removing the dewatering corral near manhole #28, looking northward.

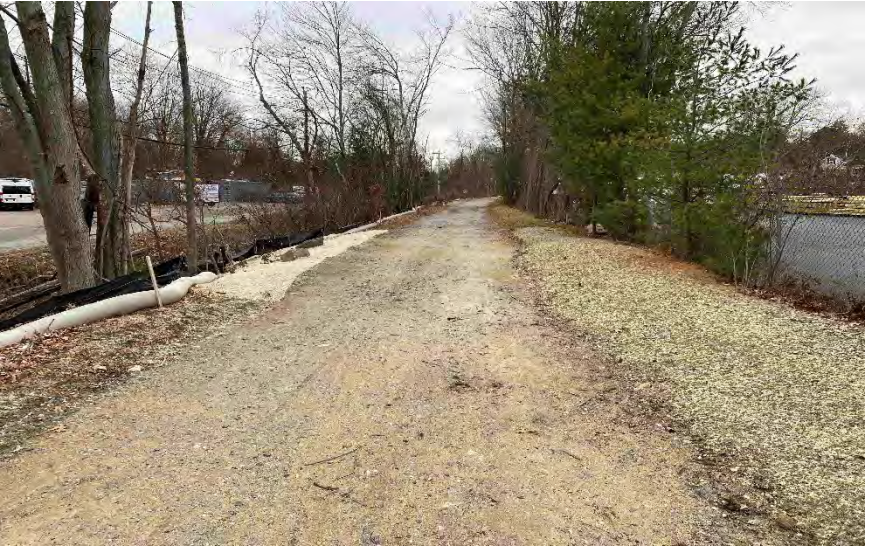
<p>Description:</p> <p>Work area within segment 12, culvert extension area, area recently planted & hydro seeded, existing erosion control, looking eastward.</p>

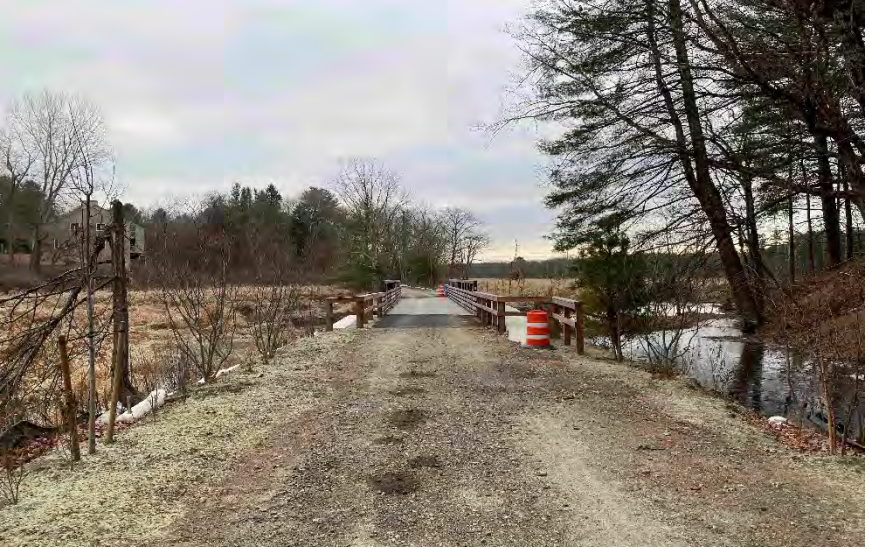
<p>Description:</p> <p>Work area within segment 13, Bridge 127, recently planted & hydroseeded, existing erosion control, looking eastward.</p>

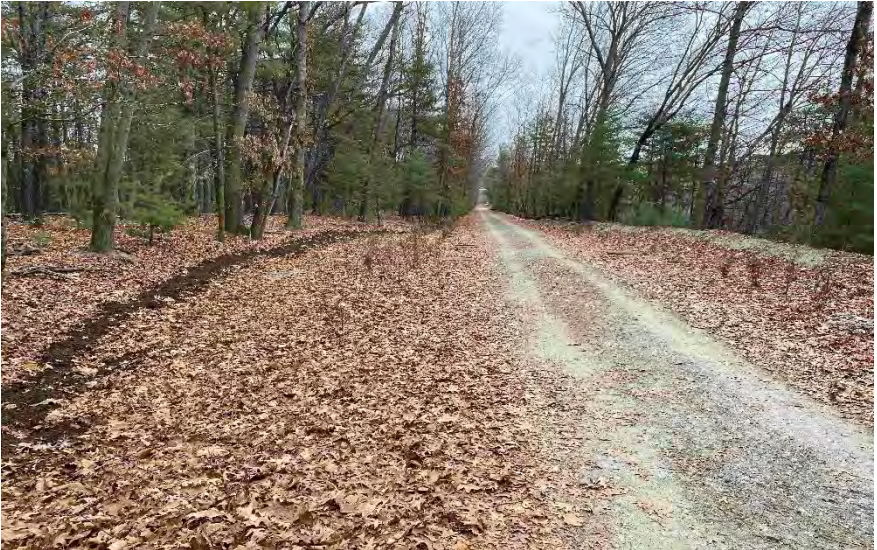
<p>Description:</p> <p>Work area within segment 11, manhole #23, area recently planted & hydroseeded, erosion control recently removed from this area, looking eastward.</p>

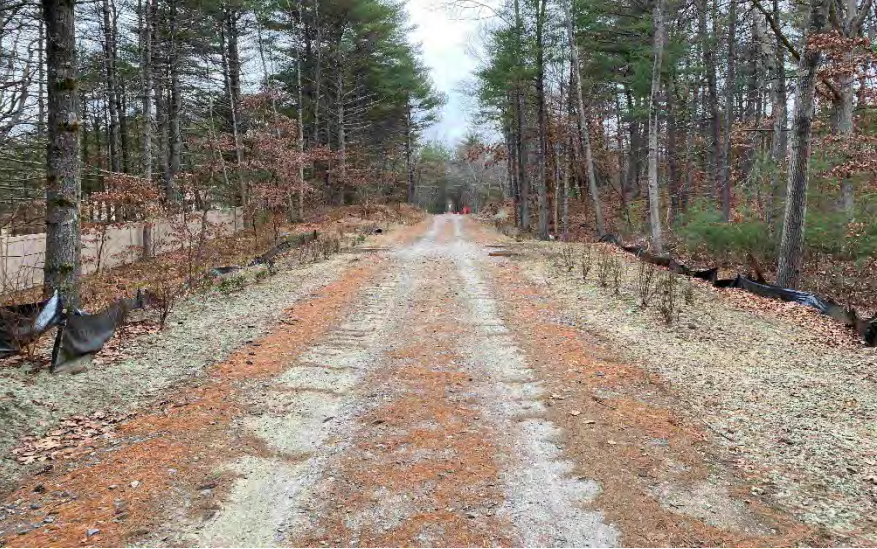
<p>Description:</p> <p>Work area within segment 10, manhole #20 area, recently planted & hydro seeded, existing erosion control, looking westward.</p>

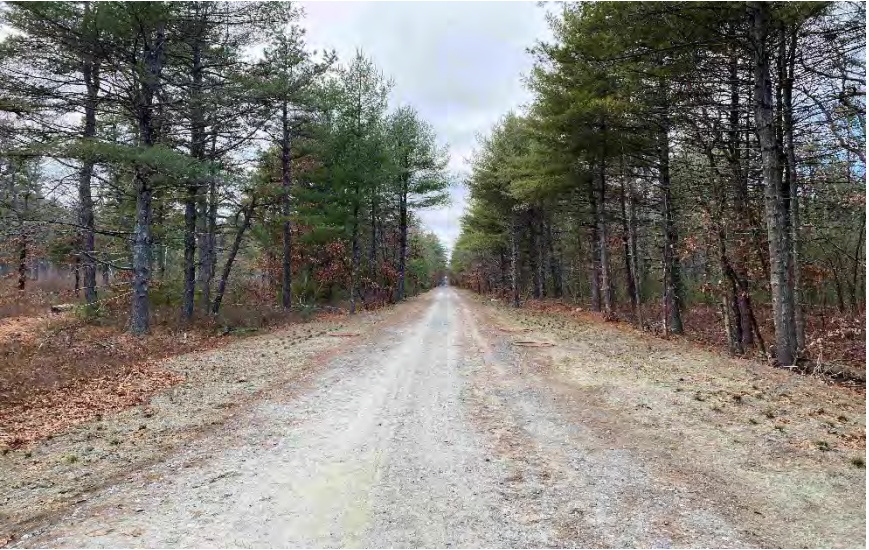
<p>Description:</p> <p>Work area within segment 7, manhole #16 area, recently planted & hydroseeded, looking westward.</p>

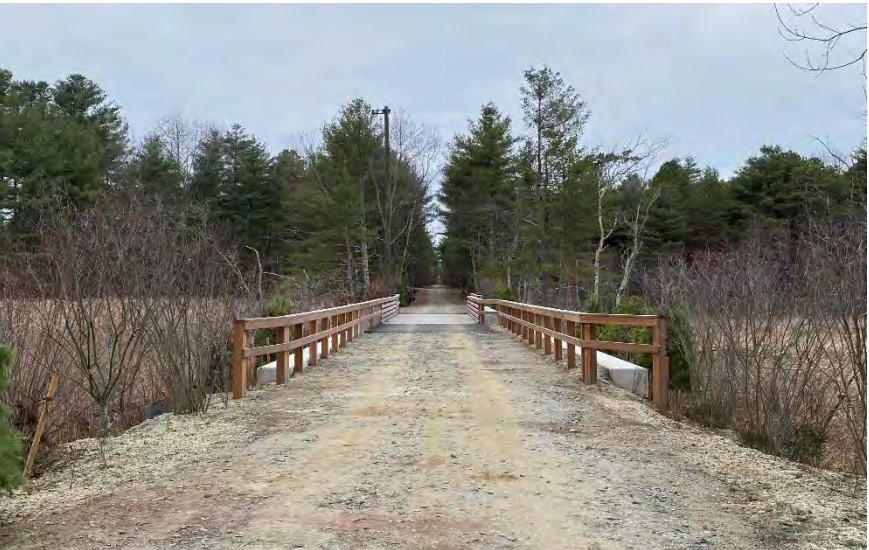
<p>Description:</p> <p>Work area within segments 8/7, Bridge 128, Osprey platform (left background), existing erosion control, looking westward.</p>

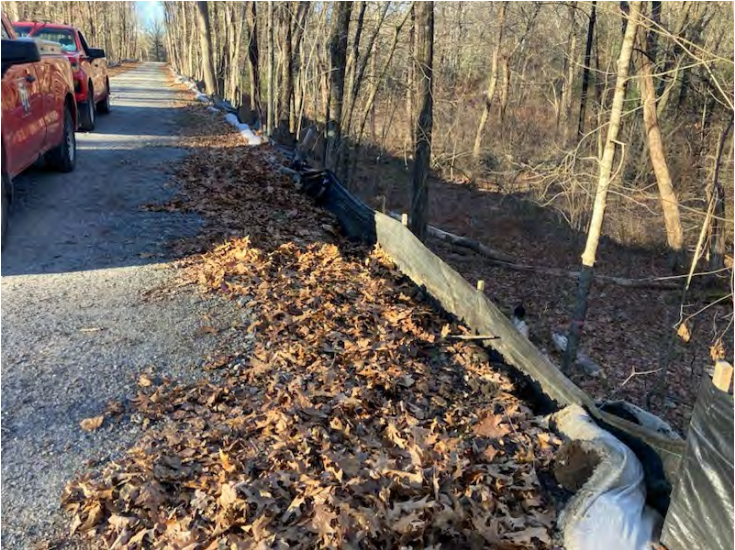
<p>Description:</p> <p>Segment 1, location of treefall, erosion controls repaired by ET&L, looking westward. Photo courtesy of Ariel Leclerc (SWCA).</p>

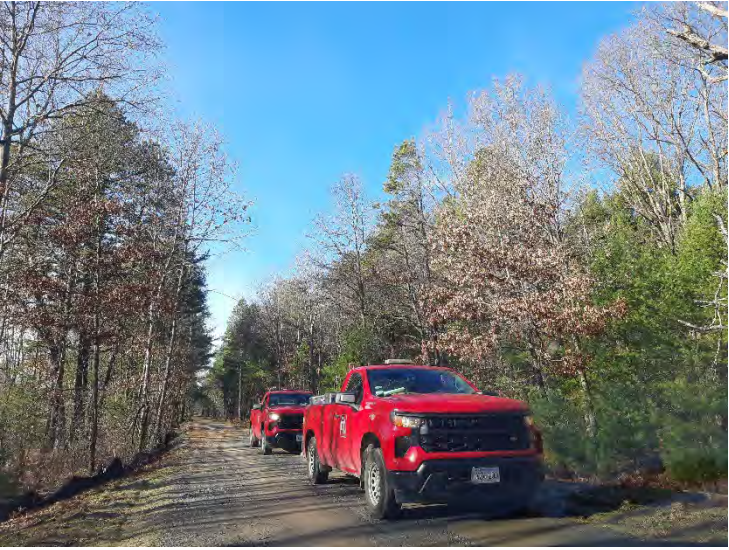
<p>Description:</p> <p>Segment 6, ET&L transiting through segment and conducting erosion control repairs, looking westward.</p>

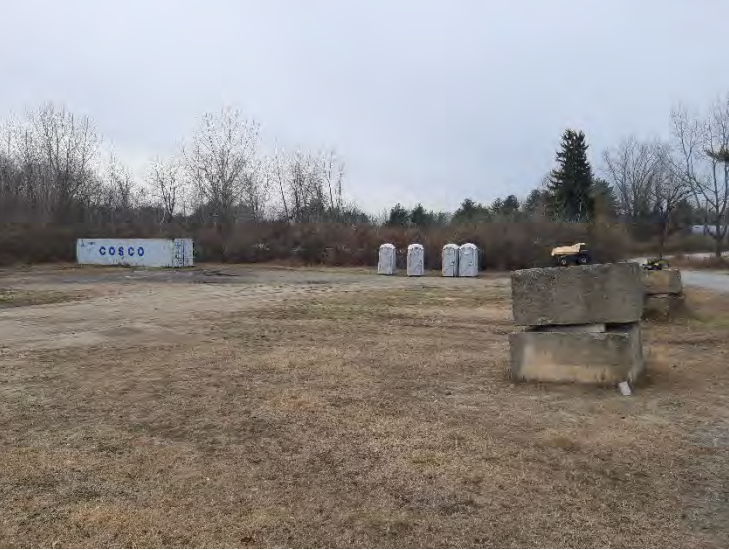
<p>Description:</p> <p>Former Haugland laydown yard, remaining sanitary facilities, no issues noted. Looking northward.</p>

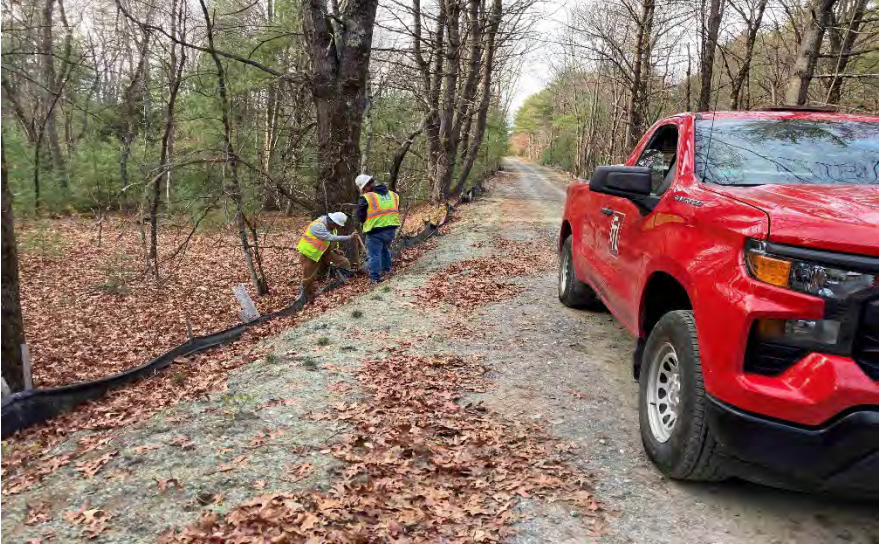
<p>Description:</p> <p>Work area within segment 7, ET&L repairing erosion controls, existing erosion control, looking westward. Photo courtesy of Ariel Leclerc (SWCA).</p>

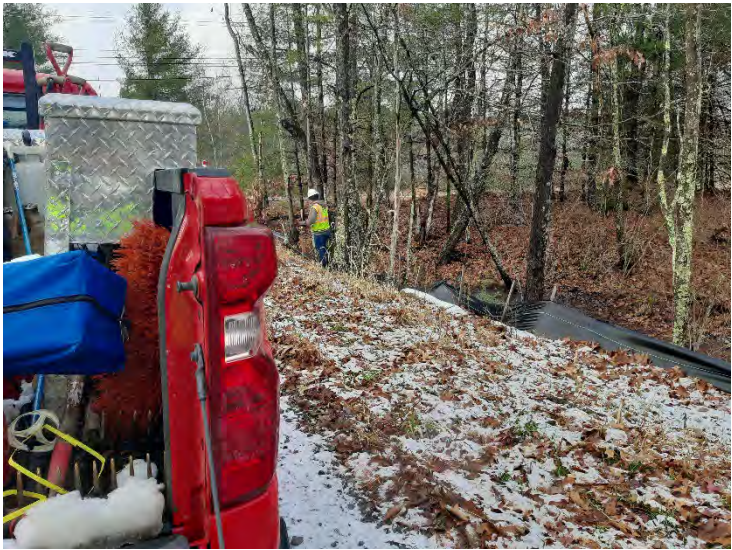
<p>Description:</p> <p>Segment 2, ET&L conducting erosion control repairs, looking westward.</p>

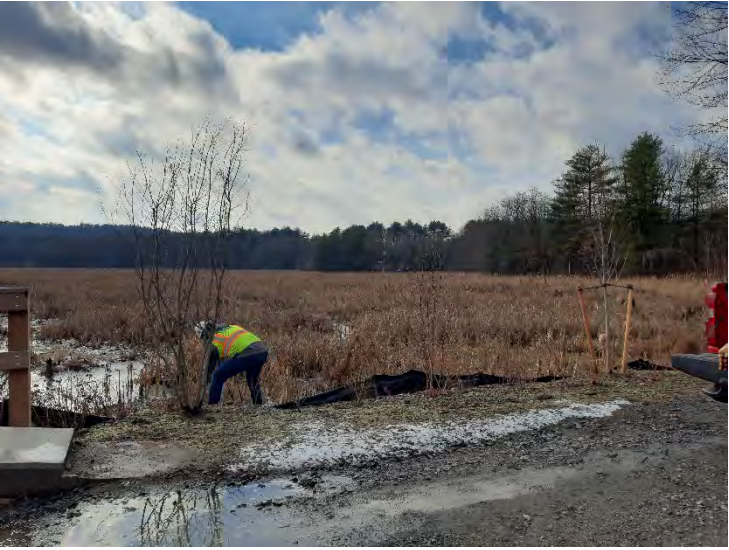
<p>Description: Bridge 130, ET&L conducting erosion control repairs, looking southward.</p>

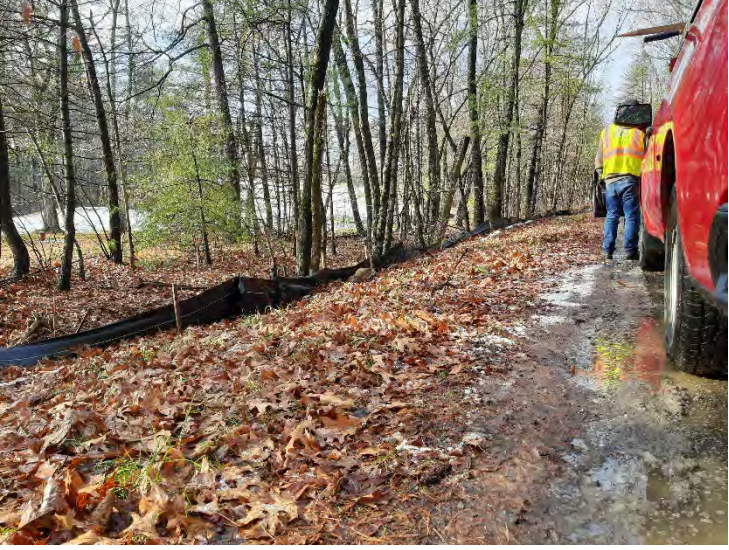
<p>Description: Segment 4, ET&L conducting erosion control repairs, looking westward.</p>

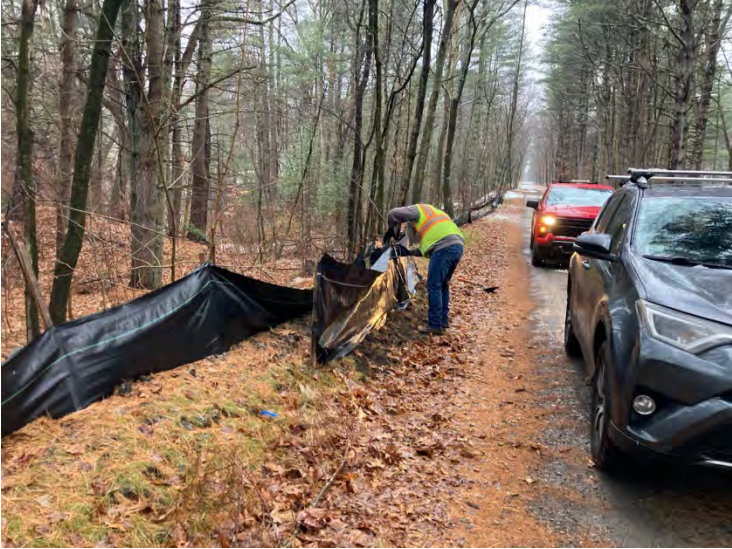
<p>Description:</p> <p>Segment 9, ET&L conducting erosion control repairs, looking westward. Photo courtesy of Ariel Leclerc (SWCA).</p>

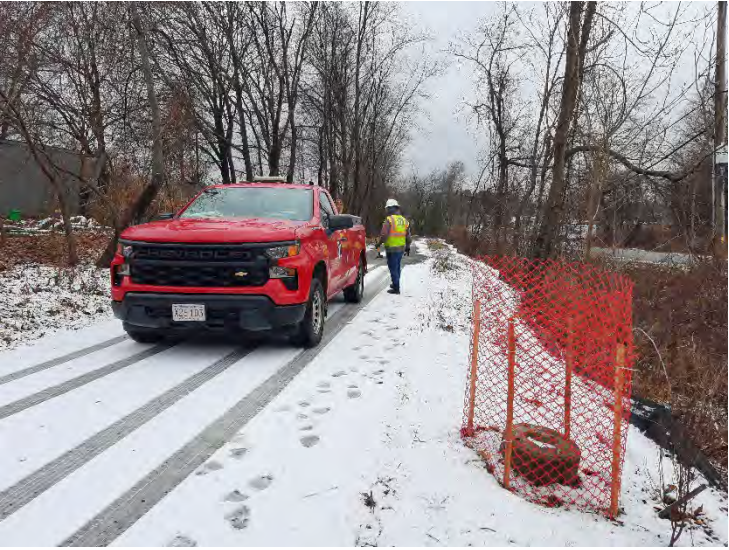
<p>Description:</p> <p>Segment 12, ET&L transiting through segment and conducting erosion control repairs, looking westward.</p>

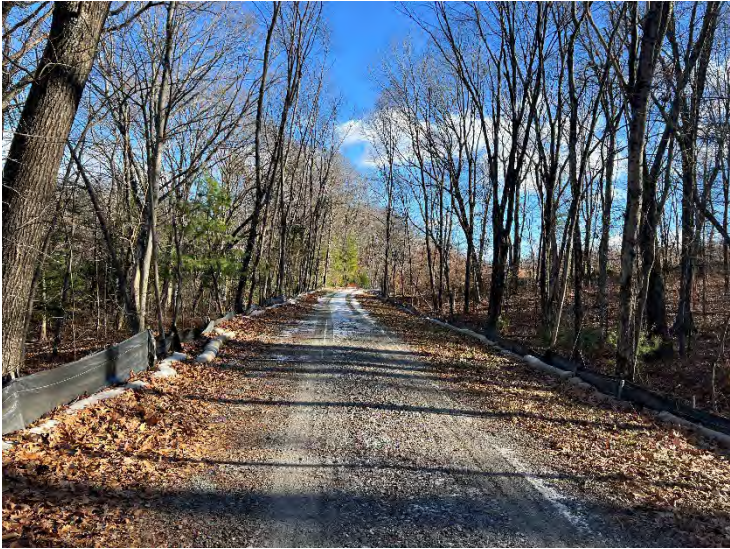
Description: View of E&S controls in segment 1. Facing east.

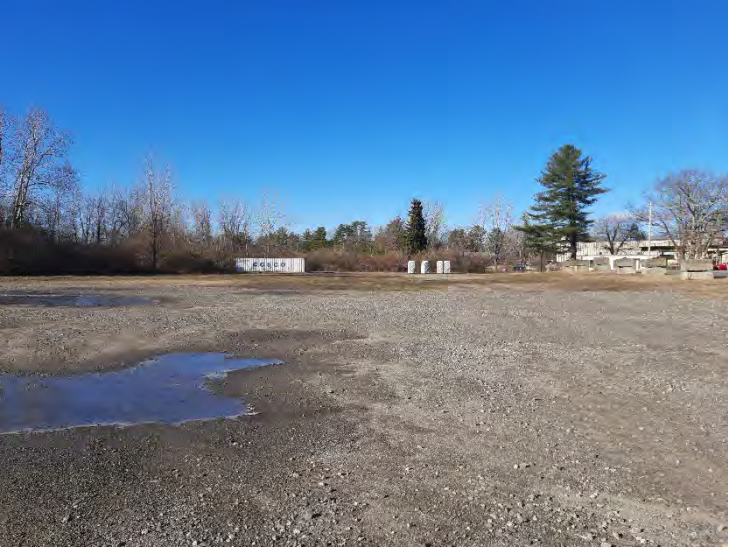
Description: Haugland laydown yard, yard following de-mobilization by Haugland, remaining sanitary facilities, looking northward.

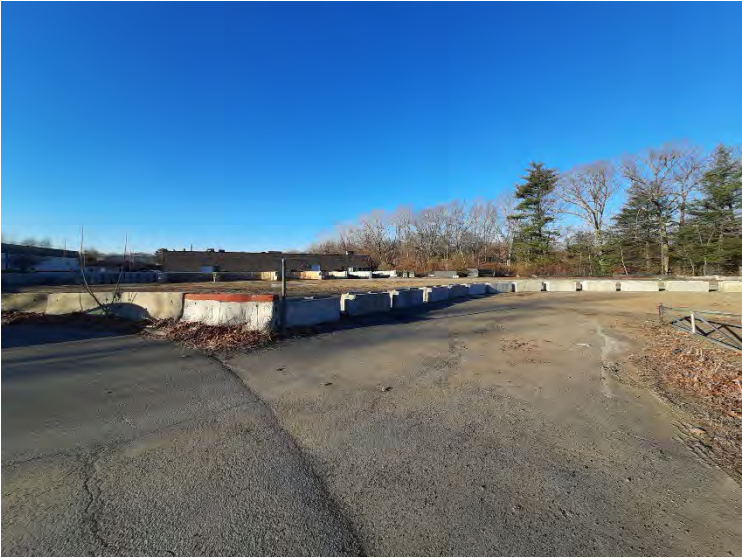
Description: Bonazzoli laydown yard, Bond material removed and area barricaded off, existing silt fence visible in back right, looking westward.

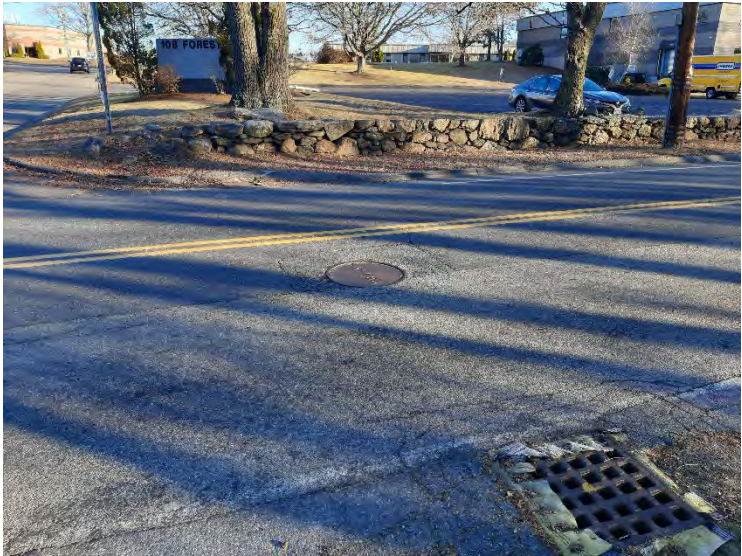
Description: Forest Ave between manholes #1 and #2 (MH1, MH2), adjacent to Bonazzoli Ave, remaining silt sack pair pending removal. Silt sacks present on north and south shoulders. Looking northward.

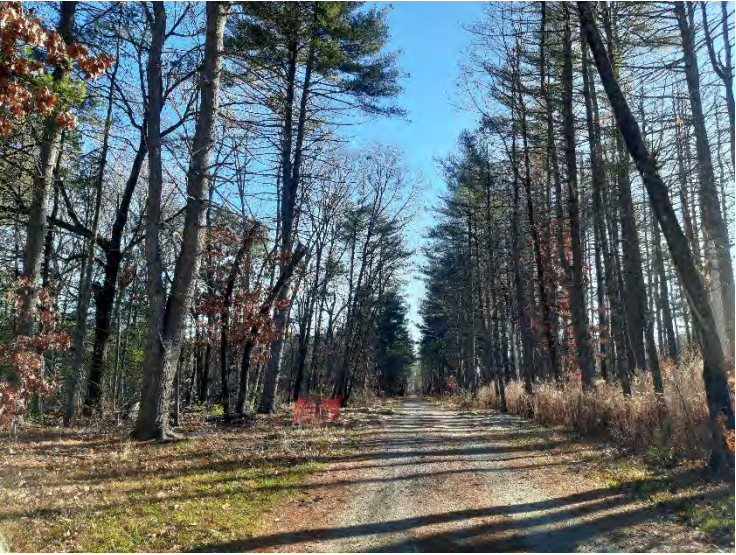
Description: Segment 4 near MH10, marked erosion controls removed previous week, no work today, looking eastward.

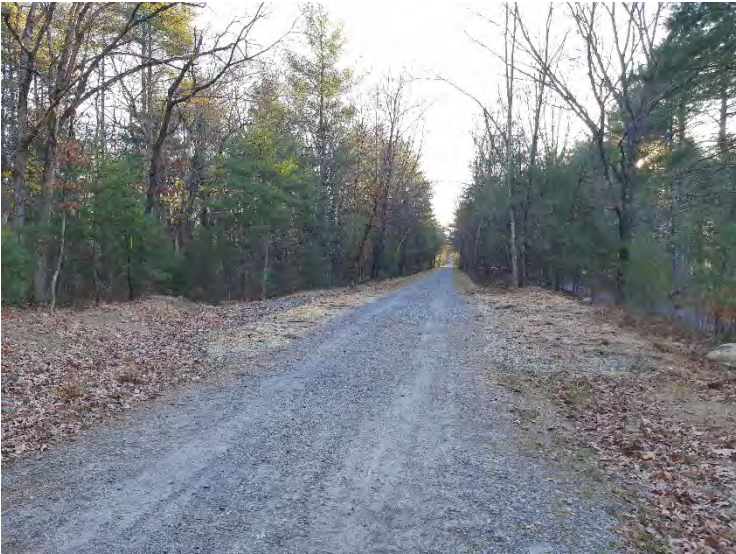
Description: Segment 5, MH 12, marked erosion controls removed previous week, looking eastward.

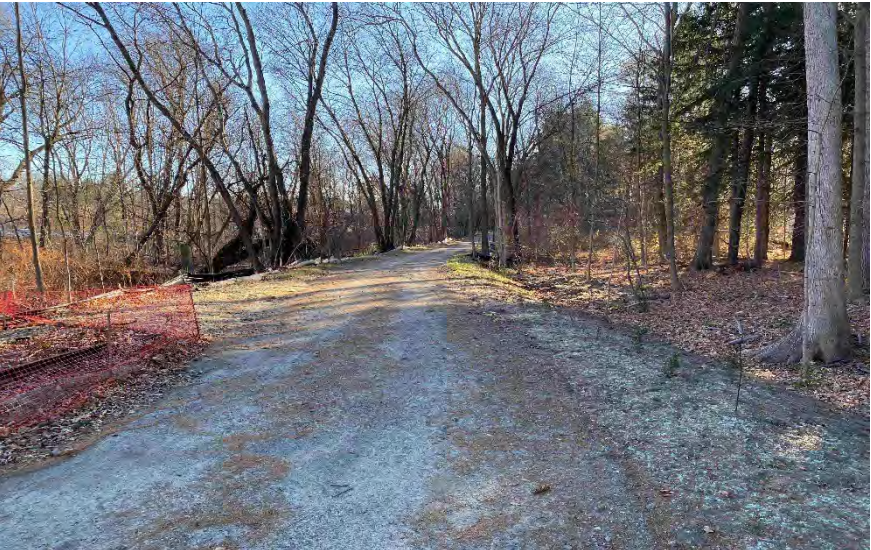
Description: Work area within segment 13, area of recently removed erosion control (right side), existing erosion control, looking eastward.

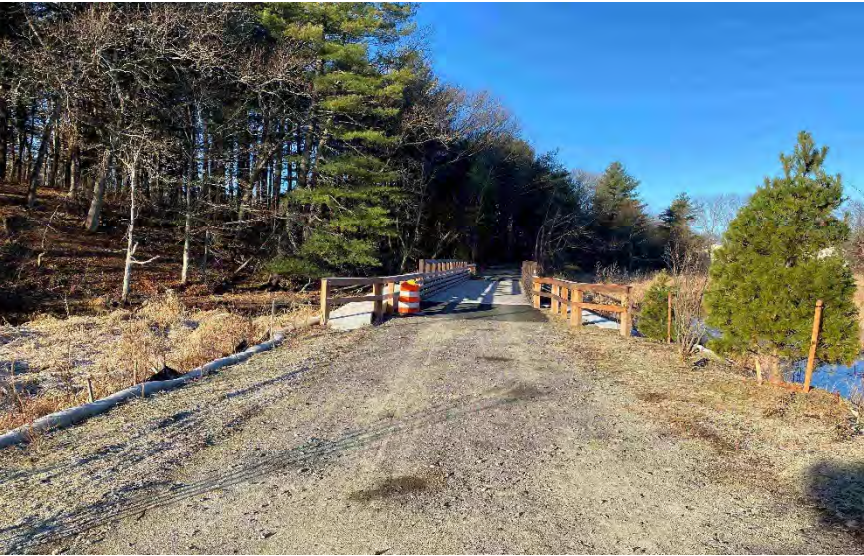
Description: Work area within Segment 14, Bridge 127, floating silt curtain recently removed and replaced with compost filter tubing, existing erosion control, looking westward.
